# Accessibility Survey

# City of Downey Neo Street - Old River School Drive To End

Date of Inspection 4/24/2017

Prepared By Disability Access Consultants (800) 743-7067

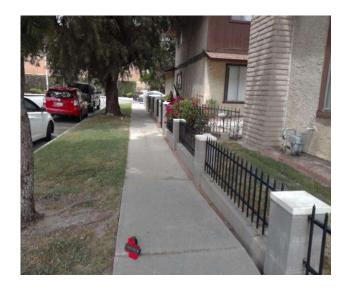
#### Change In Level West Of Haro Avenue @ 33.946158006182, -118.152945935726

Sidewalks, Change in Level : Change in Level Non Beveled

There is a change in elevation greater than recommended value.

**On-Site Finding** 1.25 inches

Ensure that the change in elevation is within the recommended value.

Recommendation Up to 0.25 inches

Remove tripping hazards \$198

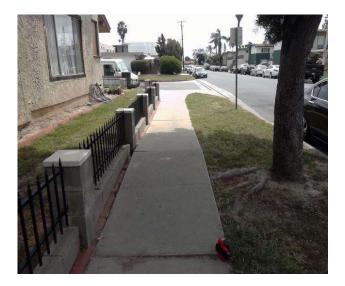
#### Change In Level West Of Haro Avenue @ 33.946165793894, -118.152970075607

Sidewalks , Change in Level : Change in Level Non Beveled

There is a change in elevation greater than recommended value.

**On-Site Finding** 1.00 inches

Ensure that the change in elevation is within the recommended value.

Recommendation Up to 0.25 inches

Remove tripping hazards \$198

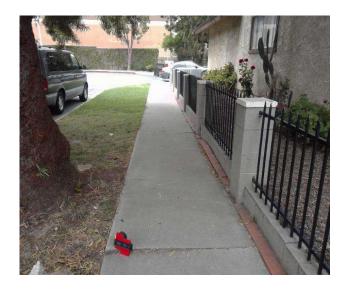
#### Change In Level West Of Haro Avenue @ 33.946192494613, -118.153038471937

Sidewalks , Change in Level : Change in Level Non Beveled

There is a change in elevation greater than recommended value.

**On-Site Finding** 1.12 inches

Ensure that the change in elevation is within the recommended value.

Recommendation Up to 0.25 inches

Remove tripping hazards \$198

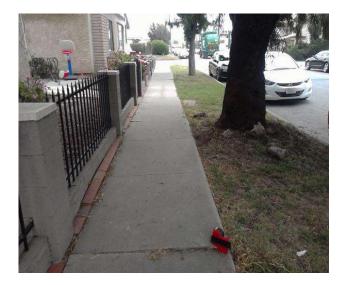
#### Change In Level West Of Haro Avenue @ 33.946225870501, -118.153093457222

Sidewalks , Change in Level : Change in Level Non Beveled

There is a change in elevation greater than recommended value.

**On-Site Finding** 1.12 inches

Ensure that the change in elevation is within the recommended value.

Recommendation Up to 0.25 inches

Remove tripping hazards \$198

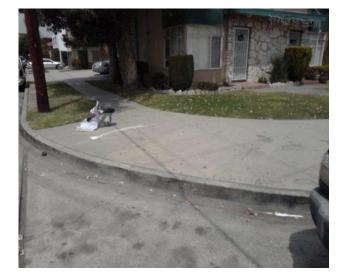
#### Curb Northwest Corner Of Adco Avenue @ 33.945530536800, -118.151811361313

Sidewalks , Hazards & Gratings : Curb is on Path of Travel

There is a curb on the designated path of travel.

**On-Site Finding** Not Compliant

Provide a compliant curb ramp.

RecommendationSee RecommendationCosting Info (Estimated)Install curb ramp\$2,500

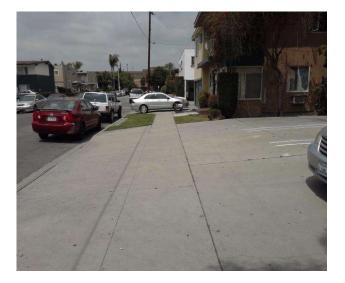
#### Driveway West Of Adco Avenue @ 33.945664041311, -118.152055442333

Sidewalks , Vehicular Traffic : Cross Walks and Detectable Warnings

There are no detectable warnings where the pedestrian route crosses vehicular traffic.

**On-Site Finding** Not Found

Provide detectable warnings.

RecommendationSee RecommendationCosting Info (Estimated)Install compliant detectable\$190

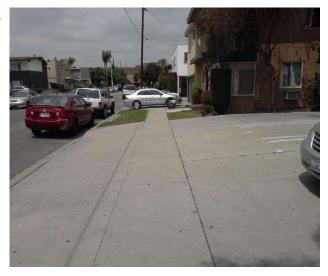
# Driveway West Of Adco Avenue @ 33.945664041311, -118.152055442333

Sidewalks : Vehicular Traffic Cross Slope

Cross slope at vehicular traffic is not compliant.

On-Site Finding 3.30 percent

Repave the surface to provide a compliant cross slope.

Recommendation Up to 2.08 percent

Repave surface \$1,092

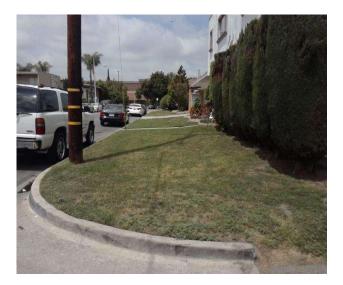
## Sidewalk West Of Adco Avenue @ 33.945780857587, -118.152290135622

Sidewalks : Missing Sidewalk

Section of sidewalk is missing and consists of dirt, grass or gravel.

**On-Site Finding** 147.00 feet

Provide a compliant sidewalk for the missing section.

\$1,260

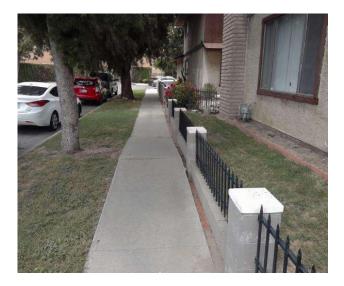
#### Sidewalk West Of Haro Avenue @ 33.946131305452, -118.152912408113

Sidewalks , Surface : Cross Slope

Sidewalk cross slope is not compliant.

**On-Site Finding** 4.40 percent for 8.00 feet

Repave the sidewalk surface with the recommended cross slope.

Recommendation Up to 2.08 percent

Repave surface \$1,092

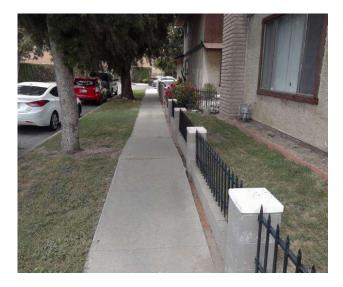
#### Sidewalk West Of Haro Avenue @ 33.946131305452, -118.152912408113

Sidewalks , Surface : Running Slope

Sidewalk running slope is not compliant.

**On-Site Finding** 6.70 percent for 20.00 feet

Repave the sidewalk surface with the recommended running slope.

Recommendation Up to 5.00 percent

Repave surface \$1,184

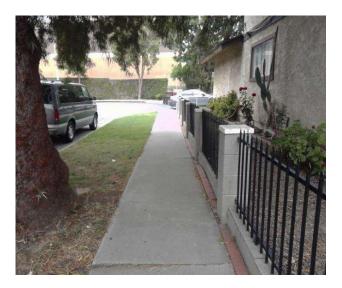
#### Sidewalk West Of Haro Avenue @ 33.946192494613, -118.153038471937

Sidewalks , Surface : Cross Slope

Sidewalk cross slope is not compliant.

**On-Site Finding** 3.80 percent for 12.00 feet

Repave the sidewalk surface with the recommended cross slope.

Recommendation Up to 2.08 percent

Repave surface \$1,092

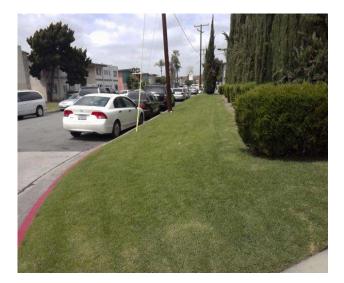
Sidewalk West Of Old River School Drive @ 33.944994291571, -118.150820285082

Sidewalks : Missing Sidewalk

Section of sidewalk is missing and consists of dirt, grass or gravel.

**On-Site Finding** 140.00 feet

Provide a compliant sidewalk for the missing section.

\$1,260

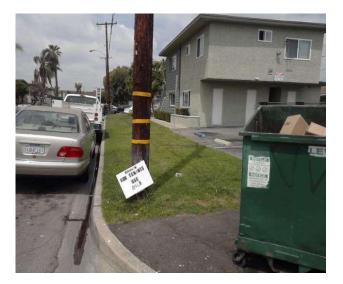
Sidewalk West Of Old River School Drive @ 33.945231263427, -118.151260167360

Sidewalks : Missing Sidewalk

Section of sidewalk is missing and consists of dirt, grass or gravel.

**On-Site Finding** 140.00 feet

Provide a compliant sidewalk for the missing section.

\$1,260

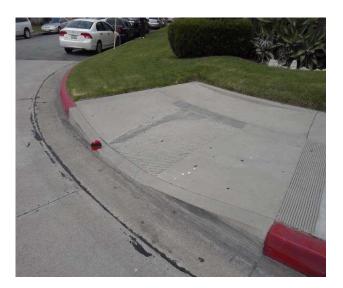
# Northeast Corner Of Old River School Drive @ 33.944995404116, - 118.150767982006

Curb Ramp : No Detectable Warnings

The curb ramp does not provide a detectable warning surface which includes truncated domes.

**On-Site Finding** Not Found

Provide compliant detectable warnings to surface.

Provide detectable warning to \$248 surface

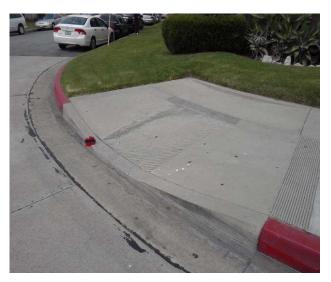
# Northeast Corner Of Old River School Drive @ 33.944995404116, - 118.150767982006

Curb Ramp : Side Flare Slope

The slope of the curb ramp side flare is greater than allowed.

On-Site Finding 11.30 percent

Provide curb ramp side flares with a compliant slope.

Recommendation Up to 10.00 percent

Install flared sides \$1,300

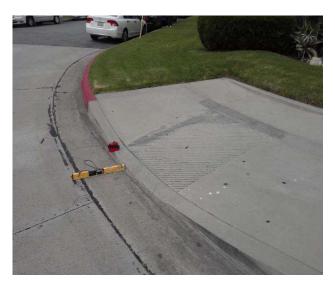
# Northeast Corner Of Old River School Drive @ 33.944995404116, - 118.150767982006

The bottom landing of the curb ramp is on the street, and the slope of the bottom landing is not compliant.

**On-Site Finding** 9.40 percent

Curb Ramp : Bottom Landing Slope

Ensure the bottom landing slope is compliant and provides a smooth transition.

Recommendation Up to 5.00 percent

Repave landing \$1,260

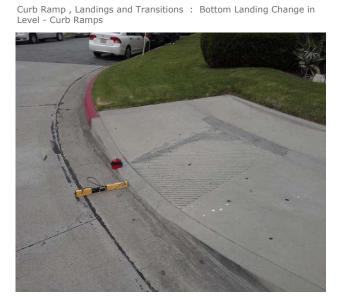
# Northeast Corner Of Old River School Drive @ 33.944995404116, - 118.150767982006

The transition from the bottom of the curb ramp to the walk, gutter, or street is abrupt.

**On-Site Finding** Not Beveled

Patch the transition area at the bottom of the curb ramp so that the transition is flush and free of abrupt changes.

Patch lip at curb ramp \$255

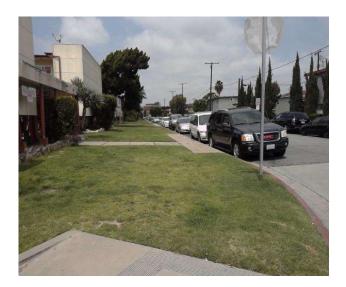
# South Side @ 33.944869686386, -118.150912821293

**On-Site Finding** Not Found

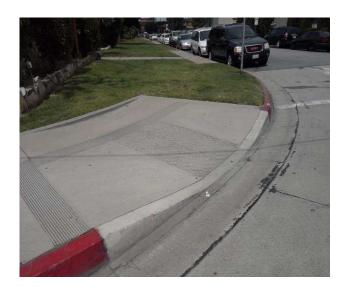
**On-Site Finding** Not Found

Provide detectable warning to \$248 surface

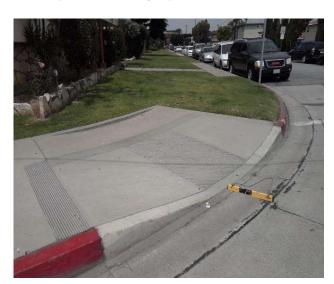
Curb Ramp : Bottom Landing Slope

Recommendation Up to 5.00 percent

Repave landing \$1,260

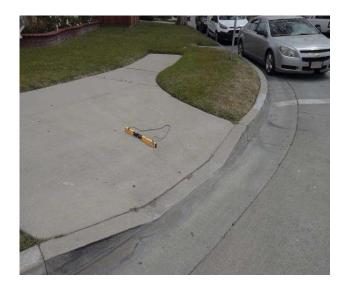
**On-Site Finding** Not Found

Provide detectable warning to \$248 surface

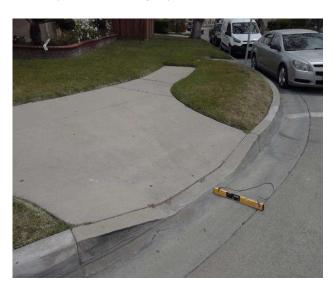
Curb Ramp : Bottom Landing Slope

Recommendation Up to 5.00 percent

Repave landing \$1,260

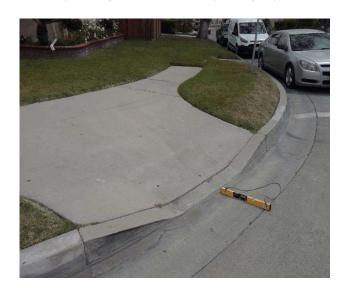
Curb Ramp, Landings and Transitions : Top Landing Slope

Recommendation Up to 2.08 percent

Provide compliant landing \$1,260

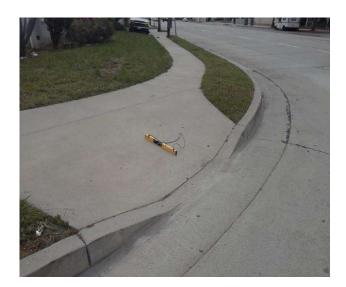
**On-Site Finding** Not Found

Provide detectable warning to \$248 surface

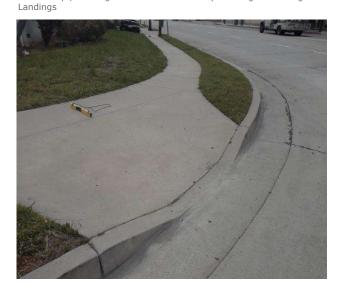
Curb Ramp, Landings and Transitions : Top Landing Clear Length -

Recommendation At least 48.00 inches

Provide compliant landing \$240

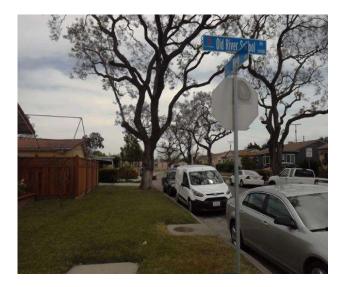
**On-Site Finding** Not Found

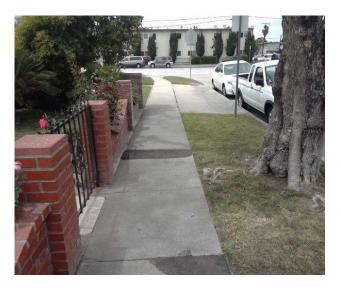
Notes : Surface is rough and uneven for 2 feet.

Repave the sidewalk surface with the recommended cross slope.

Recommendation Up to 2.08 percent

Repave surface \$1,092

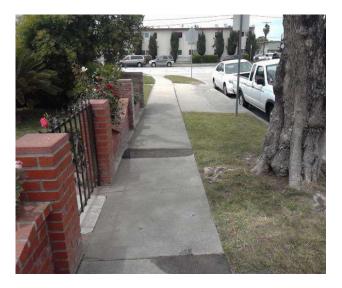
Notes : Surface is rough and uneven for 2 feet.

Repave the sidewalk surface with the recommended running slope.

Recommendation Up to 5.00 percent

Repave surface \$1,184

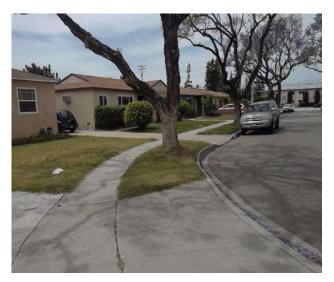
**On-Site Finding** Not Found

\$2,400
