## Accessibility Survey

### City of Downey Byers Street - Brookshire Avenue to Cul-De-Sac - East

Date of Inspection  
8/25/2017

**Disability Access Consultants**

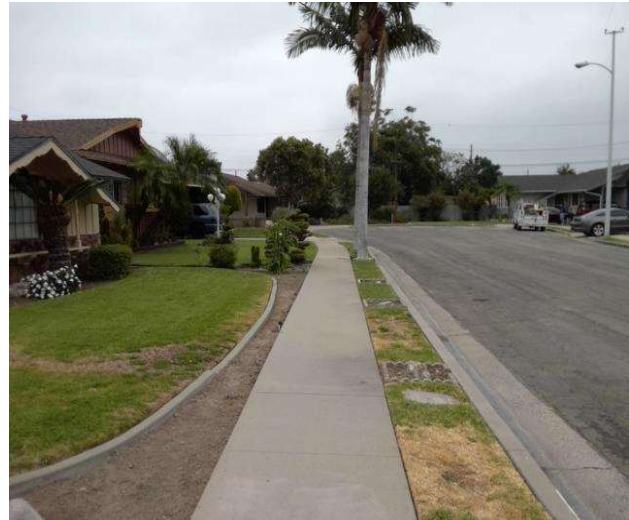
**Sidewalk East of Brookshire Avenue @ 33.928713969702, -118.136262595654**

Sidewalk cross slope is not compliant.

**On-Site Finding** 3.00 percent for 196.00 feet

**Code Reference** ADA 206, 302,CA 11B-403.3

Repave the sidewalk surface with the recommended cross slope.

Recommendation Up to 2.08 percent

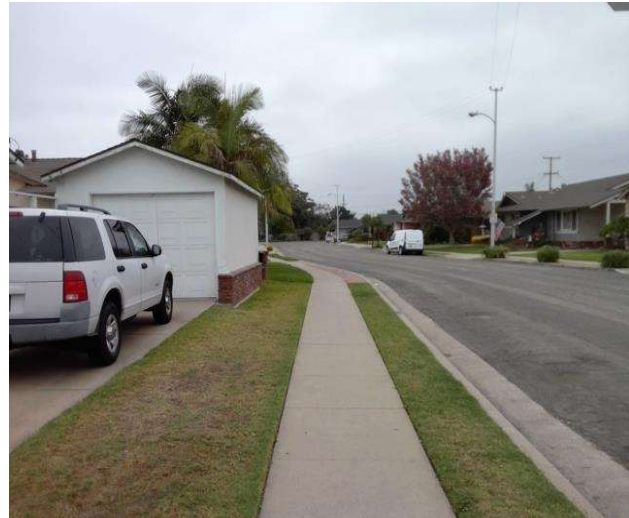
**North Side @ 33.928848613340, -118.136563003063**

There is no 60X60 turn area at every 200 feet.

**On-Site Finding** Not Found

Provide a 60X60 turn every 200 feet on the sidewalk.

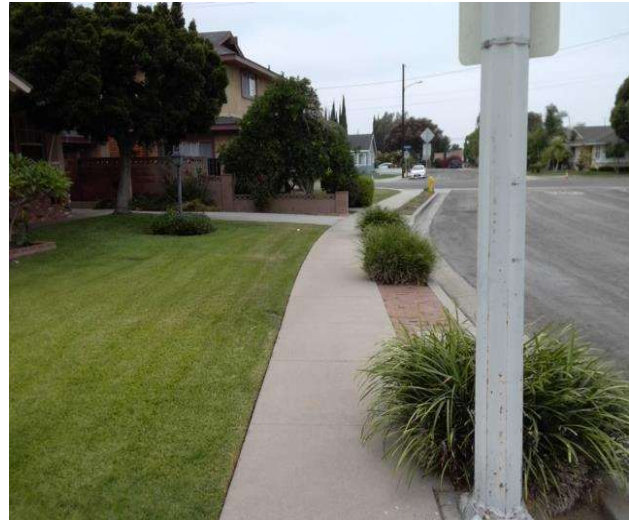
**Bush West of Cul-De-Sac @ 33.928604919327, -118.136324286461**

Sidewalk width at the obstruction is not compliant.

**On-Site Finding** 40.00 inches

**Code Reference** ADA 206, 302, 403.5.1, CA 11B-403.5

Sidewalk width at the obstruction shall have the recommended value.

Recommendation At least 48.00 inches

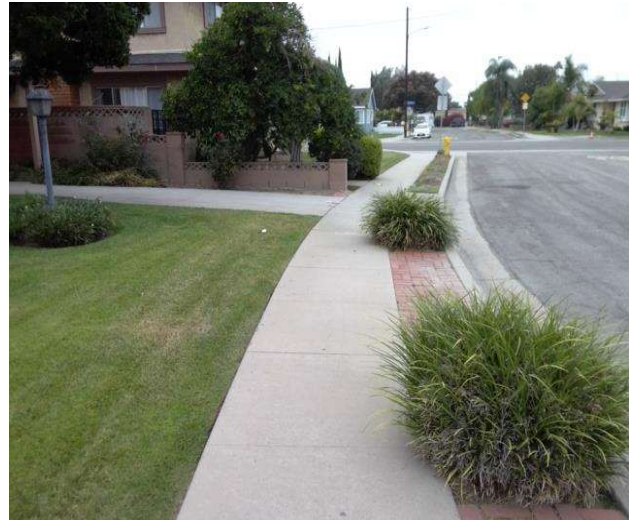
**Bush West of Cul-De-Sac @ 33.928618272442, -118.136383295059**

Sidewalk width at the obstruction is not compliant.

**On-Site Finding** 41.00 inches

**Code Reference** ADA 206, 302, 403.5.1, CA 11B-403.5

Sidewalk width at the obstruction shall have the recommended value.

Recommendation At least 48.00 inches

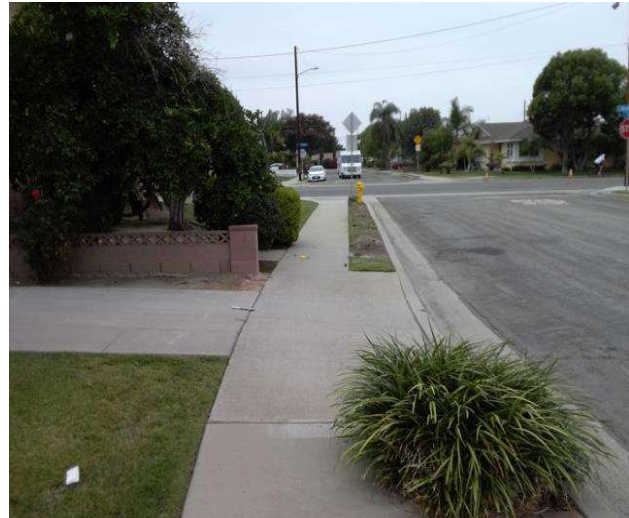
**Bush West of Cul-De-Sac @ 33.928642753146, -118.136439621449**

Sidewalk width at the obstruction is not compliant.

**On-Site Finding** 33.00 inches

**Code Reference** ADA 206, 302, 403.5.1, CA 11B-403.5

Sidewalk width at the obstruction shall have the recommended value.

Recommendation At least 48.00 inches

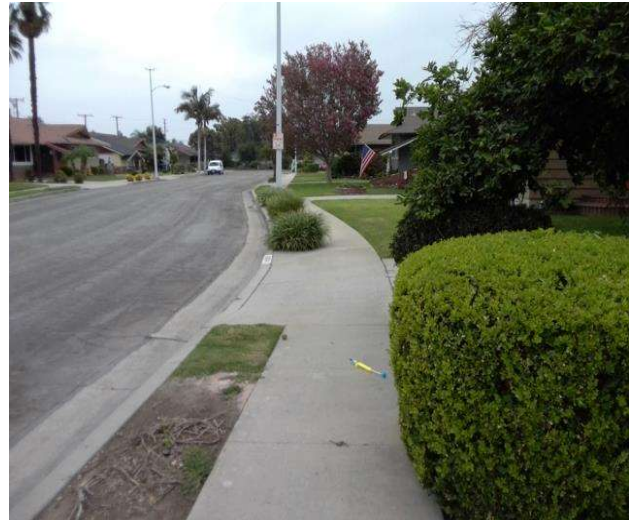
**Bush West of Cul-De-Sac @ 33.928670572120, -118.136522769928**

Sidewalk width at the obstruction is not compliant.

**On-Site Finding** 41.00 inches

**Code Reference** ADA 206, 302, 403.5.1,CA 11B-403.5

Sidewalk width at the obstruction shall have the recommended value.

Recommendation At least 48.00 inches

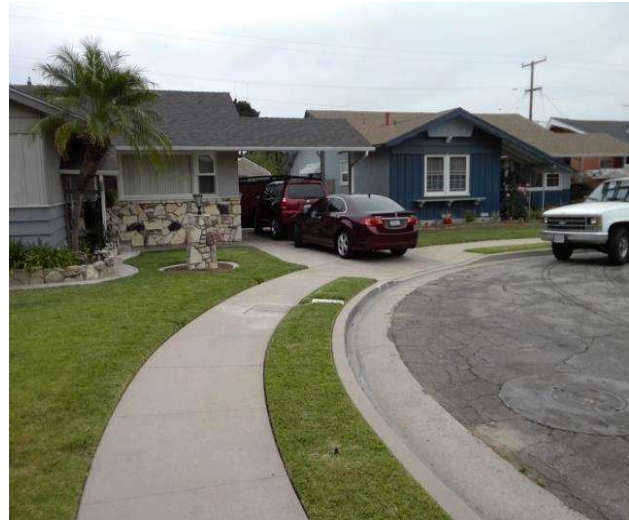
**Sidewalk West of Cul-De-Sac @ 33.928285556711, -118.135388195515**

Sidewalk cross slope is not compliant.

**On-Site Finding** 3.20 percent for 308.00 feet

**Code Reference** ADA 206, 302,CA 11B-403.3

Repave the sidewalk surface with the recommended cross slope.

Recommendation Up to 2.08 percent

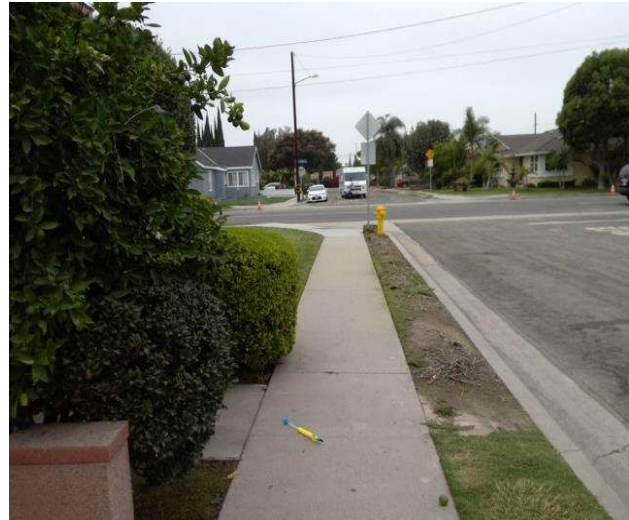
**Sidewalk West of Cul-De-Sac @ 33.928661670050, -118.136503994465**

Sidewalk cross slope is not compliant.

**On-Site Finding** 3.30 percent for 42.00 feet

**Code Reference** ADA 206, 302,CA 11B-403.3

Repave the sidewalk surface with the recommended cross slope.

Recommendation Up to 2.08 percent

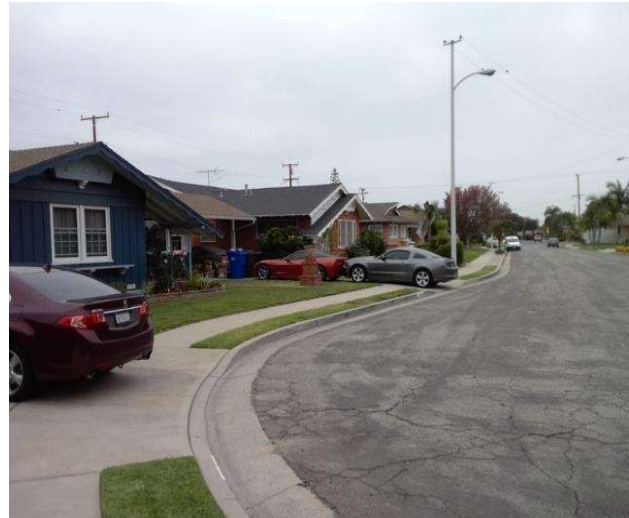
**South Side @ 33.928285556711, -118.135388195515**

There is no 60X60 turn area at every 200 feet.

**On-Site Finding** Not Found

Provide a 60X60 turn every 200 feet on the sidewalk.

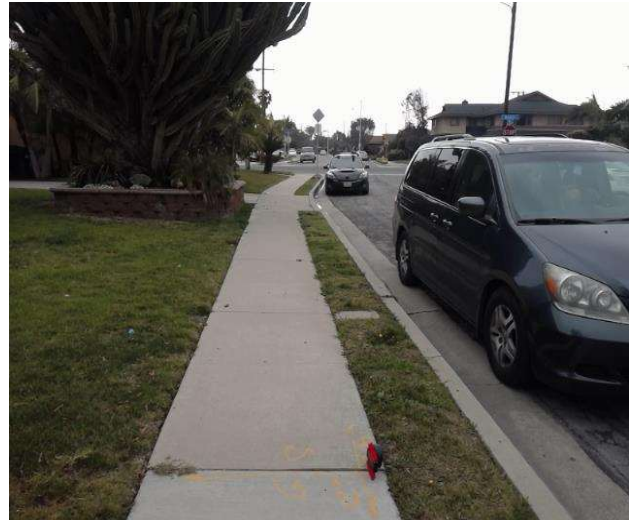
**Change In Level East Of Cul-de-sac @ 33.929101208681, -118.137165158987**

There is a change in elevation greater than recommended value.

**On-Site Finding** 0.62 inches

Ensure that the change in elevation is within the recommended value.

Recommendation Up to 0.25 inches

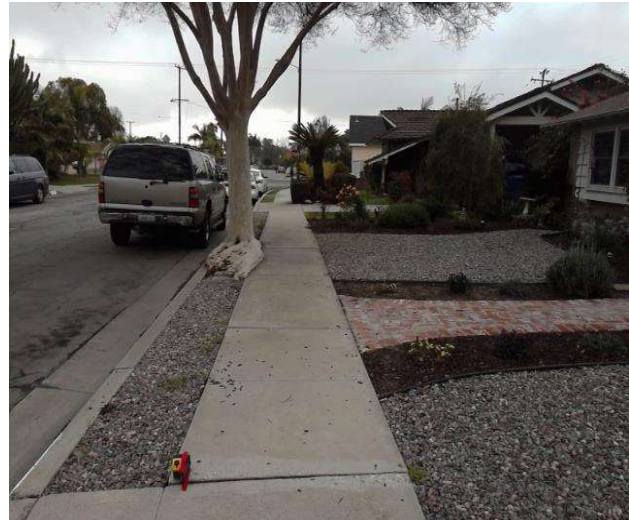
**Change In Level West Of Brookshire Avenue @ 33.929051134774, - 118.137385100126**

There is a change in elevation greater than recommended value.

**On-Site Finding** 0.50 inches

Ensure that the change in elevation is within the recommended value.

Recommendation Up to 0.25 inches

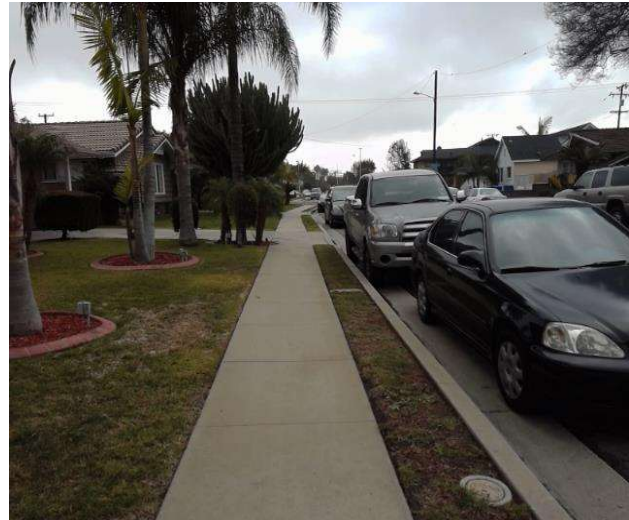
**Sidewalk East Of Cul-de-sac @ 33.929180214119, -118.137363642454**

Sidewalk does not have enough width.

**On-Site Finding** 47.50 inches

**Code Reference** ADA 206, 302, CA 11B-403.5.1

Widen the sidewalk to the recommended value.

Recommendation At least 48.00 inches

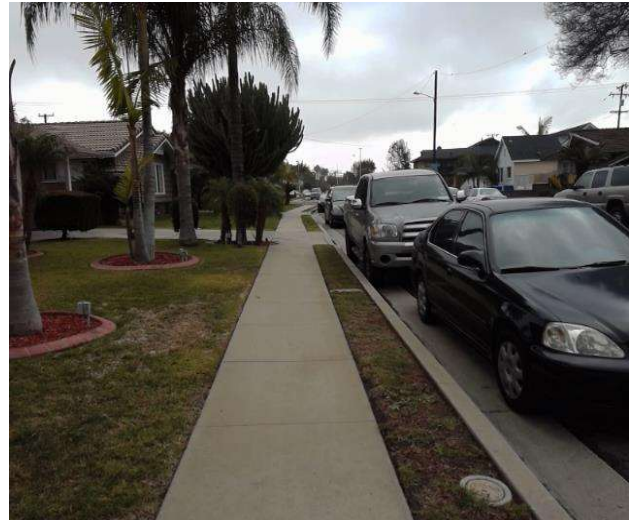
**Sidewalk East Of Cul-de-sac @ 33.929180214119, -118.137363642454**

Sidewalk cross slope is not compliant.

**On-Site Finding** 4.00 percent for 192.00 feet

**Code Reference** ADA 206, 302, CA 11B-403.3

Repave the sidewalk surface with the recommended cross slope.

Recommendation Up to 2.08 percent

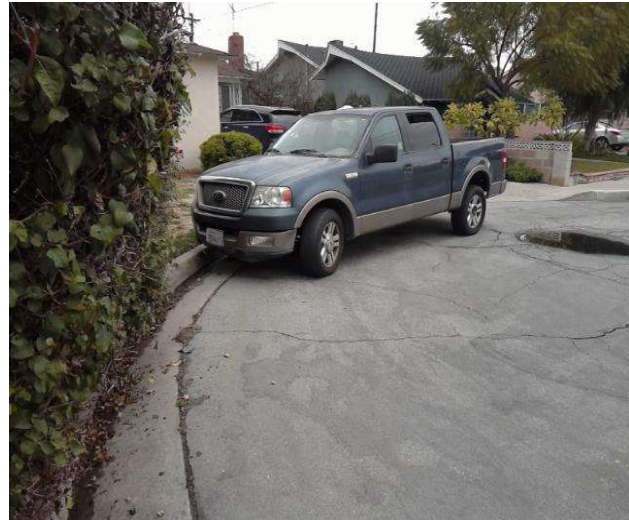
**Sidewalk East Of Cul-de-sac @ 33.929281474502, -118.137692213058**

Section of sidewalk is missing and consists of dirt, grass or gravel.

**On-Site Finding** 38.00 feet

Provide a compliant sidewalk for the missing section.

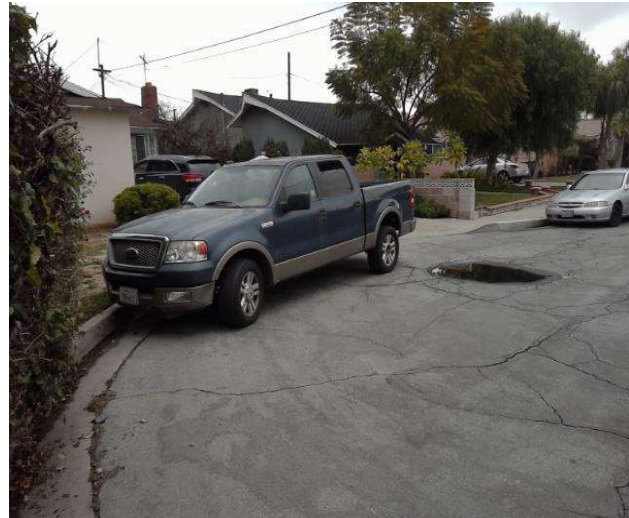
**North Side @ 33.929281474502, -118.137692213058**

There is no 60X60 turn area at every 200 feet.

**On-Site Finding** Not Found

Provide a 60X60 turn every 200 feet on the sidewalk.

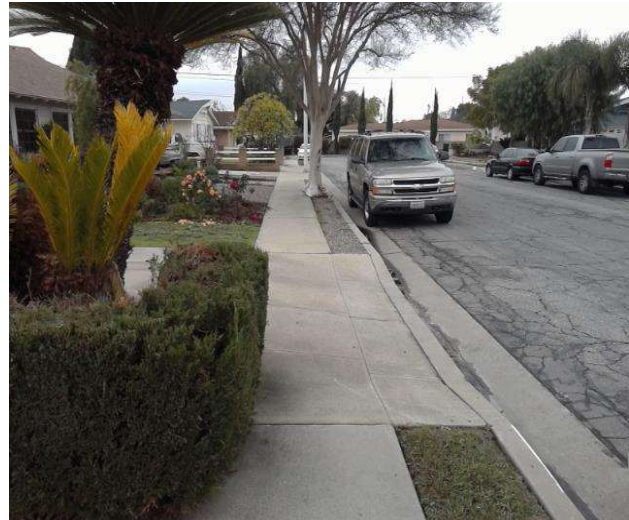
**Bush West Of Brookshire Avenue @ 33.928968790953, -118.13718527555**

Sidewalk width at the obstruction is not compliant.

**On-Site Finding** 33.00 inches

**Code Reference** ADA 206, 302, 403.5.1, CA 11B-403.5

Sidewalk width at the obstruction shall have the recommended value.

Recommendation At least 48.00 inches

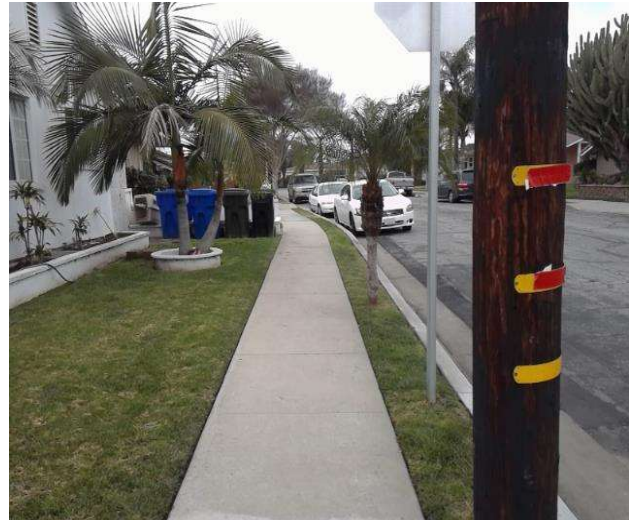
**Sidewalk West Of Brookshire Avenue @ 33.928846387827, -118.136937171221**

Sidewalk does not have enough width.

**On-Site Finding** 47.50 inches for 82.00 feet

**Code Reference** ADA 206, 302,CA 11B-403.5.1

Widen the sidewalk to the recommended value.

Recommendation At least 48.00 inches

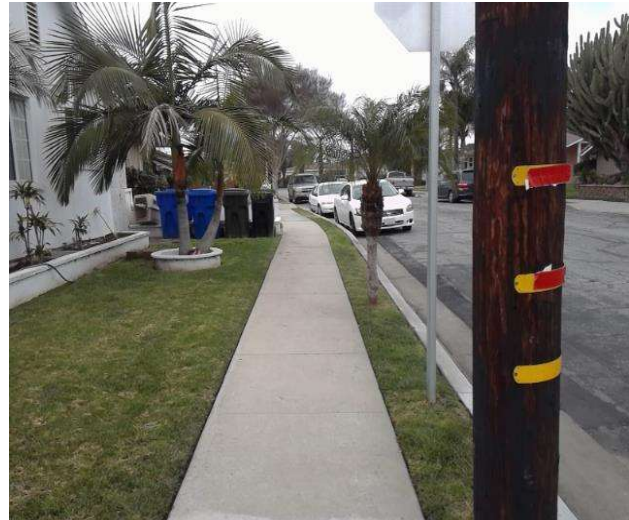
**Sidewalk West Of Brookshire Avenue @ 33.928846387827, -118.136937171221**

Sidewalk cross slope is not compliant.

**On-Site Finding** 4.30 percent for 82.00 feet

**Code Reference** ADA 206, 302,CA 11B-403.3

Repave the sidewalk surface with the recommended cross slope.

Recommendation Up to 2.08 percent

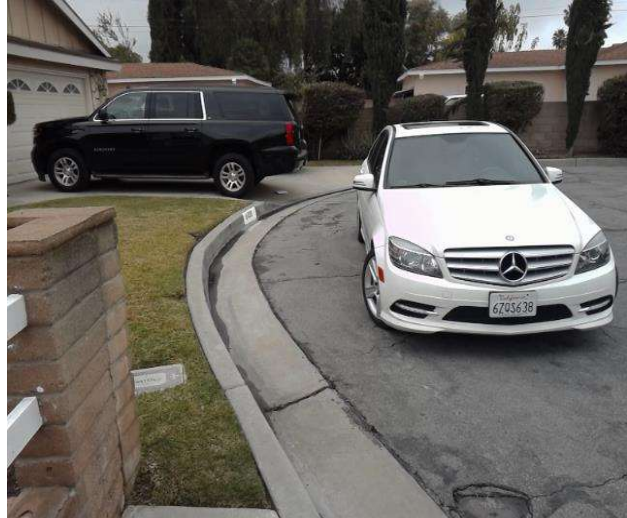
#### Sidewalk West Of Brookshire Avenue @ 33.929149057054, -118.137625157833

Section of sidewalk is missing and consists of dirt, grass or gravel.

**On-Site Finding** 32.00 feet

Provide a compliant sidewalk for the missing section.

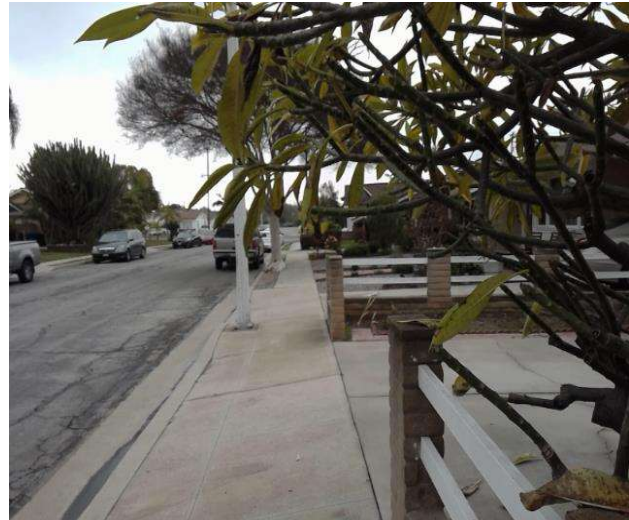
**Tree West Of Brookshire Avenue @ 33.929101208681, -118.137517869473**

Overhead obstruction height is not compliant.

**On-Site Finding** 62.50 inches

**Code Reference** ADA 206, 307.4,CA 11B-307.4

Provide a compliant vertical clearance height.

Recommendation At least 80.00 inches

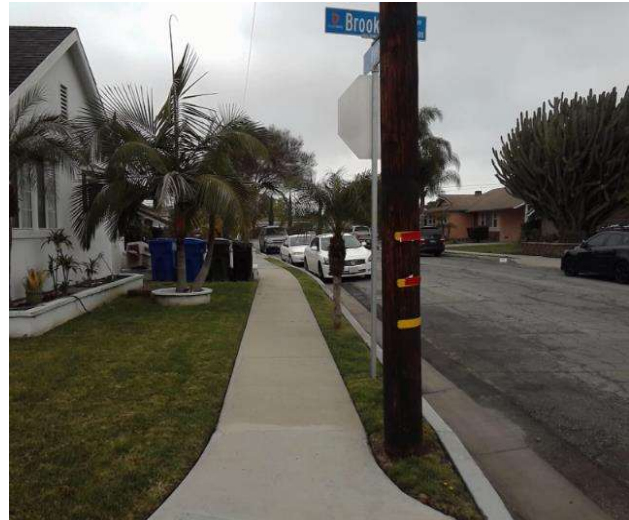
**South Side @ 33.928846387827, -118.136937171221**

There is no 60X60 turn area at every 200 feet.

**On-Site Finding** Not Found

Provide a 60X60 turn every 200 feet on the sidewalk.
