Accessibility Survey

City of Downey Dinsdale Street - Downey Avenue to End

Date of Inspection
7/12/2017

Prepared By
Disability Access Consultants
(800) 743-7067

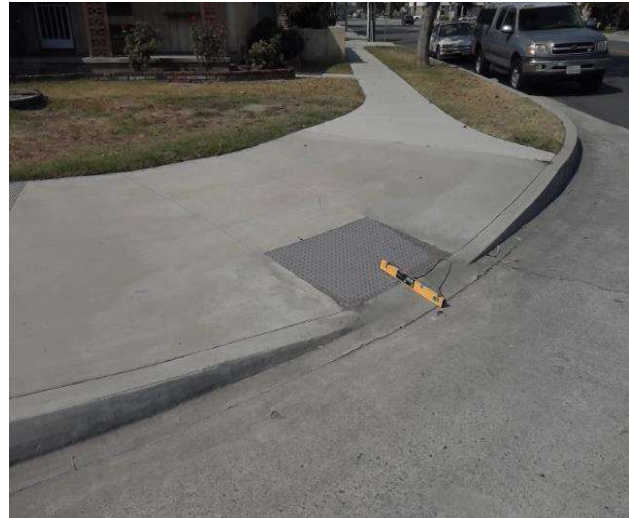
Southeast Corner of Downey Avenue @ 33.952286714743, - 118.124973177910

Curb Ramp : Curb Ramp Slope

The running slope is greater than allowed.

On-Site Finding 13.50 percent

Code Reference ADA 406, 406.1, 405.2, CA 11B-406

Provide a compliant curb ramp.

Recommendation Up to 8.33 percent

Install curb ramp \$1,300

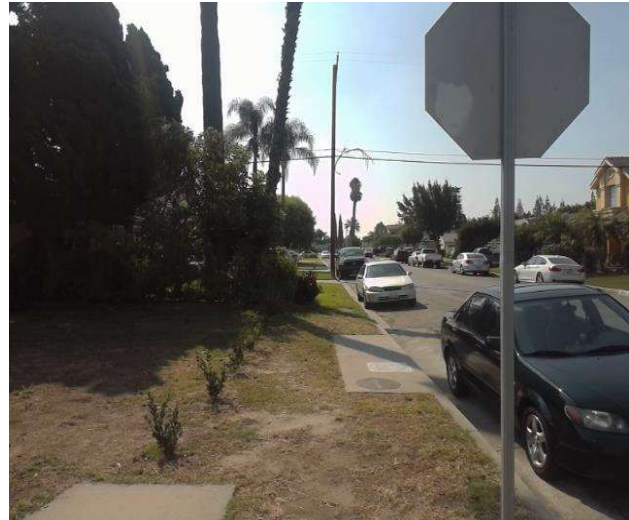
North Side @ 33.952389060095, -118.124820291996

Sidewalks : No Sidewalk

No sidewalk exists at the location.

No action necessary until a sidewalk is provided.

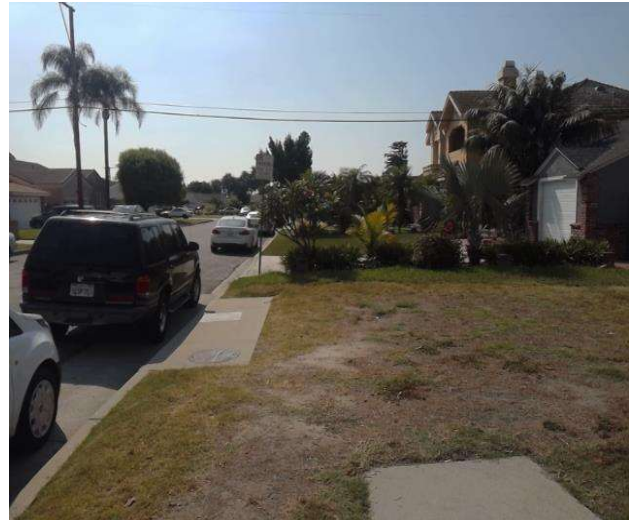
South Side @ 33.952257791034, -118.124916851521

Sidewalks : No Sidewalk

No sidewalk exists at the location.

No action necessary until a sidewalk is provided.

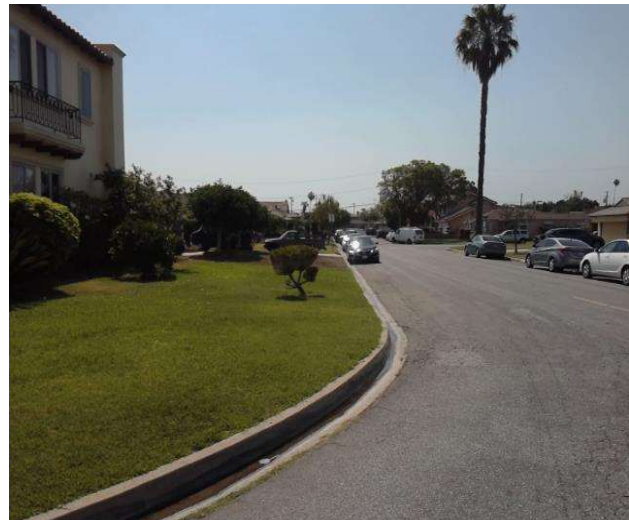
North Side @ 33.953768485444, -118.127816319466

Sidewalks : No Sidewalk

No sidewalk exists at the location.

No action necessary until a sidewalk is provided.

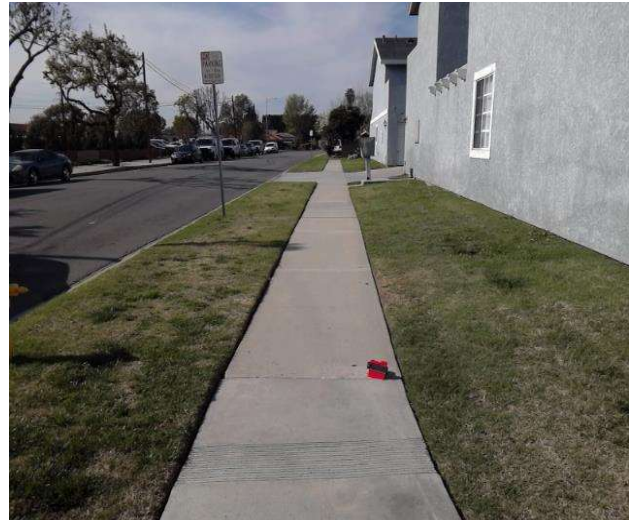
Change In Level West Of Tweedy Lane @ 33.955325874285, -118.131189197302

Sidewalks , Change in Level : Change in Level Non Beveled

There is a change in elevation greater than recommended value.

On-Site Finding 0.50 inches

Code Reference ADA 206, 302

Ensure that the change in elevation is within the recommended value.

Recommendation Up to 0.25 inches

Remove tripping hazards \$198

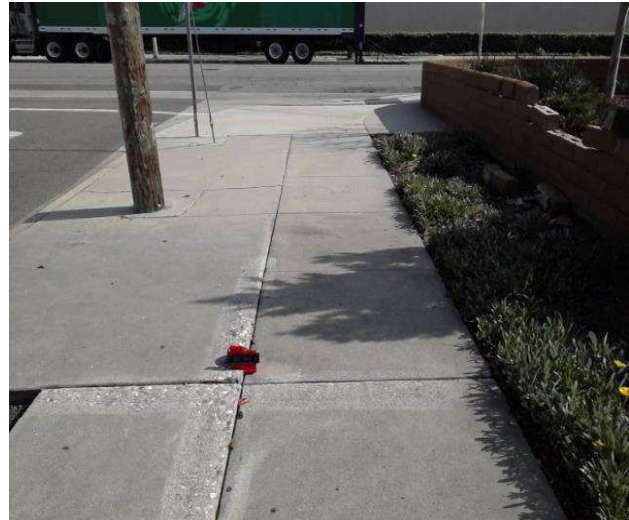
Change In Level East Of Smallwood Avenue @ 33.955219082818, - 118.131344765425

Sidewalks , Change in Level : Change in Level Non Beveled

There is a change in elevation greater than recommended value.

On-Site Finding 1.12 inches

Code Reference ADA 206, 302

Ensure that the change in elevation is within the recommended value.

Recommendation Up to 0.25 inches

Remove tripping hazards \$198

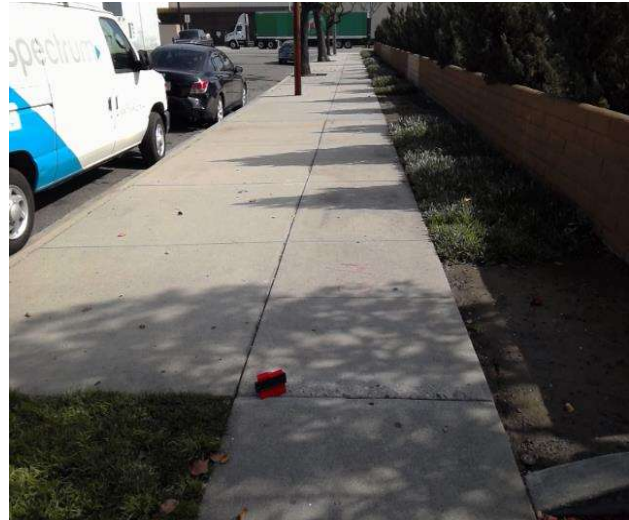
Change In Level East Of Smallwood Avenue @ 33.955463813065, - 118.131753802300

Sidewalks , Change in Level : Change in Level Non Beveled

There is a change in elevation greater than recommended value.

On-Site Finding 0.37 inches

Code Reference ADA 206, 302

Ensure that the change in elevation is within the recommended value.

Recommendation Up to 0.25 inches

Remove tripping hazards \$198

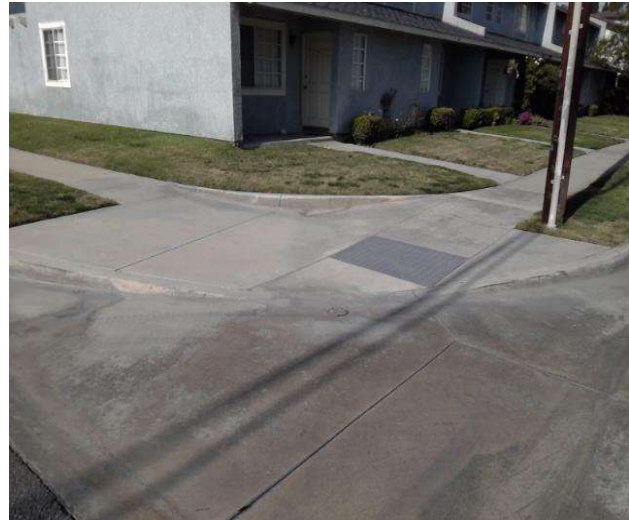
Northwest Corner Of Tweedy Lane @ 33.955321424643, - 118.131154328585

Curb Ramp : Detectable Warnings Width

Detectable warnings does not have same width as the curb ramp.

Code Reference CA 11B-406.5.12,CA 11B-705.1.2.2

Provide compliant detectable warnings that are full width of the curb ramp.

Install compliant detectable warnings \$190

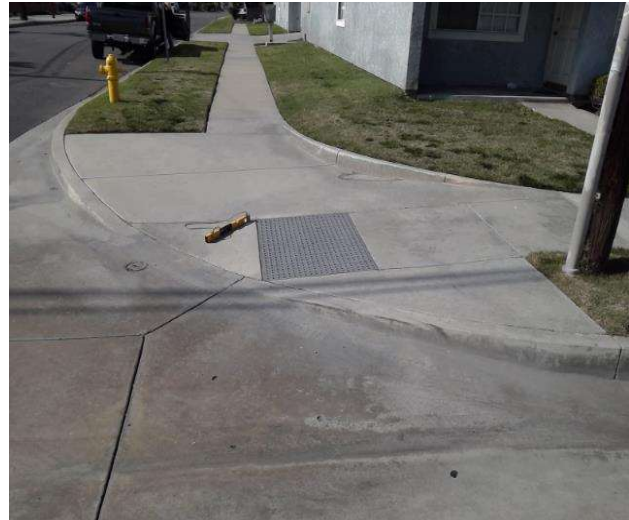
**Northwest Corner Of Tweedy Lane @ 33.955321424643, -
118.131154328585**

Curb Ramp , Landings and Transitions : Bottom Landing Slope

The slope at the bottom landing is greater than allowed.

On-Site Finding 4.40 percent

Code Reference ADA 402, 406.4, 406.2, 403.3, 406.1, CA 11B-406.5.3

Provide a compliant bottom landing that does not exceed the maximum slope requirements.

Recommendation Up to 2.08 percent

Provide compliant landing \$240

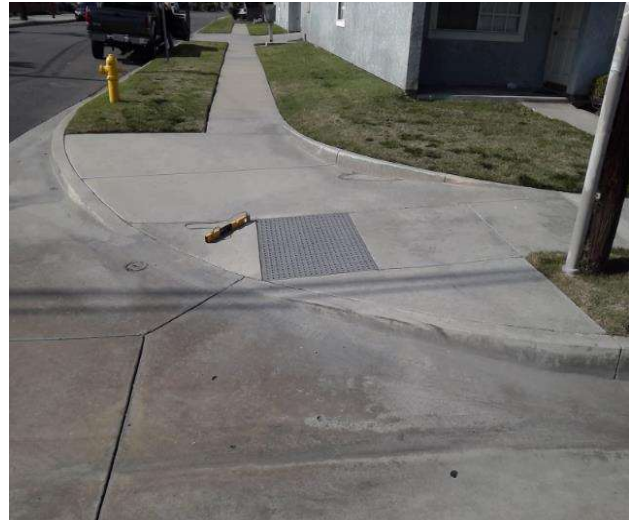
Northwest Corner Of Tweedy Lane @ 33.955321424643, - 118.131154328585

The slope at the top landing is greater than allowed.

On-Site Finding 2.50 percent

Curb Ramp , Landings and Transitions : Top Landing Right Side
Slope - Parallel Curb Ramp

Code Reference ADA 406.4, 403.3, 406.1, CA 11B-406.5.3

Provide a top landing surface that does not exceed the maximum slope and cross slope. Provide a sufficient maneuvering clearance that does not accumulate water.

Recommendation Up to 2.08 percent

Provide compliant landing \$1,260

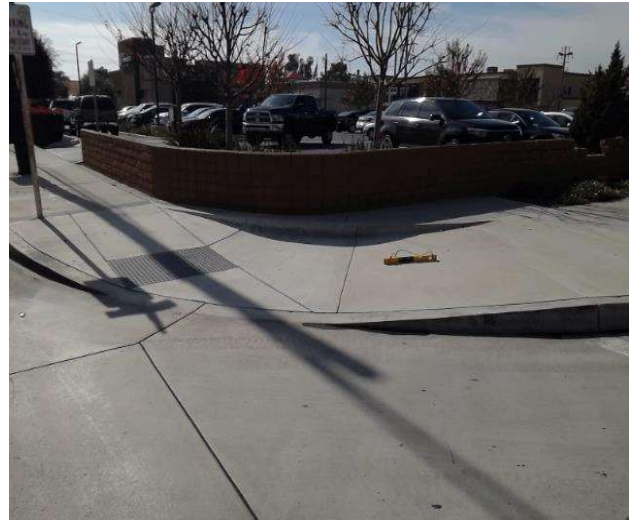
Southwest Corner Of Tweedy Lane @ 33.955182373220, - 118.131265640259

Curb Ramp : Parallel Curb Ramp Right Side Slope

The running slope is greater than allowed.

On-Site Finding 9.00 percent

Code Reference ADA 406.1, 405.2, CA 11B-406

Provide a compliant curb ramp.

Recommendation Up to 8.33 percent

Install curb ramp \$1,300

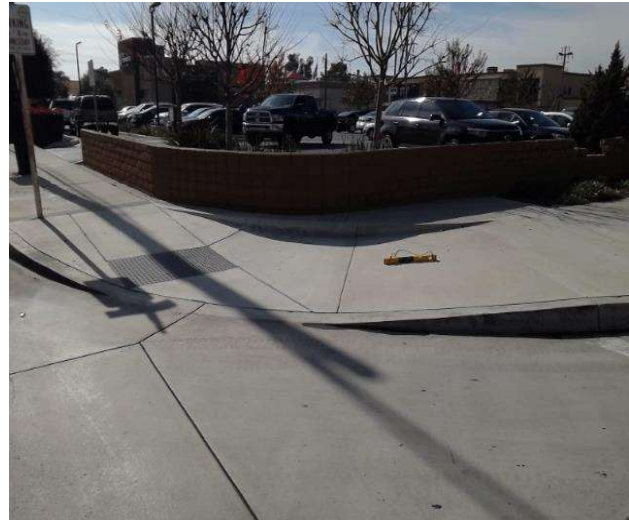
Southwest Corner Of Tweedy Lane @ 33.955182373220, - 118.131265640259

Curb Ramp : Detectable Warnings Width

Detectable warnings does not have same width as the curb ramp.

Code Reference CA 11B-406.5.12,CA 11B-705.1.2.2

Provide compliant detectable warnings that are full width of the curb ramp.

Install compliant detectable warnings \$190

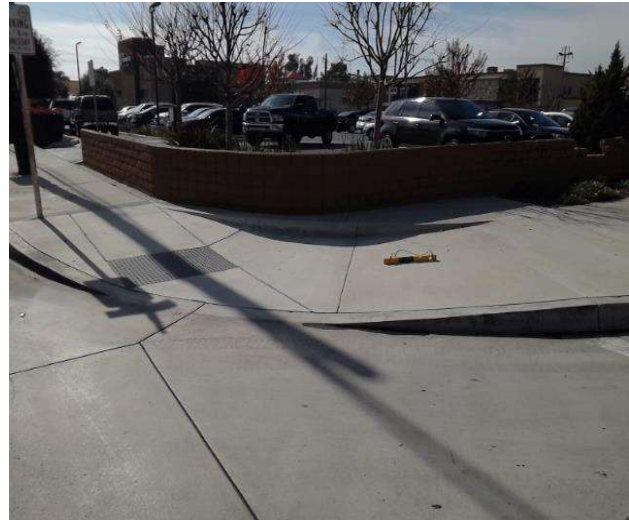
**Southwest Corner Of Tweedy Lane @ 33.955182373220, -
118.131265640259**

Curb Ramp : Appurtenances

Utilities, gratings or other appurtenances are located on the curb ramp.

Code Reference ADA 303.3,CA 11B-303.3

Provide a compliant curb ramp free of appurtenances.

Install curb ramp \$1,440

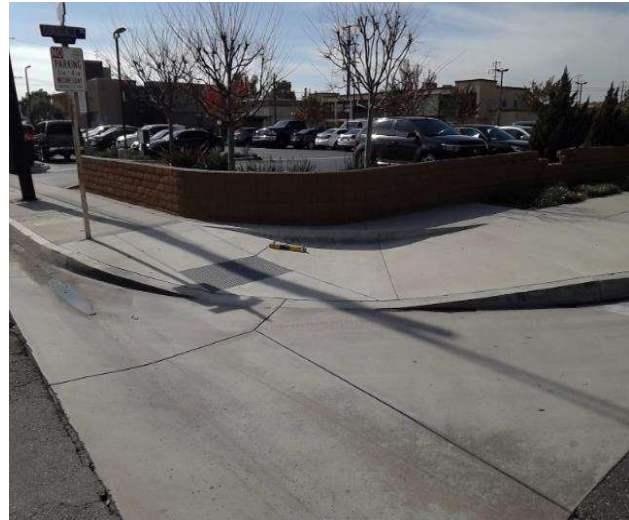
Southwest Corner Of Tweedy Lane @ 33.955182373220, - 118.131265640259

Curb Ramp , Landings and Transitions : Bottom Landing Slope

The slope at the bottom landing is greater than allowed.

On-Site Finding 5.80 percent

Code Reference ADA 402, 406.4, 406.2, 403.3, 406.1, CA 11B-406.5.3

Provide a compliant bottom landing that does not exceed the maximum slope requirements.

Recommendation Up to 2.08 percent

Provide compliant landing \$240

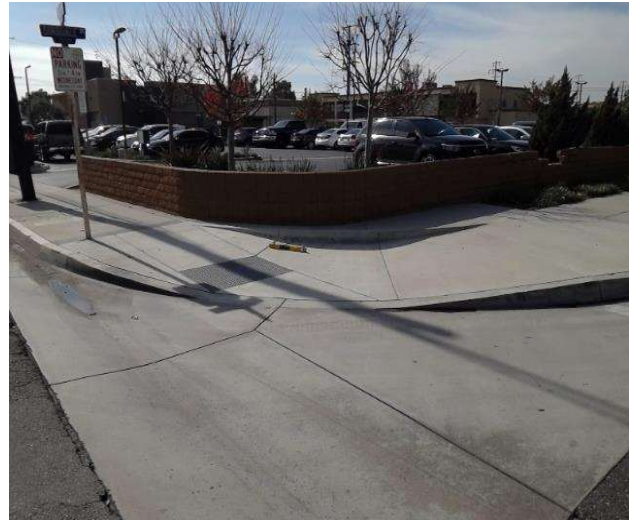
Southwest Corner Of Tweedy Lane @ 33.955182373220, - 118.131265640259

Curb Ramp , Landings and Transitions : Top Landing Slope

The slope at the top landing is greater than allowed.

On-Site Finding 3.60 percent

Code Reference ADA 402, 406.4, 403.3, 406.1, CA 11B-406.5.3

Provide a top landing surface that does not exceed the maximum slope and cross slope. Provide a sufficient maneuvering clearance that does not accumulate water.

Recommendation Up to 2.08 percent

Provide compliant landing \$1,260

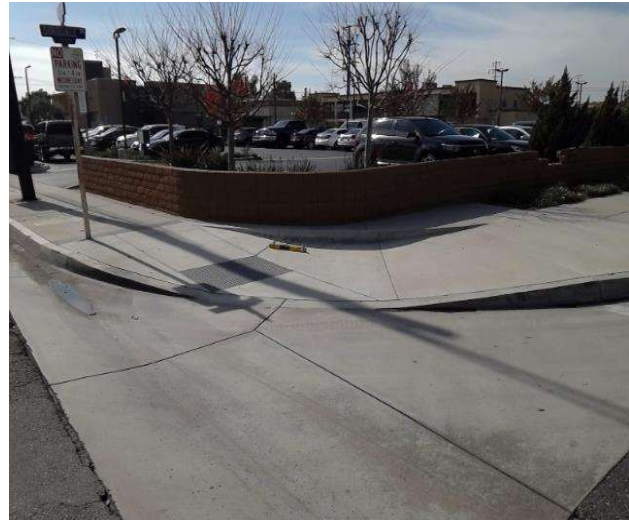
Southwest Corner Of Tweedy Lane @ 33.955182373220, - 118.131265640259

The slope at the top landing is greater than allowed.

On-Site Finding 6.90 percent

Curb Ramp , Landings and Transitions : Top Landing Right Side
Slope - Parallel Curb Ramp

Code Reference ADA 406.4, 403.3, 406.1, CA 11B-406.5.3

Provide a top landing surface that does not exceed the maximum slope and cross slope. Provide a sufficient maneuvering clearance that does not accumulate water.

Recommendation Up to 2.08 percent

Provide compliant landing \$1,260

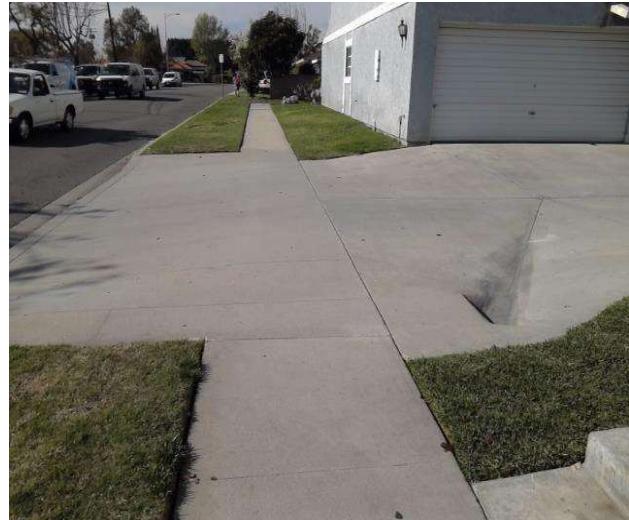
Driveway West Of Tweedy Lane @ 33.955438227663, -118.131397068501

Sidewalks , Vehicular Traffic : Cross Walks and Detectable Warnings

There are no detectable warnings where the pedestrian route crosses vehicular traffic.

Code Reference ADA 705,CA 11B-705.1.2.5,CA 11B-247.1.2.5

Provide detectable warnings.

Install compliant detectable warnings \$190

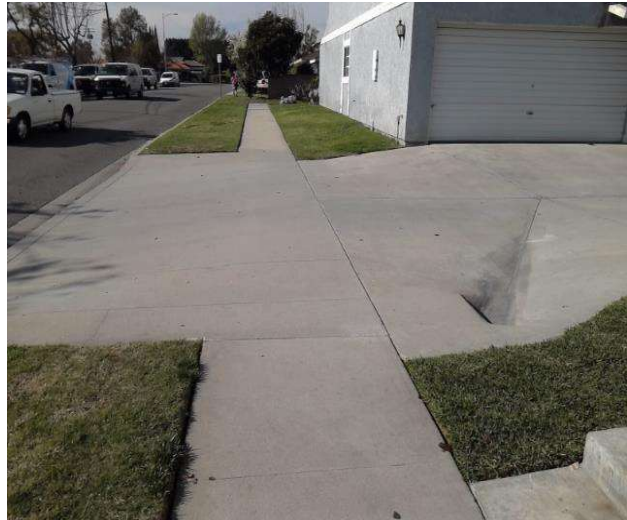
Driveway West Of Tweedy Lane @ 33.955438227663, -118.131397068501

Sidewalks : Vehicular Traffic Cross Slope

Cross slope at vehicular traffic is not compliant.

On-Site Finding 7.90 percent

Code Reference ADA 206, 302, CA 11B-403.3

Repave the surface to provide a compliant cross slope.

Recommendation Up to 2.08 percent

Repave surface \$1,092

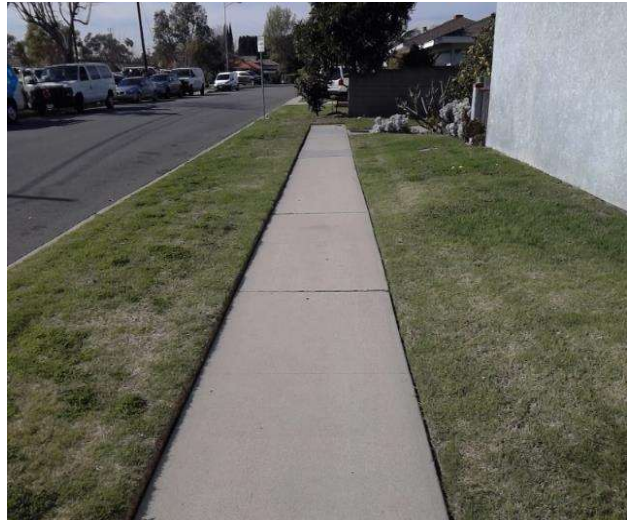
Sidewalk West Of Tweedy Lane @ 33.955438227663, -118.131397068501

Sidewalks , Surface : Cross Slope

Sidewalk cross slope is not compliant.

On-Site Finding 2.60 percent for 60.00 feet

Code Reference ADA 206, 302,CA 11B-403.3

Repave the sidewalk surface with the recommended cross slope.

Recommendation Up to 2.08 percent

Repave surface \$1,092

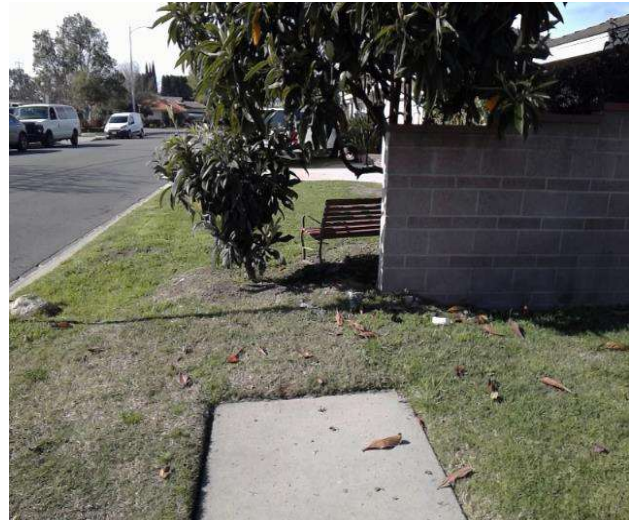
Sidewalk West Of Tweedy Lane @ 33.955570604226, -118.131666630507

Sidewalks : Missing Sidewalk

Section of sidewalk is missing and consists of dirt, grass or gravel.

On-Site Finding 160.00 feet

Code Reference ADA 206, 302,CA 11B-302,CA 11B-206

Provide a compliant sidewalk for the missing section.

\$1,260

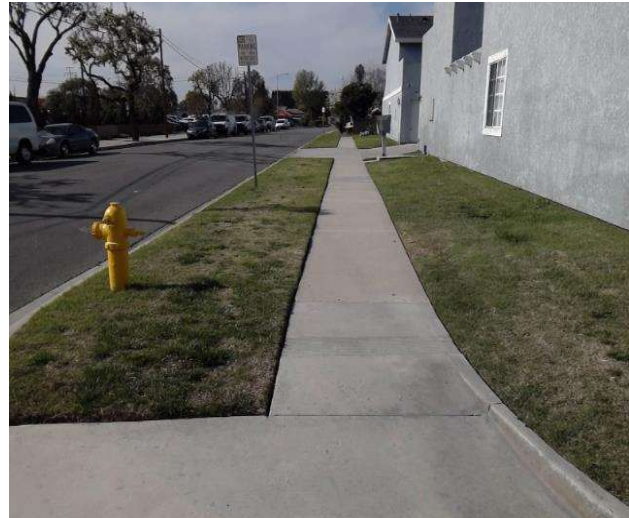
North Side @ 33.955325874285, -118.131189197302

Sidewalks : 60X60 Turn Area

There is no 60X60 turn area at every 200 feet.

Code Reference ADA 206, 302

Provide a 60X60 turn every 200 feet on the sidewalk.

\$2,400

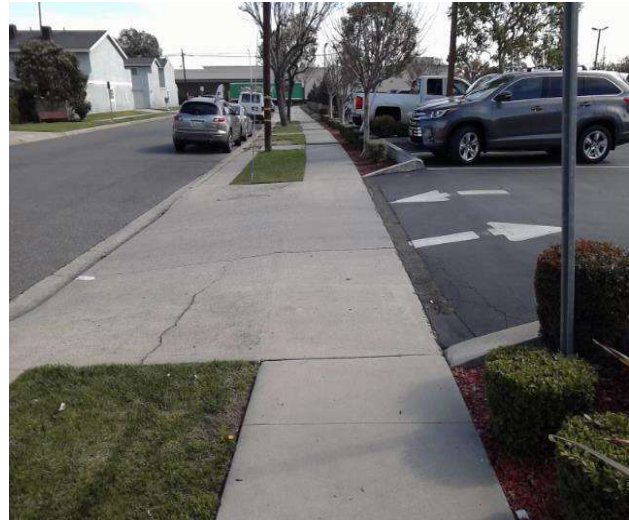
Driveway East Of Smallwood Avenue @ 33.955610650876, -118.132062256336

Sidewalks , Vehicular Traffic : Cross Walks and Detectable Warnings

There are no detectable warnings where the pedestrian route crosses vehicular traffic.

Code Reference ADA 705,CA 11B-705.1.2.5,CA 11B-247.1.2.5

Provide detectable warnings.

Install compliant detectable warnings \$190

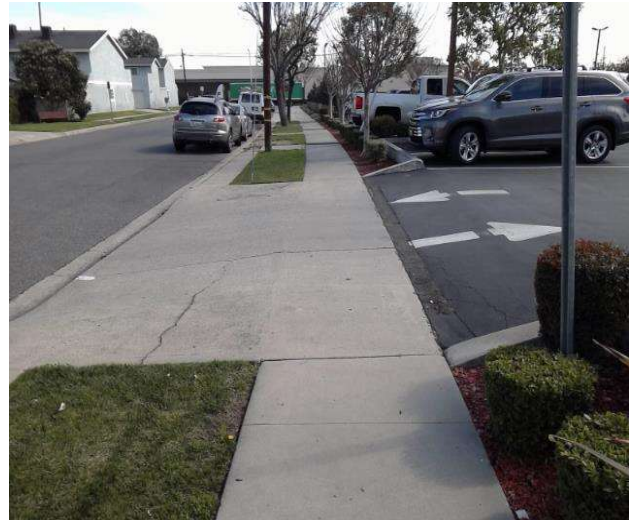
Driveway East Of Smallwood Avenue @ 33.955610650876, -118.132062256336

Sidewalks : Vehicular Traffic Cross Slope

Cross slope at vehicular traffic is not compliant.

On-Site Finding 2.60 percent

Code Reference ADA 206, 302, CA 11B-403.3

Repave the surface to provide a compliant cross slope.

Recommendation Up to 2.08 percent

Repave surface \$1,092

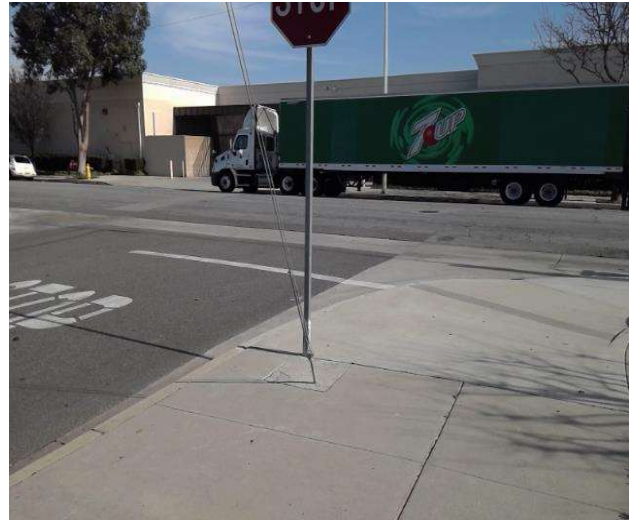
Guy Wire East Of Smallwood Avenue @ 33.955223532465, -118.131285756826

Sidewalks , Hazards & Gratings : Overhead Obstruction Height

Overhead obstruction height is not compliant.

On-Site Finding 60.00 inches

Code Reference ADA 206, 307.4, CA 11B-307.4

Provide a compliant vertical clearance height.

Recommendation At least 80.00 inches

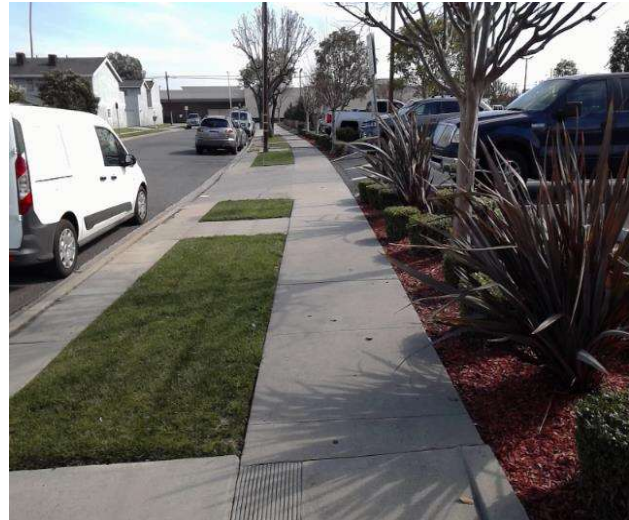
Sidewalk East Of Smallwood Avenue @ 33.955671833223, -118.132178932428

Sidewalks , Surface : Cross Slope

Sidewalk cross slope is not compliant.

On-Site Finding 3.80 percent for 110.00 feet

Code Reference ADA 206, 302,CA 11B-403.3

Notes : Slope greater than 5% located on asphalt patches.

Repave the sidewalk surface with the recommended cross slope.

Recommendation Up to 2.08 percent

Repave surface \$1,092

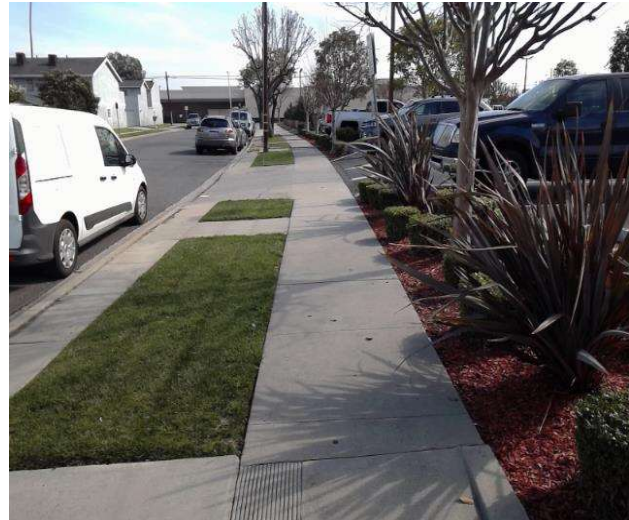
Code Reference ADA 206, 302

Notes : Slope greater than 5% located on asphalt patches.

Repave the sidewalk surface with the recommended running slope.

Recommendation Up to 5.00 percent

Repave surface \$1,184

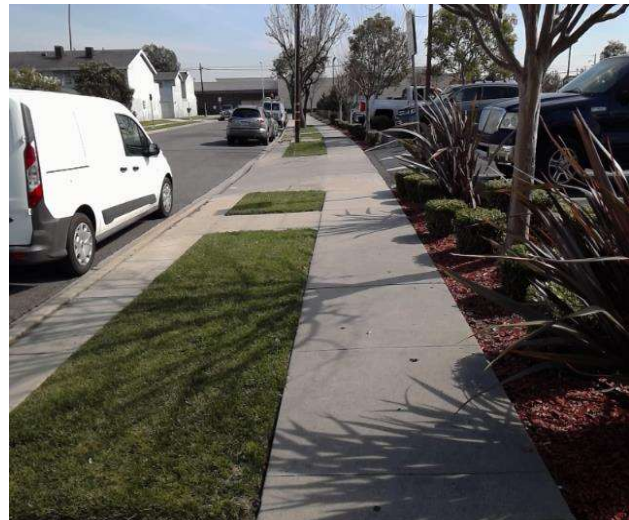
On-Site Finding Not Found

Code Reference ADA 206, 302

\$2,400
