Accessibility Survey

City of Downey Firestone Place - Old River School Road to Pomering Road

Date of Inspection 7/6/2017

Prepared By Disability Access Consultants (800) 743-7067

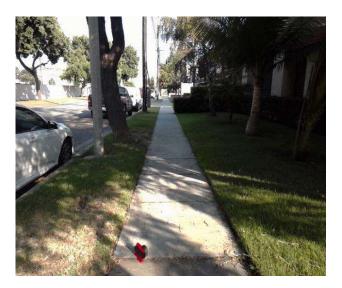
Change in Level East of Old River School Road @ 33.948235074842, - 118.147006183863

Sidewalks , Change in Level : Change in Level Non Beveled

There is a change in elevation greater than recommended value.

On-Site Finding 0.62 inches

Code	Reference	ADA	206,	302
Couc	Reference	ADA	200,	J02

Ensure that the change in elevation is within the recommended value.

Recommendation Up to 0.25 inches **Costing Info (Estimated)**

Remove tripping hazards \$198

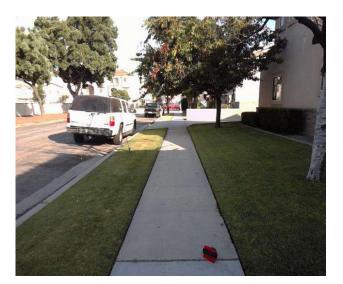
Change in Level East of Old River School Road @ 33.948445337671, - 118.147389739752

There is a change in elevation greater than recommended value.

On-Site Finding 0.50 inches

Sidewalks , Change in Level : Change in Level Non Beveled

Ensure that the change in elevation is within the recommended value.

Recommendation Up to 0.25 inches

Remove tripping hazards \$198

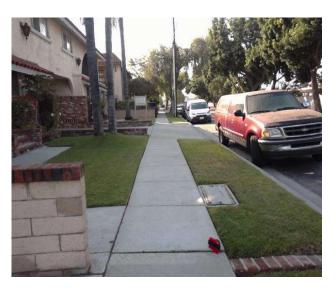
Change in Level East of Old River School Road @ 33.948445337671, - 118.147389739752

Sidewalks , Change in Level : Change in Level Non Beveled

There is a change in elevation greater than recommended value.

On-Site Finding 0.62 inches

Ensure that the change in elevation is within the recommended value.

Recommendation Up to 0.25 inches

Remove tripping hazards \$198

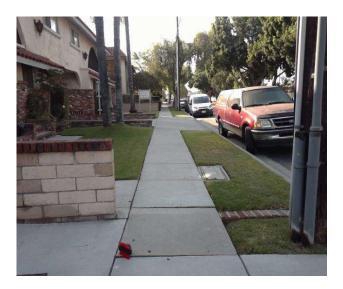
Change in Level East of Old River School Road @ 33.948445337671, - 118.147389739752

Sidewalks , Change in Level : Change in Level Non Beveled

There is a change in elevation greater than recommended value.

On-Site Finding 0.50 inches

Code	Reference	ADA	206,	302
Couc	Reference	ADA	200,	J02

Ensure that the change in elevation is within the recommended value.

Recommendation Up to 0.25 inches

Remove tripping hazards \$198

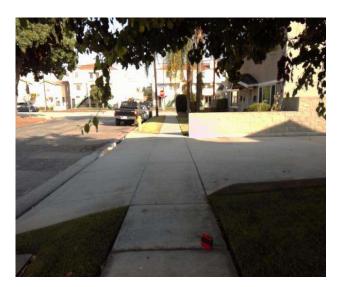
Change in Level East of Old River School Road @ 33.948507637669, - 118.147519826889

Sidewalks , Change in Level : Change in Level Non Beveled

There is a change in elevation greater than recommended value.

On-Site Finding 0.50 inches

Code Reference ADA 206, 302

Ensure that the change in elevation is within the recommended value.

Recommendation Up to 0.25 inches

Remove tripping hazards \$198

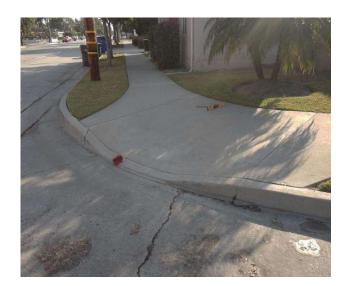
Northeast Corner of Old River School Road @ 33.948675624935, - 118.147829622030

The slope at the top landing is greater than allowed.

On-Site Finding 2.70 percent

Curb Ramp , Landings and Transitions : Top Landing Slope

Code Reference ADA 402, 406.4, 403.3, 406.1, CA 11	11B-406.5.3
---	-------------

Provide a top landing surface that does not exceed the maximum slope and cross slope. Provide a sufficient maneuvering clearance that does not accumulate water.

Recommendation Up to 2.08 percent

Provide compliant landing \$1,260

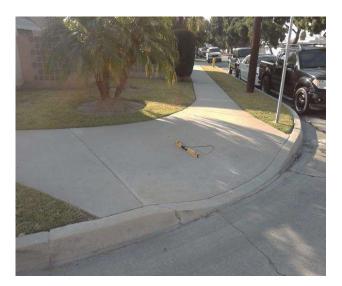
Northeast Corner of Old River School Road @ 33.948675624935, - 118.147829622030

Curb Ramp : No Detectable Warnings

The curb ramp does not provide a detectable warning surface which includes truncated domes.

On-Site Finding Not Found

Code	Reference	CA	11B-406.5.12
		U

Provide compliant detectable warnings to surface.

Provide detectable warning to \$248 surface

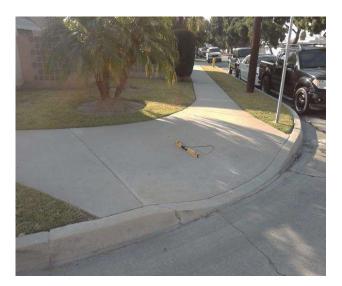
Northeast Corner of Old River School Road @ 33.948675624935, - 118.147829622030

Curb Ramp : Curb Ramp Slope

The running slope is greater than allowed.

On-Site Finding 11.10 percent

Code Reference ADA 406, 406.1, 405.2, CA 11B-406

Provide a compliant curb ramp.

Recommendation Up to 8.33 percent
Costing Info (Estimated)
Install curb ramp \$1,300

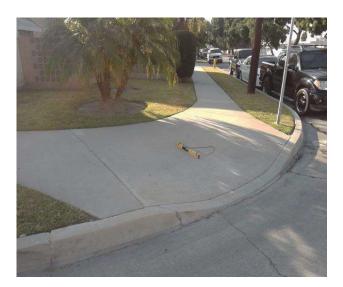
Northeast Corner of Old River School Road @ 33.948675624935, - 118.147829622030

Curb Ramp : Curb Ramp - Cross Slope

The cross slope is greater than allowed.

On-Site Finding 4.60 percent

Code Reference ADA 402, 406.1, 405.3, CA 11B-406.5.7

Provide a compliant curb ramp.

Recommendation Up to 2.08 percent
Costing Info (Estimated)
Install curb ramp \$1,300

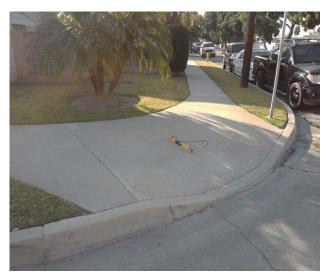
Northeast Corner of Old River School Road @ 33.948675624935, - 118.147829622030

Curb Ramp : Side Flare Slope

The slope of the curb ramp side flare is greater than allowed.

On-Site Finding 18.40 percent

Code Reference ADA 406, 406.3,CA 11B-406.2.2

Provide curb ramp side flares with a compliant slope.

Recommendation Up to 10.00 percent

Install flared sides \$1,300

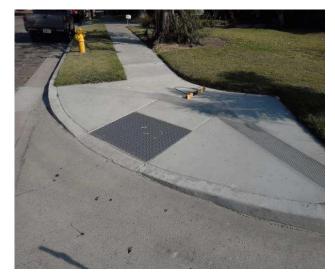
Northwest Corner of Pomering Road @ 33.947931360950, - 118.146467059851

The slope at the top landing is greater than allowed.

On-Site Finding 4.30 percent

101 102 106 1	400 0 400 4 00 440 400 5 0
Code Reference	ADA 402, 406.4,	403.3, 406.1,CA 11B-406.5.3

Provide a top landing surface that does not exceed the maximum slope and cross slope. Provide a sufficient maneuvering clearance that does not accumulate water.

Recommendation Up to 2.08 percent

Provide compliant landing \$1,260

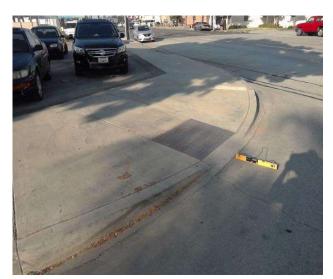
Southeast Corner of Old River School Road @ 33.948531156, - 118.147911429405

The bottom landing of the curb ramp is on the street, and the slope of the bottom landing is not compliant.

On-Site Finding 6.70 percent

Curb Ramp : Bottom Landing Slope

Code Reference ADA 406, 406.2, CA 11B-406.5.8

Ensure the bottom landing slope is compliant and provides a smooth transition.

Recommendation Up to 5.00 percent

Repave landing \$1,260

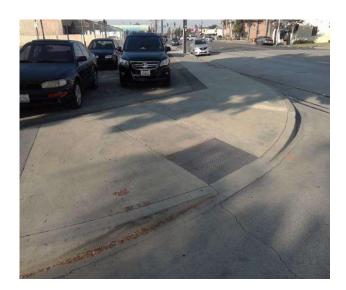
Southeast Corner of Old River School Road @ 33.948531156, - 118.147911429405

Curb Ramp : Not Wholly Contained Within The Marked Crossing

The curb ramp is not wholly contained within the marked crossing.

Code	Reference	ADA 406,	406.5

Provide a marked crossing on the path of travel; make certain the curb ramp is wholly contained within the marked crossing.

Install crosswalk \$800

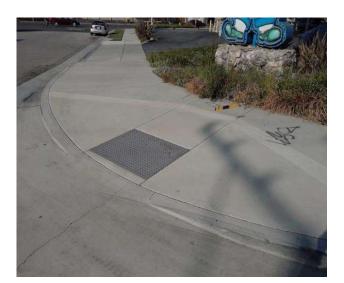
Southwest Corner of Pomering Road @ 33.947803422539, - 118.146571666002

The slope at the top landing is greater than allowed.

On-Site Finding 3.00 percent

Curb Ramp, Landings and Transitions : Top Landing Slope

Cada Defenses	ADA 402 40C 4	402 2 406 1	
Code Reference	ADA 402, 406.4,	403.3, 406.1	,CA 11B-406.5.3

Provide a top landing surface that does not exceed the maximum slope and cross slope. Provide a sufficient maneuvering clearance that does not accumulate water.

Recommendation Up to 2.08 percent

Provide compliant landing \$1,260

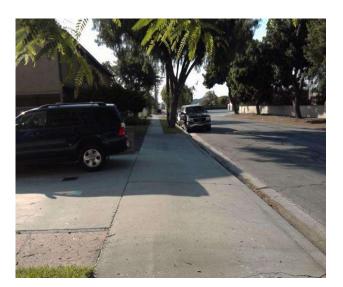
Driveway East of Old River School Road @ 33.948199474735, -118.146932423115

Sidewalks , Vehicular Traffic : Cross Walks and Detectable Warnings

There are no detectable warnings where the pedestrian route crosses vehicular traffic.

Code Reference ADA 705,CA 11B-705.1.2.5,CA 11B-247.1.2.5

Provide detectable warnings.

Install compliant detectable \$190 warnings

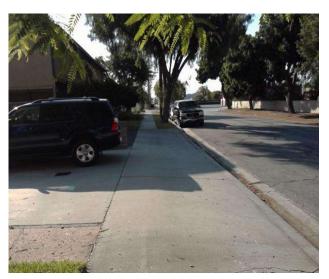
Driveway East of Old River School Road @ 33.948199474735, -118.146932423115

Sidewalks : Vehicular Traffic Cross Slope

Cross slope at vehicular traffic is not compliant.

On-Site Finding 9.60 percent

Code Reference ADA 206, 302,CA 11B-403.3

Repave the surface to provide a compliant cross slope.

Recommendation Up to 2.08 percent

Repave surface \$1,092

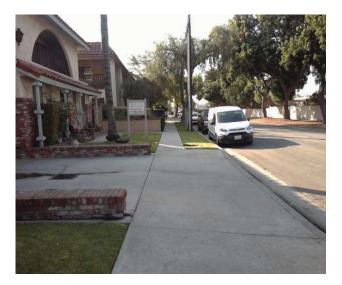
Driveway East of Old River School Road @ 33.948371912615, -118.147267699242

Sidewalks , Vehicular Traffic : Cross Walks and Detectable Warnings

There are no detectable warnings where the pedestrian route crosses vehicular traffic.

Code Reference ADA 705,CA 11B-705.1.2.5,CA 11B-247.1.2.5

Provide detectable warnings.

Install compliant detectable \$190 warnings

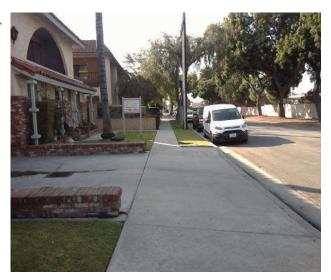
Driveway East of Old River School Road @ 33.948371912615, -118.147267699242

Sidewalks : Vehicular Traffic Cross Slope

Cross slope at vehicular traffic is not compliant.

On-Site Finding 8.90 percent

Code Reference ADA 206, 302,CA 11B-403.3

Repave the surface to provide a compliant cross slope.

Recommendation Up to 2.08 percent

Repave surface \$1,092

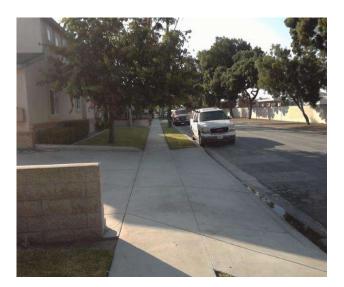
Driveway East of Old River School Road @ 33.948541012649, -118.147574812174

Sidewalks , Vehicular Traffic : Cross Walks and Detectable Warnings

There are no detectable warnings where the pedestrian route crosses vehicular traffic.

Code Reference ADA 705,CA 11B-705.1.2.5,CA 11B-247.1.2.5

Provide detectable warnings.

Install compliant detectable \$190 warnings

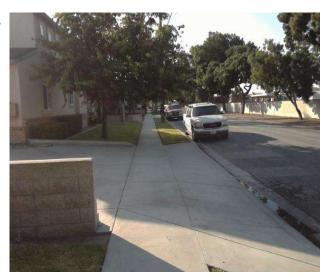
Driveway East of Old River School Road @ 33.948541012649, -118.147574812174

Sidewalks : Vehicular Traffic Cross Slope

Cross slope at vehicular traffic is not compliant.

On-Site Finding 2.60 percent

Code Reference ADA 206, 302, CA 11B-403.3

Repave the surface to provide a compliant cross slope.

Recommendation Up to 2.08 percent

Repave surface \$1,092

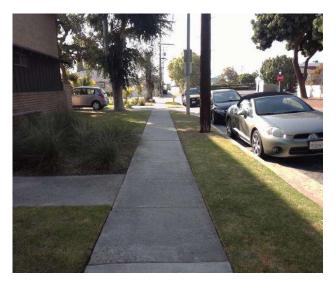
Sidewalk East of Old River School Road @ 33.948131611990, -118.146811723709

Sidewalks , Surface : Cross Slope

Sidewalk cross slope is not compliant.

On-Site Finding 4.20 percent for 106.00 feet

Code Reference ADA 206, 302,CA 11B-403.3

Repave the sidewalk surface with the recommended cross slope.

Recommendation Up to 2.08 percent

Repave surface \$1,092

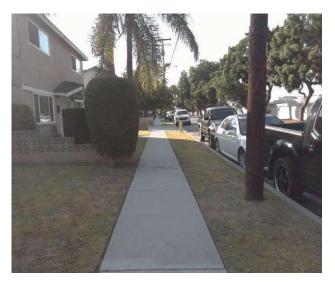
Sidewalk East of Old River School Road @ 33.948670062449, -118.147809505463

Sidewalks , Surface : Cross Slope

Sidewalk cross slope is not compliant.

On-Site Finding 4.20 percent for 239.00 feet

Code Reference ADA 206, 302,CA 11B-403.3

Repave the sidewalk surface with the recommended cross slope.

Recommendation Up to 2.08 percent

Repave surface \$1,092

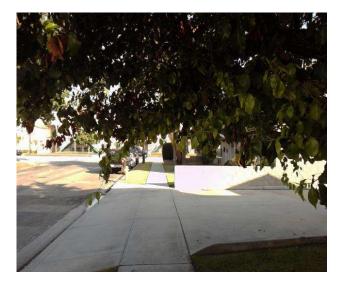
Tree East of Old River School Road @ 33.948507637669, -118.147519826889

Sidewalks , Hazards & Gratings : Overhead Obstruction Height

Overhead obstruction height is not compliant.

On-Site Finding 76.00 inches

Code Reference ADA 206, 307.4, CA 11B-307.4

Provide a compliant vertical clearance height.

At least 80,00 inches Recommendation **Costing Info (Estimated)**

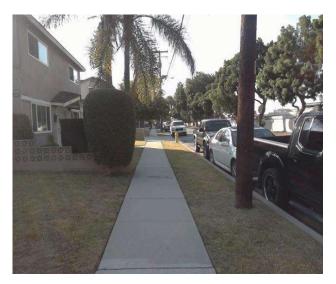
North Side @ 33.948670062449, -118.147809505463

Sidewalks : 60X60 Turn Area

There is no 60X60 turn area at every 200 feet.

Code Reference ADA 206, 302

Provide a 60X60 turn every 200 feet on the sidewalk.

\$2,400

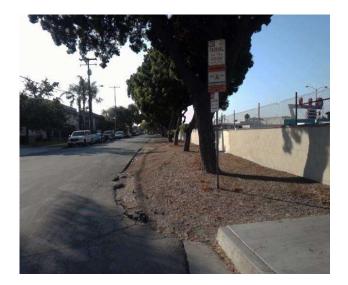
South Side @ 33.948529887657, -118.147867172956

Sidewalks : No Sidewalk

No sidewalk exists at the location.

Code Reference ADA 206

No action necessary until a sidewalk is provided.
