## Accessibility Survey

## City of Downey Horley Avenue - Adwen Street To Arnett Street

Date of Inspection  
4/11/2017

Prepared By  
**Disability Access Consultants**  
(800) 743-7067

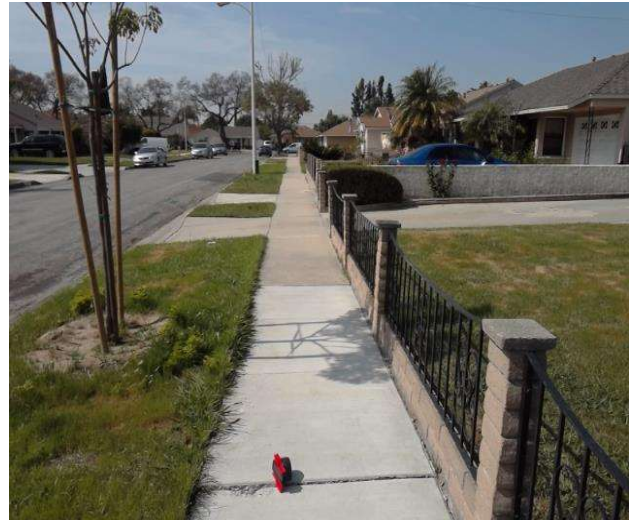
#### Change In Level North Of Adwen Street @ 33.942043769838, -118.145678490400

Sidewalks , Change in Level : Change in Level Non Beveled

There is a change in elevation greater than recommended value.

**On-Site Finding** 0.87 inches

**Code Reference** ADA 206, 302

Ensure that the change in elevation is within the recommended value.

Recommendation Up to 0.25 inches

Remove tripping hazards \$198

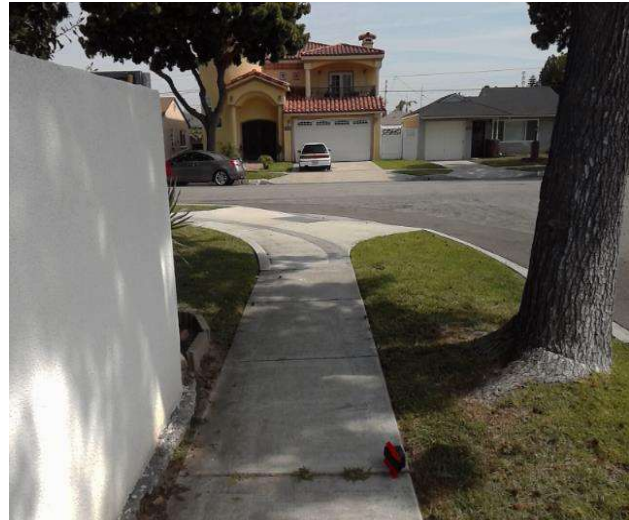
**Change In Level North Of Adwen Street @ 33.942758045793, -118.145144730806**

Sidewalks , Change in Level : Change in Level Non Beveled

There is a change in elevation greater than recommended value.

**On-Site Finding** 0.50 inches

**Code Reference** ADA 206, 302

Ensure that the change in elevation is within the recommended value.

Recommendation Up to 0.25 inches

Remove tripping hazards \$198

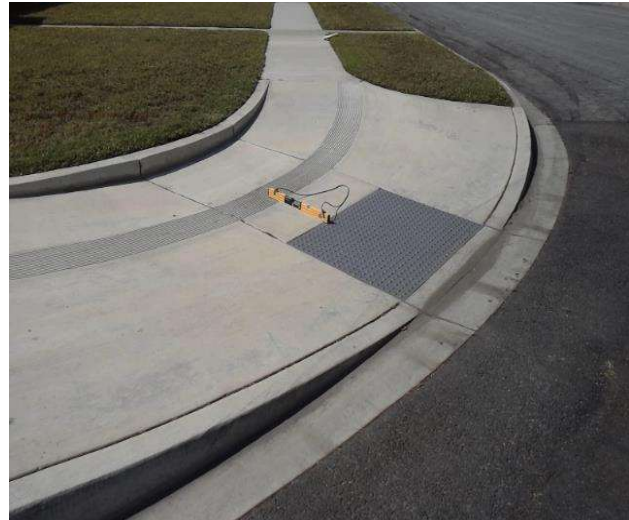
#### Northeast Corner Of Arnett Street @ 33.942726893696, - 118.144977092743

Curb Ramp : Curb Ramp Slope

The running slope is greater than allowed.

**On-Site Finding** 9.80 percent

**Code Reference** ADA 406, 406.1, 405.2, CA 11B-406

Provide a compliant curb ramp.

Recommendation Up to 8.33 percent

Install curb ramp \$1,300

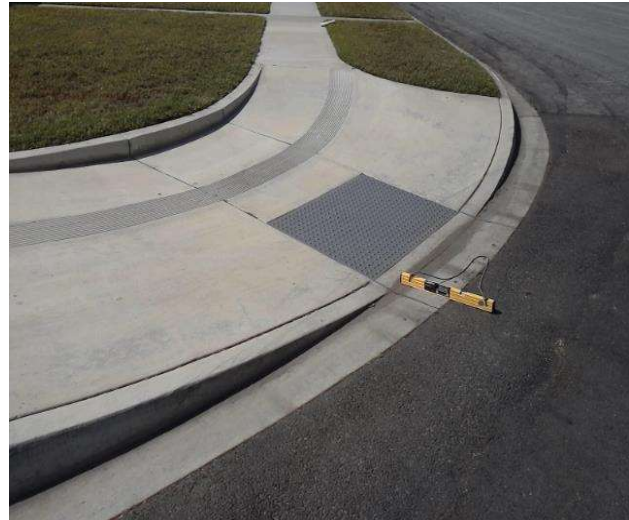
#### Northeast Corner Of Arnett Street @ 33.942726893696, - 118.144977092743

Curb Ramp : Bottom Landing Slope

The bottom landing of the curb ramp is on the street, and the slope of the bottom landing is not compliant.

**On-Site Finding** 10.30 percent

**Code Reference** ADA 406, 406.2, CA 11B-406.5.8

Ensure the bottom landing slope is compliant and provides a smooth transition.

Recommendation Up to 5.00 percent

Repave landing \$1,260

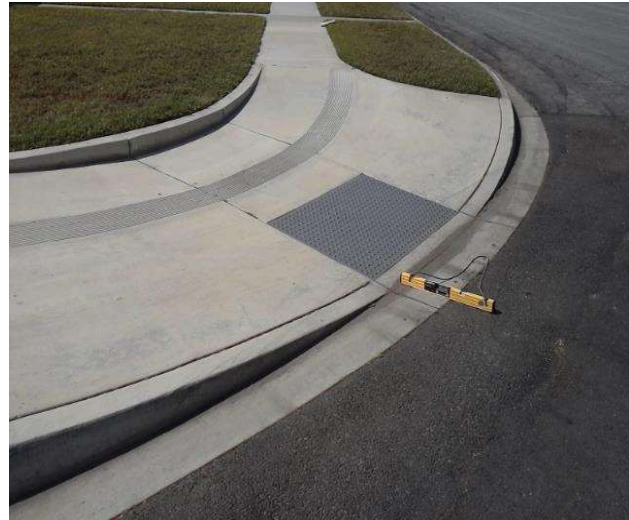
**Northeast Corner Of Arnett Street @ 33.942726893696, -  
118.144977092743**

There is not enough top landing clear length.

**On-Site Finding** 46.50 inches

Curb Ramp , Landings and Transitions : Top Landing Clear Length - Landings

**Code Reference** ADA 406, 406.4,CA 11B-406.5.3

Provide a level top landing with enough clear length.

Recommendation At least 48.00 inches

Provide compliant landing \$240

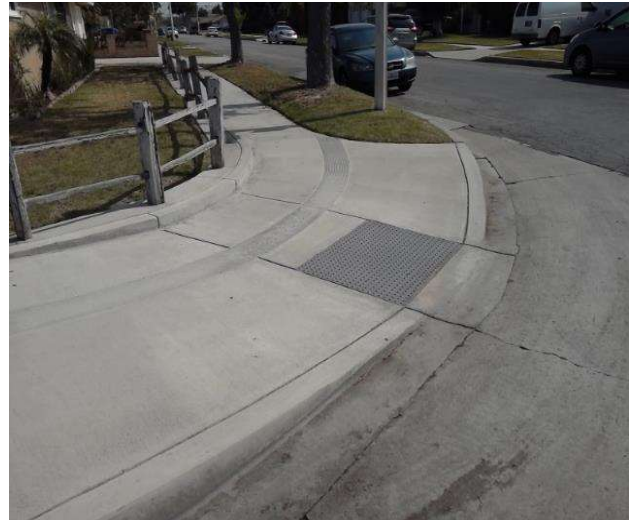
**Northwest Corner Of Adwen Street @ 33.941409594574, - 118.146137148142**

There is not enough top landing clear length.

**On-Site Finding** 45.00 inches

Curb Ramp , Landings and Transitions : Top Landing Clear Length - Landings

**Code Reference** ADA 406, 406.4,CA 11B-406.5.3

Provide a level top landing with enough clear length.

Recommendation At least 48.00 inches

Provide compliant landing \$240

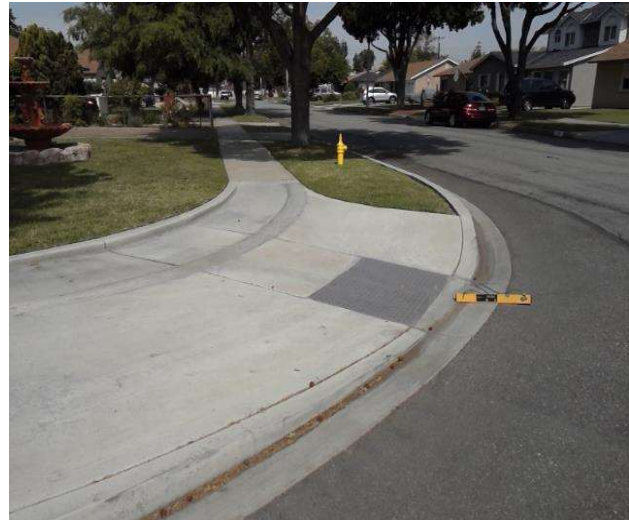
#### Southwest Corner Of Arnett Street @ 33.942805886492, - 118.145105838776

Curb Ramp : Bottom Landing Slope

The bottom landing of the curb ramp is on the street, and the slope of the bottom landing is not compliant.

**On-Site Finding** 14.80 percent

**Code Reference** ADA 406, 406.2, CA 11B-406.5.8

Ensure the bottom landing slope is compliant and provides a smooth transition.

Recommendation Up to 5.00 percent

Repave landing \$1,260

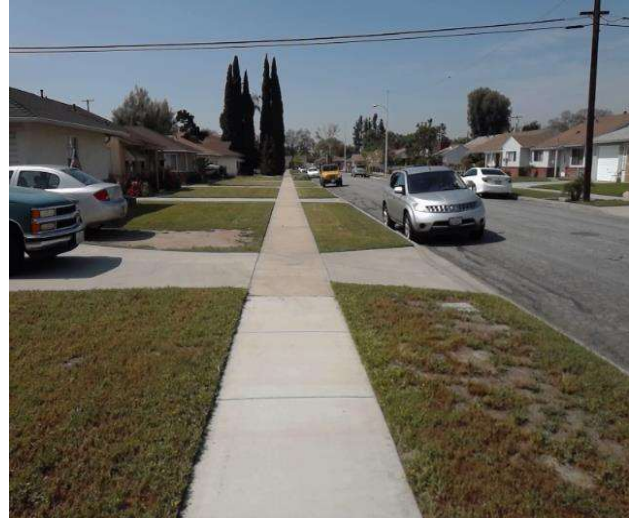
#### Sidewalk South Of Arnett Street @ 33.942641225369, -118.145032078028

Sidewalks , Surface : Cross Slope

Sidewalk cross slope is not compliant.

**On-Site Finding** 4.70 percent for 466.00 feet

**Code Reference** ADA 206, 302, CA 11B-403.3

Repave the sidewalk surface with the recommended cross slope.

Recommendation Up to 2.08 percent

Repave surface \$1,092

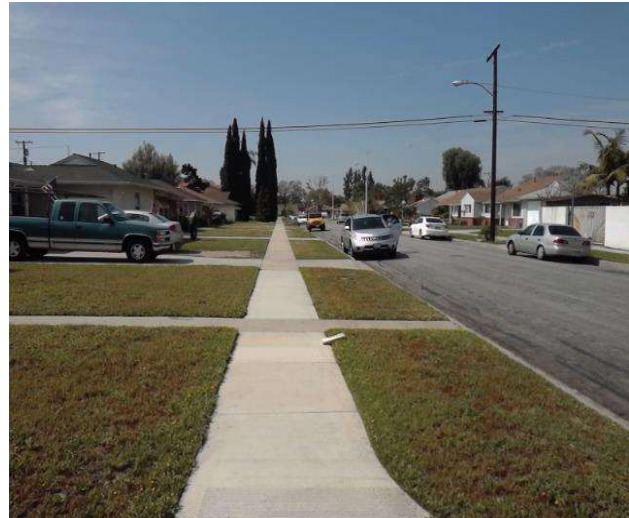
**East Side @ 33.942706867341, -118.144982457161**

Sidewalks : 60X60 Turn Area

There is no 60X60 turn area at every 200 feet.

**On-Site Finding** Not Found

**Code Reference** ADA 206, 302

Provide a 60X60 turn every 200 feet on the sidewalk.

\$2,400

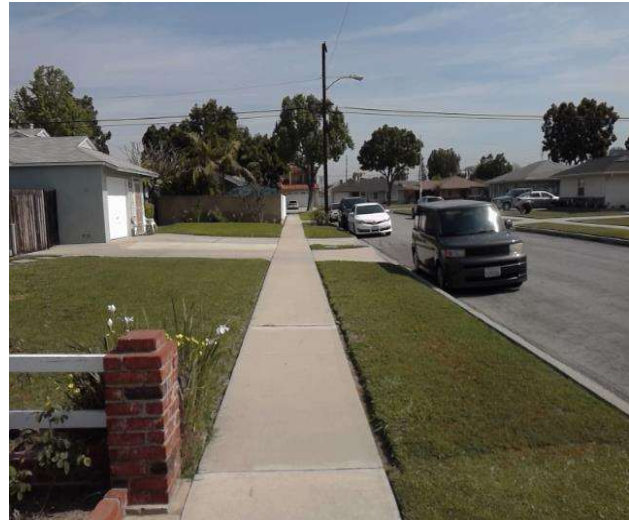
**Sidewalk North Of Adwen Street @ 33.942327478294, -118.145459890366**

Sidewalks , Surface : Cross Slope

Sidewalk cross slope is not compliant.

**On-Site Finding** 4.60 percent for 133.00 feet

**Code Reference** ADA 206, 302, CA 11B-403.3

Repave the sidewalk surface with the recommended cross slope.

Recommendation Up to 2.08 percent

Repave surface \$1,092

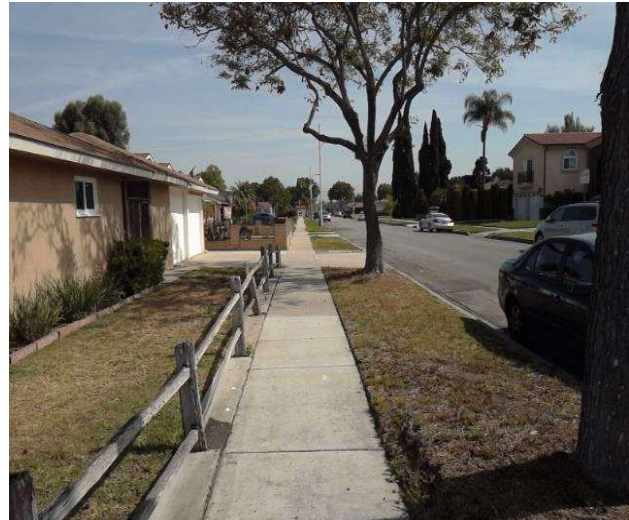
**West Side @ 33.941438521970, -118.146121054888**

Sidewalks : 60X60 Turn Area

There is no 60X60 turn area at every 200 feet.

**On-Site Finding** Not Found

**Code Reference** ADA 206, 302

Provide a 60X60 turn every 200 feet on the sidewalk.

\$2,400

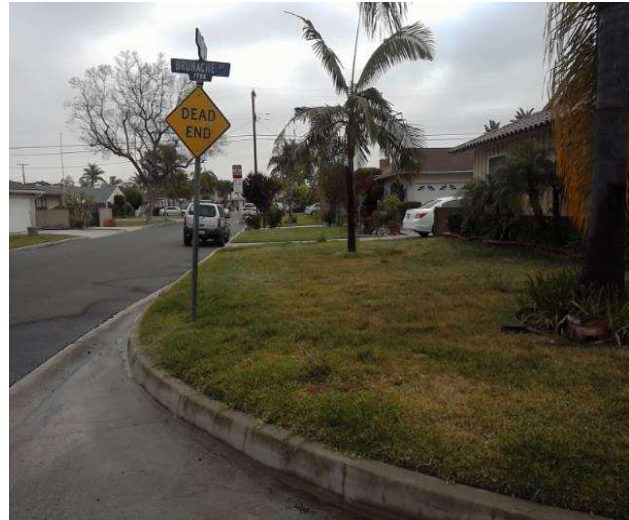
**East Side @ 33.935587199852, -118.150263726711**

Sidewalks : No Sidewalk

No sidewalk exists at the location.

No action necessary until a sidewalk is provided.

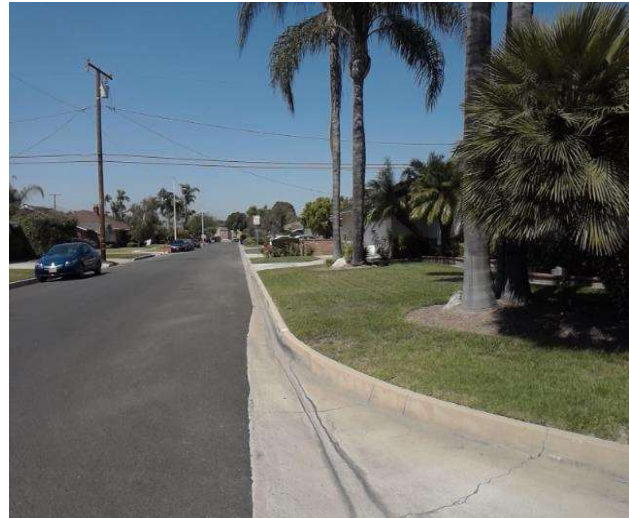
**East Side @ 33.949086135470, -118.140059262514**

Sidewalks : No Sidewalk

No sidewalk exists at the location.

No action necessary until a sidewalk is provided.

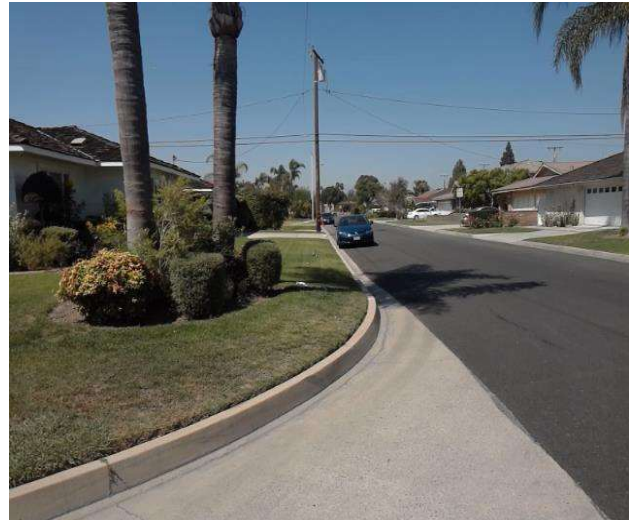
**West Side @ 33.949158447419, -118.140188008547**

Sidewalks : No Sidewalk

No sidewalk exists at the location.

No action necessary until a sidewalk is provided.

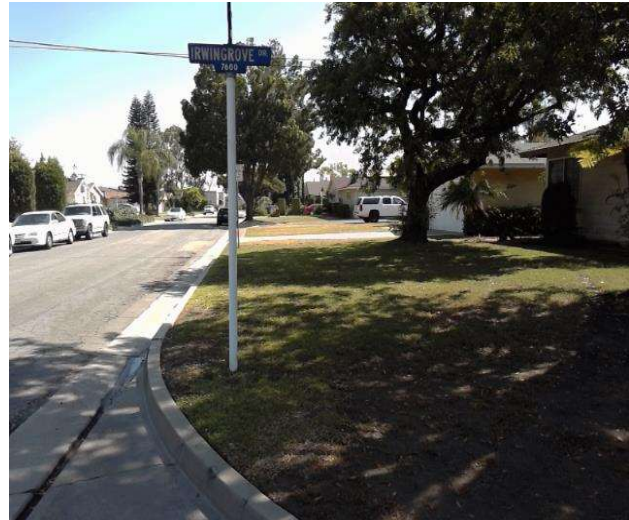
**East Side @ 33.955105616737, -118.137006908655**

Sidewalks : No Sidewalk

No sidewalk exists at the location.

No action necessary until a sidewalk is provided.

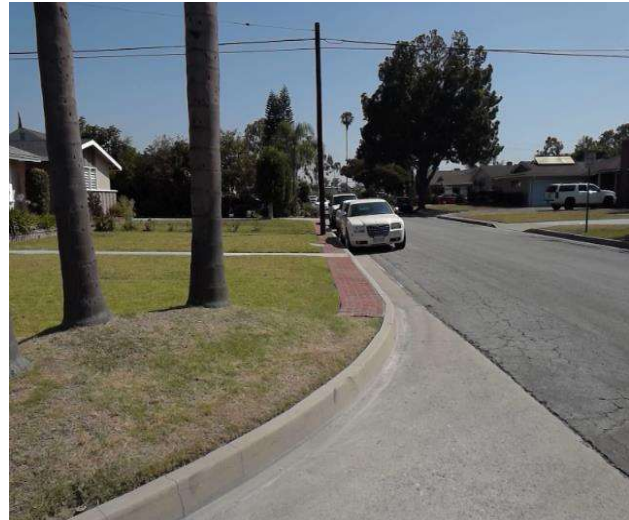
**West Side @ 33.955179035983, -118.137136995792**

Sidewalks : No Sidewalk

No sidewalk exists at the location.

No action necessary until a sidewalk is provided.
