## Accessibility Survey

### City of Downey Boyson Street - Birchdale Avenue To Brookshire Avenue

Birchdale Avenue To Brookshire Avenue  
Downey, CA 90242

Date of Inspection  
2/8/2017

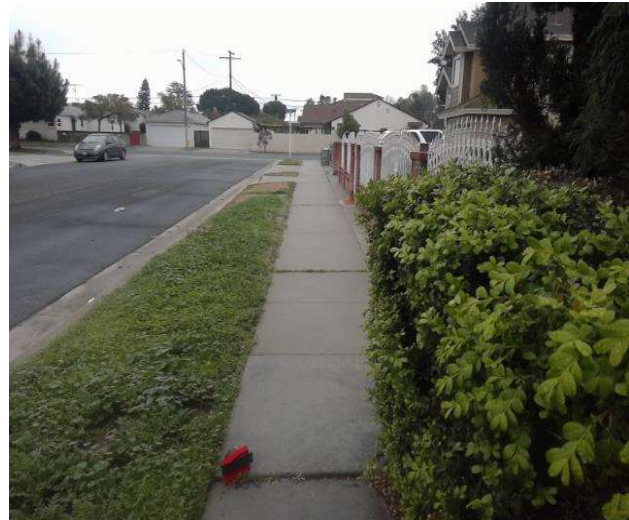
**Change In Level West Of Birchdale Avenue @ 33.924591100729, -118.137721717358**

Sidewalks , Change in Level : Change in Level Non Beveled

There is a change in elevation greater than recommended value.

**On-Site Finding** 0.75 inches

**Code Reference** ADA 206, 302

Ensure that the change in elevation is within the recommended value.

Recommendation Up to 0.25 inches

Remove tripping hazards \$198

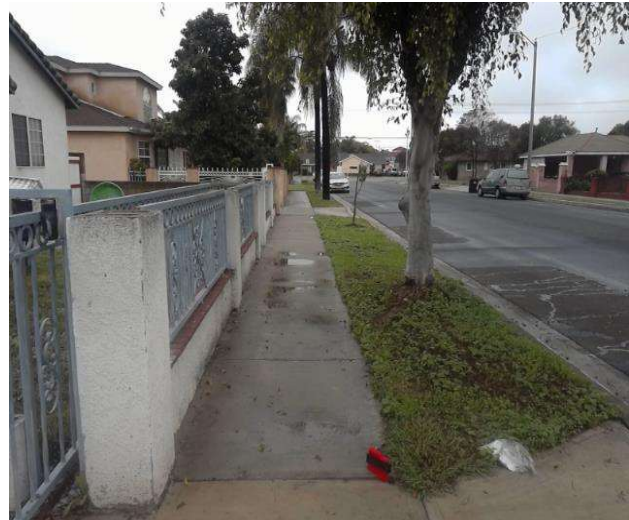
**Change In Level West Of Birchdale Avenue @ 33.924874867336, -118.138338625431**

Sidewalks , Change in Level : Change in Level Non Beveled

There is a change in elevation greater than recommended value.

**On-Site Finding** 0.62 inches

**Code Reference** ADA 206, 302

Ensure that the change in elevation is within the recommended value.

Recommendation Up to 0.25 inches

Remove tripping hazards \$198

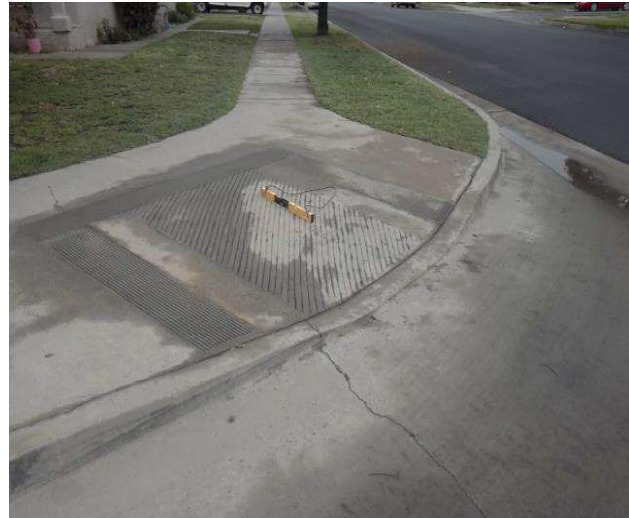
**Northwest Corner Of Birchdale Avenue @ 33.924561054797, - 118.137249648571**

Curb Ramp : No Detectable Warnings

The curb ramp does not provide a detectable warning surface which includes truncated domes.

**On-Site Finding** Not Found

**Code Reference** CA 11B-406.5.12

Provide compliant detectable warnings to surface.

Provide detectable warning to surface \$248

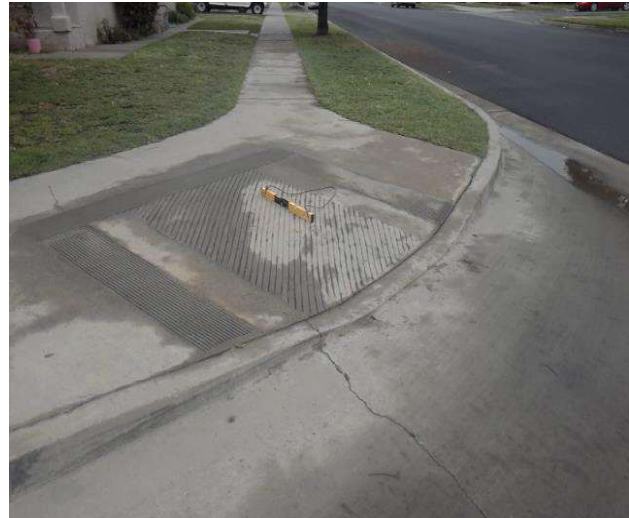
**Northwest Corner Of Birchdale Avenue @ 33.924561054797, - 118.137249648571**

Curb Ramp : Curb Ramp Slope

The running slope is greater than allowed.

**On-Site Finding** 10.00 percent

**Code Reference** ADA 406, 406.1, 405.2, CA 11B-406

Provide a compliant curb ramp.

Recommendation Up to 8.33 percent

Install curb ramp \$1,300

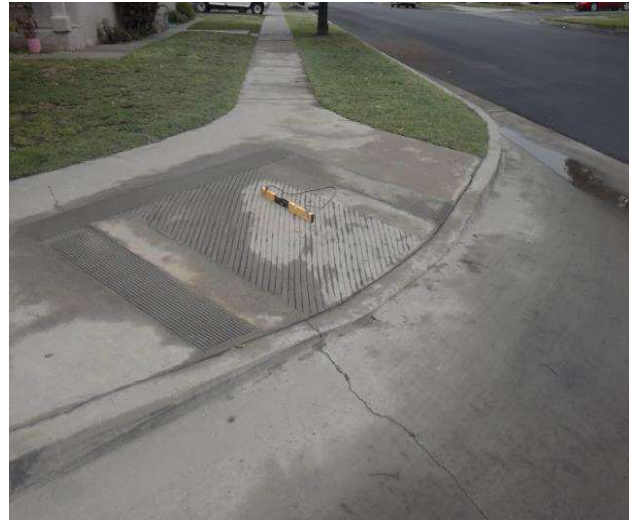
#### Northwest Corner Of Birchdale Avenue @ 33.924561054797, - 118.137249648571

Curb Ramp : Side Flare Slope

The slope of the curb ramp side flare is greater than allowed.

**On-Site Finding** 10.40 percent

**Code Reference** ADA 406, 406.3, CA 11B-406.2.2

Provide curb ramp side flares with a compliant slope.

Recommendation Up to 10.00 percent

Install flared sides \$1,300

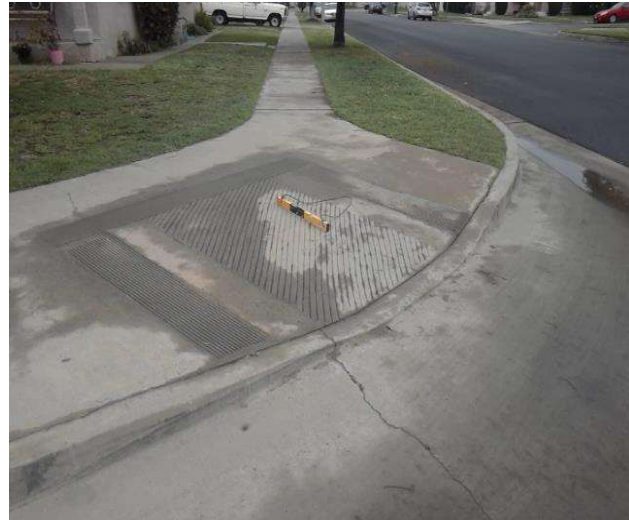
#### Northwest Corner Of Birchdale Avenue @ 33.924561054797, - 118.137249648571

The transition from the bottom of the curb ramp to the walk, gutter, or street is abrupt.

**On-Site Finding** 0.75 inches

Curb Ramp , Landings And Transitions : Bottom Landing Change in Level

**Code Reference** ADA 302, 303, 406.2, 303.1

Patch the transition area at the bottom of the curb ramp so that the transition is flush and free of abrupt changes.

Recommendation Up to 0.50 inches

Patch lip at curb ramp \$255

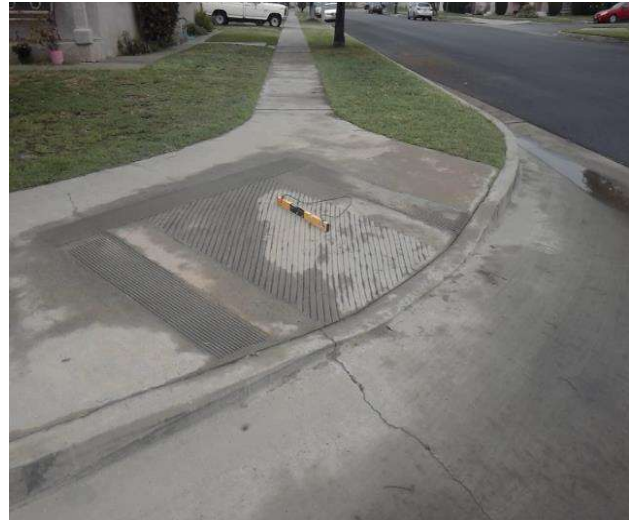
#### Northwest Corner Of Birchdale Avenue @ 33.924561054797, - 118.137249648571

Curb Ramp , Landings and Transitions : Top Landing Slope

The slope at the top landing is greater than allowed.

**On-Site Finding** 3.10 percent

**Code Reference** ADA 402, 406.4, 403.3, 406.1, CA 11B-406.5.3

Provide a top landing surface that does not exceed the maximum slope and cross slope. Provide a sufficient maneuvering clearance that does not accumulate water.

Recommendation Up to 2.08 percent

Provide compliant landing \$1,260

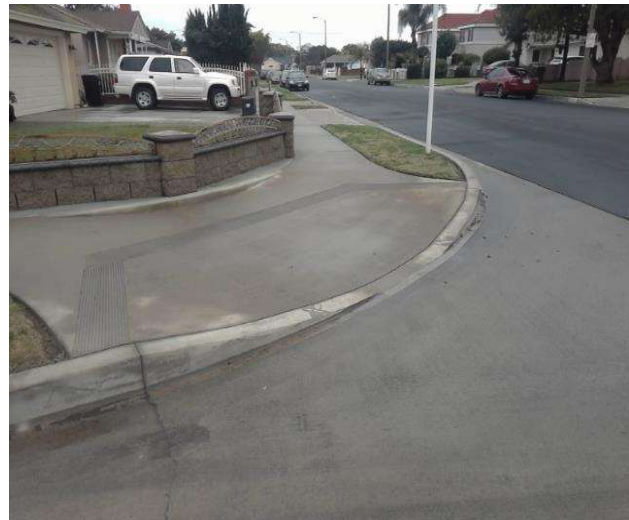
**Southwest Corner Of Birchdale Avenue @ 33.924433081267, - 118.137373030186**

Curb Ramp : No Detectable Warnings

The curb ramp does not provide a detectable warning surface which includes truncated domes.

**On-Site Finding** Not Found

**Code Reference** CA 11B-406.5.12

Provide compliant detectable warnings to surface.

Provide detectable warning to surface \$248

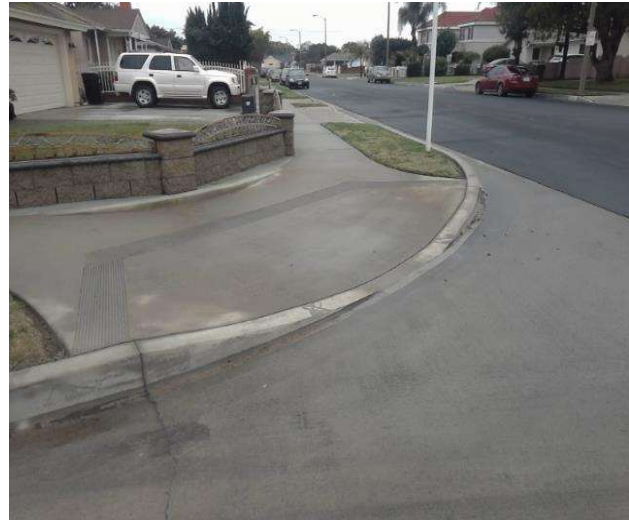
#### Southwest Corner Of Birchdale Avenue @ 33.924433081267, - 118.137373030186

Curb Ramp : Side Flare Slope

The slope of the curb ramp side flare is greater than allowed.

**On-Site Finding** 11.70 percent

**Code Reference** ADA 406, 406.3, CA 11B-406.2.2

Provide curb ramp side flares with a compliant slope.

Recommendation Up to 10.00 percent

Install flared sides \$1,300

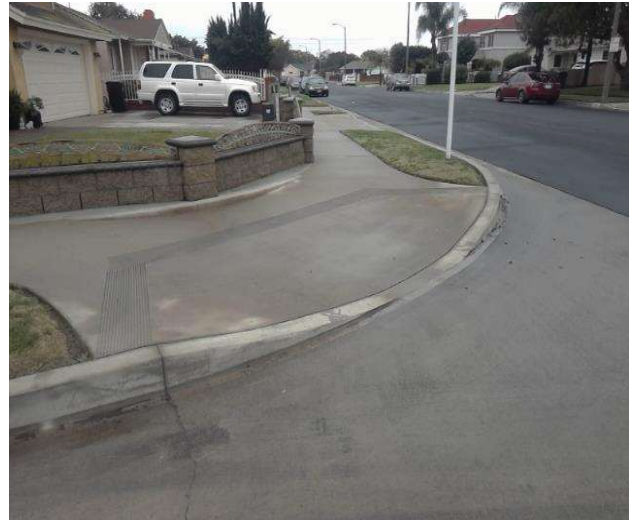
**Southwest Corner Of Birchdale Avenue @ 33.924433081267, - 118.137373030186**

There is not enough top landing clear length.

**On-Site Finding** 46.00 inches

Curb Ramp , Landings and Transitions : Top Landing Clear Length - Landings

**Code Reference** ADA 406, 406.4, CA 11B-406.5.3

Provide a level top landing with enough clear length.

Recommendation At least 48.00 inches

Provide compliant landing \$240

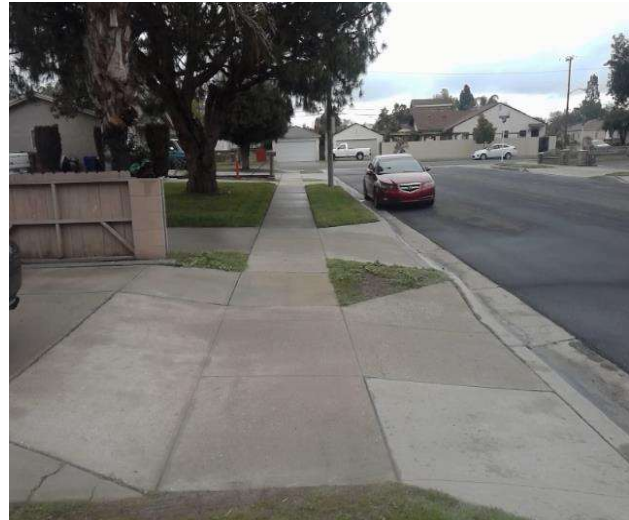
#### Sidewalk East Of Brookshire Avenue @ 33.924732427746, -118.137623816729

Sidewalks , Surface : Cross Slope

Sidewalk cross slope is not compliant.

**On-Site Finding** 4.40 percent for 124.00 feet

**Code Reference** ADA 206, 302, CA 11B-403.3

Repave the sidewalk surface with the recommended cross slope.

Recommendation Up to 2.08 percent

Repave surface \$1,092

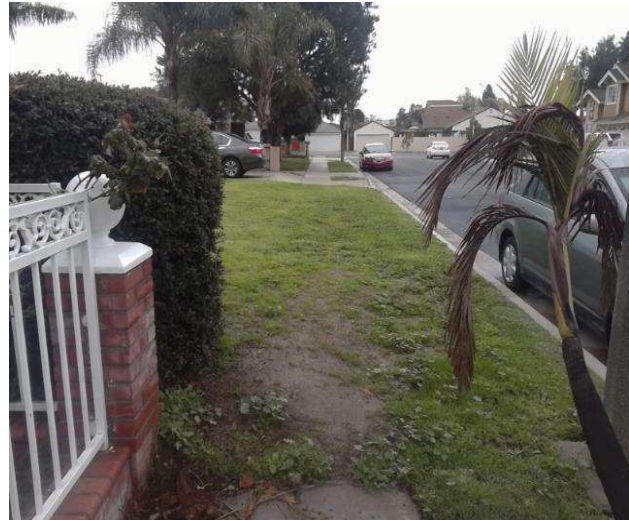
**Sidewalk East Of Brookshire Avenue @ 33.924796970715, -118.137776702642**

Sidewalks : Missing Sidewalk

Section of sidewalk is missing and consists of dirt, grass or gravel.

**On-Site Finding** 52.00 feet

**Code Reference** ADA 206, 302,CA 11B-302,CA 11B-206

Provide a compliant sidewalk for the missing section.

\$1,260

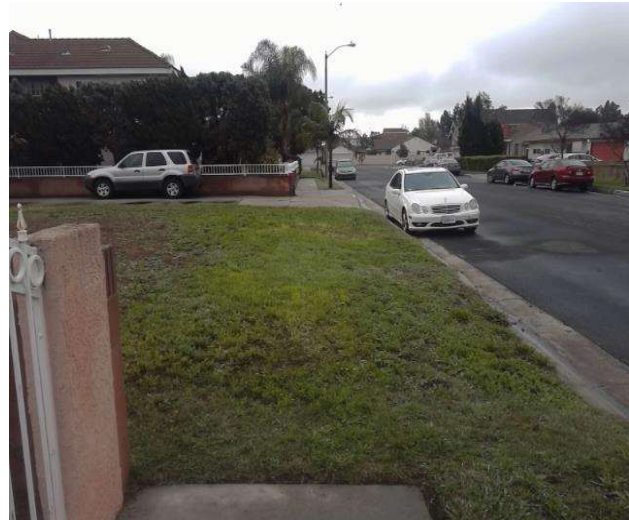
**Sidewalk East Of Brookshire Avenue @ 33.924969455995, -118.138152211905**

Sidewalks : Missing Sidewalk

Section of sidewalk is missing and consists of dirt, grass or gravel.

**On-Site Finding** 48.00 feet

**Code Reference** ADA 206, 302,CA 11B-302,CA 11B-206

Provide a compliant sidewalk for the missing section.

\$1,260

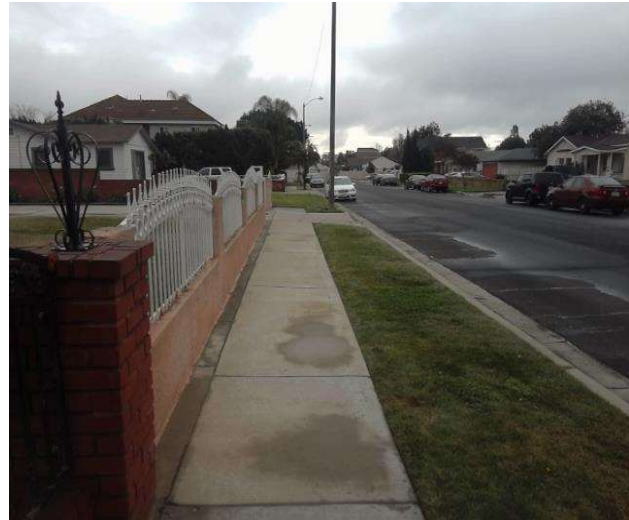
**Sidewalk East Of Brookshire Avenue @ 33.925054029296, -118.138354718685**

Sidewalks , Surface : Cross Slope

Sidewalk cross slope is not compliant.

**On-Site Finding** 5.00 percent for 67.00 feet

**Code Reference** ADA 206, 302,CA 11B-403.3

Repave the sidewalk surface with the recommended cross slope.

Recommendation Up to 2.08 percent

Repave surface \$1,092

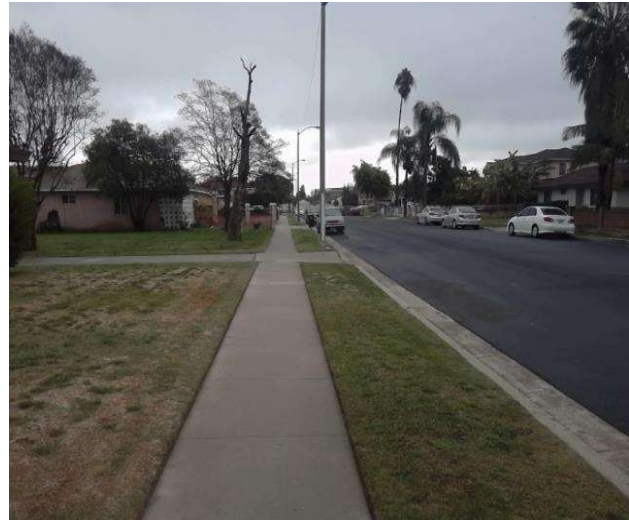
#### North Side @ 33.925371178424, -118.139058798552

Sidewalks : 60X60 Turn Area

There is no 60X60 turn area at every 200 feet.

**On-Site Finding** Not Found

**Code Reference** ADA 206, 302

Provide a 60X60 turn every 200 feet on the sidewalk.

\$2,400

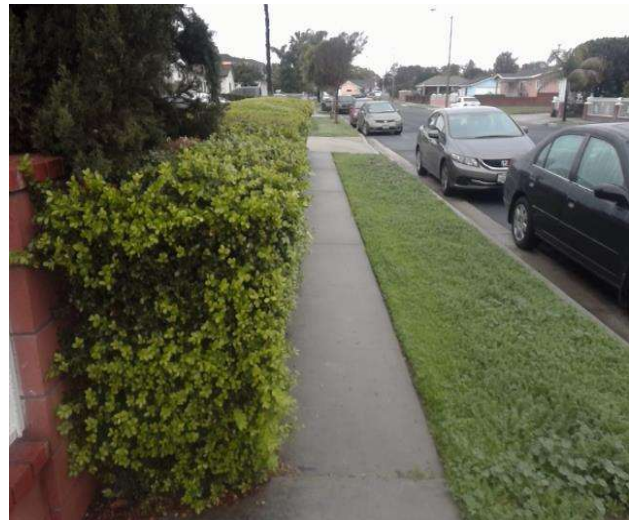
**Bush West Of Birchdale Avenue @ 33.924591100729, -118.137721717358**

Sidewalks , Hazards & Gratings : Sidewalk Width at Obstruction

Sidewalk width at the obstruction is not compliant.

**On-Site Finding** 30.00 inches

**Code Reference** ADA 206, 302, 403.5.1, CA 11B-403.5

Sidewalk width at the obstruction shall have the recommended value.

Recommendation At least 48.00 inches

\$1,260

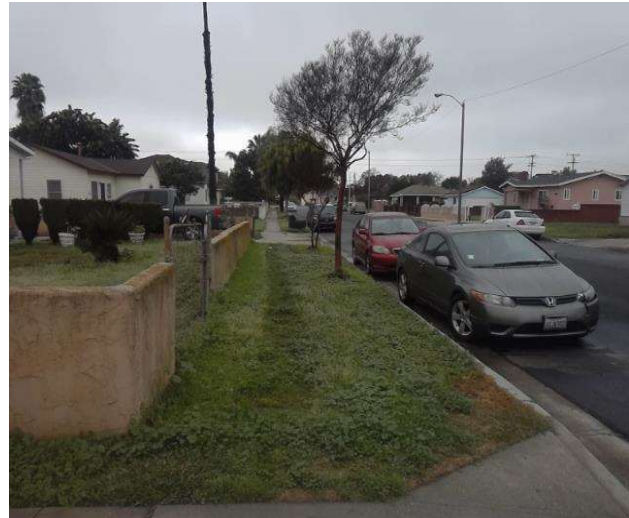
**Sidewalk West Of Birchdale Avenue @ 33.924673448783, -118.137904107571**

Sidewalks : Missing Sidewalk

Section of sidewalk is missing and consists of dirt, grass or gravel.

**On-Site Finding** 56.00 feet

**Code Reference** ADA 206, 302,CA 11B-302,CA 11B-206

Provide a compliant sidewalk for the missing section.

\$1,260

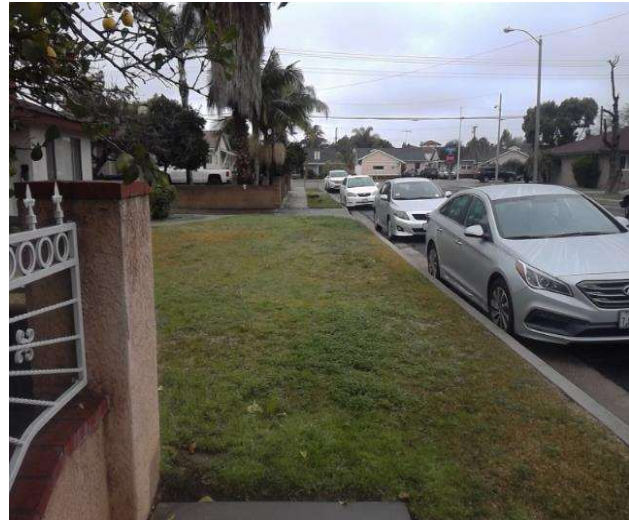
#### Sidewalk West Of Birchdale Avenue @ 33.925009517043, -118.138637691736

Sidewalks : Missing Sidewalk

Section of sidewalk is missing and consists of dirt, grass or gravel.

**On-Site Finding** 55.00 feet

**Code Reference** ADA 206, 302,CA 11B-302,CA 11B-206

Provide a compliant sidewalk for the missing section.

\$1,260

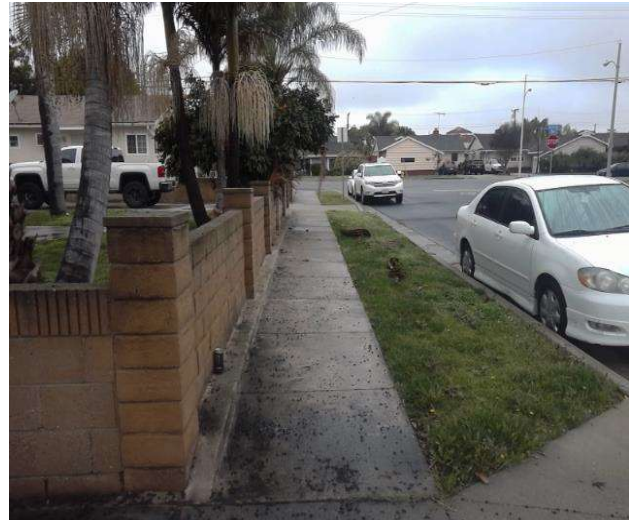
#### Sidewalk West Of Birchdale Avenue @ 33.925108556774, -118.138872385025

Sidewalks : Width

Sidewalk does not have enough width.

**On-Site Finding** 43.75 inches for 52.00 feet

**Code Reference** ADA 206, 302, CA 11B-403.5.1

Widen the sidewalk to the recommended value.

Recommendation At least 48.00 inches

\$1,260

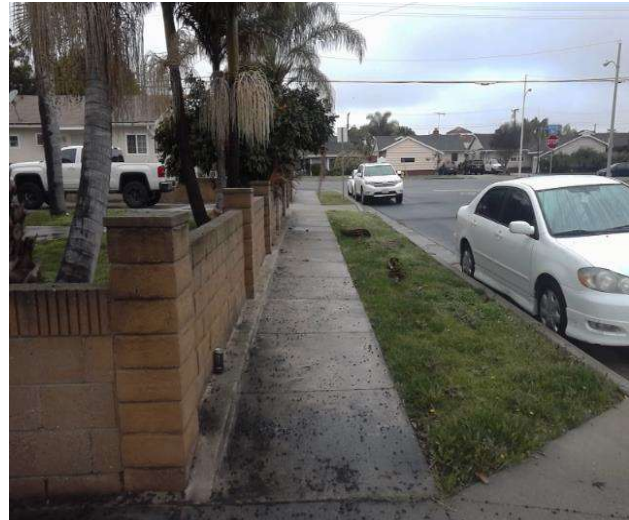
**Sidewalk West Of Birchdale Avenue @ 33.925108556774, -118.138872385025**

Sidewalks , Surface : Cross Slope

Sidewalk cross slope is not compliant.

**On-Site Finding** 5.50 percent for 40.00 feet

**Code Reference** ADA 206, 302,CA 11B-403.3

Repave the sidewalk surface with the recommended cross slope.

Recommendation Up to 2.08 percent

Repave surface \$1,092

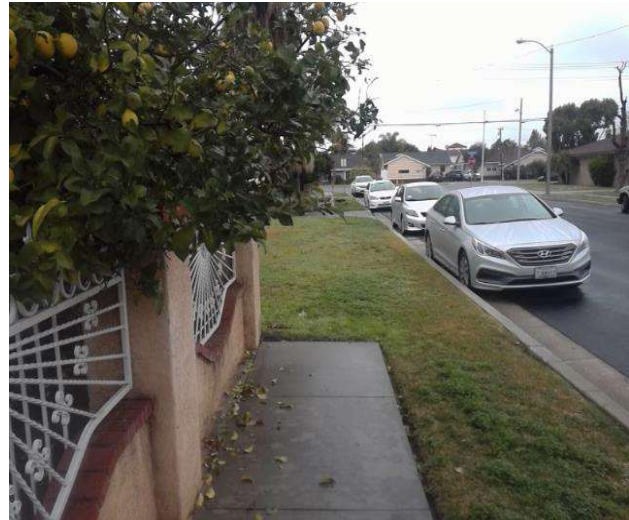
**Tree West Of Birchdale Avenue @ 33.925009517043, -118.138632327318**

Sidewalks , Hazards & Gratings : Overhead Obstruction Height

Overhead obstruction height is not compliant.

**On-Site Finding** 54.00 inches

**Code Reference** ADA 206, 307.4,CA 11B-307.4

Provide a compliant vertical clearance height.

Recommendation At least 80.00 inches

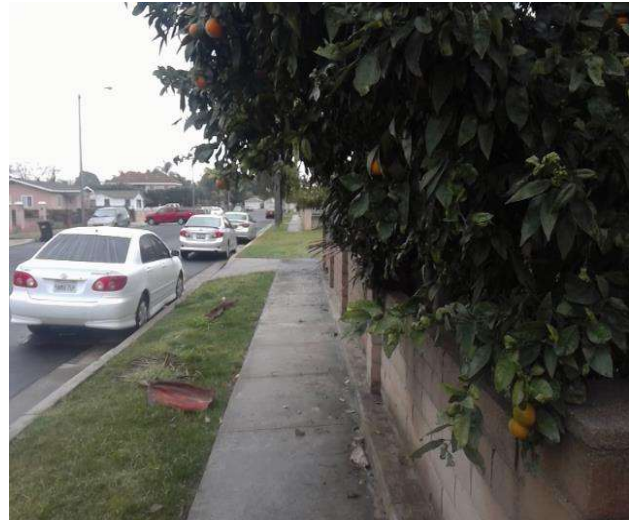
**Tree West Of Birchdale Avenue @ 33.925153068975, -118.138956874609**

Sidewalks , Hazards & Gratings : Overhead Obstruction Height

Overhead obstruction height is not compliant.

**On-Site Finding** 66.00 inches

**Code Reference** ADA 206, 307.4, CA 11B-307.4

Provide a compliant vertical clearance height.

Recommendation At least 80.00 inches

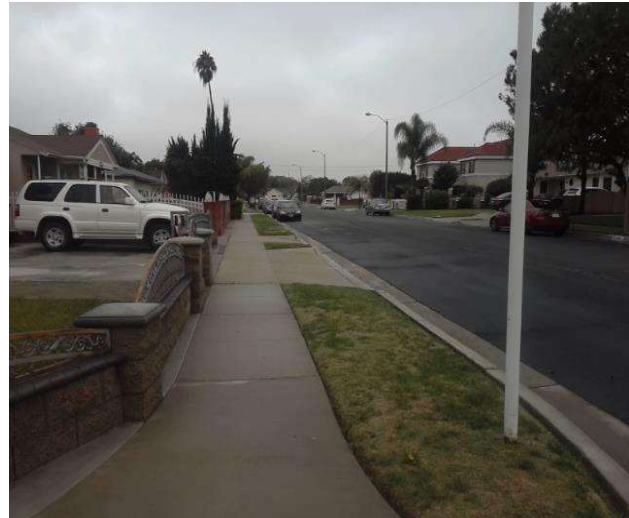
**South Side @ 33.924433081267, -118.137373030186**

Sidewalks : 60X60 Turn Area

There is no 60X60 turn area at every 200 feet.

**On-Site Finding** Not Found

**Code Reference** ADA 206, 302

Provide a 60X60 turn every 200 feet on the sidewalk.

\$2,400
