## Accessibility Survey

## City of Downey I 105 East Ramp & Lakewood Boulevard

Date of Inspection  
5/24/2017

**Disability Access Consultants**

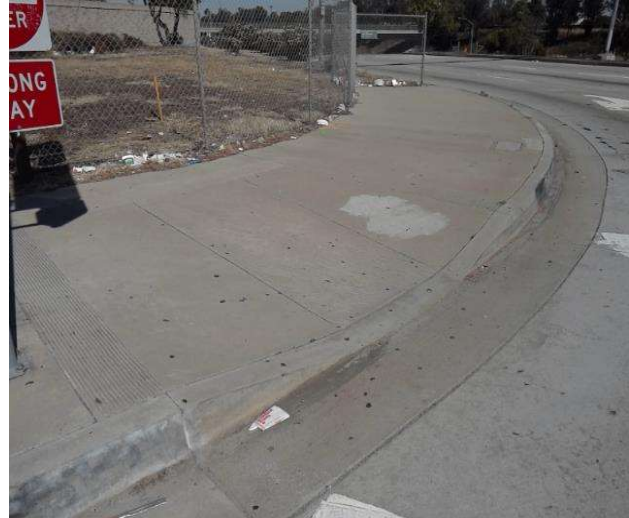
**Northeast Corner @ 33.913799478571, -118.139842003584**

Curb Ramp : No Detectable Warnings

The curb ramp does not provide a detectable warning surface which includes truncated domes.

**On-Site Finding** Not Found

**Code Reference** CA 11B-406.5.12

Provide compliant detectable warnings to surface.

Provide detectable warning to surface \$248

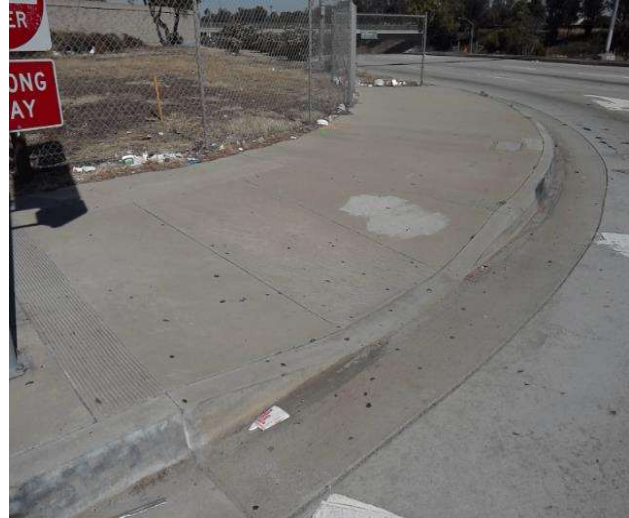
#### Northeast Corner @ 33.913799478571, -118.139842003584

Curb Ramp : Side Flare Slope

The slope of the curb ramp side flare is greater than allowed.

**On-Site Finding** 15.60 percent

**Code Reference** ADA 406, 406.3, CA 11B-406.2.2

Provide curb ramp side flares with a compliant slope.

Recommendation Up to 10.00 percent

Install flared sides \$1,300

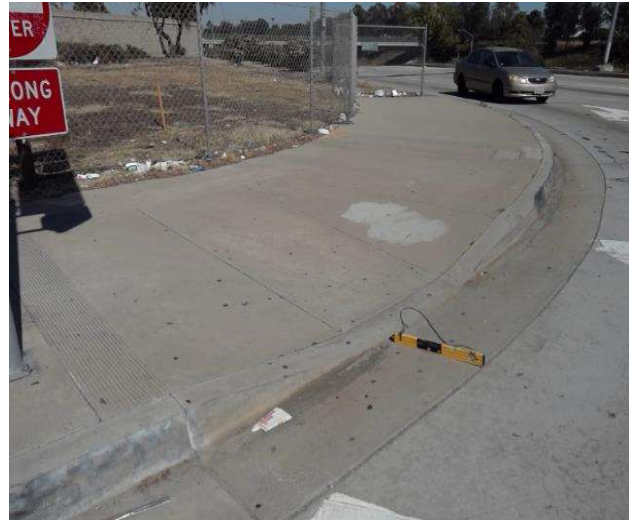
**Northeast Corner @ 33.913799478571, -118.139842003584**

Curb Ramp : Bottom Landing Slope

The bottom landing of the curb ramp is on the street, and the slope of the bottom landing is not compliant.

**On-Site Finding** 10.50 percent

**Code Reference** ADA 406, 406.2,CA 11B-406.5.8

Ensure the bottom landing slope is compliant and provides a smooth transition.

Recommendation Up to 5.00 percent

Repave landing \$1,260

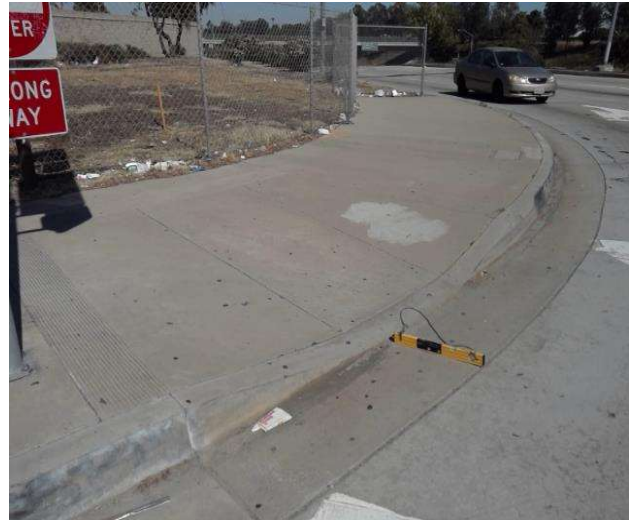
#### Northeast Corner @ 33.913799478571, -118.139842003584

Curb Ramp , Landings and Transitions : Top Landing Slope

The slope at the top landing is greater than allowed.

**On-Site Finding** 3.80 percent

**Code Reference** ADA 402, 406.4, 403.3, 406.1, CA 11B-406.5.3

Provide a top landing surface that does not exceed the maximum slope and cross slope. Provide a sufficient maneuvering clearance that does not accumulate water.

Recommendation Up to 2.08 percent

Provide compliant landing \$1,260

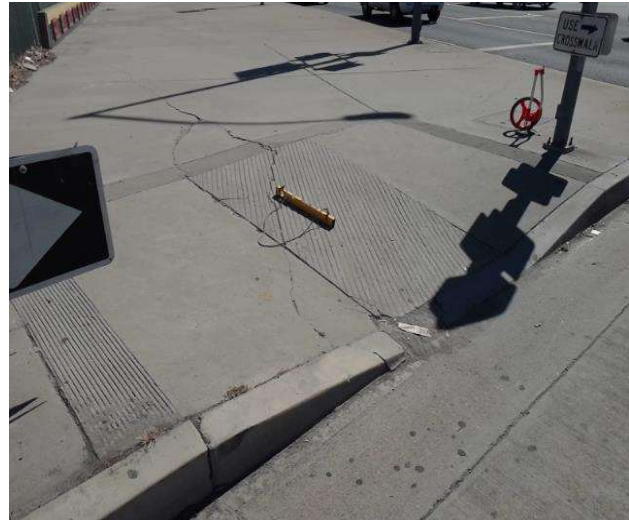
**Southeast Corner @ 33.913629196586, -118.142936125**

Curb Ramp : No Detectable Warnings

The curb ramp does not provide a detectable warning surface which includes truncated domes.

**On-Site Finding** Not Found

**Code Reference** CA 11B-406.5.12

Provide compliant detectable warnings to surface.

Provide detectable warning to surface \$248

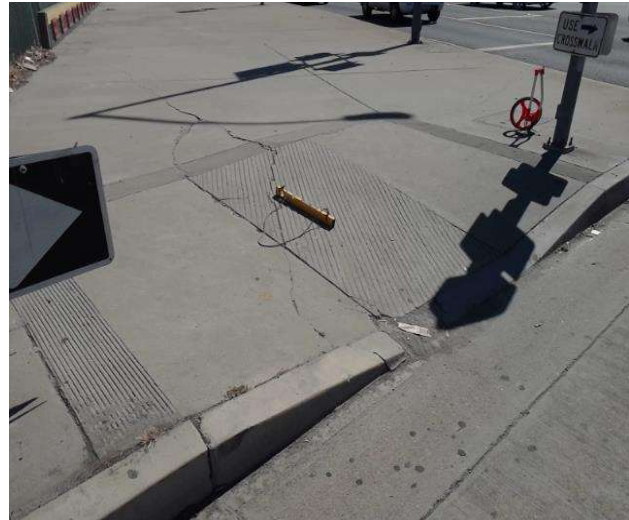
#### Southeast Corner @ 33.913629196586, -118.142936125

Curb Ramp : Not Wholly Contained Within The Marked Crossing

The curb ramp is not wholly contained within the marked crossing.

**Code Reference** ADA 406, 406.5

Provide a marked crossing on the path of travel; make certain the curb ramp is wholly contained within the marked crossing.

Install crosswalk \$800

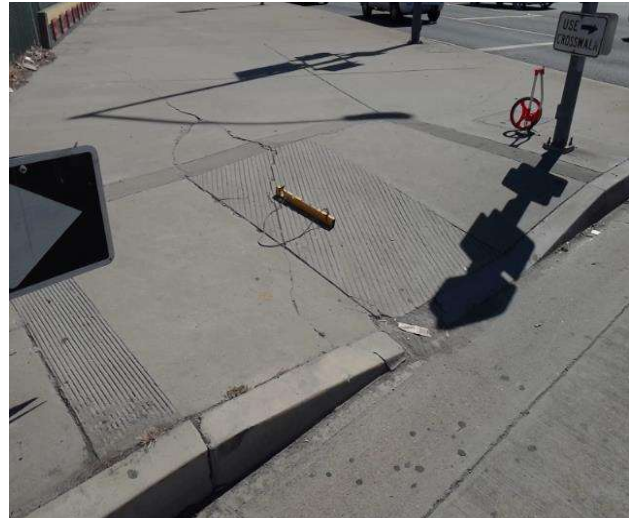
**Southeast Corner @ 33.913629196586, -118.142936125**

Curb Ramp : Curb Ramp Slope

The running slope is greater than allowed.

**On-Site Finding** 14.00 percent

**Code Reference** ADA 406, 406.1, 405.2, CA 11B-406

Provide a compliant curb ramp.

Recommendation Up to 8.33 percent

Install curb ramp \$1,300

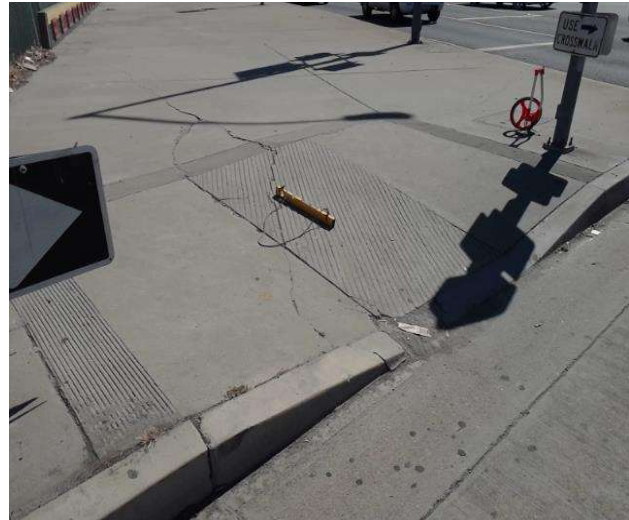
#### Southeast Corner @ 33.913629196586, -118.142936125

Curb Ramp : Side Flare Slope

The slope of the curb ramp side flare is greater than allowed.

**On-Site Finding** 13.60 percent

**Code Reference** ADA 406, 406.3, CA 11B-406.2.2

Provide curb ramp side flares with a compliant slope.

Recommendation Up to 10.00 percent

Install flared sides \$1,300

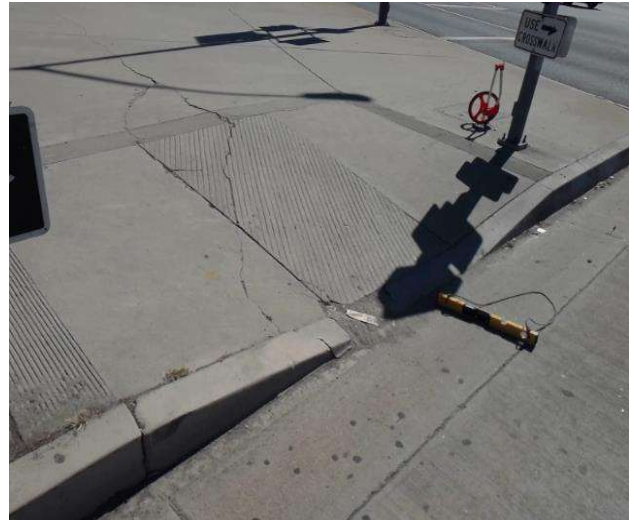
**Code Reference** ADA 406, 406.2, CA 11B-406.5.8

Recommendation Up to 5.00 percent

Repave landing \$1,260

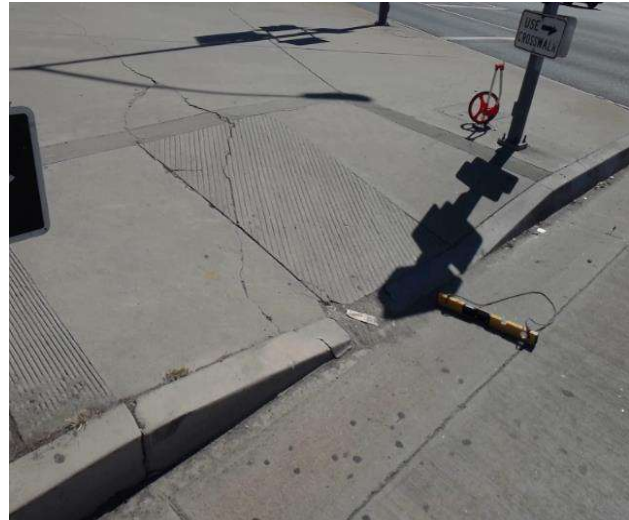
**Code Reference** ADA 302, 303, 406.2, 303.1

Recommendation Up to 0.50 inches

Patch lip at curb ramp \$255

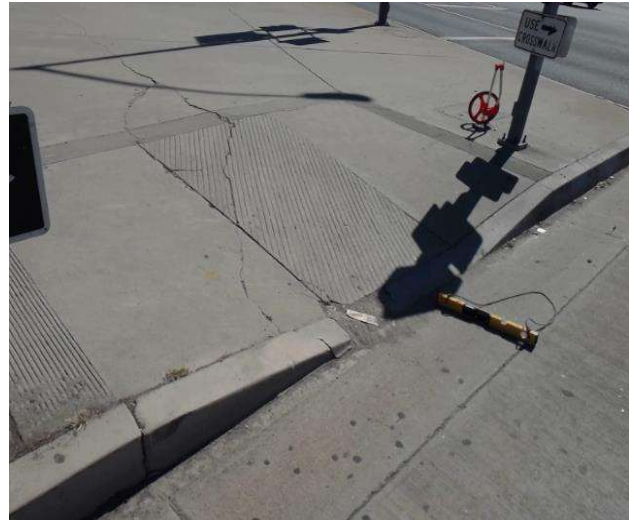
**Code Reference** ADA 402, 406.4, 403.3, 406.1, CA 11B-406.5.3

Recommendation Up to 2.08 percent

Provide compliant landing \$1,260

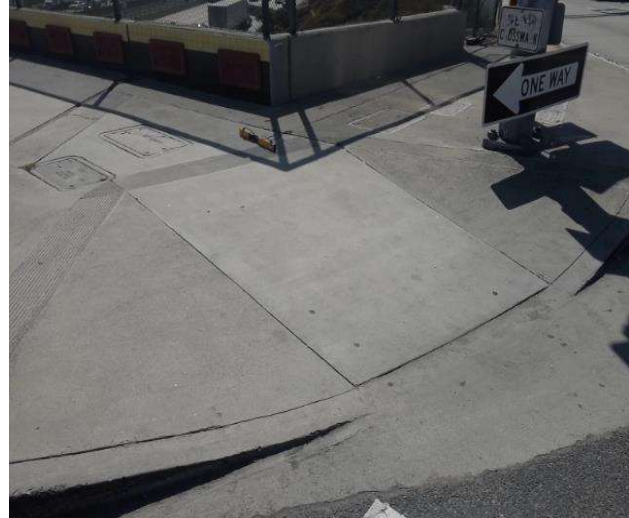
The overlayment causes a noncompliant change in level.

**Code Reference** ADA 303.2, 303.3,CA 11B-303.3,CA 11B-303.2

Ensure the change in elevation is within the recommended height.

Recommendation 0.25 - 0.50 inches

Provide smooth surface \$150
