# Accessibility Survey

## City of Downey Mantee Street - MCGovern Avenue to Gurley Avenue

Date of Inspection  
8/29/2017

**Disability Access Consultants**

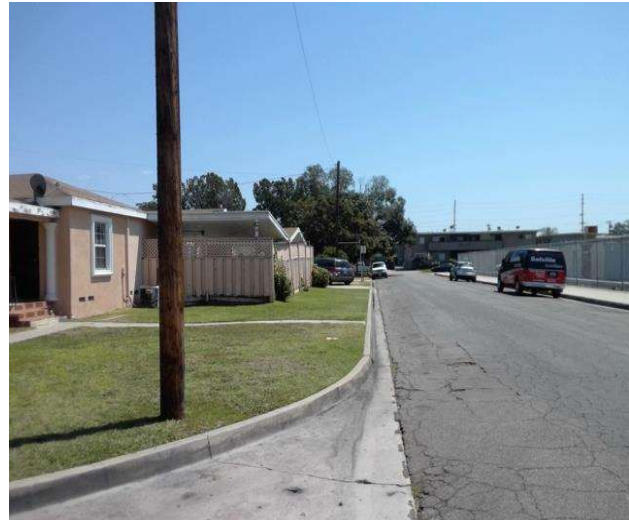
**North Side @ 33.936665368717, -118.138212561607**

Sidewalks : No Sidewalk

No sidewalk exists at the location.

**On-Site Finding** Not Found

No action necessary until a sidewalk is provided.

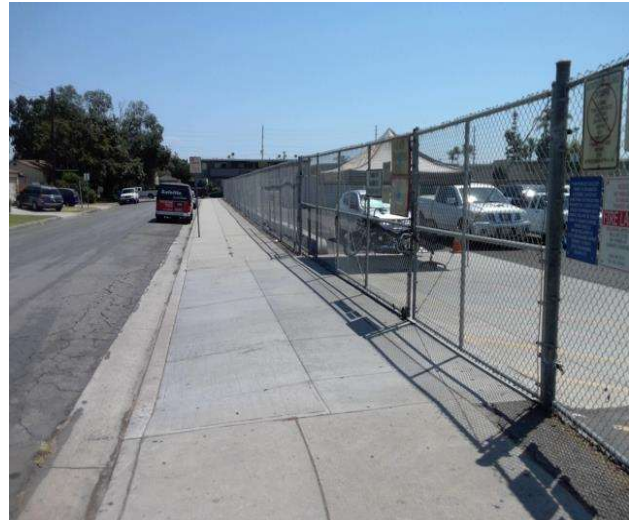
#### Driveway East of MCGovern Avenue @ 33.936578581636, -118.138307780027

Sidewalks , Vehicular Traffic : Cross Walks and Detectable Warnings

There are no detectable warnings where the pedestrian route crosses vehicular traffic.

**On-Site Finding** Not Found

Provide detectable warnings.

Install compliant detectable warnings \$190

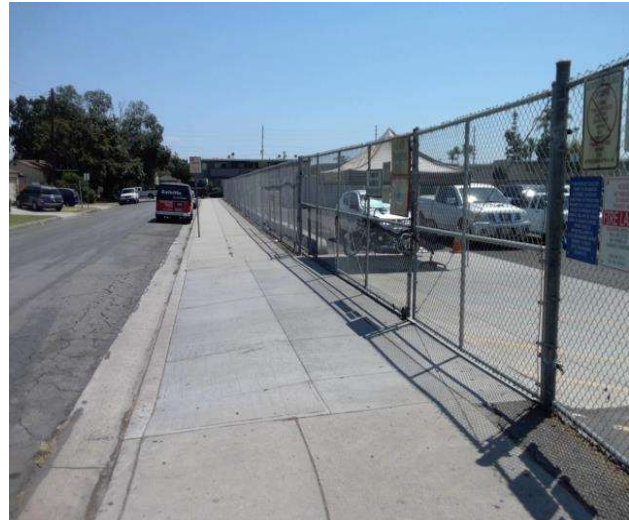
#### Driveway East of Mcgovern Avenue @ 33.936578581636, -118.138307780027

Sidewalks : Vehicular Traffic Cross Slope

Cross slope at vehicular traffic is not compliant.

**On-Site Finding** 2.80 percent

Repave the surface to provide a compliant cross slope.

Recommendation Up to 2.08 percent

Repave surface \$1,092

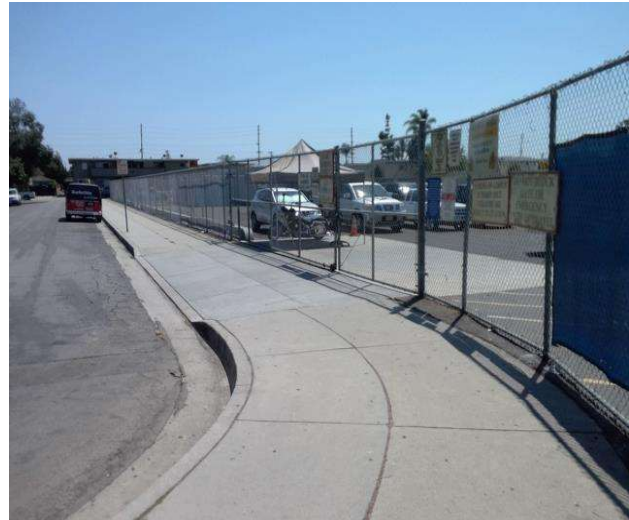
#### Sidewalk East of MCGovern Avenue to Gurley Avenue @ 33.936660918100, - 118.138390928507

Sidewalks , Surface : Cross Slope

Sidewalk cross slope is not compliant.

**On-Site Finding** 3.60 percent for 200.00 feet

Repave the sidewalk surface with the recommended cross slope.

Recommendation Up to 2.08 percent

Repave surface \$1,092

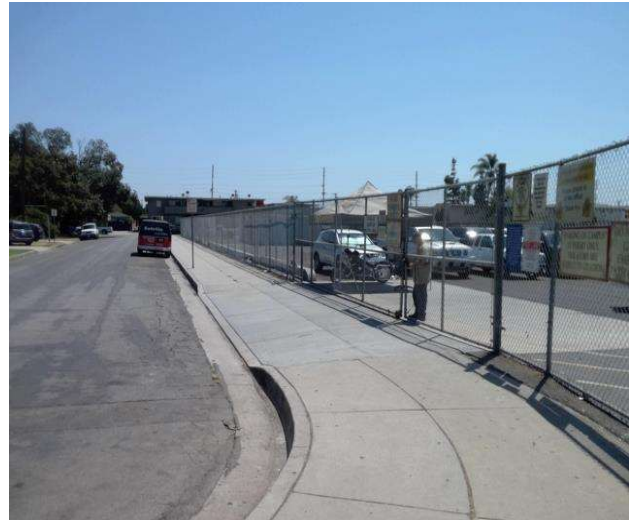
#### South Side @ 33.936626425807, -118.138366788626

Sidewalks : 60X60 Turn Area

There is no 60X60 turn area at every 200 feet.

**On-Site Finding** Not Found

Provide a 60X60 turn every 200 feet on the sidewalk.

\$2,400

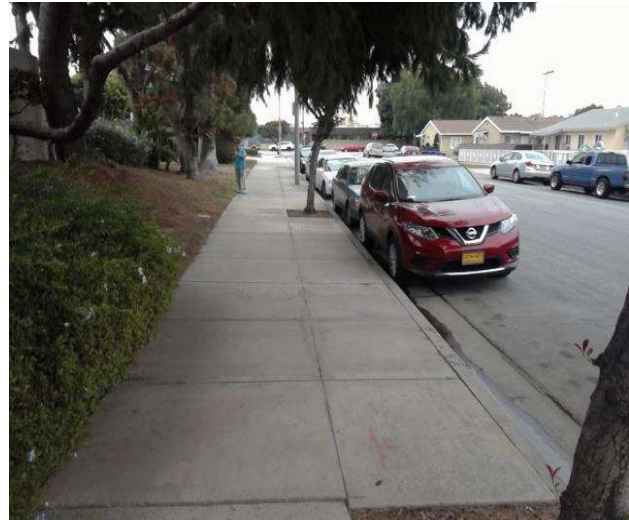
#### Change In Level East Of Brookshire Avenue @ 33.933688966383, - 118.131453394890

Sidewalks , Change in Level : Change in Level Non Beveled

There is a change in elevation greater than recommended value.

**On-Site Finding** 0.50 inches

Ensure that the change in elevation is within the recommended value.

Recommendation Up to 0.25 inches

Remove tripping hazards \$198

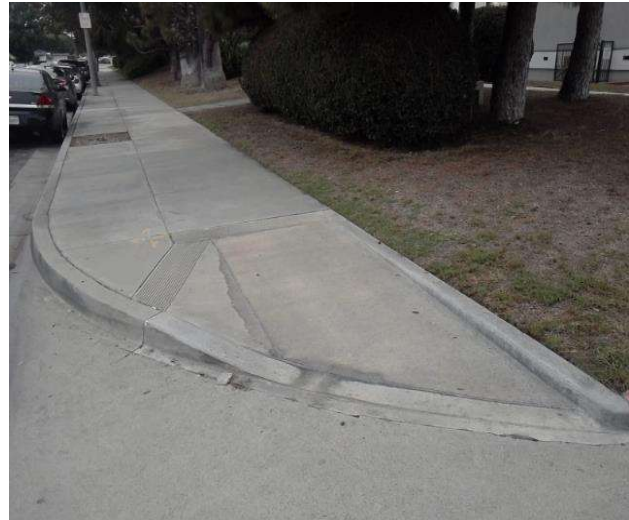
#### North Side East Of Brookshire Avenue - 1st @ 33.933519836846, - 118.131040334702

Curb Ramp , Landings and Transitions : Top Landing Slope

The slope at the top landing is greater than allowed.

**On-Site Finding** 2.30 percent

Provide a top landing surface that does not exceed the maximum slope and cross slope. Provide a sufficient maneuvering clearance that does not accumulate water.

Recommendation Up to 2.08 percent

Provide compliant landing \$1,260

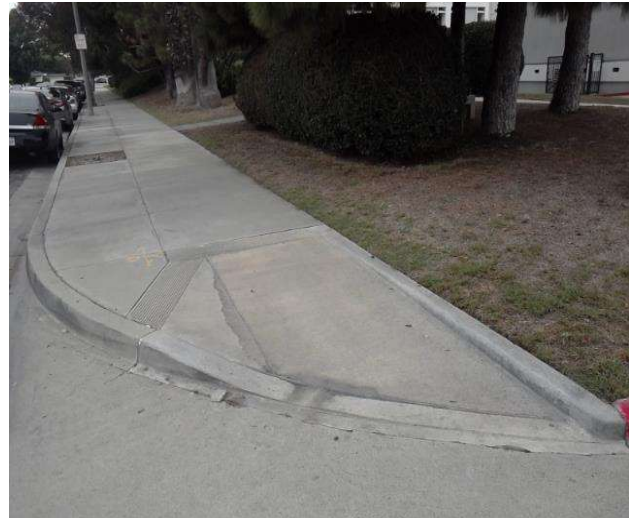
**North Side East Of Brookshire Avenue - 1st @ 33.933519836846, - 118.131040334702**

Curb Ramp : No Detectable Warnings

The curb ramp does not provide a detectable warning surface which includes truncated domes.

**On-Site Finding** Not Found

Provide compliant detectable warnings to surface.

Provide detectable warning to surface \$248

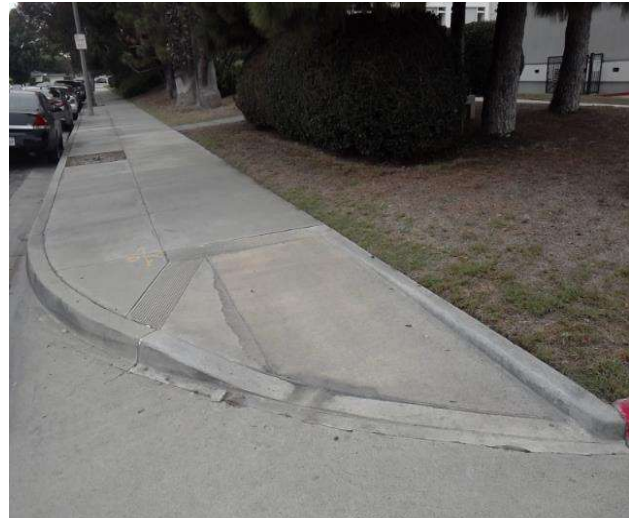
#### North Side East Of Brookshire Avenue - 1st @ 33.933519836846, - 118.131040334702

Curb Ramp : No Contrasting Finish

The surface of the curb ramp does not have a finish that contrasts with the adjacent sidewalk.

**On-Site Finding** Not Found

Provide the surface on the curb ramp that contrasts with the adjacent sidewalk.

Apply contrasting finish to surface \$155

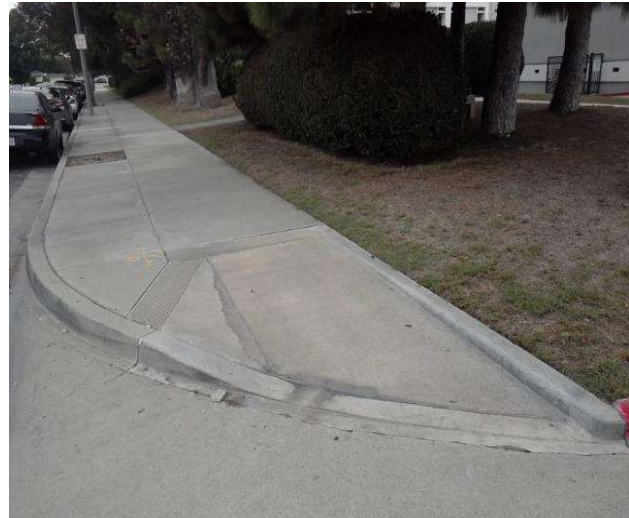
**North Side East Of Brookshire Avenue - 1st @ 33.933519836846, - 118.131040334702**

Curb Ramp : Curb Ramp - Cross Slope

The cross slope is greater than allowed.

**On-Site Finding** 3.60 percent

Provide a compliant curb ramp.

Recommendation Up to 2.08 percent

Install curb ramp \$1,300

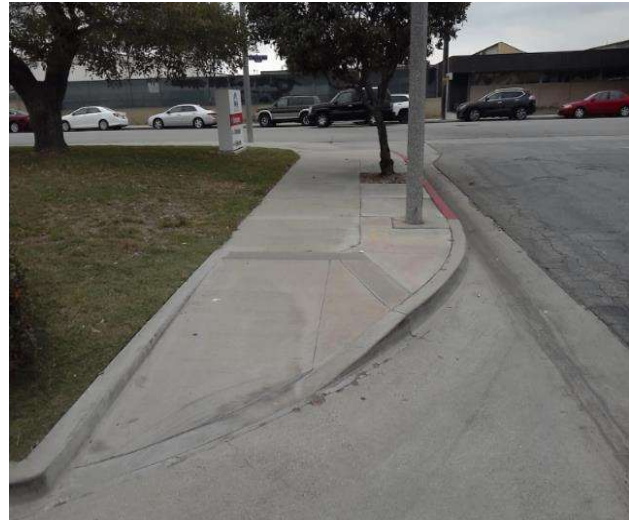
**North Side East Of Brookshire Avenue - 2nd @ 33.933488681368, - 118.130847215652**

Curb Ramp : No Detectable Warnings

The curb ramp does not provide a detectable warning surface which includes truncated domes.

**On-Site Finding** Not Found

Provide compliant detectable warnings to surface.

Provide detectable warning to surface \$248

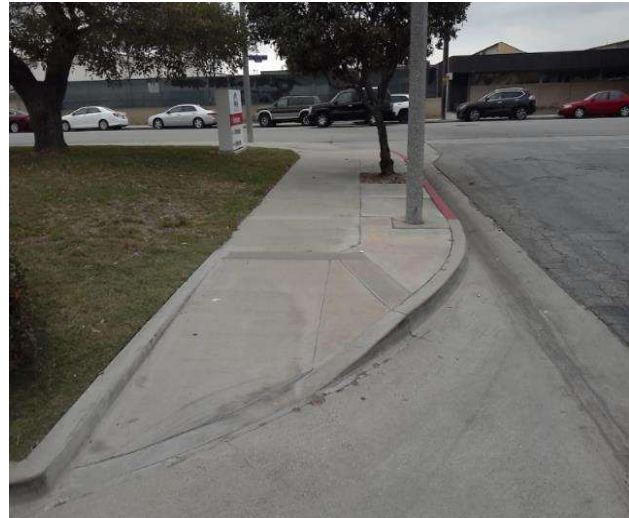
**North Side East Of Brookshire Avenue - 2nd @ 33.933488681368, - 118.130847215652**

Curb Ramp : Curb Ramp - Cross Slope

The cross slope is greater than allowed.

**On-Site Finding** 4.80 percent

Provide a compliant curb ramp.

Recommendation Up to 2.08 percent

Install curb ramp \$1,300

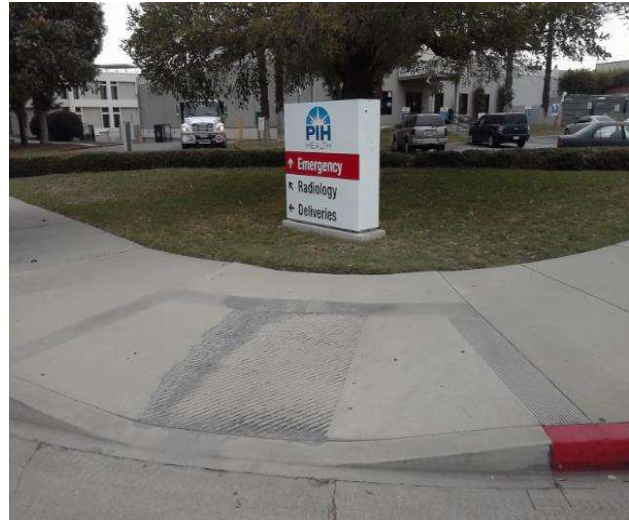
#### Northwest Corner Of Patton Road @ 33.933430821165, - 118.130713105202

Curb Ramp : No Detectable Warnings

The curb ramp does not provide a detectable warning surface which includes truncated domes.

**On-Site Finding** Not Found

Provide compliant detectable warnings to surface.

Provide detectable warning to surface \$248

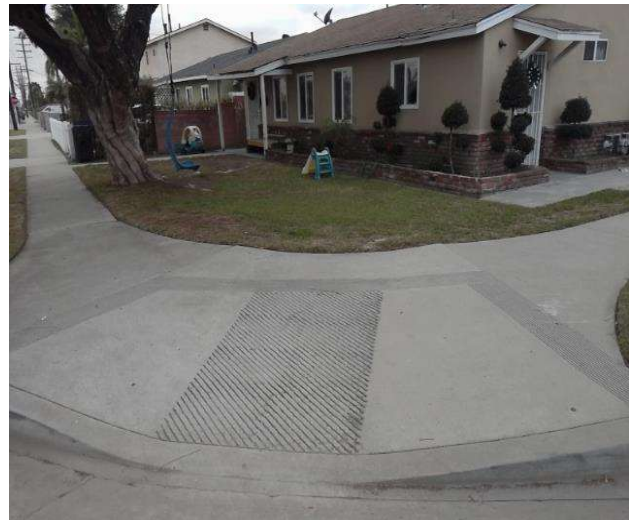
**Southwest Corner Of Patton Road @ 33.933346256182, - 118.130911588669**

Curb Ramp : No Detectable Warnings

The curb ramp does not provide a detectable warning surface which includes truncated domes.

**On-Site Finding** Not Found

Provide compliant detectable warnings to surface.

Provide detectable warning to surface \$248

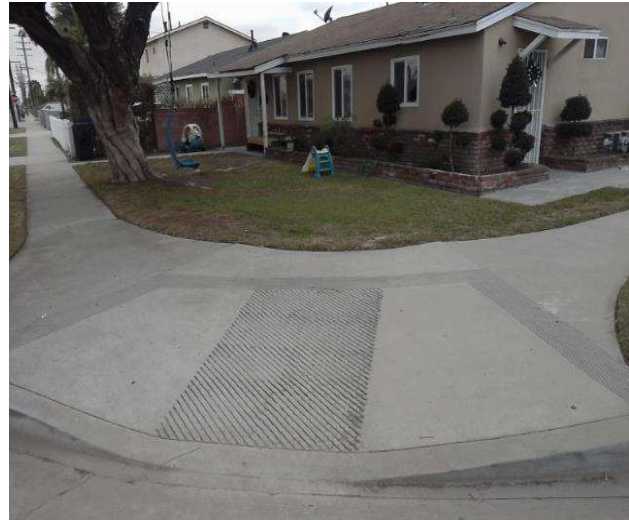
**Southwest Corner Of Patton Road @ 33.933346256182, -  
118.130911588669**

Curb Ramp : Side Flare Slope

The slope of the curb ramp side flare is greater than allowed.

**On-Site Finding** 10.40 percent

Provide curb ramp side flares with a compliant slope.

Recommendation Up to 10.00 percent

Install flared sides \$1,300

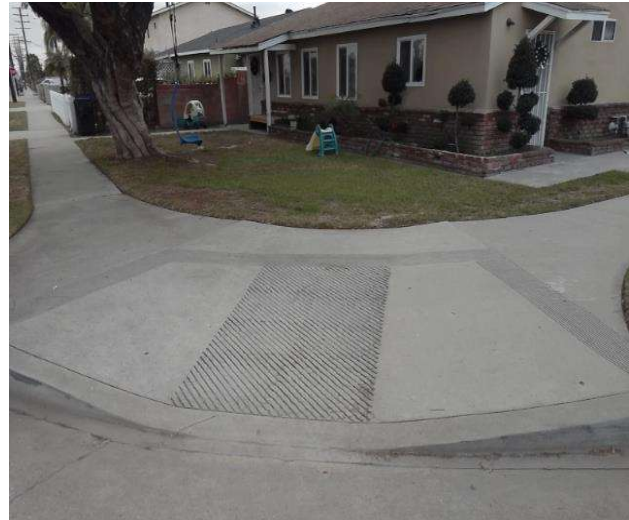
**Southwest Corner Of Patton Road @ 33.933346256182, - 118.130911588669**

Curb Ramp , Landings and Transitions : Top Landing Clear Length - Landings

There is not enough top landing clear length.

**On-Site Finding** 45.00 inches

Provide a level top landing with enough clear length.

Recommendation At least 48.00 inches

Provide compliant landing \$240

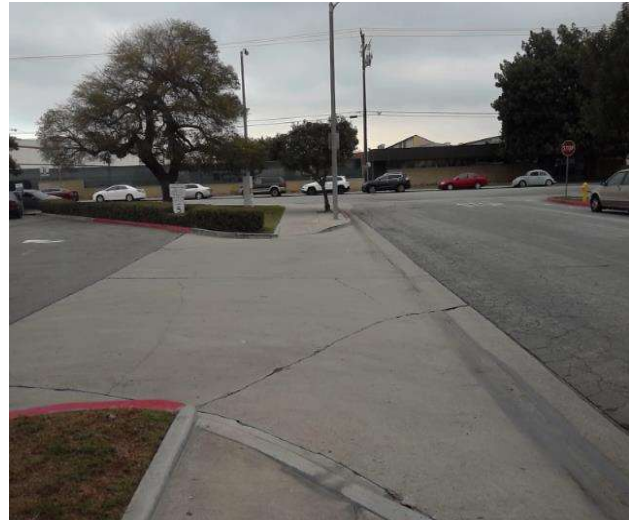
#### Driveway East Of Brookshire Avenue @ 33.933515386064, -118.130943775177

Sidewalks , Vehicular Traffic : Cross Walks and Detectable Warnings

There are no detectable warnings where the pedestrian route crosses vehicular traffic.

**On-Site Finding** Not Found

Provide detectable warnings.

Install compliant detectable warnings \$190

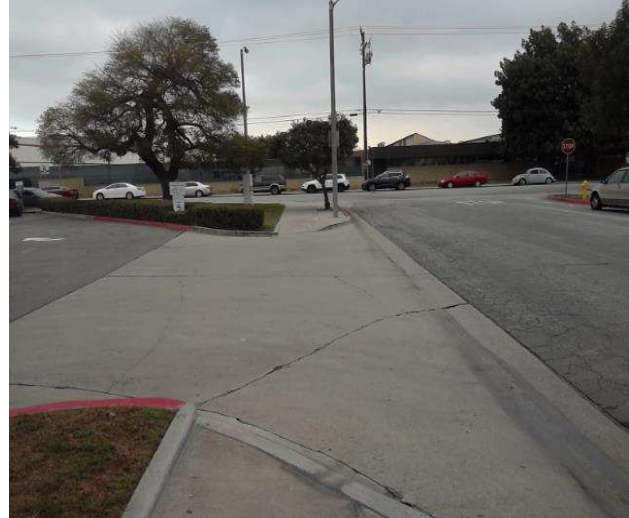
**Driveway East Of Brookshire Avenue @ 33.933515386064, -118.130943775177**

Sidewalks : Vehicular Traffic Cross Slope

Cross slope at vehicular traffic is not compliant.

**On-Site Finding** 4.40 percent

Repave the surface to provide a compliant cross slope.

Recommendation Up to 2.08 percent

Repave surface \$1,092

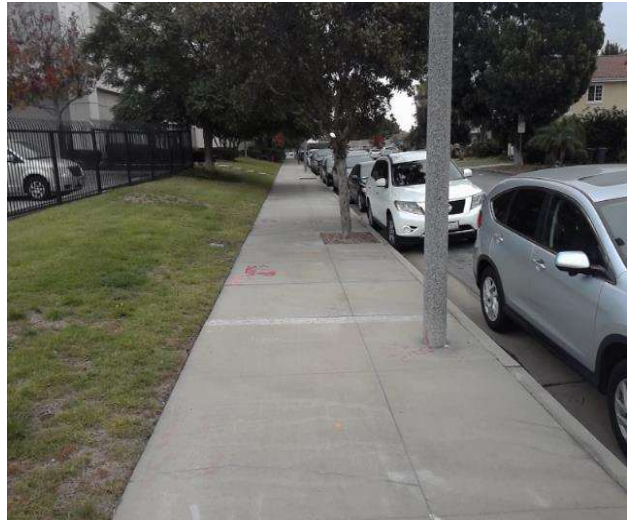
#### Sidewalk East Of Brookshire Avenue @ 33.934249761917, -118.132601380348

Sidewalks , Surface : Cross Slope

Sidewalk cross slope is not compliant.

**On-Site Finding** 2.80 percent for 95.00 feet

Repave the sidewalk surface with the recommended cross slope.

Recommendation Up to 2.08 percent

Repave surface \$1,092

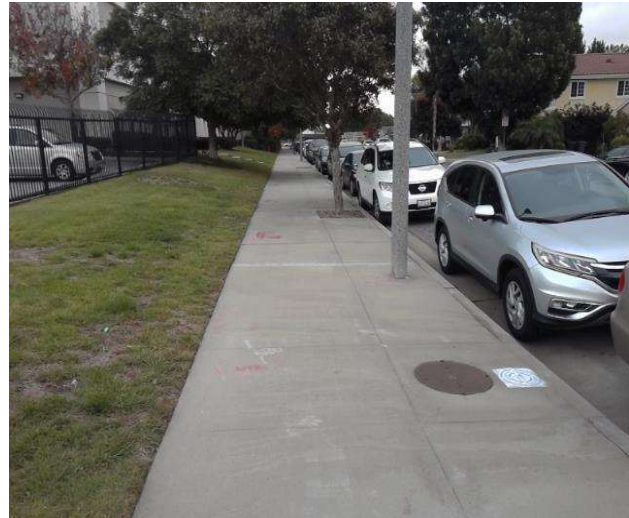
#### North Side @ 33.934249761917, -118.132601380348

Sidewalks : 60X60 Turn Area

There is no 60X60 turn area at every 200 feet.

**On-Site Finding** Not Found

Provide a 60X60 turn every 200 feet on the sidewalk.

\$2,400

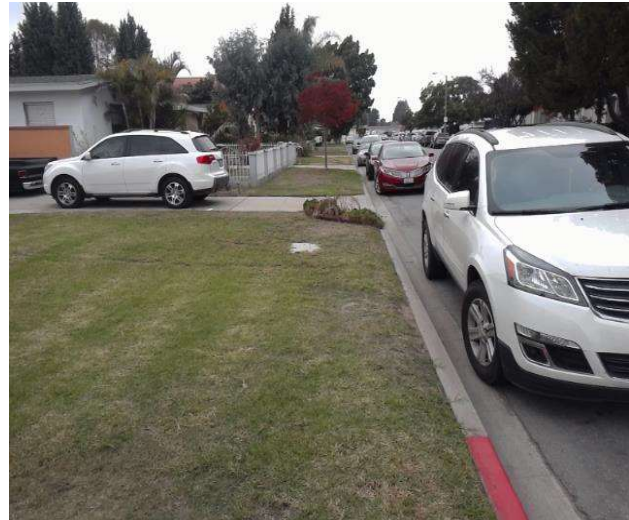
#### Sidewalk West Of Patton Road @ 33.933809137165, -118.131941556931

Sidewalks : Missing Sidewalk

Section of sidewalk is missing and consists of dirt, grass or gravel.

**On-Site Finding** 387.00 feet

Provide a compliant sidewalk for the missing section.

\$1,260

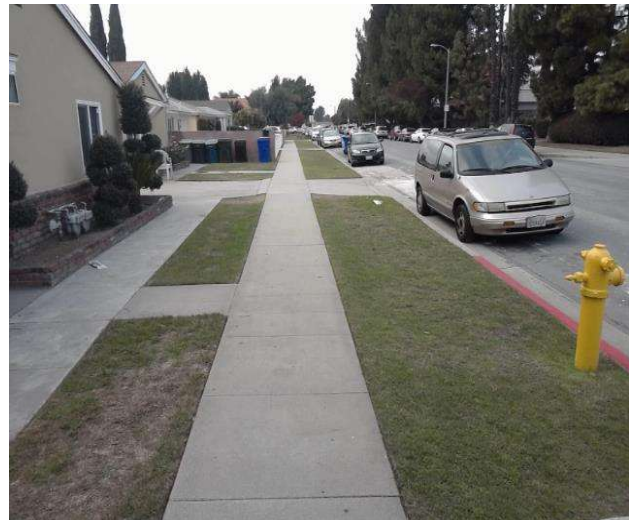
**South Side @ 33.933346256182, -118.130911588669**

Sidewalks : 60X60 Turn Area

There is no 60X60 turn area at every 200 feet.

**On-Site Finding** Not Found

Provide a 60X60 turn every 200 feet on the sidewalk.

\$2,400
