Accessibility Survey

City of Downey Via Rio Nido - Old River School Road to Sherry Avenue

Date of Inspection 6/27/2017

Disability Access Consultants

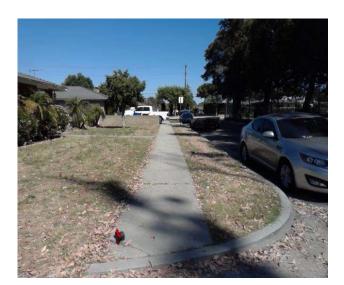
Change in Level West of Old River School Road @ 33.956087872011, - 118.143332898617

Sidewalks , Change in Level : Change in Level Non Beveled

There is a change in elevation greater than recommended value.

On-Site Finding 1.50 inches

Code Reference ADA 206, 302

Ensure that the change in elevation is within the recommended value.

Recommendation Up to 0.25 inches

Remove tripping hazards \$198

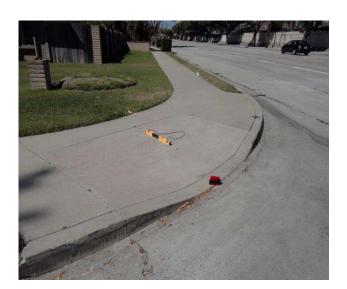
Northwest Corner of Old River School Road @ 33.955846480769, - 118.142864853144

Curb Ramp : No Detectable Warnings

The curb ramp does not provide a detectable warning surface which includes truncated domes.

On-Site Finding Not Found

Code Reference CA 11B-406.5.12

Provide compliant detectable warnings to surface.

Provide detectable warning to \$248 surface

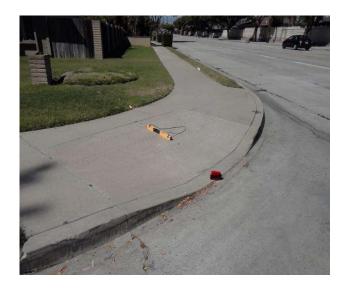
Northwest Corner of Old River School Road @ 33.955846480769, - 118.142864853144

Curb Ramp : Curb Ramp Slope

The running slope is greater than allowed.

On-Site Finding 10.50 percent

Code Reference ADA 406, 406.1, 405.2,CA 11B-406

Provide a compliant curb ramp.

Recommendation Up to 8.33 percent

Install curb ramp \$1,300

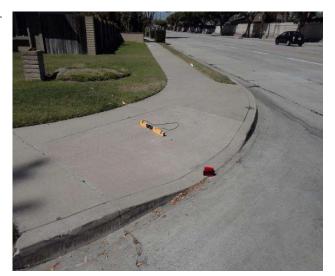
Northwest Corner of Old River School Road @ 33.955846480769, - 118.142864853144

Curb Ramp : Side Flare Slope

The slope of the curb ramp side flare is greater than allowed.

On-Site Finding 13.60 percent

Code Reference ADA 406, 406.3,CA 11B-406.2.2

Provide curb ramp side flares with a compliant slope.

Recommendation Up to 10.00 percent

Install flared sides \$1,300

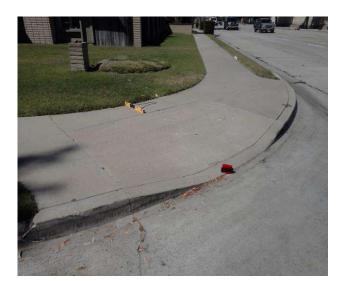
Northwest Corner of Old River School Road @ 33.955846480769, - 118.142864853144

The slope at the top landing is greater than allowed.

On-Site Finding 2.60 percent

Curb Ramp , Landings and Transitions : Top Landing Slope

Code Reference ADA 402, 406.4, 403.3, 406.1,CA 11B-406.5.3

Provide a top landing surface that does not exceed the maximum slope and cross slope. Provide a sufficient maneuvering clearance that does not accumulate water.

Recommendation Up to 2.08 percent

Provide compliant landing \$1,260

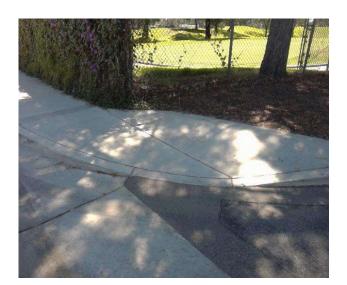
Southwest Corner of Old River School Road @ 33.955778624122, - 118.142943978310

Curb Ramp : No Detectable Warnings

The curb ramp does not provide a detectable warning surface which includes truncated domes.

On-Site Finding Not Found

Code Reference CA 11B-406.5.12

Provide compliant detectable warnings to surface.

Provide detectable warning to \$248 surface

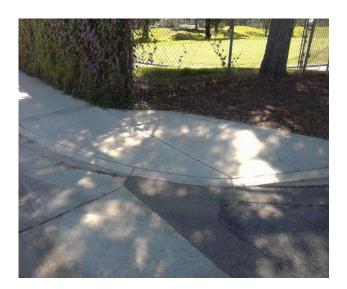
Southwest Corner of Old River School Road @ 33.955778624122, - 118.142943978310

Curb Ramp : Curb Ramp Width

The width of the curb ramp is less than required.

On-Site Finding 29.00 inches

Code Reference ADA 406, 406.1, 405.5,CA 11B-406.5.2

Provide a compliant curb ramp.

Recommendation At least 48.00 inches

Install curb ramp \$1,300

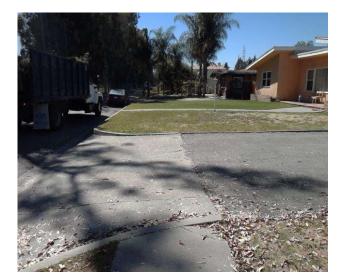
Alley West of Old River School Road @ 33.956088984411, -118.143377155066

Sidewalks , Vehicular Traffic : Cross Walks and Detectable Warnings

There are no detectable warnings where the pedestrian route crosses vehicular traffic.

On-Site Finding Not Found

Code Reference ADA 705,CA 11B-705.1.2.5,CA 11B-247.1.2.5

Provide detectable warnings.

Install compliant detectable \$190 warnings

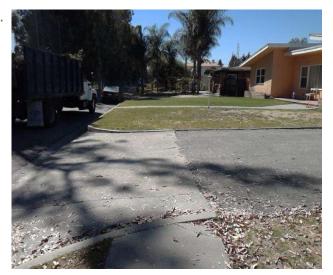
Alley West of Old River School Road @ 33.956088984411, -118.143377155066

Sidewalks : Vehicular Traffic Cross Slope

Cross slope at vehicular traffic is not compliant.

On-Site Finding 4.00 percent

Code Reference ADA 206, 302,CA 11B-403.3

Repave the surface to provide a compliant cross slope.

Recommendation Up to 2.08 percent

Repave surface \$1,092

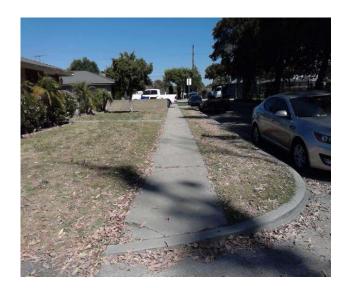
Curb West of Old River School Road @ 33.956087872011, -118.143332898617

Sidewalks , Hazards & Gratings : Curb is on Path of Travel

There is a curb on the designated path of travel.

On-Site Finding Not Compliant

Code Reference ADA 402, 303, 406, 403.4, 303.4

Provide a compliant curb ramp.

Install curb ramp \$2,500

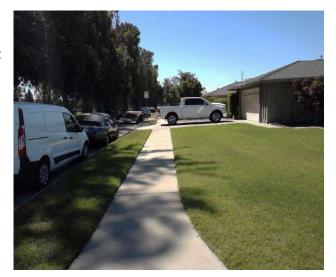
Sidewalk West of Old River School Road @ 33.955856492401, -118.142899721861

Sidewalks , Surface : Cross Slope

Sidewalk cross slope is not compliant.

On-Site Finding 3.20 percent for 160.00 feet

Code Reference ADA 206, 302,CA 11B-403.3

Repave the sidewalk surface with the recommended cross slope.

Recommendation Up to 2.08 percent

Repave surface \$1,092

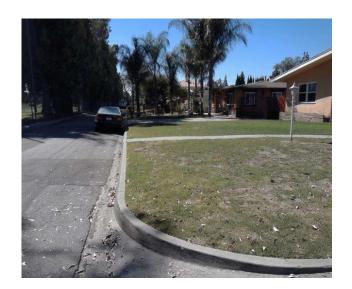
Sidewalk West of Old River School Road @ 33.956112344818, -118.143410682678

Sidewalks : Missing Sidewalk

Section of sidewalk is missing and consists of dirt, grass or gravel.

On-Site Finding 500.00 feet

Code Reference ADA 206, 302, CA 11B-302, CA 11B-206

Provide a compliant sidewalk for the missing section.

\$1,260

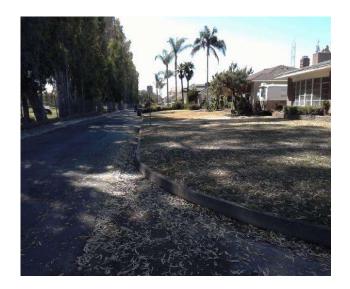
Sidewalk West of Susan Avenue @ 33.956922168264, -118.144928812981

Sidewalks : Missing Sidewalk

Section of sidewalk is missing and consists of dirt, grass or gravel.

On-Site Finding 830.00 feet

Code Reference ADA 206, 302,CA 11B-302,CA 11B-206

Provide a compliant sidewalk for the missing section.

\$1,260

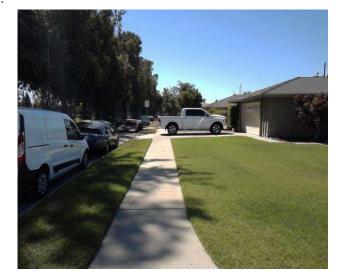
North Side @ 33.955852042787, -118.142887651920

Sidewalks : 60X60 Turn Area

There is no 60X60 turn area at every 200 feet.

On-Site Finding Not Found

Code Reference ADA 206, 302

Provide a 60X60 turn every 200 feet on the sidewalk.

\$2,400

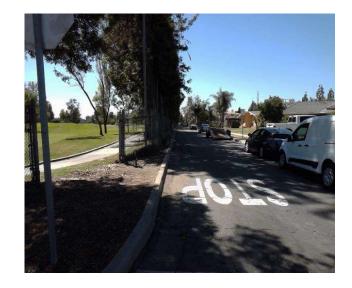
South Side @ 33.955778624122, -118.142943978310

Sidewalks : No Sidewalk

No sidewalk exists at the location.

On-Site Finding Not Found

No action necessary until a sidewalk is provided.

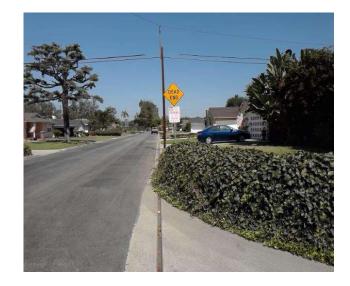
North Side @ 33.954969902206, -118.141144216061

Sidewalks : No Sidewalk

No sidewalk exists at the location.

On-Site Finding Not Found

No action necessary until a sidewalk is provided.

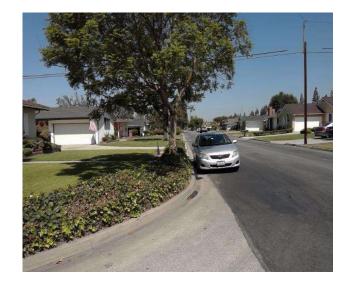
South Side @ 33.954867559957, -118.141222122

Sidewalks : No Sidewalk

No sidewalk exists at the location.

On-Site Finding Not Found

No action necessary until a sidewalk is provided.
