# Accessibility Survey

## City of Downey Dalen Street - Barlin Avenue To Lakewood Boulevard

Date of Inspection  
4/5/2017

**Disability Access Consultants**

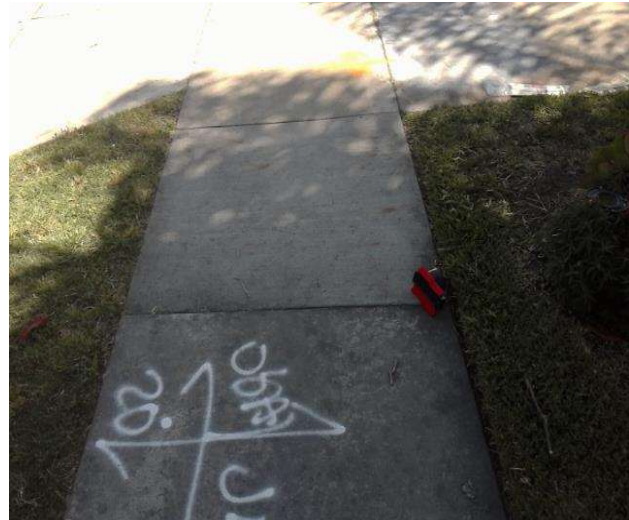
**Change In Level West Of Lakewood Boulevard @ 33.916493895266, - 118.141075819731**

Sidewalks , Change in Level : Change in Level Non Beveled

There is a change in elevation greater than recommended value.

**On-Site Finding** 0.37 inches

**Code Reference** ADA 206, 302

Ensure that the change in elevation is within the recommended value.

Recommendation Up to 0.25 inches

Remove tripping hazards \$198

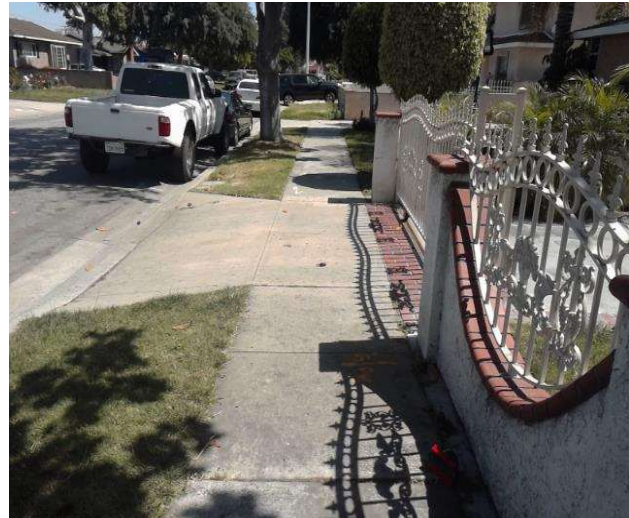
**Change In Level West Of Lakewood Boulevard @ 33.916567347812, - 118.141216635704**

Sidewalks , Change in Level : Change in Level Non Beveled

There is a change in elevation greater than recommended value.

**On-Site Finding** 0.50 inches

**Code Reference** ADA 206, 302

Ensure that the change in elevation is within the recommended value.

Recommendation Up to 0.25 inches

Remove tripping hazards \$198

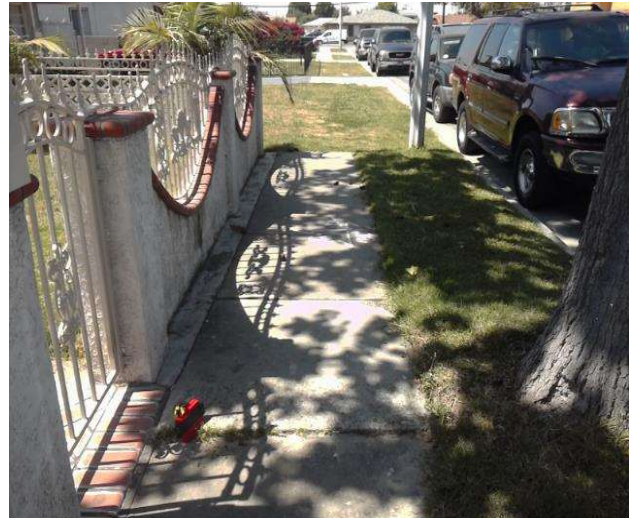
**Change In Level West Of Lakewood Boulevard @ 33.916580702814, - 118.141236752272**

Sidewalks , Change in Level : Change in Level Non Beveled

There is a change in elevation greater than recommended value.

**On-Site Finding** 0.75 inches

**Code Reference** ADA 206, 302

Ensure that the change in elevation is within the recommended value.

Recommendation Up to 0.25 inches

Remove tripping hazards \$198

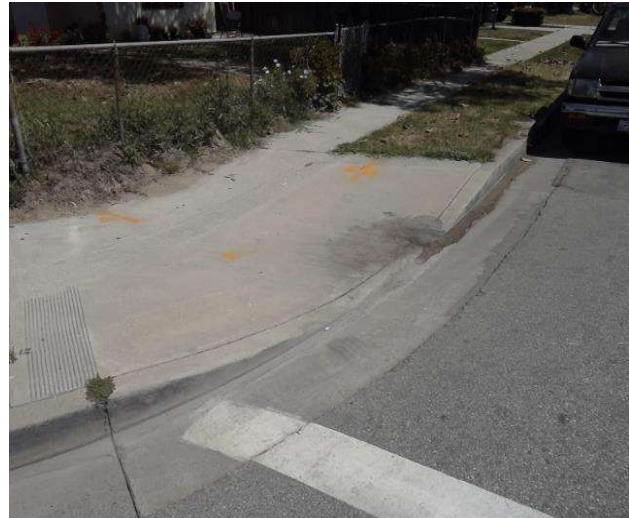
**Northeast Corner Of Barlin Avenue @ 33.916978013153, - 118.141728937626**

Curb Ramp : No Detectable Warnings

The curb ramp does not provide a detectable warning surface which includes truncated domes.

**On-Site Finding** Not Found

**Code Reference** CA 11B-406.5.12

Provide compliant detectable warnings to surface.

Provide detectable warning to surface \$248

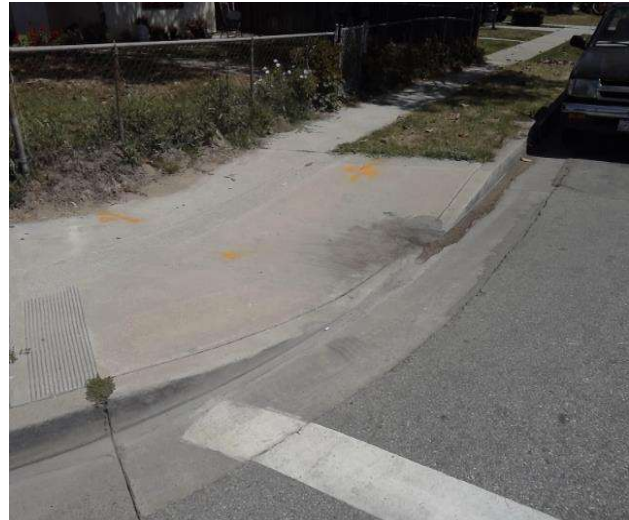
#### Northeast Corner Of Barlin Avenue @ 33.916978013153, - 118.141728937626

Curb Ramp : Side Flare Slope

The slope of the curb ramp side flare is greater than allowed.

**On-Site Finding** 10.80 percent

**Code Reference** ADA 406, 406.3, CA 11B-406.2.2

Provide curb ramp side flares with a compliant slope.

Recommendation Up to 10.00 percent

Install flared sides \$1,300

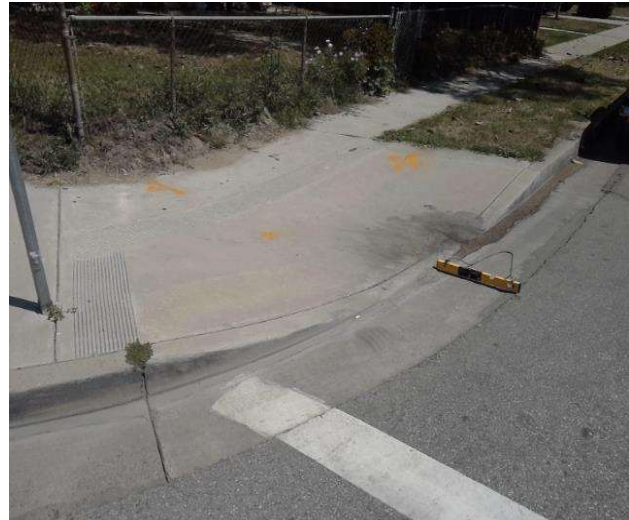
**Northeast Corner Of Barlin Avenue @ 33.916978013153, - 118.141728937626**

Curb Ramp : Bottom Landing Slope

The bottom landing of the curb ramp is on the street, and the slope of the bottom landing is not compliant.

**On-Site Finding** 9.40 percent

**Code Reference** ADA 406, 406.2, CA 11B-406.5.8

Ensure the bottom landing slope is compliant and provides a smooth transition.

Recommendation Up to 5.00 percent

Repave landing \$1,260

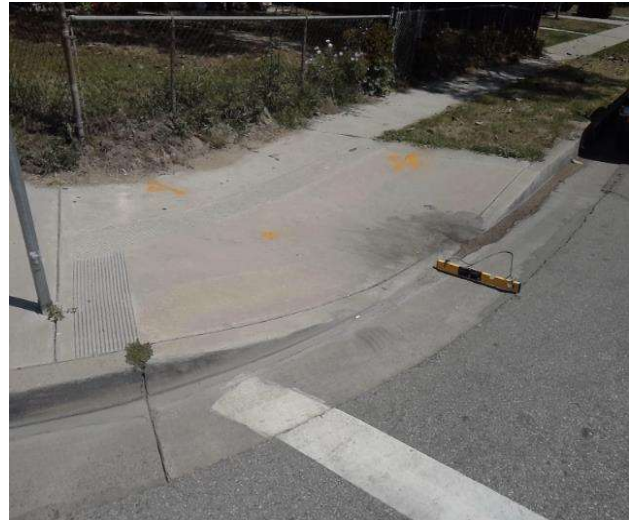
**Northeast Corner Of Barlin Avenue @ 33.916978013153, - 118.141728937626**

Curb Ramp , Landings and Transitions : Top Landing Clear Length - Landings

There is not enough top landing clear length.

**On-Site Finding** 46.50 inches

**Code Reference** ADA 406, 406.4,CA 11B-406.5.3

Provide a level top landing with enough clear length.

Recommendation At least 48.00 inches

Provide compliant landing \$240

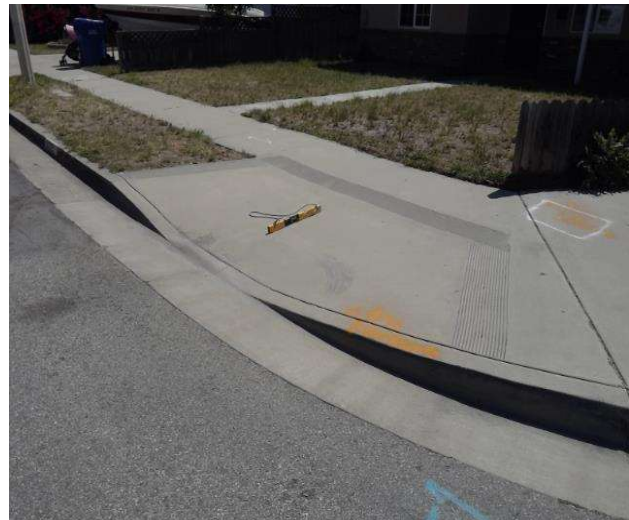
**Southeast Corner Of Barlin Avenue @ 33.916887867272, - 118.141777217388**

Curb Ramp : No Detectable Warnings

The curb ramp does not provide a detectable warning surface which includes truncated domes.

**On-Site Finding** Not Found

**Code Reference** CA 11B-406.5.12

Provide compliant detectable warnings to surface.

Provide detectable warning to surface \$248

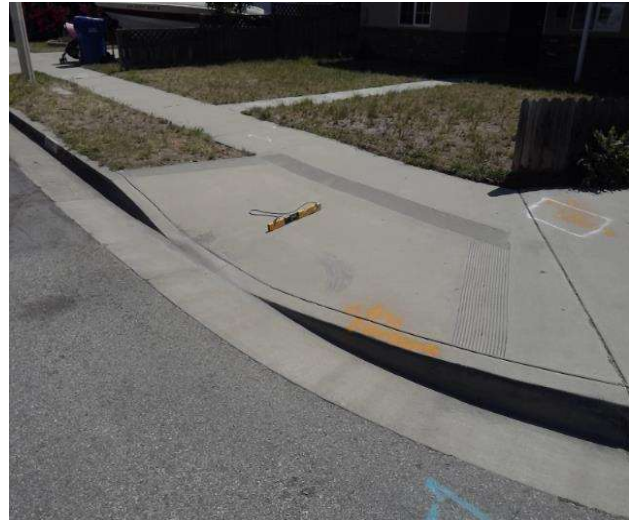
**Southeast Corner Of Barlin Avenue @ 33.916887867272, - 118.141777217388**

Curb Ramp : Curb Ramp Slope

The running slope is greater than allowed.

**On-Site Finding** 12.20 percent

**Code Reference** ADA 406, 406.1, 405.2, CA 11B-406

Provide a compliant curb ramp.

Recommendation Up to 8.33 percent

Install curb ramp \$1,300

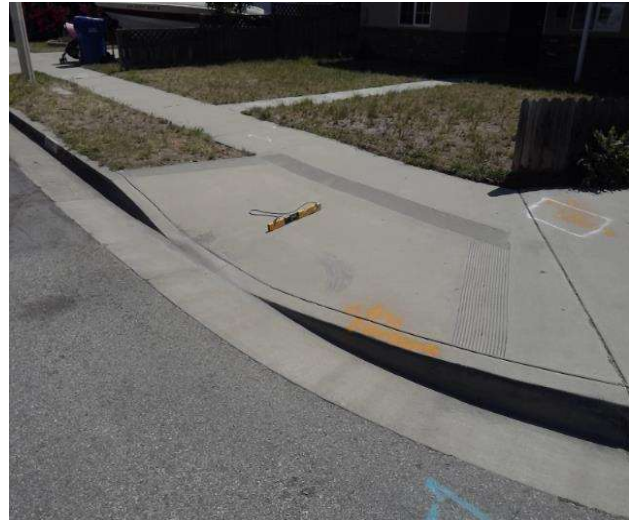
#### Southeast Corner Of Barlin Avenue @ 33.916887867272, - 118.141777217388

Curb Ramp : Side Flare Slope

The slope of the curb ramp side flare is greater than allowed.

**On-Site Finding** 12.90 percent

**Code Reference** ADA 406, 406.3, CA 11B-406.2.2

Provide curb ramp side flares with a compliant slope.

Recommendation Up to 10.00 percent

Install flared sides \$1,300

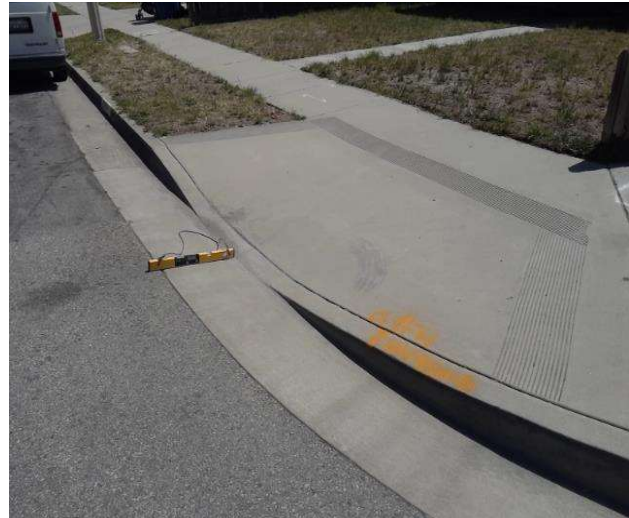
**Southeast Corner Of Barlin Avenue @ 33.916887867272, - 118.141777217388**

Curb Ramp : Bottom Landing Slope

The bottom landing of the curb ramp is on the street, and the slope of the bottom landing is not compliant.

**On-Site Finding** 14.90 percent

**Code Reference** ADA 406, 406.2, CA 11B-406.5.8

Ensure the bottom landing slope is compliant and provides a smooth transition.

Recommendation Up to 5.00 percent

Repave landing \$1,260

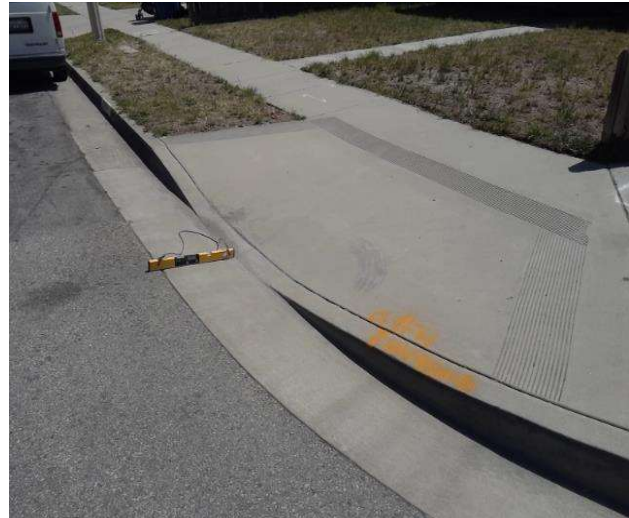
**Southeast Corner Of Barlin Avenue @ 33.916887867272, - 118.141777217388**

Curb Ramp , Landings and Transitions : Top Landing Slope

The slope at the top landing is greater than allowed.

**On-Site Finding** 3.30 percent

**Code Reference** ADA 402, 406.4, 403.3, 406.1,CA 11B-406.5.3

Provide a top landing surface that does not exceed the maximum slope and cross slope. Provide a sufficient maneuvering clearance that does not accumulate water.

Recommendation Up to 2.08 percent

Provide compliant landing \$1,260

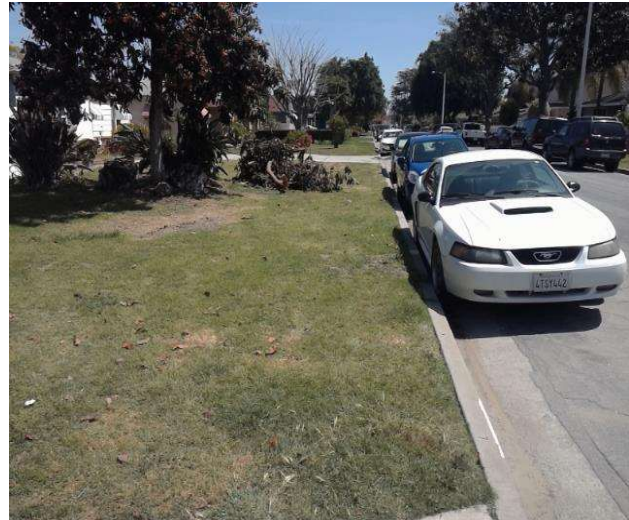
#### Sidewalk East Of Barlin Avenue @ 33.916840012013, -118.141449987888

Sidewalks : Missing Sidewalk

Section of sidewalk is missing and consists of dirt, grass or gravel.

**On-Site Finding** 865.00 feet

**Code Reference** ADA 206, 302,CA 11B-302,CA 11B-206

Provide a compliant sidewalk for the missing section.

\$1,260

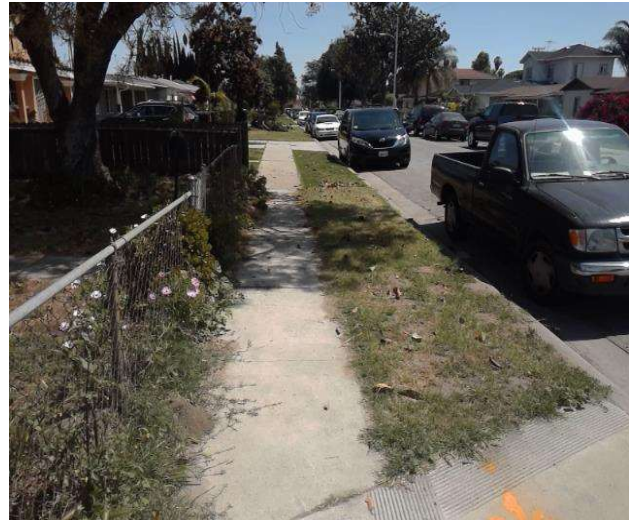
**Sidewalk East Of Barlin Avenue @ 33.916978013153, -118.141698092222**

Sidewalks , Surface : Cross Slope

Sidewalk cross slope is not compliant.

**On-Site Finding** 3.30 percent for 31.00 feet

**Code Reference** ADA 206, 302,CA 11B-403.3

Repave the sidewalk surface with the recommended cross slope.

Recommendation Up to 2.08 percent

Repave surface \$1,092

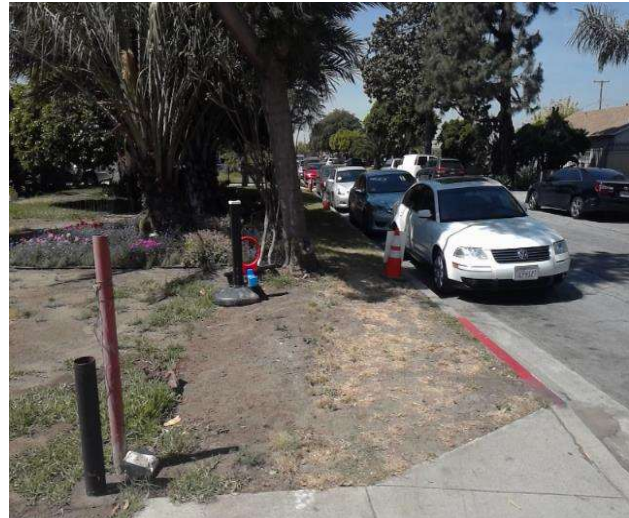
#### Sidewalk West Of Lakewood Boulevard @ 33.915572394310, -118.139407485724

Sidewalks : Missing Sidewalk

Section of sidewalk is missing and consists of dirt, grass or gravel.

**On-Site Finding** 593.00 feet

**Code Reference** ADA 206, 302,CA 11B-302,CA 11B-206

Provide a compliant sidewalk for the missing section.

\$1,260

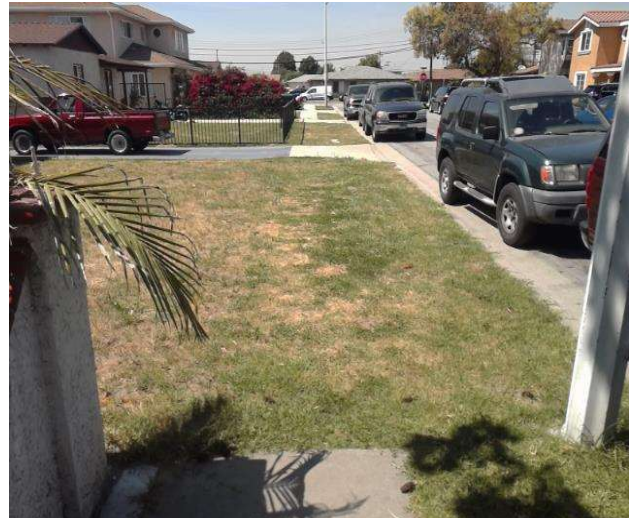
#### Sidewalk West Of Lakewood Boulevard @ 33.916604074062, -118.141287714243

Sidewalks : Missing Sidewalk

Section of sidewalk is missing and consists of dirt, grass or gravel.

**On-Site Finding** 84.00 feet

**Code Reference** ADA 206, 302,CA 11B-302,CA 11B-206

Provide a compliant sidewalk for the missing section.

\$1,260

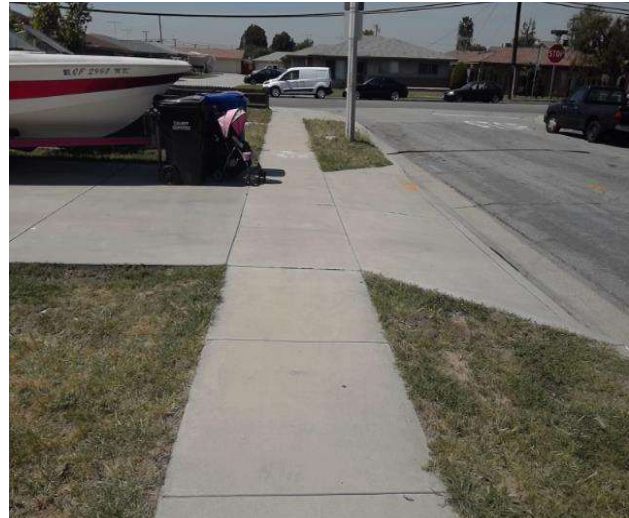
**Sidewalk West Of Lakewood Boulevard @ 33.916778801758, -118.141602873802**

Sidewalks , Surface : Cross Slope

Sidewalk cross slope is not compliant.

**On-Site Finding** 4.30 percent for 60.00 feet

**Code Reference** ADA 206, 302,CA 11B-403.3

Repave the sidewalk surface with the recommended cross slope.

Recommendation Up to 2.08 percent

Repave surface \$1,092
