Accessibility Survey

City of Downey Woodruff Avenue & Firestone Boulevard East

Date of Inspection
1/9/2017

Disability Access Consultants

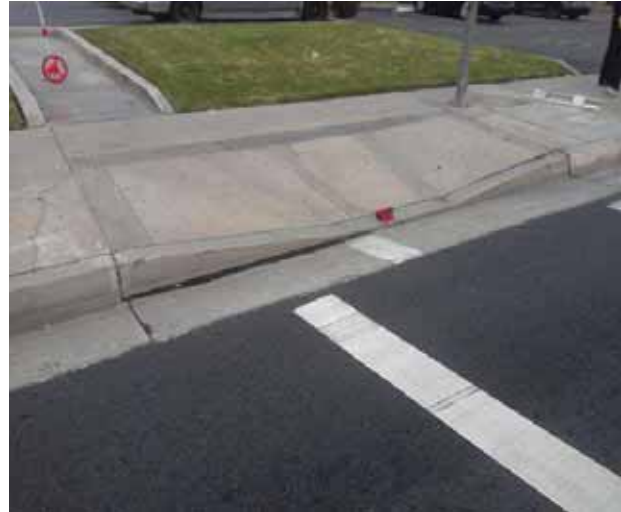
Northeast Corner @ 33.931966499864, -118.116441071033

Curb Ramp : No Detectable Warnings

The curb ramp does not provide a detectable warning surface which includes truncated domes.

Provide compliant detectable warnings to surface.

Provide detectable warning to surface \$248

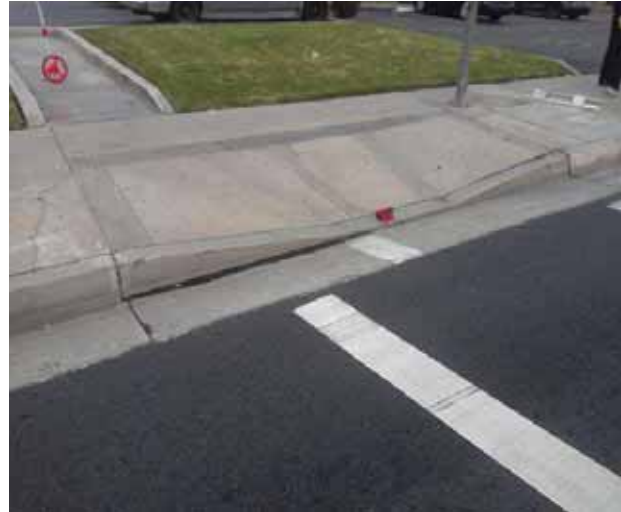
Northeast Corner @ 33.931966499864, -118.116441071033

Curb Ramp : Curb Ramp Slope

The running slope is greater than allowed.

Recommendation Up to 8.33 percent

Install curb ramp \$1,300

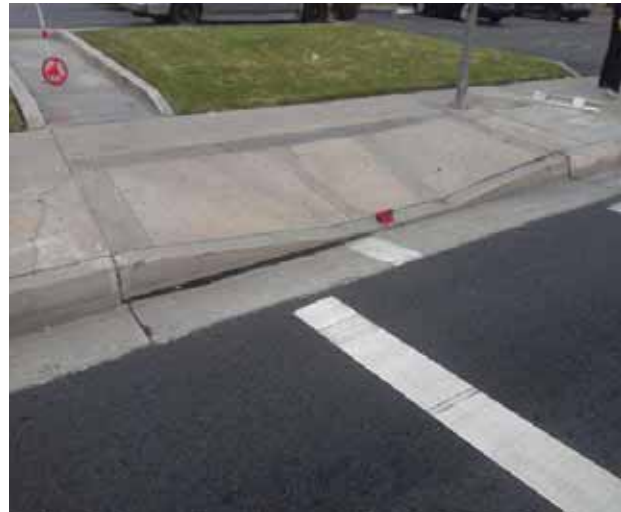
Finding

Recommendation Up to 10.00 percent

Install flared sides \$1,300

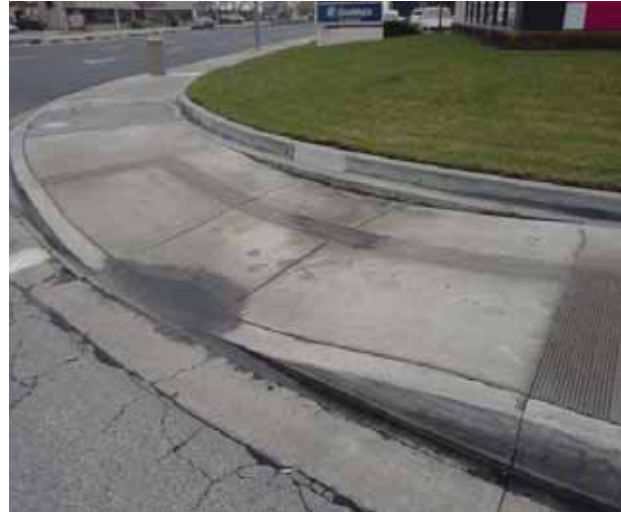
Curb Ramp , Landings and Transitions : Landing Accumulates Water - Wet Conditions

Provide compliant landing \$255
