Accessibility Survey

City of Downey Mueller Street - Pangborn Avenue To Lesterford Avenue

Date of Inspection
5/4/2017

Disability Access Consultants

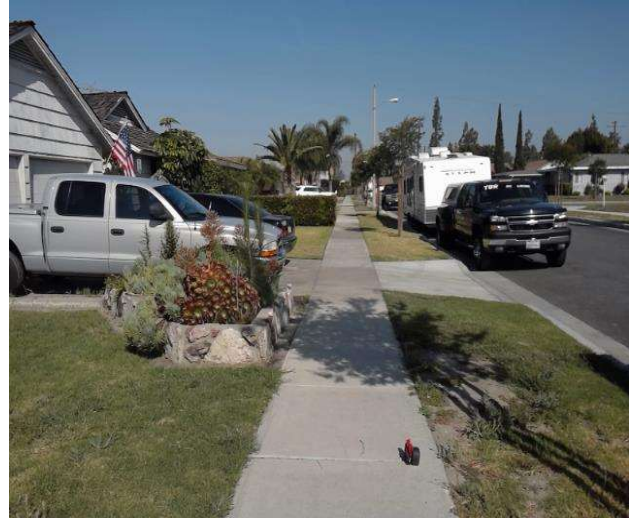
Change In Level West Of Lesterford Avenue @ 33.934665905422, - 118.109132051468

Sidewalks , Change in Level : Change in Level Non Beveled

There is a change in elevation greater than recommended value.

On-Site Finding 0.87 inches

Code Reference ADA 206, 302

Ensure that the change in elevation is within the recommended value.

Recommendation Up to 0.25 inches

Remove tripping hazards \$198

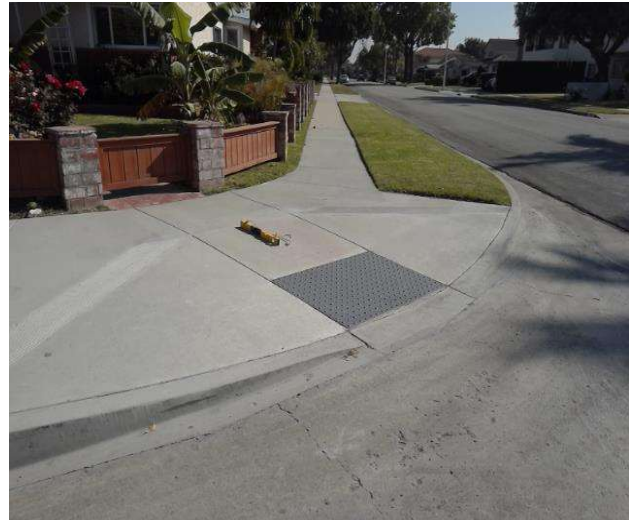
Code Reference ADA 406, 406.1, 405.2, CA 11B-406

Recommendation Up to 8.33 percent

Install curb ramp \$1,300

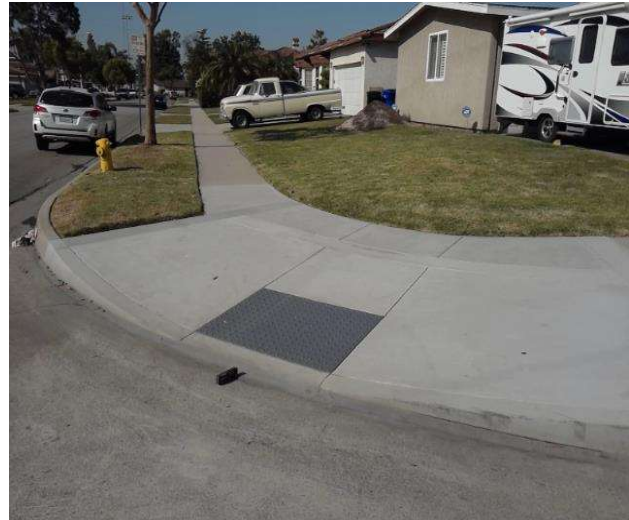
Code Reference ADA 406, 406.2, CA 11B-406.5.8

Recommendation Up to 5.00 percent

Repave landing \$1,260

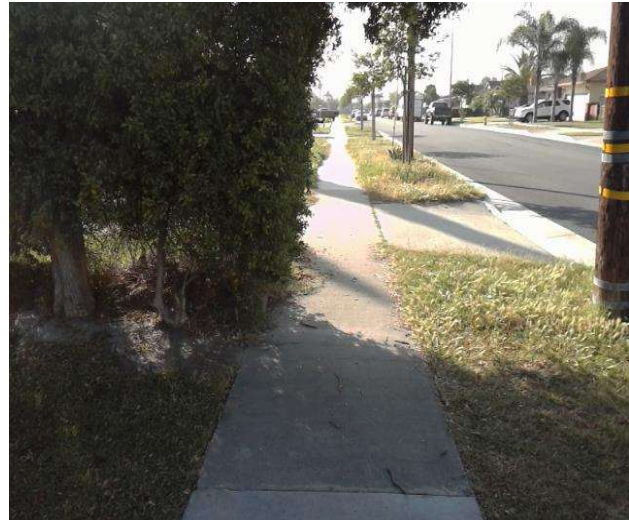
Code Reference ADA 206, 302, CA 11B-403.3

Repave the sidewalk surface with the recommended cross slope.

Recommendation Up to 2.08 percent

Repave surface \$1,092

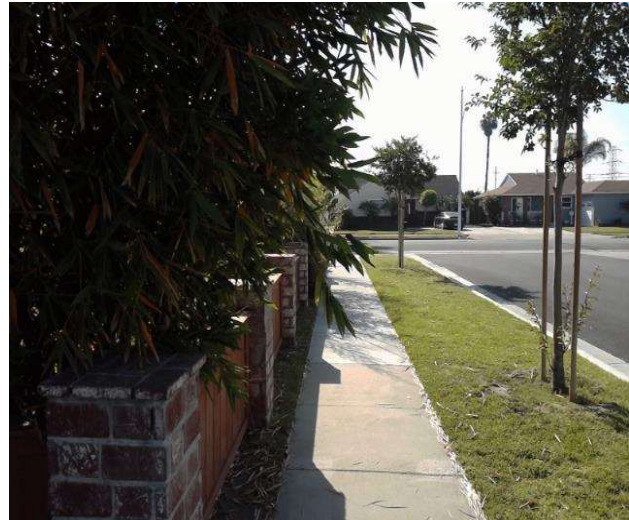
Sidewalks , Hazards & Gratings : Overhead Obstruction Height

Code Reference ADA 206, 307.4,CA 11B-307.4

Recommendation At least 80.00 inches

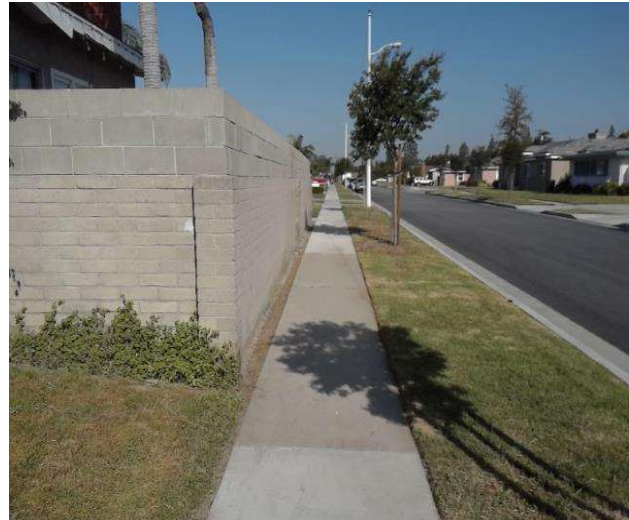
Code Reference ADA 206, 302, CA 11B-403.3

Repave the sidewalk surface with the recommended cross slope.

Recommendation Up to 2.08 percent

Repave surface \$1,092

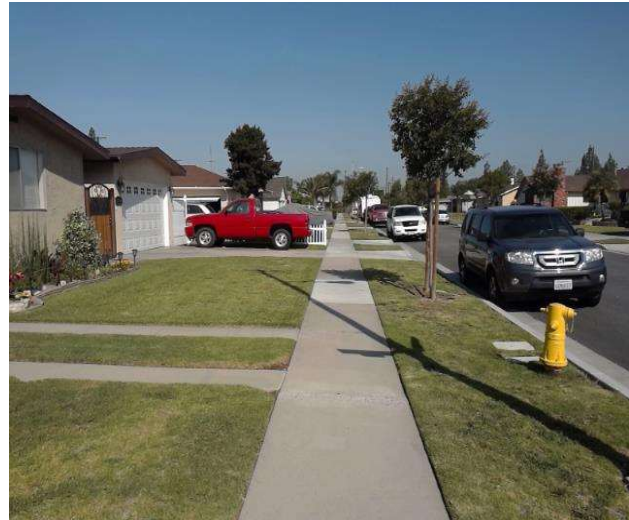
Code Reference ADA 206, 302, CA 11B-403.3

Repave the sidewalk surface with the recommended cross slope.

Recommendation Up to 2.08 percent

Repave surface \$1,092

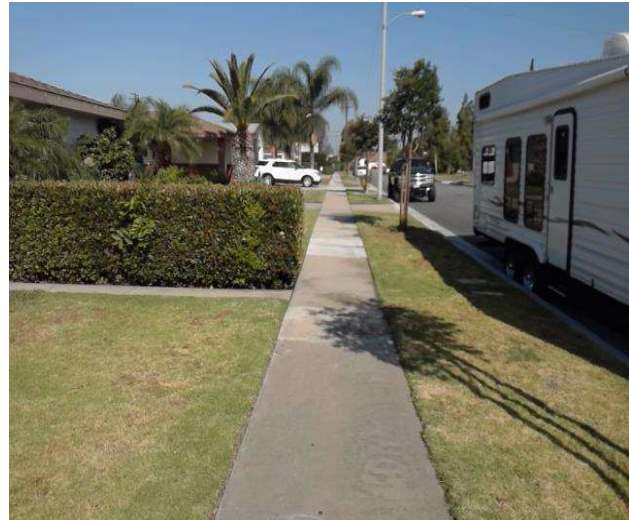
Code Reference ADA 206, 302,CA 11B-403.3

Repave the sidewalk surface with the recommended cross slope.

Recommendation Up to 2.08 percent

Repave surface \$1,092

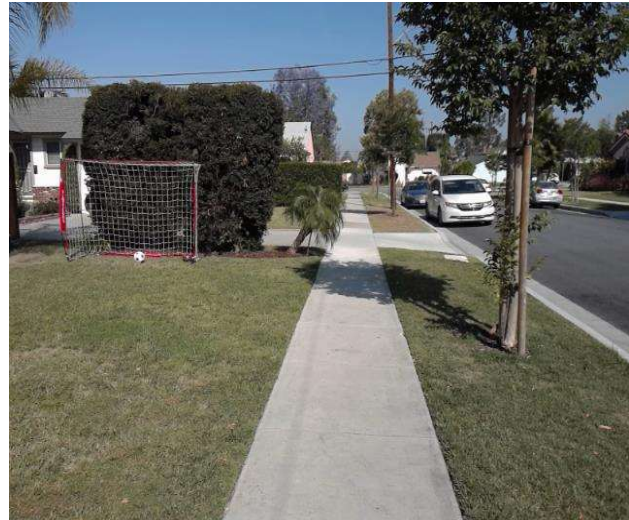
Code Reference ADA 206, 302,CA 11B-403.3

Repave the sidewalk surface with the recommended cross slope.

Recommendation Up to 2.08 percent

Repave surface \$1,092

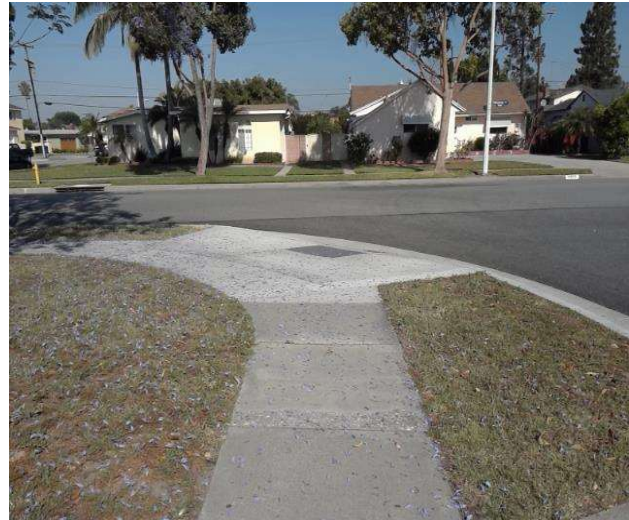
Code Reference ADA 206, 302,CA 11B-403.3

Repave the sidewalk surface with the recommended cross slope.

Recommendation Up to 2.08 percent

Repave surface \$1,092

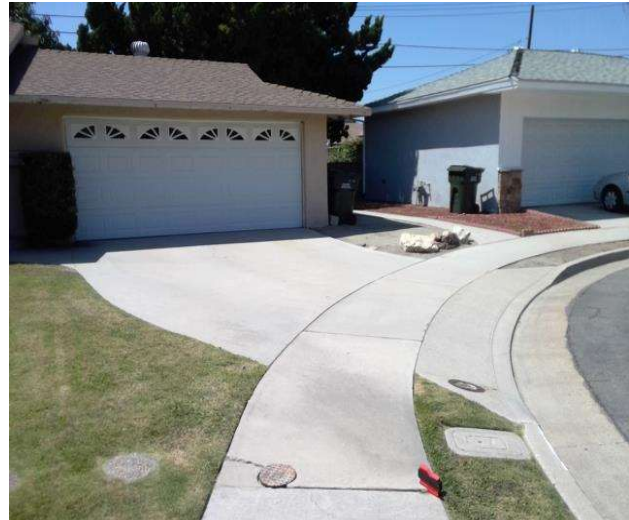
There is a change in elevation greater than recommended value.

Code Reference ADA 206, 302

Ensure that the change in elevation is within the recommended value.

Recommendation Up to 0.25 inches

Remove tripping hazards \$198

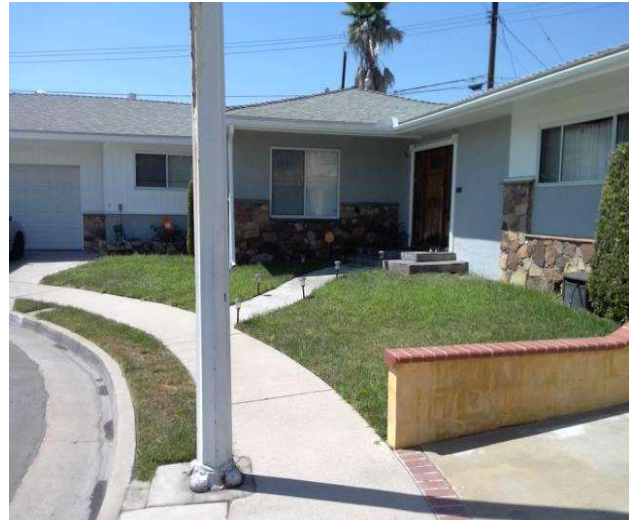
Sidewalks , Hazards & Gratings : Sidewalk Width at Obstruction

Code Reference ADA 206, 302, 403.5.1,CA 11B-403.5

Sidewalk width at the obstruction shall have the recommended value.

Recommendation At least 48.00 inches

\$1,260

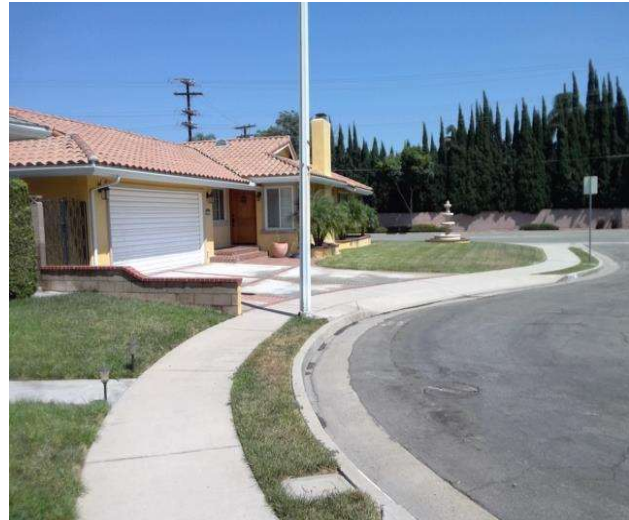
Code Reference ADA 206, 302,CA 11B-403.3

Repave the sidewalk surface with the recommended cross slope.

Recommendation Up to 2.08 percent

Repave surface \$1,092

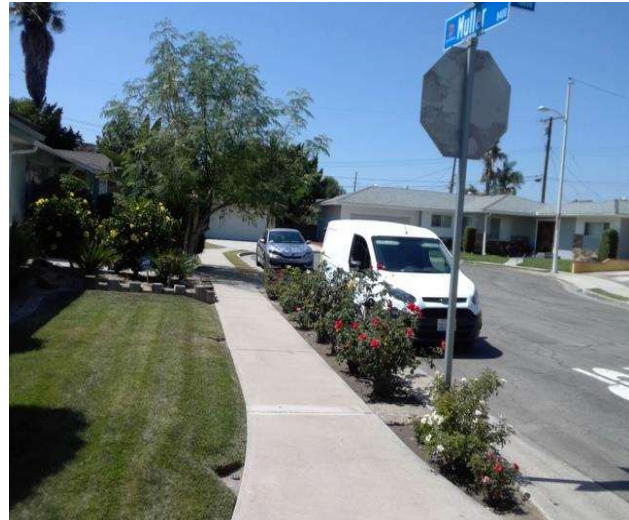
Code Reference ADA 206, 302, CA 11B-403.3

Repave the sidewalk surface with the recommended cross slope.

Recommendation Up to 2.08 percent

Repave surface \$1,092

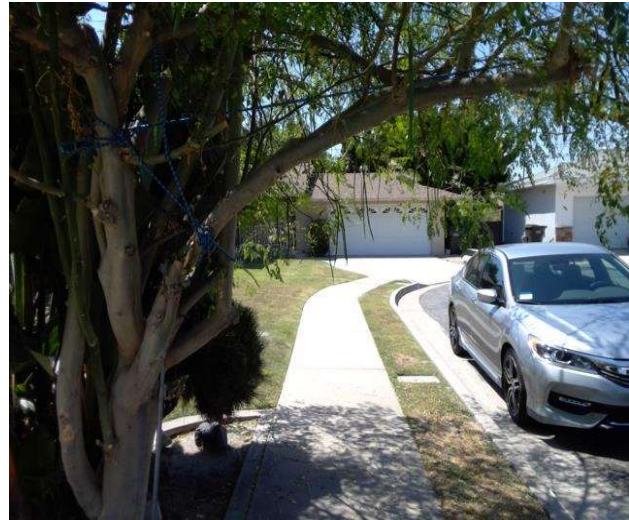
Sidewalks , Hazards & Gratings : Overhead Obstruction Height

Code Reference ADA 206, 307.4,CA 11B-307.4

Recommendation At least 80.00 inches

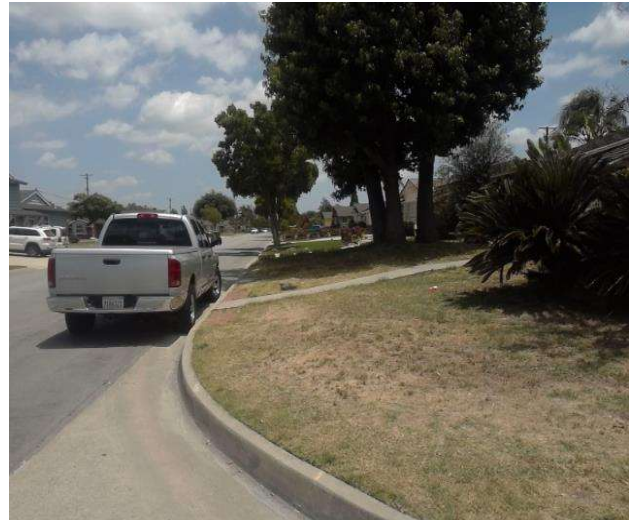
On-Site Finding Not Found

Code Reference ADA 206

Recommendation See Recommendation

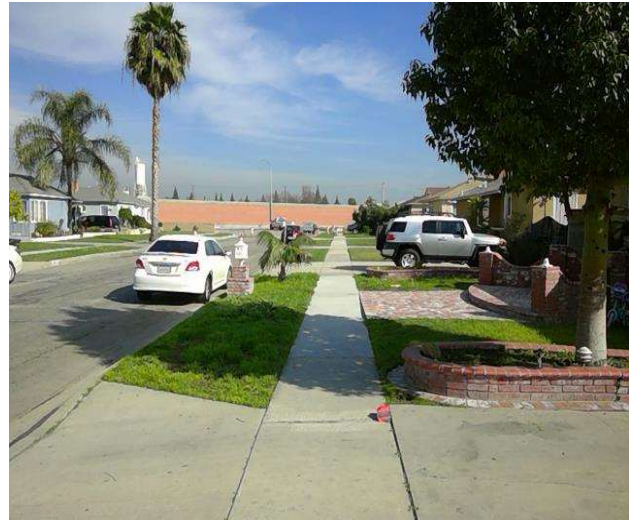
There is a change in elevation greater than recommended value.

Code Reference ADA 206, 302

Ensure that the change in elevation is within the recommended value.

Recommendation Up to 0.25 inches

Remove tripping hazards \$198

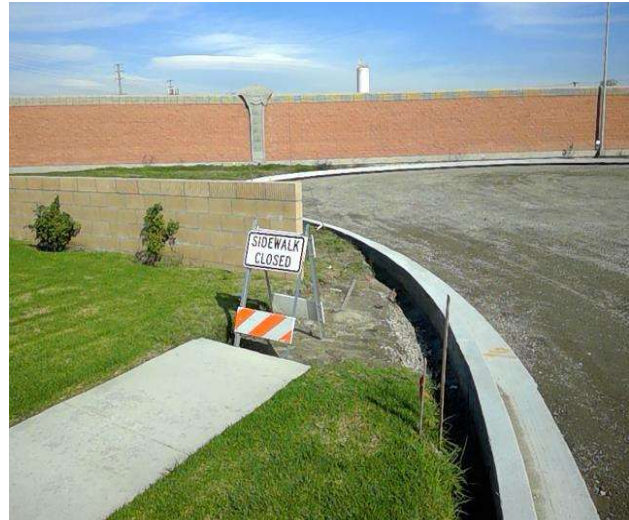
Sidewalks : Missing Sidewalk

Section of sidewalk is missing and consists of dirt, grass or gravel.

Code Reference ADA 206, 302,CA 11B-302,CA 11B-206

Provide a compliant sidewalk for the missing section.

\$1,260

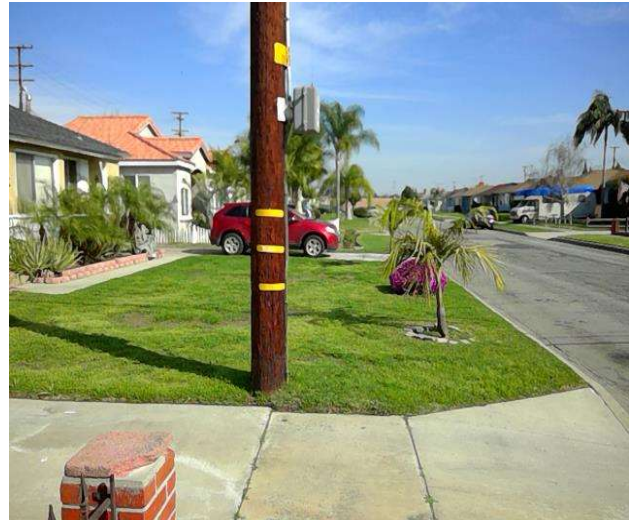
Sidewalks : Missing Sidewalk

Section of sidewalk is missing and consists of dirt, grass or gravel.

Code Reference ADA 206, 302,CA 11B-302,CA 11B-206

Provide a compliant sidewalk for the missing section.

\$1,260

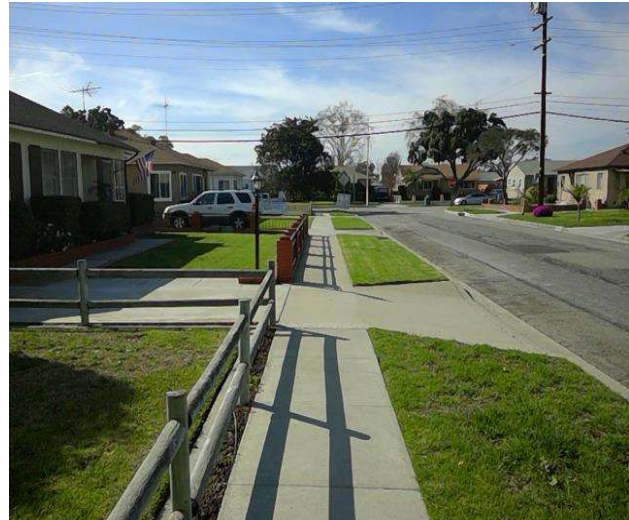
Code Reference ADA 206, 302, CA 11B-403.3

Repave the sidewalk surface with the recommended cross slope.

Recommendation Up to 2.08 percent

Repave surface \$1,092

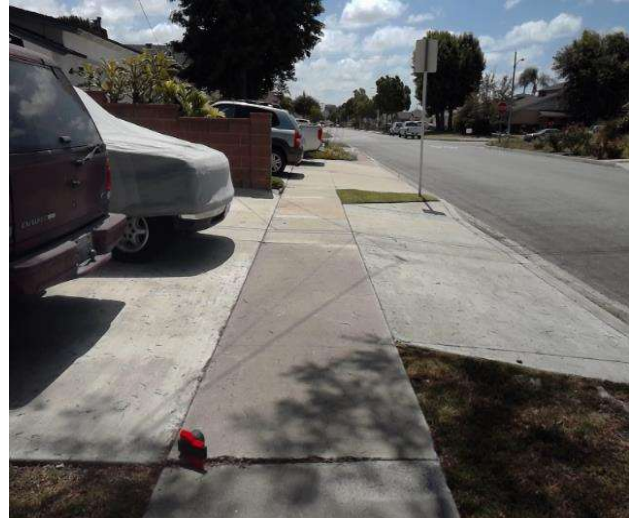
There is a change in elevation greater than recommended value.

Code Reference ADA 206, 302

Ensure that the change in elevation is within the recommended value.

Recommendation Up to 0.25 inches

Remove tripping hazards \$198

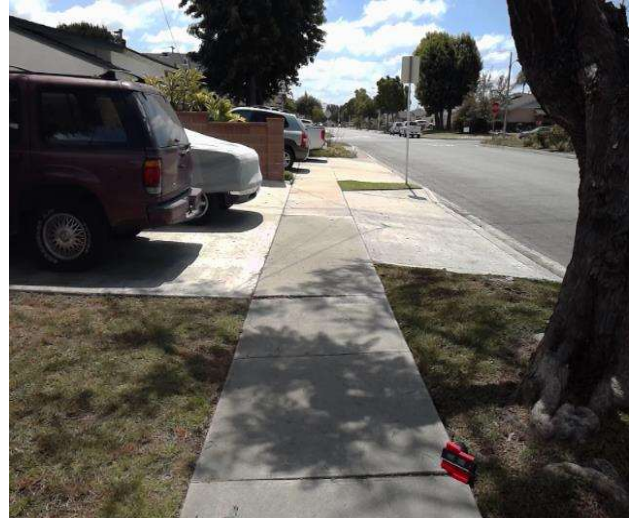
There is a change in elevation greater than recommended value.

Code Reference ADA 206, 302

Ensure that the change in elevation is within the recommended value.

Recommendation Up to 0.25 inches

Remove tripping hazards \$198

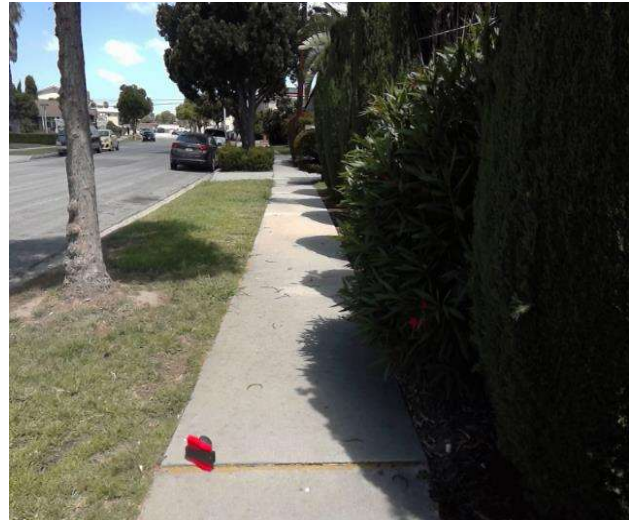
There is a change in elevation greater than recommended value.

Code Reference ADA 206, 302

Ensure that the change in elevation is within the recommended value.

Recommendation Up to 0.25 inches

Remove tripping hazards \$198

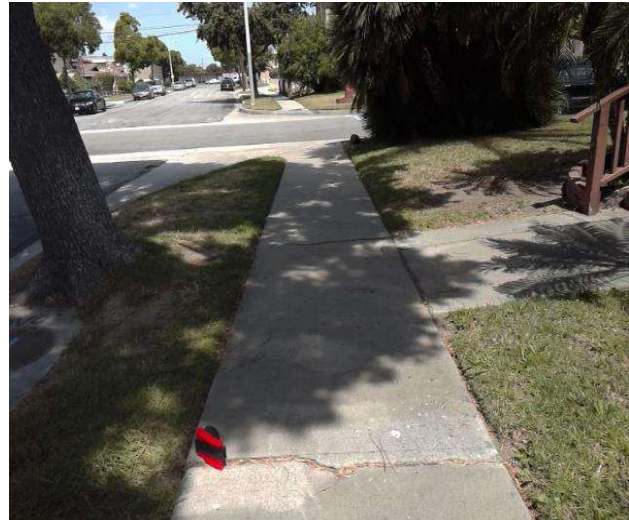
There is a change in elevation greater than recommended value.

Code Reference ADA 206, 302

Ensure that the change in elevation is within the recommended value.

Recommendation Up to 0.25 inches

Remove tripping hazards \$198

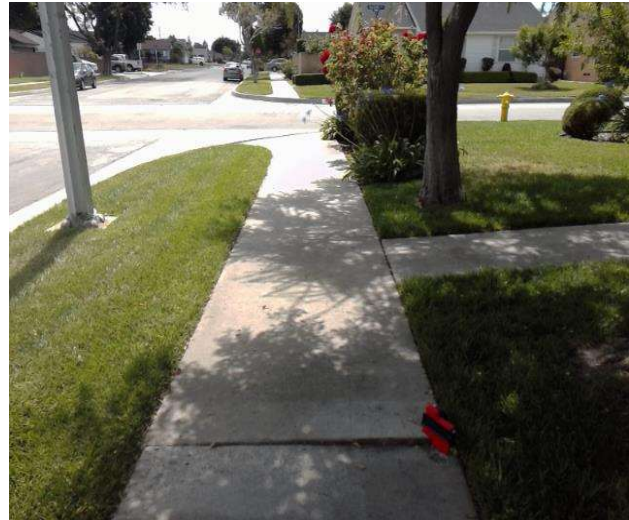
There is a change in elevation greater than recommended value.

Code Reference ADA 206, 302

Ensure that the change in elevation is within the recommended value.

Recommendation Up to 0.25 inches

Remove tripping hazards \$198

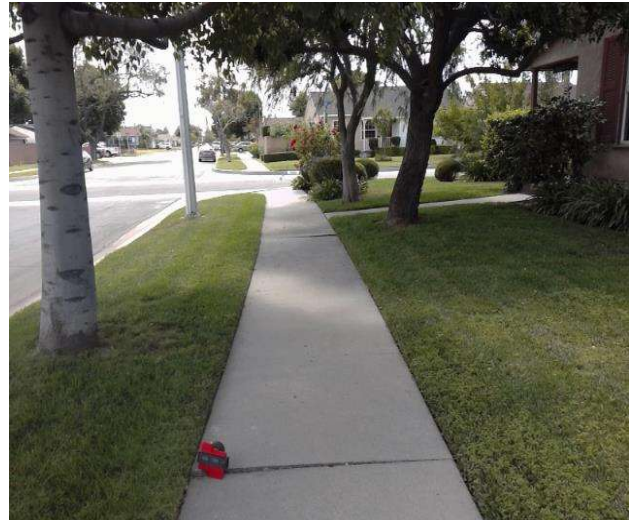
There is a change in elevation greater than recommended value.

Code Reference ADA 206, 302

Ensure that the change in elevation is within the recommended value.

Recommendation Up to 0.25 inches

Remove tripping hazards \$198

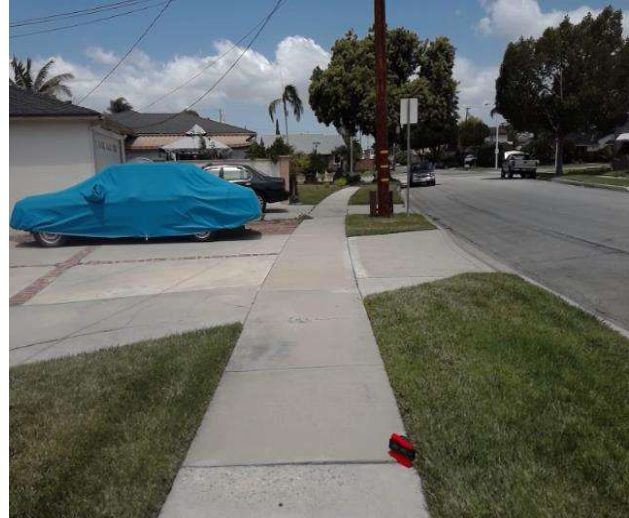
There is a change in elevation greater than recommended value.

Code Reference ADA 206, 302

Ensure that the change in elevation is within the recommended value.

Recommendation Up to 0.25 inches

Remove tripping hazards \$198

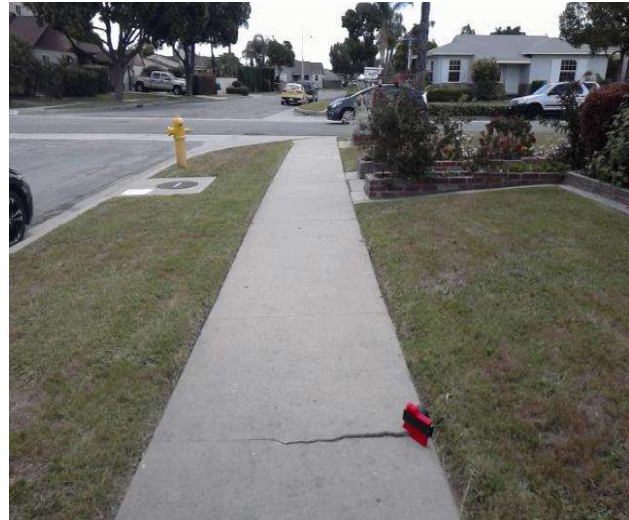
There is a change in elevation greater than recommended value.

Code Reference ADA 206, 302

Ensure that the change in elevation is within the recommended value.

Recommendation Up to 0.25 inches

Remove tripping hazards \$198

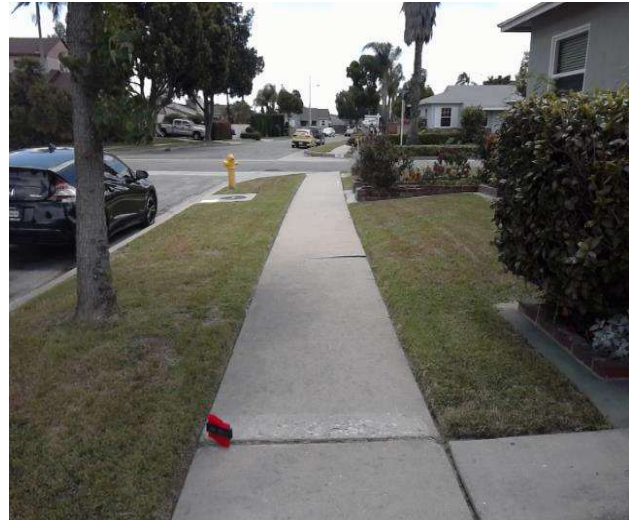
There is a change in elevation greater than recommended value.

Code Reference ADA 206, 302

Ensure that the change in elevation is within the recommended value.

Recommendation Up to 0.25 inches

Remove tripping hazards \$198

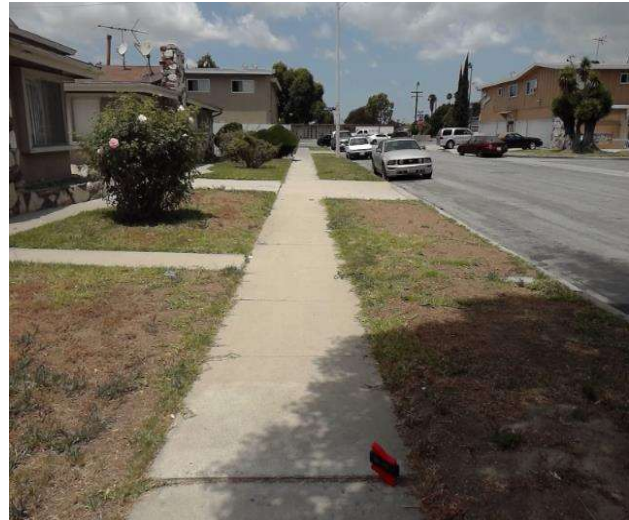
There is a change in elevation greater than recommended value.

Code Reference ADA 206, 302

Ensure that the change in elevation is within the recommended value.

Recommendation Up to 0.25 inches

Remove tripping hazards \$198

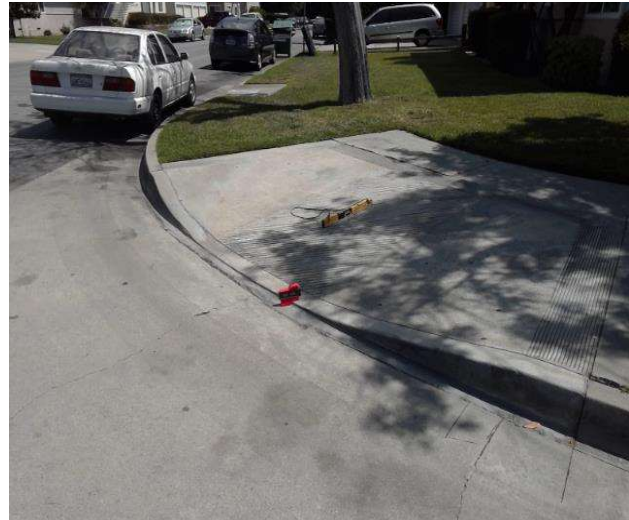
On-Site Finding Not Found

Code Reference CA 11B-406.5.12

Provide detectable warning to surface \$248

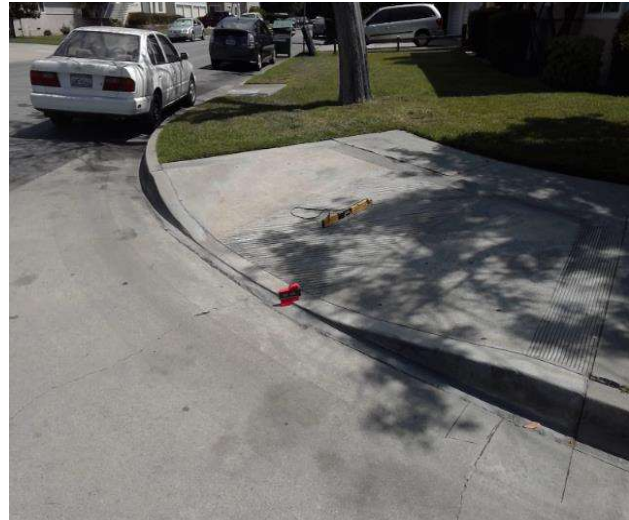
Code Reference ADA 406, 406.3, CA 11B-406.2.2

Recommendation Up to 10.00 percent

Install flared sides \$1,300

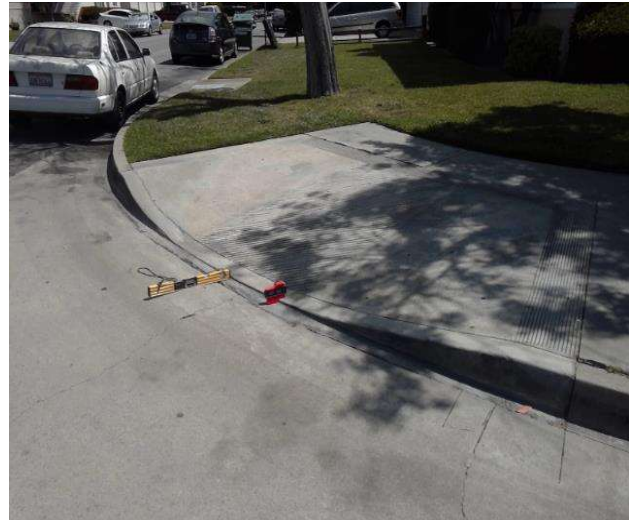
Code Reference ADA 406, 406.2, CA 11B-406.5.8

Recommendation Up to 5.00 percent

Repave landing \$1,260

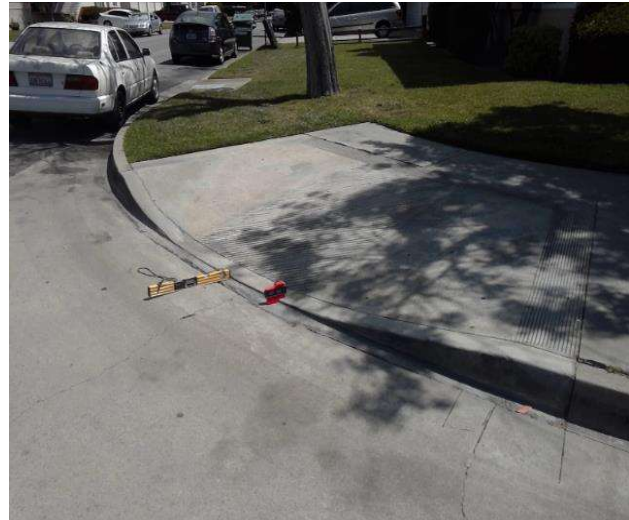
Curb Ramp , Landings And Transitions : Bottom Landing Change in Level

Code Reference ADA 302, 303, 406.2, 303.1

Recommendation Up to 0.50 inches

Patch lip at curb ramp \$255

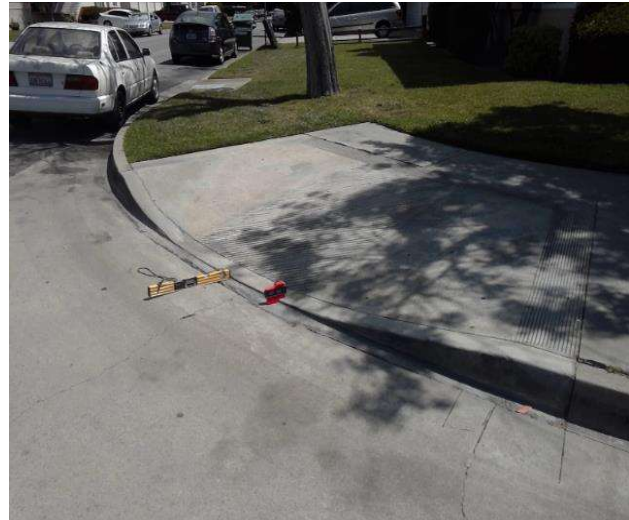
Curb Ramp , Landings and Transitions : Top Landing Clear Length - Landings

Code Reference ADA 406, 406.4,CA 11B-406.5.3

Recommendation At least 48.00 inches

Provide compliant landing \$240

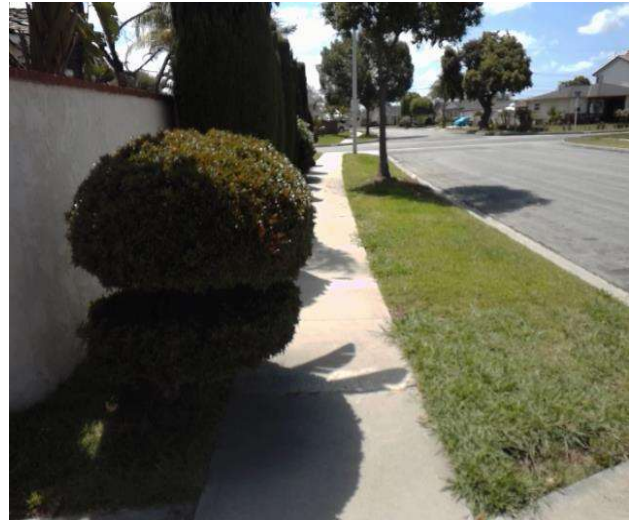
Sidewalks , Hazards & Gratings : Sidewalk Width at Obstruction

Code Reference ADA 206, 302, 403.5.1, CA 11B-403.5

Sidewalk width at the obstruction shall have the recommended value.

Recommendation At least 48.00 inches

\$1,260

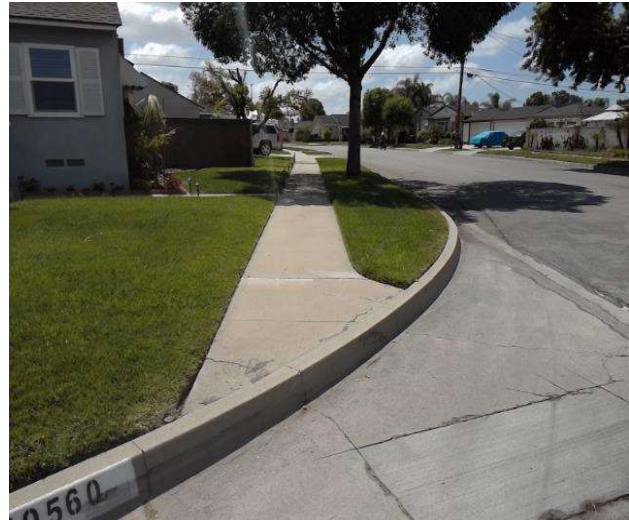
Sidewalks , Hazards & Gratings : Curb is on Path of Travel

Code Reference ADA 402, 303, 406, 403.4, 303.4

Install curb ramp \$2,500

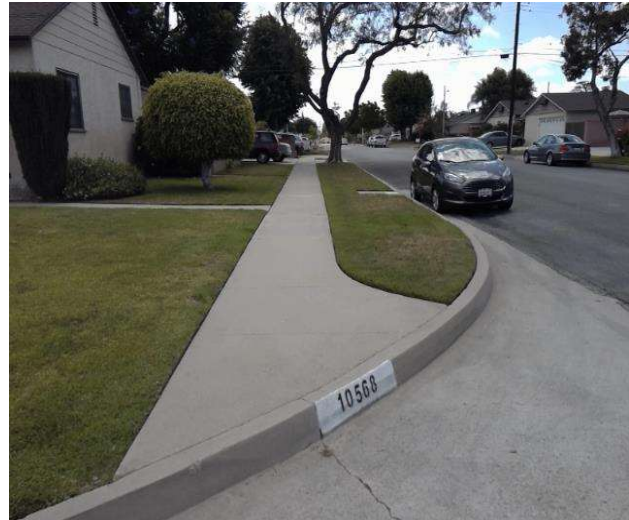
Sidewalks , Hazards & Gratings : Curb is on Path of Travel

Code Reference ADA 402, 303, 406, 403.4, 303.4

Install curb ramp \$2,500

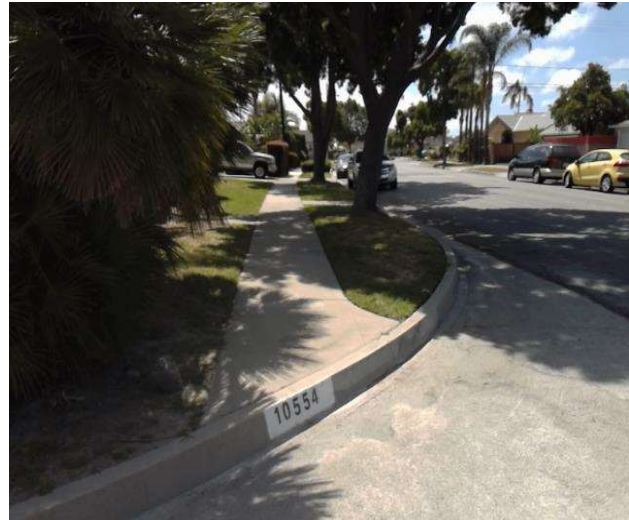
Sidewalks , Hazards & Gratings : Curb is on Path of Travel

Code Reference ADA 402, 303, 406, 403.4, 303.4

Install curb ramp \$2,500

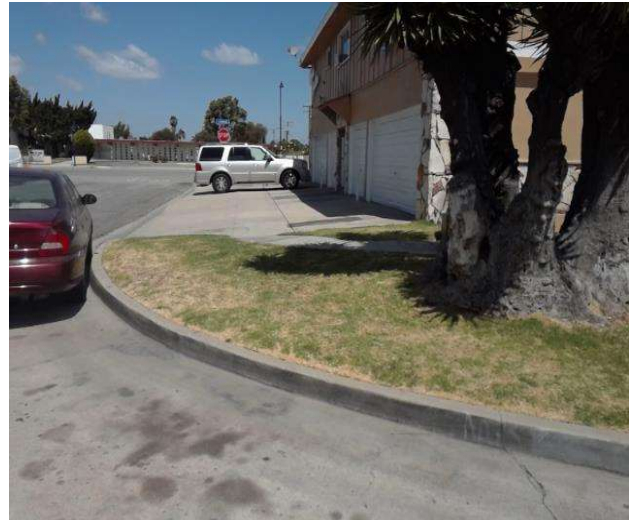
Sidewalks , Hazards & Gratings : Curb is on Path of Travel

Code Reference ADA 402, 303, 406, 403.4, 303.4

Install curb ramp \$2,500

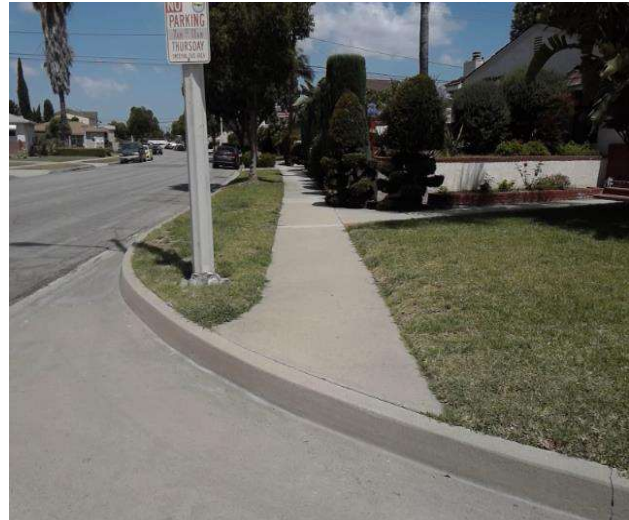
Sidewalks , Hazards & Gratings : Curb is on Path of Travel

Code Reference ADA 402, 303, 406, 403.4, 303.4

Install curb ramp \$2,500

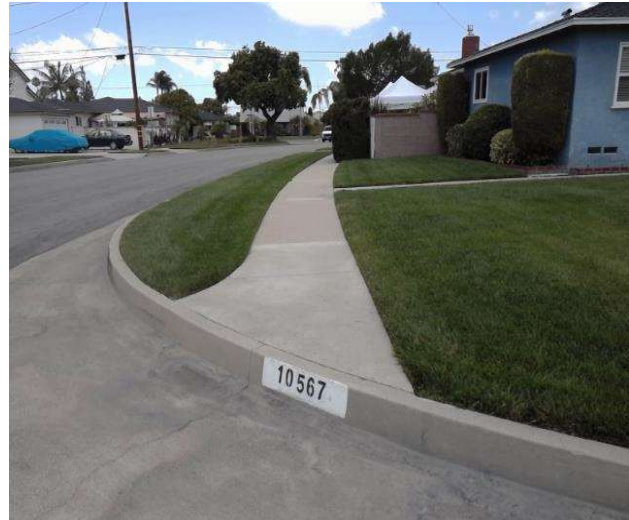
Sidewalks , Hazards & Gratings : Curb is on Path of Travel

Code Reference ADA 402, 303, 406, 403.4, 303.4

Install curb ramp \$2,500

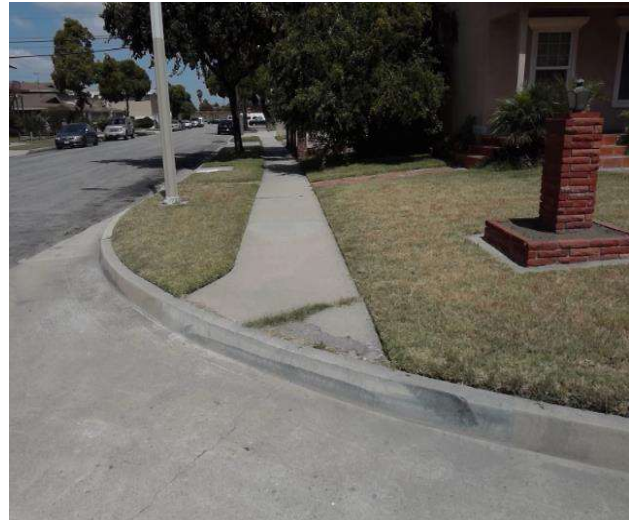
Sidewalks , Hazards & Gratings : Curb is on Path of Travel

Code Reference ADA 402, 303, 406, 403.4, 303.4

Install curb ramp \$2,500

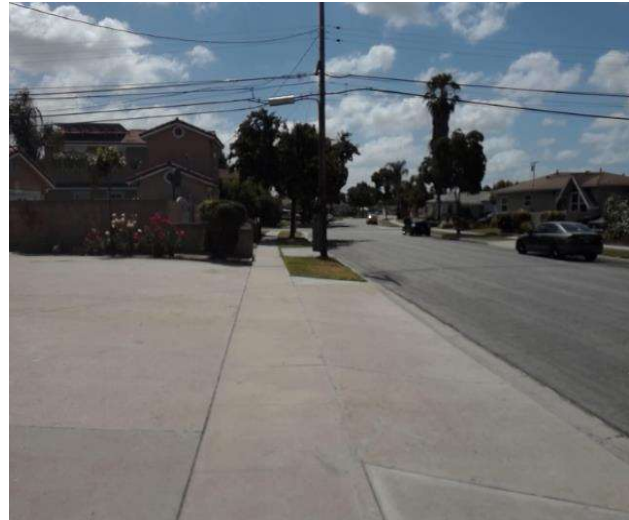
On-Site Finding Not Found

Code Reference ADA 705,CA 11B-705.1.2.5,CA 11B-247.1.2.5

Install compliant detectable warnings \$190

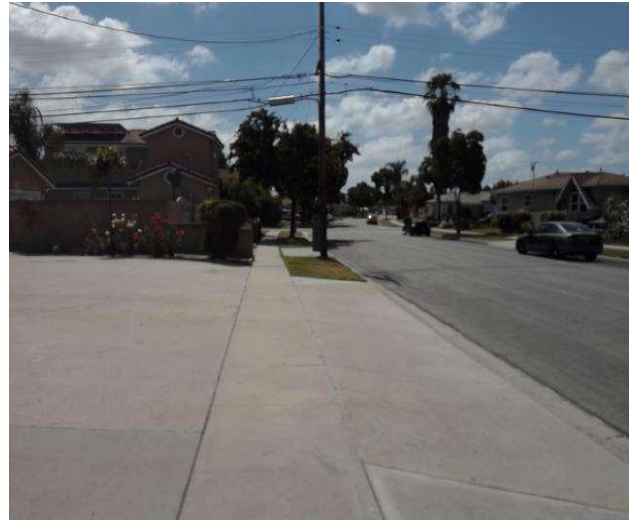
Code Reference ADA 206, 302, CA 11B-403.3

Recommendation Up to 2.08 percent

Repave surface \$1,092

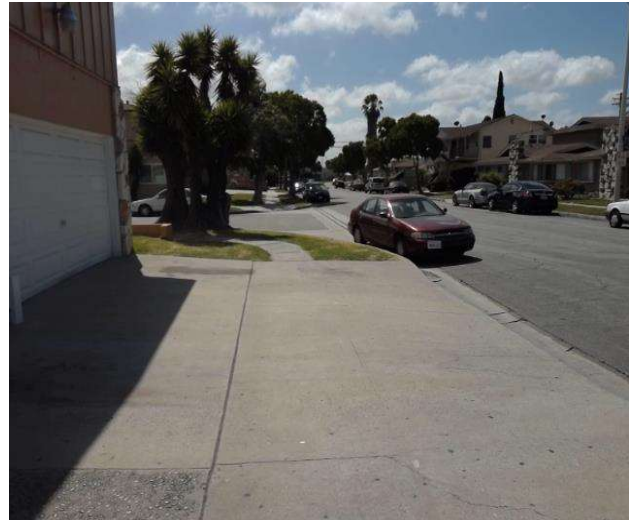
On-Site Finding Not Found

Code Reference ADA 705,CA 11B-705.1.2.5,CA 11B-247.1.2.5

Install compliant detectable warnings \$190

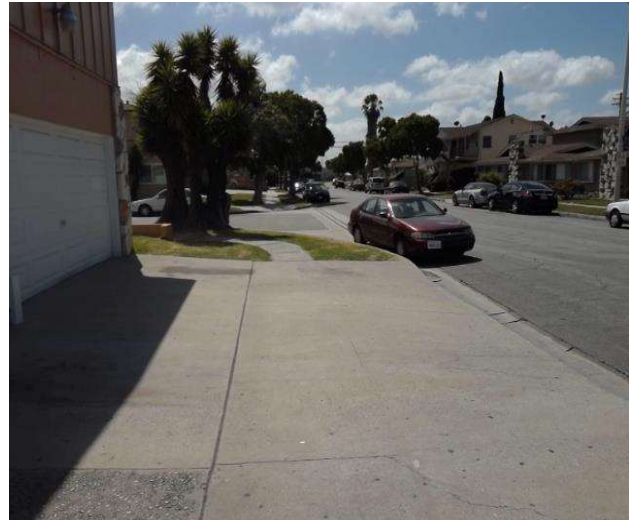
Code Reference ADA 206, 302, CA 11B-403.3

Recommendation Up to 2.08 percent

Repave surface \$1,092

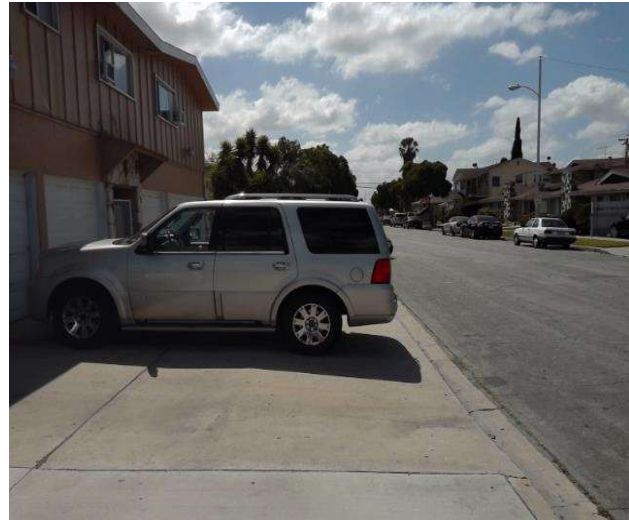
On-Site Finding Not Found

Code Reference ADA 705,CA 11B-705.1.2.5,CA 11B-247.1.2.5

Install compliant detectable warnings \$190

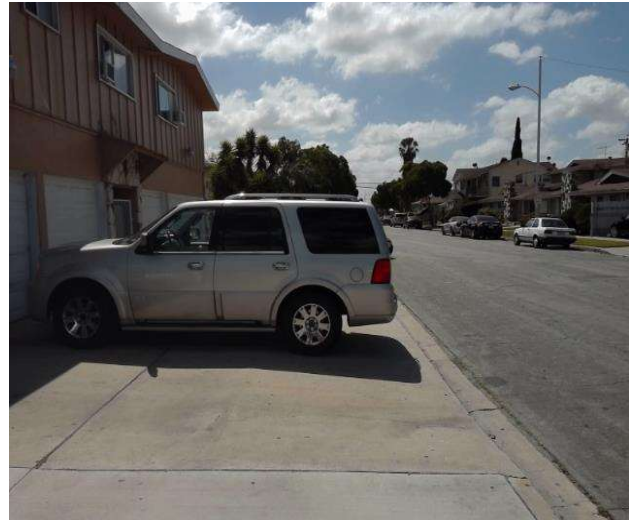
Code Reference ADA 206, 302, CA 11B-403.3

Recommendation Up to 2.08 percent

Repave surface \$1,092

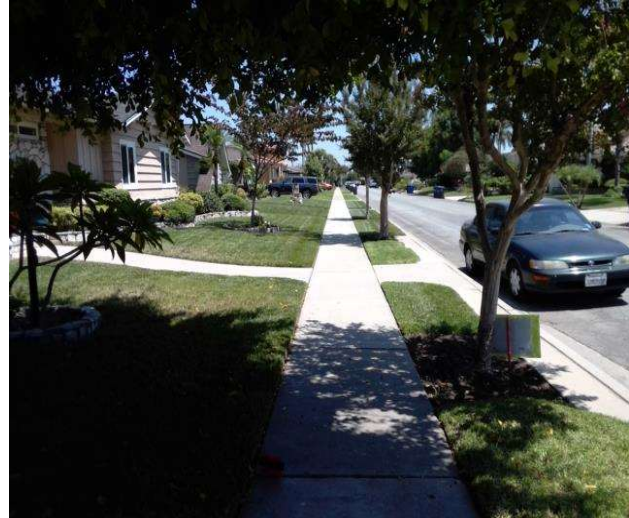
Code Reference ADA 206, 302

Remove tripping hazards \$198

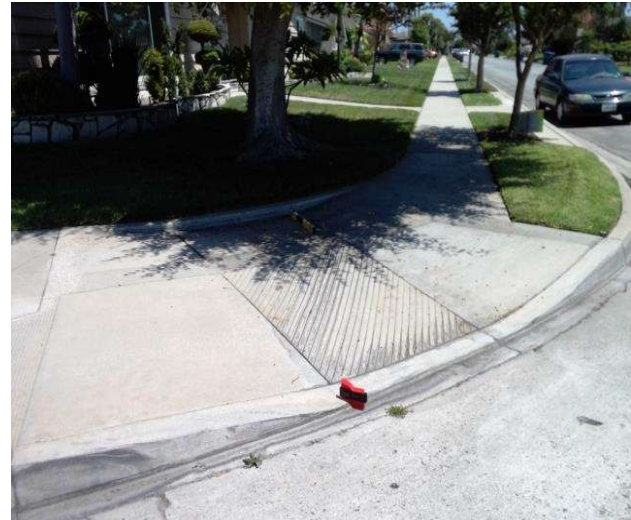
Code Reference ADA 406, 406.4,CA 11B-406.5.3

Provide compliant landing \$240

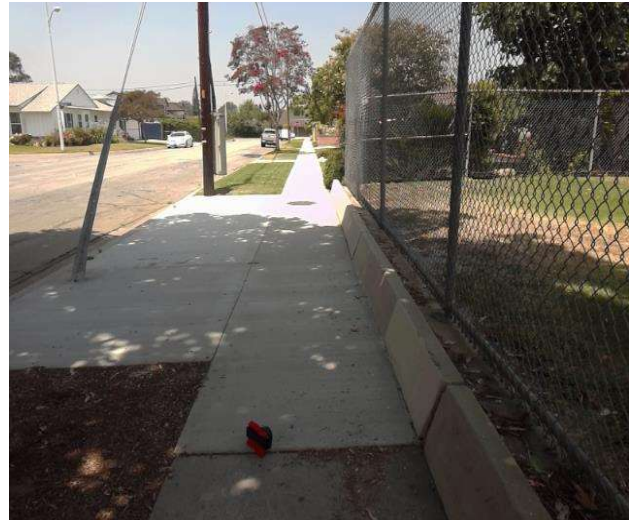
Code Reference ADA 206, 302

Remove tripping hazards \$198
