Accessibility Survey

City of Downey Quill Drive & Old River School Road

Date of Inspection
4/11/2017

Prepared By
Disability Access Consultants
(800) 743-7067

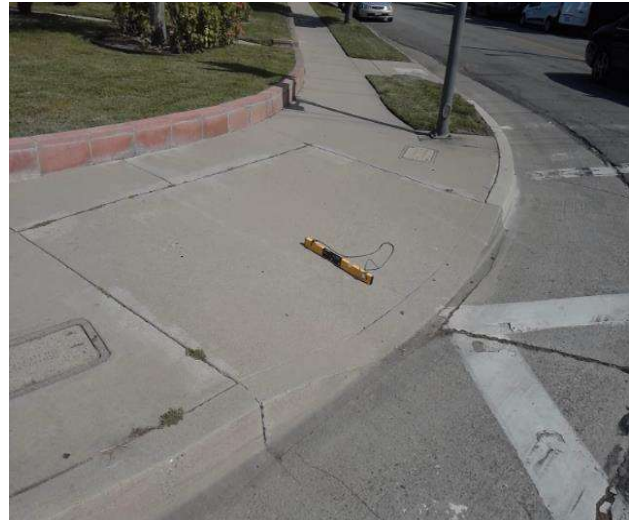
Curb Ramp : Curb Ramp Slope

The running slope is greater than allowed.

On-Site Finding 12.60 percent

Recommendation Up to 8.33 percent

Install curb ramp \$1,300

Code Reference ADA 406, 406.1, 405.2, CA 11B-406

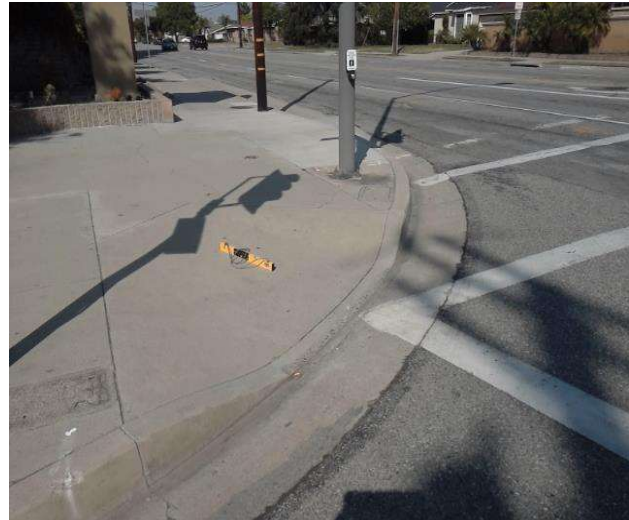
On-Site Finding Not Found

Provide detectable warning to surface \$248

Code Reference CA 11B-406.5.12

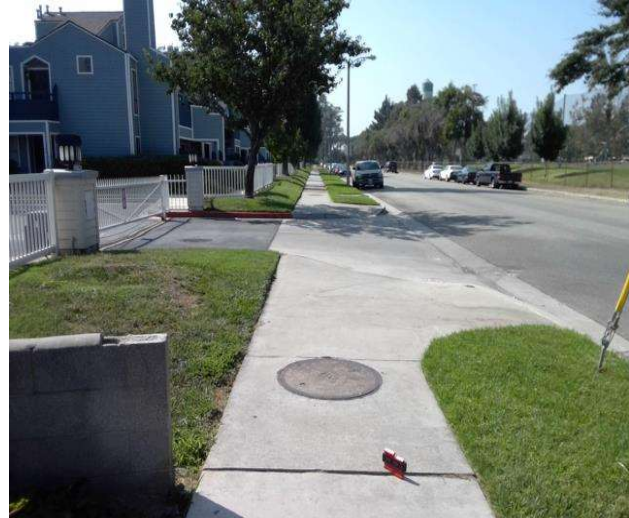
There is a change in elevation greater than recommended value.

Ensure that the change in elevation is within the recommended value.

Recommendation Up to 0.25 inches

Remove tripping hazards \$198

Code Reference ADA 206, 302

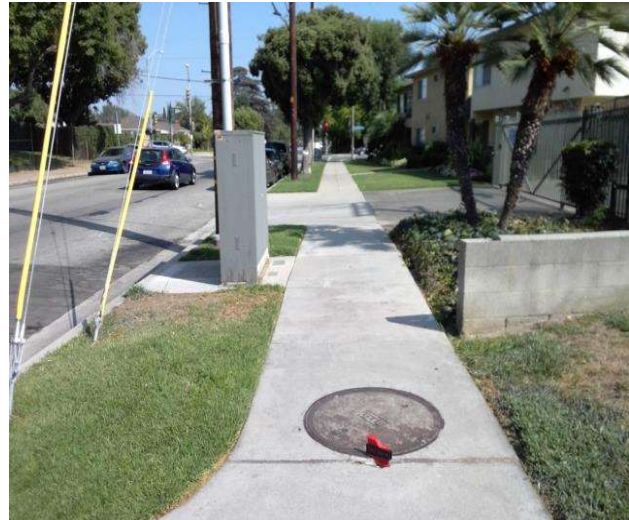
There is a change in elevation greater than recommended value.

Ensure that the change in elevation is within the recommended value.

Recommendation Up to 0.25 inches

Remove tripping hazards \$198

Code Reference ADA 206, 302

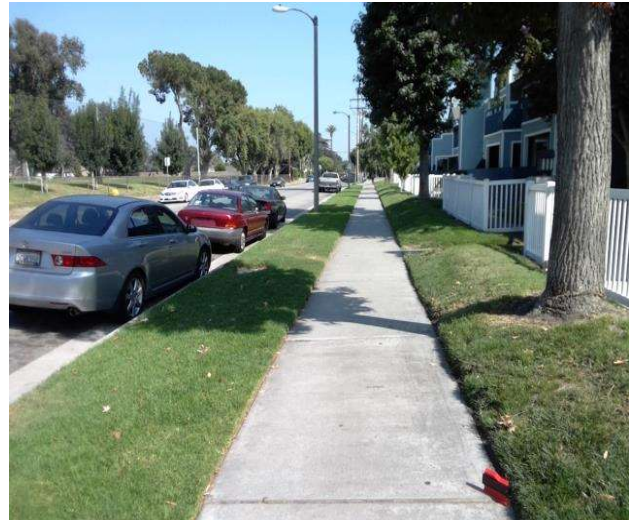
There is a change in elevation greater than recommended value.

Ensure that the change in elevation is within the recommended value.

Recommendation Up to 0.25 inches

Remove tripping hazards \$198

Code Reference ADA 206, 302

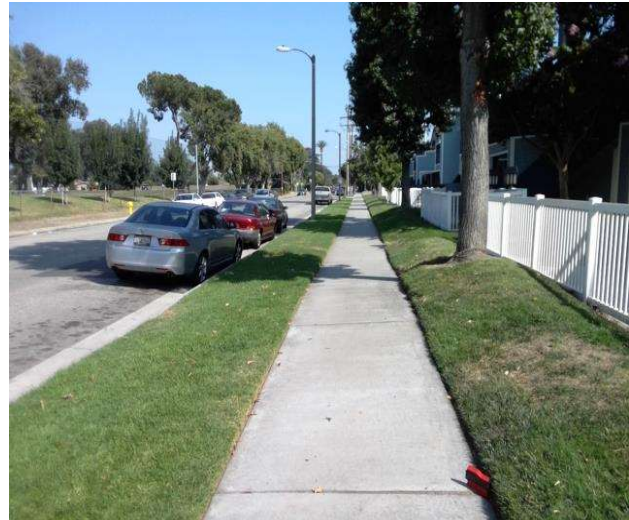
There is a change in elevation greater than recommended value.

Ensure that the change in elevation is within the recommended value.

Recommendation Up to 0.25 inches

Remove tripping hazards \$198

Code Reference ADA 206, 302

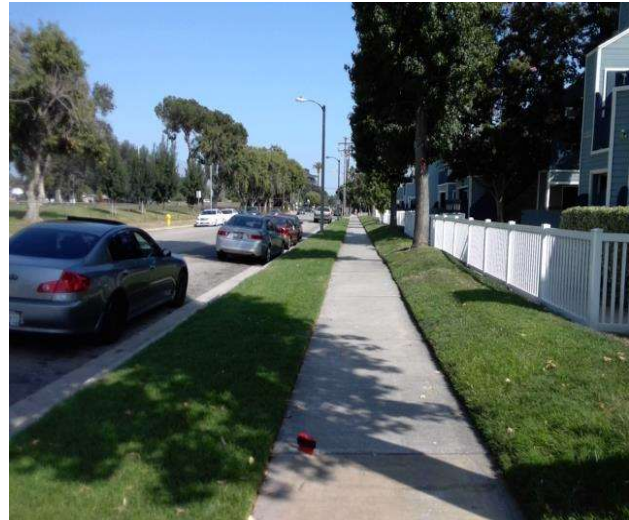
There is a change in elevation greater than recommended value.

Ensure that the change in elevation is within the recommended value.

Recommendation Up to 0.25 inches

Remove tripping hazards \$198

Code Reference ADA 206, 302

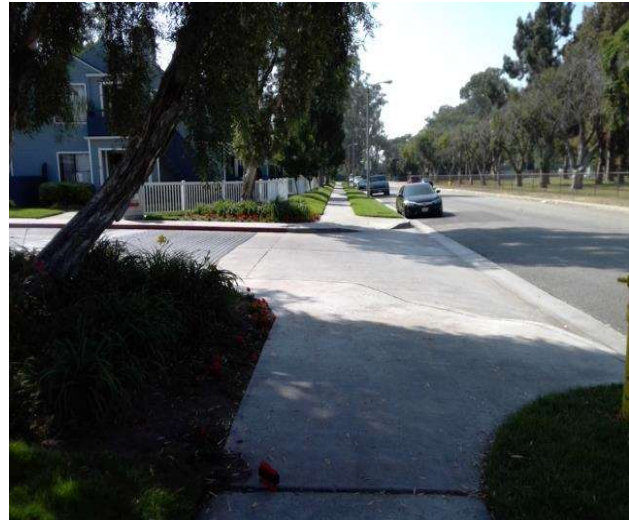
There is a change in elevation greater than recommended value.

Ensure that the change in elevation is within the recommended value.

Recommendation Up to 0.25 inches

Remove tripping hazards \$198

Code Reference ADA 206, 302

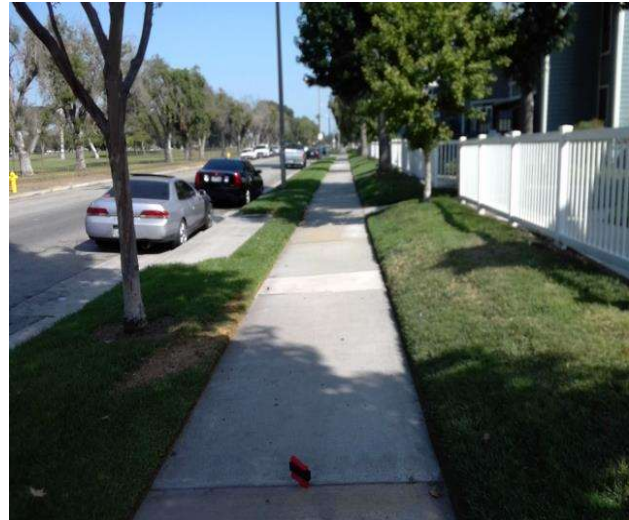
There is a change in elevation greater than recommended value.

Ensure that the change in elevation is within the recommended value.

Recommendation Up to 0.25 inches

Remove tripping hazards \$198

Code Reference ADA 206, 302

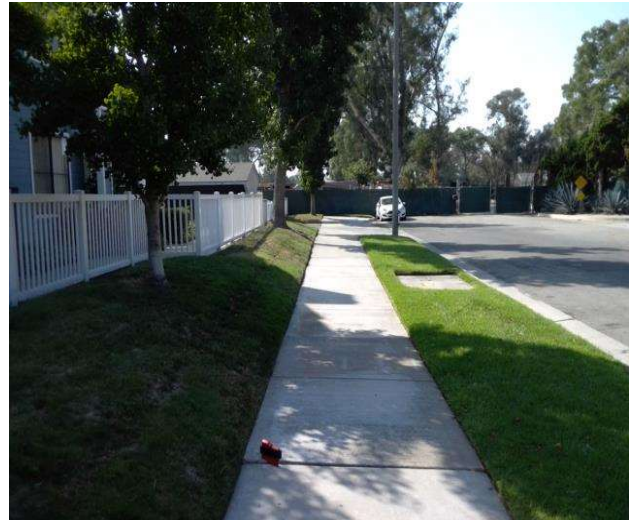
There is a change in elevation greater than recommended value.

Ensure that the change in elevation is within the recommended value.

Recommendation Up to 0.25 inches

Remove tripping hazards \$198

Code Reference ADA 206, 302

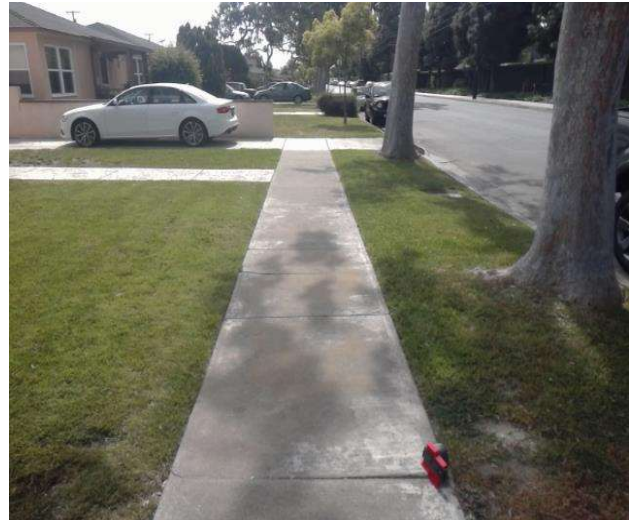
There is a change in elevation greater than recommended value.

Ensure that the change in elevation is within the recommended value.

Recommendation Up to 0.25 inches

Remove tripping hazards \$198

Code Reference ADA 206, 302

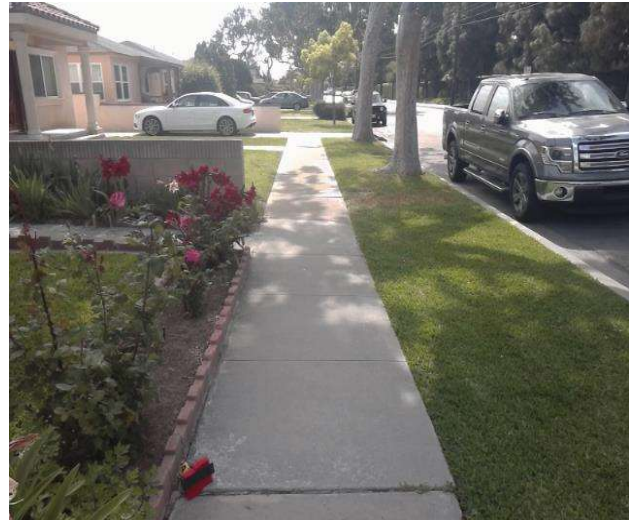
There is a change in elevation greater than recommended value.

Ensure that the change in elevation is within the recommended value.

Recommendation Up to 0.25 inches

Remove tripping hazards \$198

Code Reference ADA 206, 302

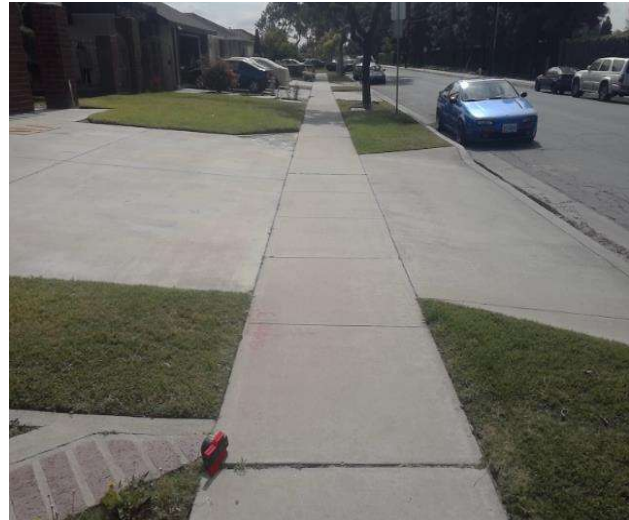
There is a change in elevation greater than recommended value.

Ensure that the change in elevation is within the recommended value.

Recommendation Up to 0.25 inches

Remove tripping hazards \$198

Code Reference ADA 206, 302

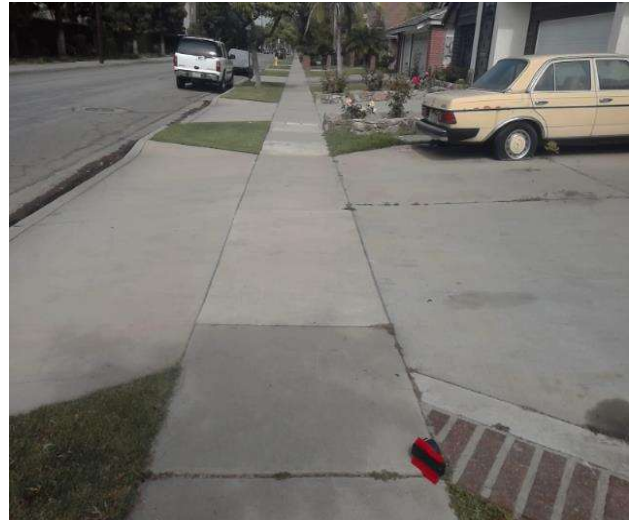
There is a change in elevation greater than recommended value.

Ensure that the change in elevation is within the recommended value.

Remove tripping hazards \$198

Code Reference ADA 206, 302
