Accessibility Survey

City of Downey Rives Avenue - Brookpark Avenue to Cul-De-Sac

Date of Inspection 6/22/2017

Disability Access Consultants

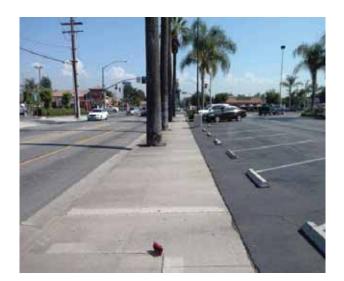
Change in Level South of Burns Avenue @ 33.944278921824, -118.142483979464

There is a change in elevation greater than recommended value.

Ensure that the change in elevation is within the recommended value.

Remove tripping hazards \$198

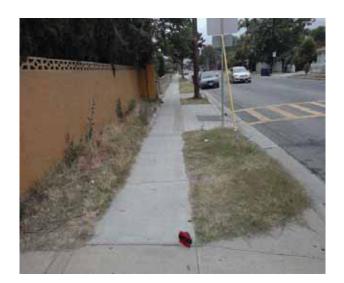
There is a change in elevation greater than recommended value.

Ensure that the change in elevation is within the recommended value.

Remove tripping hazards \$198

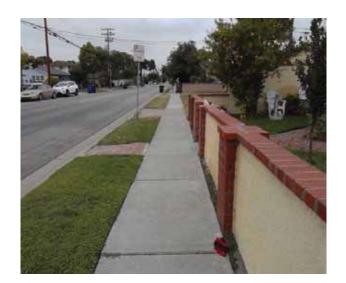
There is a change in elevation greater than recommended value.

Ensure that the change in elevation is within the recommended value.

Remove tripping hazards \$198

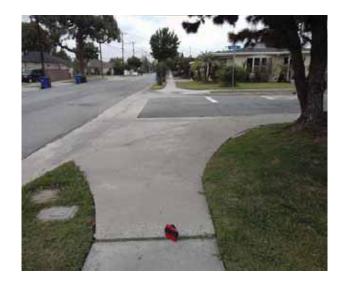
There is a change in elevation greater than recommended value.

Ensure that the change in elevation is within the recommended value.

Remove tripping hazards \$198

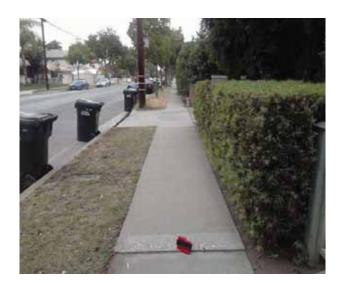
There is a change in elevation greater than recommended value.

Ensure that the change in elevation is within the recommended value.

Remove tripping hazards \$198

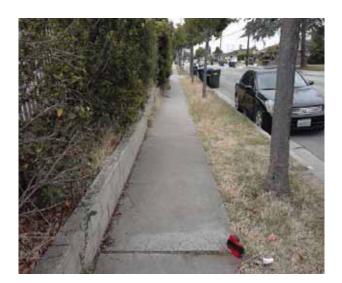
There is a change in elevation greater than recommended value.

Ensure that the change in elevation is within the recommended value.

Remove tripping hazards \$198

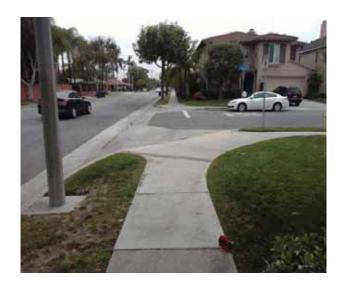
There is a change in elevation greater than recommended value.

Ensure that the change in elevation is within the recommended value.

Remove tripping hazards \$198

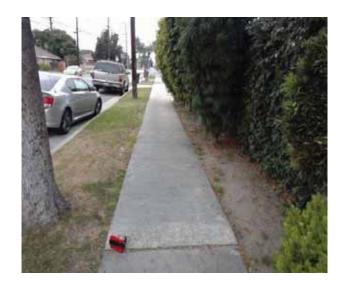
Change in Level South of Burns Avenue @ 33.943303205651, -118.143253773451

There is a change in elevation greater than recommended value.

Ensure that the change in elevation is within the recommended value.

Remove tripping hazards \$198

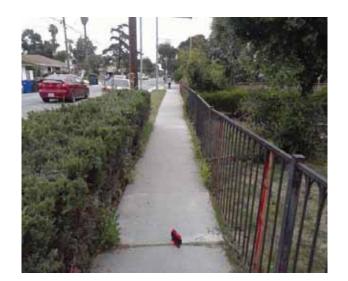
There is a change in elevation greater than recommended value.

Ensure that the change in elevation is within the recommended value.

Remove tripping hazards \$198

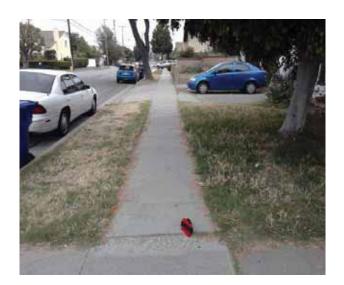
There is a change in elevation greater than recommended value.

Ensure that the change in elevation is within the recommended value.

Remove tripping hazards \$198

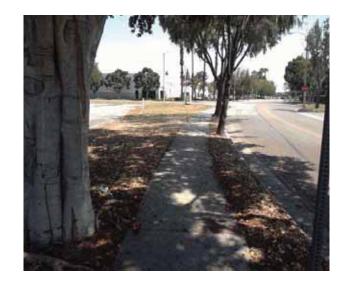
Sidewalks , Change in Level : Change in Level Non Beveled

Remove tripping hazards \$198

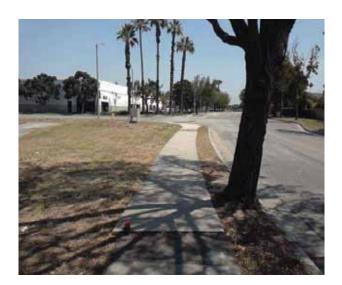
Sidewalks , Change in Level : Change in Level Non Beveled

Remove tripping hazards \$198

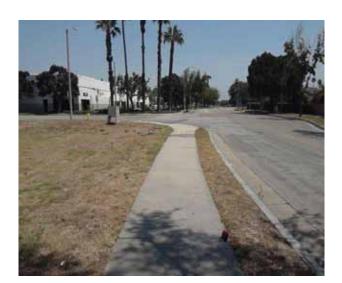
Sidewalks , Change in Level : Change in Level Non Beveled

Remove tripping hazards \$198

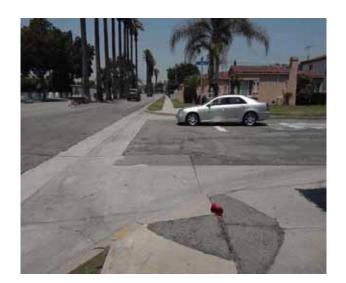
Code Reference ADA 206, 302 Notes: Surface is Rough And Uneven.

Remove tripping hazards \$198

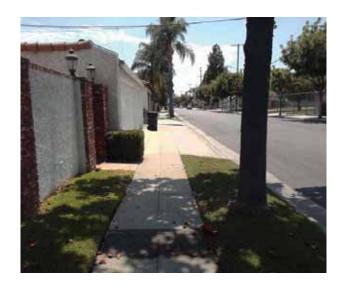
Code Reference ADA 206, 302 Notes: Surface is Rough And Uneven.

Remove tripping hazards \$198

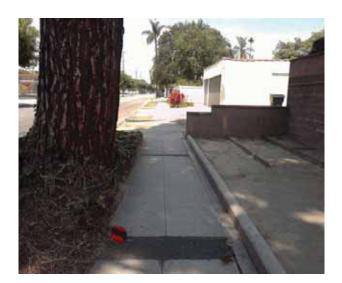
Code Reference ADA 206, 302 Notes: Surface is Rough And Uneven.

Remove tripping hazards \$198

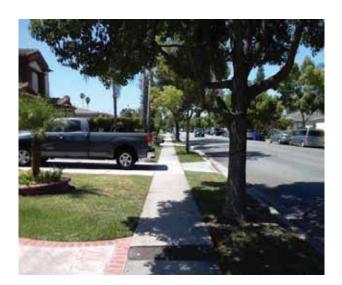
Code Reference ADA 206, 302 Notes: Surface is Rough And Uneven

Remove tripping hazards \$198

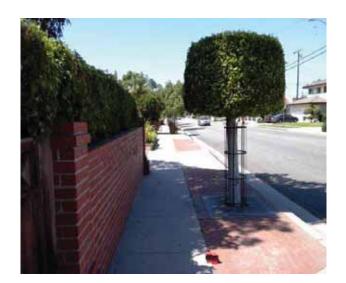
Notes: Change in Level Parallel With Path of Travel For 20 Feet

Remove tripping hazards \$198

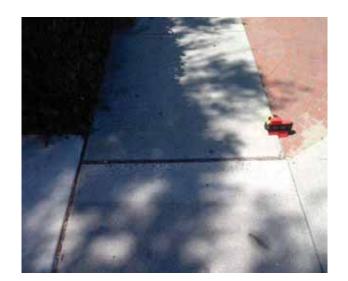
Notes: Change in Level Parallel With Path of Travel For 20 Feet

Remove tripping hazards \$198

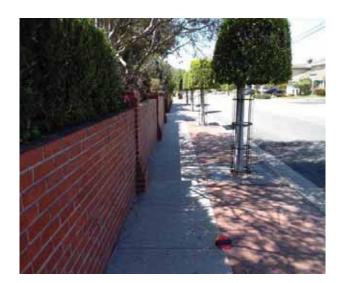
Notes: Change in Level Parallel With Path of Travel For 78 Feet

Remove tripping hazards \$198

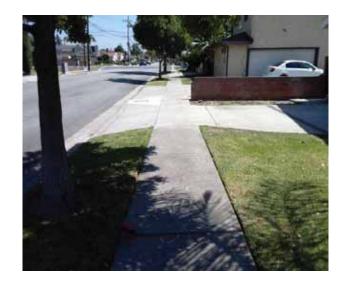
Sidewalks , Change in Level : Change in Level Non Beveled

Remove tripping hazards \$198
