Accessibility Survey

City of Downey Tweedy Lane - Brookpark Road to Telegraph Road

Date of Inspection
6/22/2017

Prepared By
Disability Access Consultants
(800) 743-7067

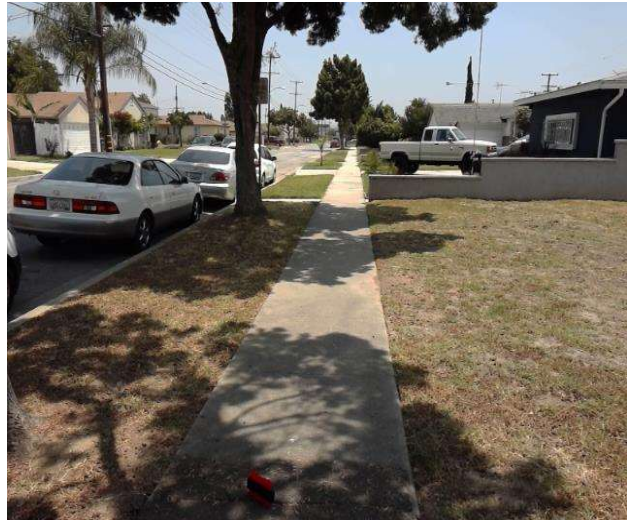
Change in Level South of Telegraph Road @ 33.967961918200, -118.121377676725

Sidewalks , Change in Level : Change in Level Non Beveled

There is a change in elevation greater than recommended value.

On-Site Finding 1.00 inches

Ensure that the change in elevation is within the recommended value.

Recommendation Up to 0.25 inches

Remove tripping hazards \$198

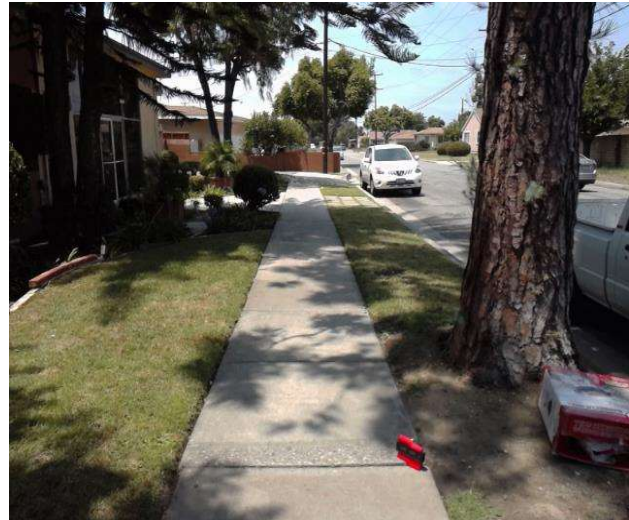
Change in Level South of Telegraph Road @ 33.968873954368, -118.119260072708

Sidewalks , Change in Level : Change in Level Non Beveled

There is a change in elevation greater than recommended value.

Ensure that the change in elevation is within the recommended value.

Recommendation Up to 0.25 inches

Remove tripping hazards \$198

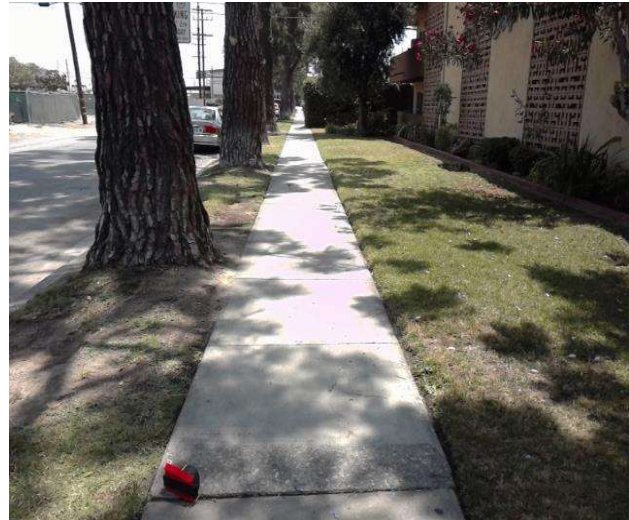
There is a change in elevation greater than recommended value.

Ensure that the change in elevation is within the recommended value.

Recommendation Up to 0.25 inches

Remove tripping hazards \$198

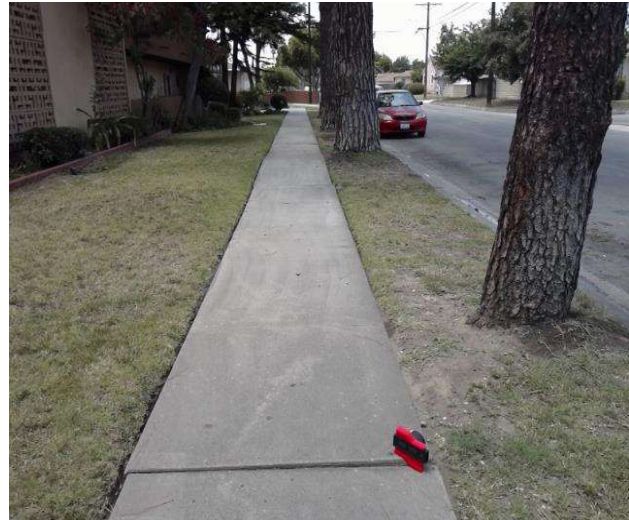
There is a change in elevation greater than recommended value.

Ensure that the change in elevation is within the recommended value.

Recommendation Up to 0.25 inches

Remove tripping hazards \$198

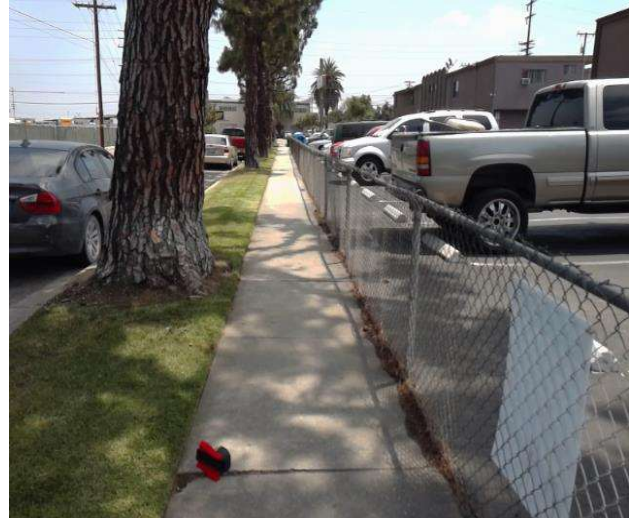
There is a change in elevation greater than recommended value.

Ensure that the change in elevation is within the recommended value.

Recommendation Up to 0.25 inches

Remove tripping hazards \$198

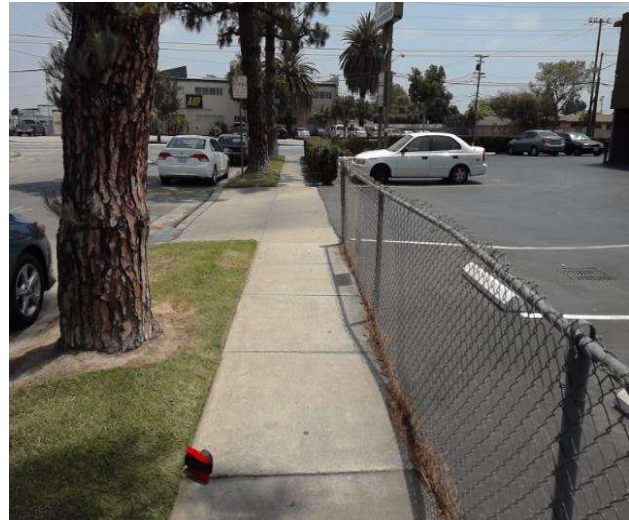
There is a change in elevation greater than recommended value.

Ensure that the change in elevation is within the recommended value.

Recommendation Up to 0.25 inches

Remove tripping hazards \$198

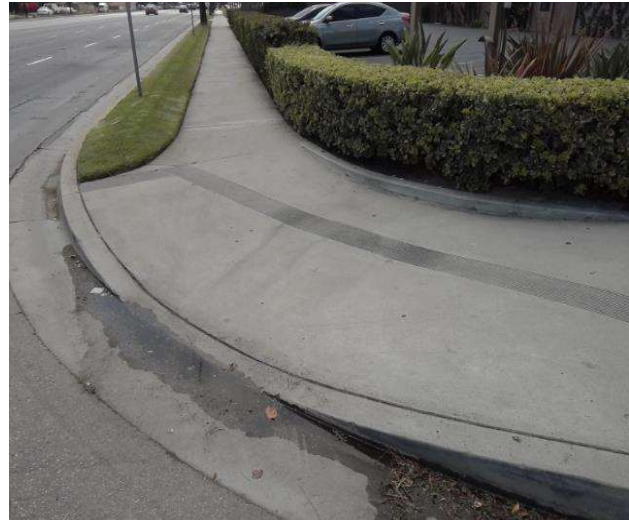
On-Site Finding Not Found

Provide detectable warning to surface \$248

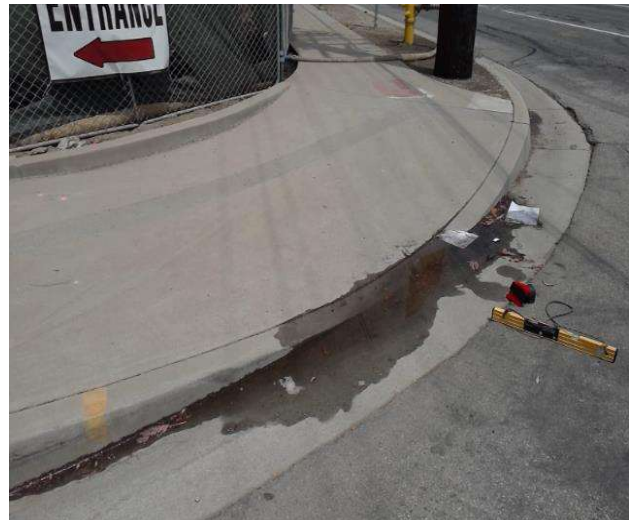
Curb Ramp , Landings and Transitions : Landing Accumulates Water - Wet Conditions

Provide compliant landing \$255

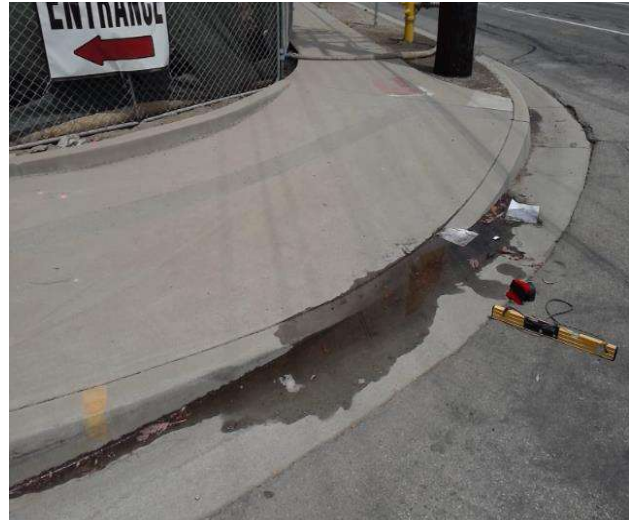
Curb Ramp , Landings and Transitions : Top Landing Clear Length - Landings

Recommendation At least 48.00 inches

Provide compliant landing \$240

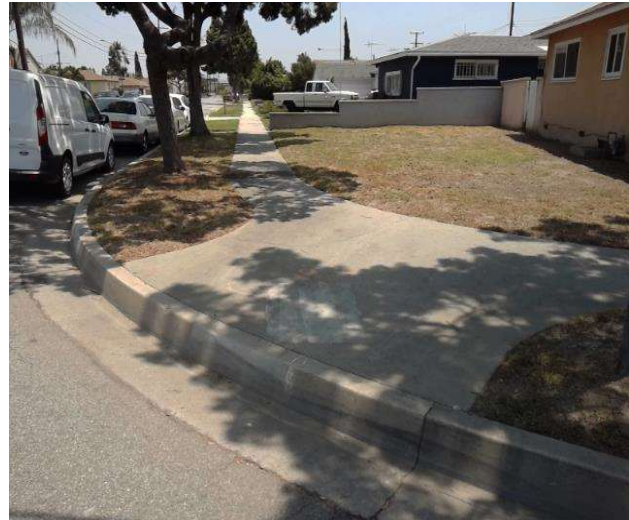
Sidewalks , Hazards & Gratings : Curb is on Path of Travel

Install curb ramp \$2,500

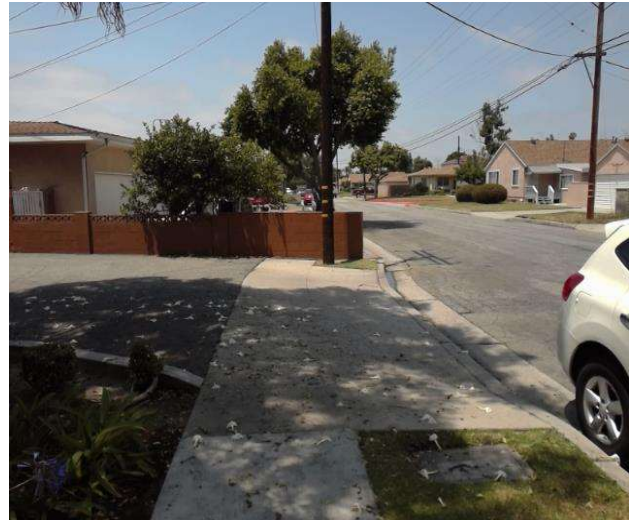
On-Site Finding Not Found

Install compliant detectable warnings \$190

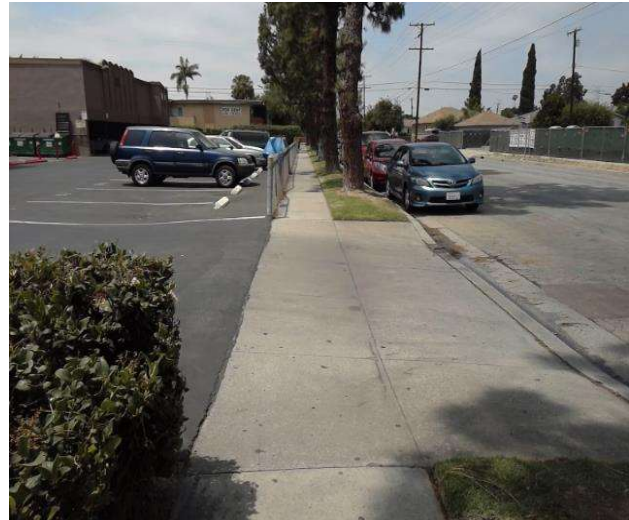
On-Site Finding Not Found

Install compliant detectable warnings \$190

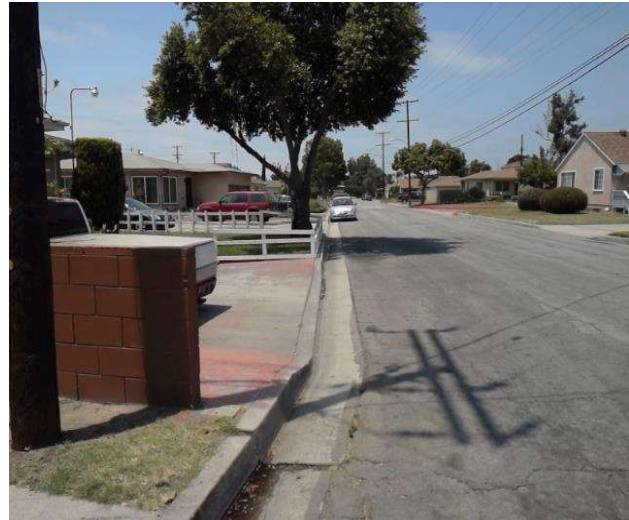
Sidewalks : Missing Sidewalk

Section of sidewalk is missing and consists of dirt, grass or gravel.

Provide a compliant sidewalk for the missing section.

\$1,260

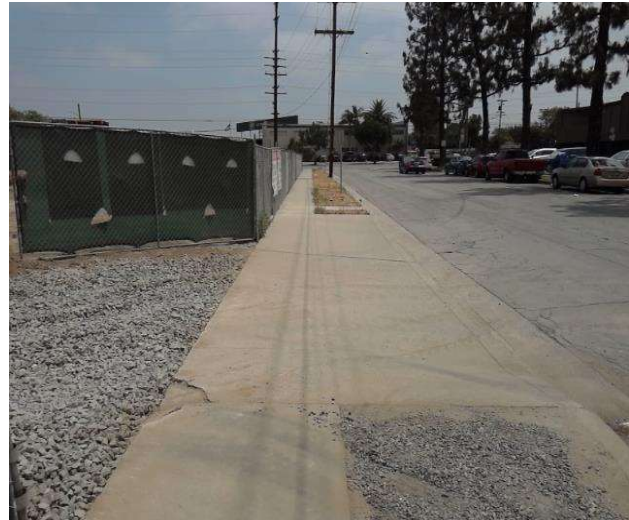
On-Site Finding Not Found

Install compliant detectable warnings \$190

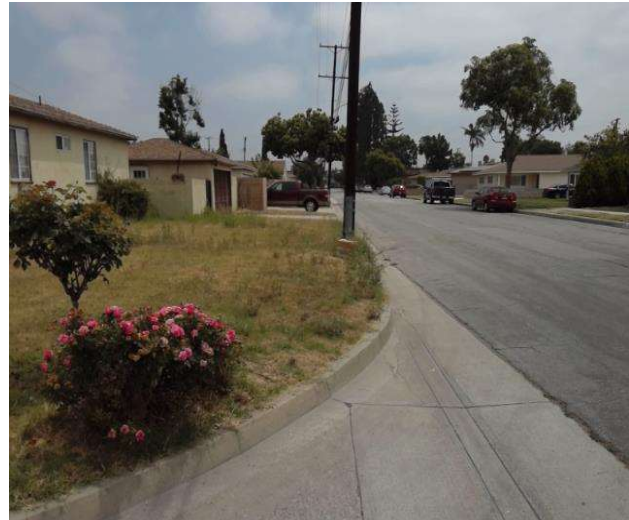
Sidewalks : Missing Sidewalk

Section of sidewalk is missing and consists of dirt, grass or gravel.

Provide a compliant sidewalk for the missing section.

\$1,260

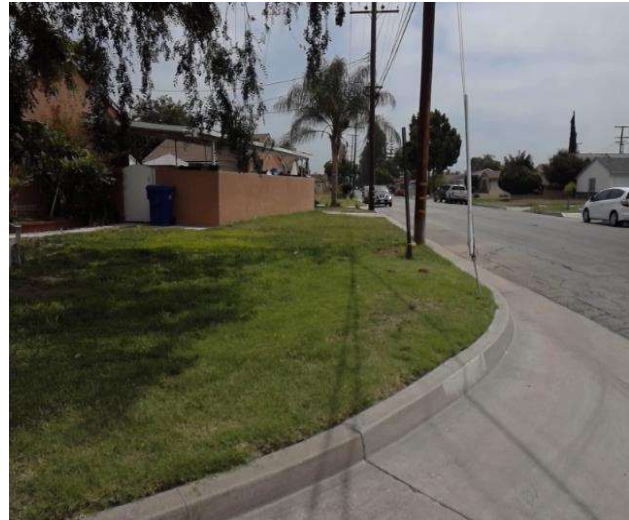
Sidewalks : Missing Sidewalk

Section of sidewalk is missing and consists of dirt, grass or gravel.

Provide a compliant sidewalk for the missing section.

\$1,260

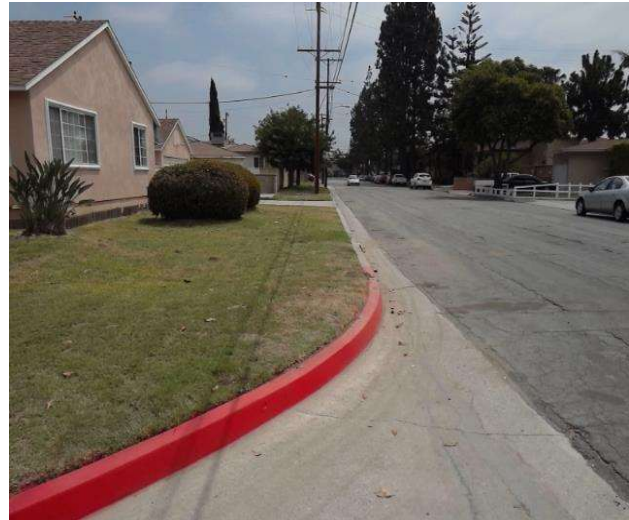
Sidewalks : Missing Sidewalk

Section of sidewalk is missing and consists of dirt, grass or gravel.

Provide a compliant sidewalk for the missing section.

\$1,260

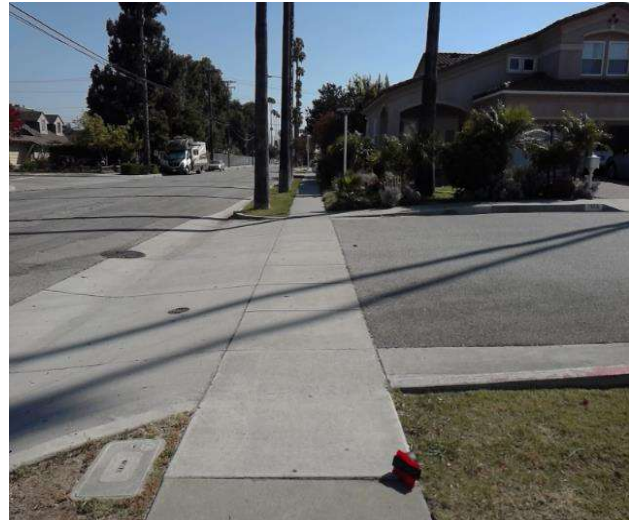
There is a change in elevation greater than recommended value.

Ensure that the change in elevation is within the recommended value.

Recommendation Up to 0.25 inches

Remove tripping hazards \$198

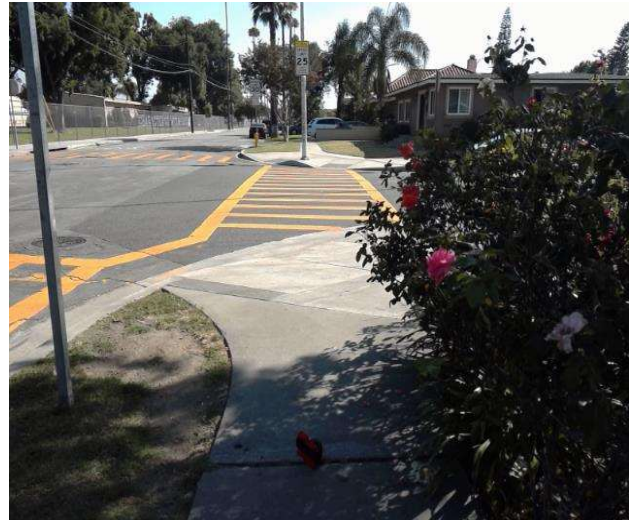
There is a change in elevation greater than recommended value.

Ensure that the change in elevation is within the recommended value.

Recommendation Up to 0.25 inches

Remove tripping hazards \$198

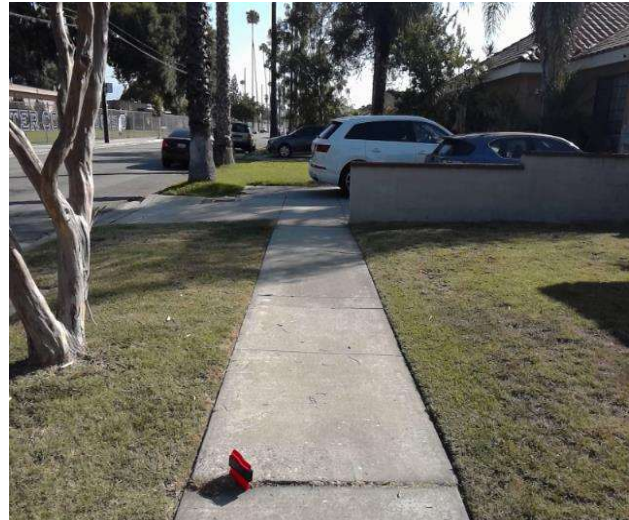
There is a change in elevation greater than recommended value.

Ensure that the change in elevation is within the recommended value.

Recommendation Up to 0.25 inches

Remove tripping hazards \$198

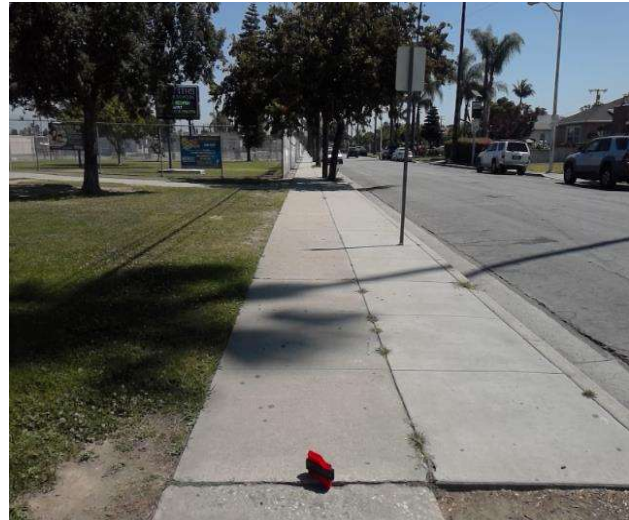
There is a change in elevation greater than recommended value.

Ensure that the change in elevation is within the recommended value.

Recommendation Up to 0.25 inches

Remove tripping hazards \$198

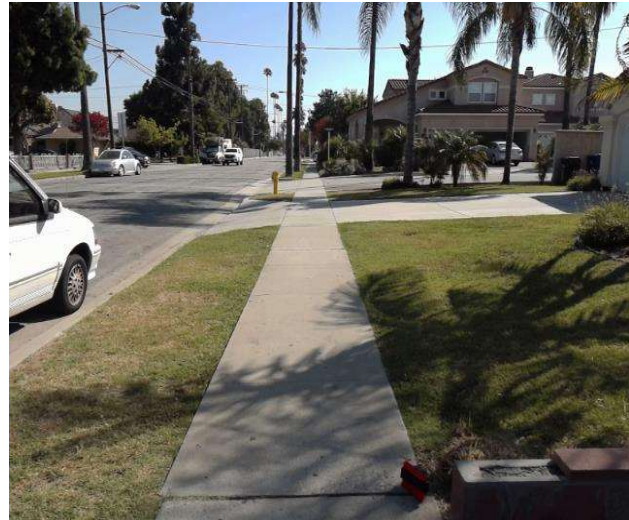
There is a change in elevation greater than recommended value.

Ensure that the change in elevation is within the recommended value.

Recommendation Up to 0.25 inches

Remove tripping hazards \$198

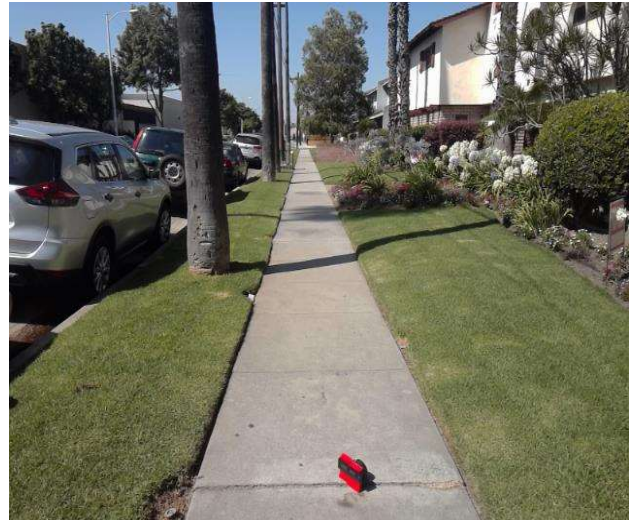
There is a change in elevation greater than recommended value.

Ensure that the change in elevation is within the recommended value.

Recommendation Up to 0.25 inches

Remove tripping hazards \$198

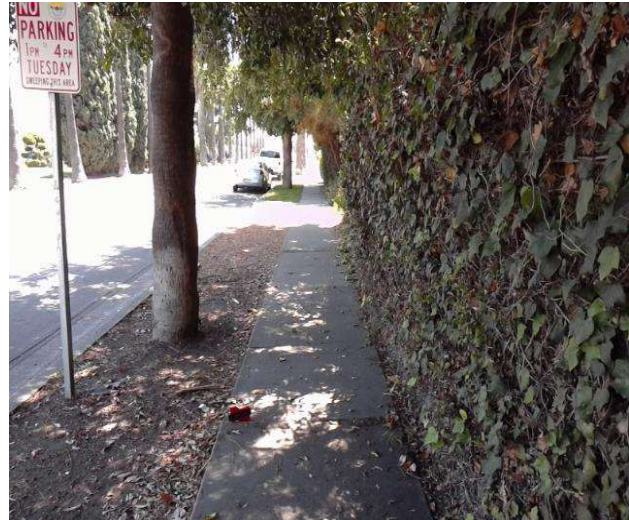
There is a change in elevation greater than recommended value.

Ensure that the change in elevation is within the recommended value.

Recommendation Up to 0.25 inches

Remove tripping hazards \$198

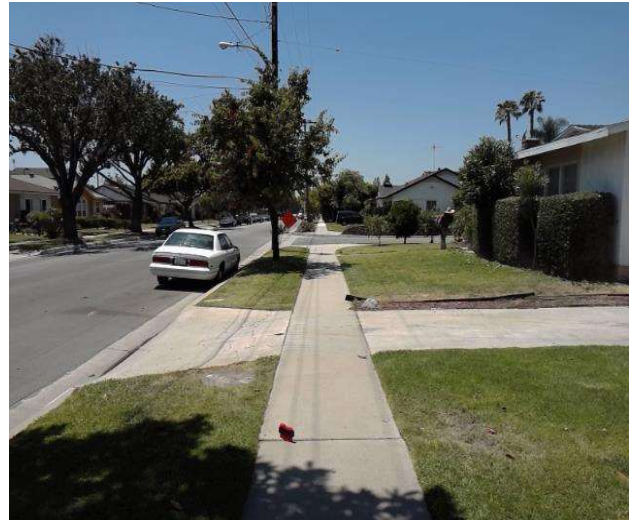
There is a change in elevation greater than recommended value.

Ensure that the change in elevation is within the recommended value.

Recommendation Up to 0.25 inches

Remove tripping hazards \$198

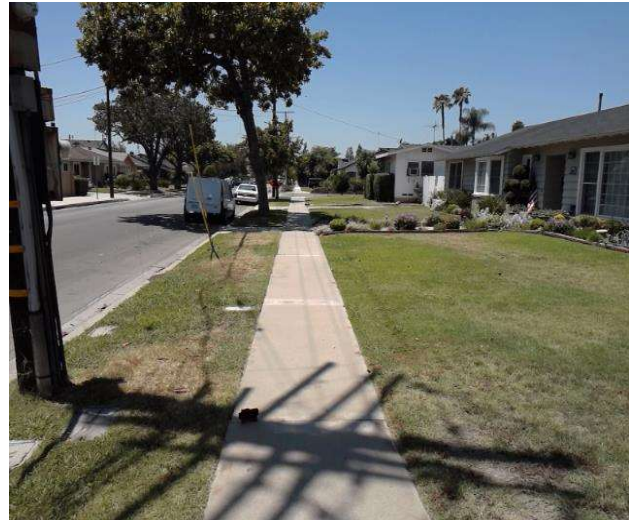
There is a change in elevation greater than recommended value.

Ensure that the change in elevation is within the recommended value.

Recommendation Up to 0.25 inches

Remove tripping hazards \$198

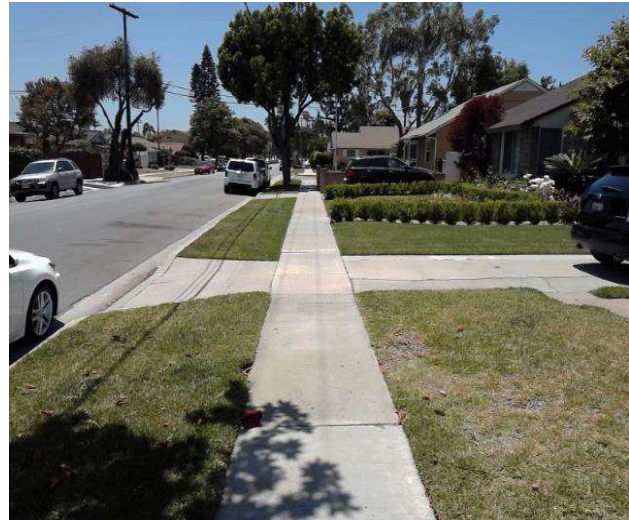
There is a change in elevation greater than recommended value.

Ensure that the change in elevation is within the recommended value.

Recommendation Up to 0.25 inches

Remove tripping hazards \$198

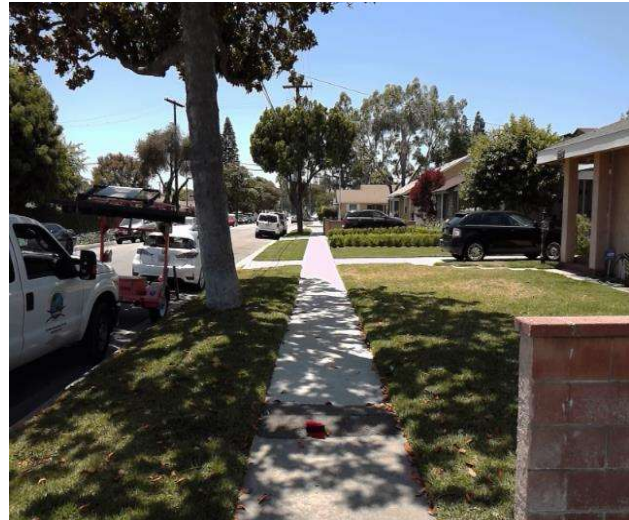
There is a change in elevation greater than recommended value.

Remove tripping hazards \$198
