## Accessibility Survey

### City of Downey De Palma Street - Downey Avenue To Paramount Boulevard

Date of Inspection  
1/31/2017

**Disability Access Consultants**

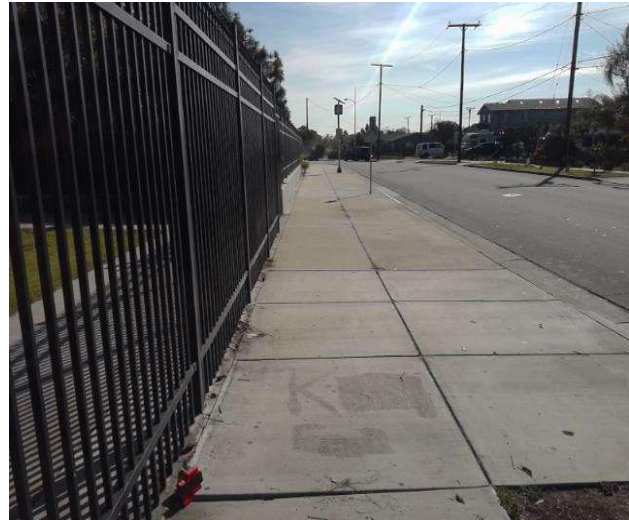
**Change In Level East Of Paramount Boulevard @ 33.935156596087, - 118.141405731440**

Sidewalks , Change in Level : Change in Level Non Beveled

There is a change in elevation greater than recommended value.

**On-Site Finding** 0.75 inches

Ensure that the change in elevation is within the recommended value.

Recommendation Up to 0.25 inches

Remove tripping hazards \$198

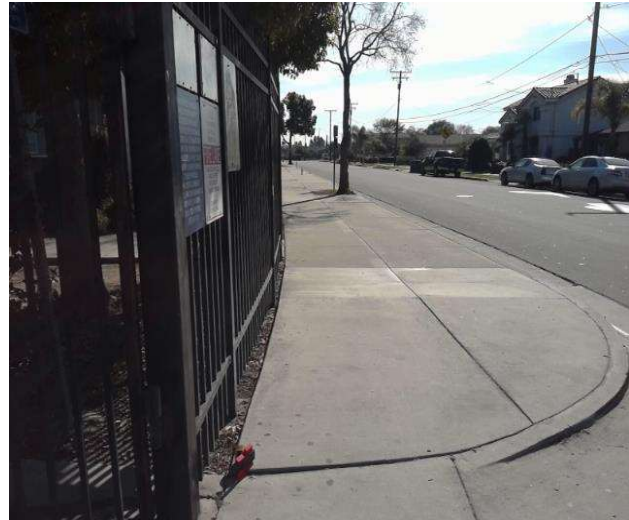
There is a change in elevation greater than recommended value.

Ensure that the change in elevation is within the recommended value.

Recommendation Up to 0.25 inches

Remove tripping hazards \$198

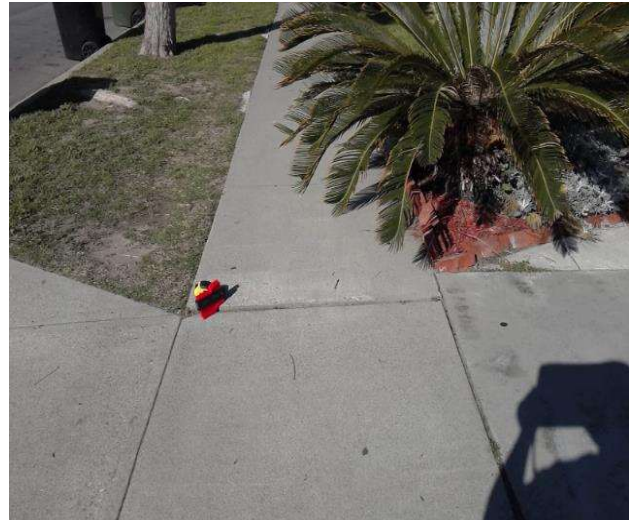
There is a change in elevation greater than recommended value.

Ensure that the change in elevation is within the recommended value.

Recommendation Up to 0.25 inches

Remove tripping hazards \$198

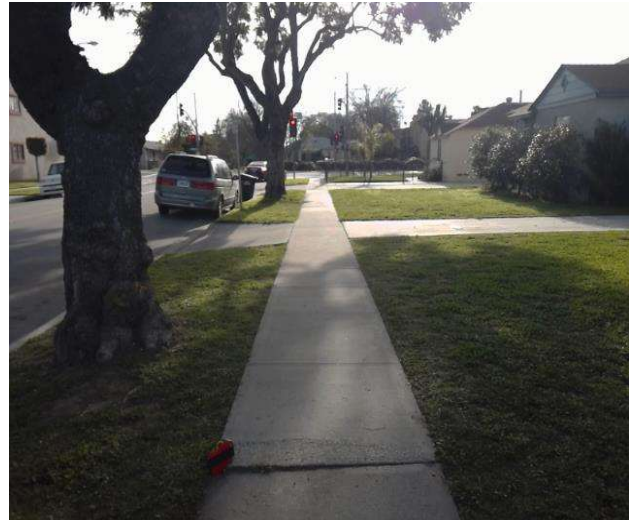
There is a change in elevation greater than recommended value.

Ensure that the change in elevation is within the recommended value.

Recommendation Up to 0.25 inches

Remove tripping hazards \$198

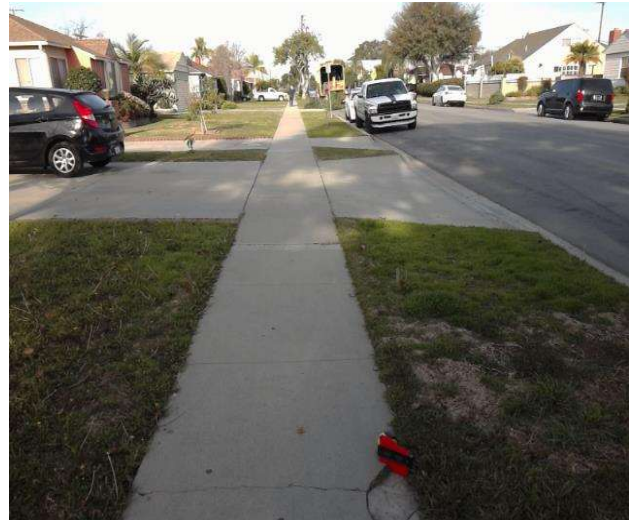
There is a change in elevation greater than recommended value.

Ensure that the change in elevation is within the recommended value.

Recommendation Up to 0.25 inches

Remove tripping hazards \$198

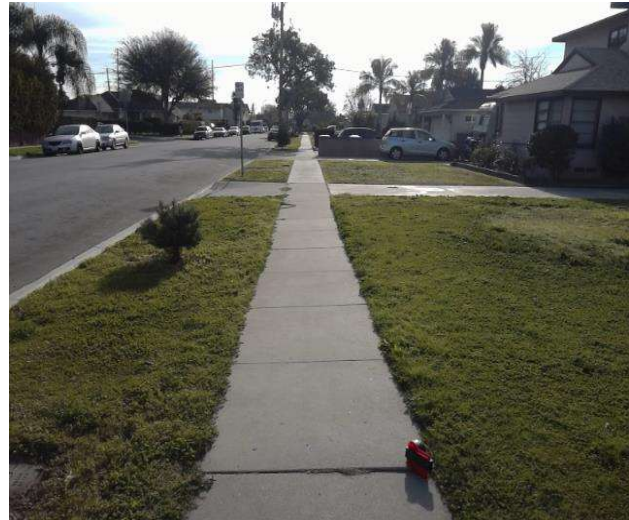
There is a change in elevation greater than recommended value.

Ensure that the change in elevation is within the recommended value.

Recommendation Up to 0.25 inches

Remove tripping hazards \$198

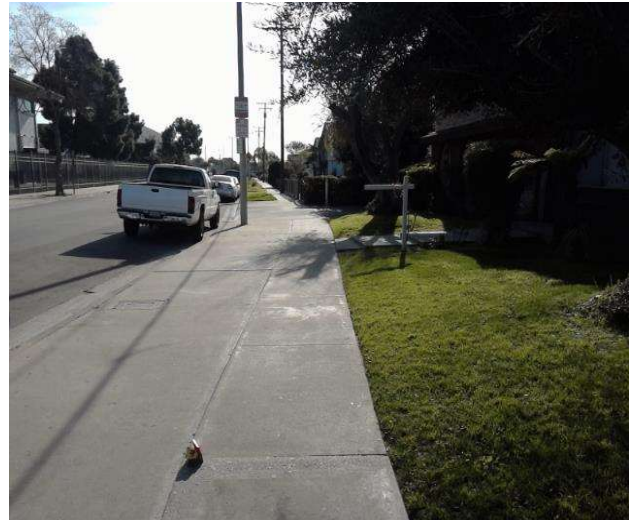
There is a change in elevation greater than recommended value.

Ensure that the change in elevation is within the recommended value.

Recommendation Up to 0.25 inches

Remove tripping hazards \$198

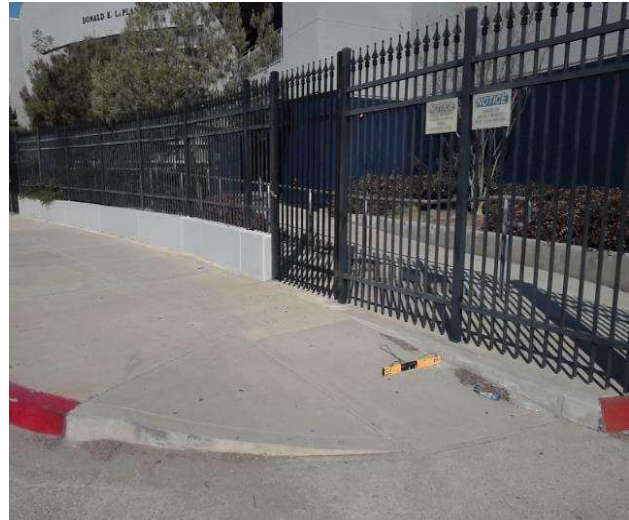
**On-Site Finding** Not Found

Provide detectable warning to surface \$248

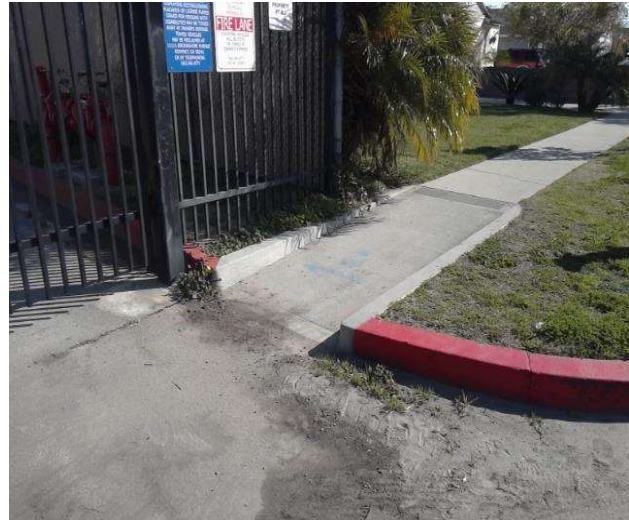
**On-Site Finding** Not Found

Provide detectable warning to surface \$248

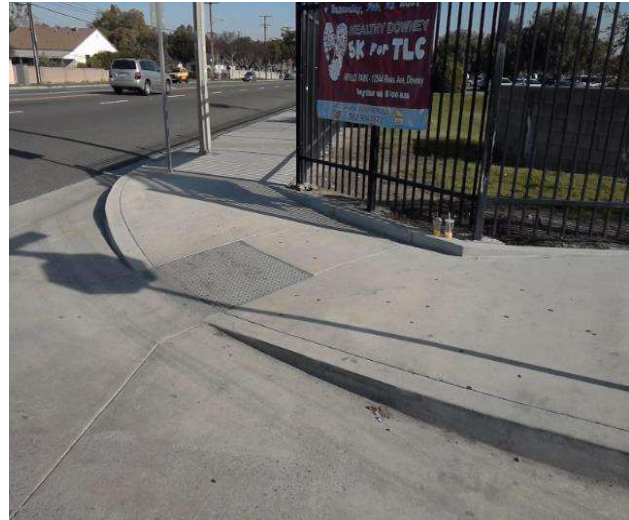
**On-Site Finding** Not Found

Install crosswalk \$800

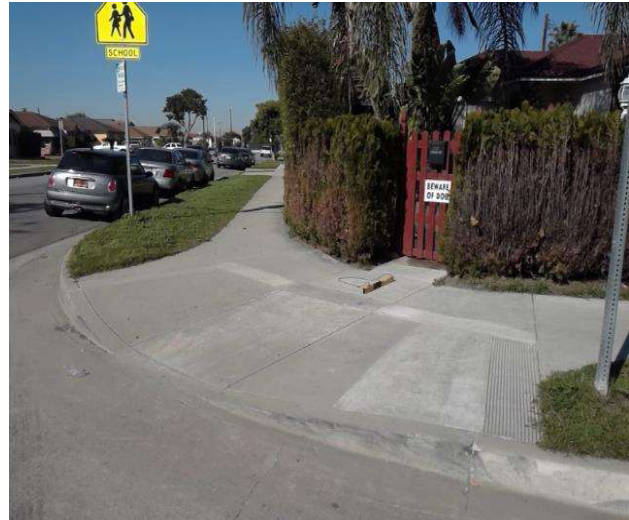
**On-Site Finding** Not Found

Provide detectable warning to surface \$248

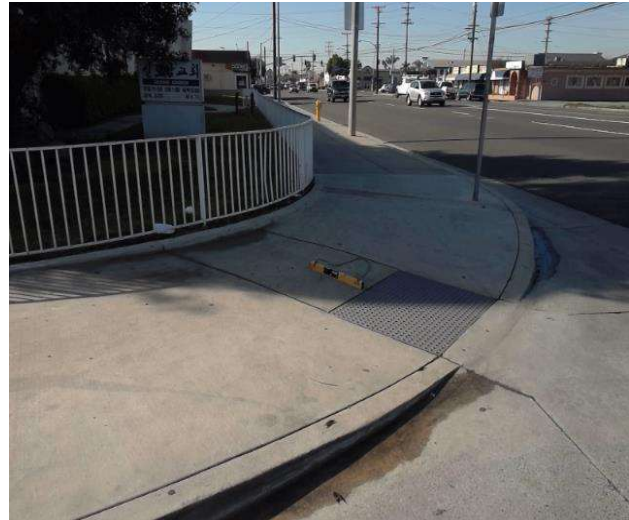
**On-Site Finding** Not Found

Install crosswalk \$800

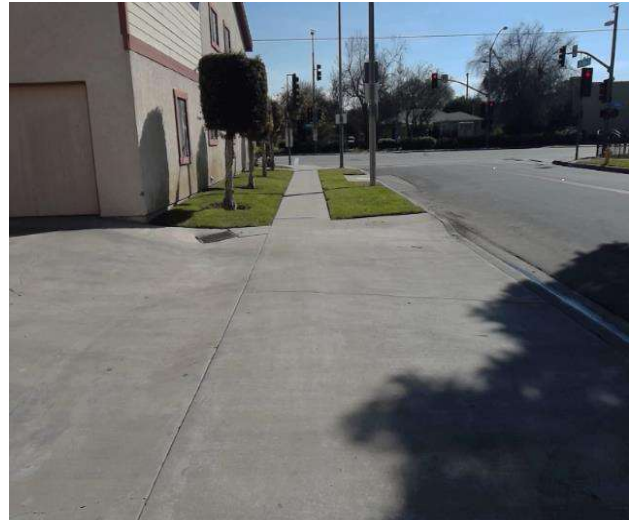
**On-Site Finding** Not Found

Install compliant detectable warnings \$190

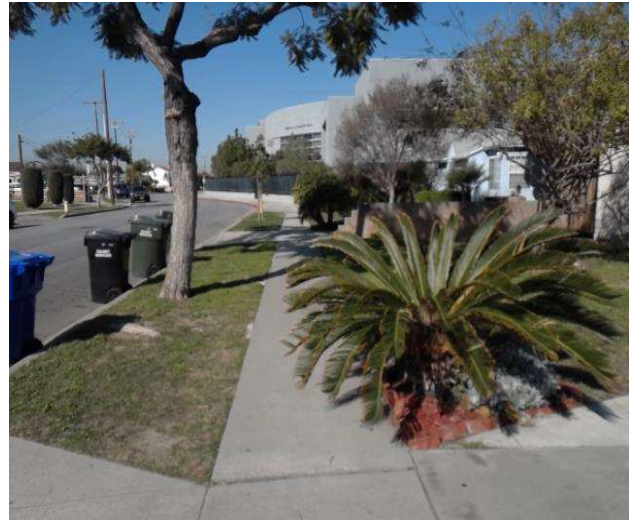
Sidewalks , Hazards & Gratings : Sidewalk Width at Obstruction

Sidewalk width at the obstruction shall have the recommended value.

Recommendation At least 48.00 inches

\$1,260

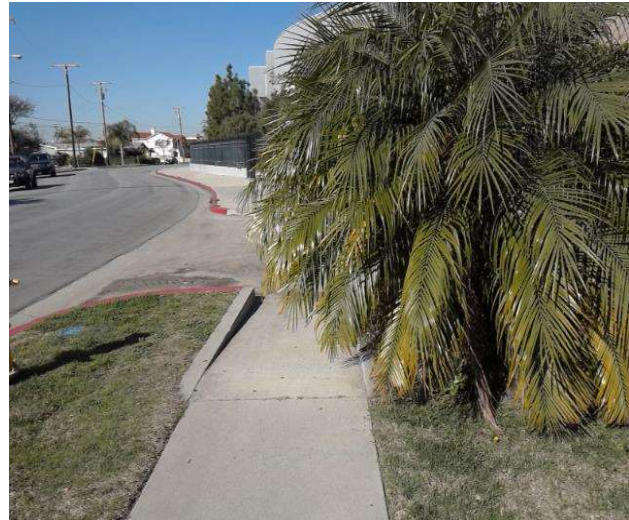
Sidewalks , Hazards & Gratings : Sidewalk Width at Obstruction

Sidewalk width at the obstruction shall have the recommended value.

Recommendation At least 48.00 inches

\$1,260

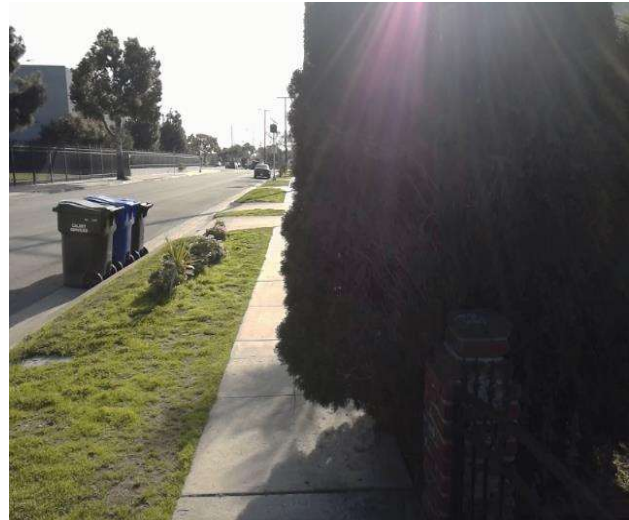
Sidewalks , Hazards & Gratings : Sidewalk Width at Obstruction

Sidewalk width at the obstruction shall have the recommended value.

Recommendation At least 48.00 inches

\$1,260

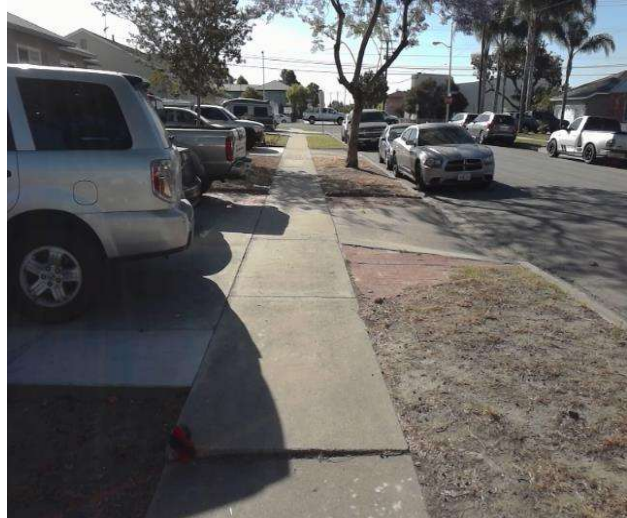
There is a change in elevation greater than recommended value.

Ensure that the change in elevation is within the recommended value.

Recommendation Up to 0.25 inches

Remove tripping hazards \$198

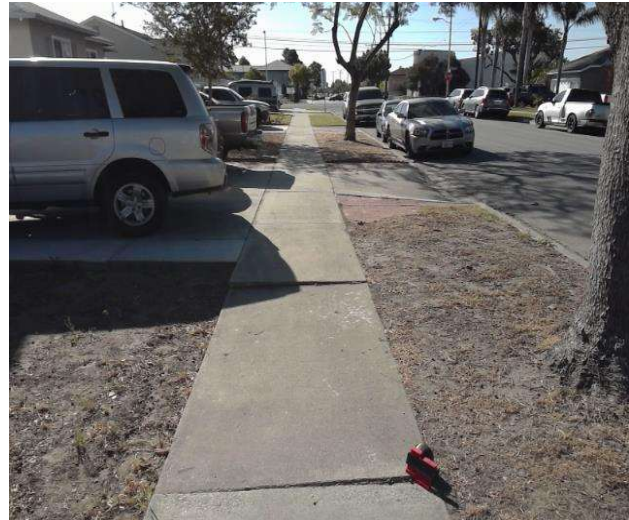
There is a change in elevation greater than recommended value.

Ensure that the change in elevation is within the recommended value.

Recommendation Up to 0.25 inches

Remove tripping hazards \$198

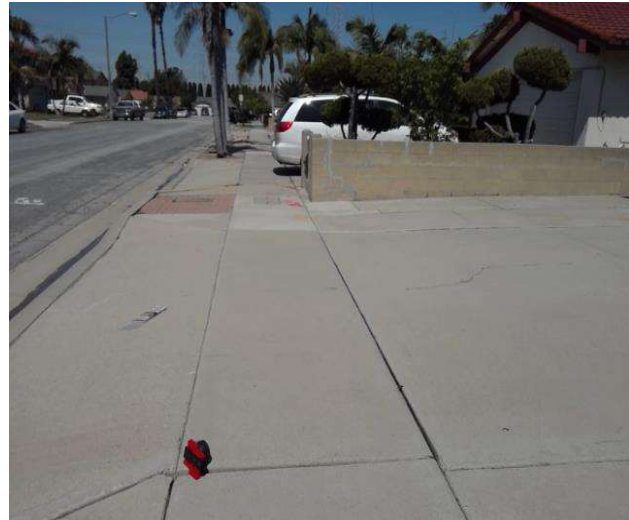
There is a change in elevation greater than recommended value.

Ensure that the change in elevation is within the recommended value.

Recommendation Up to 0.25 inches

Remove tripping hazards \$198

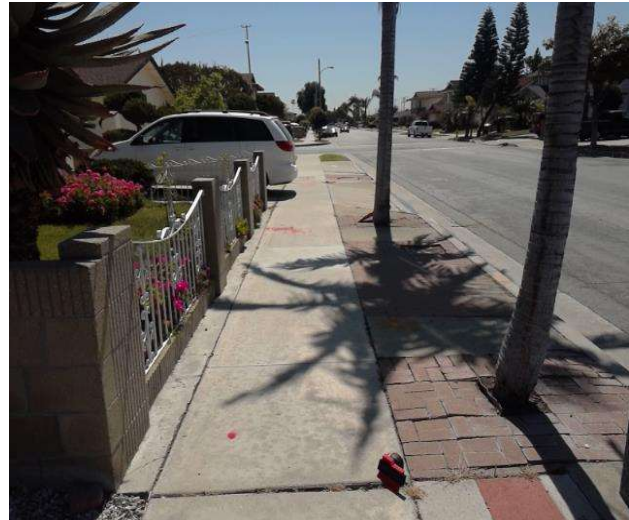
There is a change in elevation greater than recommended value.

Ensure that the change in elevation is within the recommended value.

Recommendation Up to 0.25 inches

Remove tripping hazards \$198
