Accessibility Survey

City of Downey Downey Avenue & De Palma Street

Date of Inspection
1/31/2017

Prepared By
Disability Access Consultants
(800) 743-7067

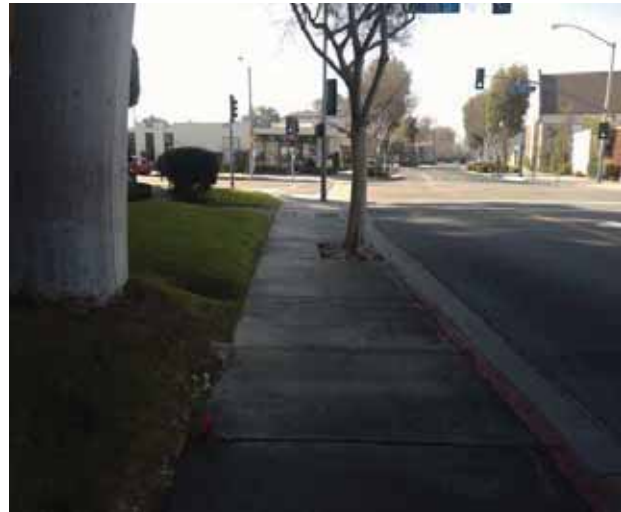
Code Reference ADA 206, 302

Remove tripping hazards \$198

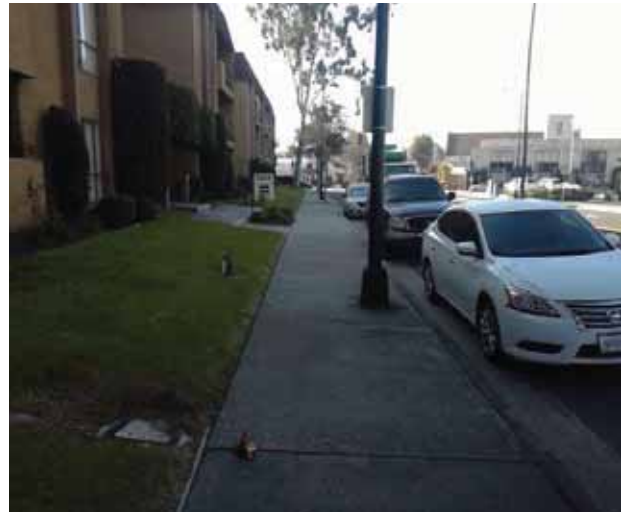
Code Reference ADA 206, 302

Remove tripping hazards \$198

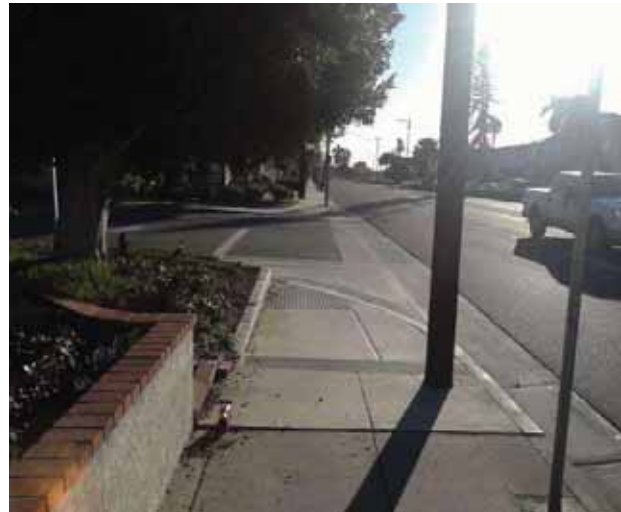
Code Reference ADA 206, 302

Remove tripping hazards \$198

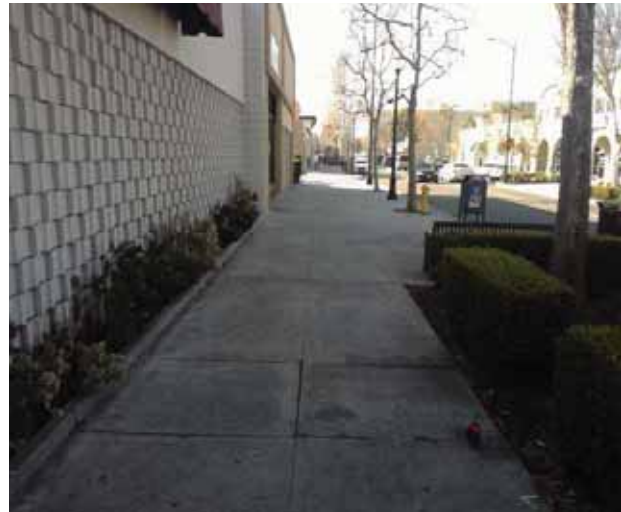
Code Reference ADA 206, 302

Remove tripping hazards \$198

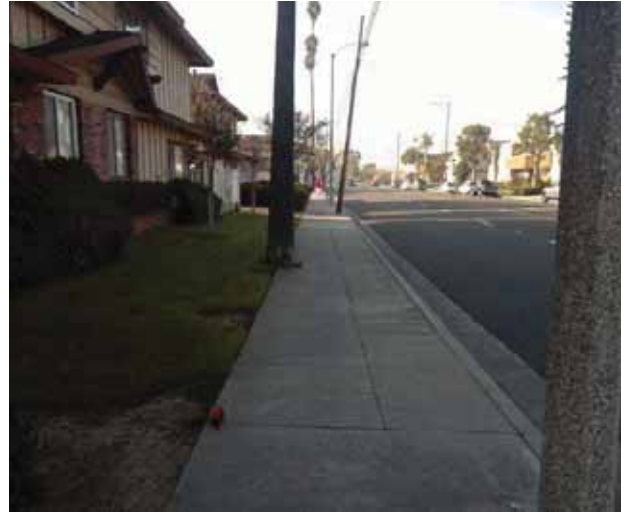
Code Reference ADA 206, 302

Remove tripping hazards \$198

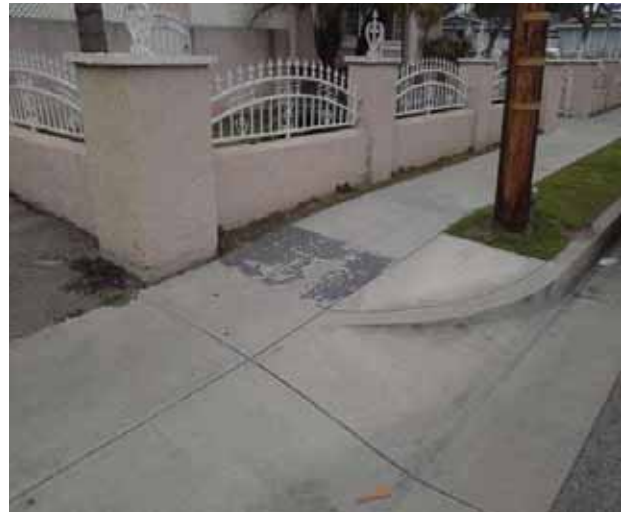
Code Reference CA 11B-406.5.12

Notes : Detectable warnings are damaged.

Provide detectable warning to surface \$248
