# Accessibility Survey

# City of Downey La Reina Avenue - 5th Street to Firestone Boulevard

5th Street to Firestone Boulevard Downey, CA 90242

> Date of Inspection 7/24/2017

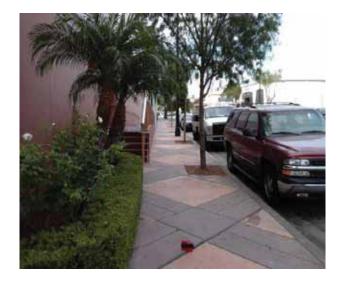
There is a change in elevation greater than recommended value.

Ensure that the change in elevation is within the recommended value.

Recommendation Up to 0.25 inches

Remove tripping hazards \$198

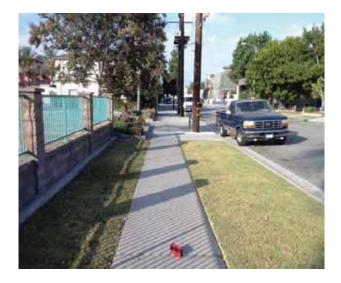
There is a change in elevation greater than recommended value.

Ensure that the change in elevation is within the recommended value.

Recommendation Up to 0.25 inches

Remove tripping hazards \$198

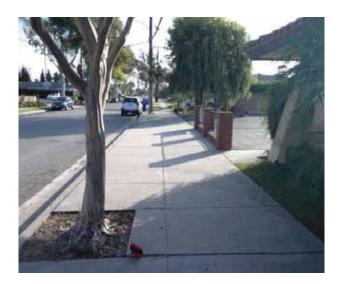
There is a change in elevation greater than recommended value.

Ensure that the change in elevation is within the recommended value.

Recommendation Up to 0.25 inches

Remove tripping hazards \$198

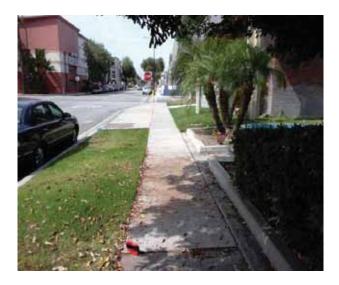
There is a change in elevation greater than recommended value.

Ensure that the change in elevation is within the recommended value.

Recommendation Up to 0.25 inches

Remove tripping hazards \$198

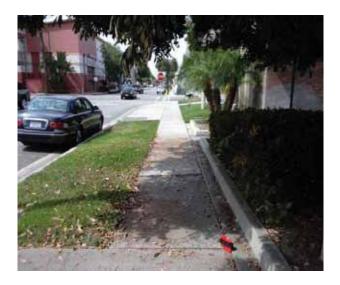
There is a change in elevation greater than recommended value.

Ensure that the change in elevation is within the recommended value.

Recommendation Up to 0.25 inches

Remove tripping hazards \$198

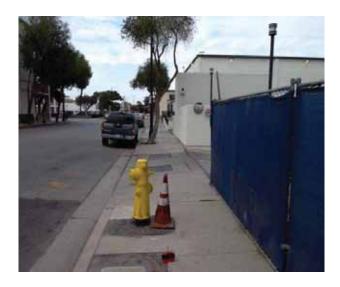
There is a change in elevation greater than recommended value.

Ensure that the change in elevation is within the recommended value.

Recommendation Up to 0.25 inches

Remove tripping hazards \$198

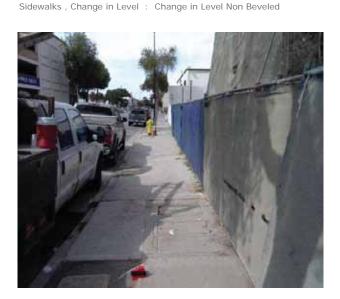
There is a change in elevation greater than recommended value.

Ensure that the change in elevation is within the recommended value.

Recommendation Up to 0.25 inches

Remove tripping hazards \$198

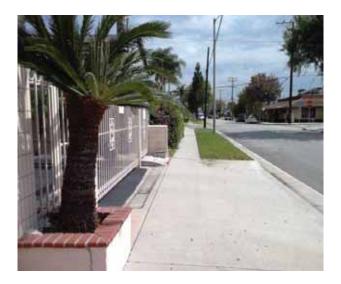
Sidewalks , Hazards & Gratings : Overhead Obstruction Height

At least 80.00 inches Recommendation Costing Info (Estimated)

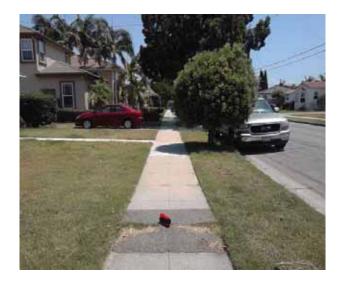
Code Reference	ADA 20	6, 302
Notes : Surface is Rough	And Un	ieven.

Remove tripping hazards \$198
