Accessibility Survey

6th Street - Brookshire Avenue to Downey Avenue

Date of Inspection
7/18/2017

Disability Access Consultants

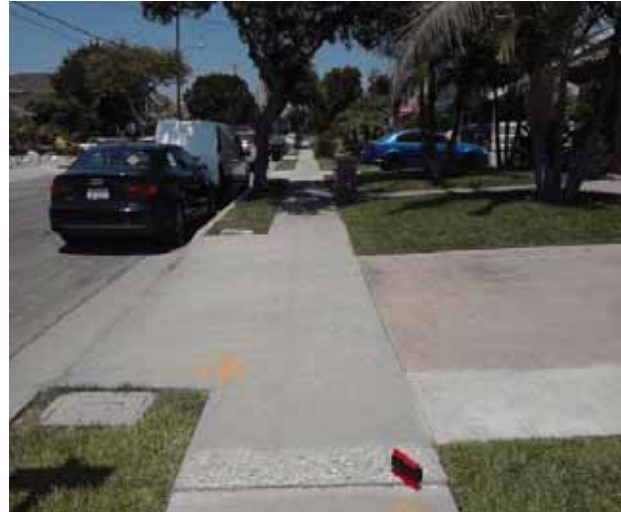
Change in Level East of Dolan Avenue @ 33.943161909452, -118.126213699579

Sidewalks , Change in Level : Change in Level Non Beveled

There is a change in elevation greater than recommended value.

On-Site Finding 0.50 inches

Ensure that the change in elevation is within the recommended value.

Recommendation Up to 0.25 inches

Remove tripping hazards \$198

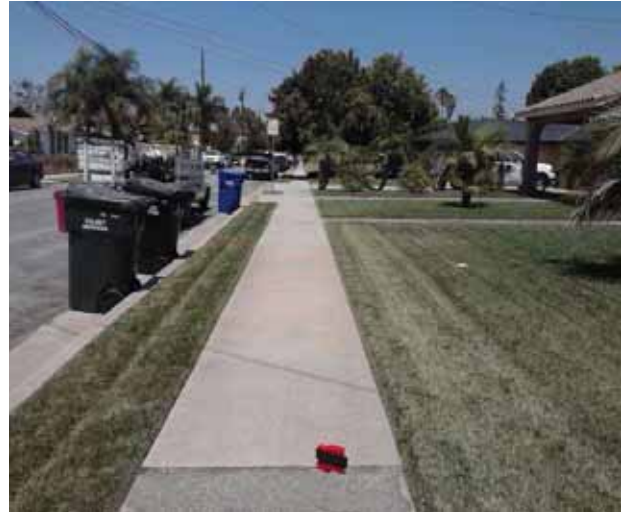
Change in Level East of Dolan Avenue @ 33.943955167755, -118.127782791853

Sidewalks , Change in Level : Change in Level Non Beveled

There is a change in elevation greater than recommended value.

Ensure that the change in elevation is within the recommended value.

Recommendation Up to 0.25 inches

Remove tripping hazards \$198

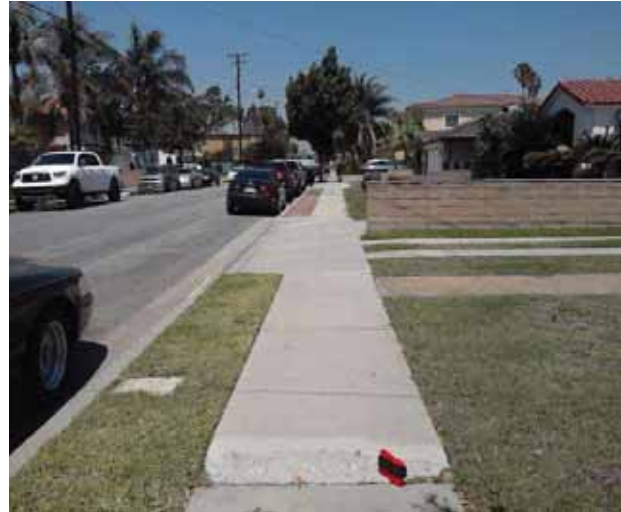
There is a change in elevation greater than recommended value.

Ensure that the change in elevation is within the recommended value.

Recommendation Up to 0.25 inches

Remove tripping hazards \$198

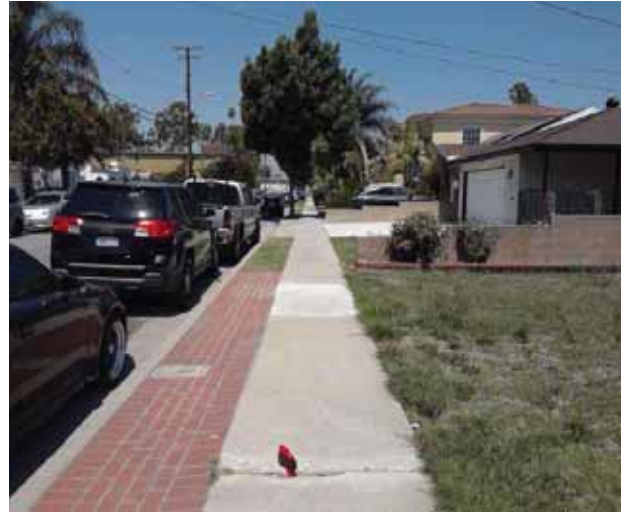
There is a change in elevation greater than recommended value.

Ensure that the change in elevation is within the recommended value.

Recommendation Up to 0.25 inches

Remove tripping hazards \$198

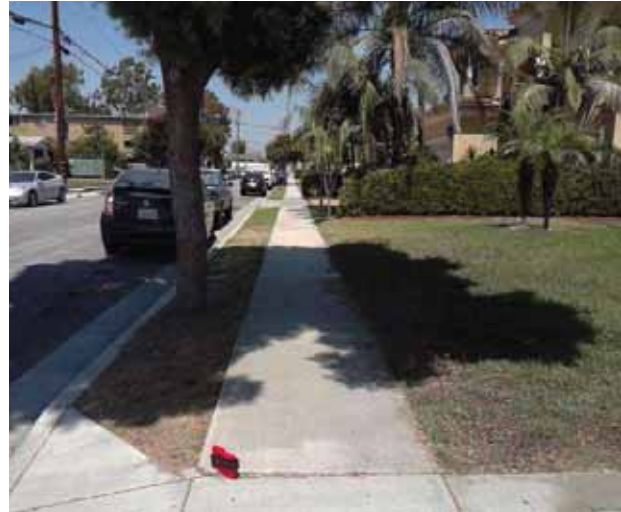
There is a change in elevation greater than recommended value.

Ensure that the change in elevation is within the recommended value.

Recommendation Up to 0.25 inches

Remove tripping hazards \$198

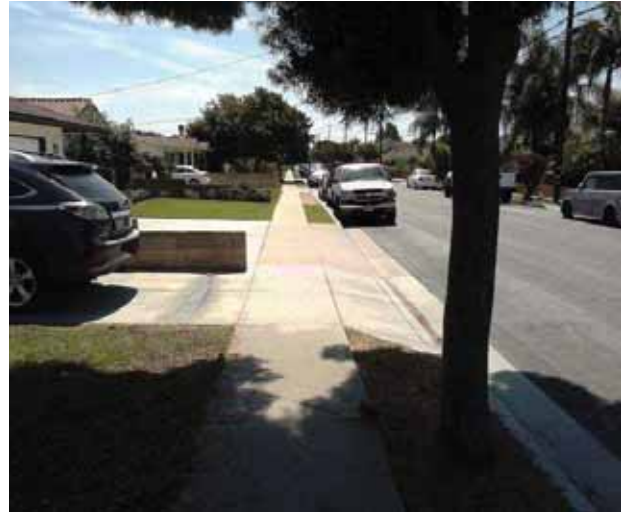
There is a change in elevation greater than recommended value.

Ensure that the change in elevation is within the recommended value.

Recommendation Up to 0.25 inches

Remove tripping hazards \$198

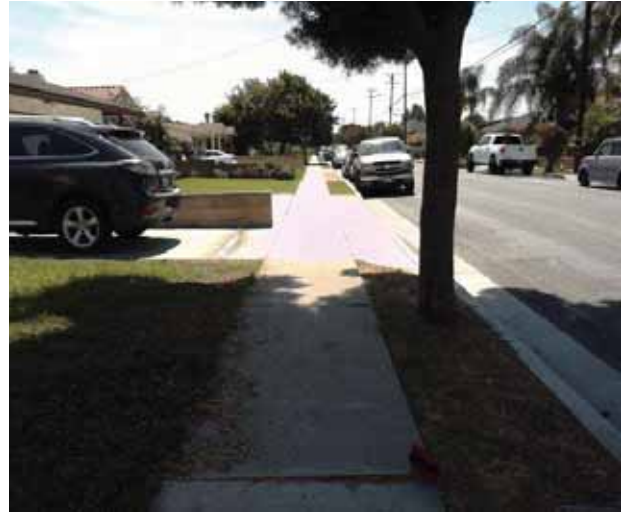
There is a change in elevation greater than recommended value.

Ensure that the change in elevation is within the recommended value.

Recommendation Up to 0.25 inches

Remove tripping hazards \$198

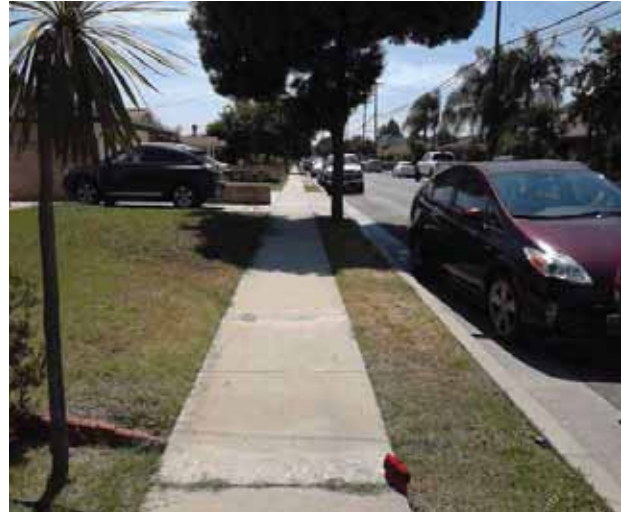
There is a change in elevation greater than recommended value.

Ensure that the change in elevation is within the recommended value.

Recommendation Up to 0.25 inches

Remove tripping hazards \$198

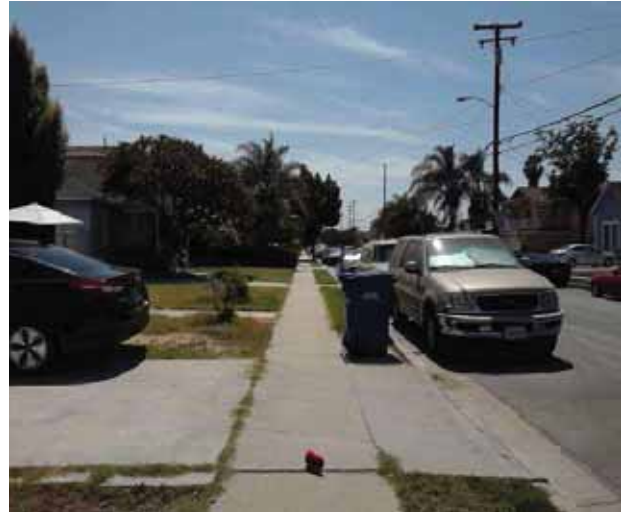
There is a change in elevation greater than recommended value.

Ensure that the change in elevation is within the recommended value.

Recommendation Up to 0.25 inches

Remove tripping hazards \$198

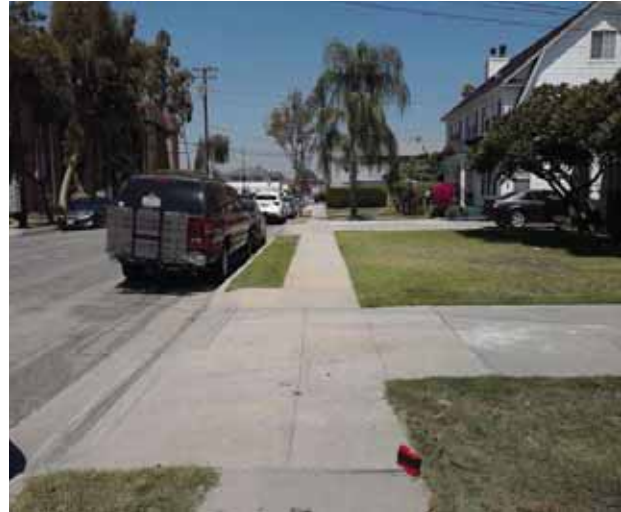
There is a change in elevation greater than recommended value.

Ensure that the change in elevation is within the recommended value.

Recommendation Up to 0.25 inches

Remove tripping hazards \$198

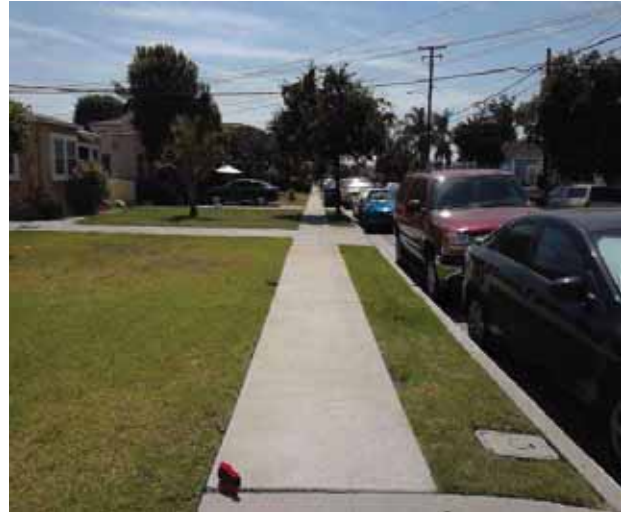
There is a change in elevation greater than recommended value.

Ensure that the change in elevation is within the recommended value.

Recommendation Up to 0.25 inches

Remove tripping hazards \$198

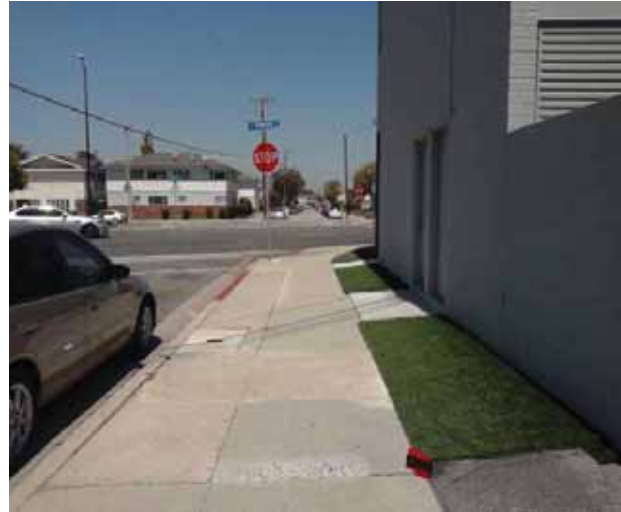
There is a change in elevation greater than recommended value.

Ensure that the change in elevation is within the recommended value.

Recommendation Up to 0.25 inches

Remove tripping hazards \$198

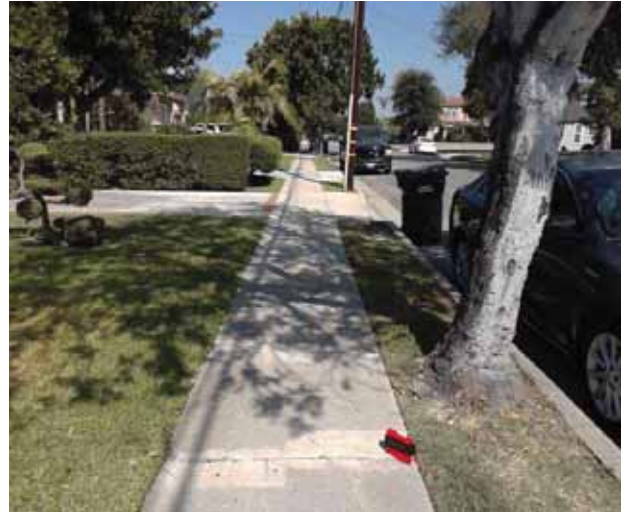
There is a change in elevation greater than recommended value.

Ensure that the change in elevation is within the recommended value.

Recommendation Up to 0.25 inches

Remove tripping hazards \$198

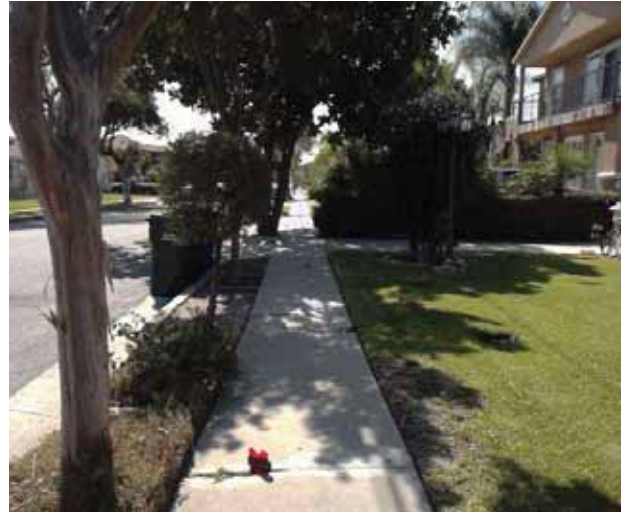
There is a change in elevation greater than recommended value.

Ensure that the change in elevation is within the recommended value.

Recommendation Up to 0.25 inches

Remove tripping hazards \$198

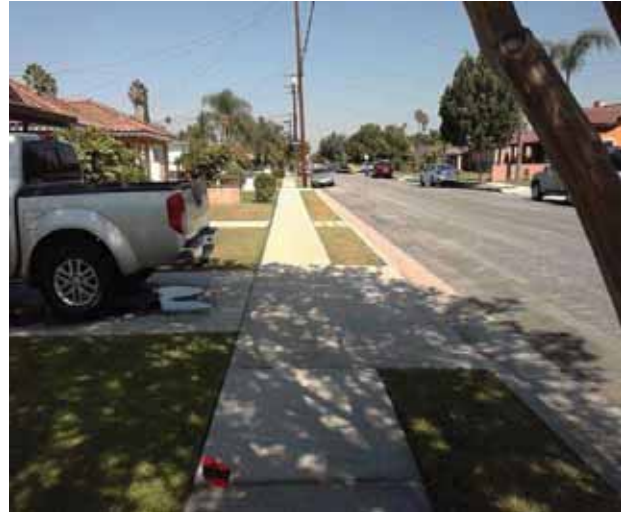
There is a change in elevation greater than recommended value.

Ensure that the change in elevation is within the recommended value.

Recommendation Up to 0.25 inches

Remove tripping hazards \$198

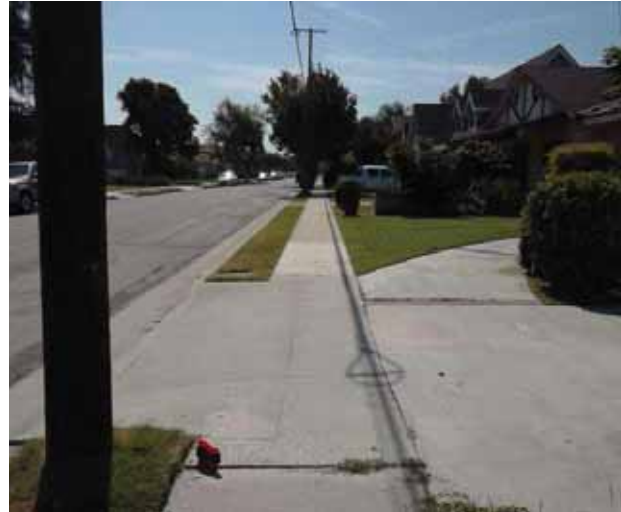
There is a change in elevation greater than recommended value.

Ensure that the change in elevation is within the recommended value.

Recommendation Up to 0.25 inches

Remove tripping hazards \$198

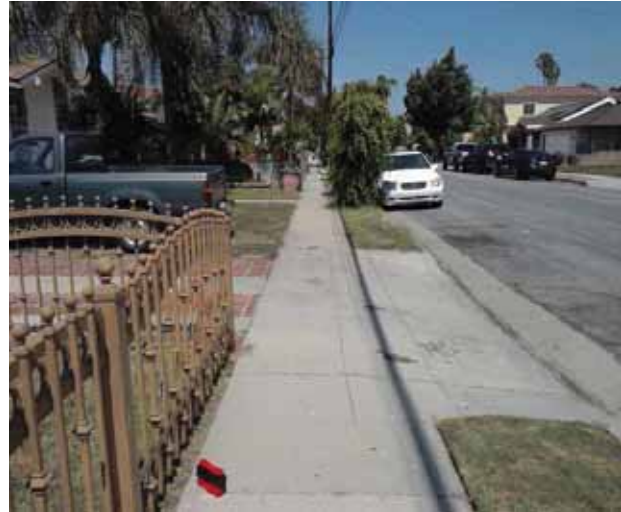
There is a change in elevation greater than recommended value.

Ensure that the change in elevation is within the recommended value.

Recommendation Up to 0.25 inches

Remove tripping hazards \$198

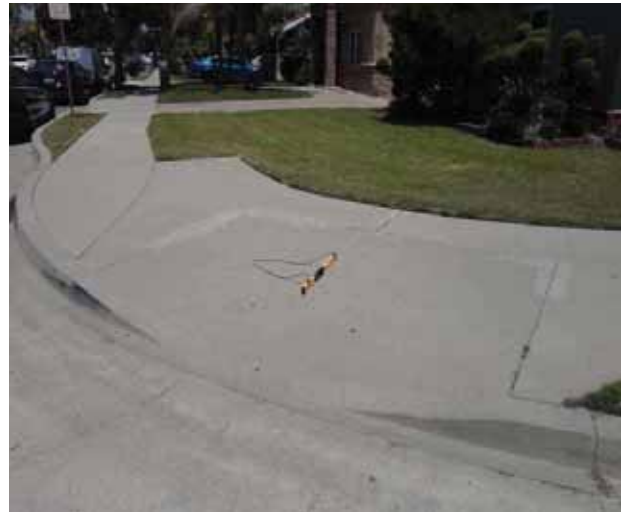
On-Site Finding Not Found

Recommendation See Recommendation

Provide detectable warning to surface \$248

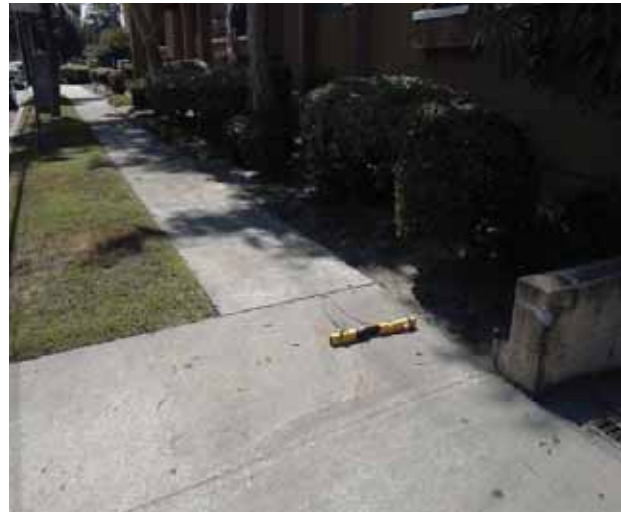
On-Site Finding Not Found

Recommendation See Recommendation

Provide detectable warning to surface \$248

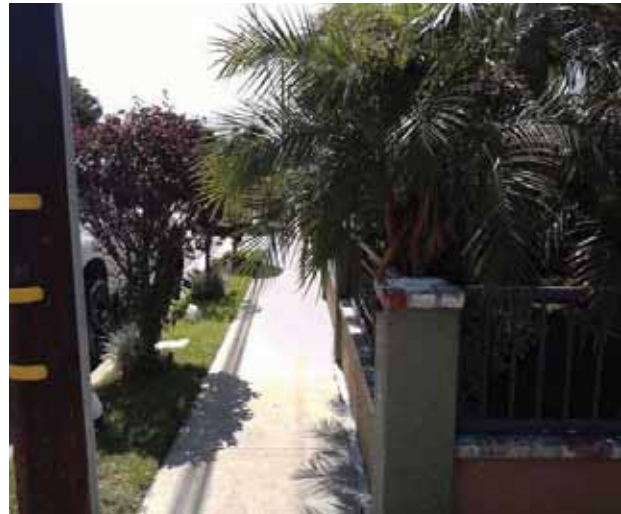
Sidewalks , Hazards & Gratings : Overhead Obstruction Height

Recommendation At least 80.00 inches

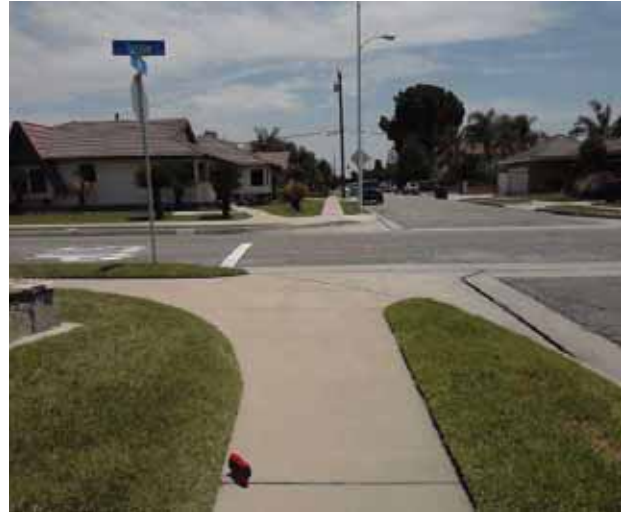
There is a change in elevation greater than recommended value.

Ensure that the change in elevation is within the recommended value.

Recommendation Up to 0.25 inches

Remove tripping hazards \$198

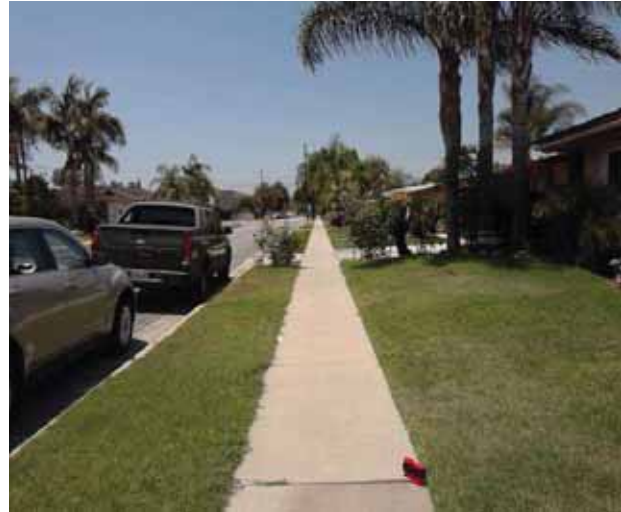
There is a change in elevation greater than recommended value.

Ensure that the change in elevation is within the recommended value.

Recommendation Up to 0.25 inches

Remove tripping hazards \$198

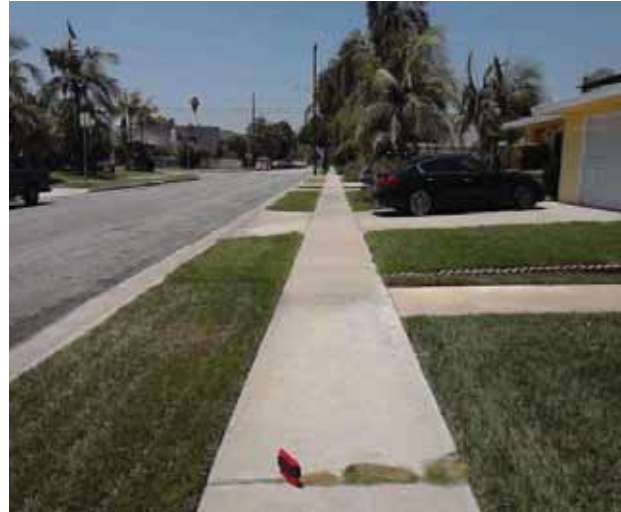
There is a change in elevation greater than recommended value.

Ensure that the change in elevation is within the recommended value.

Recommendation Up to 0.25 inches

Remove tripping hazards \$198

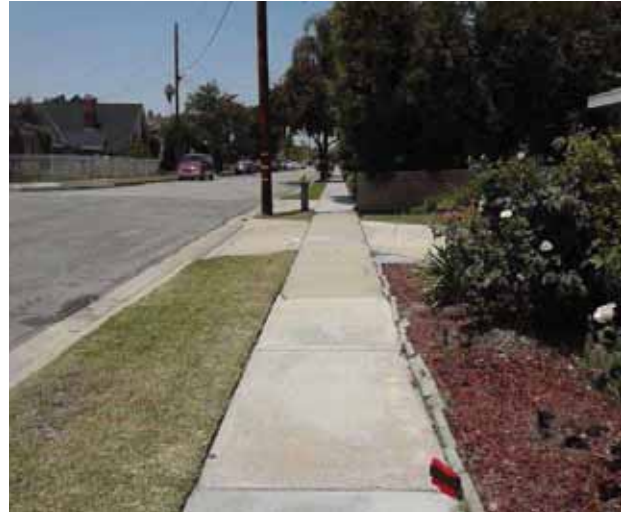
There is a change in elevation greater than recommended value.

Ensure that the change in elevation is within the recommended value.

Recommendation Up to 0.25 inches

Remove tripping hazards \$198

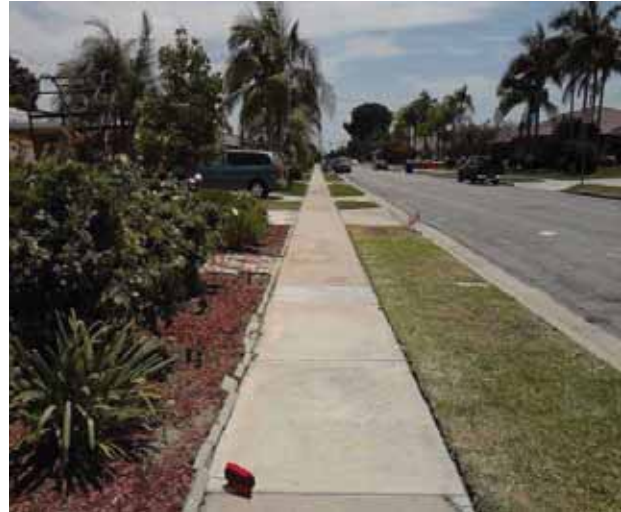
There is a change in elevation greater than recommended value.

Ensure that the change in elevation is within the recommended value.

Recommendation Up to 0.25 inches

Remove tripping hazards \$198

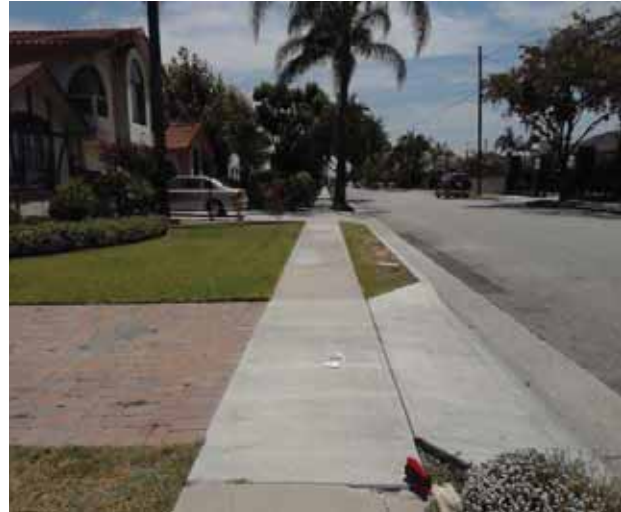
There is a change in elevation greater than recommended value.

Ensure that the change in elevation is within the recommended value.

Recommendation Up to 0.25 inches

Remove tripping hazards \$198

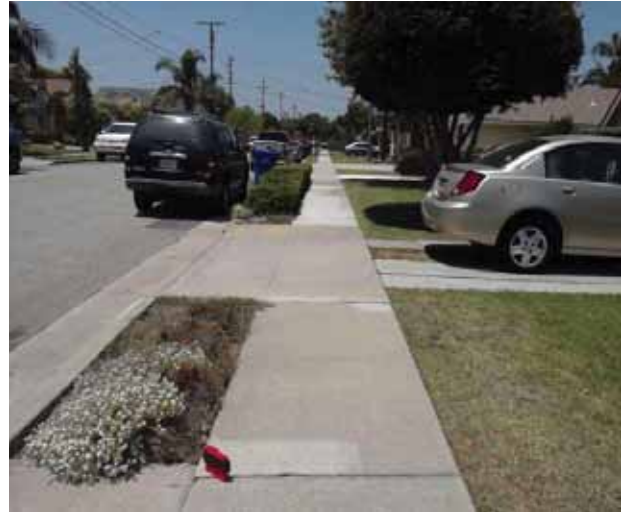
There is a change in elevation greater than recommended value.

Ensure that the change in elevation is within the recommended value.

Recommendation Up to 0.25 inches

Remove tripping hazards \$198

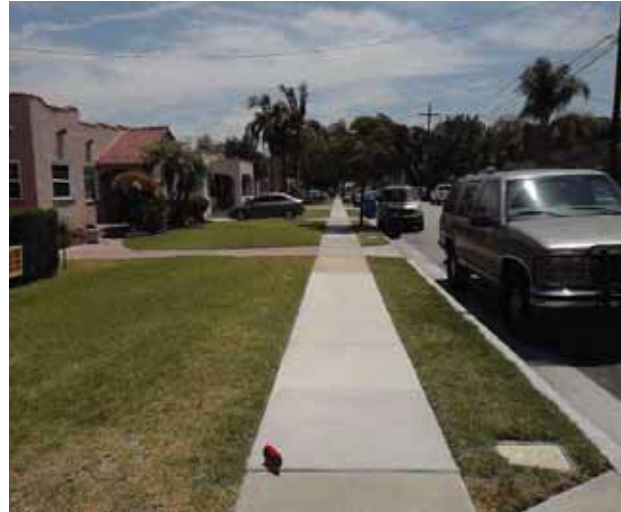
There is a change in elevation greater than recommended value.

Ensure that the change in elevation is within the recommended value.

Recommendation Up to 0.25 inches

Remove tripping hazards \$198

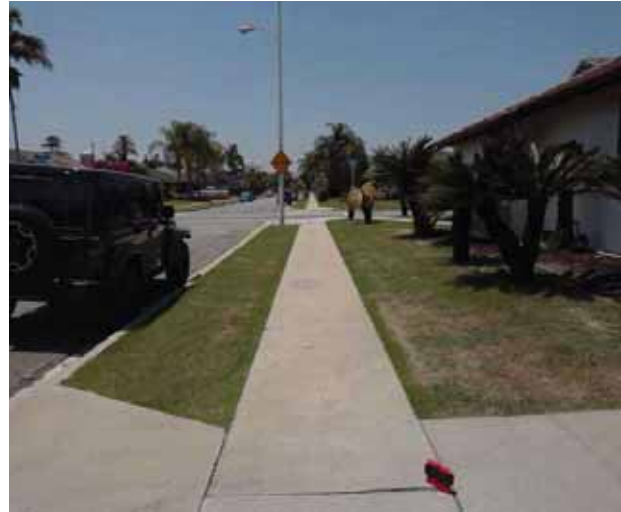
There is a change in elevation greater than recommended value.

Ensure that the change in elevation is within the recommended value.

Recommendation Up to 0.25 inches

Remove tripping hazards \$198

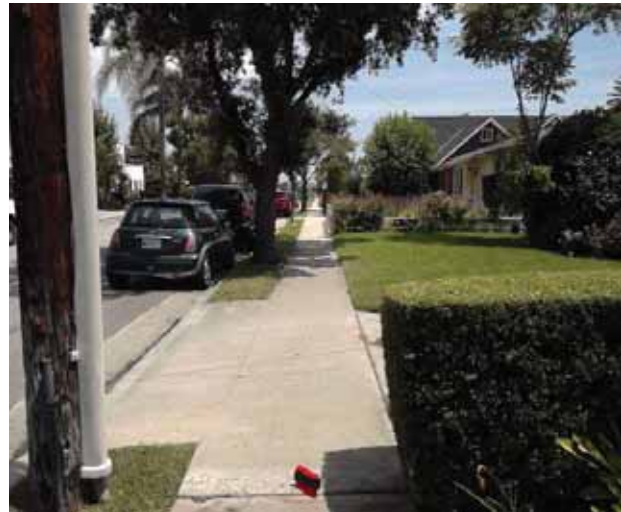
There is a change in elevation greater than recommended value.

Ensure that the change in elevation is within the recommended value.

Recommendation Up to 0.25 inches

Remove tripping hazards \$198
