Accessibility Survey

Adwen Street & Old River School Road

Date of Inspection 4/11/2017

Disability Access Consultants

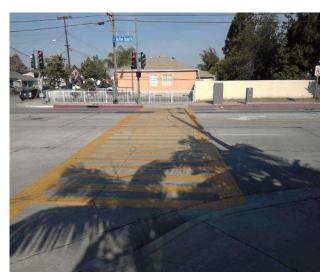
Notes: Spalled concrete continues for 15 feet.

Repave the walking surface with recommended slope.

Recommendation Up to 5.00 percent

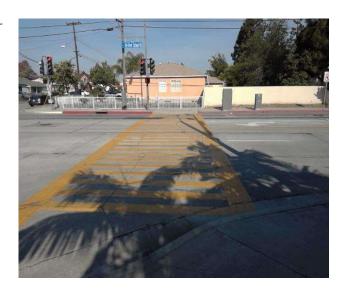
Notes: Spalled concrete continues for 15 feet.

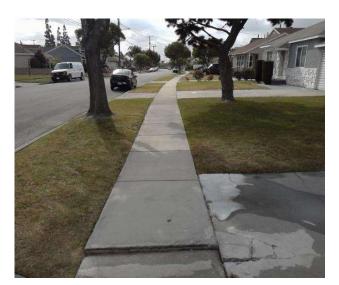
There is a change in elevation greater than recommended value.

Ensure that the change in elevation is within the recommended value.

Recommendation Up to 0.25 inches

Remove tripping hazards \$198

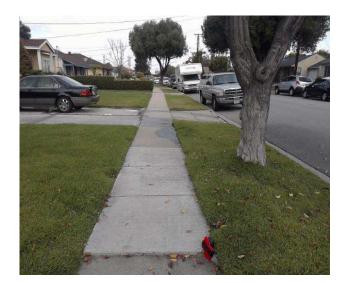
There is a change in elevation greater than recommended value.

Ensure that the change in elevation is within the recommended value.

Recommendation Up to 0.25 inches

Remove tripping hazards \$198

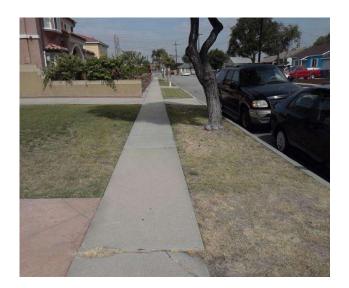
There is a change in elevation greater than recommended value.

Ensure that the change in elevation is within the recommended value.

Recommendation Up to 0.25 inches

Remove tripping hazards \$198

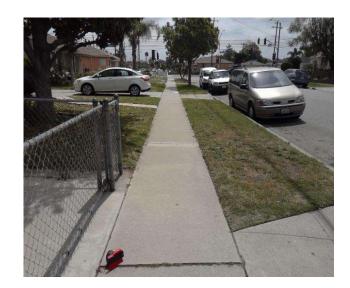
There is a change in elevation greater than recommended value.

Ensure that the change in elevation is within the recommended value.

Recommendation Up to 0.25 inches

Remove tripping hazards \$198

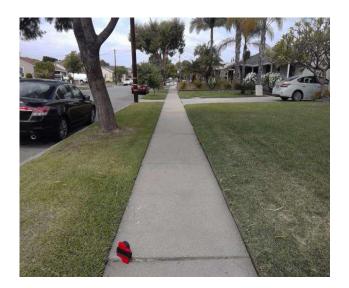
There is a change in elevation greater than recommended value.

Ensure that the change in elevation is within the recommended value.

Recommendation Up to 0.25 inches

Remove tripping hazards \$198

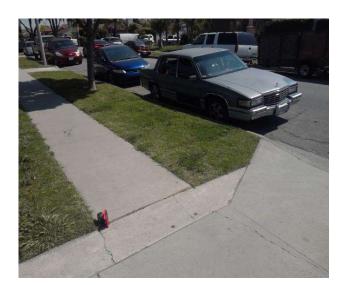
Sidewalks , Change in Level : Change in Level Non Beveled

Remove tripping hazards \$198

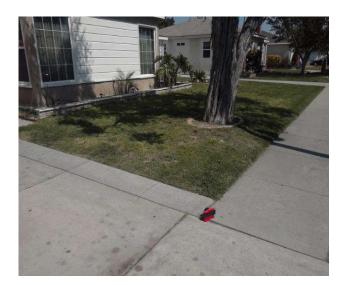
Sidewalks , Change in Level : Change in Level Non Beveled

Remove tripping hazards \$198
