Accessibility Survey

City of Downey Vista Del Rosa Street & Paramount Boulevard

Date of Inspection
5/11/2017

Prepared By
Disability Access Consultants
(800) 743-7067

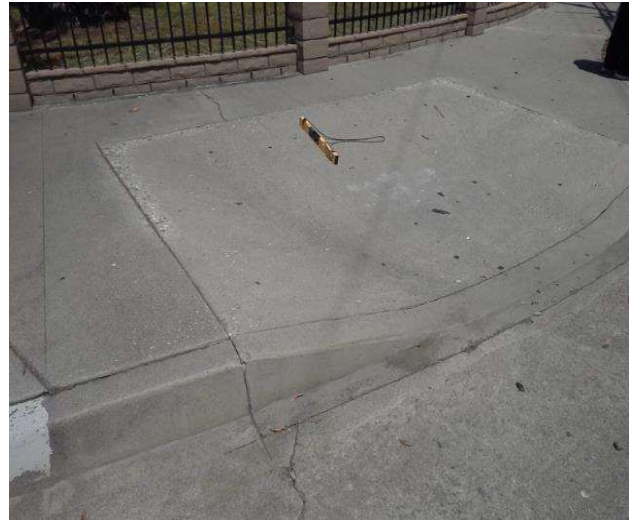
Northwest Corner @ 33.966037712248, -118.117719143629

Curb Ramp : No Detectable Warnings

The curb ramp does not provide a detectable warning surface which includes truncated domes.

Code Reference CA 11B-406.5.12

Provide compliant detectable warnings to surface.

Provide detectable warning to surface \$248

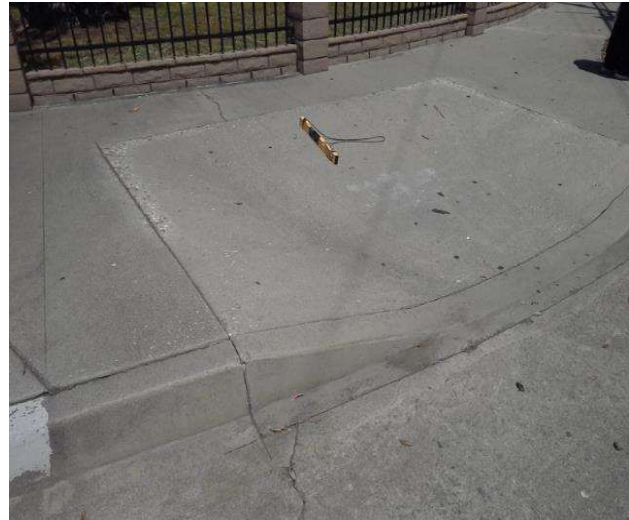
Northwest Corner @ 33.966037712248, -118.117719143629

Curb Ramp : Curb Ramp Width

The width of the curb ramp is less than required.

On-Site Finding 40.00 inches

Code Reference ADA 406, 406.1, 405.5, CA 11B-406.5.2

Recommendation At least 48.00 inches

Install curb ramp \$1,300

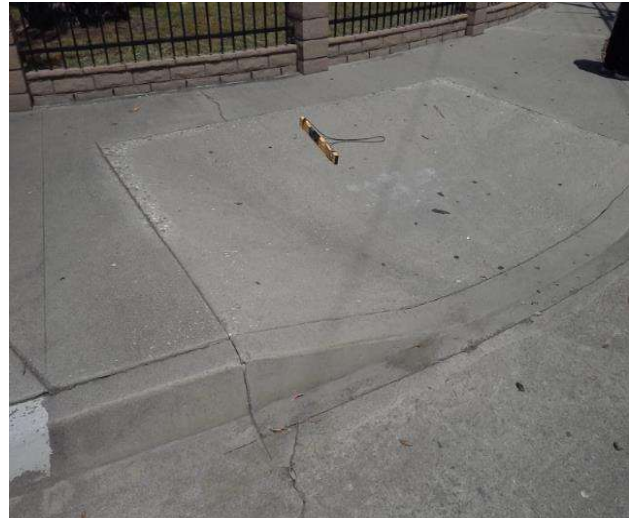
Recommendation Up to 8.33 percent

Code Reference ADA 406, 406.1, 405.2, CA 11B-406

Costing Info (Estimated)

Install curb ramp \$1,300

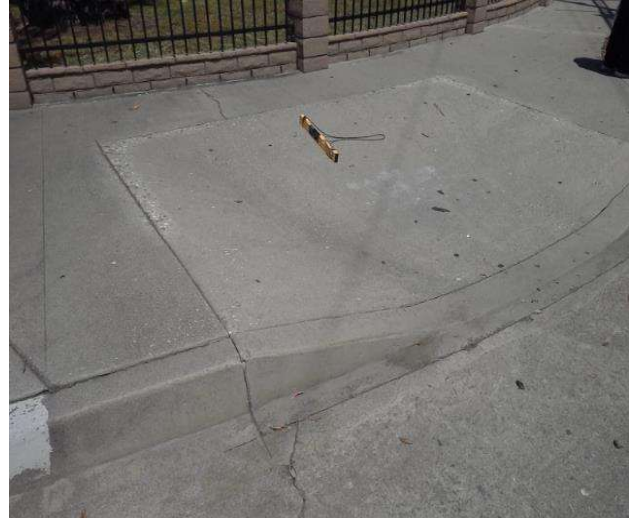
Recommendation Up to 10.00 percent

Code Reference ADA 406, 406.3, CA 11B-406.2.2

Costing Info (Estimated)

Install flared sides \$1,300

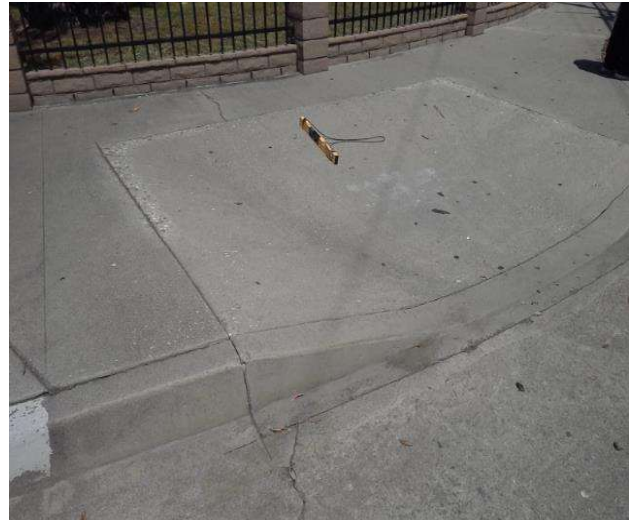
Code Reference ADA 406, 406.4, CA 11B-406.5.3

Recommendation At least 48.00 inches

Provide compliant landing \$240

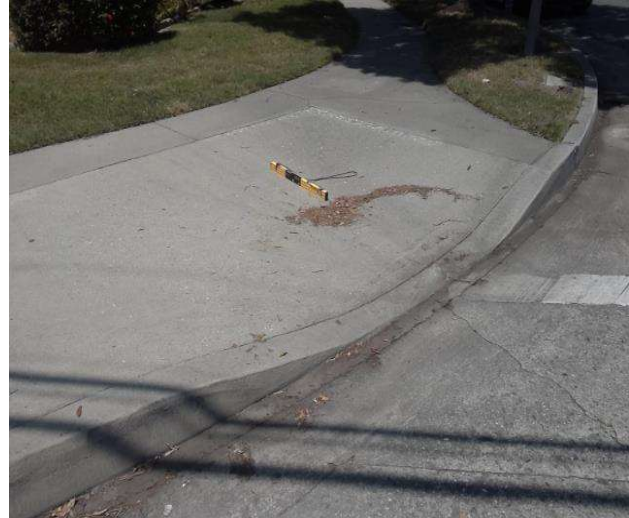
On-Site Finding Not Found

Code Reference CA 11B-406.5.12

Provide detectable warning to surface \$248

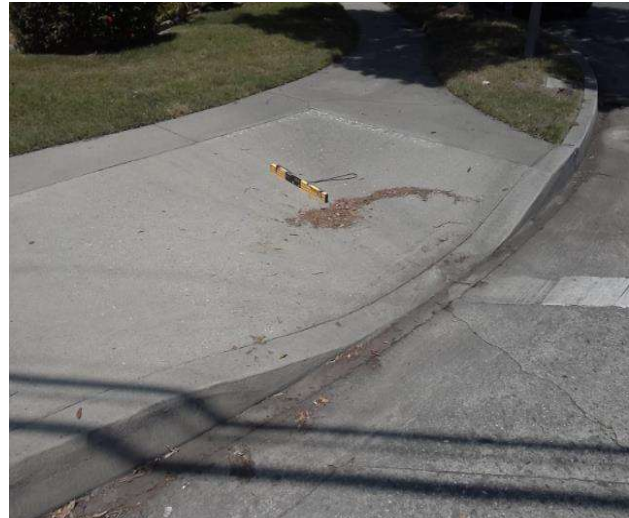
On-Site Finding Not Found

Code Reference ADA 406, 406.5

Install crosswalk \$800

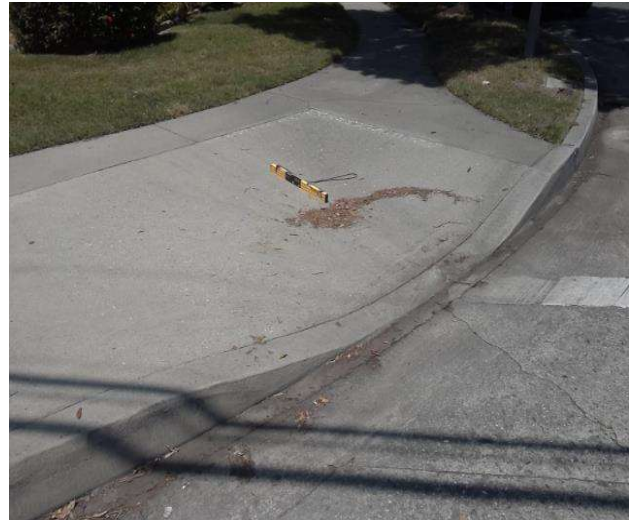
Code Reference ADA 406, 406.1, 405.5, CA 11B-406.5.2

Recommendation At least 48.00 inches

Install curb ramp \$1,300

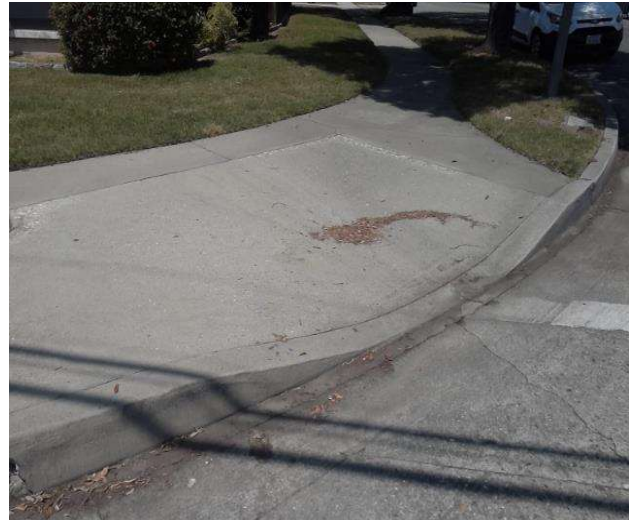
Code Reference ADA 406, 406.6, 406.1, 405.10

Recommendation At least 48.00 inches

Provide compliant landing \$255

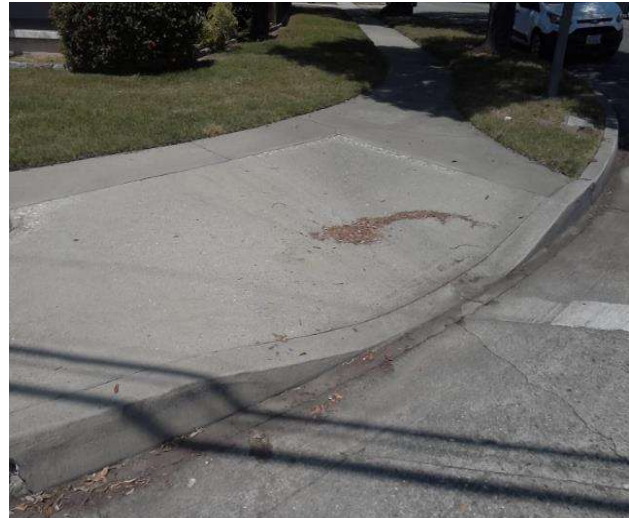
Recommendation At least 48.00 inches

Code Reference ADA 406, 406.4, CA 11B-406.5.3

Provide compliant landing \$240

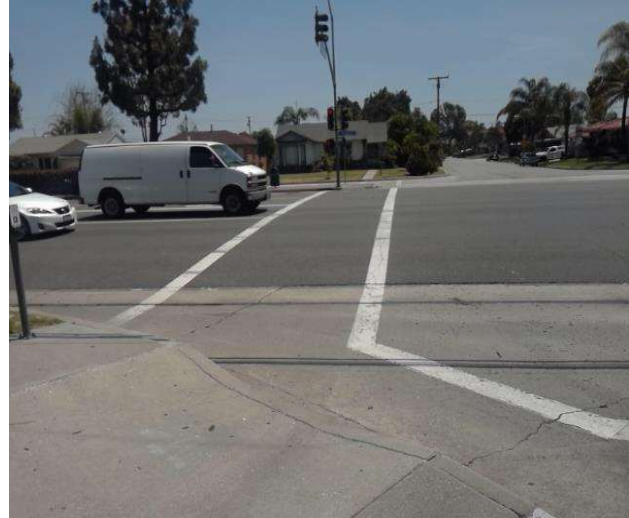
Recommendation Up to 5.00 percent

Repave the walking surface with recommended slope.

\$1,260

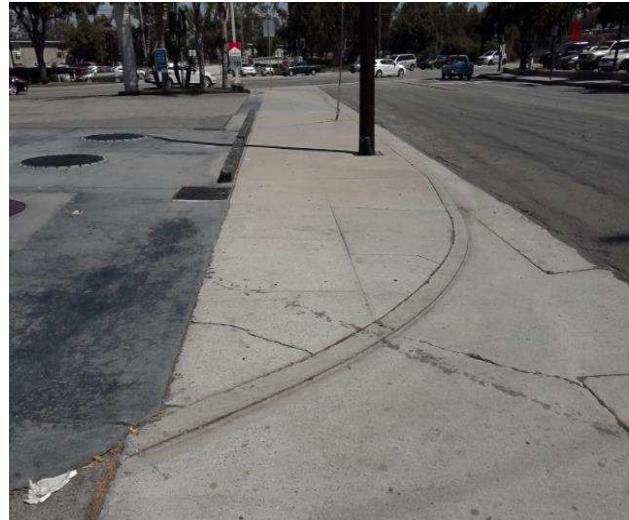
Code Reference ADA 402, 303, 406, 403.4, 303.4

Install curb ramp \$2,500

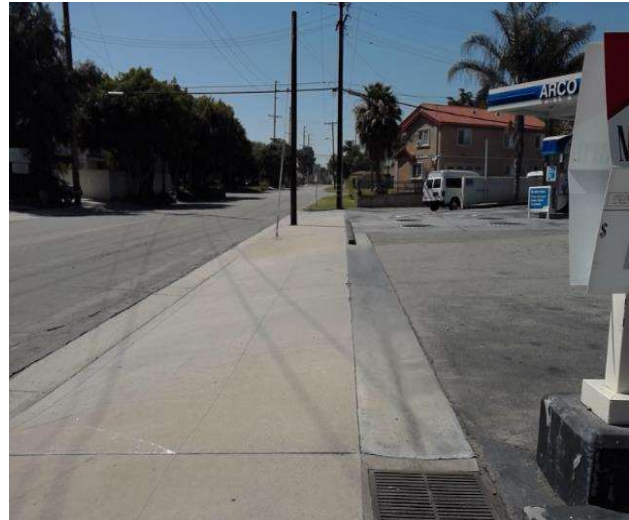
Code Reference ADA 705,CA 11B-705.1.2.5,CA 11B-247.1.2.5

Install compliant detectable warnings \$190

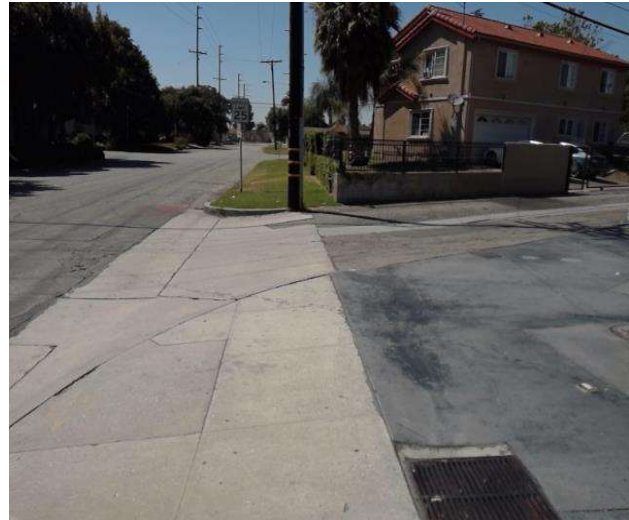
Code Reference ADA 705,CA 11B-705.1.2.5,CA 11B-247.1.2.5

Install compliant detectable warnings \$190

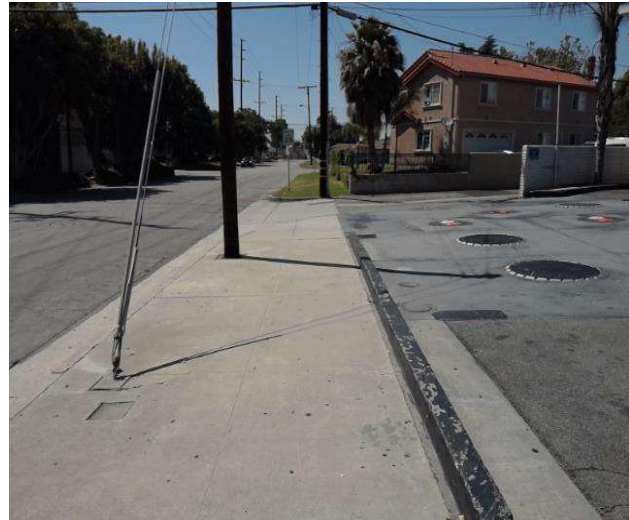
Code Reference ADA 206, 302, CA 11B-403.3

Repave surface \$1,092

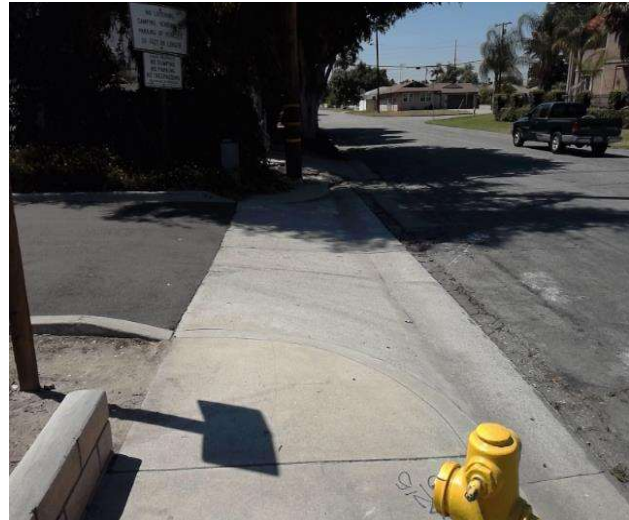
Code Reference ADA 705,CA 11B-705.1.2.5,CA 11B-247.1.2.5

Install compliant detectable warnings \$190

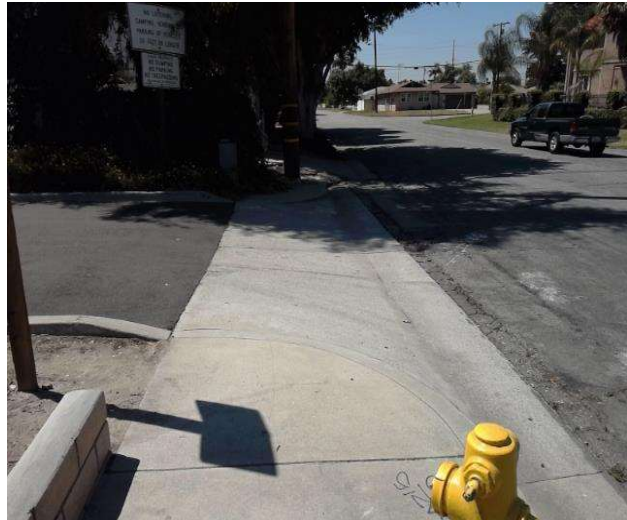
Code Reference ADA 206, 302, CA 11B-403.3

Repave surface \$1,092

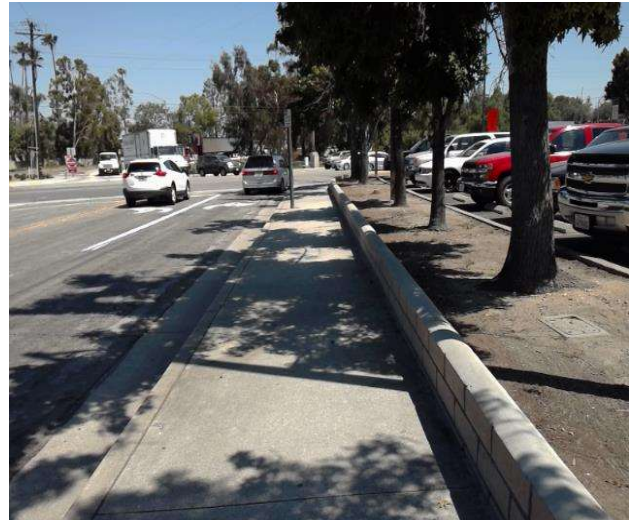
Code Reference ADA 206, 302, CA 11B-403.3

Repave surface \$1,092

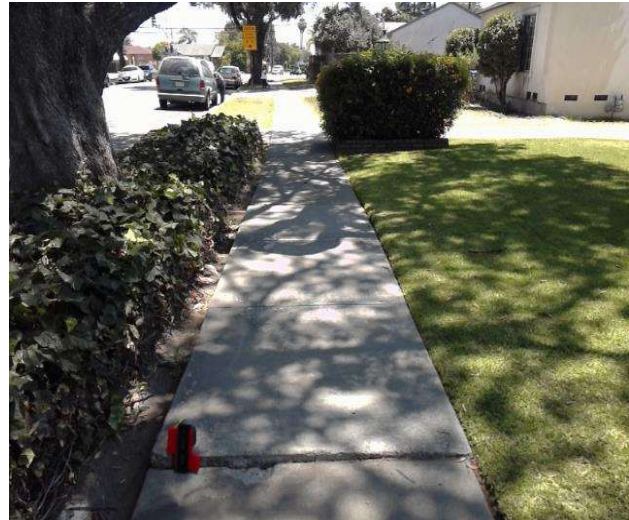
There is a change in elevation greater than recommended value.

Code Reference ADA 206, 302

Ensure that the change in elevation is within the recommended value.

Recommendation Up to 0.25 inches

Remove tripping hazards \$198

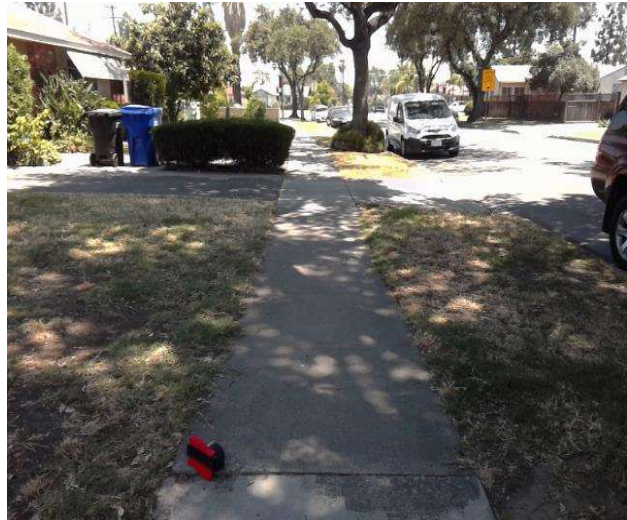
There is a change in elevation greater than recommended value.

Code Reference ADA 206, 302

Ensure that the change in elevation is within the recommended value.

Recommendation Up to 0.25 inches

Remove tripping hazards \$198

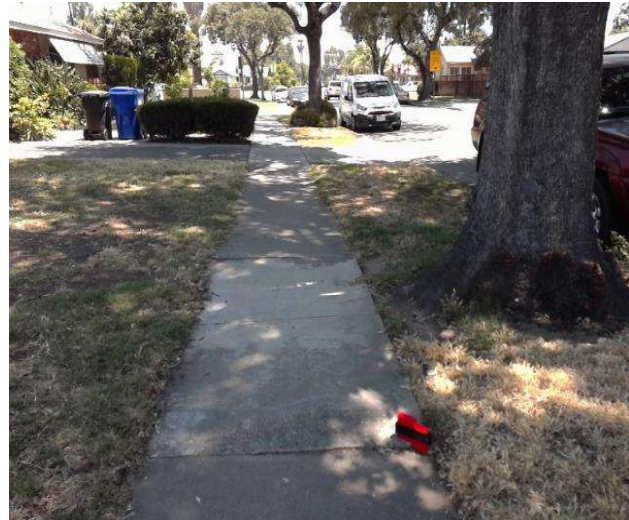
There is a change in elevation greater than recommended value.

Code Reference ADA 206, 302

Ensure that the change in elevation is within the recommended value.

Recommendation Up to 0.25 inches

Remove tripping hazards \$198

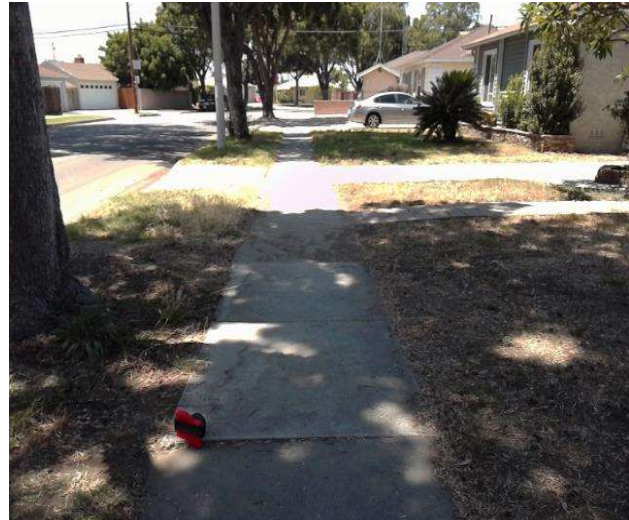
There is a change in elevation greater than recommended value.

Code Reference ADA 206, 302

Ensure that the change in elevation is within the recommended value.

Recommendation Up to 0.25 inches

Remove tripping hazards \$198

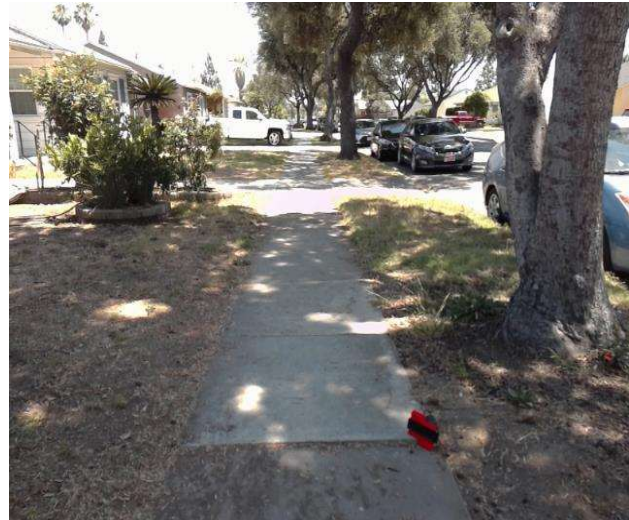
There is a change in elevation greater than recommended value.

Code Reference ADA 206, 302

Ensure that the change in elevation is within the recommended value.

Recommendation Up to 0.25 inches

Remove tripping hazards \$198

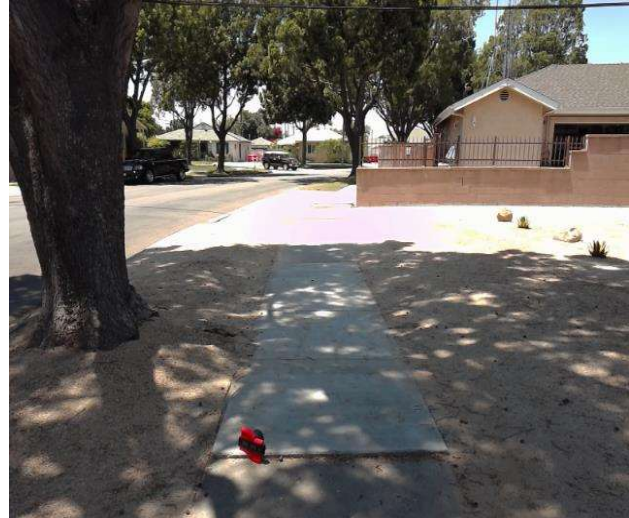
There is a change in elevation greater than recommended value.

Code Reference ADA 206, 302

Ensure that the change in elevation is within the recommended value.

Recommendation Up to 0.25 inches

Remove tripping hazards \$198

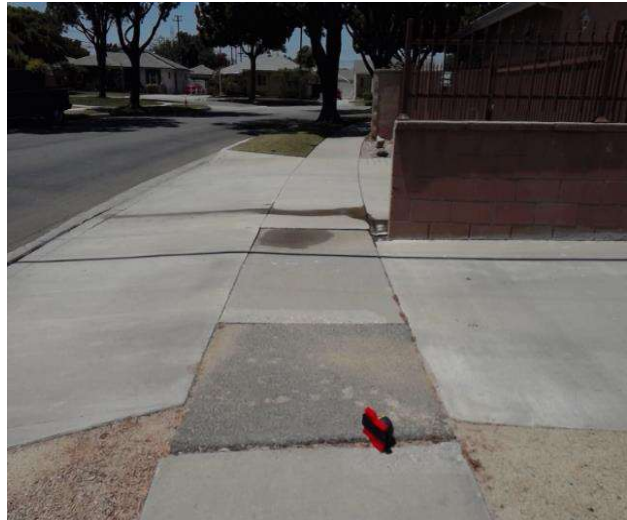
There is a change in elevation greater than recommended value.

Code Reference ADA 206, 302

Ensure that the change in elevation is within the recommended value.

Remove tripping hazards \$198

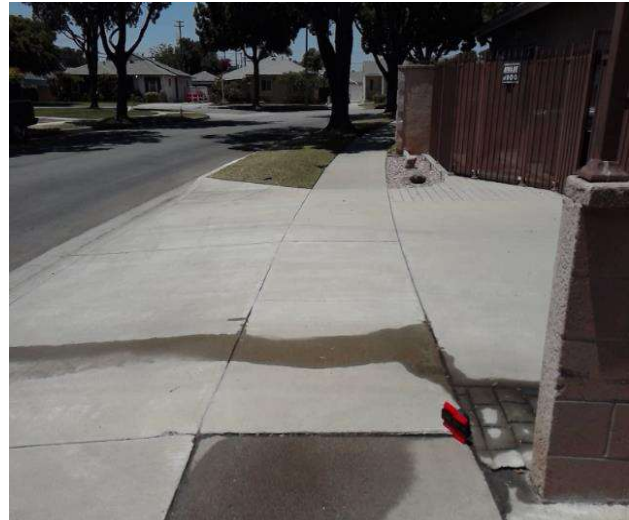
There is a change in elevation greater than recommended value.

Ensure that the change in elevation is within the recommended value.

Recommendation Up to 0.25 inches

Remove tripping hazards \$198

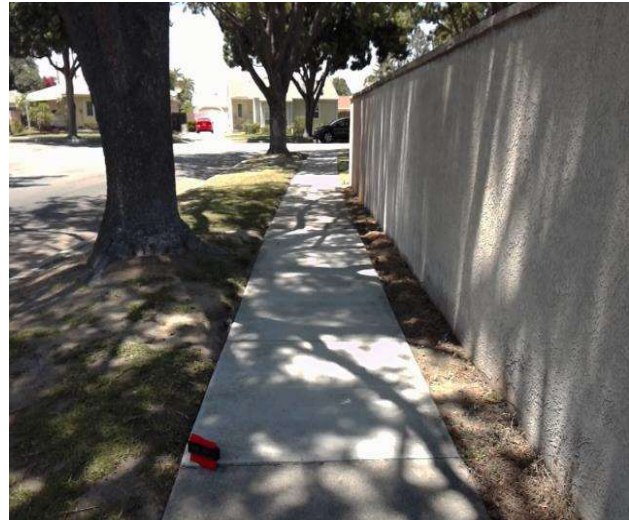
There is a change in elevation greater than recommended value.

Ensure that the change in elevation is within the recommended value.

Recommendation Up to 0.25 inches

Remove tripping hazards \$198

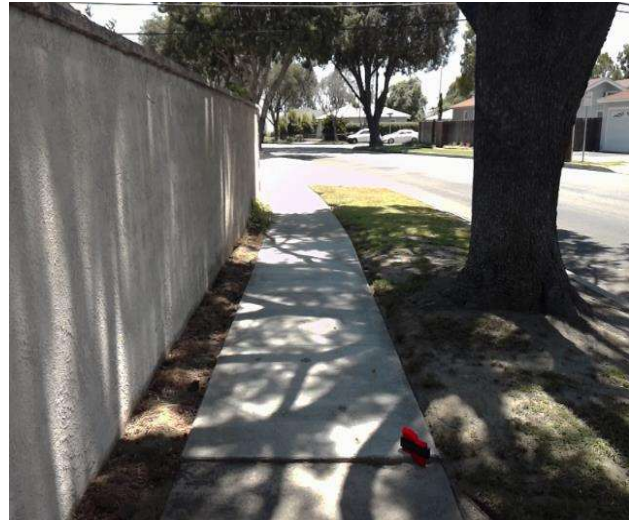
There is a change in elevation greater than recommended value.

Ensure that the change in elevation is within the recommended value.

Recommendation Up to 0.25 inches

Remove tripping hazards \$198

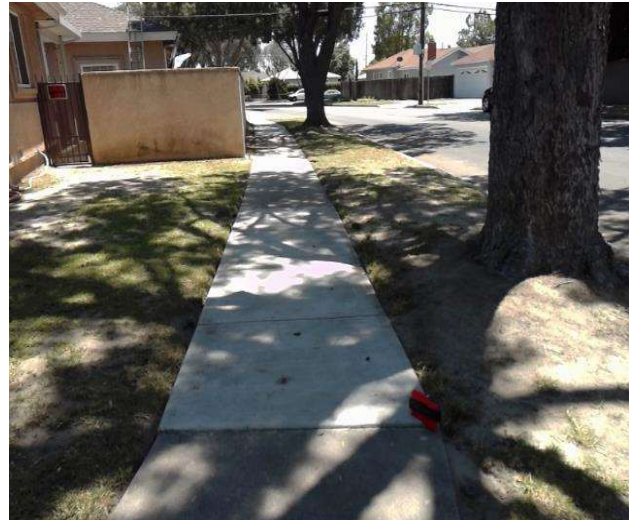
There is a change in elevation greater than recommended value.

Ensure that the change in elevation is within the recommended value.

Recommendation Up to 0.25 inches

Remove tripping hazards \$198

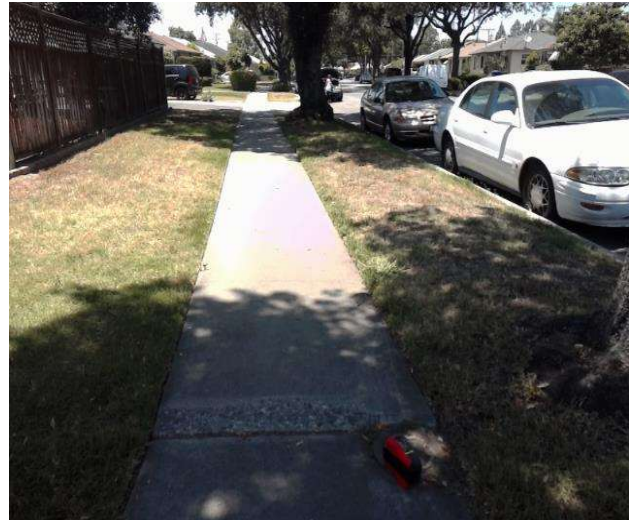
There is a change in elevation greater than recommended value.

Ensure that the change in elevation is within the recommended value.

Recommendation Up to 0.25 inches

Remove tripping hazards \$198

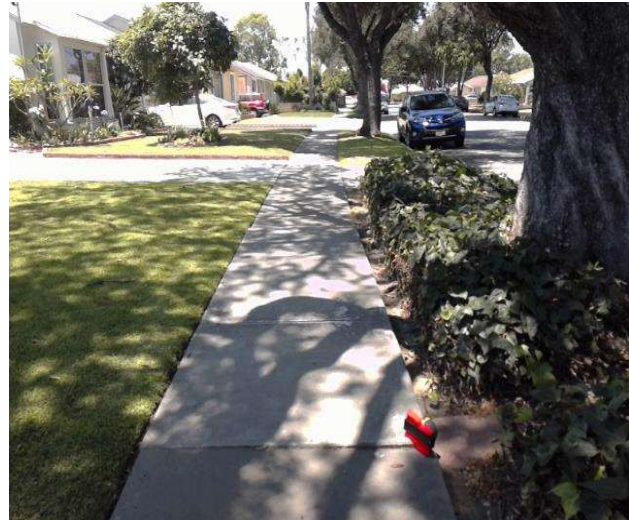
There is a change in elevation greater than recommended value.

Ensure that the change in elevation is within the recommended value.

Recommendation Up to 0.25 inches

Remove tripping hazards \$198

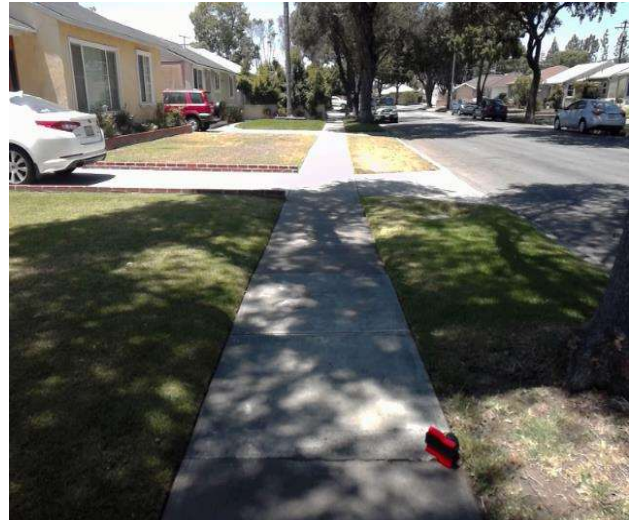
There is a change in elevation greater than recommended value.

Ensure that the change in elevation is within the recommended value.

Recommendation Up to 0.25 inches

Remove tripping hazards \$198

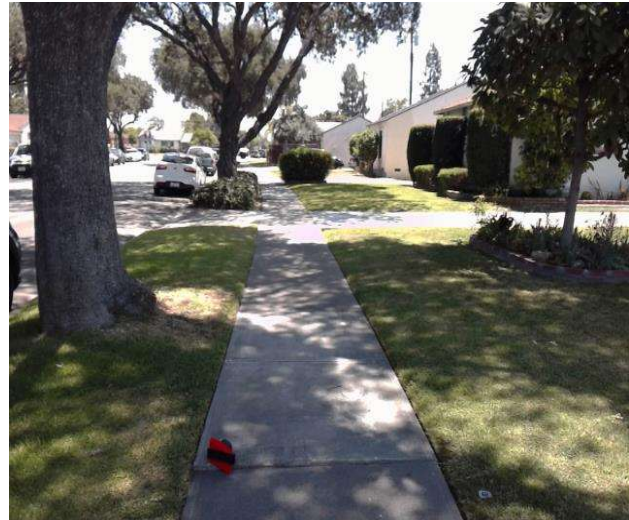
There is a change in elevation greater than recommended value.

Ensure that the change in elevation is within the recommended value.

Recommendation Up to 0.25 inches

Remove tripping hazards \$198

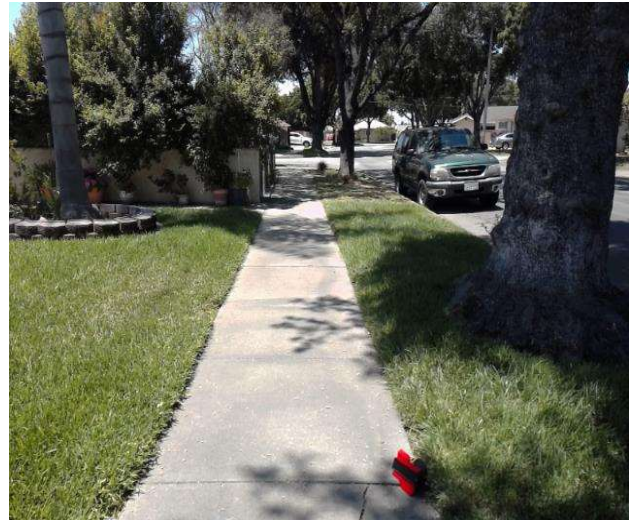
There is a change in elevation greater than recommended value.

Ensure that the change in elevation is within the recommended value.

Recommendation Up to 0.25 inches

Remove tripping hazards \$198

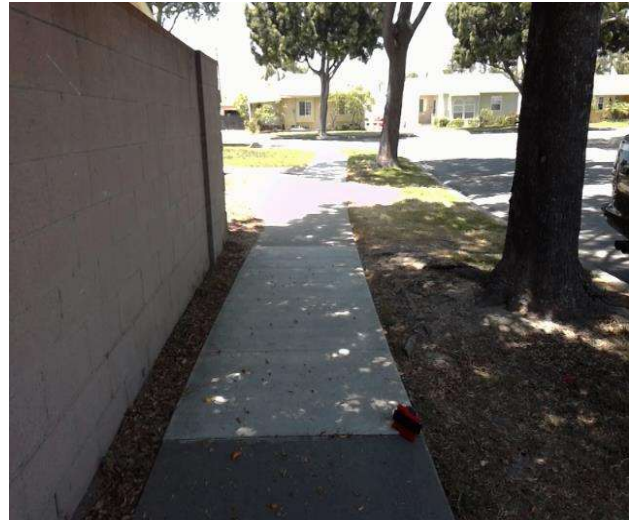
There is a change in elevation greater than recommended value.

Ensure that the change in elevation is within the recommended value.

Recommendation Up to 0.25 inches

Remove tripping hazards \$198

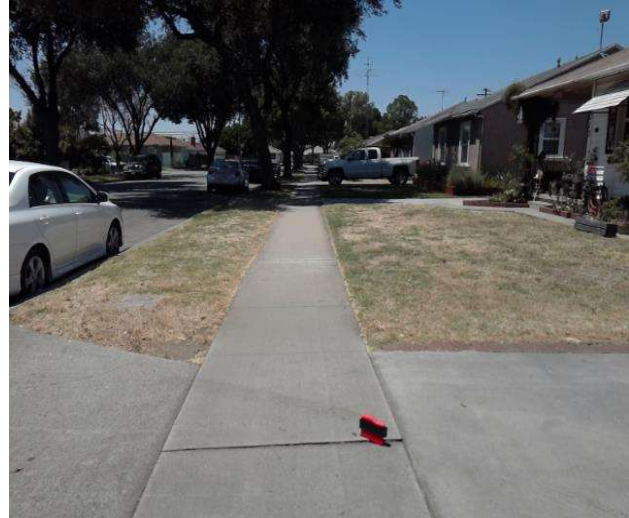
There is a change in elevation greater than recommended value.

Ensure that the change in elevation is within the recommended value.

Recommendation Up to 0.25 inches

Remove tripping hazards \$198

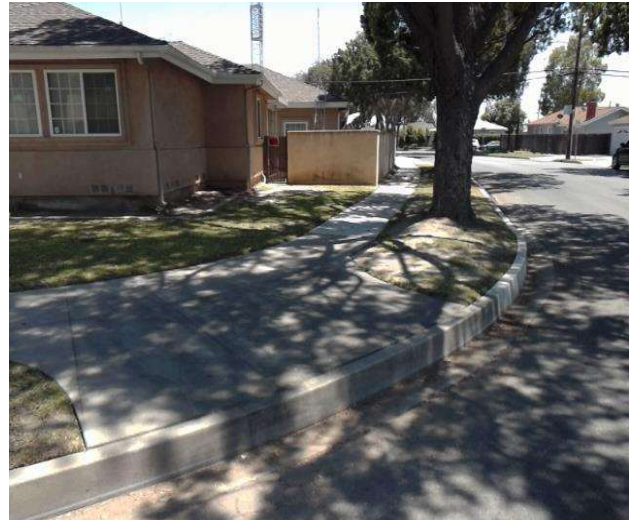
Sidewalks , Hazards & Gratings : Curb is on Path of Travel

Install curb ramp \$2,500

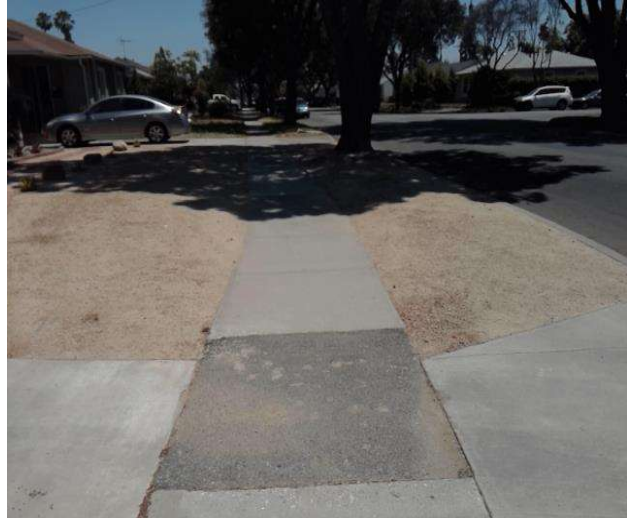
Notes : Surface is Rough And Uneven.

Repave the sidewalk surface with the recommended running slope.

Recommendation Up to 5.00 percent

Repave surface \$1,184

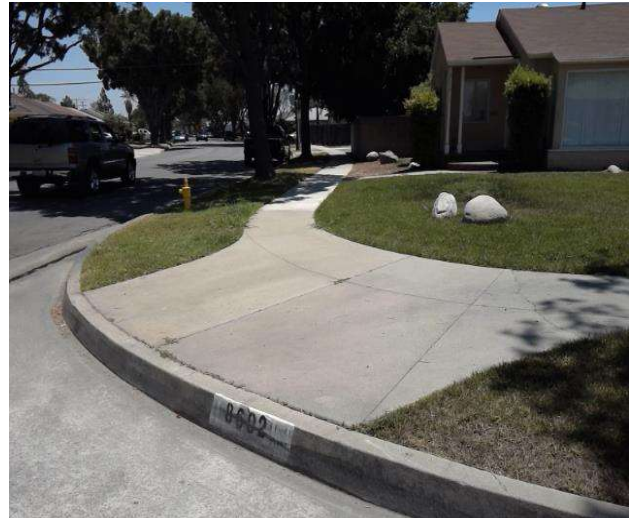
Sidewalks , Hazards & Gratings : Curb is on Path of Travel

Install curb ramp \$2,500

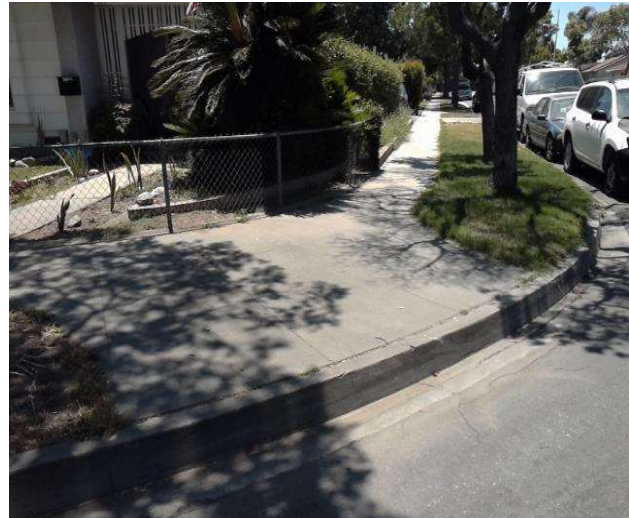
Sidewalks , Hazards & Gratings : Curb is on Path of Travel

Install curb ramp \$2,500

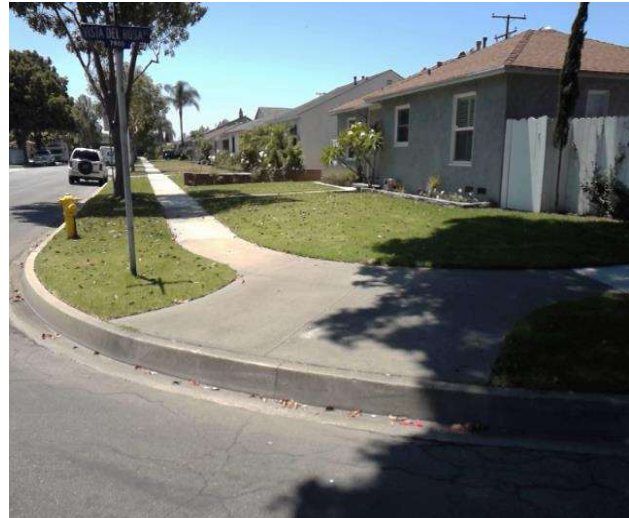
Sidewalks , Hazards & Gratings : Curb is on Path of Travel

Install curb ramp \$2,500

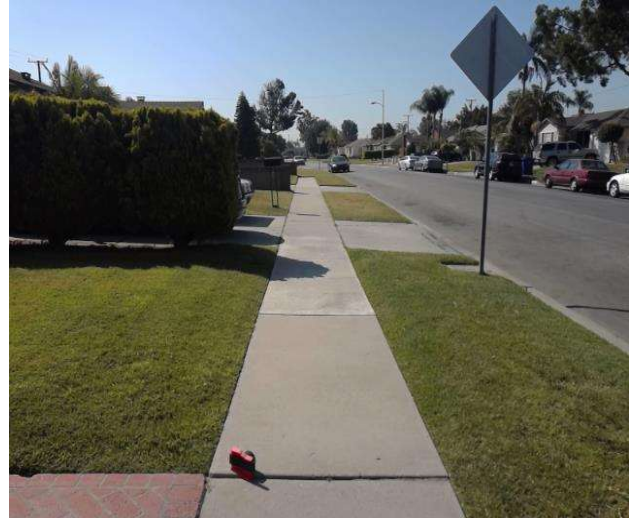
There is a change in elevation greater than recommended value.

Ensure that the change in elevation is within the recommended value.

Recommendation Up to 0.25 inches

Remove tripping hazards \$198

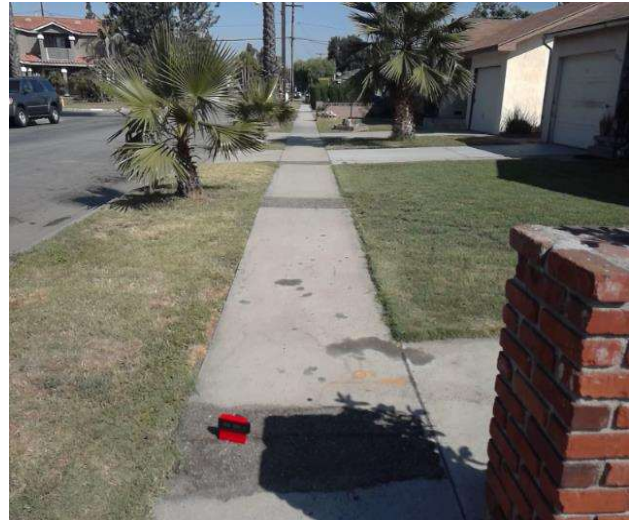
There is a change in elevation greater than recommended value.

Remove tripping hazards \$198

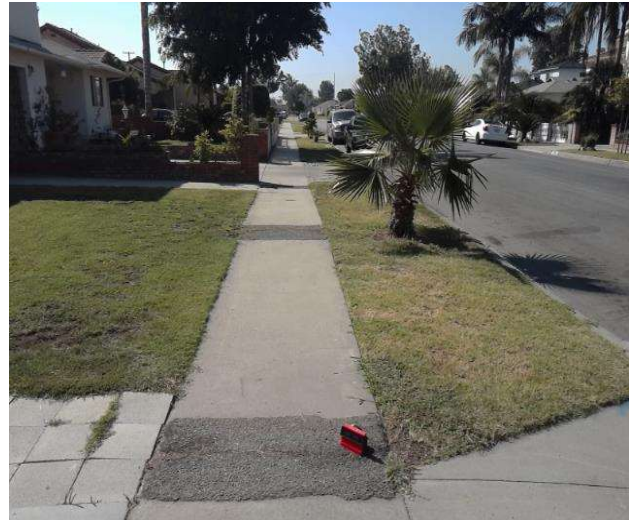
Code Reference ADA 206, 302

Notes : Surface is Rough And Uneven.

Remove tripping hazards \$198

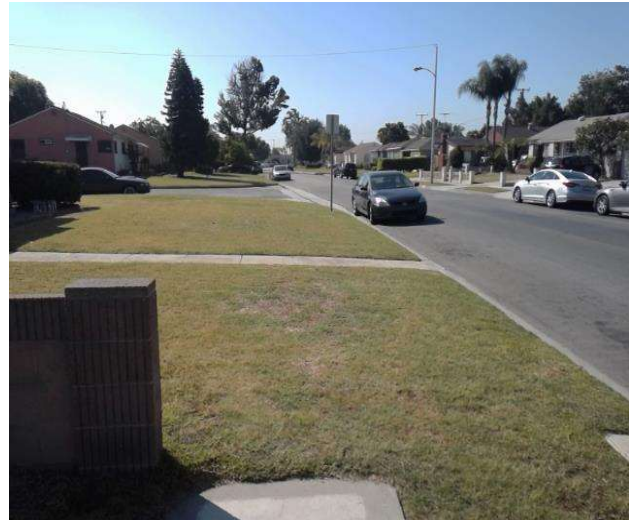
Section of sidewalk is missing and consists of dirt, grass or gravel.

Provide a compliant sidewalk for the missing section.

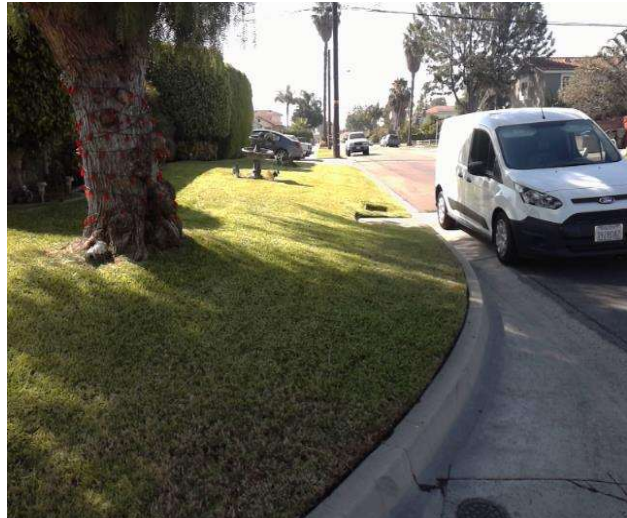
Section of sidewalk is missing and consists of dirt, grass or gravel.

Provide a compliant sidewalk for the missing section.

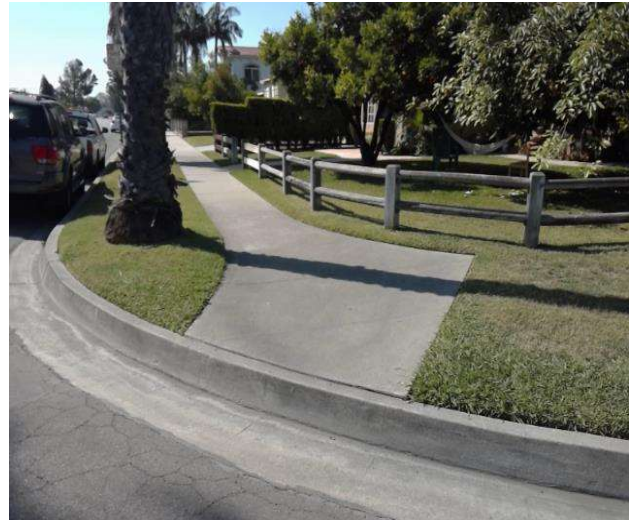
Sidewalks , Hazards & Gratings : Curb is on Path of Travel

Install curb ramp \$2,500

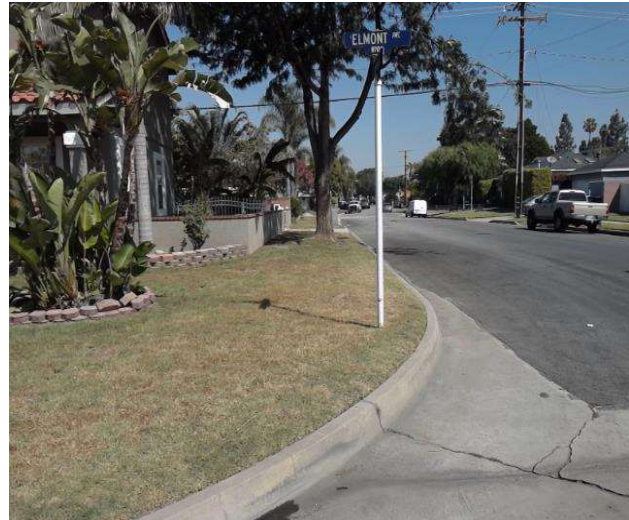
Section of sidewalk is missing and consists of dirt, grass or gravel.

Provide a compliant sidewalk for the missing section.

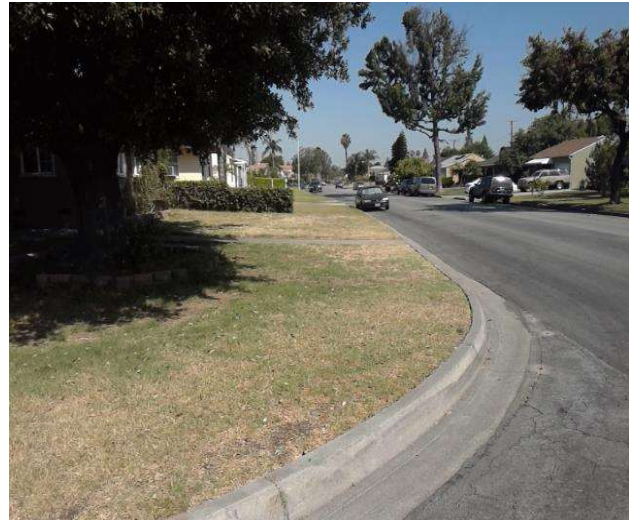
Section of sidewalk is missing and consists of dirt, grass or gravel.

Provide a compliant sidewalk for the missing section.

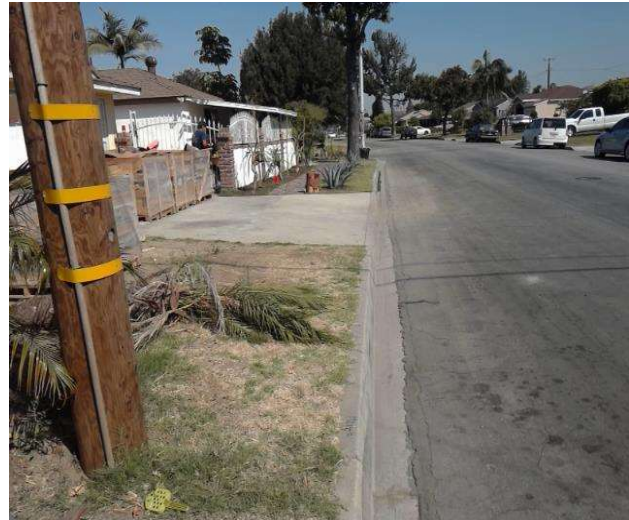
Section of sidewalk is missing and consists of dirt, grass or gravel.

Provide a compliant sidewalk for the missing section.
