Accessibility Survey

City of Downey Lubec Street & Paramount Boulevard

Lubec Street & Paramount Boulevard
Downey, CA 90242

Date of Inspection
4/14/2017

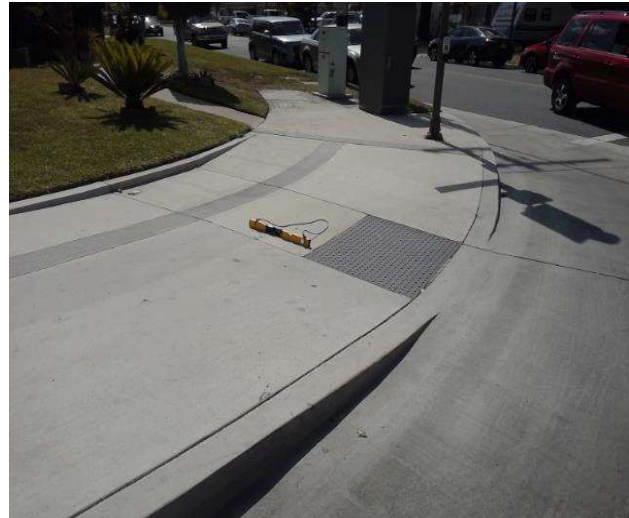
Northeast Corner @ 33.956759759235, -118.127431422472

Curb Ramps - Exterior : Curb Ramp

Curb Ramp : Curb Ramp Slope

The running slope is greater than allowed.

On-Site Finding 9.00 percent

Provide a compliant curb ramp.

Recommendation Up to 8.33 percent

Install curb ramp \$1,300

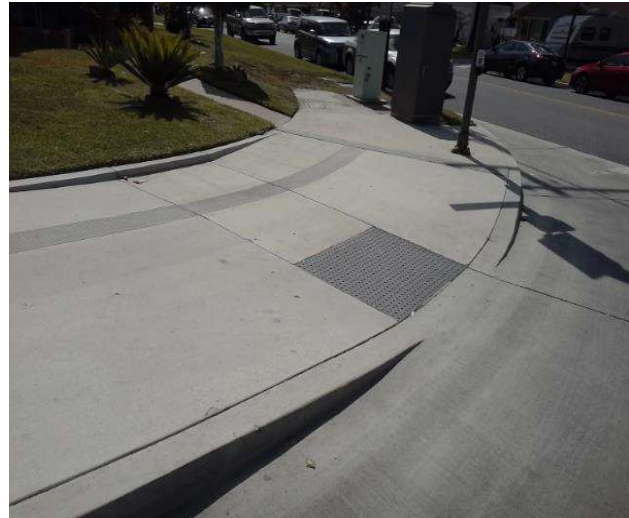
Northeast Corner @ 33.956759759235, -118.127431422472

Curb Ramps - Exterior : Curb Ramp , Landings and Transitions

Top Landing

Curb Ramp , Landings and Transitions : Top Landing Clear Length - Landings

There is not enough top landing clear length.

On-Site Finding 46.00 inches

Recommendation At least 48.00 inches

Provide compliant landing \$240

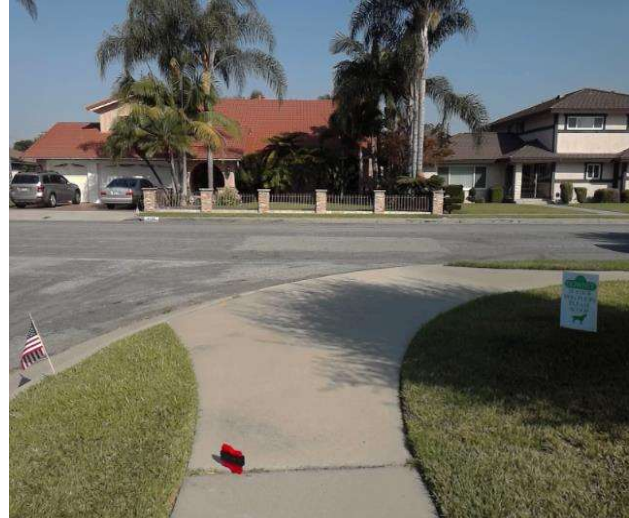
There is a change in elevation greater than recommended value.

Ensure that the change in elevation is within the recommended value.

Recommendation Up to 0.25 inches

Remove tripping hazards \$198

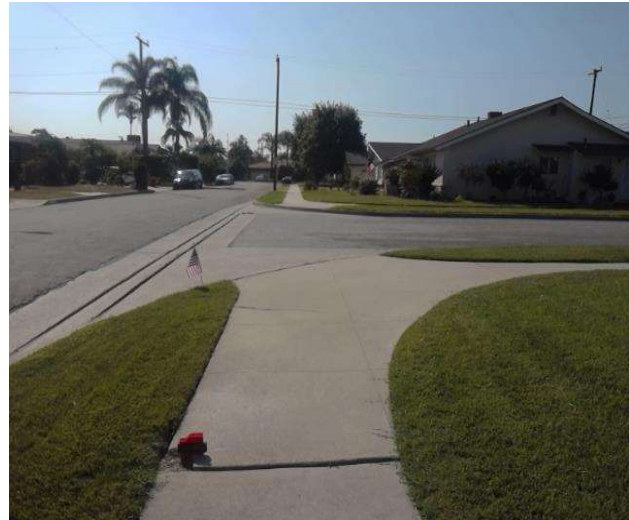
There is a change in elevation greater than recommended value.

Ensure that the change in elevation is within the recommended value.

Recommendation Up to 0.25 inches

Remove tripping hazards \$198

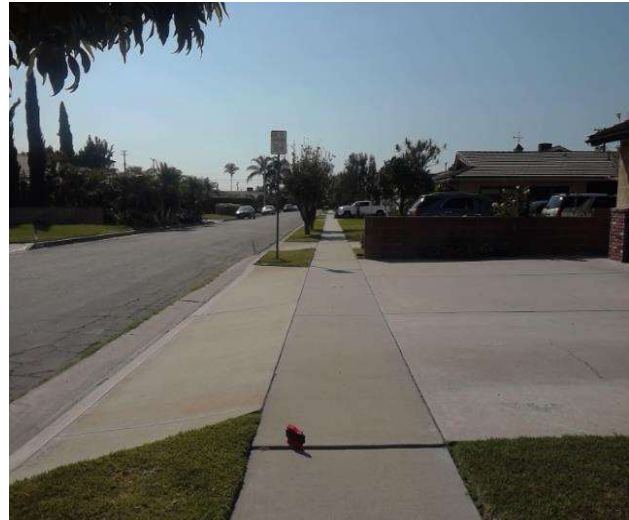
There is a change in elevation greater than recommended value.

Remove tripping hazards \$198

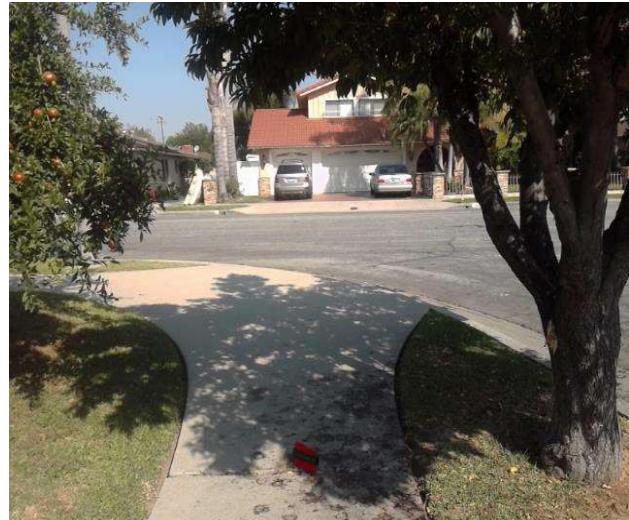
There is a change in elevation greater than recommended value.

Ensure that the change in elevation is within the recommended value.

Recommendation Up to 0.25 inches

Remove tripping hazards \$198

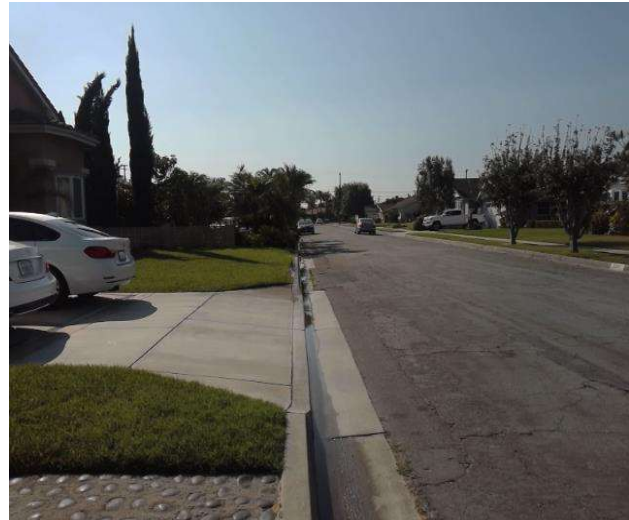
Sidewalks : Missing Sidewalk

Section of sidewalk is missing and consists of dirt, grass or gravel.

Provide a compliant sidewalk for the missing section.

\$1,260

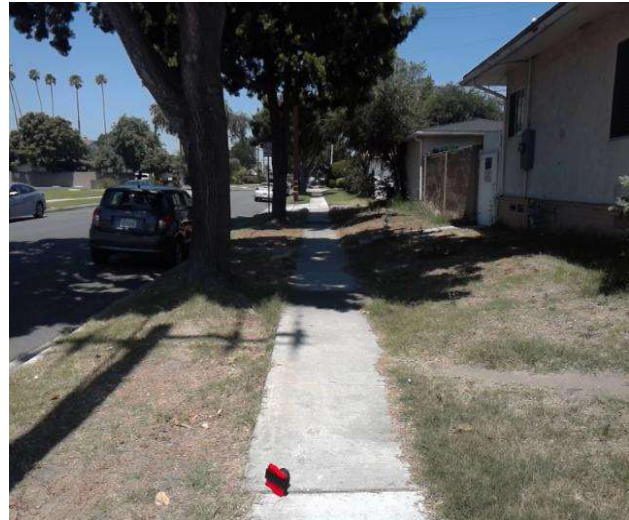
There is a change in elevation greater than recommended value.

Ensure that the change in elevation is within the recommended value.

Recommendation Up to 0.25 inches

Remove tripping hazards \$198

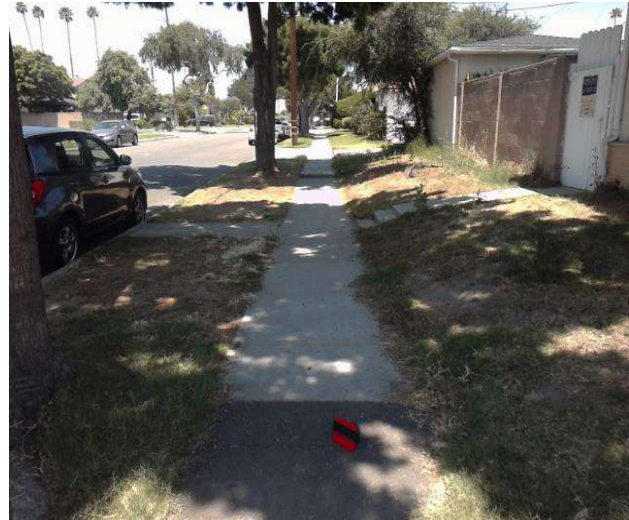
Notes : Surface is Rough And Uneven.

Remove tripping hazards \$198

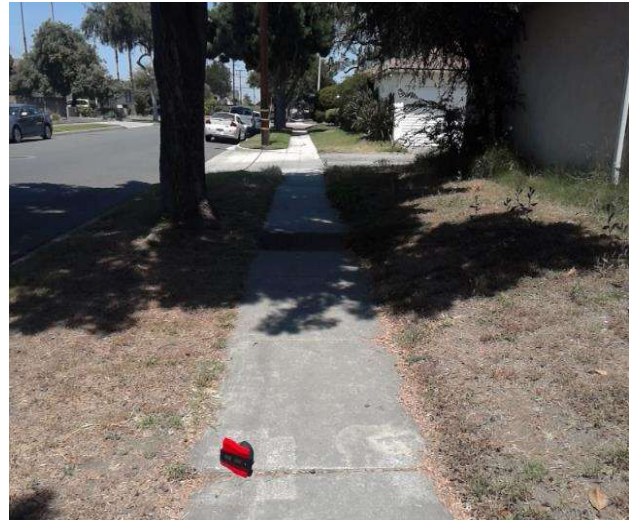
There is a change in elevation greater than recommended value.

Ensure that the change in elevation is within the recommended value.

Recommendation Up to 0.25 inches

Remove tripping hazards \$198

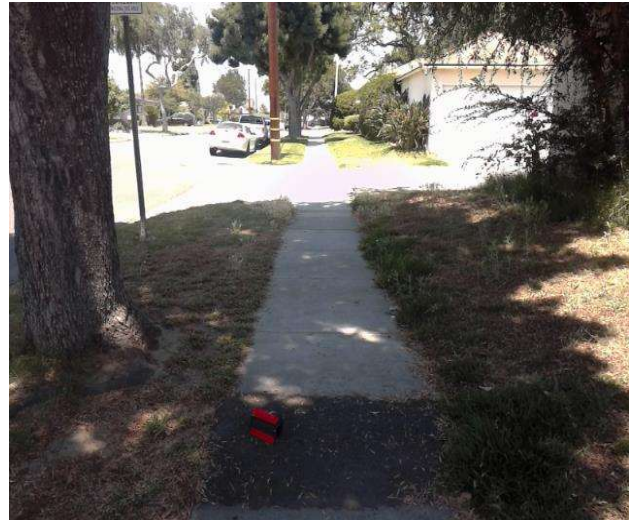
Notes : Surface is Rough And Uneven.

Remove tripping hazards \$198

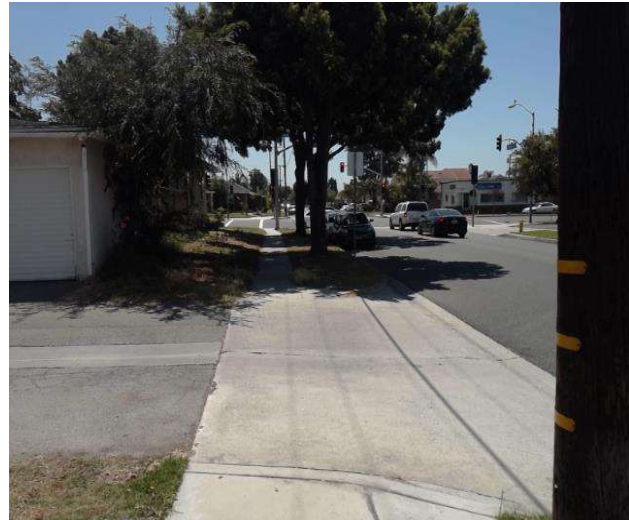
On-Site Finding Not Found

Install compliant detectable warnings \$190

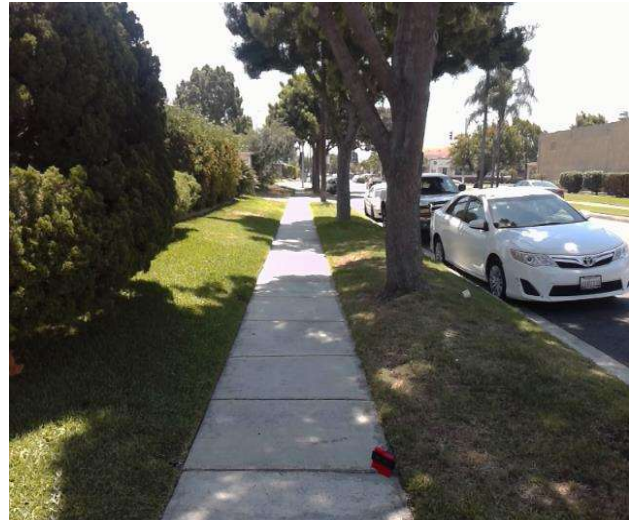
There is a change in elevation greater than recommended value.

Ensure that the change in elevation is within the recommended value.

Recommendation Up to 0.25 inches

Remove tripping hazards \$198

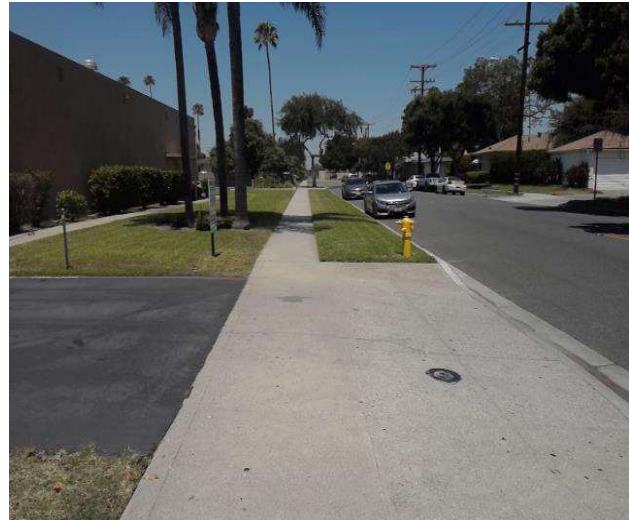
On-Site Finding Not Found

Install compliant detectable warnings \$190

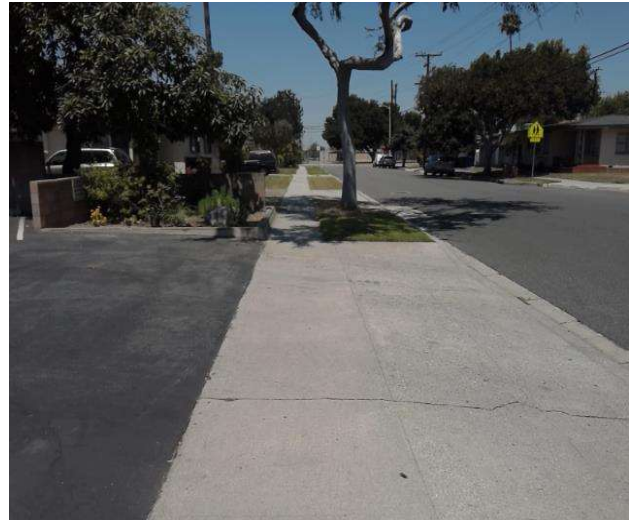
On-Site Finding Not Found

Install compliant detectable warnings \$190
