## Accessibility Survey

## City of Downey Garfield Avenue & Gardendale Avenue

Garfield Avenue & Gardendale Avenue  
Downey, CA 90240

Date of Inspection  
5/26/2017

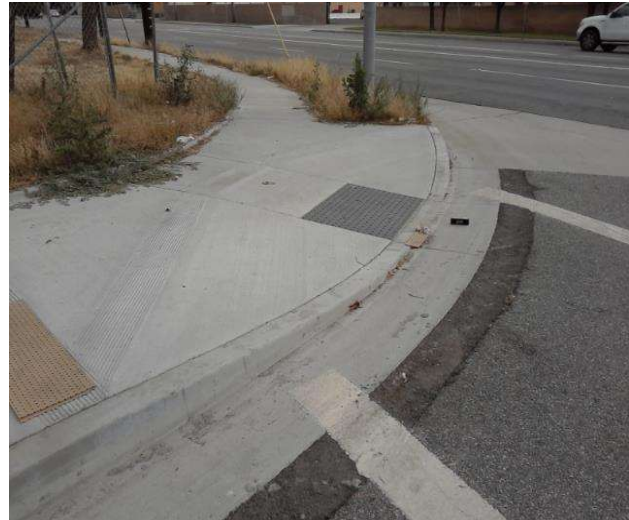
Curb Ramp : Detectable Warning Domes Direction

Detectable warning domes are not aligned in the direction of travel.

**On-Site Finding** Not Compliant

Provide compliant detectable warnings with domes aligned in the direction of travel.

Install compliant detectable warnings \$190

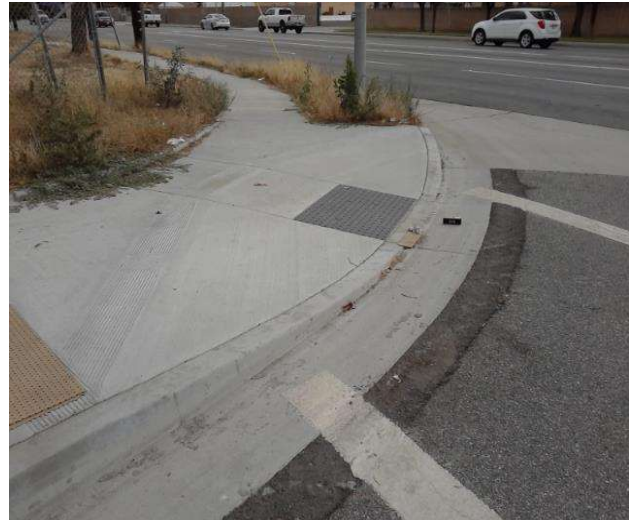
Curb Ramp : Bottom Landing Slope

The bottom landing of the curb ramp is on the street, and the slope of the bottom landing is not compliant.

**On-Site Finding** 7.60 percent

**Code Reference** ADA 406, 406.2, CA 11B-406.5.8

Ensure the bottom landing slope is compliant and provides a smooth transition.

Recommendation Up to 5.00 percent

Repave landing \$1,260

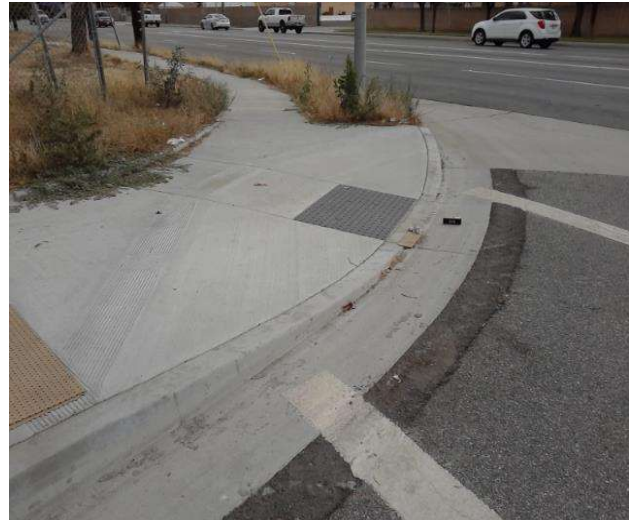
Curb Ramp , Landings and Transitions : Top Landing Clear Length - Landings

There is not enough top landing clear length.

**On-Site Finding** 47.12 inches

**Code Reference** ADA 406, 406.4, CA 11B-406.5.3

Provide a level top landing with enough clear length.

Recommendation At least 48.00 inches

Provide compliant landing \$240

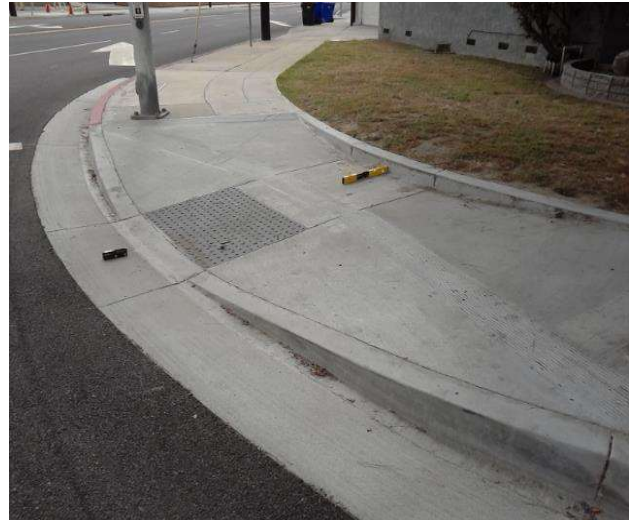
Curb Ramp : Side Flare Slope

**On-Site Finding** 12.00 percent

**Code Reference** ADA 406, 406.3, CA 11B-406.2.2

Recommendation Up to 10.00 percent

Install flared sides \$1,300

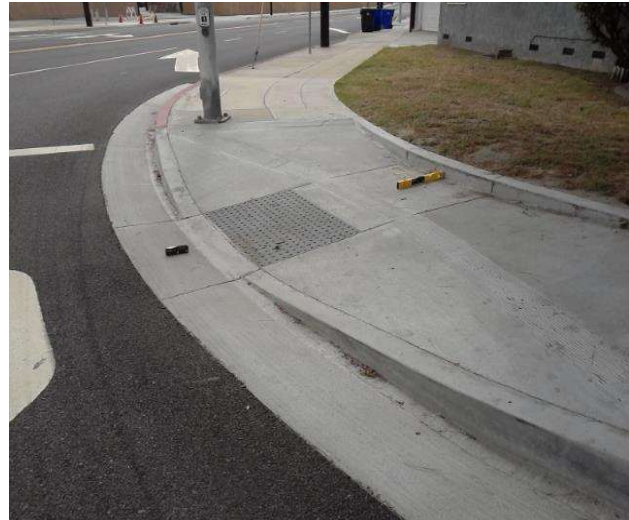
Curb Ramp , Landings and Transitions : Top Landing Clear Length - Landings

**Code Reference** ADA 406, 406.4, CA 11B-406.5.3

Recommendation At least 48.00 inches

Provide compliant landing \$240

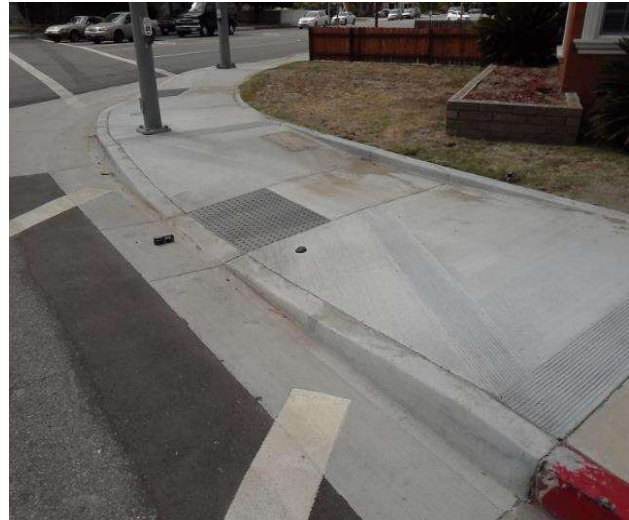
**Code Reference** ADA 303.3,CA 11B-303.3

Recommendation See Recommendation

Install curb ramp \$1,440

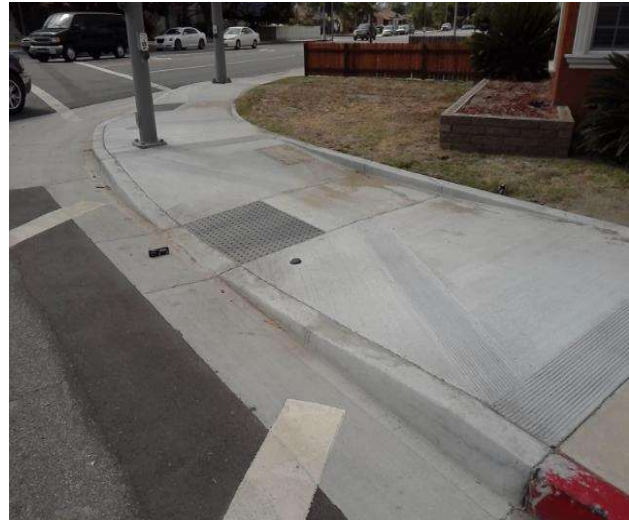
**Code Reference** ADA 406, 406.2, CA 11B-406.5.8

Recommendation Up to 5.00 percent

Repave landing \$1,260

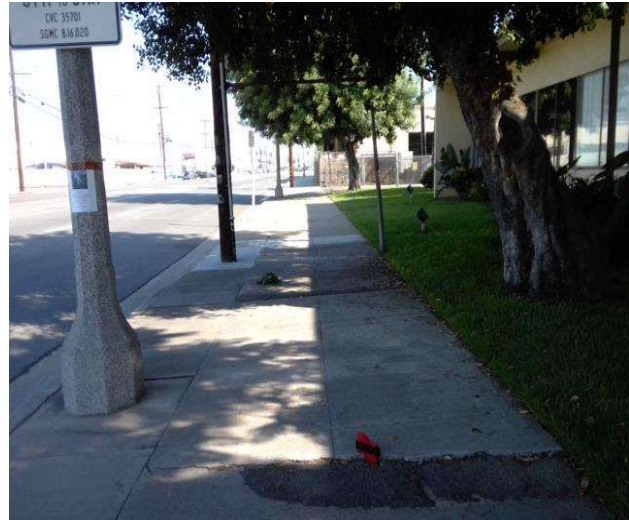
There is a change in elevation greater than recommended value.

**Code Reference** ADA 206, 302

Ensure that the change in elevation is within the recommended value.

Recommendation Up to 0.25 inches

Remove tripping hazards \$198

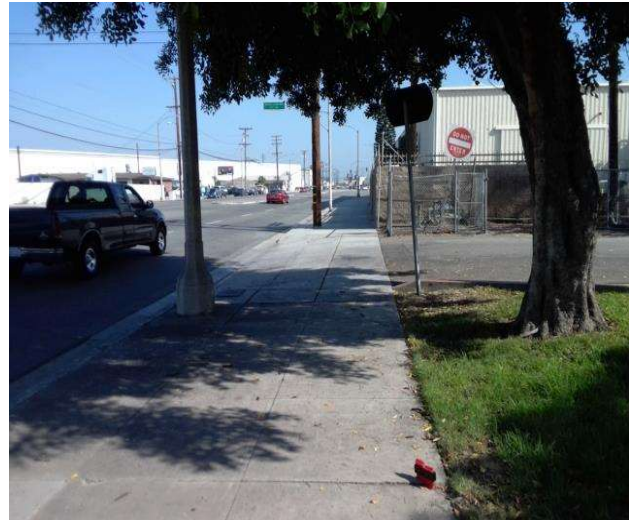
There is a change in elevation greater than recommended value.

**Code Reference** ADA 206, 302

Ensure that the change in elevation is within the recommended value.

Recommendation Up to 0.25 inches

Remove tripping hazards \$198
