Accessibility Survey

City of Downey Lakewood Boulevard & Columbia Way

Date of Inspection
5/25/2017

Disability Access Consultants

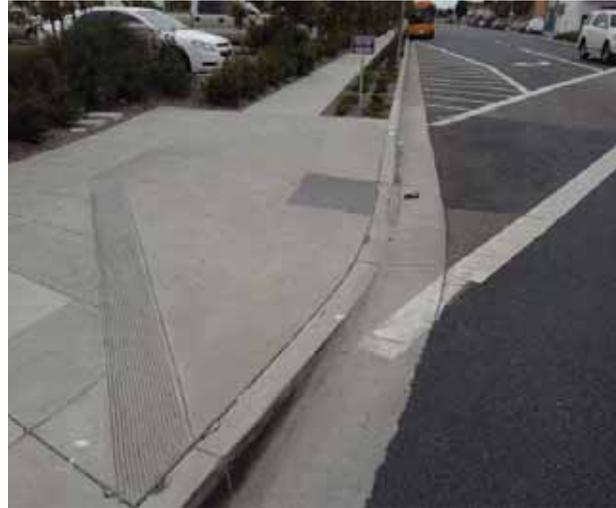
Curb Ramp : Detectable Warning Domes Direction

Detectable warning domes are not aligned in the direction of travel.

On-Site Finding Not Compliant

Provide compliant detectable warnings with domes aligned in the direction of travel.

Install compliant detectable warnings \$190

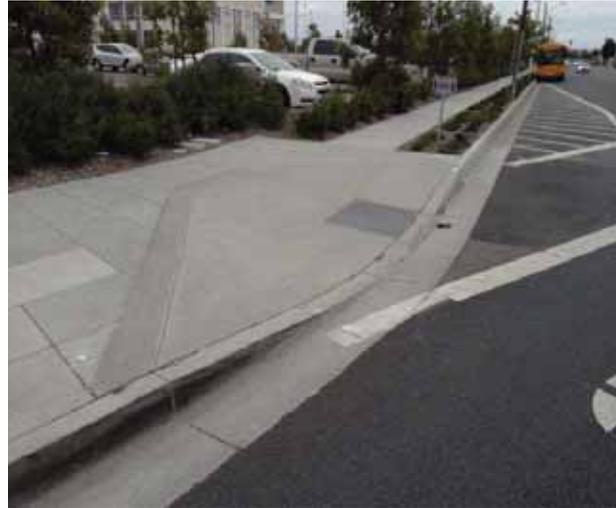
Bottom Landing

Curb Ramp : Bottom Landing Slope

Recommendation Up to 5.00 percent

Repave landing \$1,260

Code Reference ADA 406, 406.2,CA 11B-406.5.8

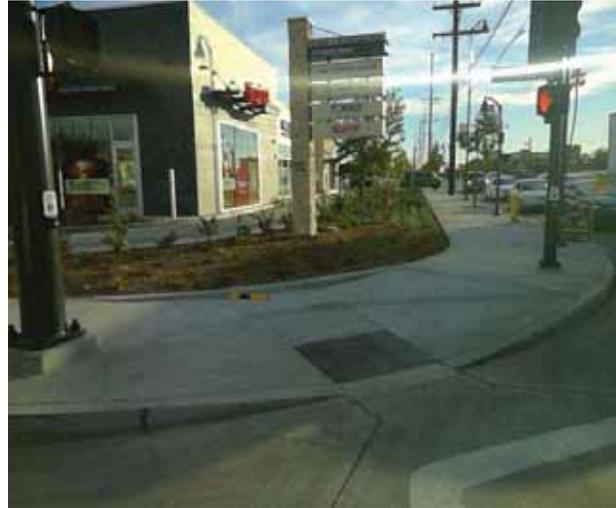
Code Reference ADA 402, 406.4, 403.3, 406.1, CA 11B-406.5.3

Provide compliant landing \$1,260

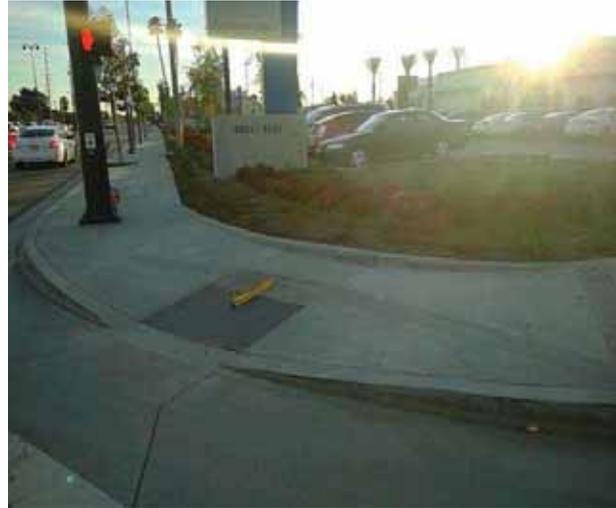
Code Reference ADA 406, 406.1, 405.2, CA 11B-406

Recommendation Up to 8.33 percent

Install curb ramp \$1,300

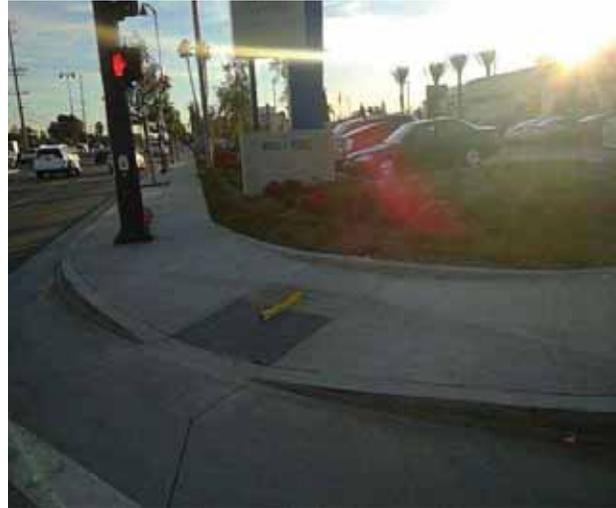
Code Reference ADA 406, 406.4, CA 11B-406.5.3

Recommendation At least 48.00 inches

Provide compliant landing \$240

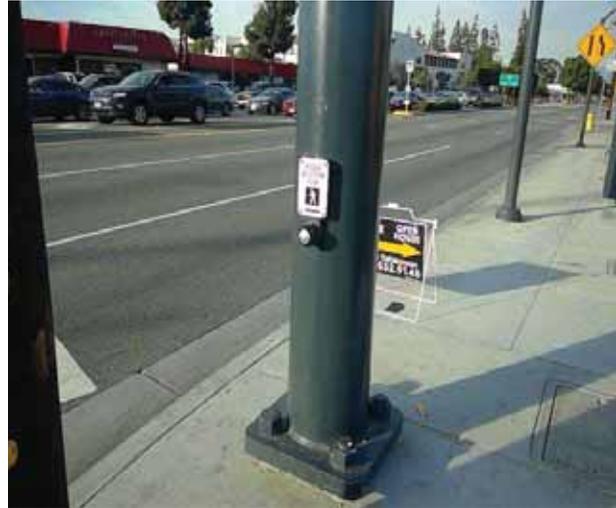
Code Reference CA MUTCD 4E.08

Recommendation Up to 60.00 inches

\$900

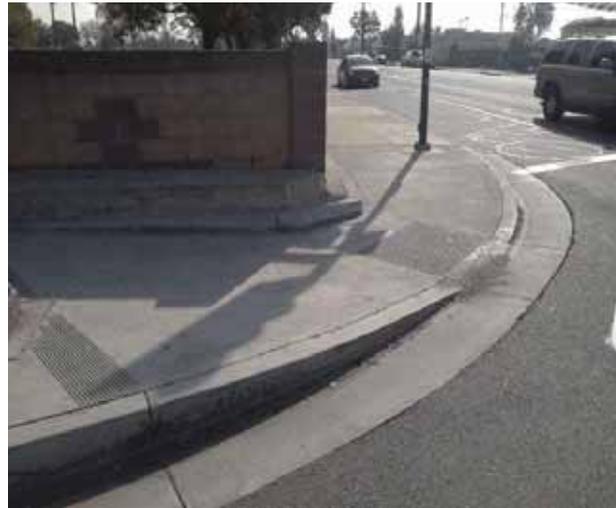
Code Reference ADA 406.1, 405.3, CA 11B-406.5.7

Install curb ramp \$1,300

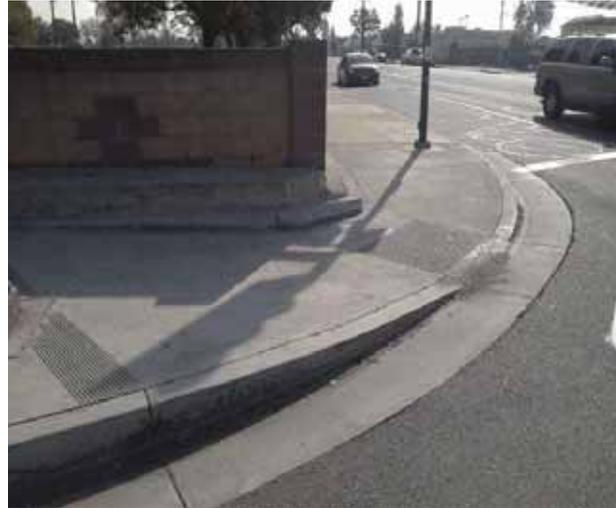
Code Reference CA 11B-406.5.6

Install curb ramp \$1,440

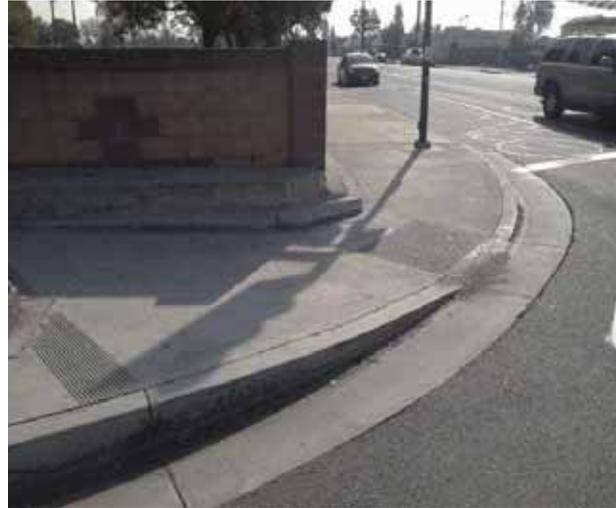
Code Reference ADA 405, 406.1, 405.10

Provide compliant landing \$255

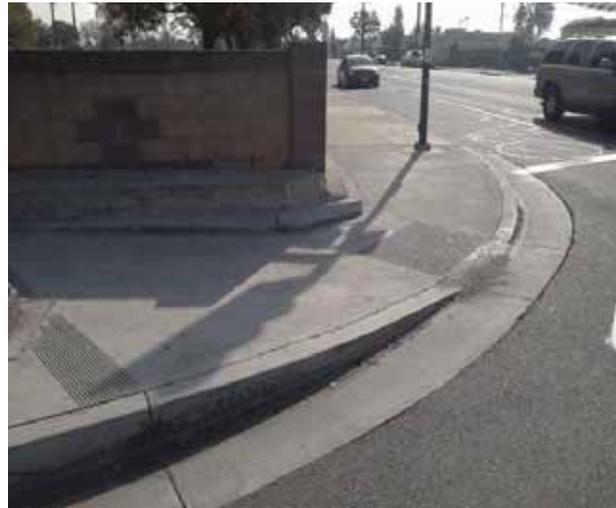
Code Reference ADA 402, 406.4, 403.3, 406.1, CA 11B-406.5.3

Provide compliant landing \$1,260

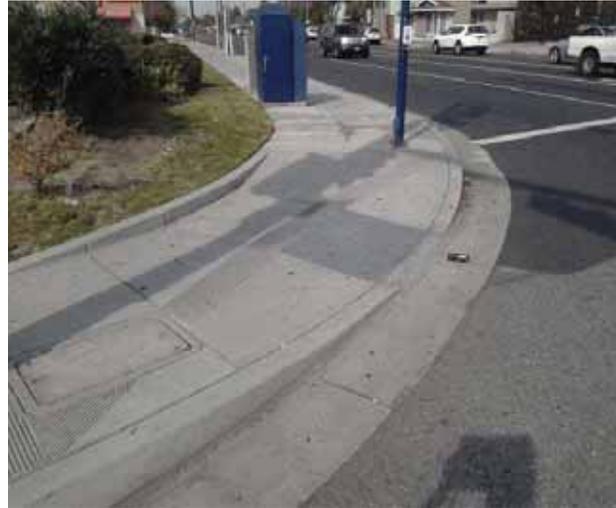
Code Reference ADA 303.3, CA 11B-303.3

Install curb ramp \$1,440

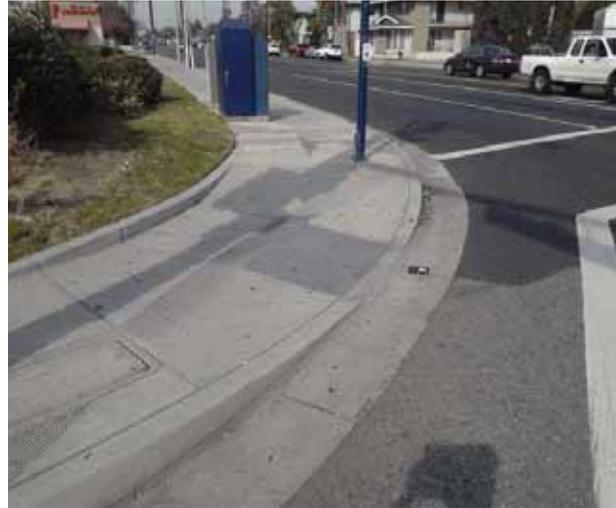
Code Reference ADA 406, 406.2, CA 11B-406.5.8

Repave landing \$1,260

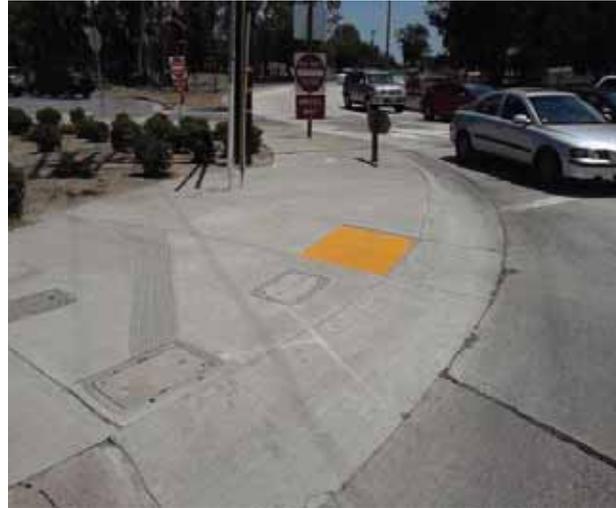
The overlayment causes a noncompliant change in level.

Ensure the change in elevation is within the recommended height.

Recommendation Up to 0.50 inches

Provide smooth surface \$150

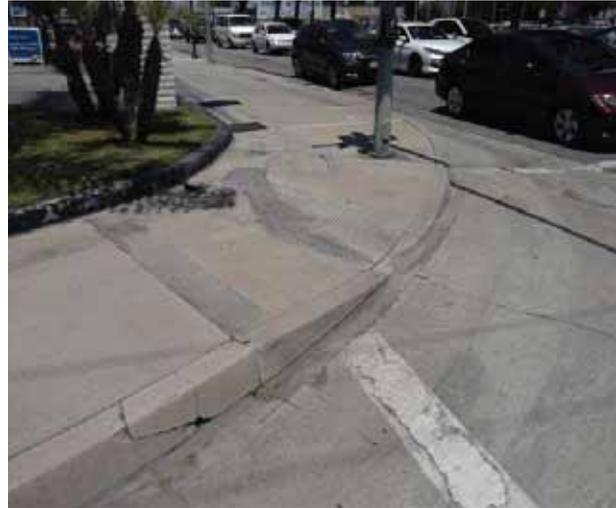
On-Site Finding Not Found

Provide detectable warning to surface \$248

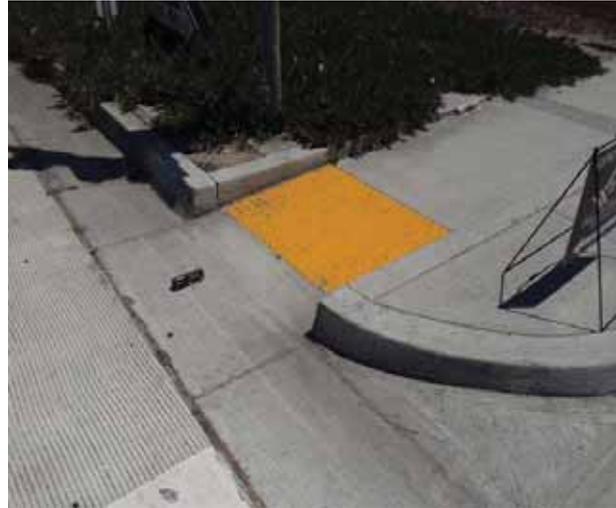
On-Site Finding Not Found

Provide detectable warning to surface \$248

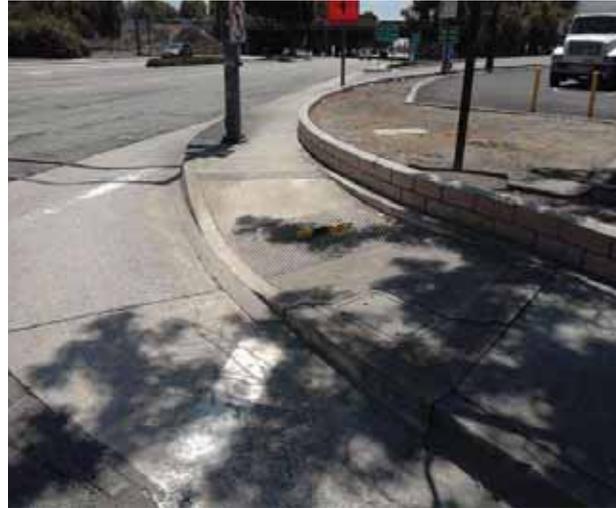
On-Site Finding Not Found

Provide detectable warning to surface \$248

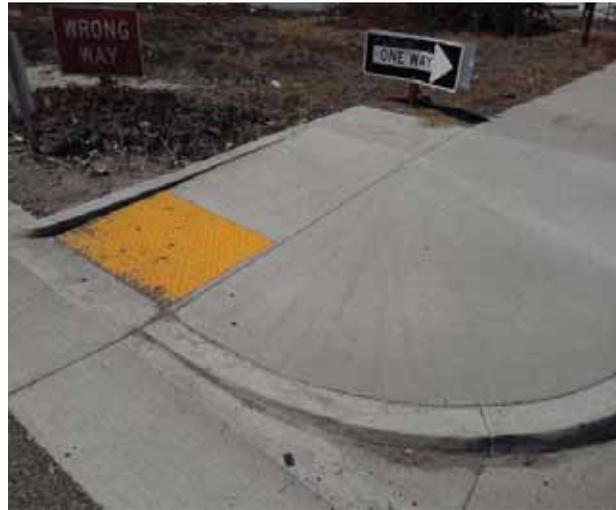
Curb Ramp , Landings and Transitions : Landing Accumulates Water - Wet Conditions

Provide compliant landing \$255

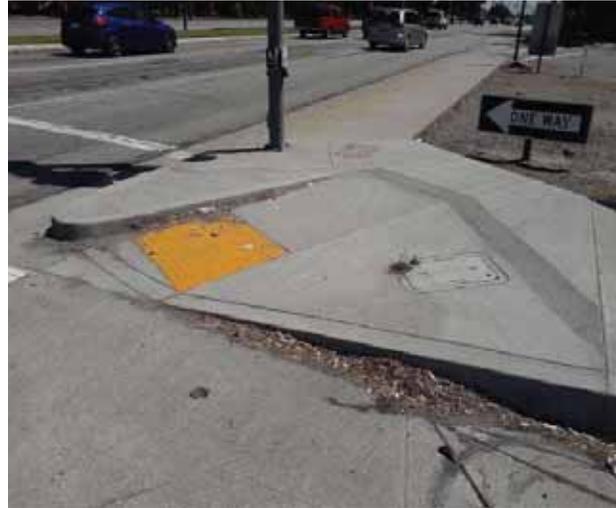
Curb Ramp , Landings and Transitions : Landing Accumulates Water - Wet Conditions

Provide compliant landing \$255

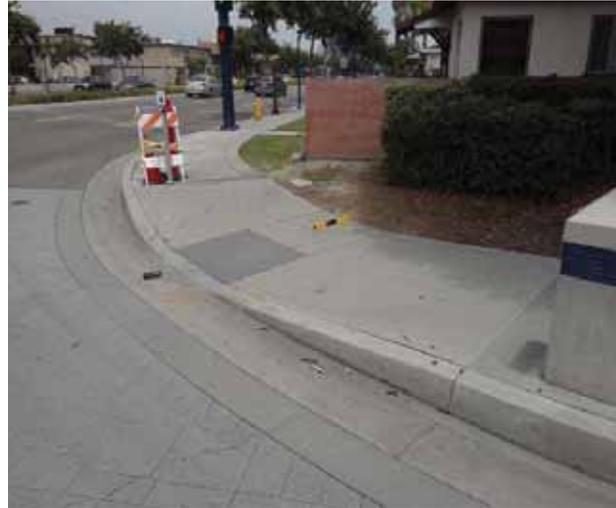
Recommendation Up to 2.08 percent

Provide compliant landing \$1,260

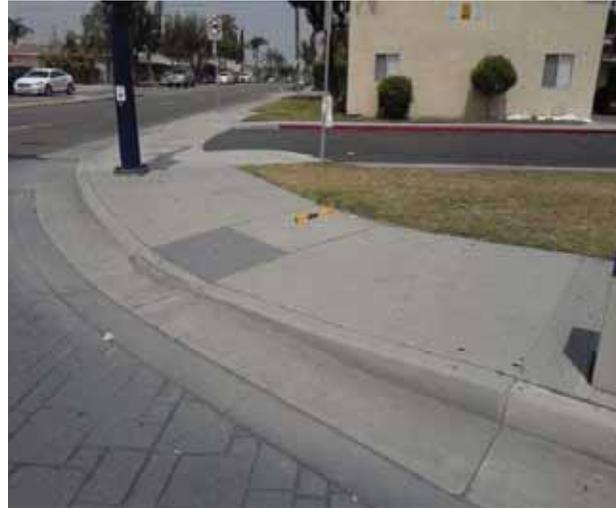
Recommendation Up to 2.08 percent

Provide compliant landing \$1,260

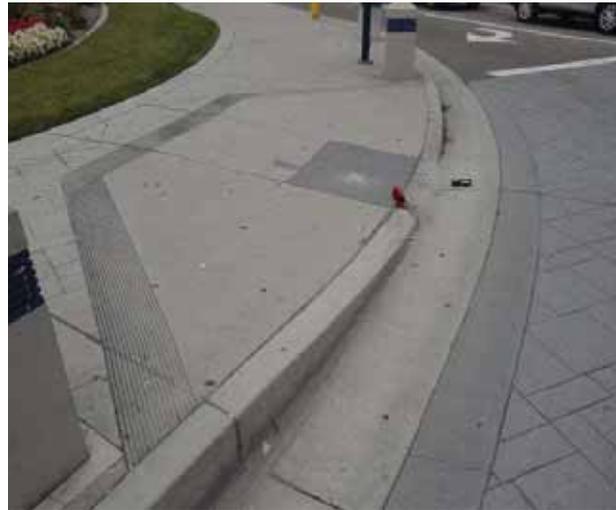
Recommendation Up to 5.00 percent

Repave landing \$1,260

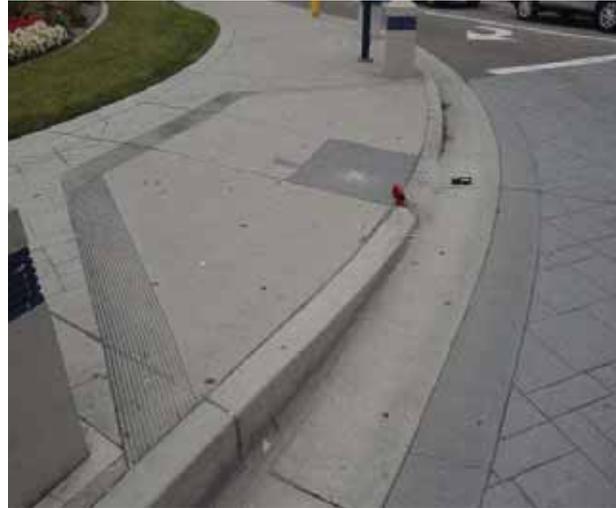
Recommendation Up to 0.50 inches

Patch lip at curb ramp \$255

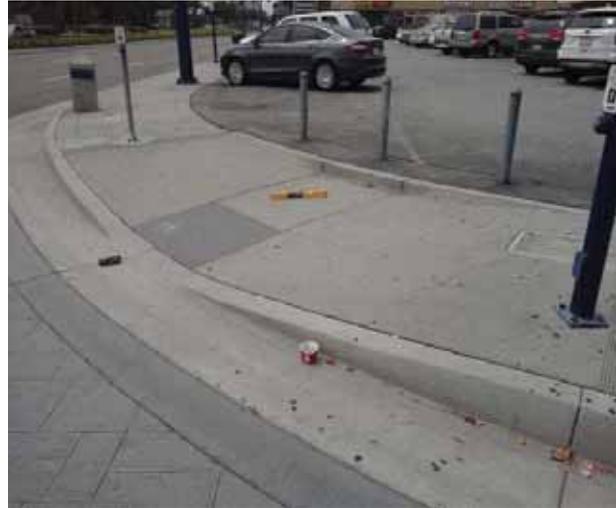
Recommendation Up to 5.00 percent

Repave landing \$1,260

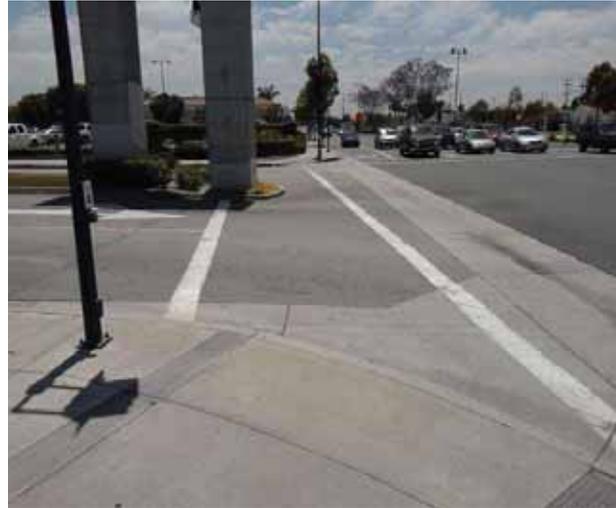
Code Reference CA MUTCD 4E.08

Recommendation Up to 60.00 inches

\$900

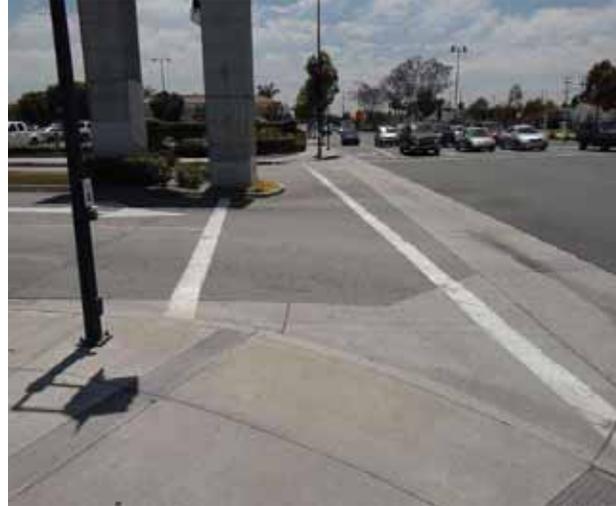
CA 11B-703.7.2.7, CA MUTCD 4E.08

\$158

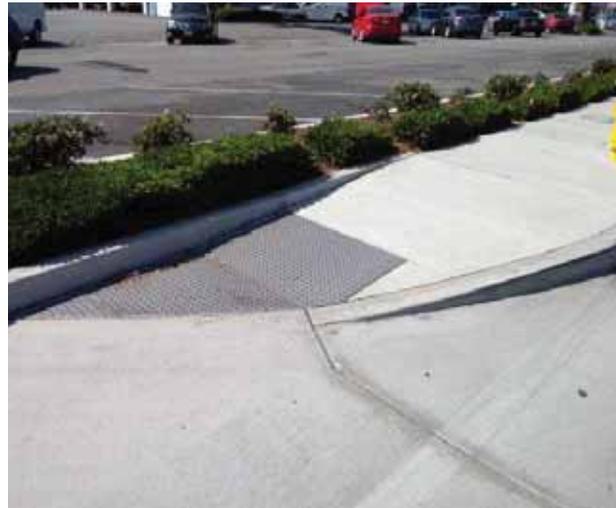
Code Reference ADA 406, 406.1, 405.2, CA 11B-406

Install curb ramp \$1,300

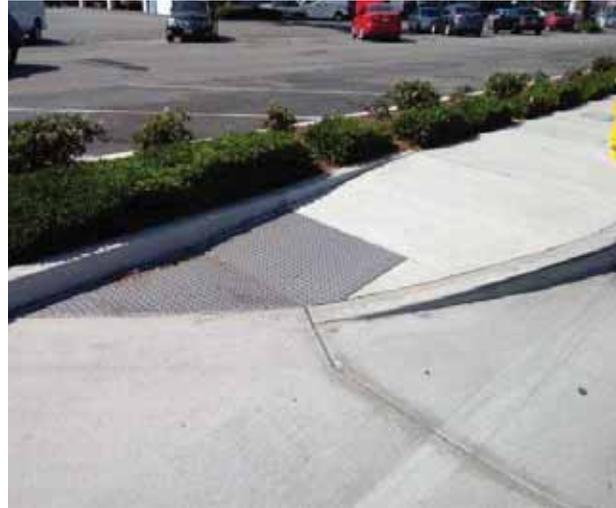
Code Reference CA 11B-406.5.6

Install curb ramp \$1,440

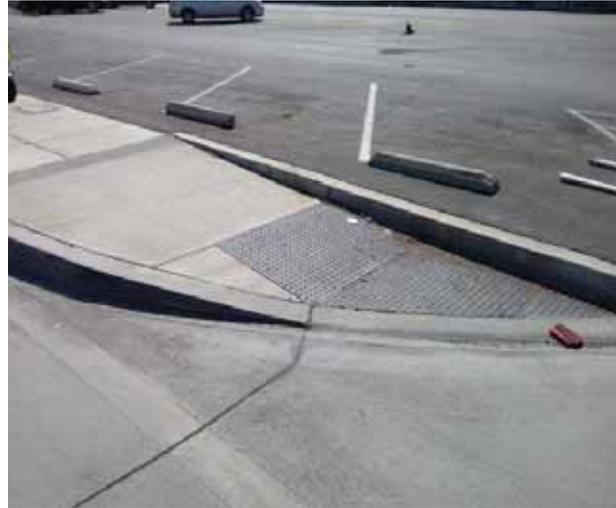
Code Reference CA 11B-406.5.6

Install curb ramp \$1,440

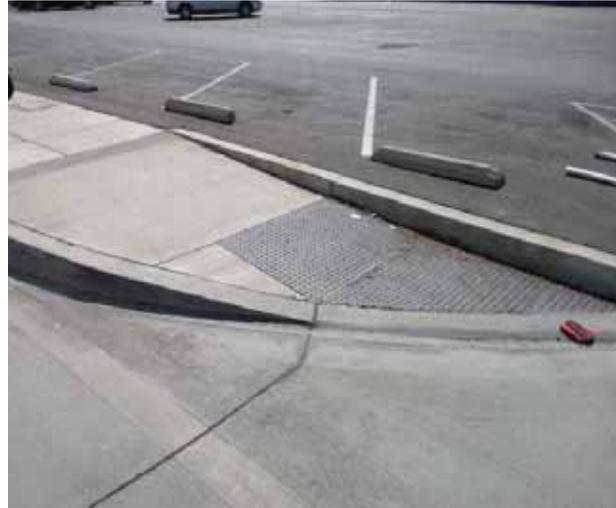
Code Reference ADA 302, 303, 406.2, 303.1

Patch lip at curb ramp \$255

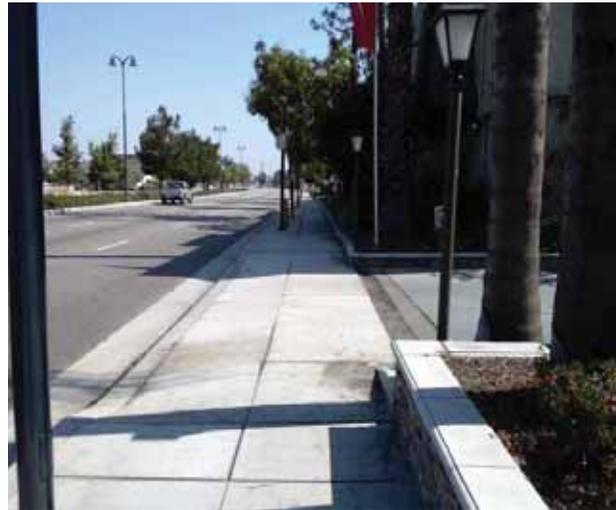
Code Reference ADA 705,CA 11B-705.1.2.5,CA 11B-247.1.2.5

Install compliant detectable warnings \$190

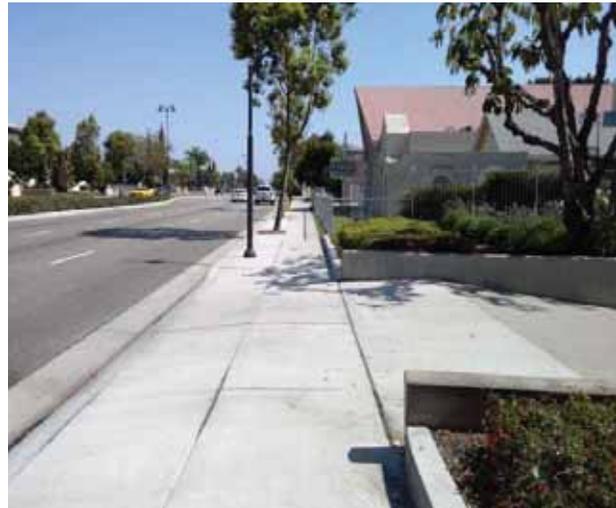
Code Reference ADA 705,CA 11B-705.1.2.5,CA 11B-247.1.2.5

Install compliant detectable warnings \$190

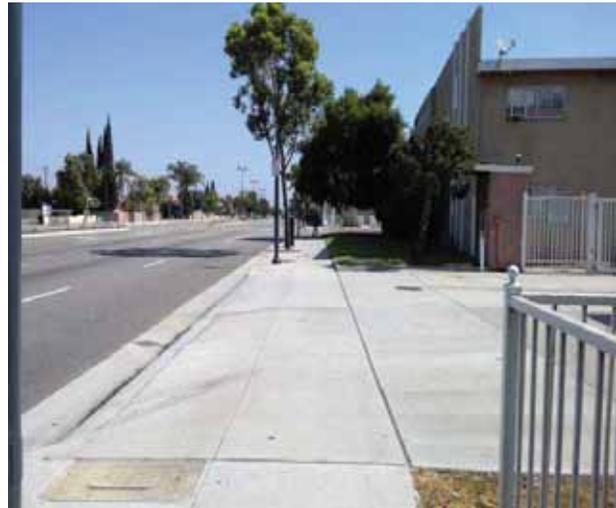
Code Reference ADA 705,CA 11B-705.1.2.5,CA 11B-247.1.2.5

Install compliant detectable warnings \$190

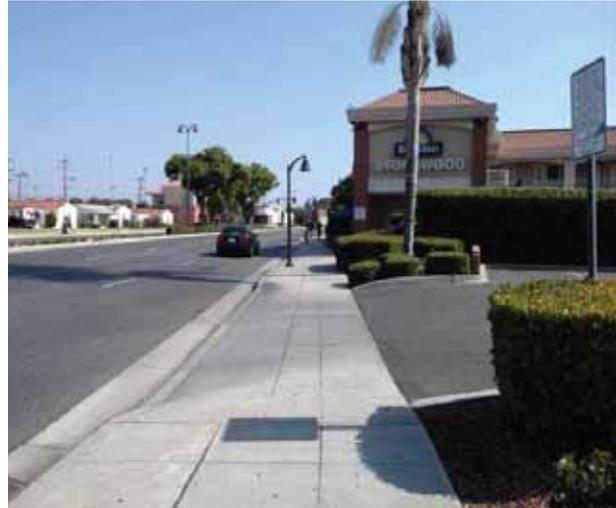
Code Reference ADA 705,CA 11B-705.1.2.5,CA 11B-247.1.2.5

Install compliant detectable warnings \$190

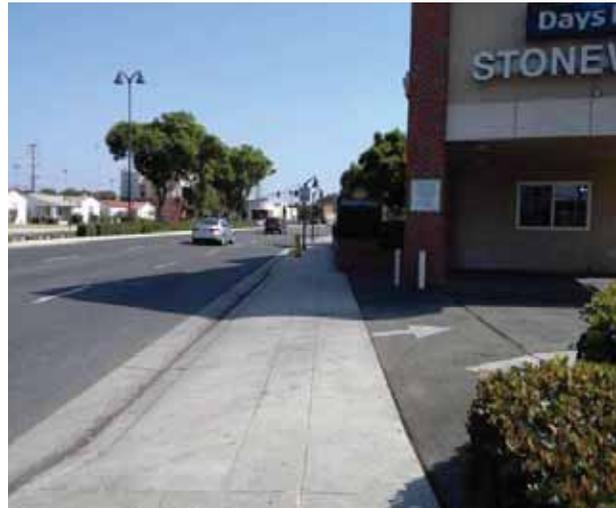
Code Reference ADA 705,CA 11B-705.1.2.5,CA 11B-247.1.2.5

Install compliant detectable warnings \$190

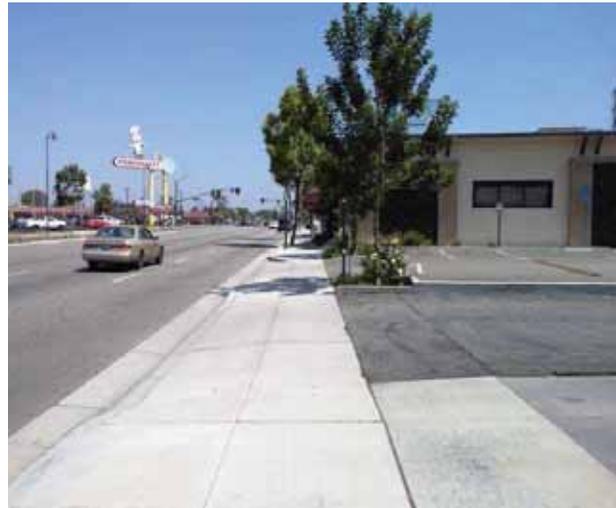
Code Reference ADA 705,CA 11B-705.1.2.5,CA 11B-247.1.2.5

Install compliant detectable warnings \$190

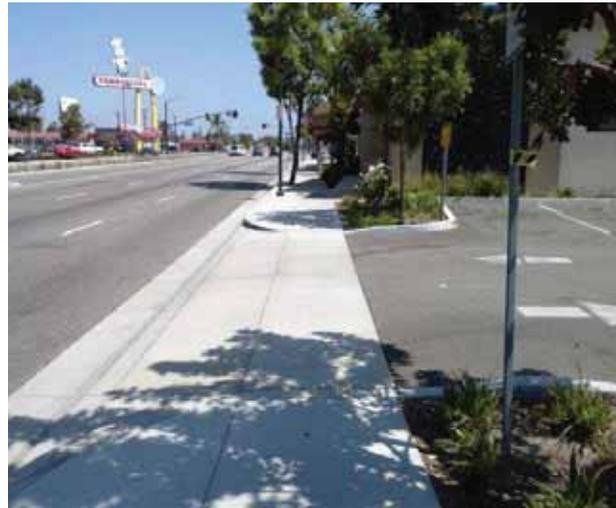
Code Reference ADA 705,CA 11B-705.1.2.5,CA 11B-247.1.2.5

Install compliant detectable warnings \$190

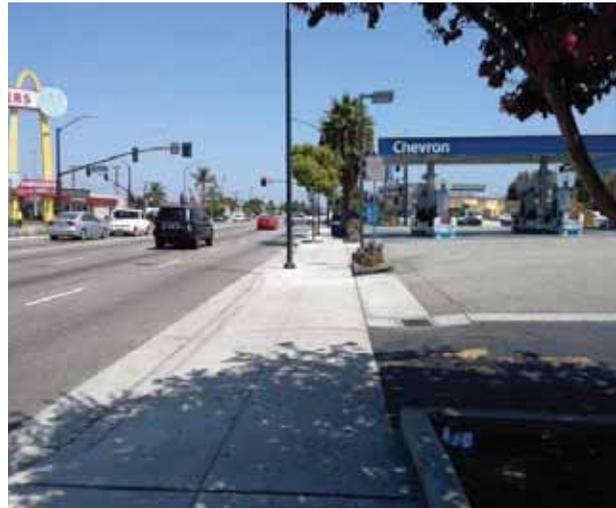
Code Reference ADA 705,CA 11B-705.1.2.5,CA 11B-247.1.2.5

Install compliant detectable warnings \$190

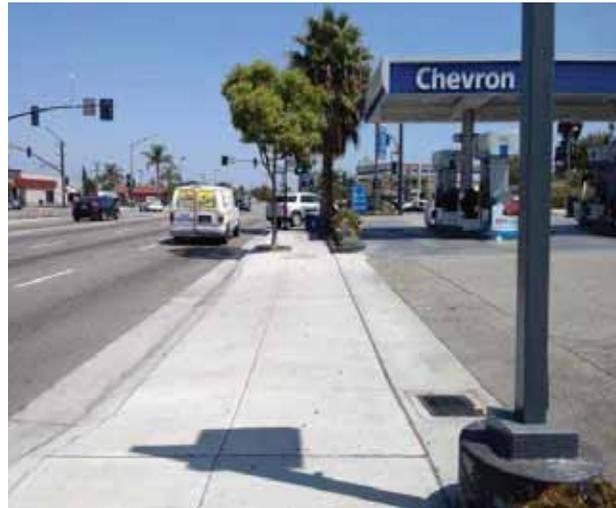
Code Reference ADA 705,CA 11B-705.1.2.5,CA 11B-247.1.2.5

Install compliant detectable warnings \$190

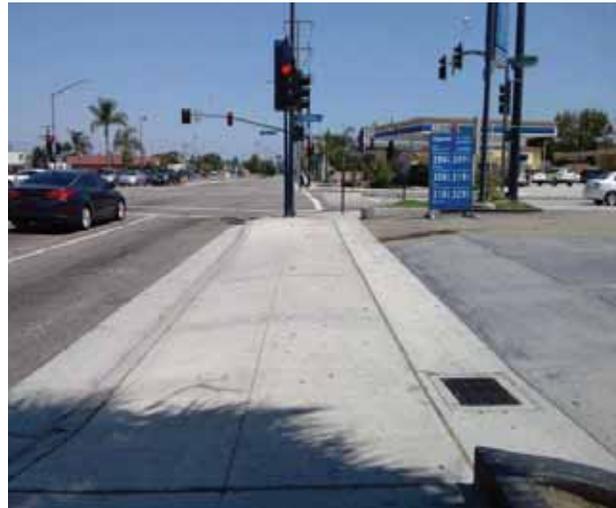
Code Reference ADA 705,CA 11B-705.1.2.5,CA 11B-247.1.2.5

Install compliant detectable warnings \$190

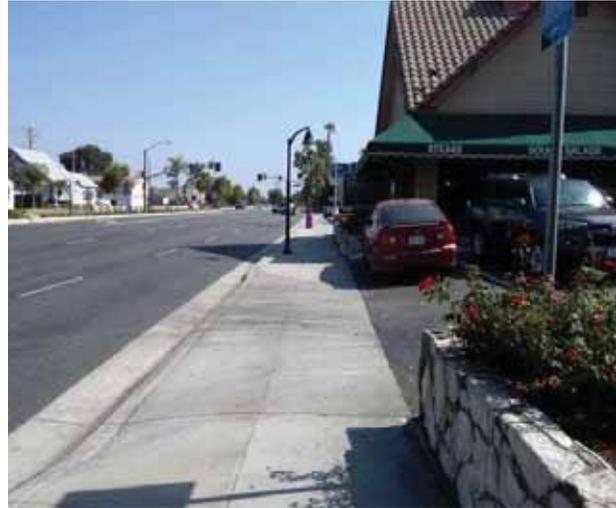
Code Reference ADA 705,CA 11B-705.1.2.5,CA 11B-247.1.2.5

Install compliant detectable warnings \$190

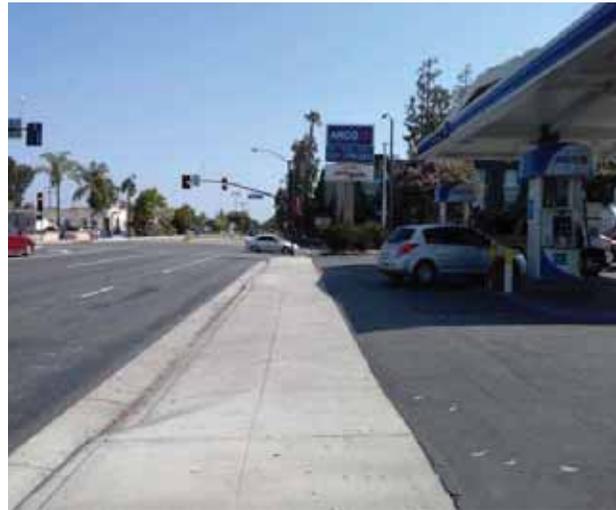
Code Reference ADA 705,CA 11B-705.1.2.5,CA 11B-247.1.2.5

Install compliant detectable warnings \$190

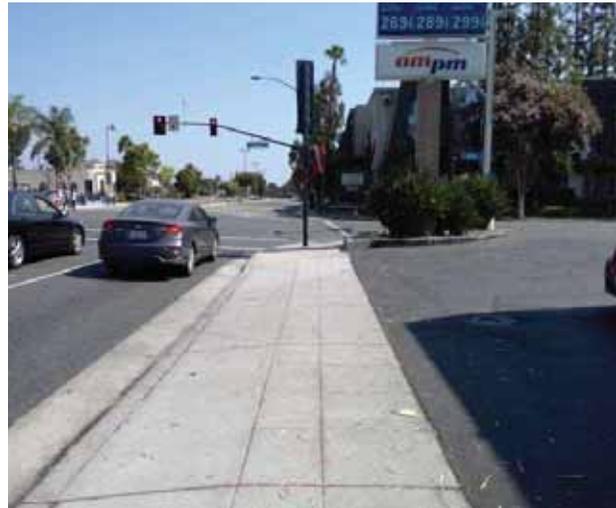
On-Site Finding Not Found

Install compliant detectable warnings \$190

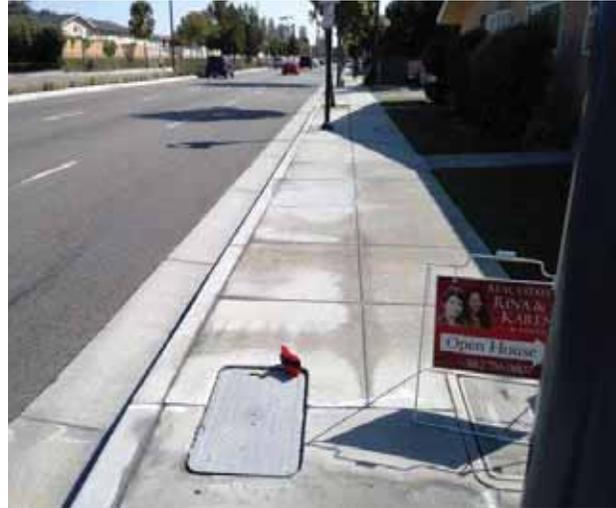
There is a change in elevation greater than recommended value.

Ensure that the change in elevation is within the recommended value.

Recommendation Up to 0.25 inches

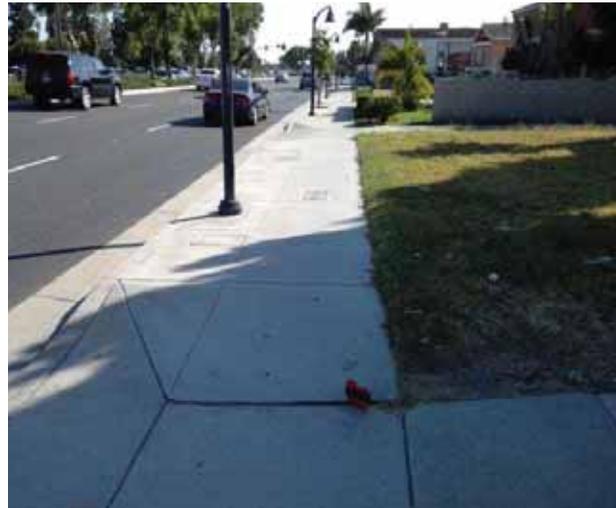
There is a change in elevation greater than recommended value.

Ensure that the change in elevation is within the recommended value.

Recommendation Up to 0.25 inches

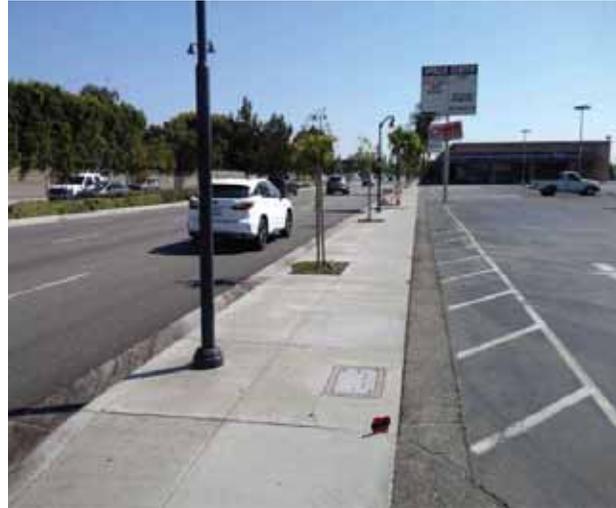
There is a change in elevation greater than recommended value.

Ensure that the change in elevation is within the recommended value.

Recommendation Up to 0.25 inches

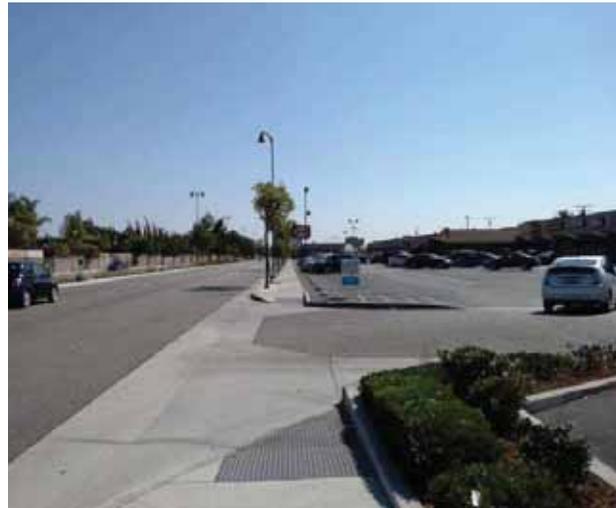
On-Site Finding Not Found

Install compliant detectable warnings \$190

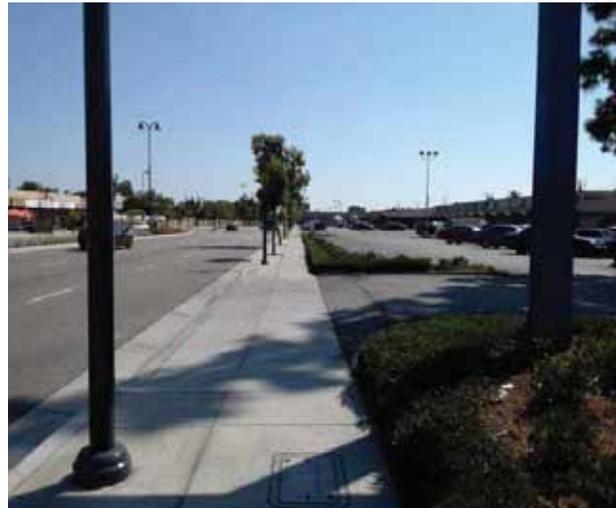
On-Site Finding Not Found

Install compliant detectable warnings \$190

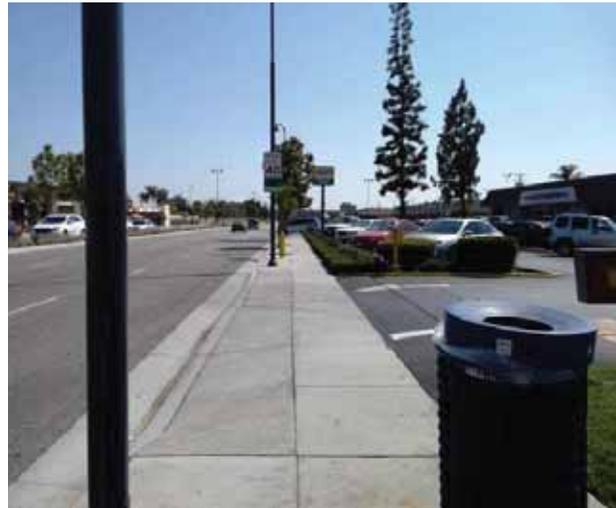
On-Site Finding Not Found

Install compliant detectable warnings \$190

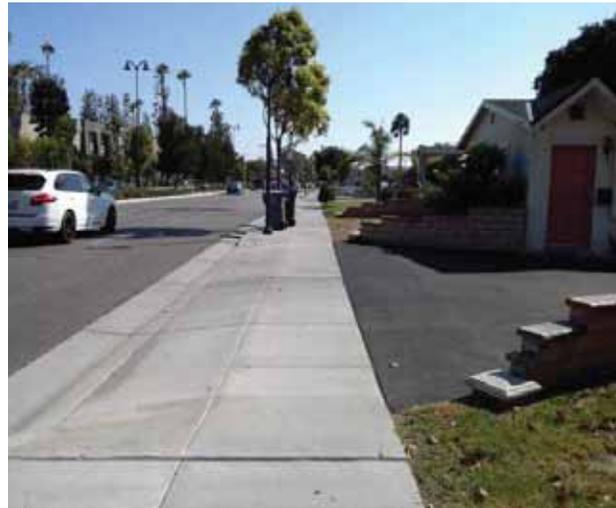
On-Site Finding Not Found

Install compliant detectable warnings \$190

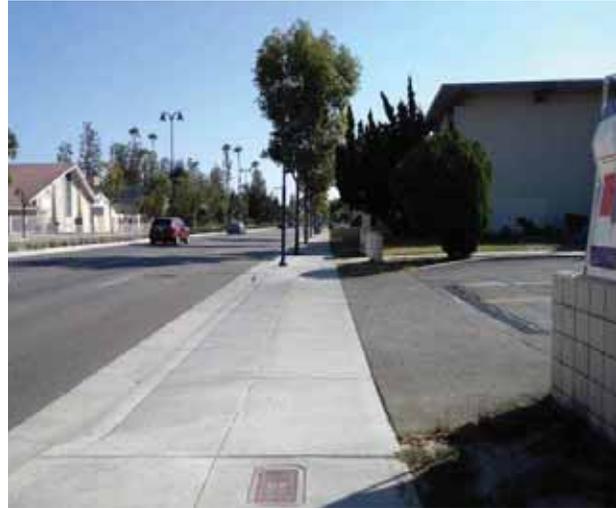
On-Site Finding Not Found

Install compliant detectable warnings \$190

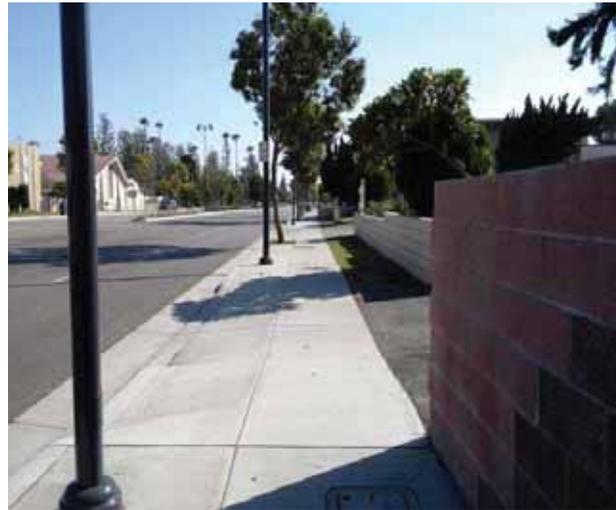
On-Site Finding Not Found

Install compliant detectable warnings \$190

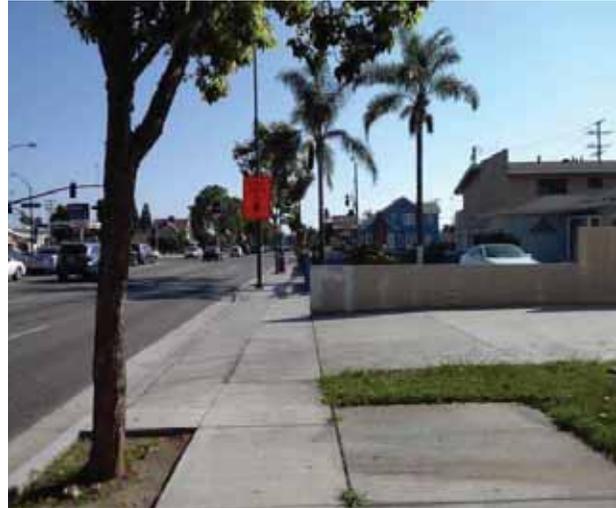
On-Site Finding Not Found

Install compliant detectable warnings \$190

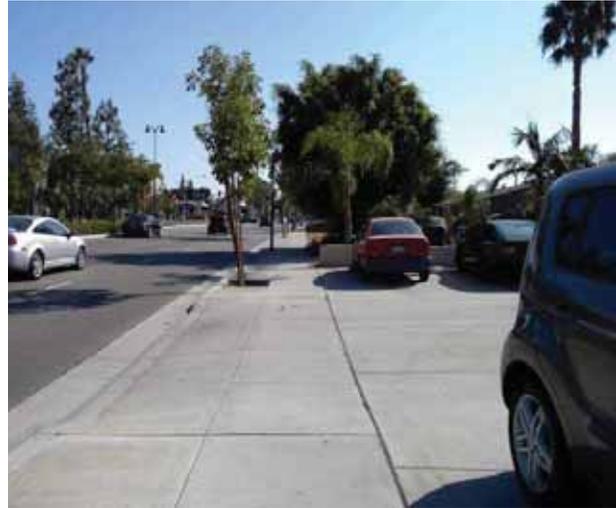
On-Site Finding Not Found

Install compliant detectable warnings \$190

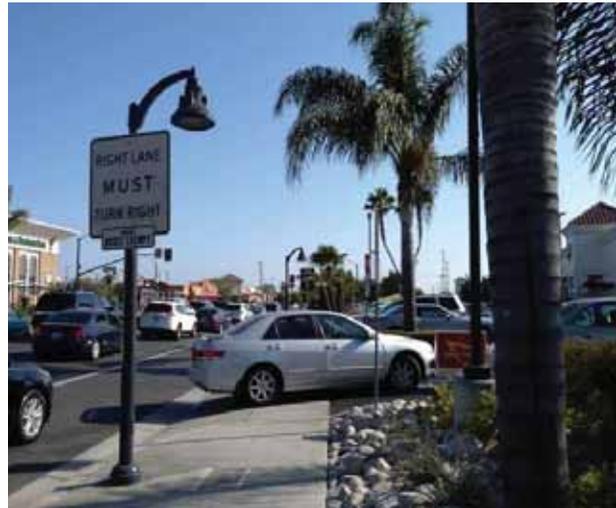
On-Site Finding Not Found

Install compliant detectable warnings \$190

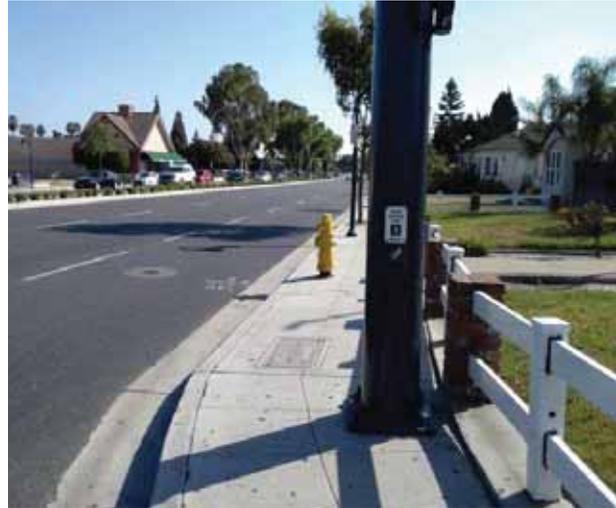
Sidewalks , Hazards & Gratings : Sidewalk Width at Obstruction

Sidewalk width at the obstruction shall have the recommended value.

Recommendation At least 48.00 inches

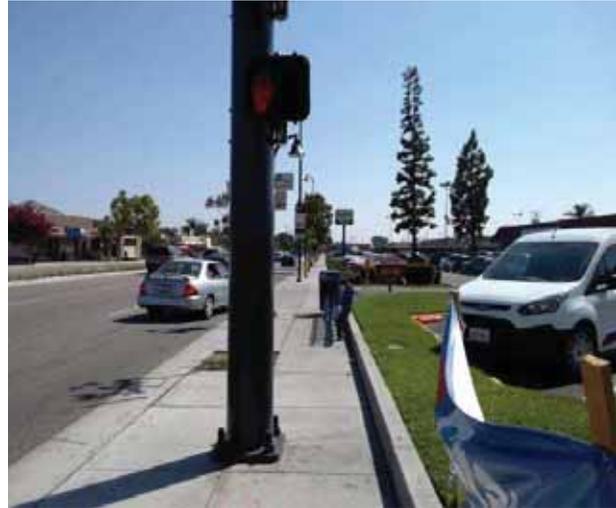
Sidewalks , Hazards & Gratings : Sidewalk Width at Obstruction

Sidewalk width at the obstruction shall have the recommended value.

Recommendation At least 48.00 inches

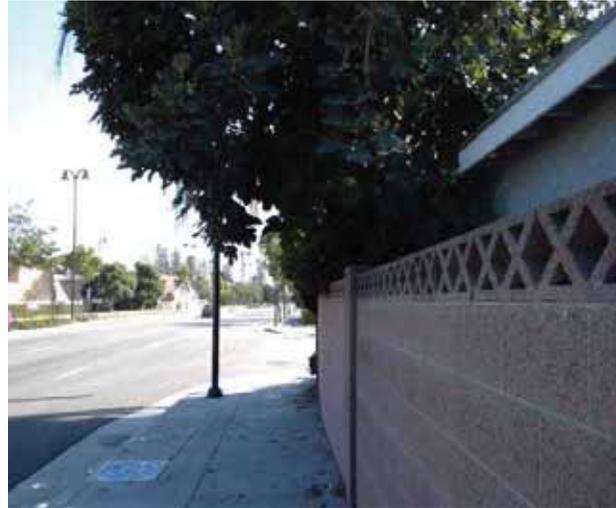
Sidewalks , Hazards & Gratings : Overhead Obstruction Height

Recommendation At least 80.00 inches

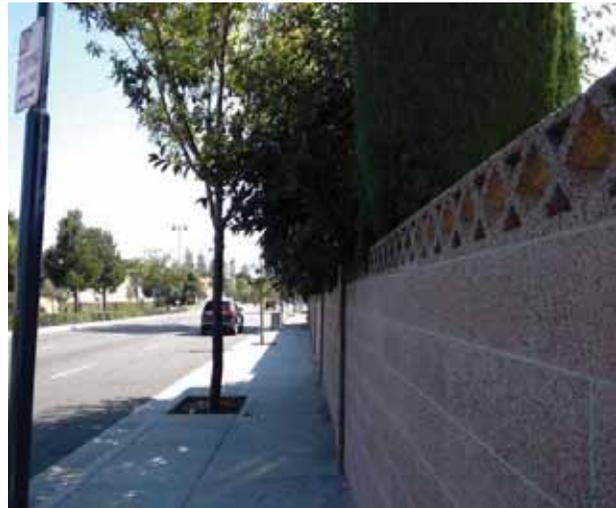
Sidewalks , Hazards & Gratings : Overhead Obstruction Height

Recommendation At least 80.00 inches

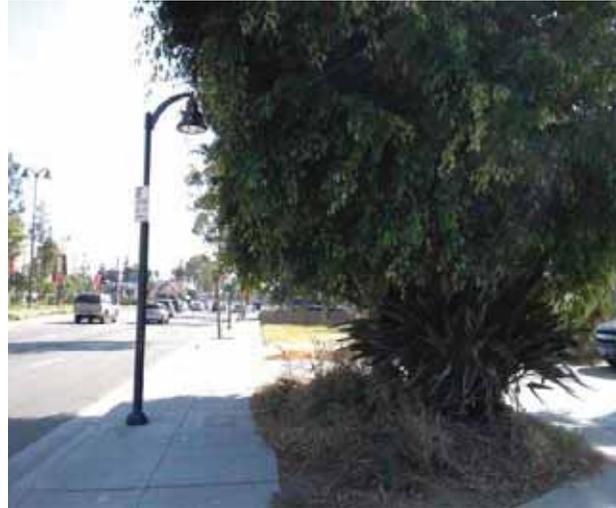
Sidewalks , Hazards & Gratings : Overhead Obstruction Height

Recommendation At least 80.00 inches

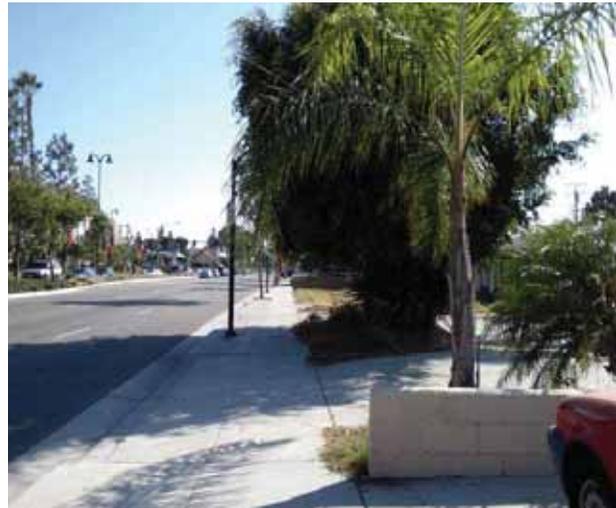
Sidewalks , Hazards & Gratings : Overhead Obstruction Height

Recommendation At least 80.00 inches

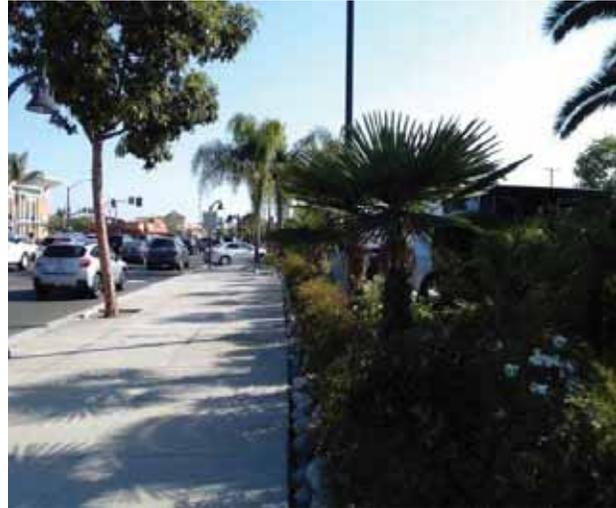
Sidewalks , Hazards & Gratings : Protruding Object Height

Recommendation Up to 4.00 inches

Install wing walls or relocate object \$640

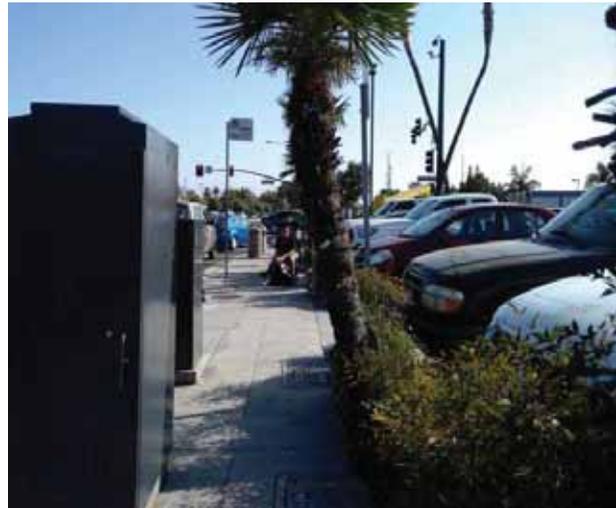
Sidewalks , Hazards & Gratings : Overhead Obstruction Height

Recommendation At least 80.00 inches

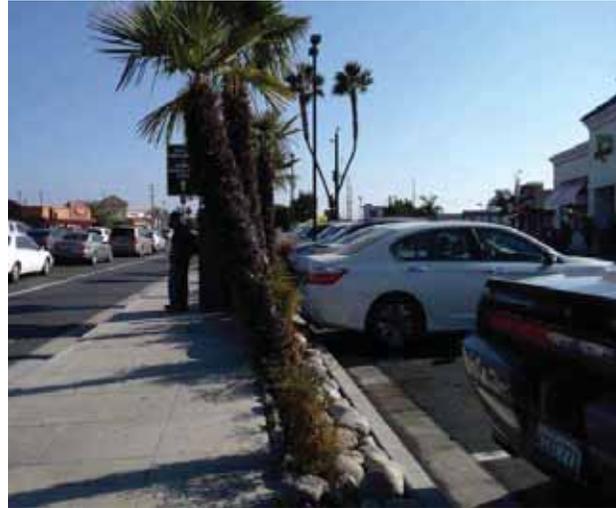
Sidewalks , Hazards & Gratings : Overhead Obstruction Height

Recommendation At least 80.00 inches

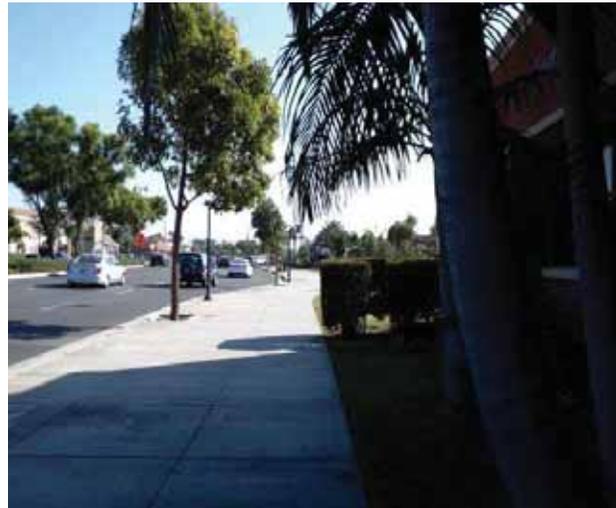
Sidewalks , Hazards & Gratings : Overhead Obstruction Height

Recommendation At least 80.00 inches

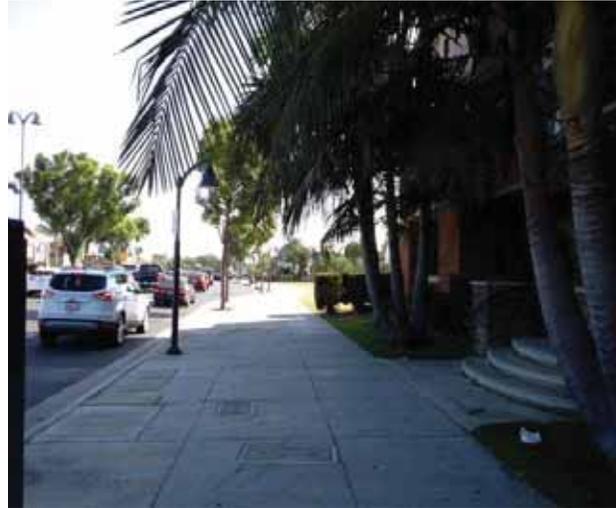
Sidewalks , Hazards & Gratings : Overhead Obstruction Height

Recommendation At least 80.00 inches

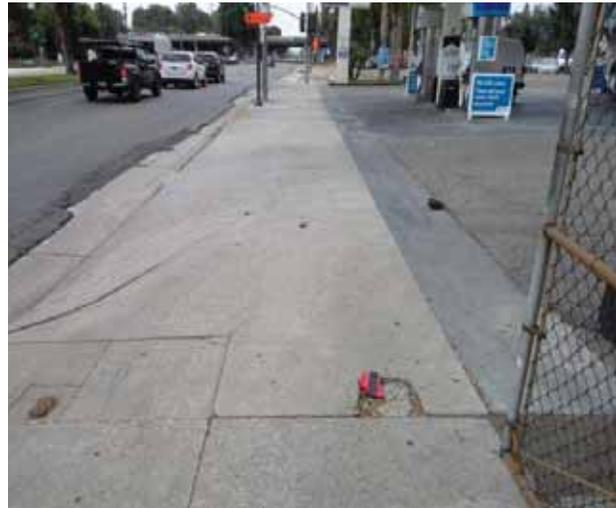
There is a change in elevation greater than recommended value.

Ensure that the change in elevation is within the recommended value.

Recommendation Up to 0.25 inches

Remove tripping hazards \$198

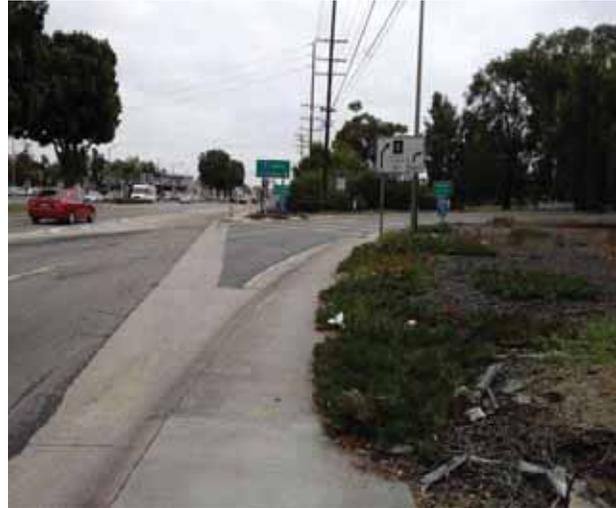
Sidewalks , Hazards & Gratings : Sidewalk Width at Obstruction

Sidewalk width at the obstruction shall have the recommended value.

Recommendation At least 48.00 inches

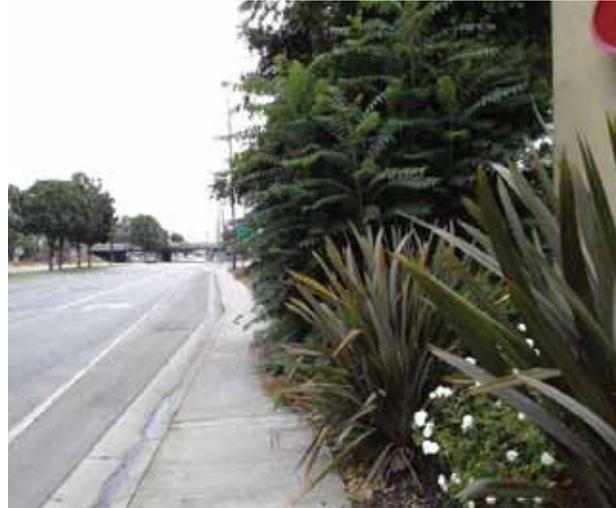
Sidewalks , Hazards & Gratings : Sidewalk Width at Obstruction

Sidewalk width at the obstruction shall have the recommended value.

Recommendation At least 48.00 inches
