Accessibility Survey

City of Downey Lakewood Boulevard & Columbia Way

Date of Inspection
5/25/2017

Disability Access Consultants

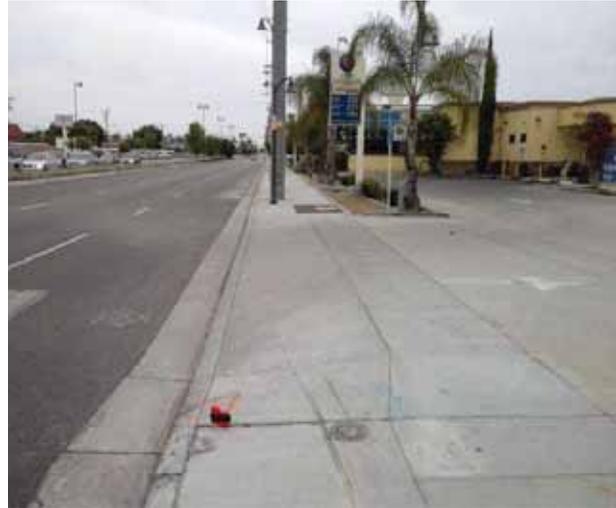
There is a change in elevation greater than recommended value.

Ensure that the change in elevation is within the recommended value.

Recommendation Up to 0.25 inches

Remove tripping hazards \$198

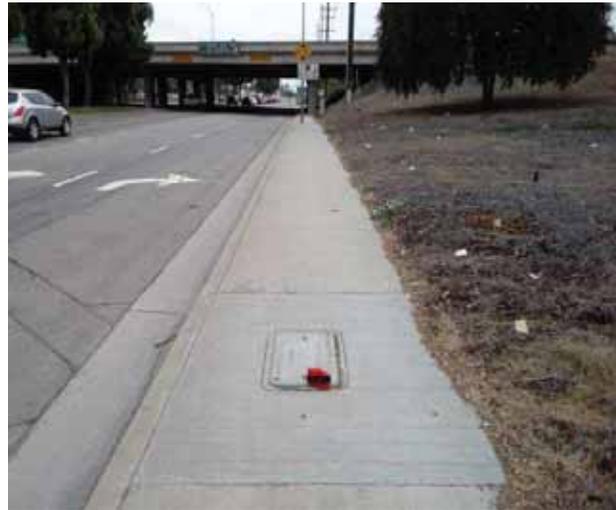
There is a change in elevation greater than recommended value.

Ensure that the change in elevation is within the recommended value.

Recommendation Up to 0.25 inches

Remove tripping hazards \$198

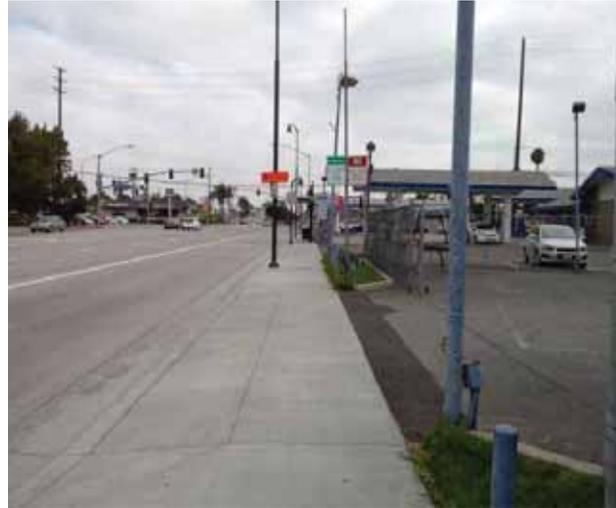
Code Reference ADA 705,CA 11B-705.1.2.5,CA 11B-247.1.2.5

Install compliant detectable warnings \$190

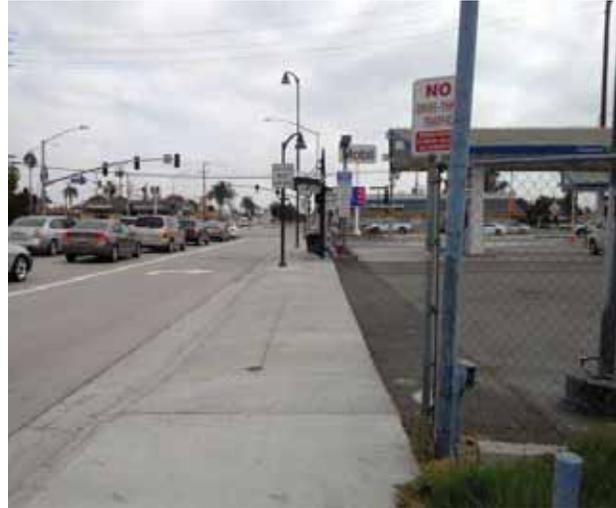
On-Site Finding Not Found

Code Reference ADA 705,CA 11B-705.1.2.5,CA 11B-247.1.2.5

Recommendation See Recommendation

Install compliant detectable warnings \$190

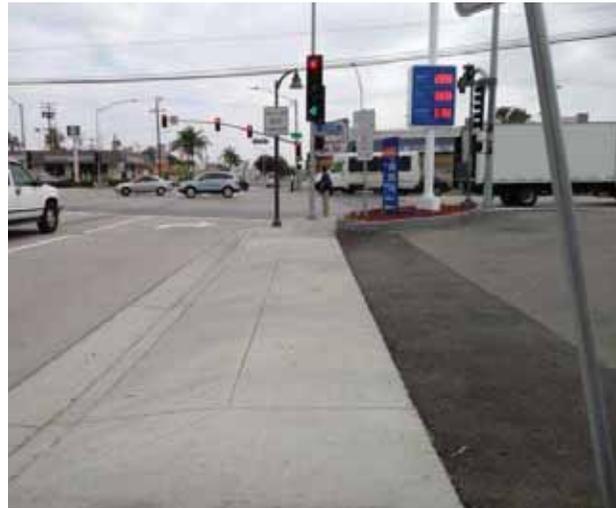
On-Site Finding Not Found

Code Reference ADA 705,CA 11B-705.1.2.5,CA 11B-247.1.2.5

Recommendation See Recommendation

Install compliant detectable warnings \$190

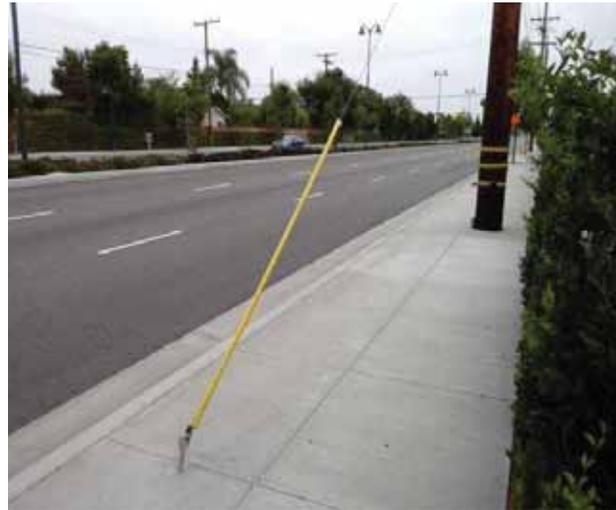
Sidewalks , Hazards & Gratings : Overhead Obstruction Height

Code Reference ADA 206, 307.4, CA 11B-307.4

Recommendation At least 80.00 inches

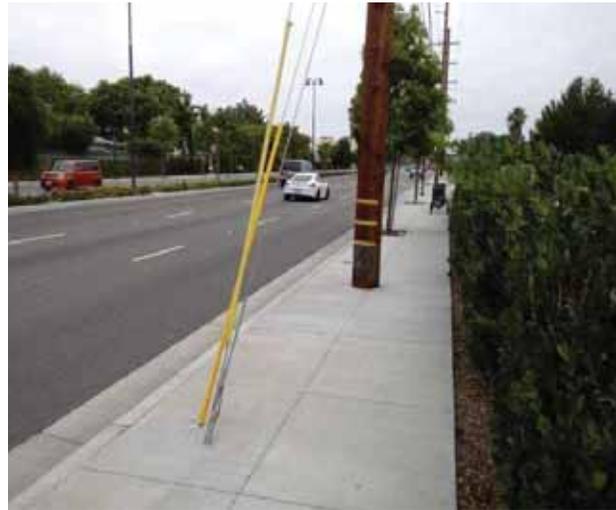
Sidewalks , Hazards & Gratings : Overhead Obstruction Height

Code Reference ADA 206, 307.4, CA 11B-307.4

Recommendation At least 80.00 inches

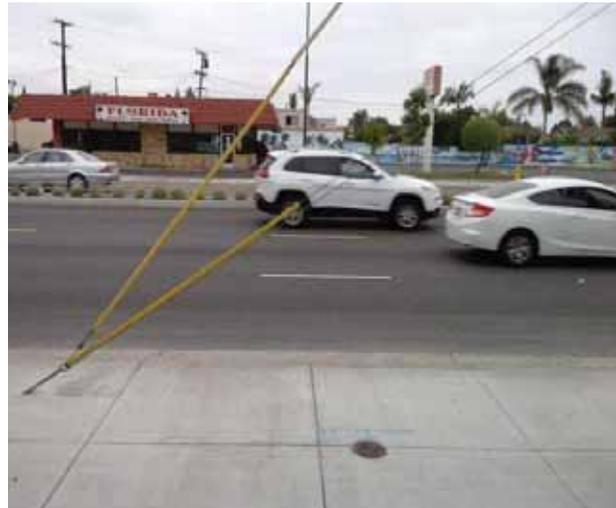
Sidewalks , Hazards & Gratings : Overhead Obstruction Height

Code Reference ADA 206, 307.4, CA 11B-307.4

Recommendation At least 80.00 inches

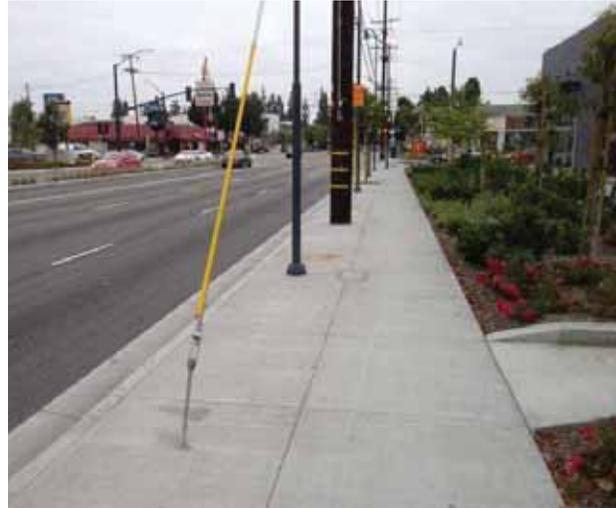
Sidewalks , Hazards & Gratings : Overhead Obstruction Height

Code Reference ADA 206, 307.4, CA 11B-307.4

Recommendation At least 80.00 inches

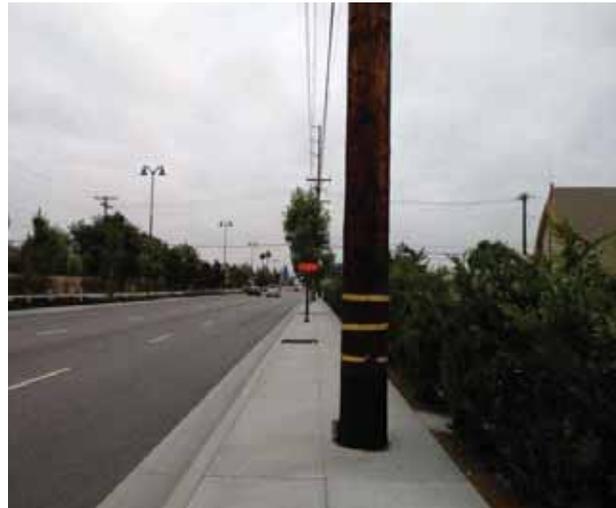
Sidewalks , Hazards & Gratings : Sidewalk Width at Obstruction

Code Reference ADA 206, 302, 403.5.1, CA 11B-403.5

Sidewalk width at the obstruction shall have the recommended value.

Recommendation At least 48.00 inches

\$1,260

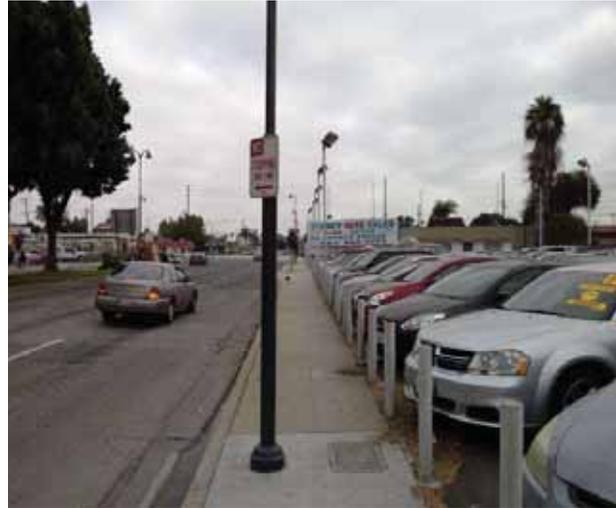
Sidewalks , Hazards & Gratings : Sidewalk Width at Obstruction

Code Reference ADA 206, 302, 403.5.1, CA 11B-403.5

Sidewalk width at the obstruction shall have the recommended value.

Recommendation At least 48.00 inches

\$1,260

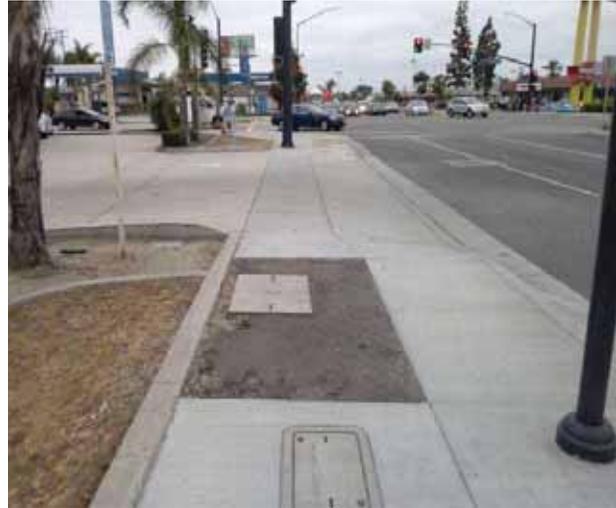
Sidewalks : Missing Sidewalk

Section of sidewalk is missing and consists of dirt, grass or gravel.

Code Reference ADA 206, 302,CA 11B-302,CA 11B-206

Provide a compliant sidewalk for the missing section.

\$1,260

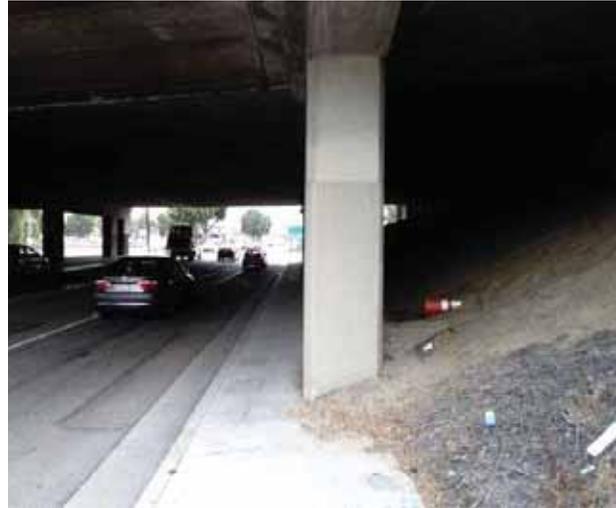
Code Reference ADA 206, 302, CA 11B-403.5.1

Widen the sidewalk to the recommended value.

Recommendation At least 48.00 inches

\$1,260

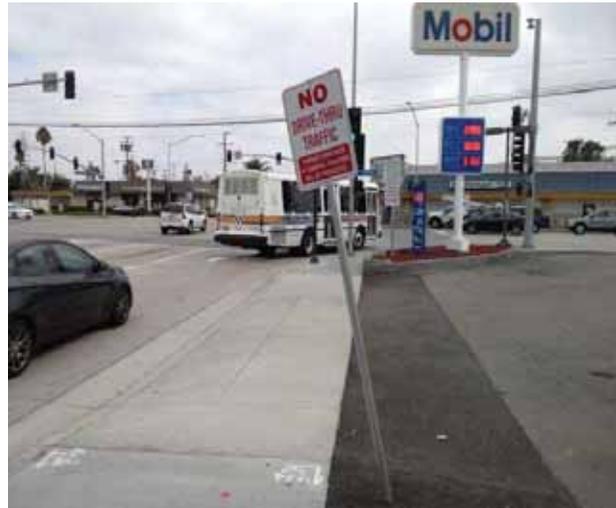
Sidewalks , Hazards & Gratings : Overhead Obstruction Height

Code Reference ADA 206, 307.4, CA 11B-307.4

Recommendation At least 80.00 inches

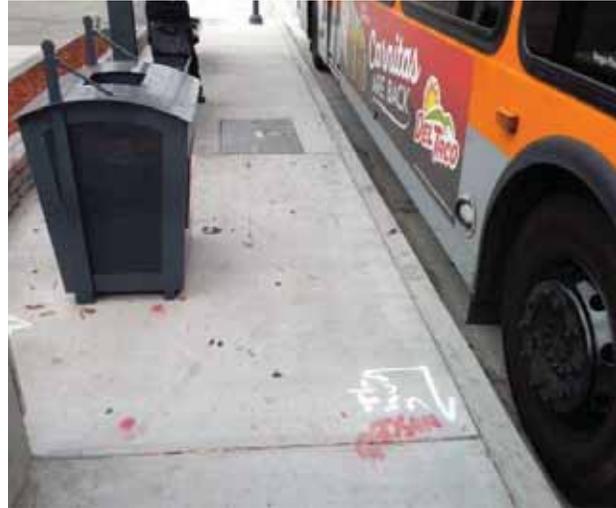
Sidewalks , Hazards & Gratings : Sidewalk Width at Obstruction

Code Reference ADA 206, 302, 403.5.1, CA 11B-403.5

Sidewalk width at the obstruction shall have the recommended value.

Recommendation At least 48.00 inches

\$1,260

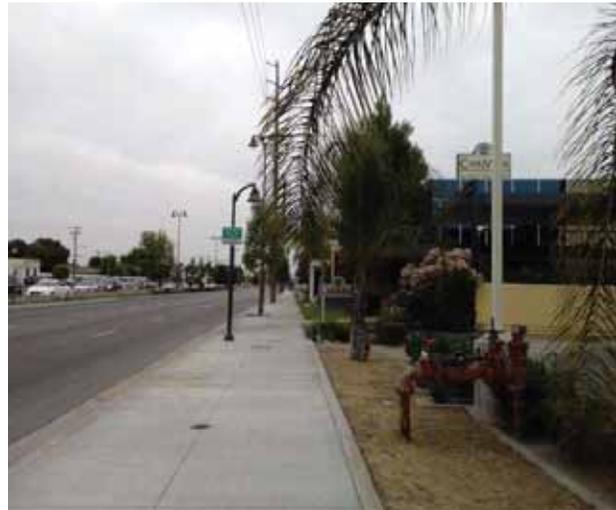
Sidewalks , Hazards & Gratings : Overhead Obstruction Height

Code Reference ADA 206, 307.4, CA 11B-307.4

Recommendation At least 80.00 inches

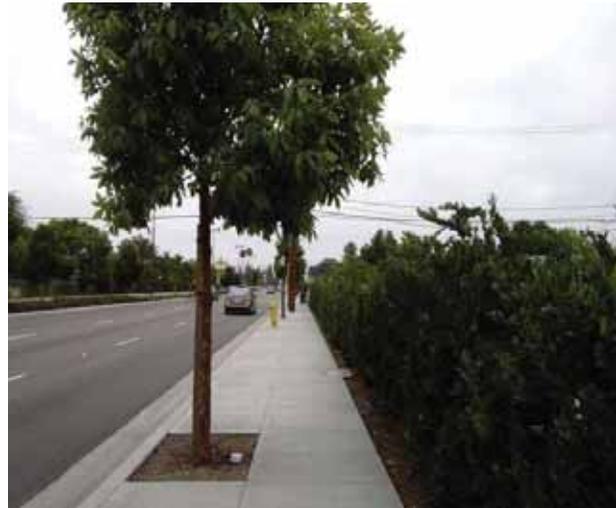
Sidewalks , Hazards & Gratings : Overhead Obstruction Height

Code Reference ADA 206, 307.4, CA 11B-307.4

Recommendation At least 80.00 inches

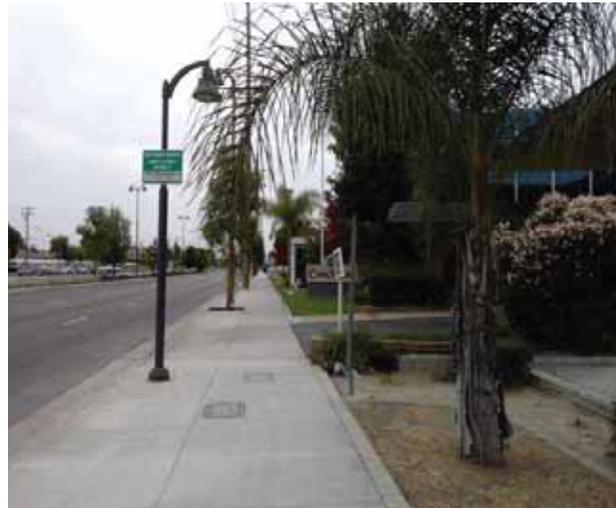
Sidewalks , Hazards & Gratings : Overhead Obstruction Height

Code Reference ADA 206, 307.4, CA 11B-307.4

Recommendation At least 80.00 inches

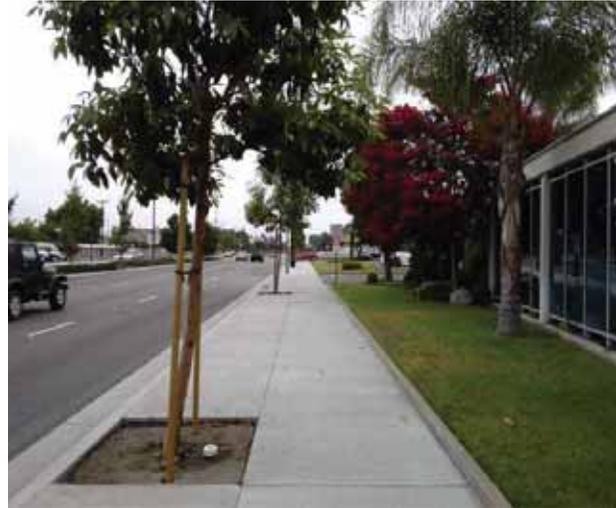
There is a change in elevation greater than recommended value.

Code Reference ADA 206, 302

Ensure that the change in elevation is within the recommended value.

Recommendation Up to 0.25 inches

Remove tripping hazards \$198

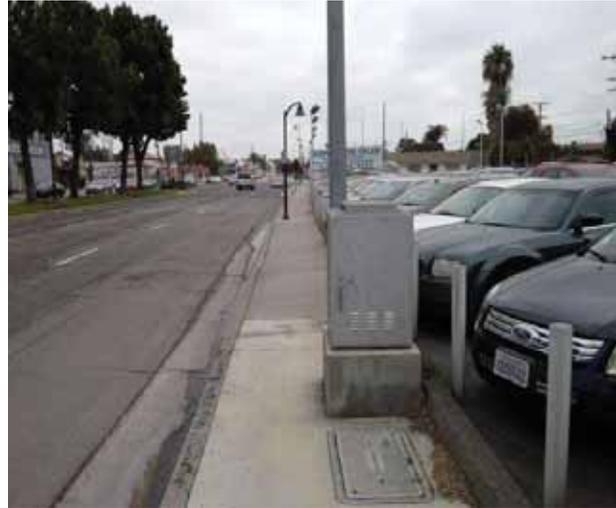
Sidewalks , Hazards & Gratings : Sidewalk Width at Obstruction

Code Reference ADA 206, 302, 403.5.1, CA 11B-403.5

Sidewalk width at the obstruction shall have the recommended value.

Recommendation At least 48.00 inches

\$1,260

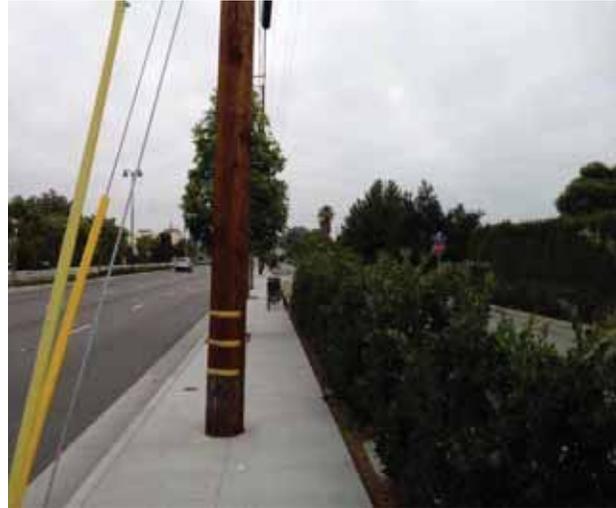
Sidewalks , Hazards & Gratings : Sidewalk Width at Obstruction

Code Reference ADA 206, 302, 403.5.1, CA 11B-403.5

Sidewalk width at the obstruction shall have the recommended value.

Recommendation At least 48.00 inches

\$1,260

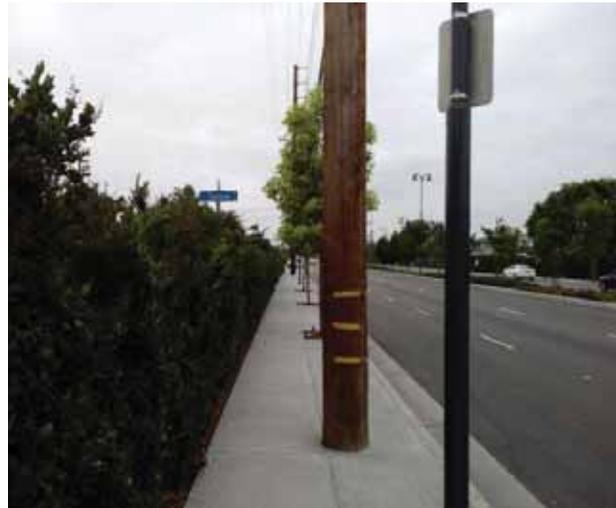
Sidewalks , Hazards & Gratings : Sidewalk Width at Obstruction

Code Reference ADA 206, 302, 403.5.1, CA 11B-403.5

Sidewalk width at the obstruction shall have the recommended value.

Recommendation At least 48.00 inches

\$1,260

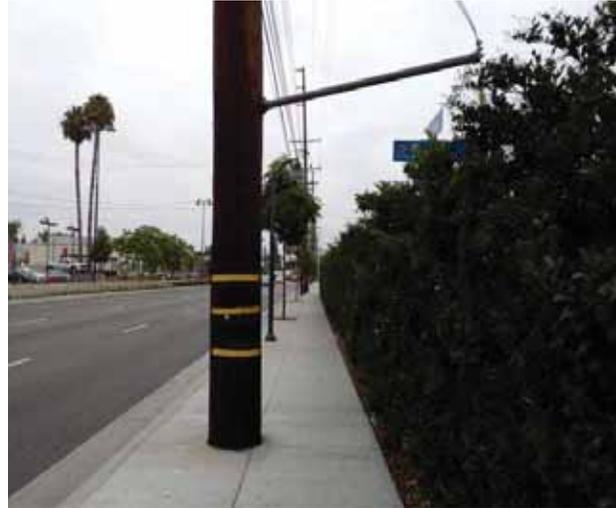
Sidewalks , Hazards & Gratings : Sidewalk Width at Obstruction

Code Reference ADA 206, 302, 403.5.1, CA 11B-403.5

Sidewalk width at the obstruction shall have the recommended value.

Recommendation At least 48.00 inches

\$1,260

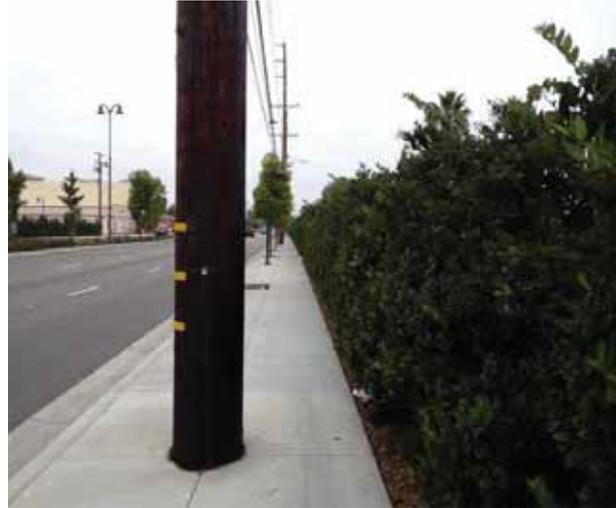
Sidewalks , Hazards & Gratings : Sidewalk Width at Obstruction

Code Reference ADA 206, 302, 403.5.1,CA 11B-403.5

Sidewalk width at the obstruction shall have the recommended value.

Recommendation At least 48.00 inches

\$1,260

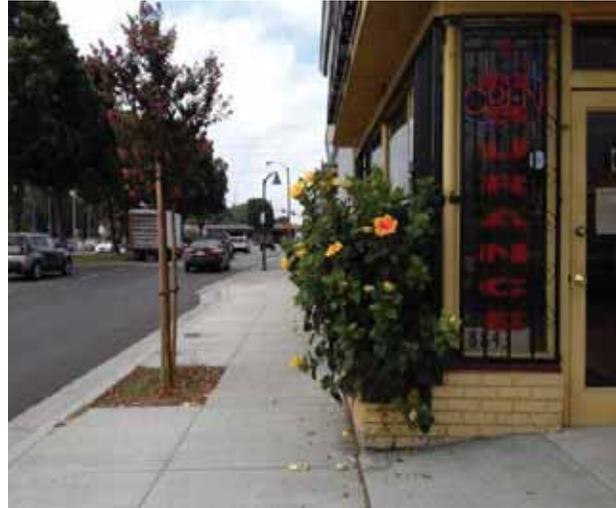
Sidewalks , Hazards & Gratings : Sidewalk Width at Obstruction

Code Reference ADA 206, 302, 403.5.1, CA 11B-403.5

Sidewalk width at the obstruction shall have the recommended value.

Recommendation At least 48.00 inches

\$1,260

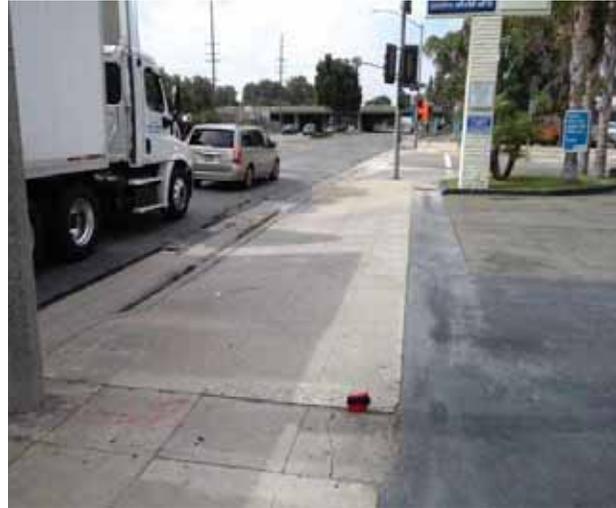
There is a change in elevation greater than recommended value.

Code Reference ADA 206, 302

Ensure that the change in elevation is within the recommended value.

Recommendation Up to 0.25 inches

Remove tripping hazards \$198

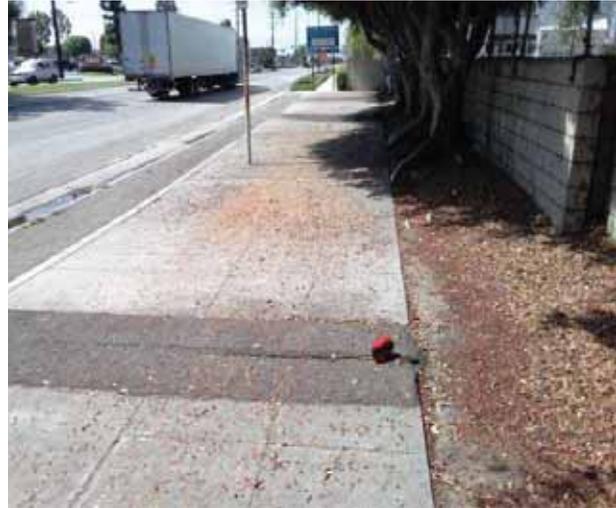
There is a change in elevation greater than recommended value.

Code Reference ADA 206, 302

Ensure that the change in elevation is within the recommended value.

Recommendation Up to 0.25 inches

Remove tripping hazards \$198

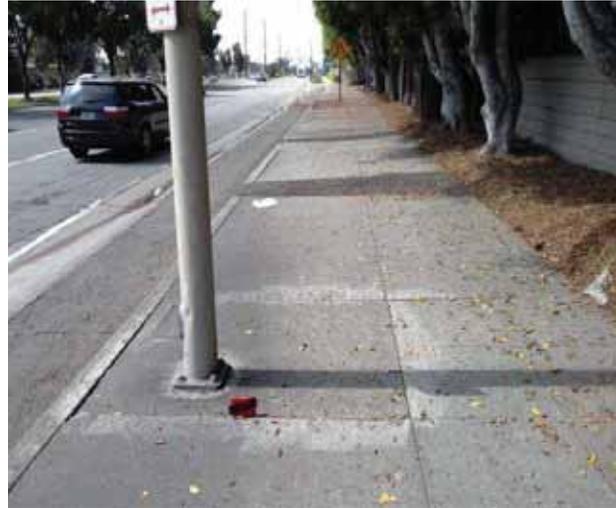
There is a change in elevation greater than recommended value.

Code Reference ADA 206, 302

Ensure that the change in elevation is within the recommended value.

Recommendation Up to 0.25 inches

Remove tripping hazards \$198

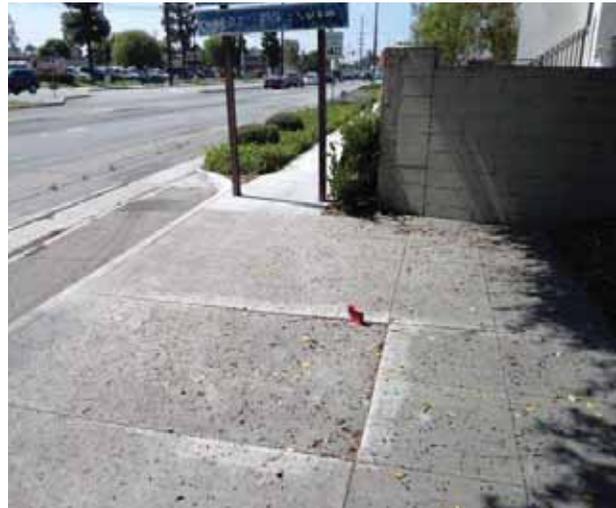
There is a change in elevation greater than recommended value.

Code Reference ADA 206, 302

Recommendation Up to 0.50 inches

Remove tripping hazards \$198

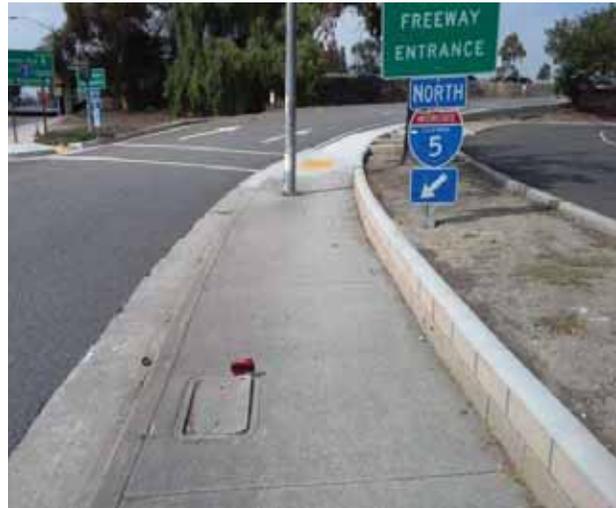
There is a change in elevation greater than recommended value.

Code Reference ADA 206, 302

Ensure that the change in elevation is within the recommended value.

Recommendation Up to 0.25 inches

Remove tripping hazards \$198

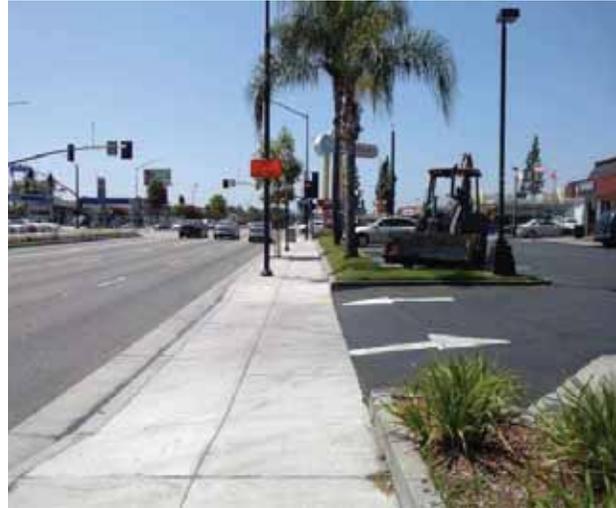
Code Reference ADA 705,CA 11B-705.1.2.5,CA 11B-247.1.2.5

Install compliant detectable warnings \$190

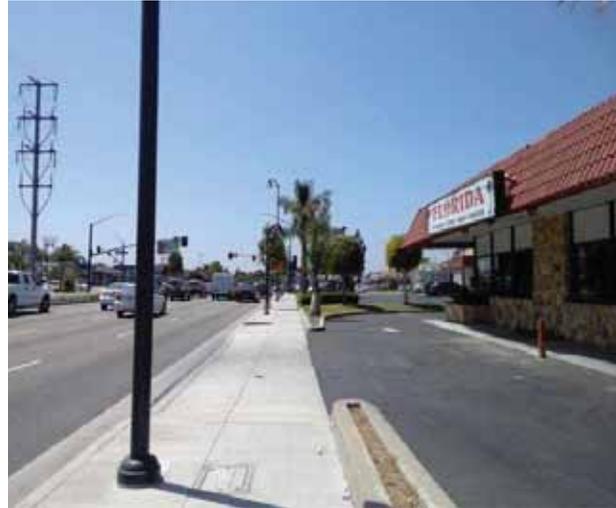
Code Reference ADA 705,CA 11B-705.1.2.5,CA 11B-247.1.2.5

Install compliant detectable warnings \$190

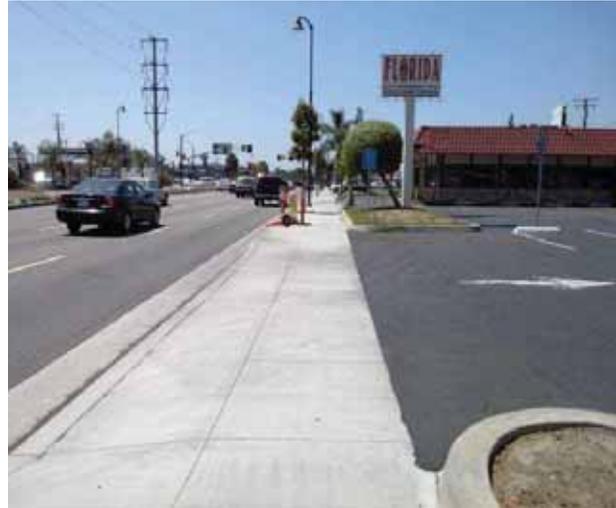
Code Reference ADA 705,CA 11B-705.1.2.5,CA 11B-247.1.2.5

Install compliant detectable warnings \$190

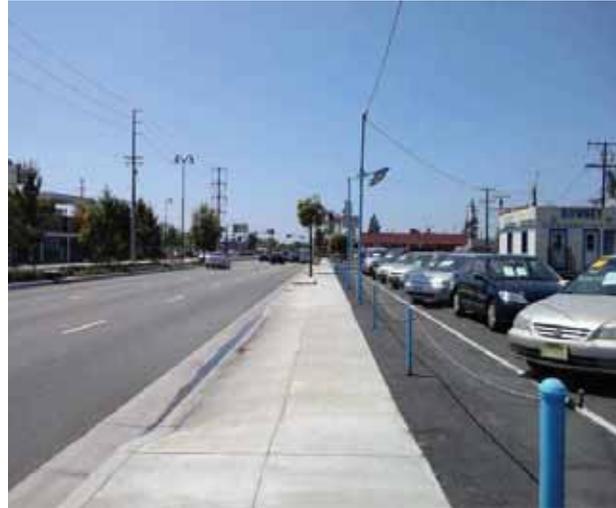
Code Reference ADA 705,CA 11B-705.1.2.5,CA 11B-247.1.2.5

Install compliant detectable warnings \$190

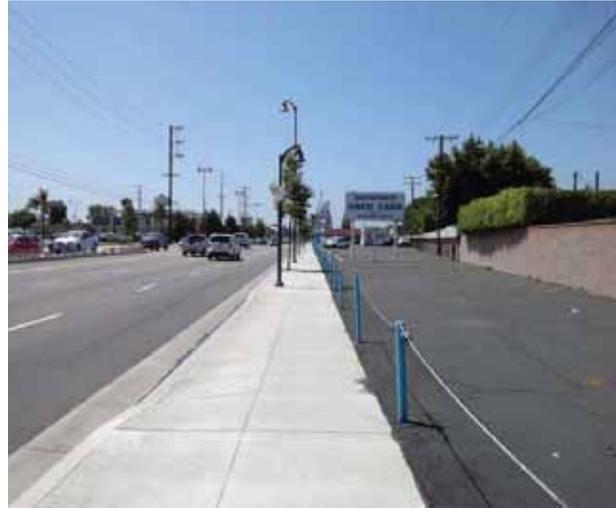
Code Reference ADA 705,CA 11B-705.1.2.5,CA 11B-247.1.2.5

Install compliant detectable warnings \$190

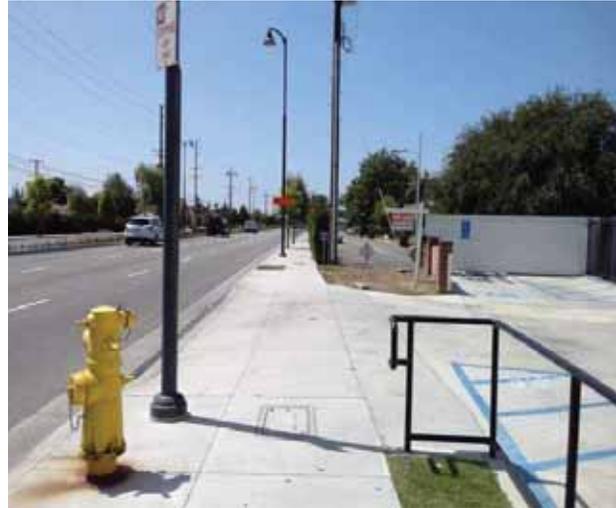
Code Reference ADA 705,CA 11B-705.1.2.5,CA 11B-247.1.2.5

Install compliant detectable warnings \$190

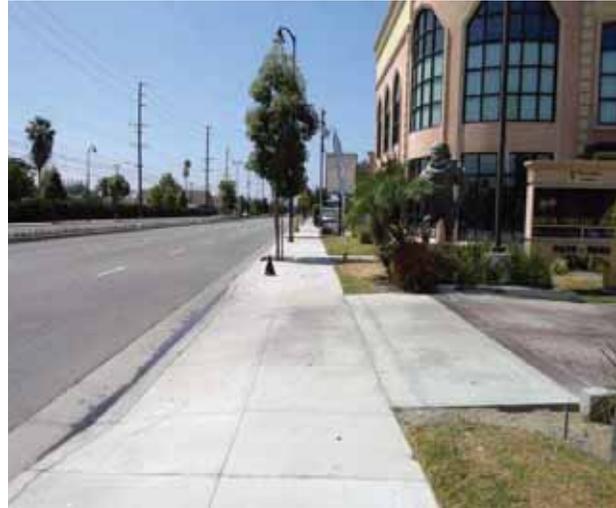
Code Reference ADA 705,CA 11B-705.1.2.5,CA 11B-247.1.2.5

Install compliant detectable warnings \$190

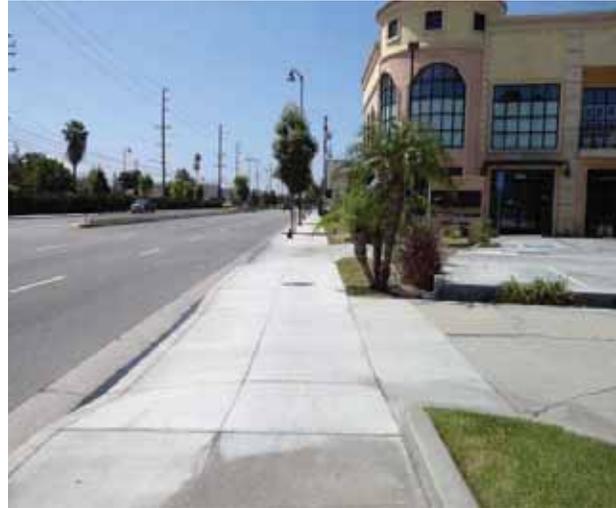
Code Reference ADA 705,CA 11B-705.1.2.5,CA 11B-247.1.2.5

Install compliant detectable warnings \$190

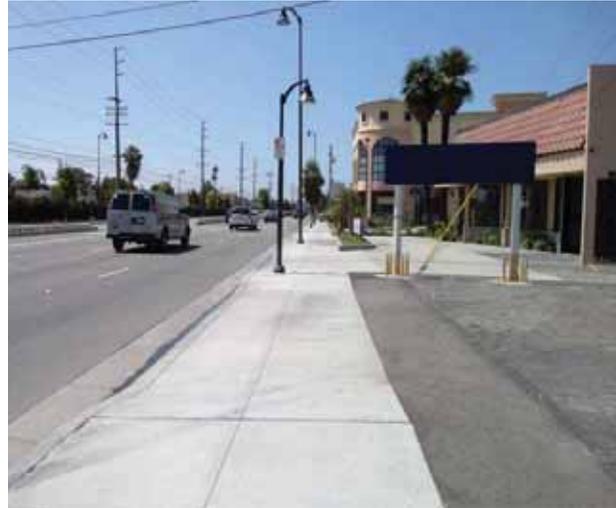
Code Reference ADA 705,CA 11B-705.1.2.5,CA 11B-247.1.2.5

Install compliant detectable warnings \$190

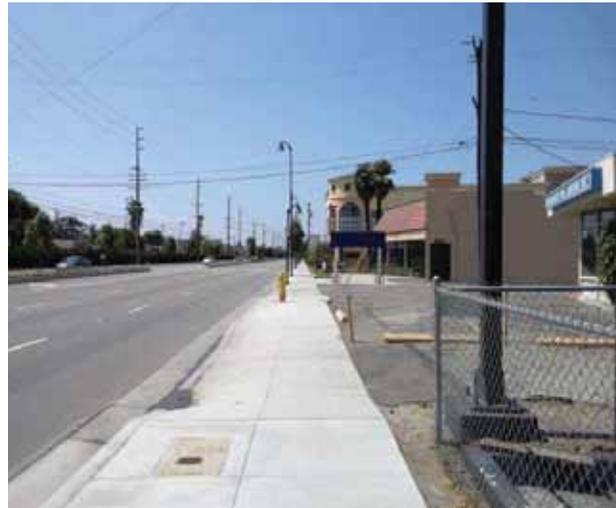
Code Reference ADA 705,CA 11B-705.1.2.5,CA 11B-247.1.2.5

Install compliant detectable warnings \$190

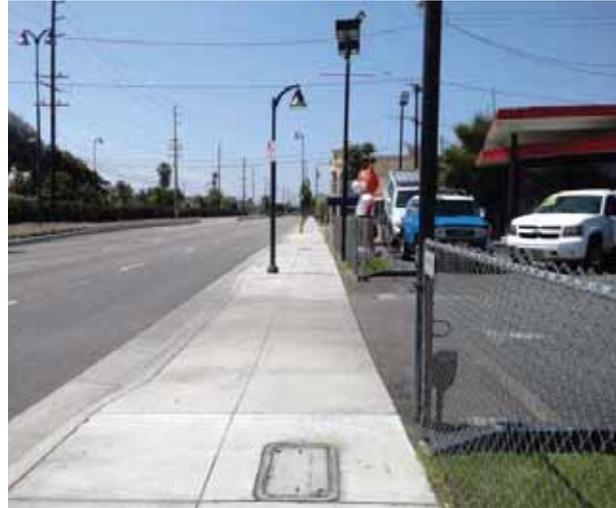
Code Reference ADA 705,CA 11B-705.1.2.5,CA 11B-247.1.2.5

Install compliant detectable warnings \$190

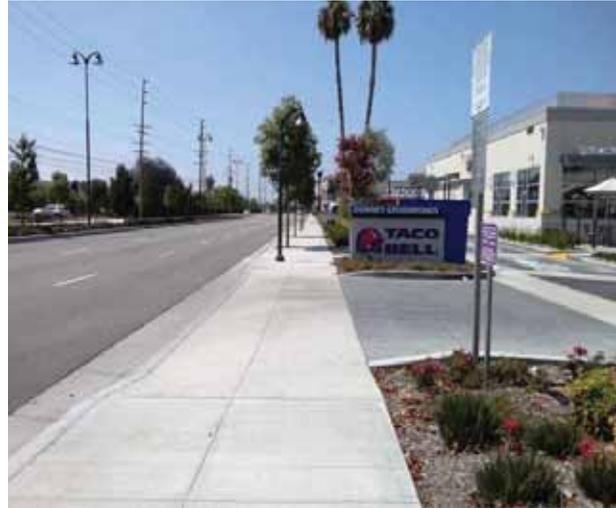
On-Site Finding Not Found

Install compliant detectable warnings \$190

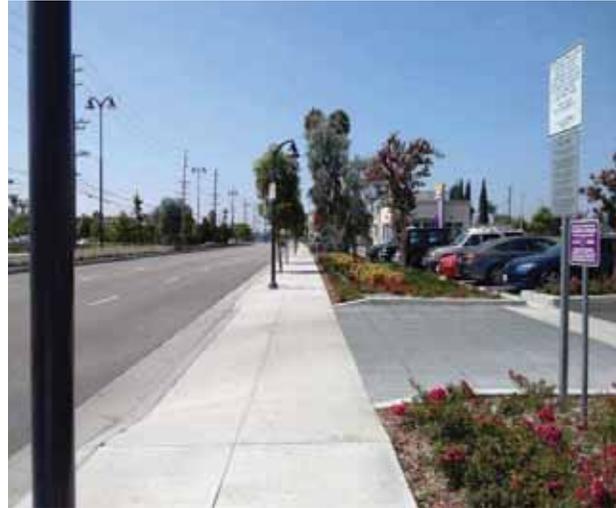
On-Site Finding Not Found

Install compliant detectable warnings \$190

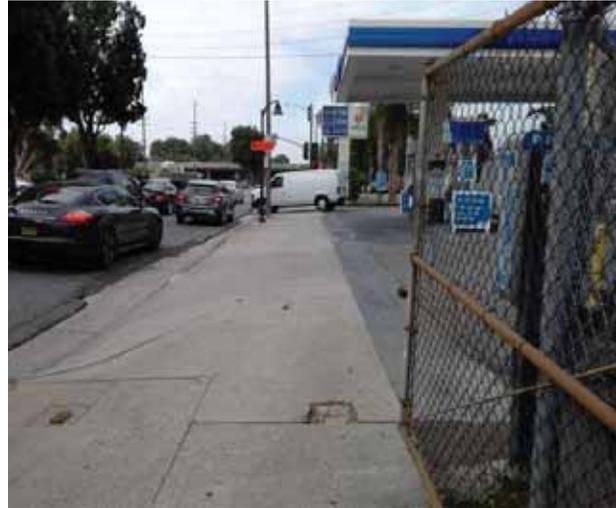
On-Site Finding Not Found

Install compliant detectable warnings \$190

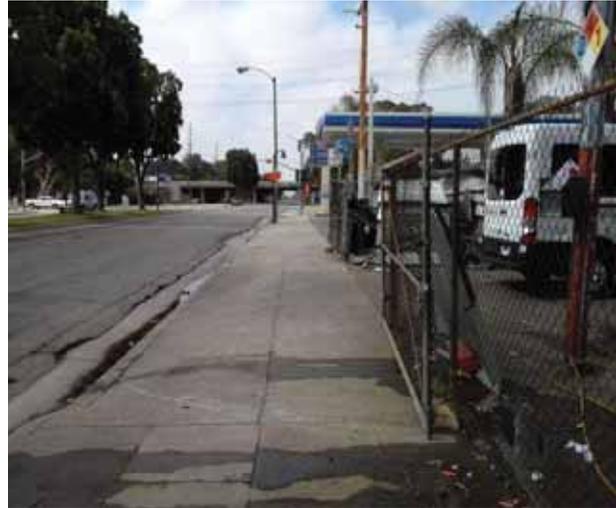
On-Site Finding Not Found

Install compliant detectable warnings \$190

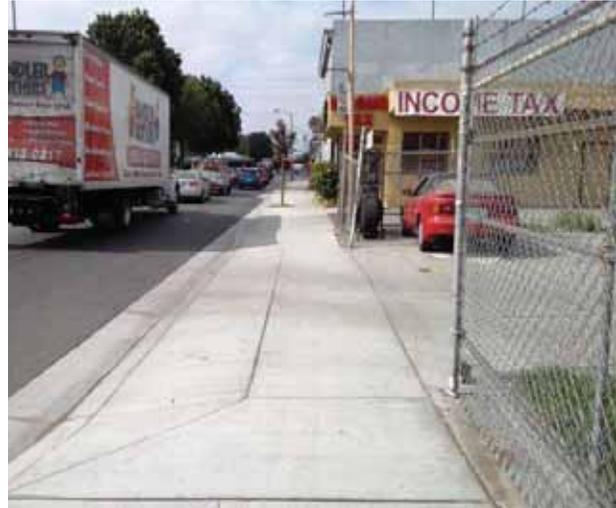
On-Site Finding Not Found

Install compliant detectable warnings \$190

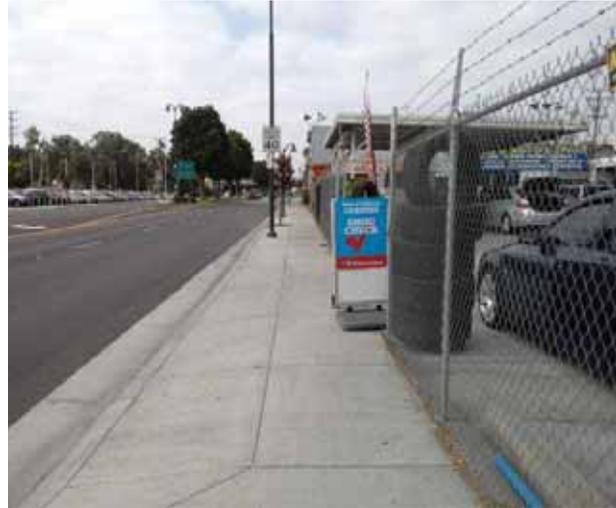
On-Site Finding Not Found

Install compliant detectable warnings \$190

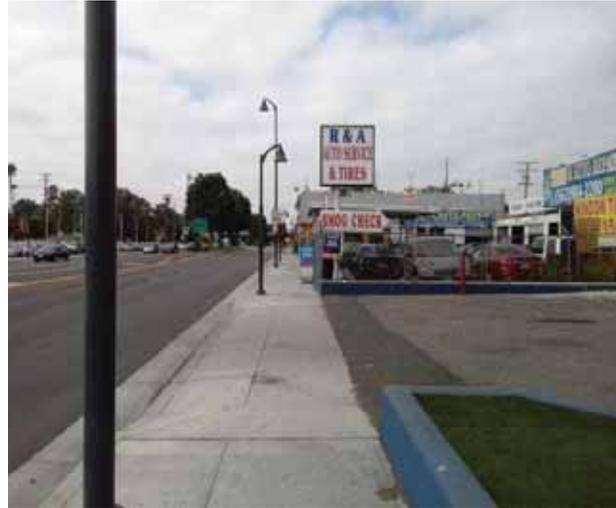
On-Site Finding Not Found

Install compliant detectable warnings \$190

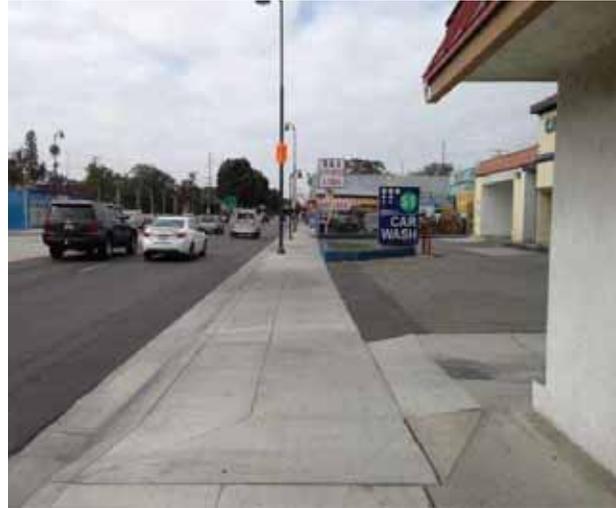
On-Site Finding Not Found

Install compliant detectable warnings \$190

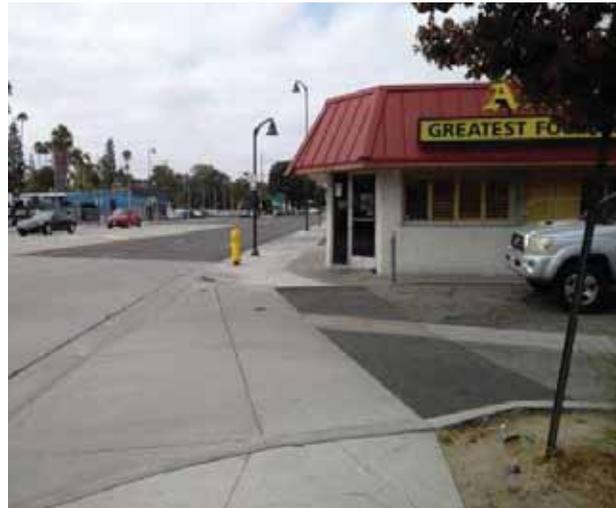
On-Site Finding Not Found

Install compliant detectable warnings \$190

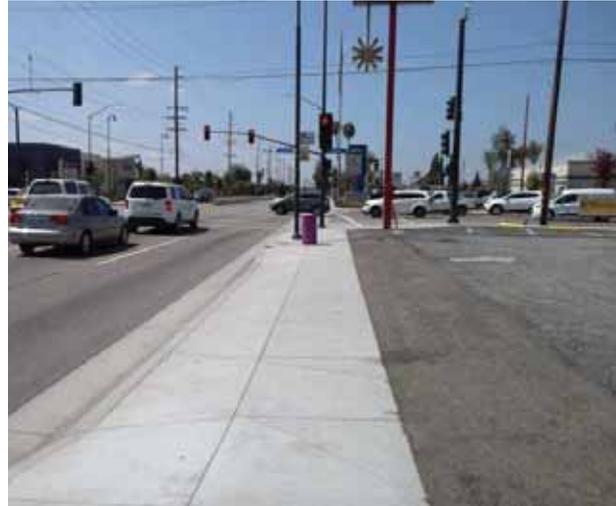
On-Site Finding Not Found

Install compliant detectable warnings \$190

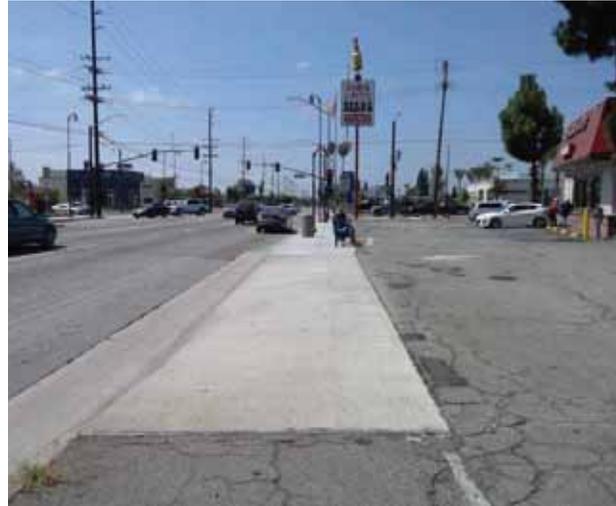
On-Site Finding Not Found

Install compliant detectable warnings \$190

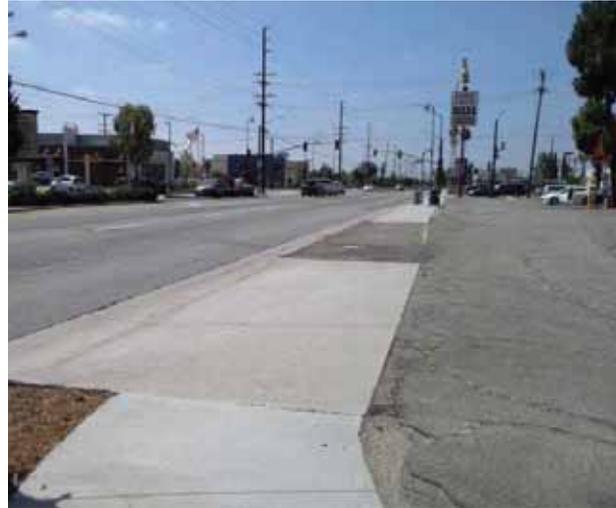
On-Site Finding Not Found

Install compliant detectable warnings \$190

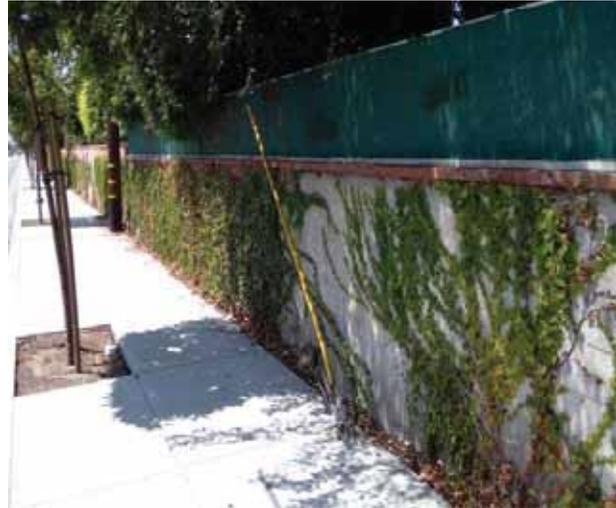
Sidewalks , Hazards & Gratings : Overhead Obstruction Height

Recommendation At least 80.00 inches

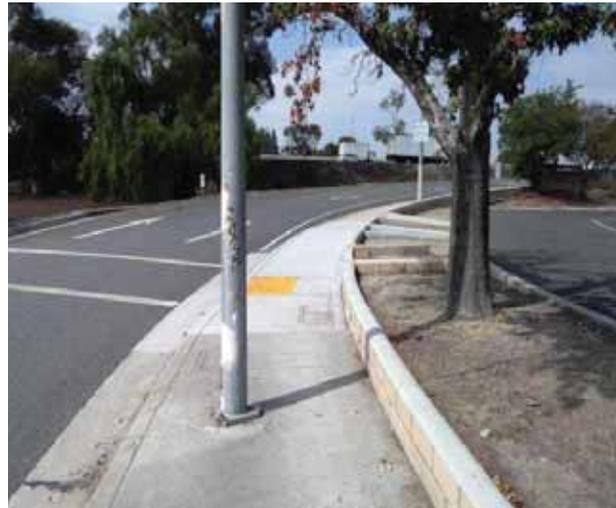
Sidewalks , Hazards & Gratings : Sidewalk Width at Obstruction

Sidewalk width at the obstruction shall have the recommended value.

Recommendation At least 48.00 inches

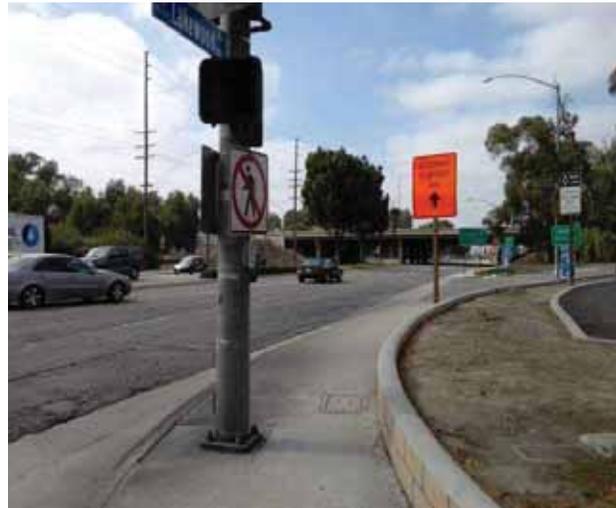
Sidewalks , Hazards & Gratings : Sidewalk Width at Obstruction

Sidewalk width at the obstruction shall have the recommended value.

Recommendation At least 48.00 inches

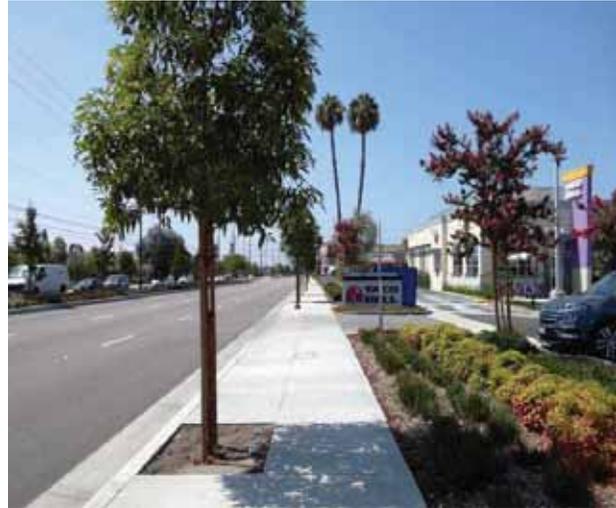
Sidewalks , Hazards & Gratings : Overhead Obstruction Height

Recommendation At least 80.00 inches

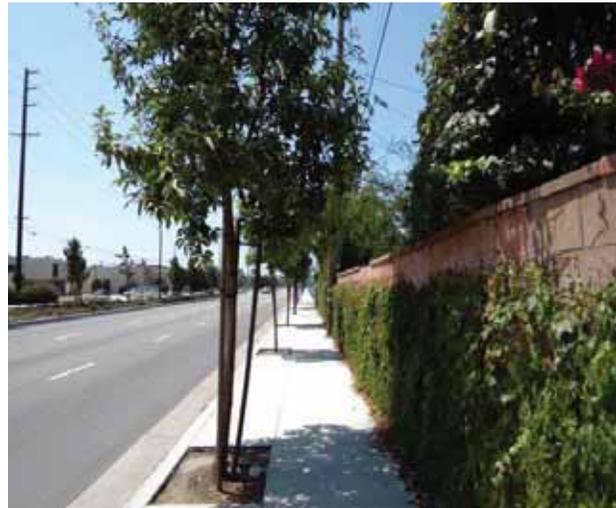
Sidewalks , Hazards & Gratings : Overhead Obstruction Height

Recommendation At least 80.00 inches

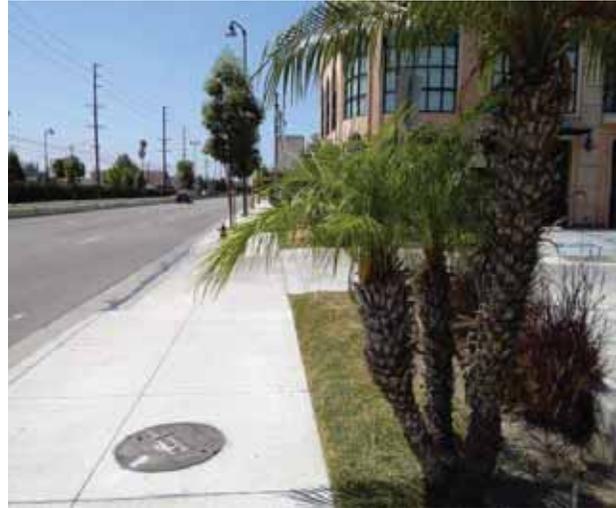
Sidewalks , Hazards & Gratings : Protruding Object Height

Recommendation Up to 4.00 inches

Install wing walls or relocate object \$640

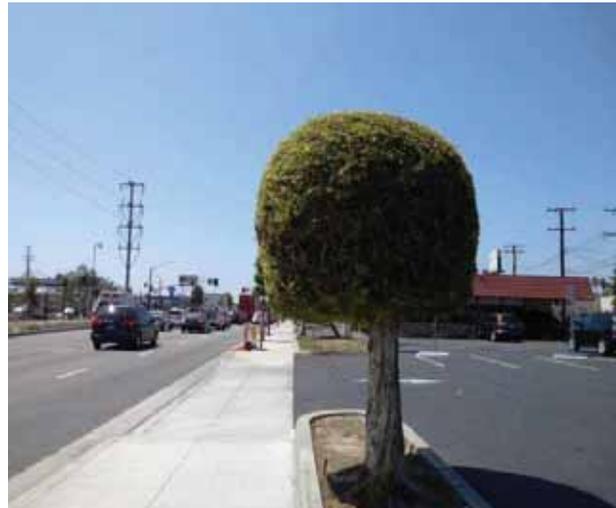
Sidewalks , Hazards & Gratings : Overhead Obstruction Height

Recommendation At least 80.00 inches

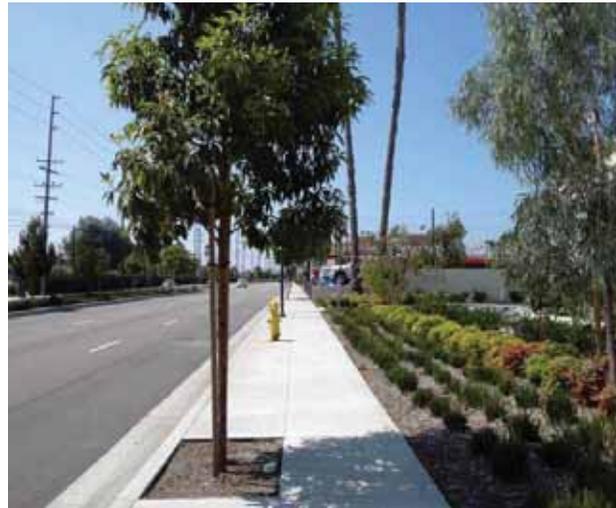
Sidewalks , Hazards & Gratings : Overhead Obstruction Height

Recommendation At least 80.00 inches

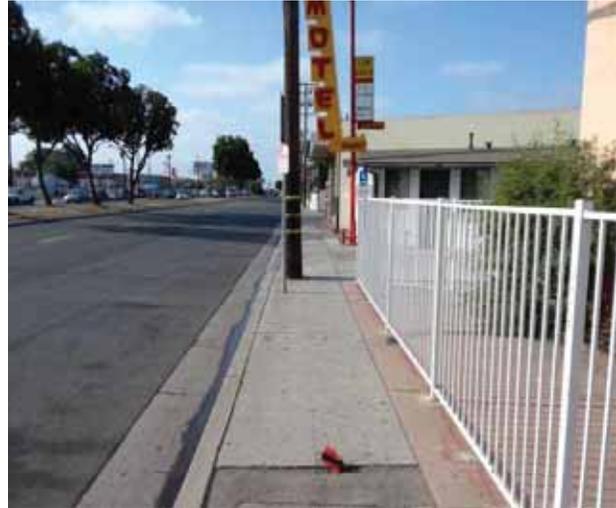
There is a change in elevation greater than recommended value.

Ensure that the change in elevation is within the recommended value.

Remove tripping hazards \$198

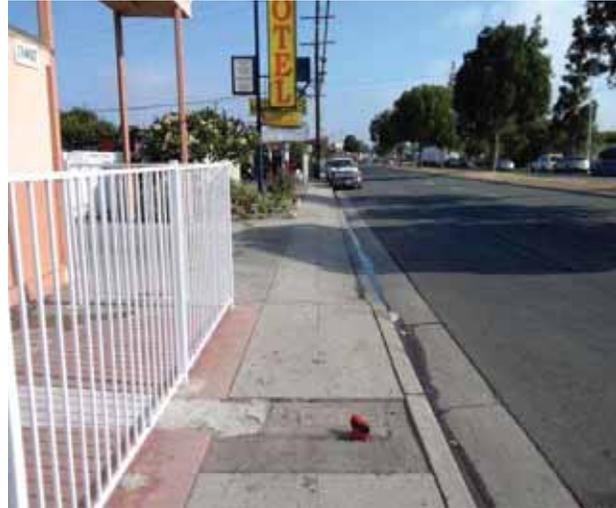
There is a change in elevation greater than recommended value.

Ensure that the change in elevation is within the recommended value.

Remove tripping hazards \$198

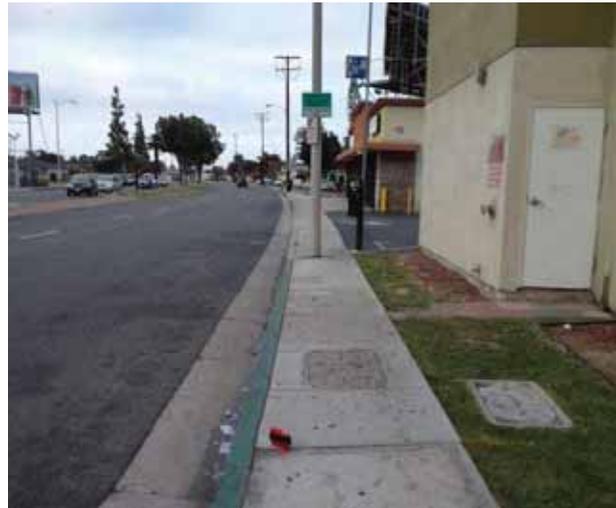
There is a change in elevation greater than recommended value.

Ensure that the change in elevation is within the recommended value.

Remove tripping hazards \$198

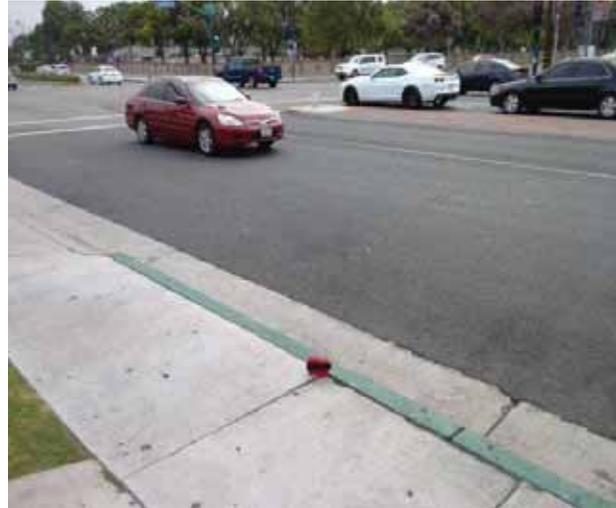
There is a change in elevation greater than recommended value.

Ensure that the change in elevation is within the recommended value.

Remove tripping hazards \$198
