Accessibility Survey

City of Downey Lakewood Boulevard & Columbia Way

Date of Inspection
5/25/2017

Disability Access Consultants

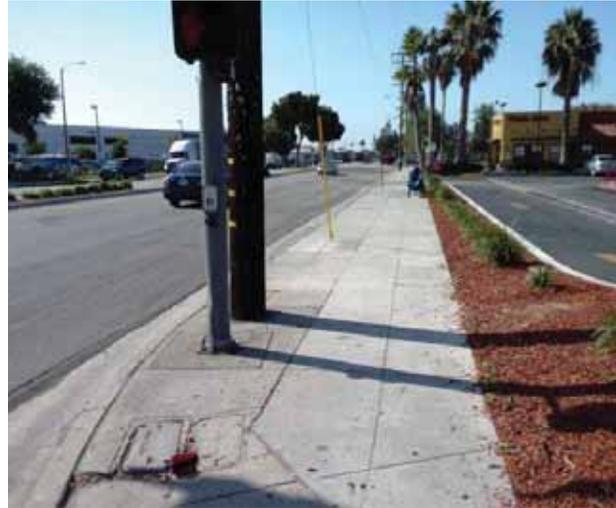
There is a change in elevation greater than recommended value.

Ensure that the change in elevation is within the recommended value.

Remove tripping hazards \$198

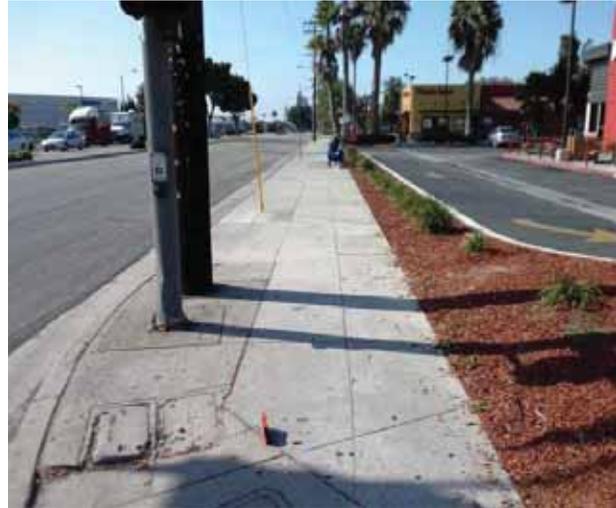
There is a change in elevation greater than recommended value.

Ensure that the change in elevation is within the recommended value.

Remove tripping hazards \$198

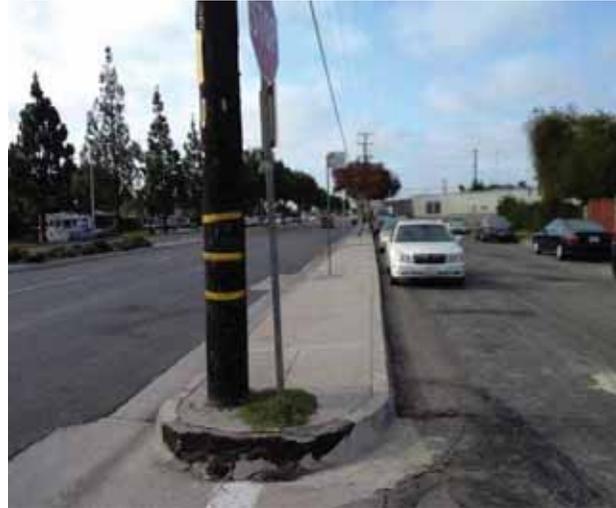
Sidewalks , Hazards & Gratings : Curb is on Path of Travel

Install curb ramp \$2,500

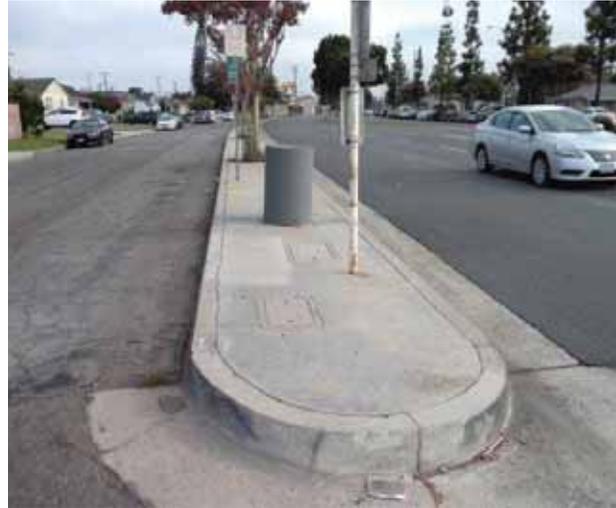
Sidewalks , Hazards & Gratings : Curb is on Path of Travel

Install curb ramp \$2,500

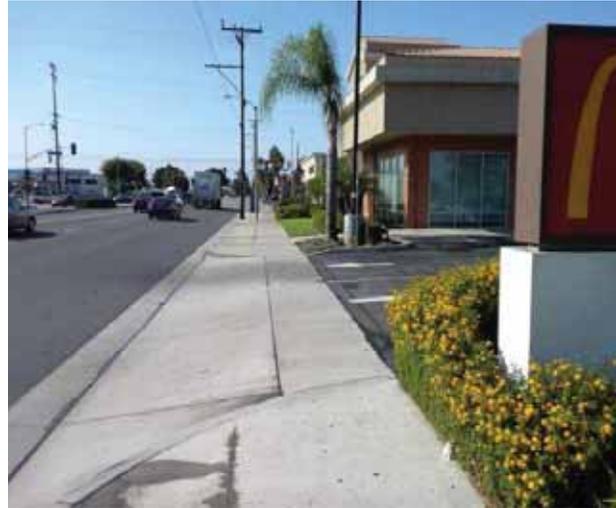
On-Site Finding Not Found

Install compliant detectable warnings \$190

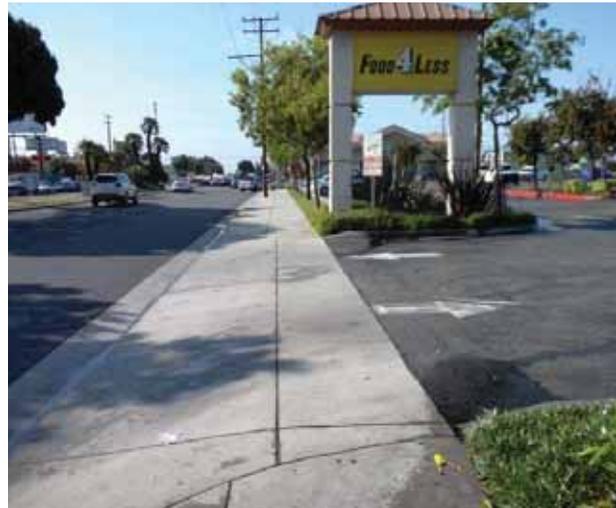
Code Reference ADA 705,CA 11B-705.1.2.5,CA 11B-247.1.2.5

Install compliant detectable warnings \$190

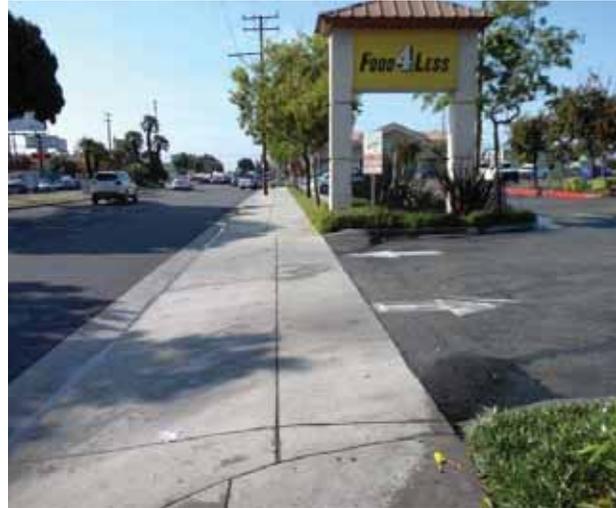
Recommendation Up to 2.08 percent

Code Reference ADA 206, 302, CA 11B-403.3

Repave surface \$1,092

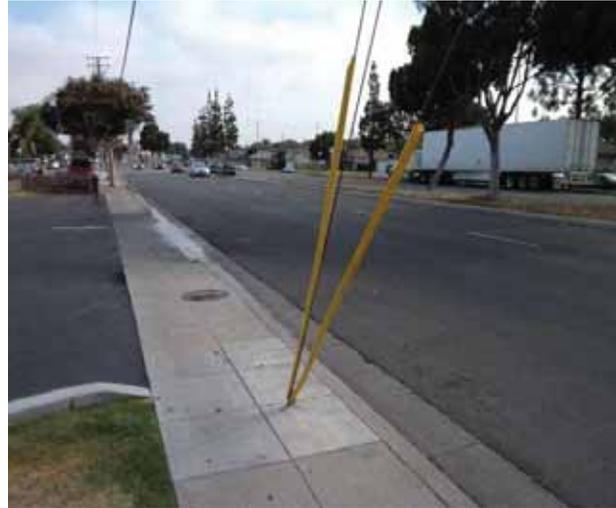
Sidewalks , Hazards & Gratings : Sidewalk Width at Obstruction

Code Reference ADA 206, 302, 403.5.1, CA 11B-403.5

Sidewalk width at the obstruction shall have the recommended value.

Recommendation At least 48.00 inches

\$1,260

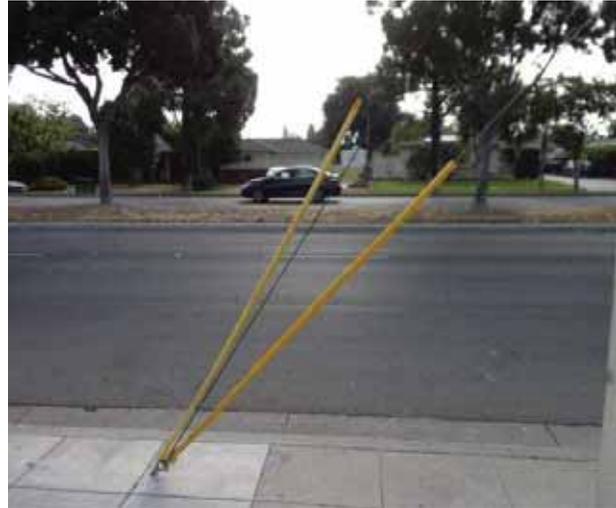
Sidewalks , Hazards & Gratings : Overhead Obstruction Height

Code Reference ADA 206, 307.4, CA 11B-307.4

Recommendation At least 80.00 inches

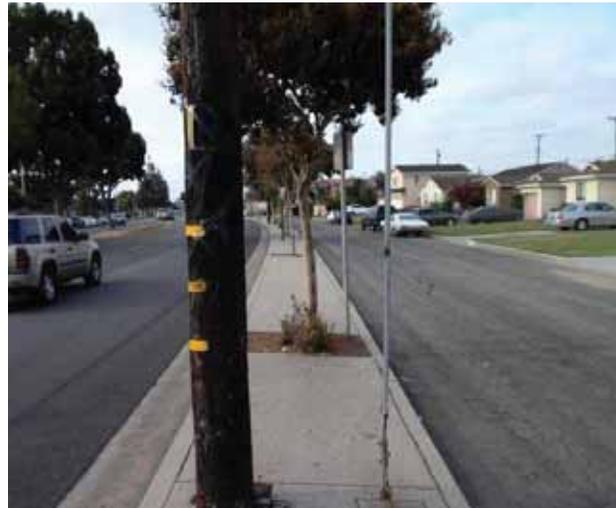
Sidewalks , Hazards & Gratings : Sidewalk Width at Obstruction

Code Reference ADA 206, 302, 403.5.1,CA 11B-403.5

Sidewalk width at the obstruction shall have the recommended value.

Recommendation At least 48.00 inches

\$1,260

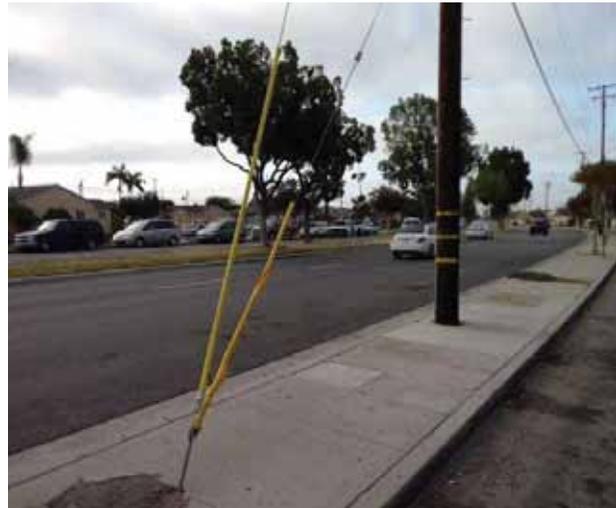
Sidewalks , Hazards & Gratings : Overhead Obstruction Height

Code Reference ADA 206, 307.4, CA 11B-307.4

Recommendation At least 80.00 inches

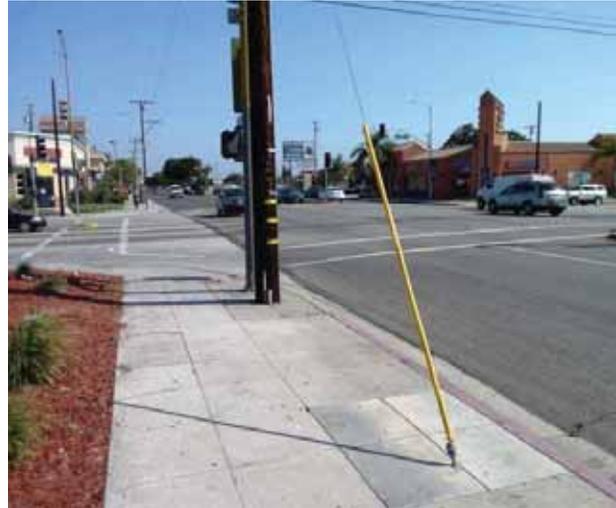
Sidewalks , Hazards & Gratings : Overhead Obstruction Height

Code Reference ADA 206, 307.4, CA 11B-307.4

Recommendation At least 80.00 inches

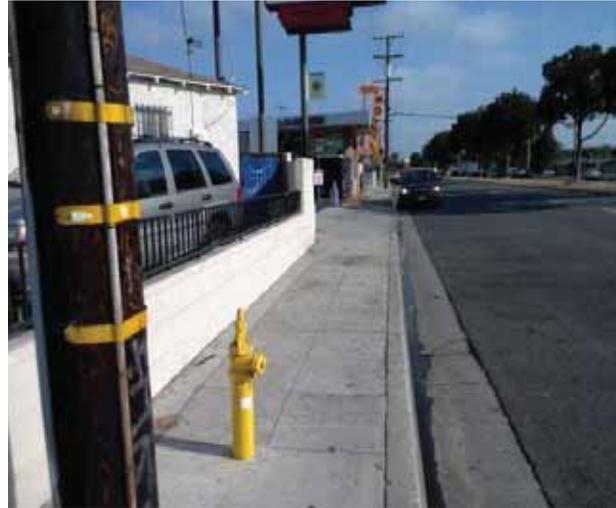
Sidewalks , Hazards & Gratings : Sidewalk Width at Obstruction

Code Reference ADA 206, 302, 403.5.1,CA 11B-403.5

Sidewalk width at the obstruction shall have the recommended value.

Recommendation At least 48.00 inches

\$1,260

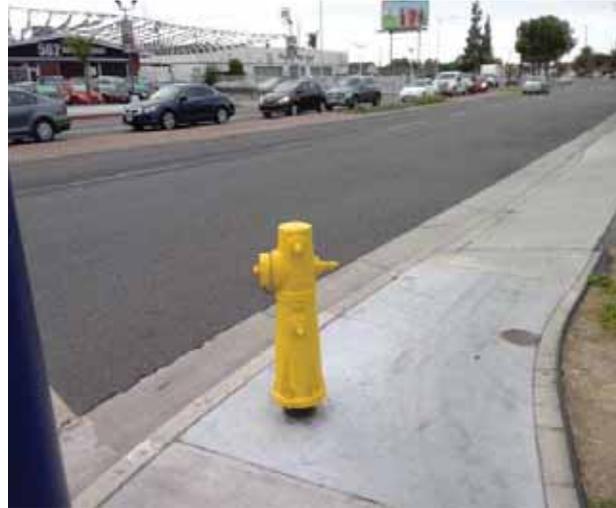
Sidewalks , Hazards & Gratings : Sidewalk Width at Obstruction

Code Reference ADA 206, 302, 403.5.1, CA 11B-403.5

Sidewalk width at the obstruction shall have the recommended value.

Recommendation At least 48.00 inches

\$1,260

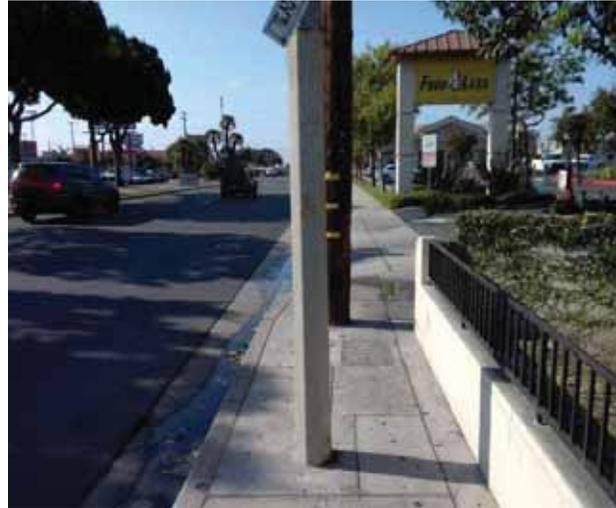
Sidewalks , Hazards & Gratings : Sidewalk Width at Obstruction

Code Reference ADA 206, 302, 403.5.1, CA 11B-403.5

Sidewalk width at the obstruction shall have the recommended value.

Recommendation At least 48.00 inches

\$1,260

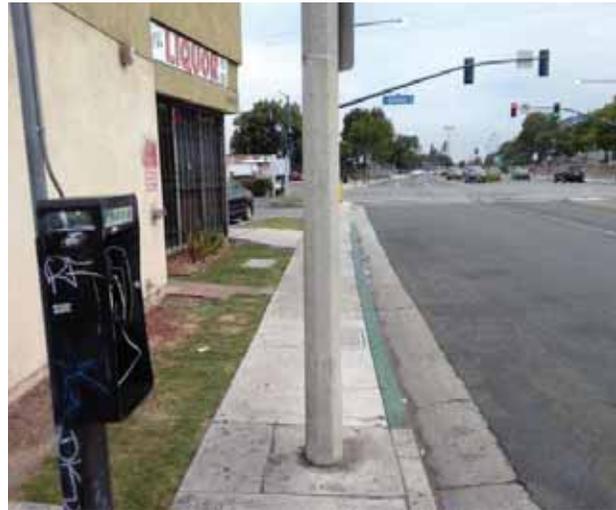
Sidewalks , Hazards & Gratings : Sidewalk Width at Obstruction

Code Reference ADA 206, 302, 403.5.1, CA 11B-403.5

Sidewalk width at the obstruction shall have the recommended value.

Recommendation At least 48.00 inches

\$1,260

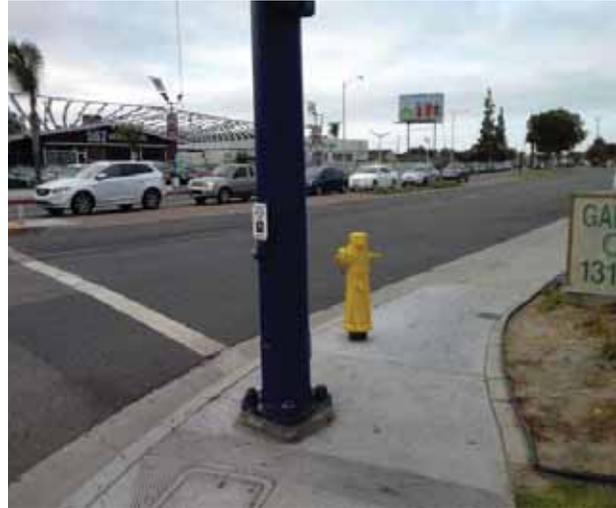
Sidewalks , Hazards & Gratings : Sidewalk Width at Obstruction

Code Reference ADA 206, 302, 403.5.1, CA 11B-403.5

Sidewalk width at the obstruction shall have the recommended value.

Recommendation At least 48.00 inches

\$1,260

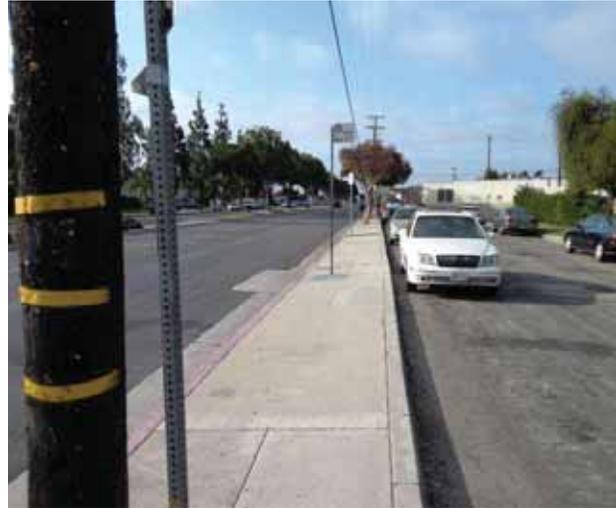
Code Reference ADA 206, 302,CA 11B-403.3

Repave the sidewalk surface with the recommended cross slope.

Recommendation Up to 2.08 percent

Repave surface \$1,092

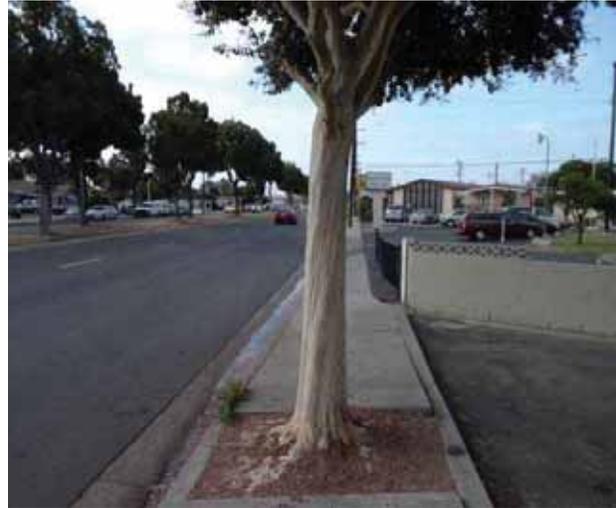
Sidewalks : Missing Sidewalk

Section of sidewalk is missing and consists of dirt, grass or gravel.

Code Reference ADA 206, 302,CA 11B-302,CA 11B-206

Provide a compliant sidewalk for the missing section.

\$1,260

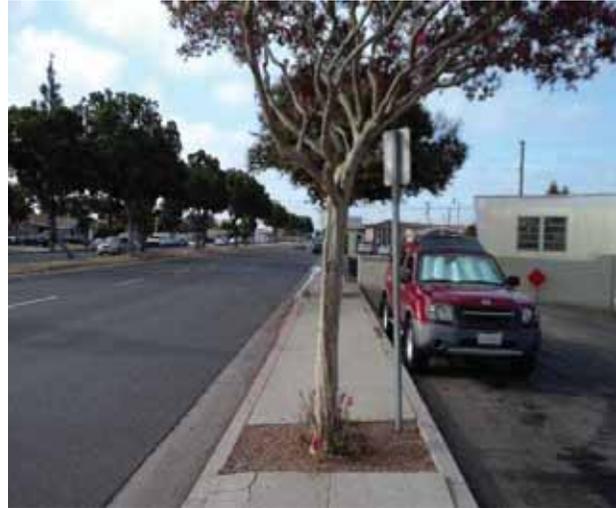
Sidewalks : Missing Sidewalk

Section of sidewalk is missing and consists of dirt, grass or gravel.

Code Reference ADA 206, 302,CA 11B-302,CA 11B-206

Provide a compliant sidewalk for the missing section.

\$1,260

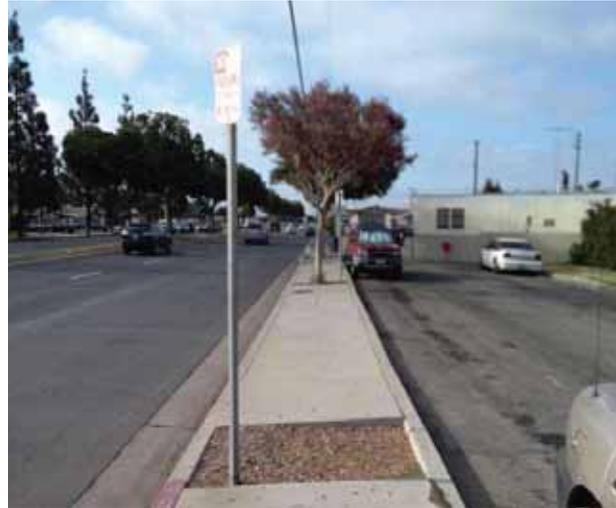
Sidewalks : Missing Sidewalk

Section of sidewalk is missing and consists of dirt, grass or gravel.

Code Reference ADA 206, 302,CA 11B-302,CA 11B-206

Provide a compliant sidewalk for the missing section.

\$1,260

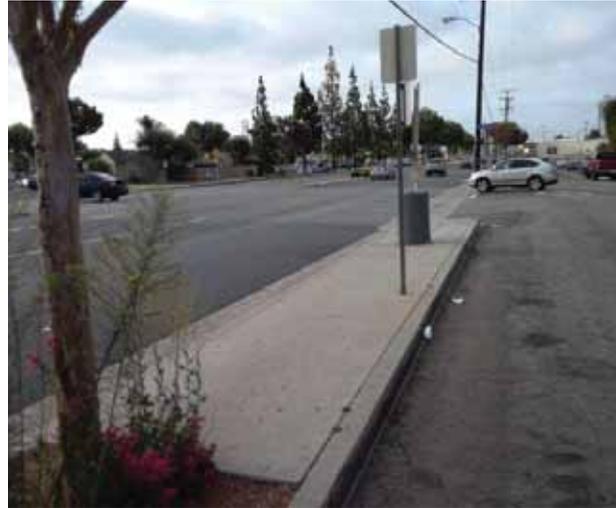
Code Reference ADA 206, 302, CA 11B-403.3

Repave the sidewalk surface with the recommended cross slope.

Recommendation Up to 2.08 percent

Repave surface \$1,092

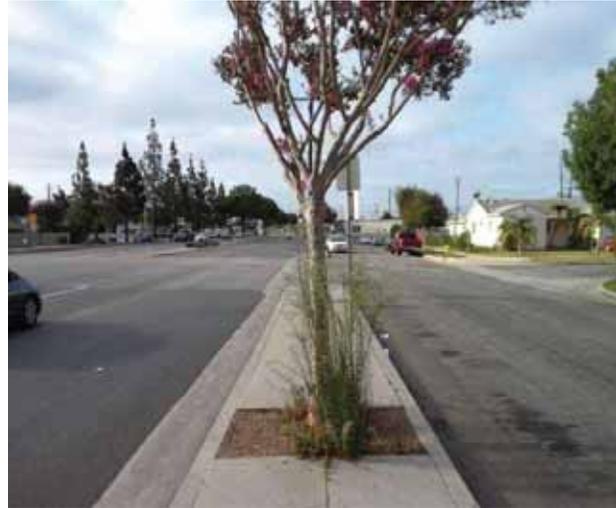
Sidewalks : Missing Sidewalk

Section of sidewalk is missing and consists of dirt, grass or gravel.

Code Reference ADA 206, 302,CA 11B-302,CA 11B-206

Provide a compliant sidewalk for the missing section.

\$1,260

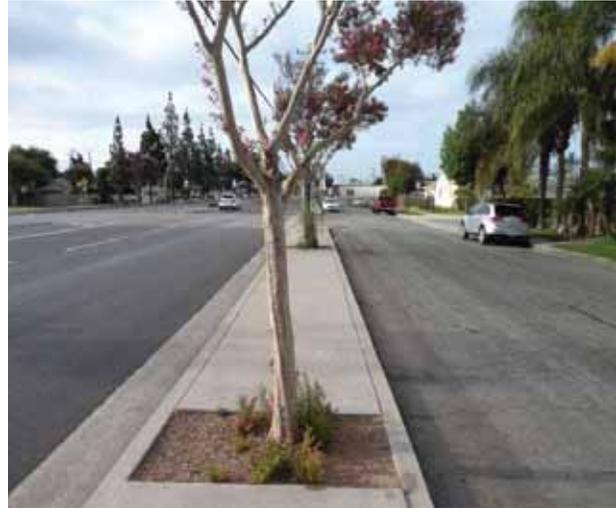
Sidewalks : Missing Sidewalk

Section of sidewalk is missing and consists of dirt, grass or gravel.

Code Reference ADA 206, 302,CA 11B-302,CA 11B-206

Provide a compliant sidewalk for the missing section.

\$1,260

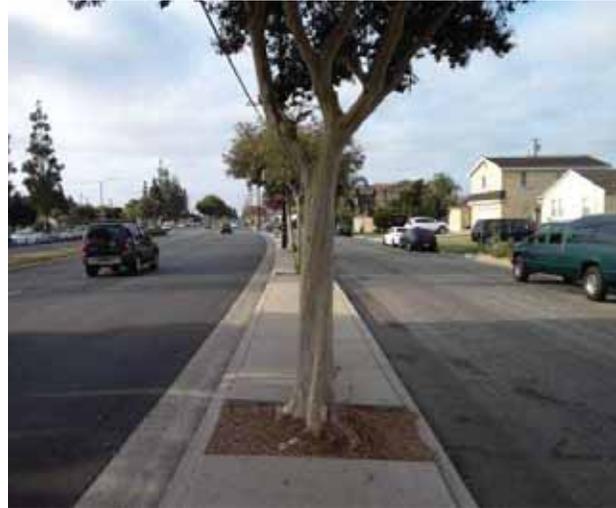
Sidewalks : Missing Sidewalk

Section of sidewalk is missing and consists of dirt, grass or gravel.

Provide a compliant sidewalk for the missing section.

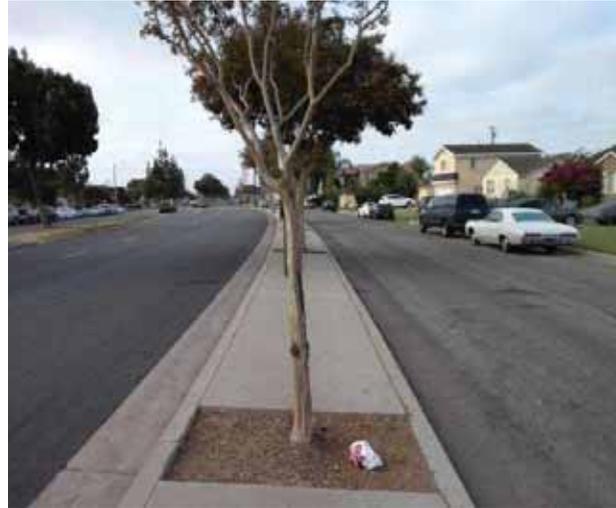
Sidewalks : Missing Sidewalk

Section of sidewalk is missing and consists of dirt, grass or gravel.

Provide a compliant sidewalk for the missing section.

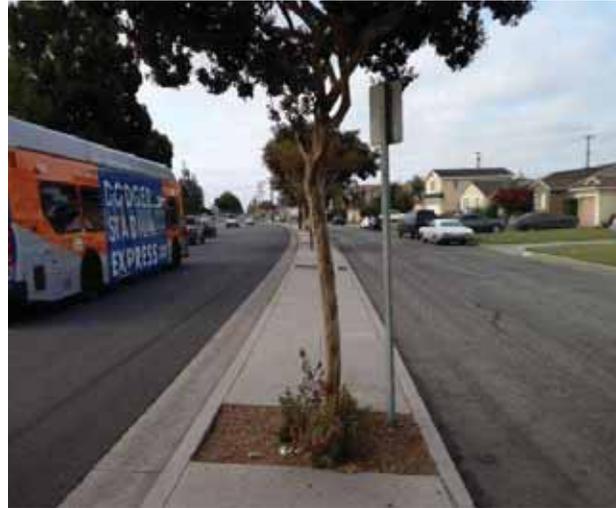
Sidewalks : Missing Sidewalk

Section of sidewalk is missing and consists of dirt, grass or gravel.

Provide a compliant sidewalk for the missing section.

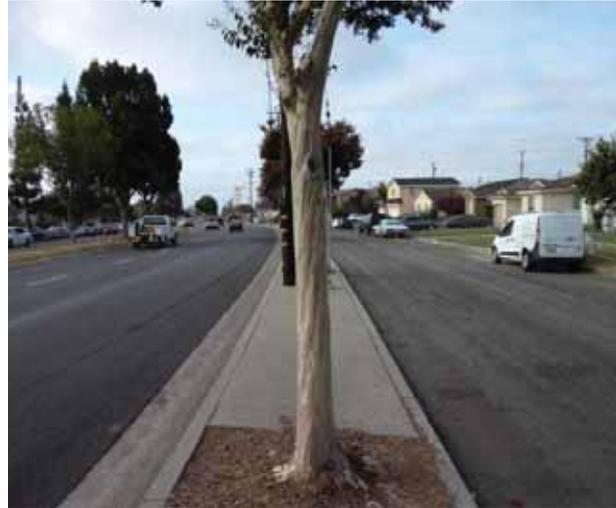
Sidewalks : Missing Sidewalk

Section of sidewalk is missing and consists of dirt, grass or gravel.

Provide a compliant sidewalk for the missing section.

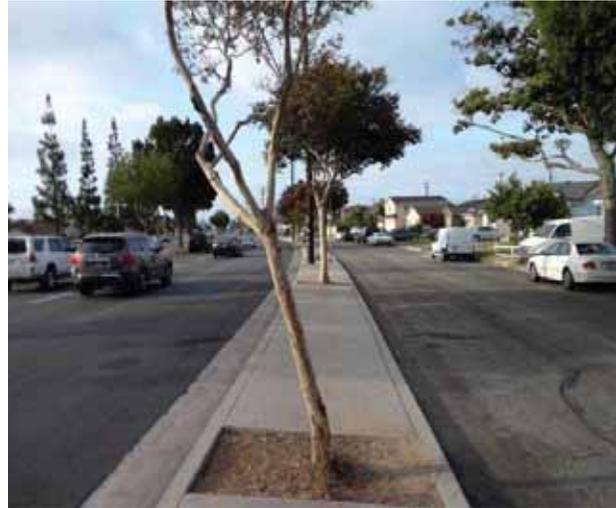
Sidewalks : Missing Sidewalk

Section of sidewalk is missing and consists of dirt, grass or gravel.

Provide a compliant sidewalk for the missing section.

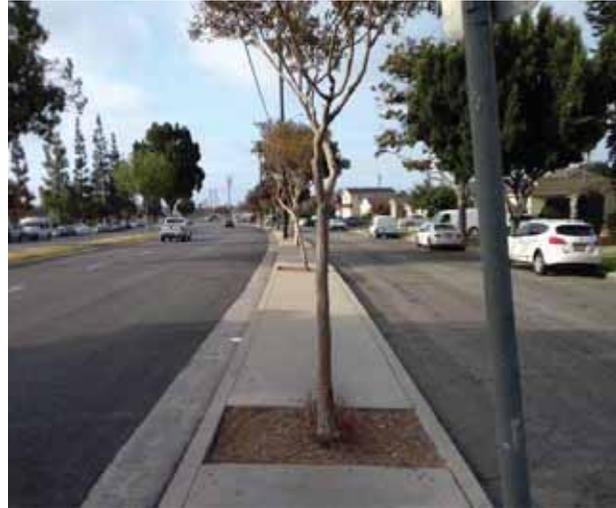
Sidewalks : Missing Sidewalk

Section of sidewalk is missing and consists of dirt, grass or gravel.

Provide a compliant sidewalk for the missing section.

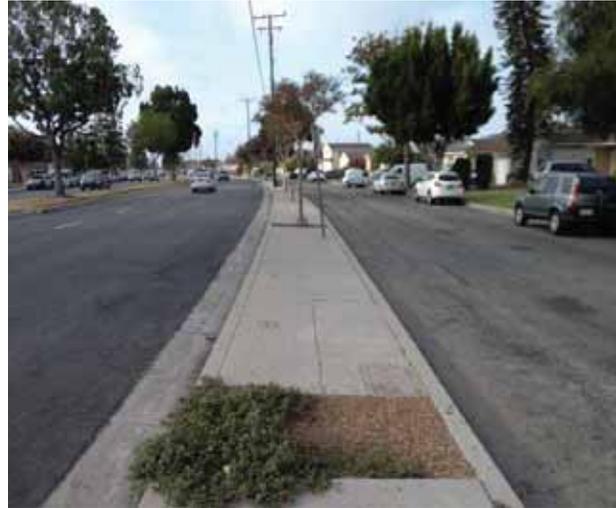
Sidewalks : Missing Sidewalk

Section of sidewalk is missing and consists of dirt, grass or gravel.

Provide a compliant sidewalk for the missing section.

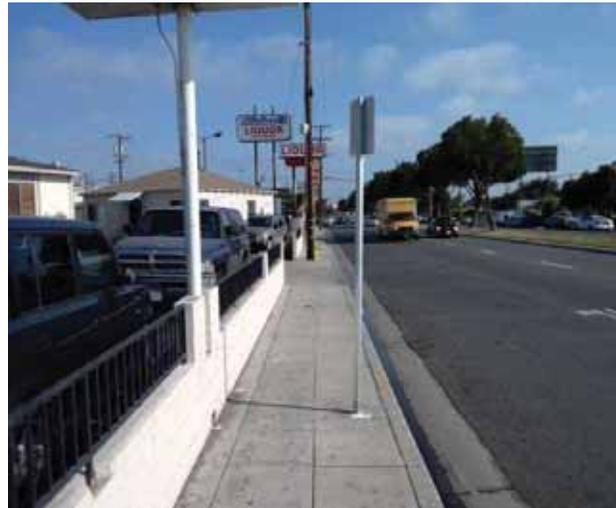
Sidewalks , Hazards & Gratings : Sidewalk Width at Obstruction

Sidewalk width at the obstruction shall have the recommended value.

Recommendation At least 48.00 inches

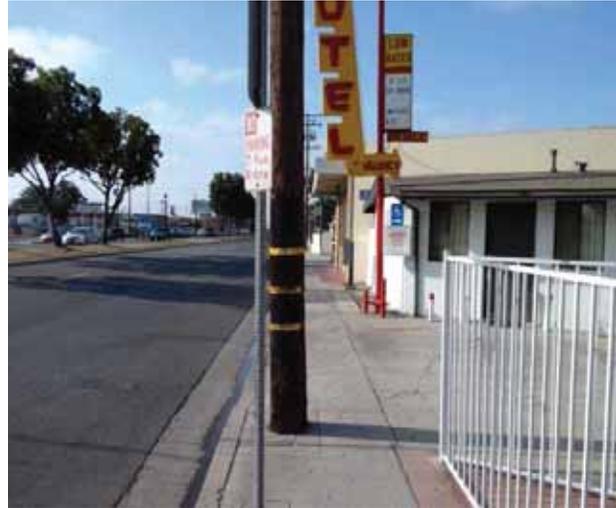
Sidewalks , Hazards & Gratings : Sidewalk Width at Obstruction

Sidewalk width at the obstruction shall have the recommended value.

Recommendation At least 48.00 inches

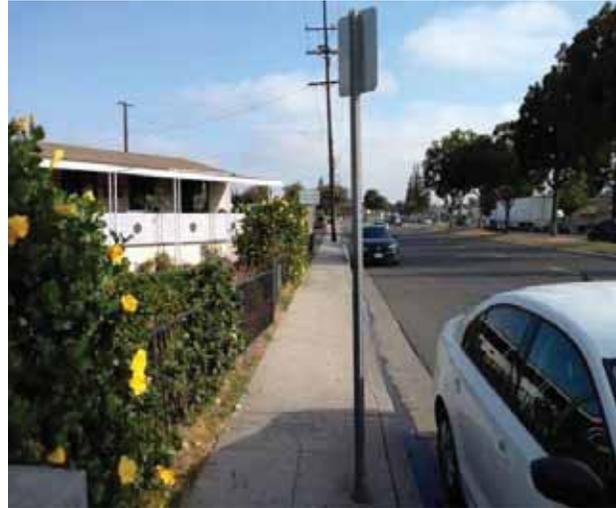
Sidewalks , Hazards & Gratings : Sidewalk Width at Obstruction

Sidewalk width at the obstruction shall have the recommended value.

Recommendation At least 48.00 inches

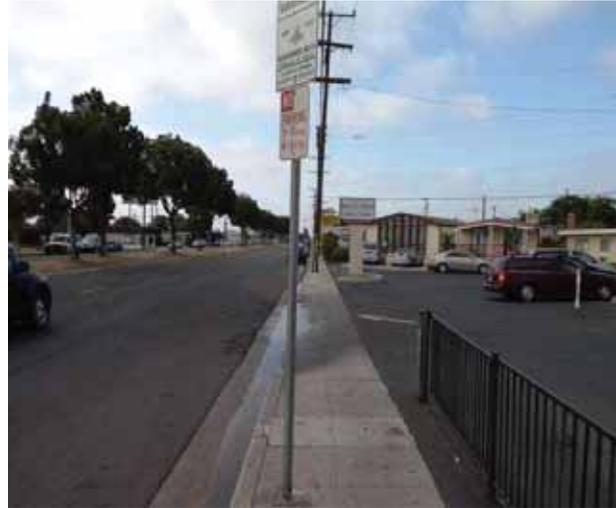
Sidewalks , Hazards & Gratings : Sidewalk Width at Obstruction

Sidewalk width at the obstruction shall have the recommended value.

Recommendation At least 48.00 inches

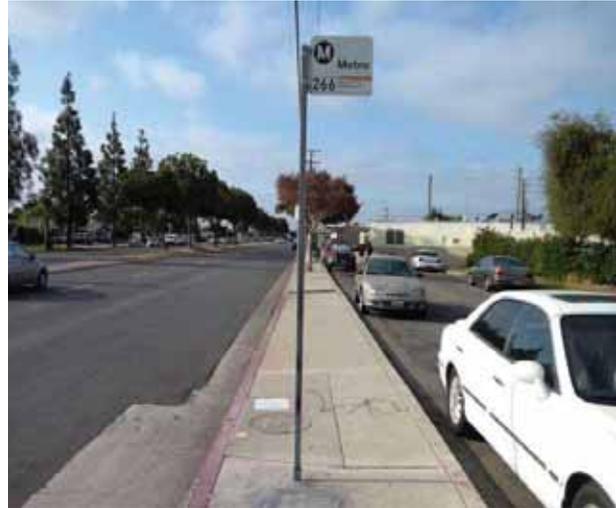
Sidewalks , Hazards & Gratings : Sidewalk Width at Obstruction

Sidewalk width at the obstruction shall have the recommended value.

Recommendation At least 48.00 inches

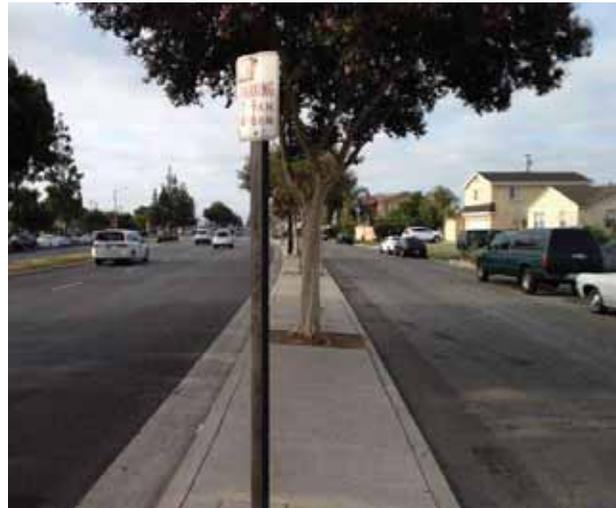
Sidewalks , Hazards & Gratings : Sidewalk Width at Obstruction

Sidewalk width at the obstruction shall have the recommended value.

Recommendation At least 48.00 inches

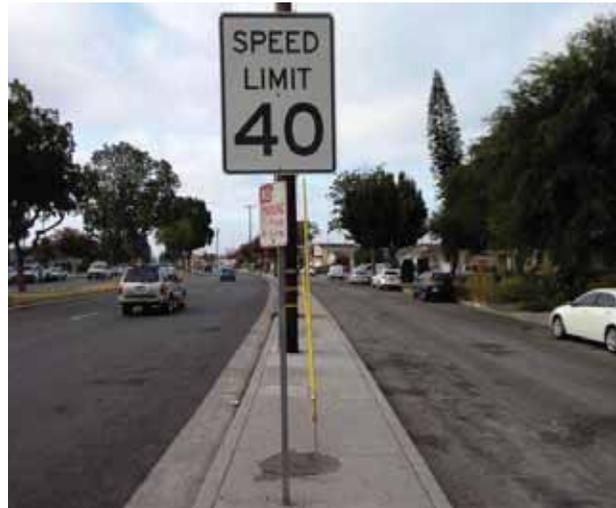
Sidewalks , Hazards & Gratings : Sidewalk Width at Obstruction

Sidewalk width at the obstruction shall have the recommended value.

Recommendation At least 48.00 inches

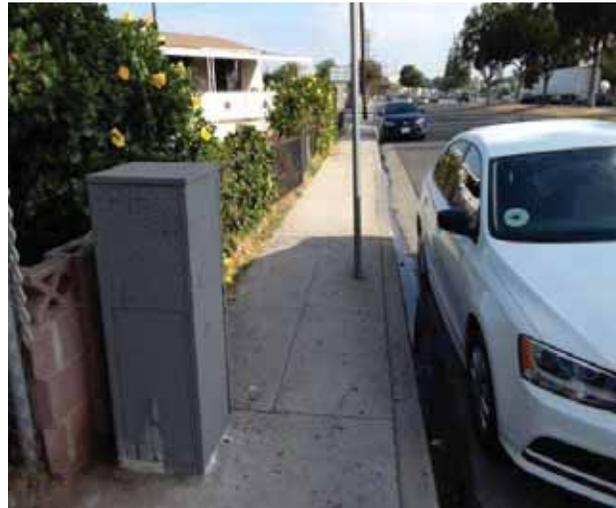
Sidewalks , Hazards & Gratings : Sidewalk Width at Obstruction

Sidewalk width at the obstruction shall have the recommended value.

Recommendation At least 48.00 inches

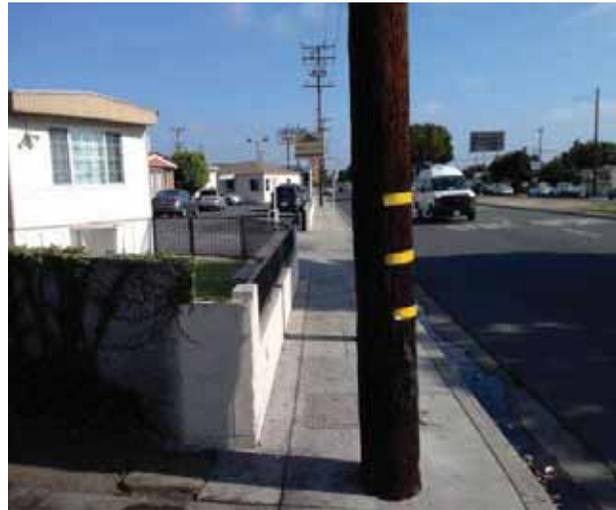
Sidewalks , Hazards & Gratings : Sidewalk Width at Obstruction

Sidewalk width at the obstruction shall have the recommended value.

Recommendation At least 48.00 inches

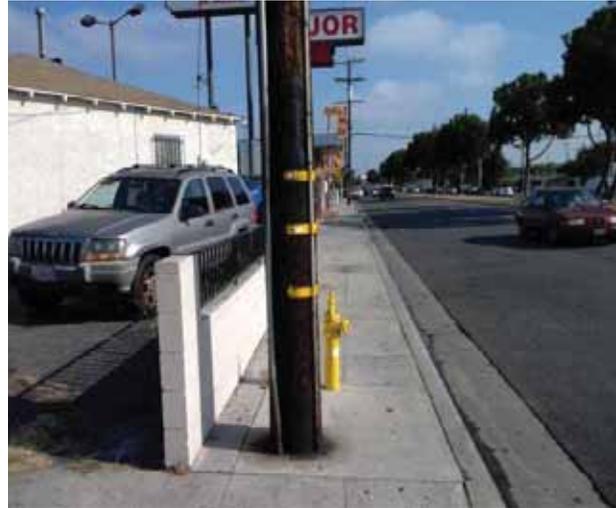
Sidewalks , Hazards & Gratings : Sidewalk Width at Obstruction

Sidewalk width at the obstruction shall have the recommended value.

Recommendation At least 48.00 inches

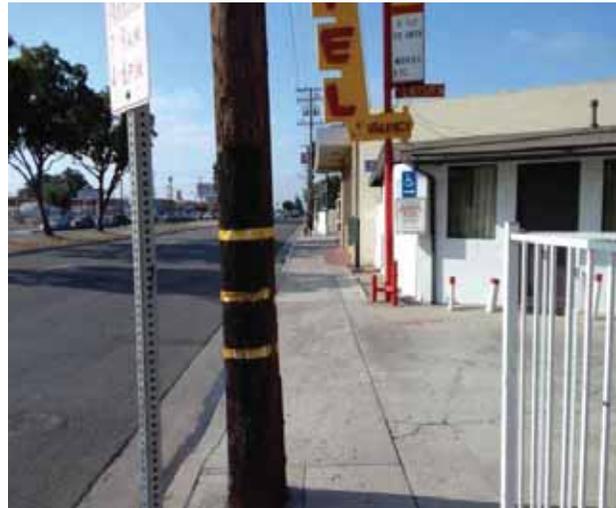
Sidewalks , Hazards & Gratings : Sidewalk Width at Obstruction

Sidewalk width at the obstruction shall have the recommended value.

Recommendation At least 48.00 inches

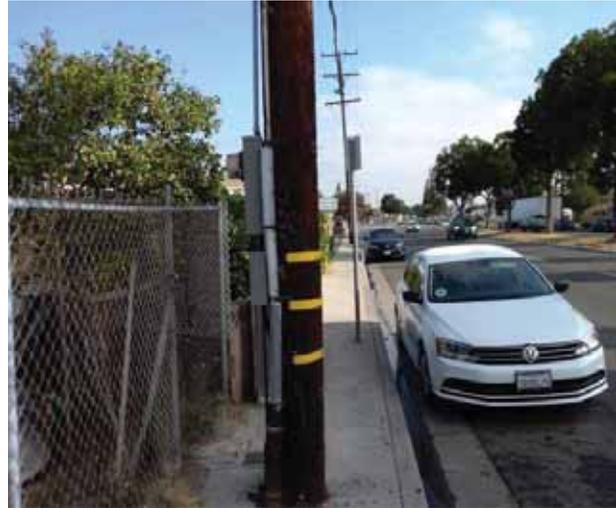
Sidewalks , Hazards & Gratings : Sidewalk Width at Obstruction

Sidewalk width at the obstruction shall have the recommended value.

Recommendation At least 48.00 inches

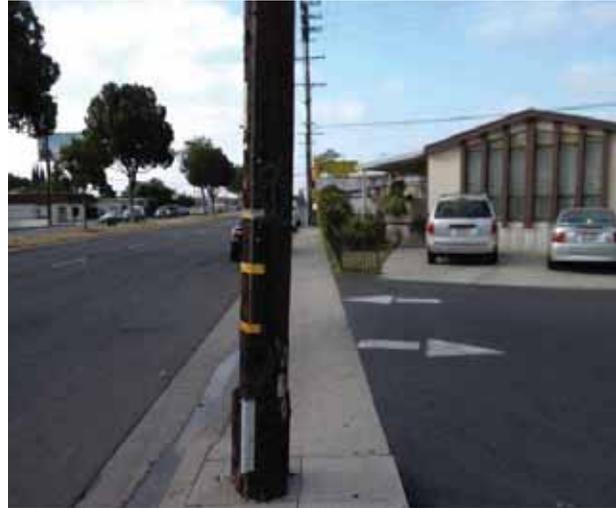
Sidewalks , Hazards & Gratings : Sidewalk Width at Obstruction

Sidewalk width at the obstruction shall have the recommended value.

Recommendation At least 48.00 inches

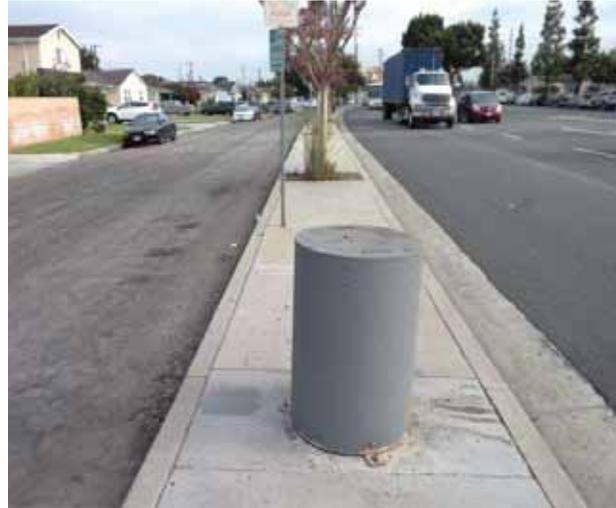
Sidewalks , Hazards & Gratings : Sidewalk Width at Obstruction

Sidewalk width at the obstruction shall have the recommended value.

Recommendation At least 48.00 inches

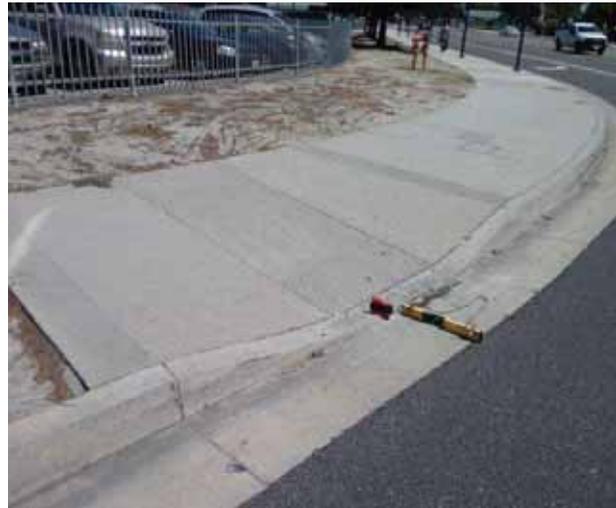
Recommendation Up to 5.00 percent

Repave landing \$1,260

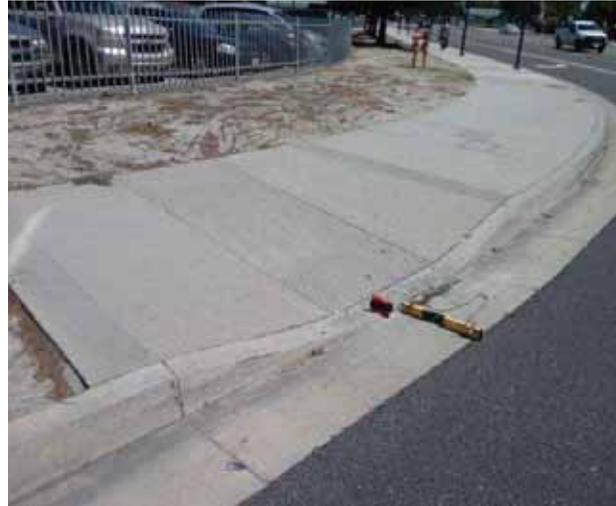
Recommendation At least 48.00 inches

Provide compliant landing \$240

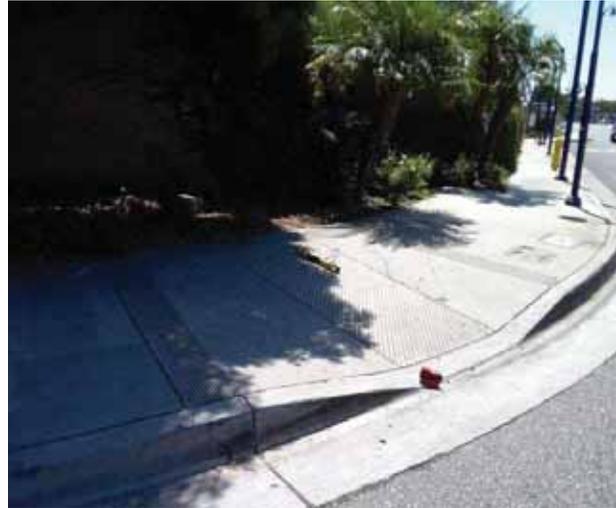
On-Site Finding Not Found

Provide detectable warning to surface \$248

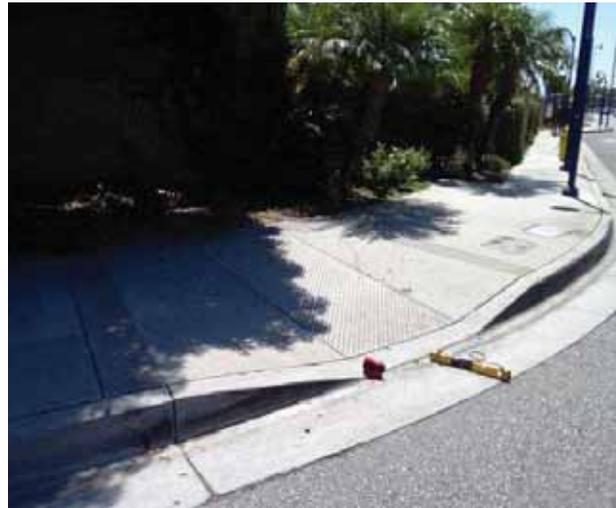
Recommendation Up to 5.00 percent

Repave landing \$1,260

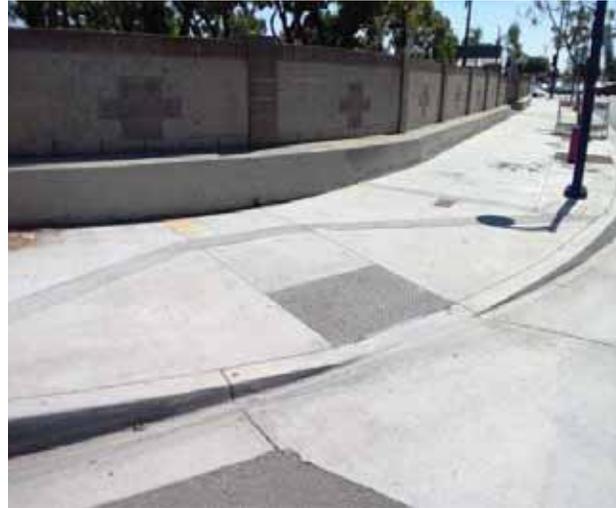
Recommendation At least 48.00 inches

Provide compliant landing \$240

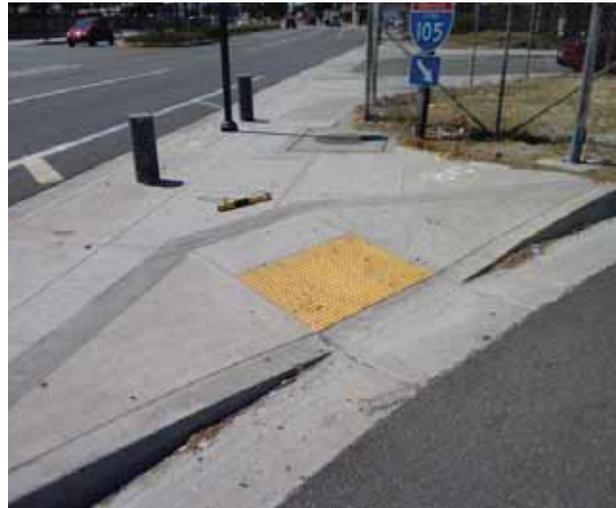
Recommendation Up to 2.08 percent

Provide compliant landing \$1,260

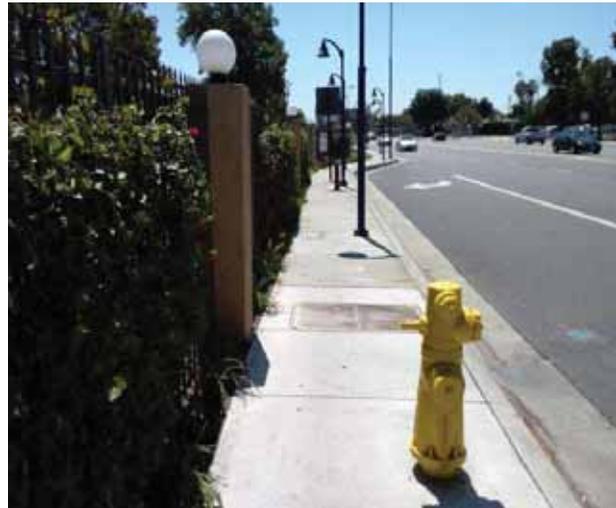
Sidewalks , Hazards & Gratings : Sidewalk Width at Obstruction

Recommendation At least 48.00 inches

Sidewalk width at the obstruction shall have the recommended value.

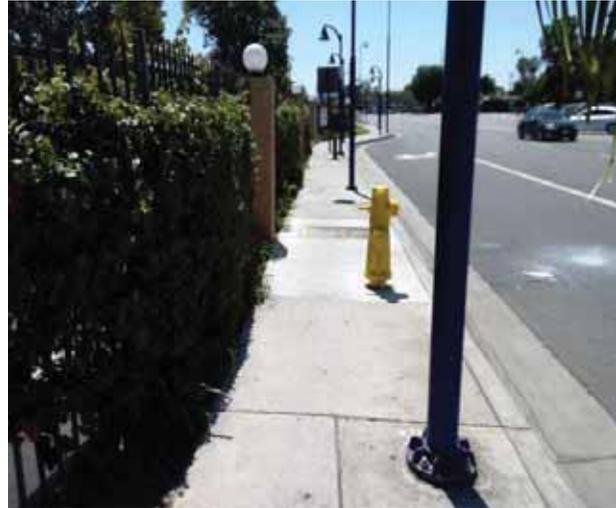
Sidewalks , Hazards & Gratings : Sidewalk Width at Obstruction

Recommendation At least 48.00 inches

Sidewalk width at the obstruction shall have the recommended value.

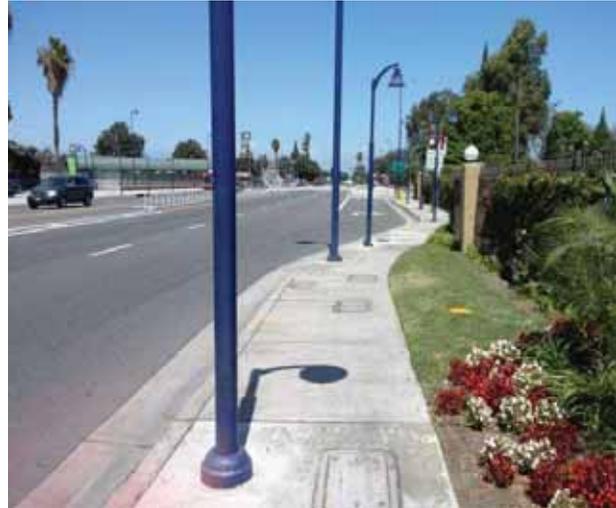
Sidewalks , Hazards & Gratings : Sidewalk Width at Obstruction

Recommendation At least 48.00 inches

Sidewalk width at the obstruction shall have the recommended value.

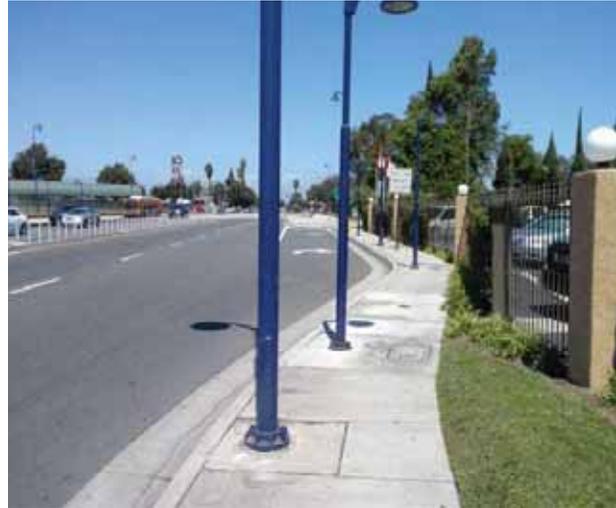
Sidewalks , Hazards & Gratings : Sidewalk Width at Obstruction

Recommendation At least 48.00 inches

Sidewalk width at the obstruction shall have the recommended value.

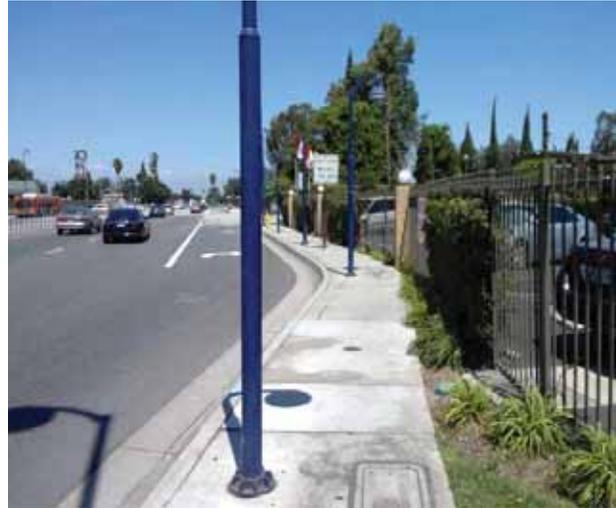
Sidewalks , Hazards & Gratings : Sidewalk Width at Obstruction

Recommendation At least 48.00 inches

Sidewalk width at the obstruction shall have the recommended value.

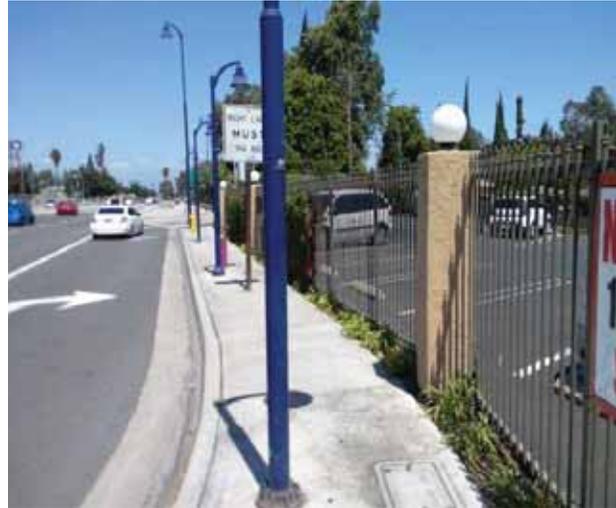
Sidewalks , Hazards & Gratings : Sidewalk Width at Obstruction

Recommendation At least 48.00 inches

Sidewalk width at the obstruction shall have the recommended value.

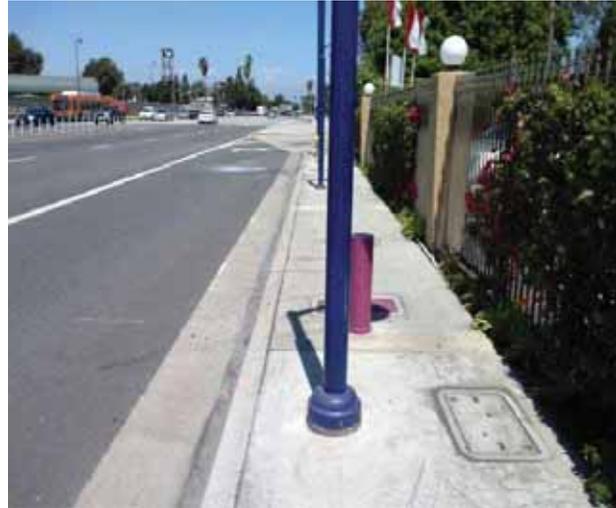
Sidewalks , Hazards & Gratings : Sidewalk Width at Obstruction

Recommendation At least 48.00 inches

Sidewalk width at the obstruction shall have the recommended value.

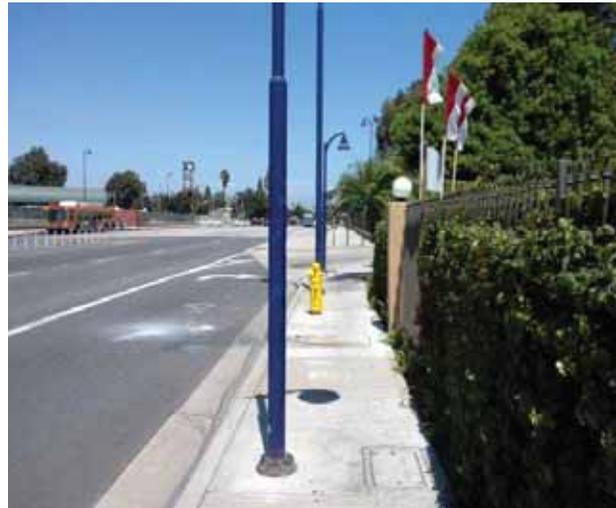
Sidewalks , Hazards & Gratings : Sidewalk Width at Obstruction

Recommendation At least 48.00 inches

Sidewalk width at the obstruction shall have the recommended value.

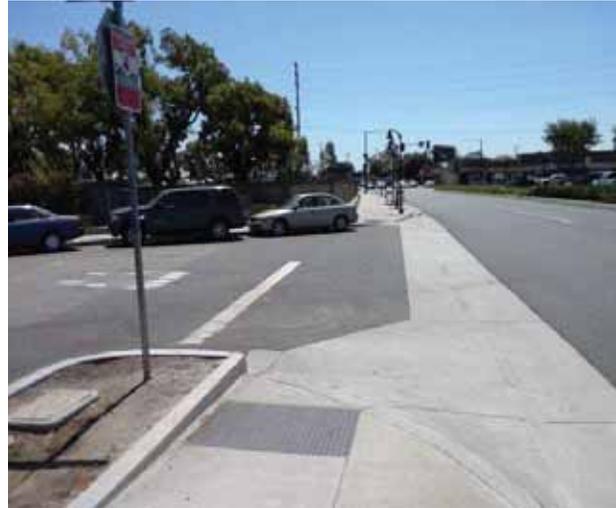
Recommendation Up to 2.08 percent

Repave surface \$1,092

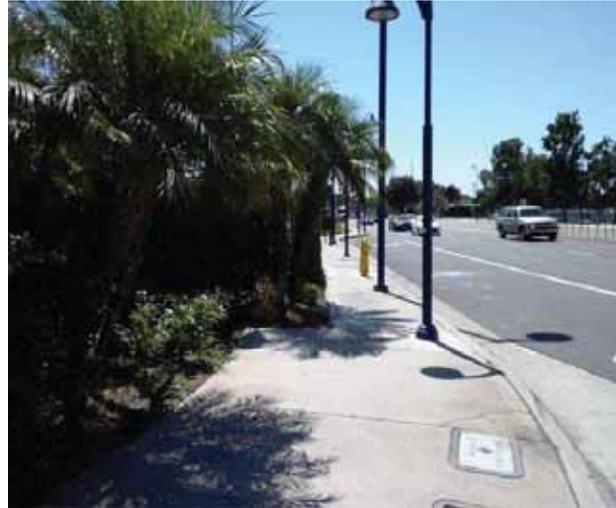
Recommendation Up to 2.08 percent

Repave the sidewalk surface with the recommended cross slope.

Repave surface \$1,092

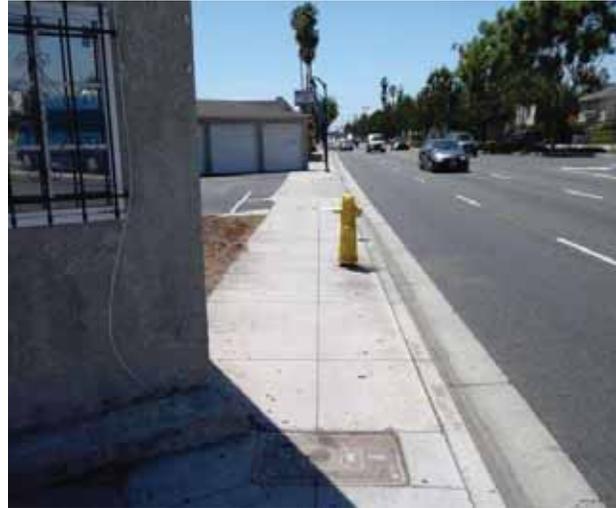
Recommendation At least 48.00 inches

Widen the sidewalk to the recommended value.

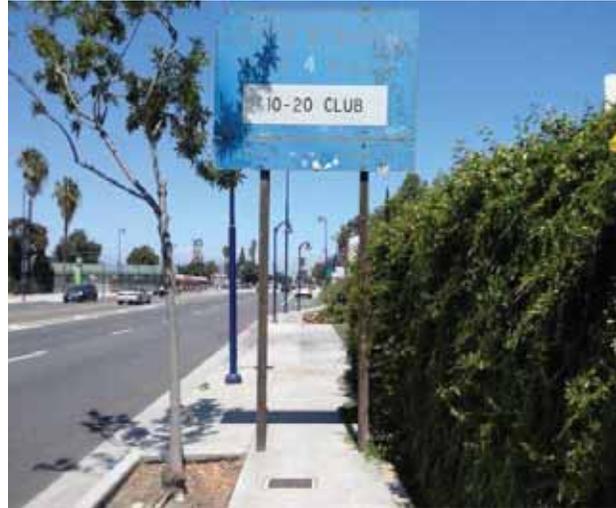
Sidewalks , Hazards & Gratings : Sidewalk Width at Obstruction

Recommendation At least 48.00 inches

Sidewalk width at the obstruction shall have the recommended value.

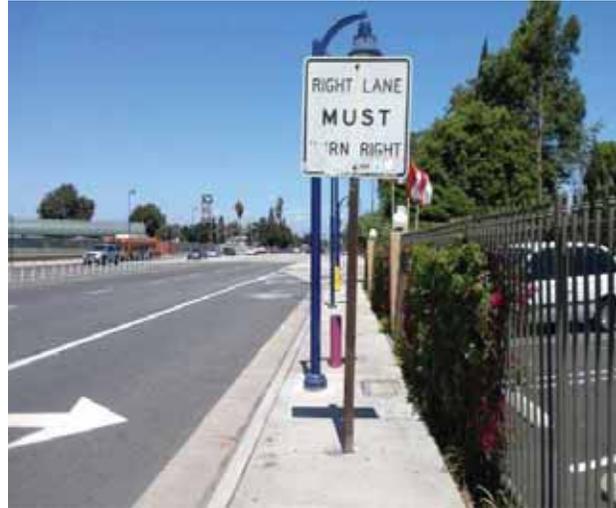
Sidewalks , Hazards & Gratings : Sidewalk Width at Obstruction

Recommendation At least 48.00 inches

Sidewalk width at the obstruction shall have the recommended value.
