Accessibility Survey

City of Downey Lakewood Boulevard & Columbia Way

Date of Inspection
5/25/2017

Disability Access Consultants

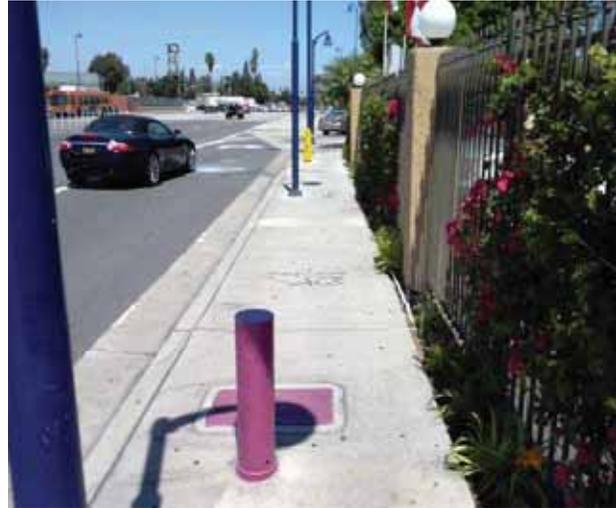
Sidewalks , Hazards & Gratings : Sidewalk Width at Obstruction

Recommendation At least 48.00 inches

Sidewalk width at the obstruction shall have the recommended value.

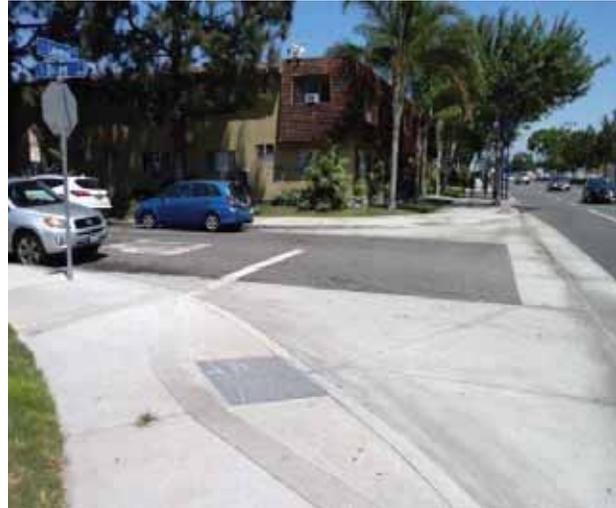
Recommendation Up to 5.00 percent

Repave surface \$1,092

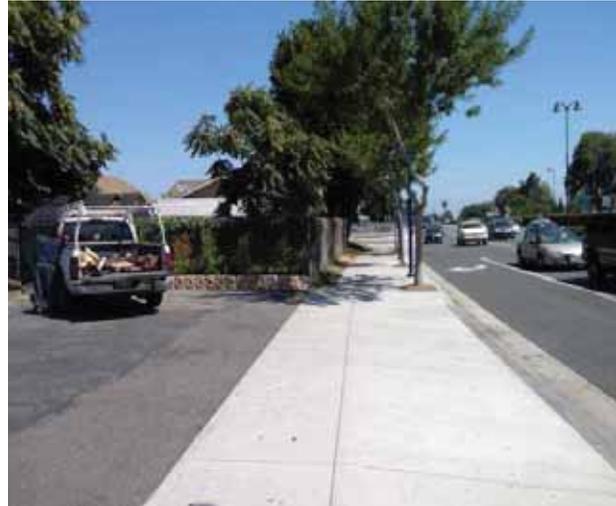
Recommendation Up to 2.08 percent

Repave surface \$1,092

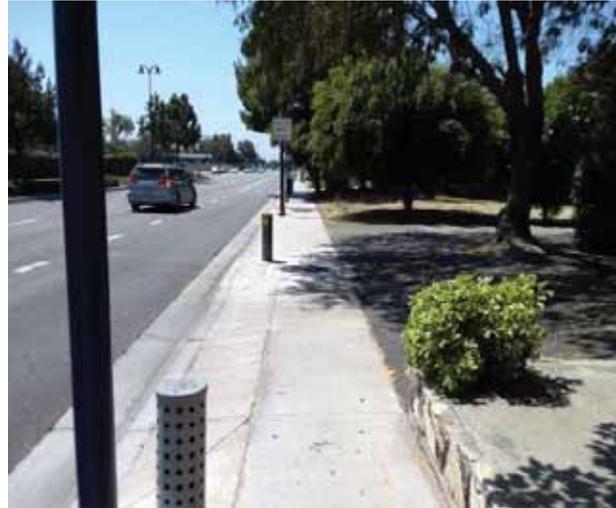
On-Site Finding Not Found

Install compliant detectable warnings \$190

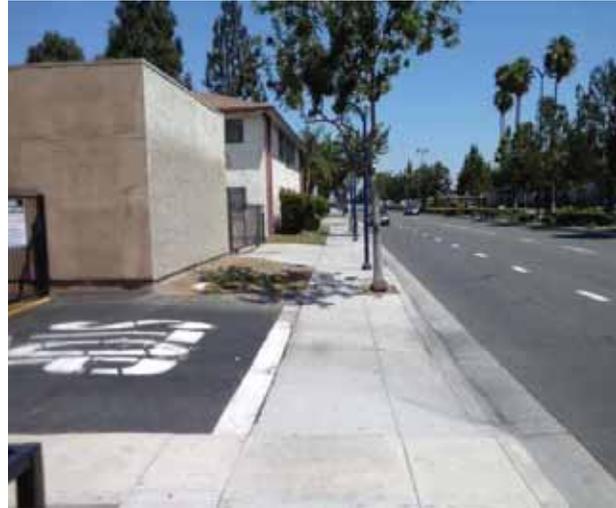
On-Site Finding Not Found

Install compliant detectable warnings \$190

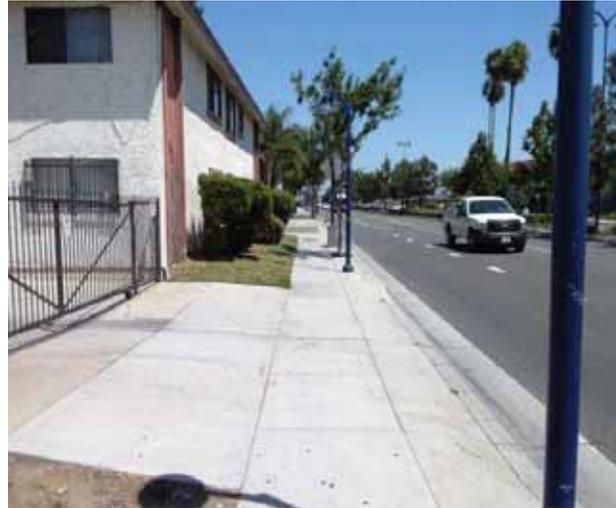
On-Site Finding Not Found

Install compliant detectable warnings \$190

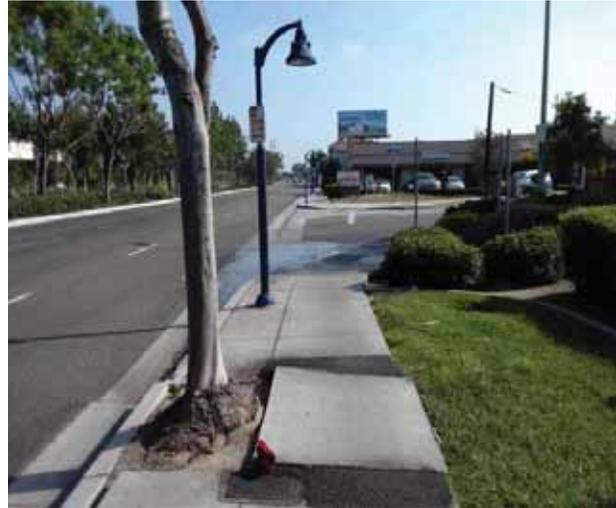
There is a change in elevation greater than recommended value.

Ensure that the change in elevation is within the recommended value.

Recommendation Up to 0.25 inches

Remove tripping hazards \$198

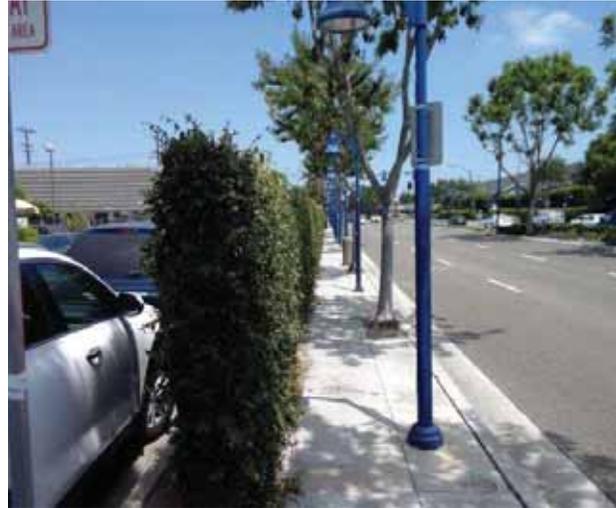
Notes : Wall And Vines Reduces Width

Widen the sidewalk to the recommended value.

Recommendation At least 48.00 inches

\$1,260

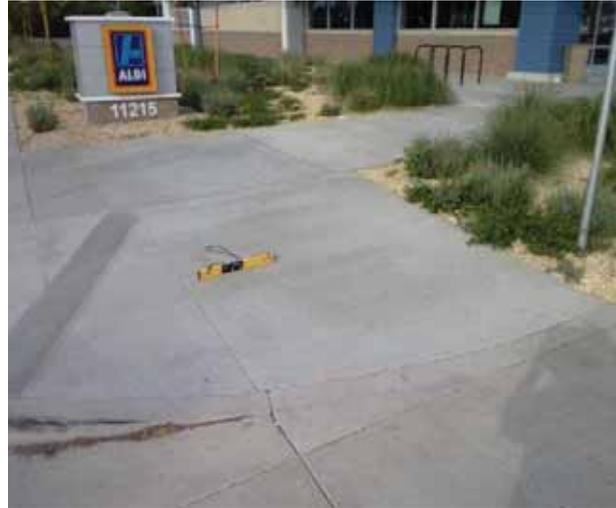
On-Site Finding Not Found

Provide detectable warning to surface \$248

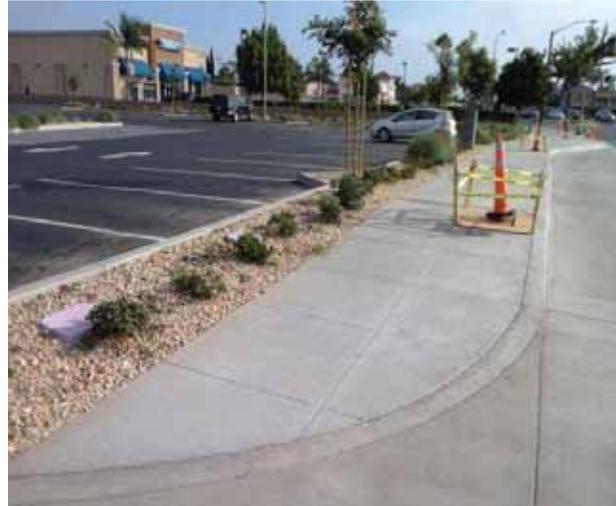
On-Site Finding Not Found

Provide detectable warning to surface \$248

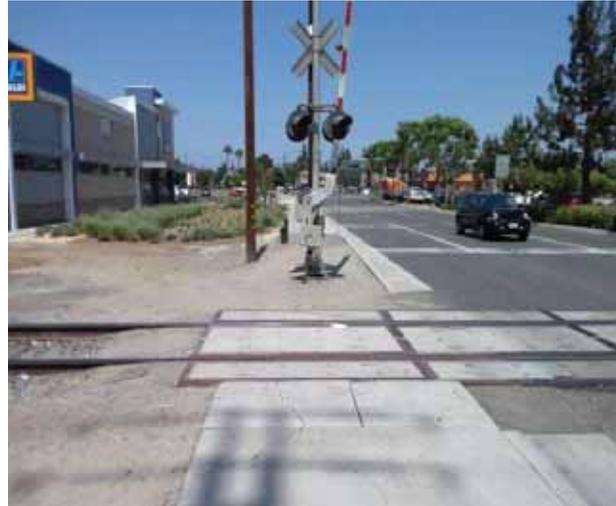
Notes : Railroad Crossing Opening = 3"

Install compliant detectable warnings \$190

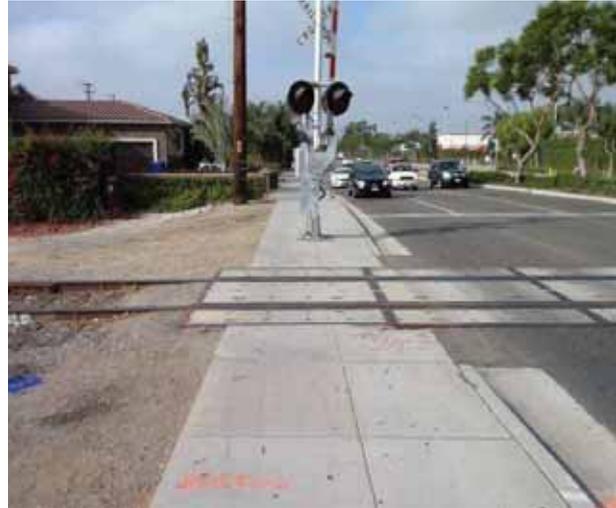
Notes : Railroad Crossing Opening = 3"

Install compliant detectable warnings \$190

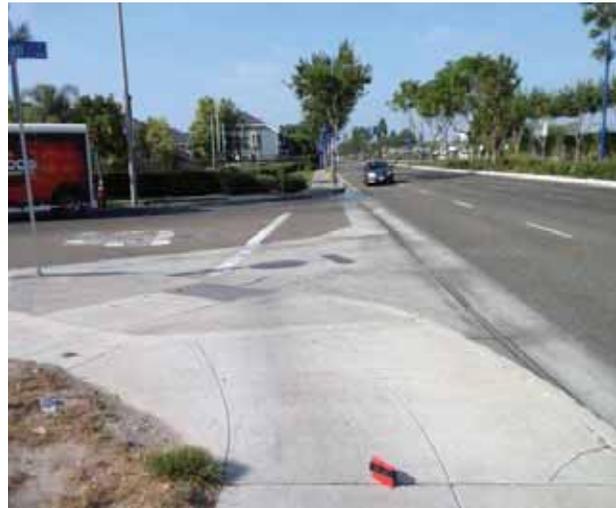
There is a change in elevation greater than recommended value.

Ensure that the change in elevation is within the recommended value.

Recommendation Up to 0.25 inches

Remove tripping hazards \$198

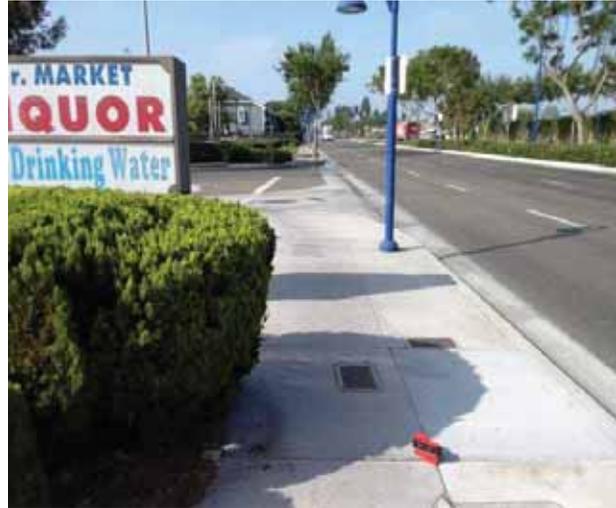
There is a change in elevation greater than recommended value.

Ensure that the change in elevation is within the recommended value.

Recommendation Up to 0.25 inches

Remove tripping hazards \$198

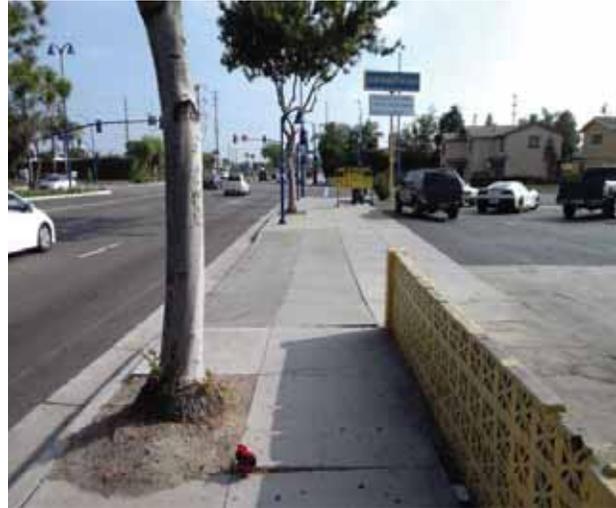
There is a change in elevation greater than recommended value.

Ensure that the change in elevation is within the recommended value.

Recommendation Up to 0.25 inches

Remove tripping hazards \$198

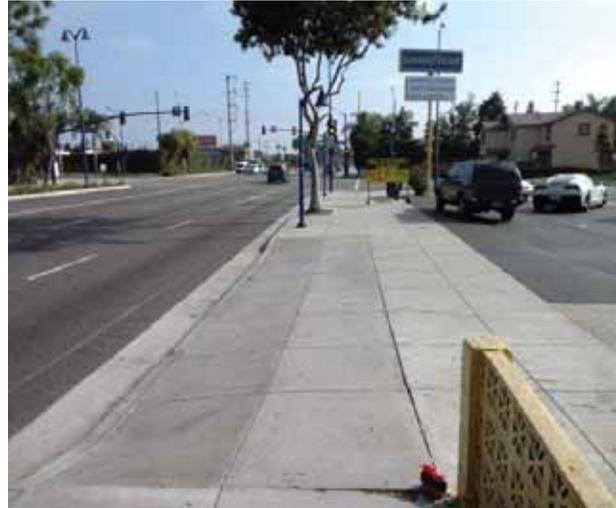
There is a change in elevation greater than recommended value.

Ensure that the change in elevation is within the recommended value.

Recommendation Up to 0.25 inches

Remove tripping hazards \$198

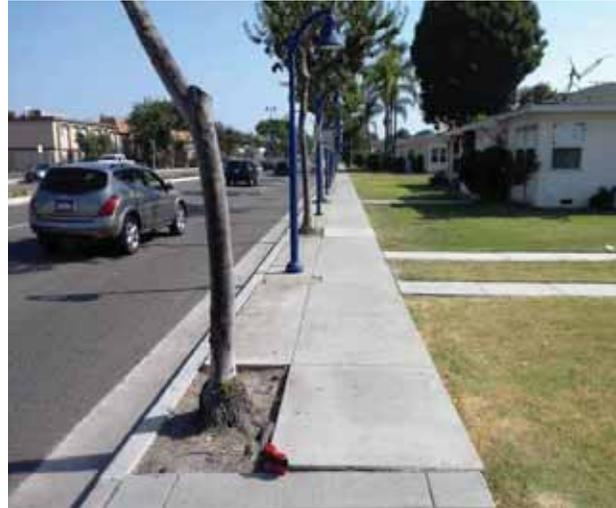
There is a change in elevation greater than recommended value.

Ensure that the change in elevation is within the recommended value.

Recommendation Up to 0.25 inches

Remove tripping hazards \$198

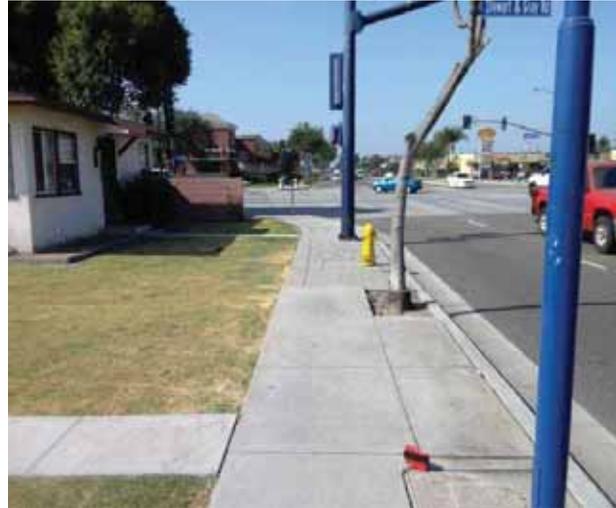
There is a change in elevation greater than recommended value.

Ensure that the change in elevation is within the recommended value.

Recommendation Up to 0.25 inches

Remove tripping hazards \$198

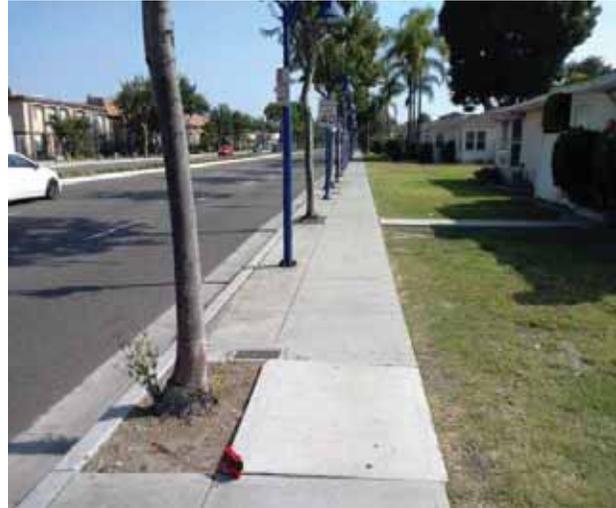
There is a change in elevation greater than recommended value.

Ensure that the change in elevation is within the recommended value.

Recommendation Up to 0.25 inches

Remove tripping hazards \$198

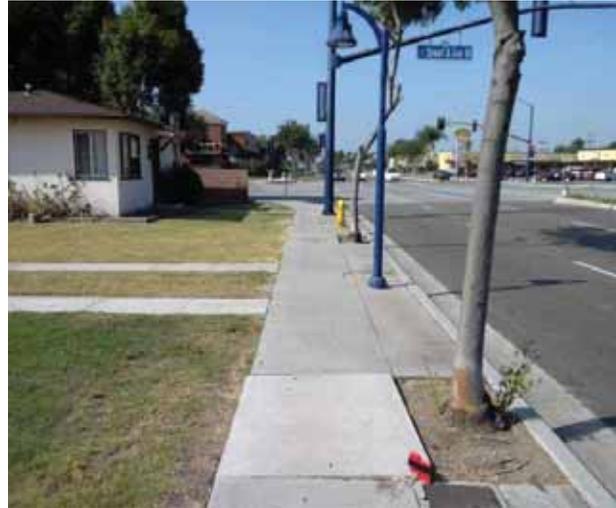
There is a change in elevation greater than recommended value.

Ensure that the change in elevation is within the recommended value.

Recommendation Up to 0.25 inches

Remove tripping hazards \$198

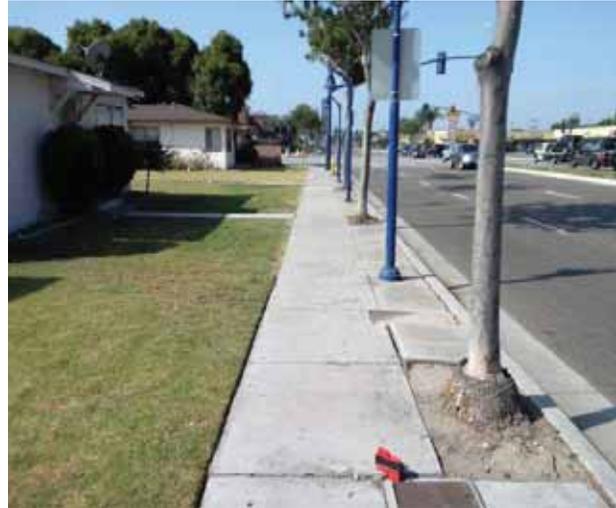
There is a change in elevation greater than recommended value.

Ensure that the change in elevation is within the recommended value.

Recommendation Up to 0.25 inches

Remove tripping hazards \$198

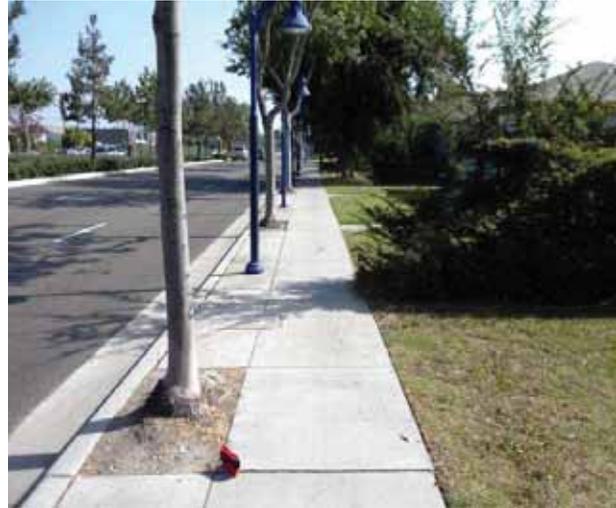
There is a change in elevation greater than recommended value.

Ensure that the change in elevation is within the recommended value.

Recommendation Up to 0.25 inches

Remove tripping hazards \$198

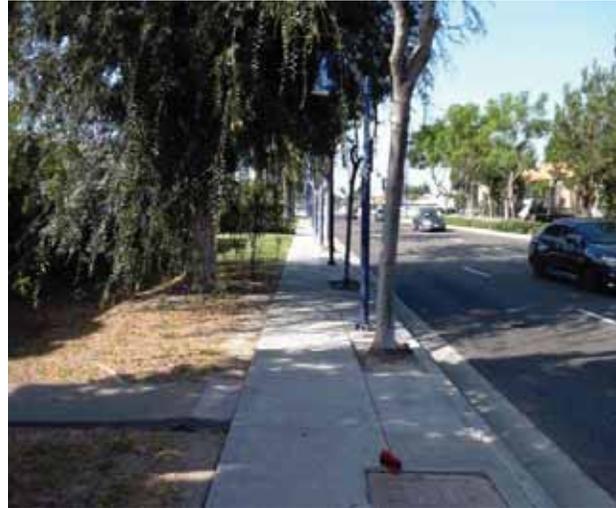
There is a change in elevation greater than recommended value.

Ensure that the change in elevation is within the recommended value.

Recommendation Up to 0.25 inches

Remove tripping hazards \$198

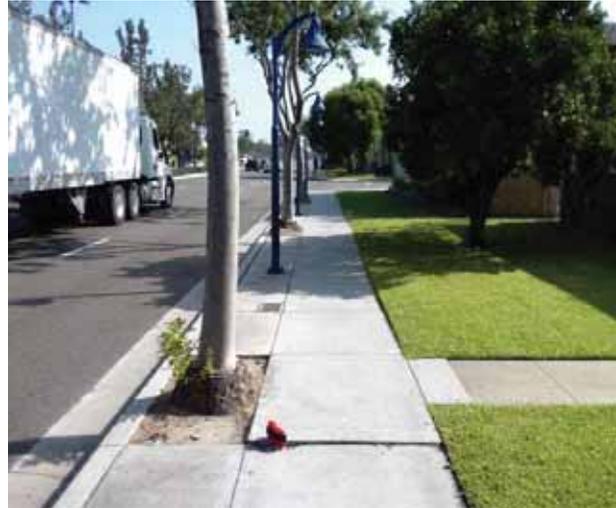
There is a change in elevation greater than recommended value.

Ensure that the change in elevation is within the recommended value.

Recommendation Up to 0.25 inches

Remove tripping hazards \$198

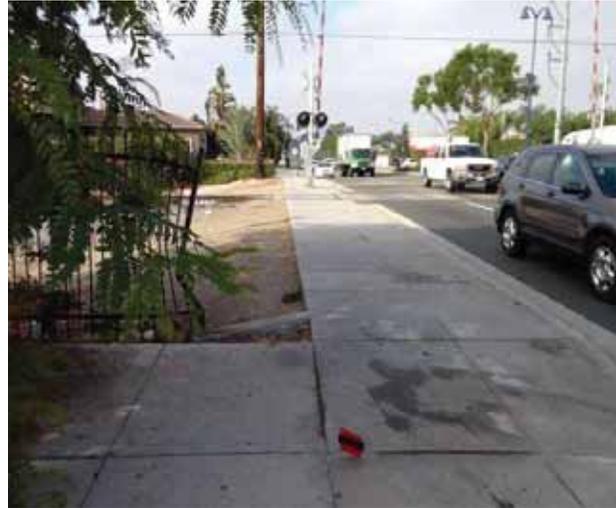
There is a change in elevation greater than recommended value.

Ensure that the change in elevation is within the recommended value.

Recommendation Up to 0.25 inches

Remove tripping hazards \$198

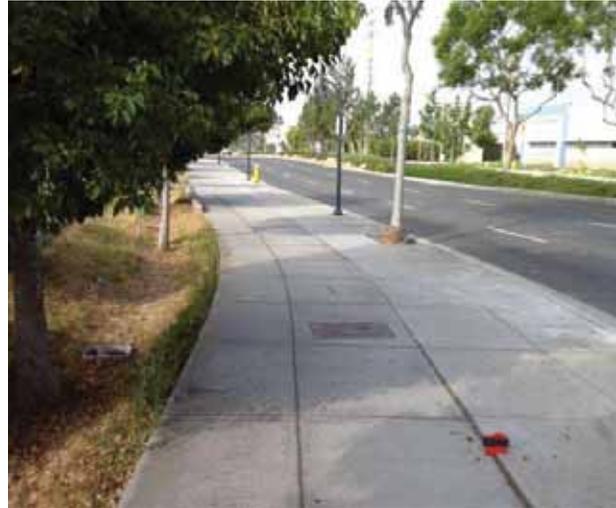
There is a change in elevation greater than recommended value.

Ensure that the change in elevation is within the recommended value.

Recommendation Up to 0.25 inches

Remove tripping hazards \$198

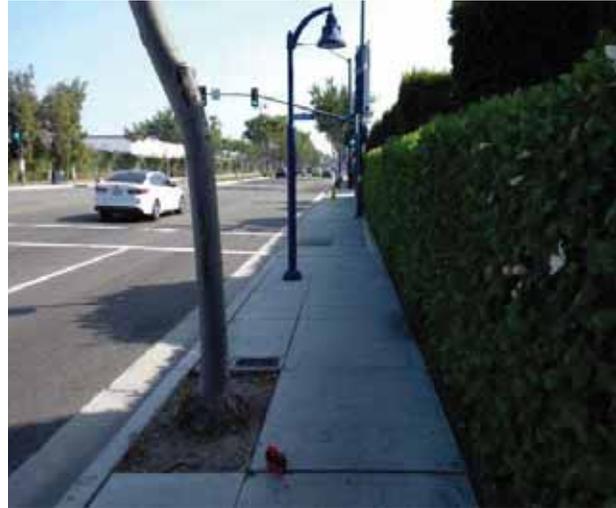
There is a change in elevation greater than recommended value.

Ensure that the change in elevation is within the recommended value.

Recommendation Up to 0.25 inches

Remove tripping hazards \$198

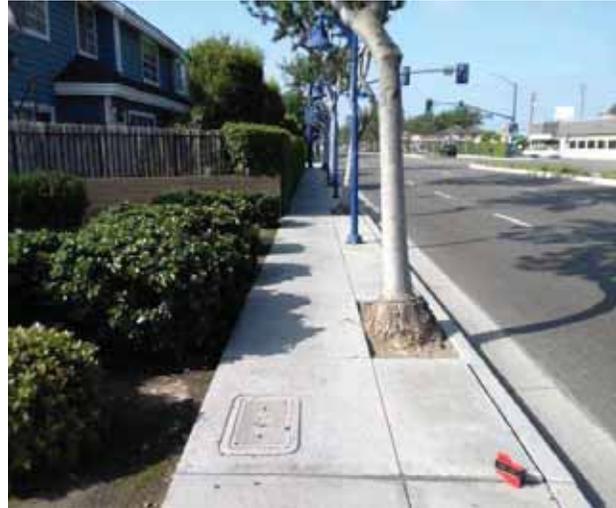
There is a change in elevation greater than recommended value.

Ensure that the change in elevation is within the recommended value.

Recommendation Up to 0.25 inches

Remove tripping hazards \$198

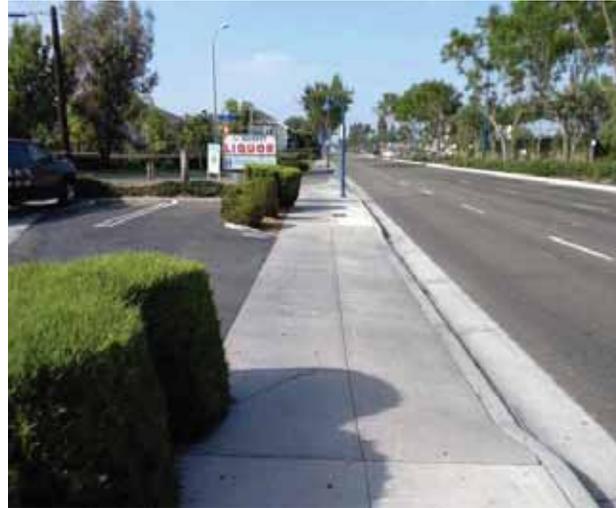
On-Site Finding Not Found

Install compliant detectable warnings \$190

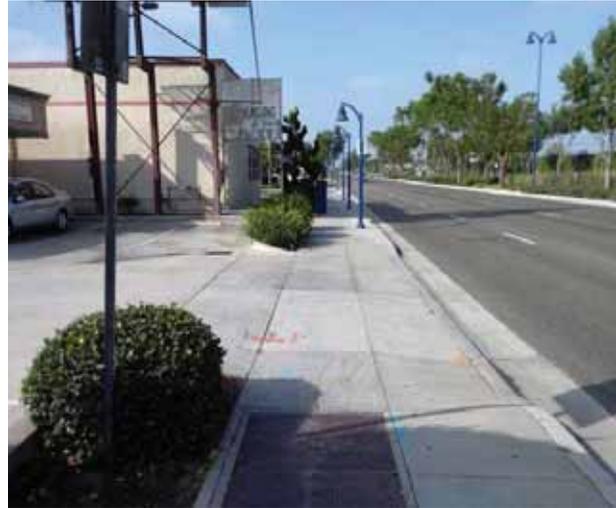
On-Site Finding Not Found

Install compliant detectable warnings \$190

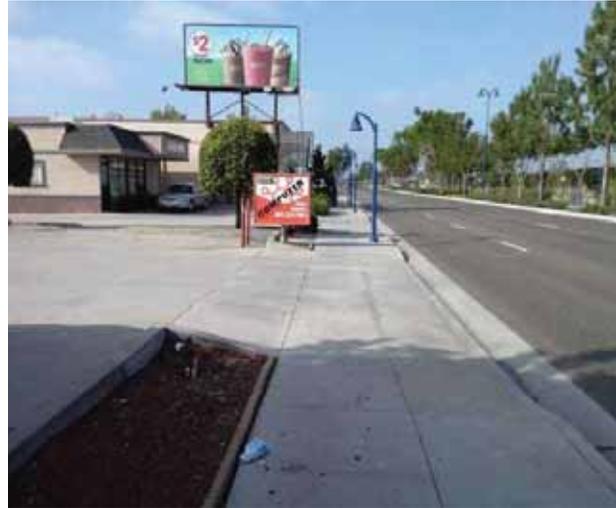
On-Site Finding Not Found

Install compliant detectable warnings \$190

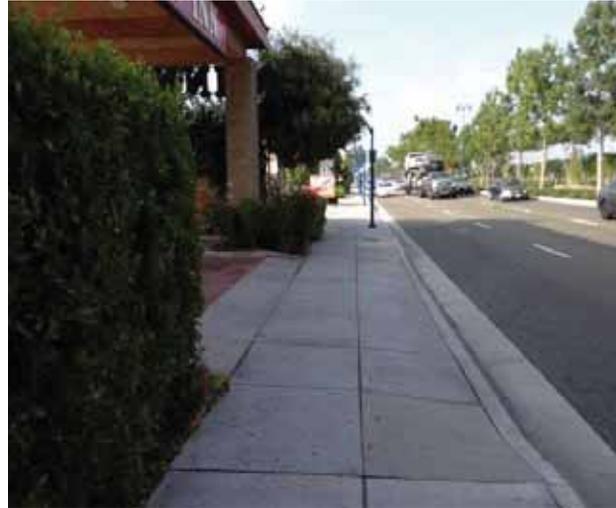
On-Site Finding Not Found

Install compliant detectable warnings \$190

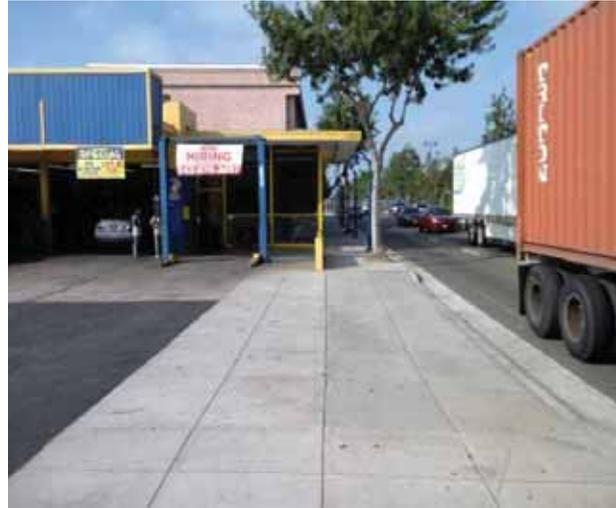
Code Reference ADA 705,CA 11B-705.1.2.5,CA 11B-247.1.2.5

Install compliant detectable warnings \$190

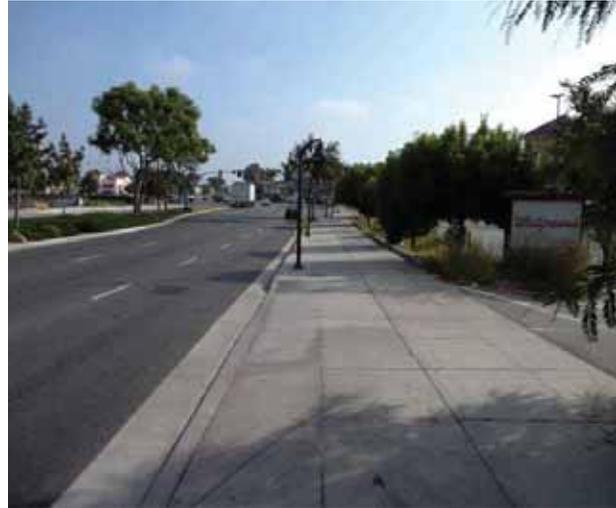
On-Site Finding Not Found

Code Reference ADA 705,CA 11B-705.1.2.5,CA 11B-247.1.2.5

Install compliant detectable warnings \$190

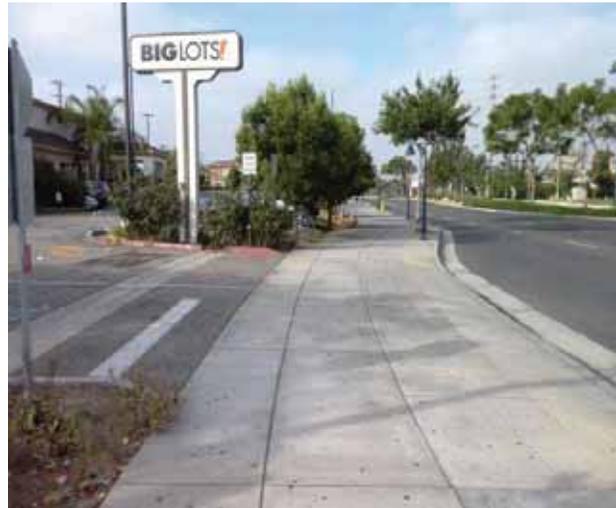
On-Site Finding Not Found

Code Reference ADA 705,CA 11B-705.1.2.5,CA 11B-247.1.2.5

Install compliant detectable warnings \$190

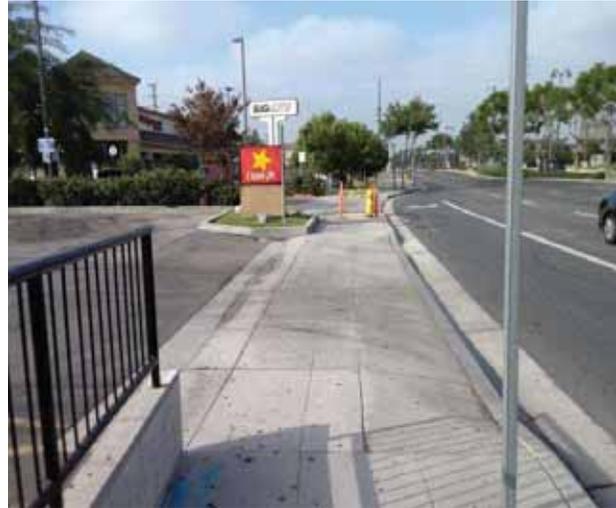
On-Site Finding Not Found

Code Reference ADA 705,CA 11B-705.1.2.5,CA 11B-247.1.2.5

Install compliant detectable warnings \$190

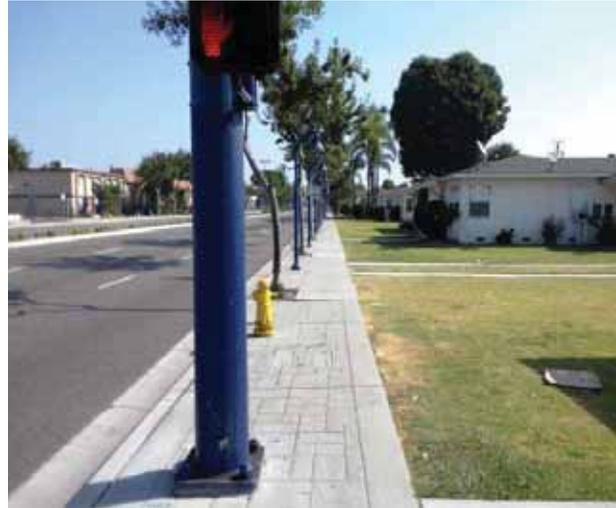
Sidewalks , Hazards & Gratings : Sidewalk Width at Obstruction

Code Reference ADA 206, 302, 403.5.1, CA 11B-403.5

Sidewalk width at the obstruction shall have the recommended value.

Recommendation At least 48.00 inches

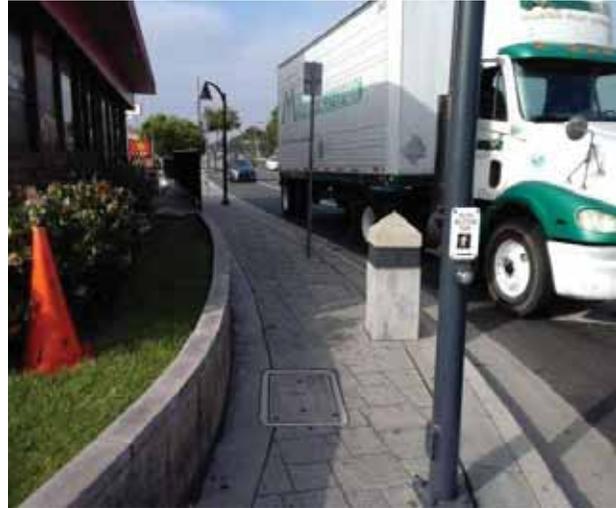
Sidewalks , Hazards & Gratings : Sidewalk Width at Obstruction

Code Reference ADA 206, 302, 403.5.1, CA 11B-403.5

Sidewalk width at the obstruction shall have the recommended value.

Recommendation At least 48.00 inches

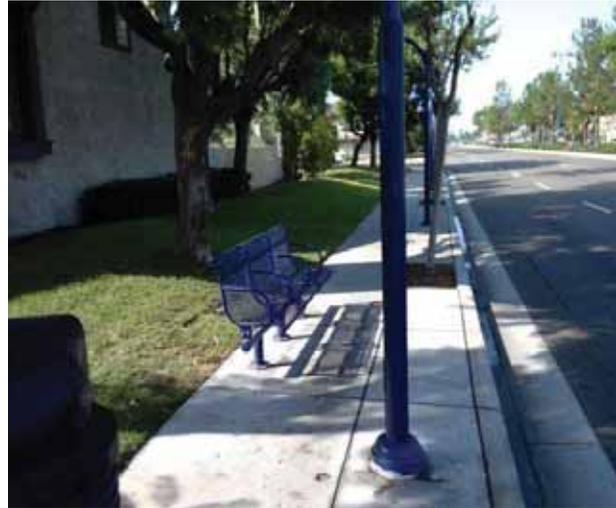
Sidewalks , Hazards & Gratings : Sidewalk Width at Obstruction

Code Reference ADA 206, 302, 403.5.1, CA 11B-403.5

Sidewalk width at the obstruction shall have the recommended value.

Recommendation At least 48.00 inches

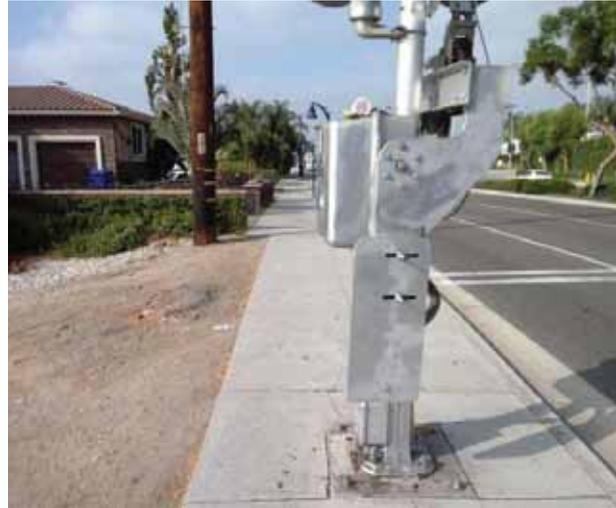
Sidewalks , Hazards & Gratings : Protruding Object Height

Code Reference ADA 307.2,CA 11B-307.2

Recommendation Up to 4.00 inches

Install wing walls or relocate object \$640

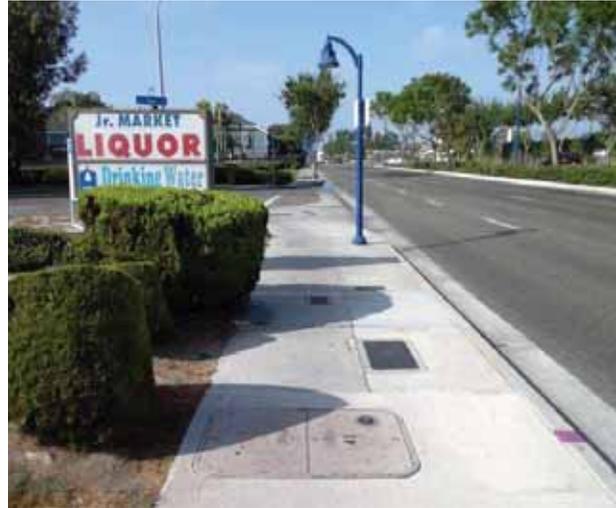
Code Reference ADA 206, 302, CA 11B-403.3

Repave the sidewalk surface with the recommended cross slope.

Recommendation Up to 2.08 percent

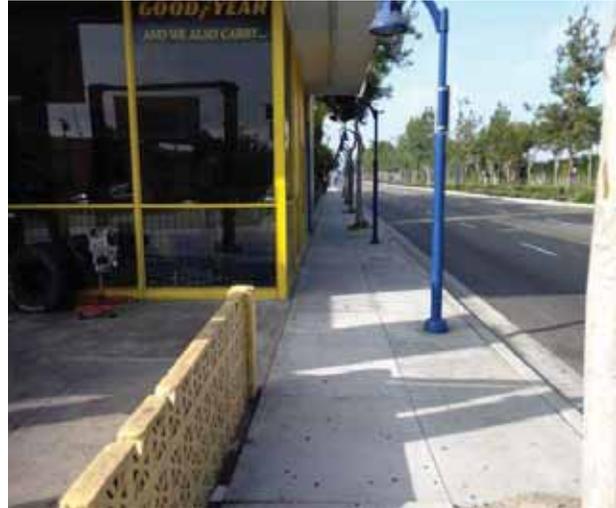
Code Reference ADA 206, 302, CA 11B-403.3

Repave the sidewalk surface with the recommended cross slope.

Recommendation Up to 2.08 percent

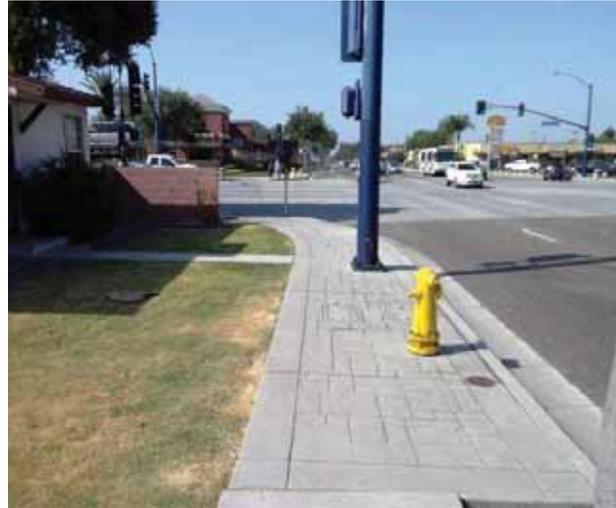
Code Reference ADA 206, 302, CA 11B-403.3

Repave the sidewalk surface with the recommended cross slope.

Recommendation Up to 2.08 percent

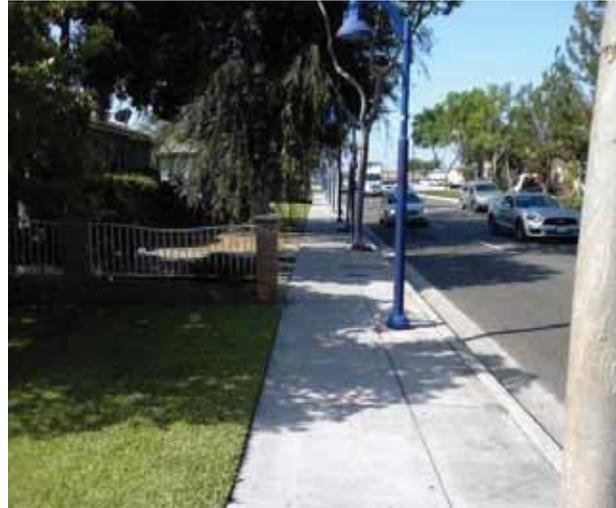
Code Reference ADA 206, 302, CA 11B-403.3

Repave the sidewalk surface with the recommended cross slope.

Recommendation Up to 2.08 percent

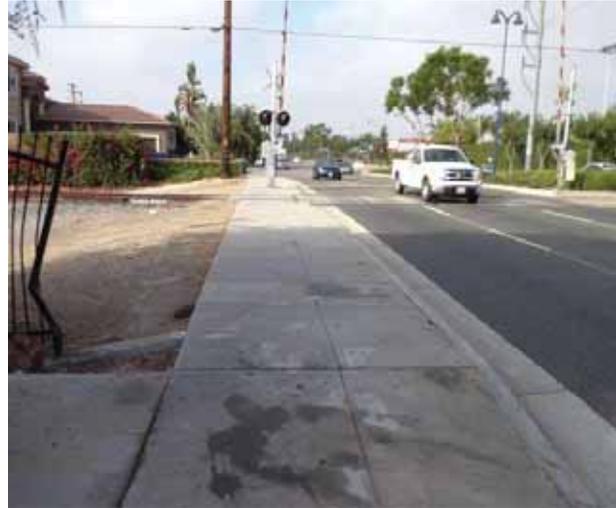
Code Reference ADA 206, 302

Repave the sidewalk surface with the recommended running slope.

Recommendation Up to 5.00 percent

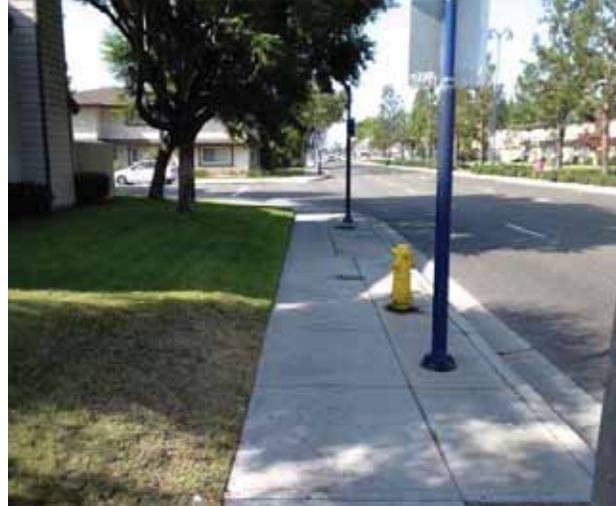
Code Reference ADA 206, 302, CA 11B-403.3

Repave the sidewalk surface with the recommended cross slope.

Recommendation Up to 2.08 percent

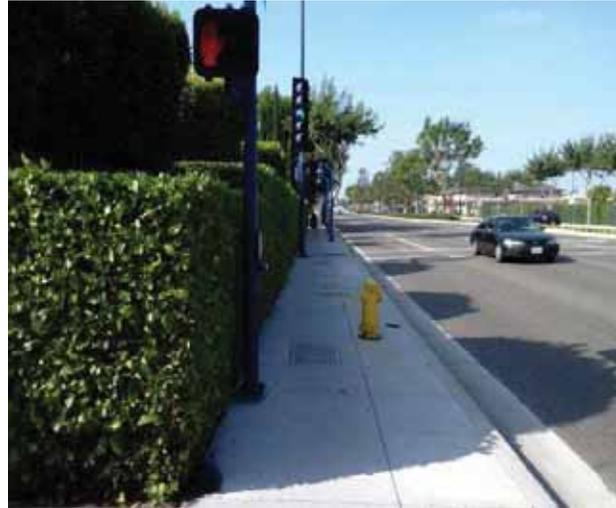
Code Reference ADA 206, 302, CA 11B-403.3

Repave the sidewalk surface with the recommended cross slope.

Recommendation Up to 2.08 percent

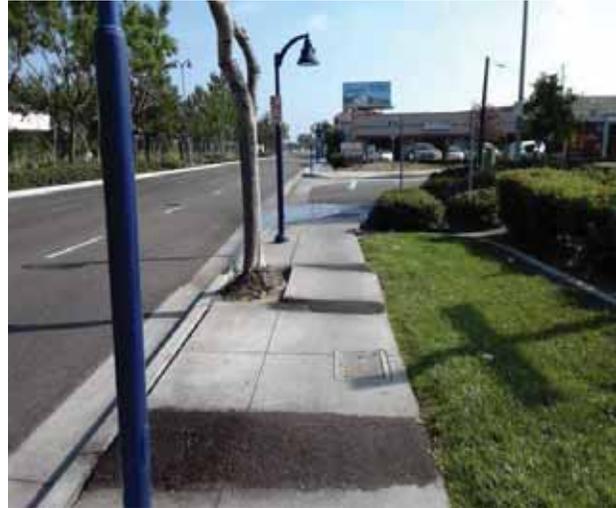
Code Reference ADA 206, 302,CA 11B-403.5.1

Notes : Surface is Rough And Uneven

Widen the sidewalk to the recommended value.

Recommendation At least 48.00 inches

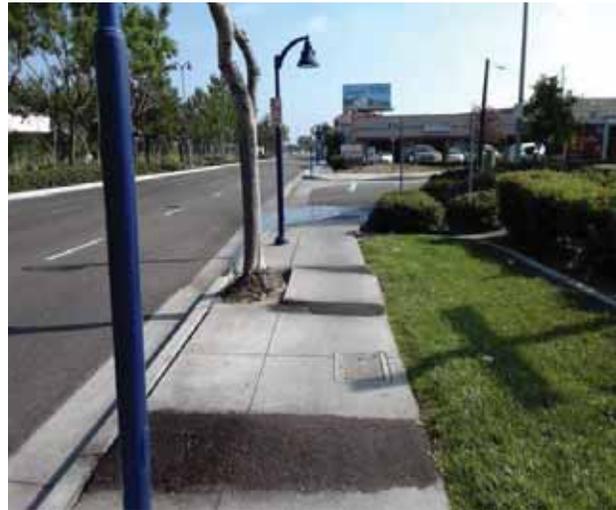
Code Reference ADA 206, 302,CA 11B-403.3

Notes : Surface is Rough And Uneven

Repave the sidewalk surface with the recommended cross slope.

Recommendation Up to 2.08 percent

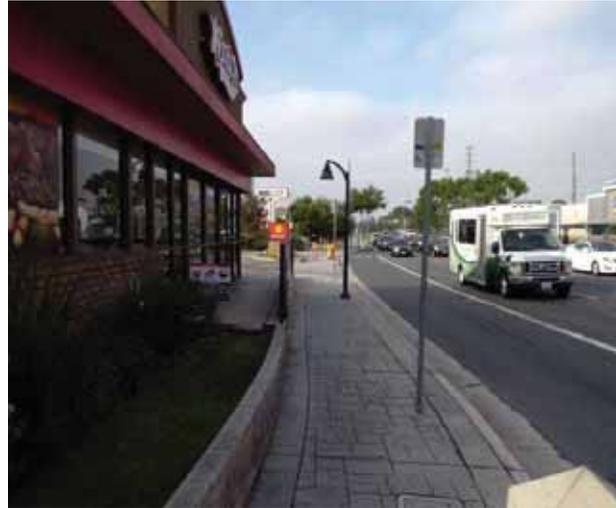
On-Site Finding Not Found

Code Reference ADA 206, 302

\$2,400

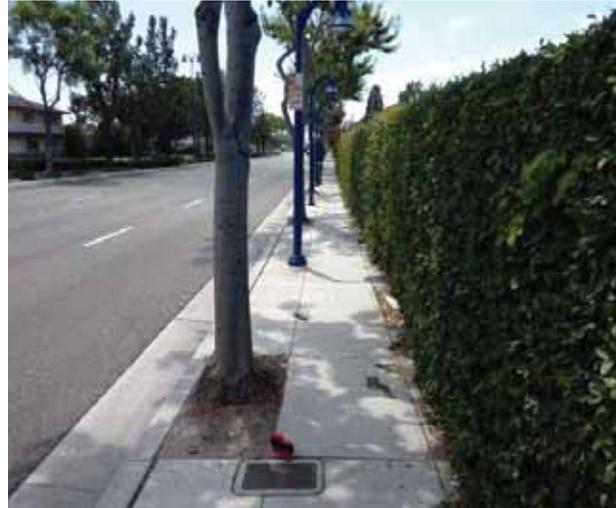
There is a change in elevation greater than recommended value.

Ensure that the change in elevation is within the recommended value.

Recommendation Up to 0.25 inches

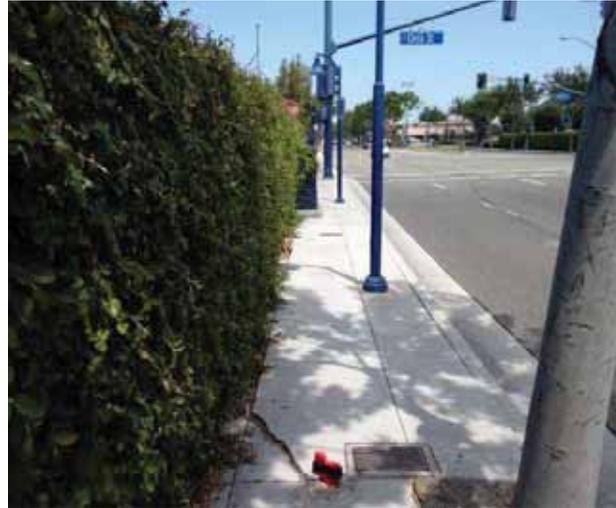
There is a change in elevation greater than recommended value.

Ensure that the change in elevation is within the recommended value.

Recommendation Up to 0.25 inches

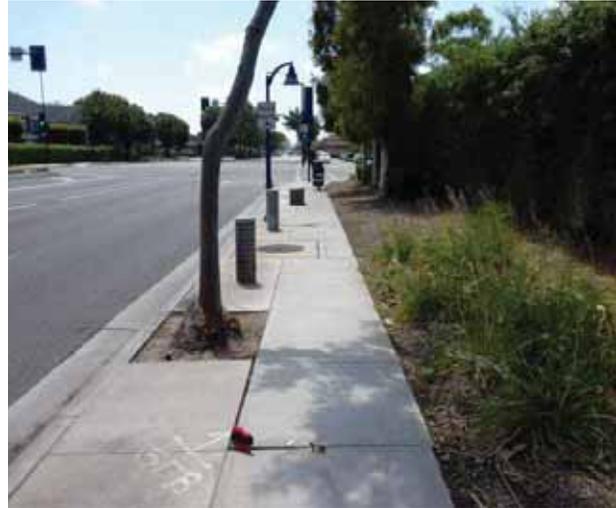
There is a change in elevation greater than recommended value.

Ensure that the change in elevation is within the recommended value.

Recommendation Up to 0.25 inches

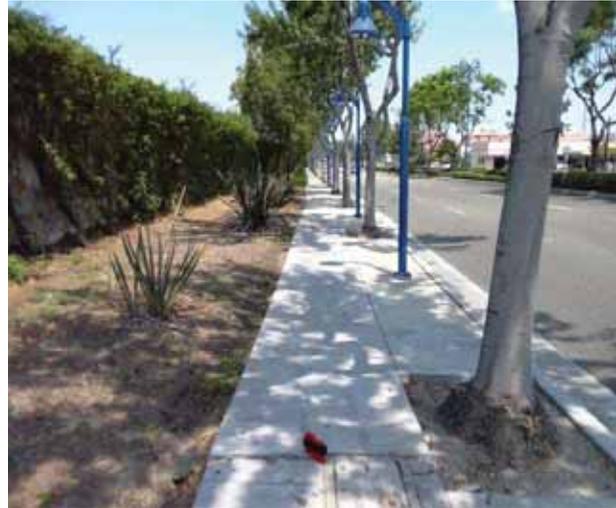
There is a change in elevation greater than recommended value.

Ensure that the change in elevation is within the recommended value.

Recommendation Up to 0.25 inches

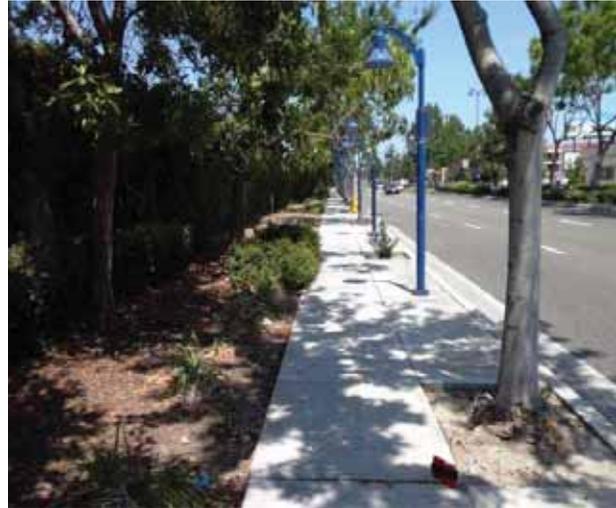
There is a change in elevation greater than recommended value.

Ensure that the change in elevation is within the recommended value.

Recommendation Up to 0.25 inches

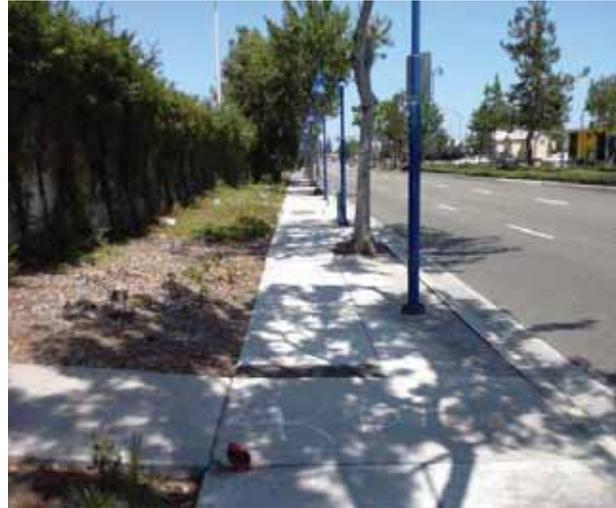
There is a change in elevation greater than recommended value.

Ensure that the change in elevation is within the recommended value.

Recommendation Up to 0.25 inches

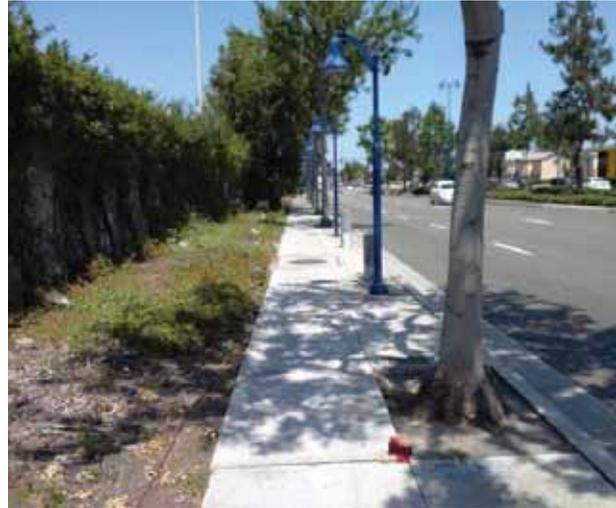
There is a change in elevation greater than recommended value.

Ensure that the change in elevation is within the recommended value.

Recommendation Up to 0.25 inches

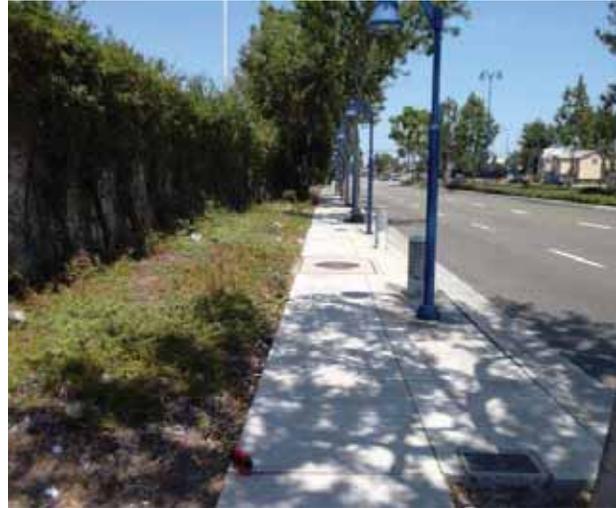
There is a change in elevation greater than recommended value.

Ensure that the change in elevation is within the recommended value.

Recommendation Up to 0.25 inches

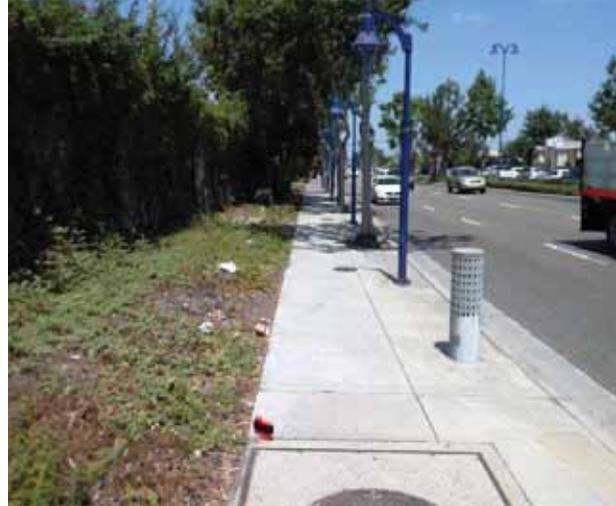
There is a change in elevation greater than recommended value.

Ensure that the change in elevation is within the recommended value.

Recommendation Up to 0.25 inches

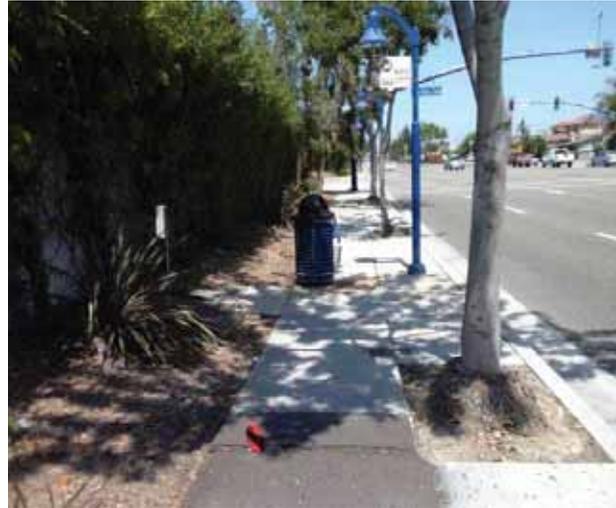
There is a change in elevation greater than recommended value.

Ensure that the change in elevation is within the recommended value.

Recommendation Up to 0.25 inches

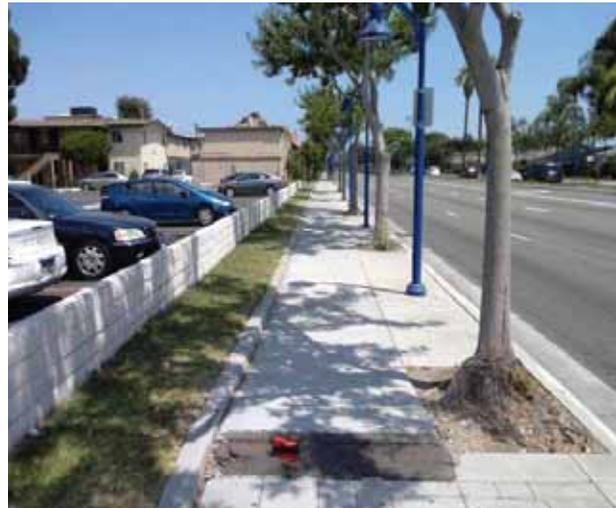
There is a change in elevation greater than recommended value.

Ensure that the change in elevation is within the recommended value.

Recommendation Up to 0.25 inches

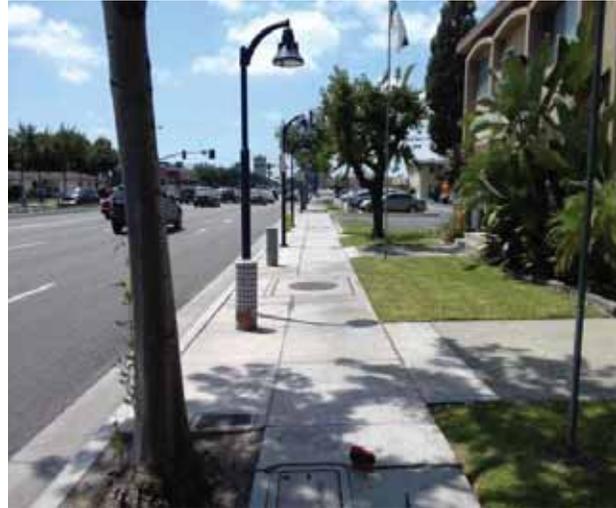
There is a change in elevation greater than recommended value.

Ensure that the change in elevation is within the recommended value.

Recommendation Up to 0.25 inches

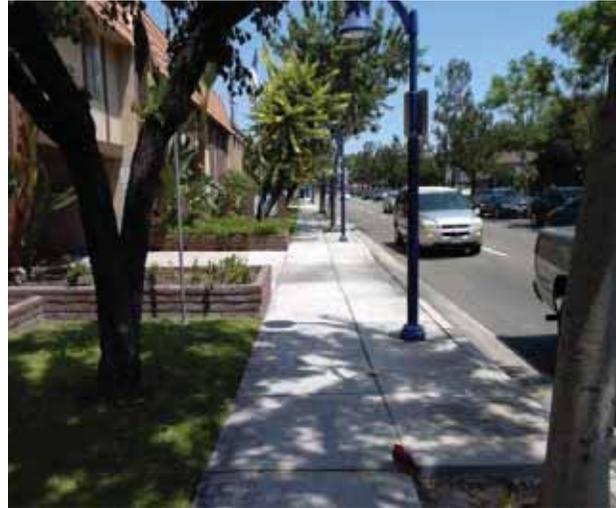
There is a change in elevation greater than recommended value.

Ensure that the change in elevation is within the recommended value.

Recommendation Up to 0.25 inches

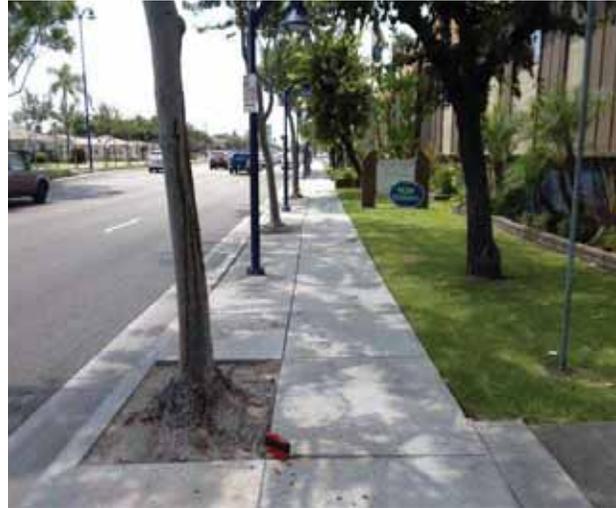
There is a change in elevation greater than recommended value.

Ensure that the change in elevation is within the recommended value.

Recommendation Up to 0.25 inches

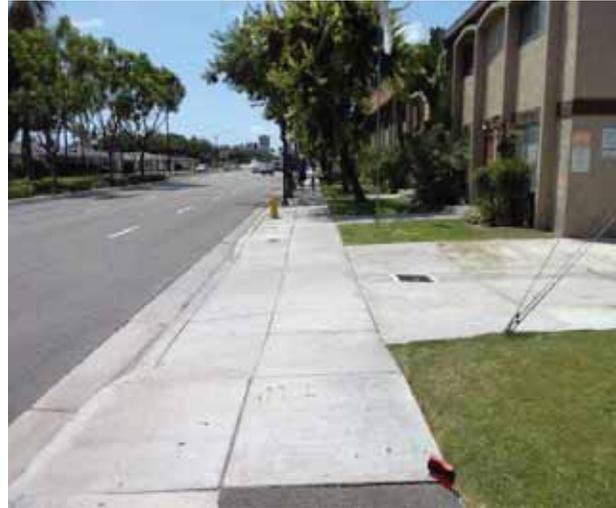
There is a change in elevation greater than recommended value.

Remove tripping hazards \$198
