Accessibility Survey

City of Downey Lakewood Boulevard & Columbia Way

Date of Inspection
5/25/2017

Disability Access Consultants

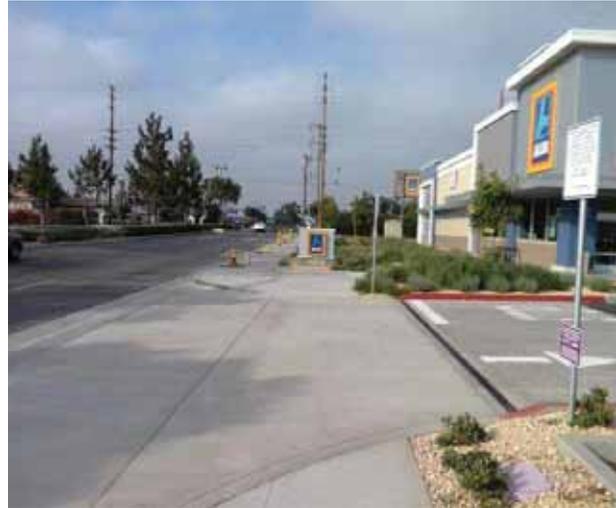
Code Reference ADA 705,CA 11B-705.1.2.5,CA 11B-247.1.2.5

Install compliant detectable warnings \$190

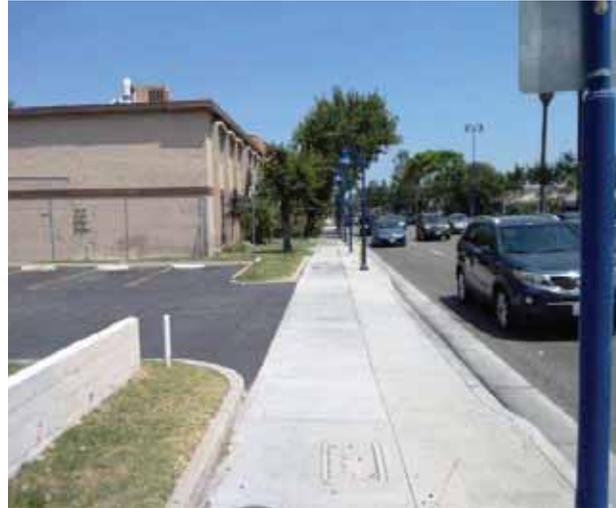
Code Reference ADA 705,CA 11B-705.1.2.5,CA 11B-247.1.2.5

Install compliant detectable warnings \$190

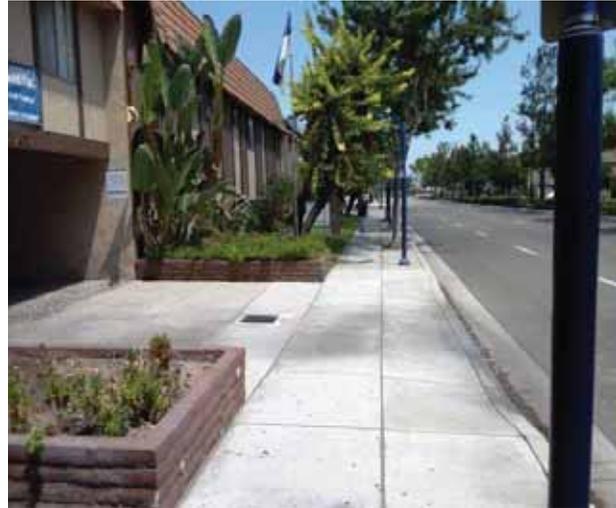
Code Reference ADA 705,CA 11B-705.1.2.5,CA 11B-247.1.2.5

Install compliant detectable warnings \$190

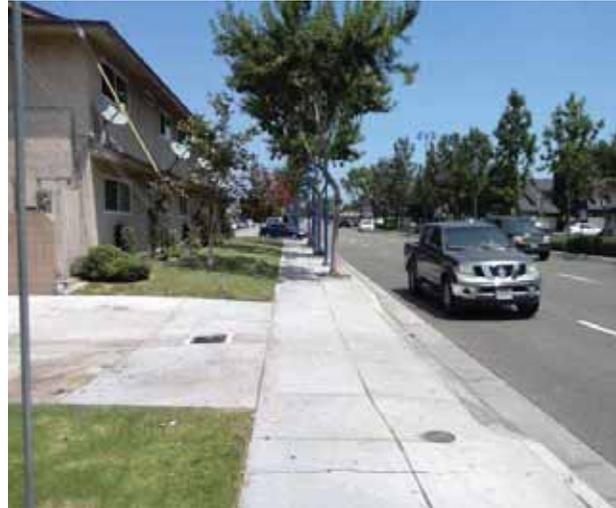
Code Reference ADA 705,CA 11B-705.1.2.5,CA 11B-247.1.2.5

Install compliant detectable warnings \$190

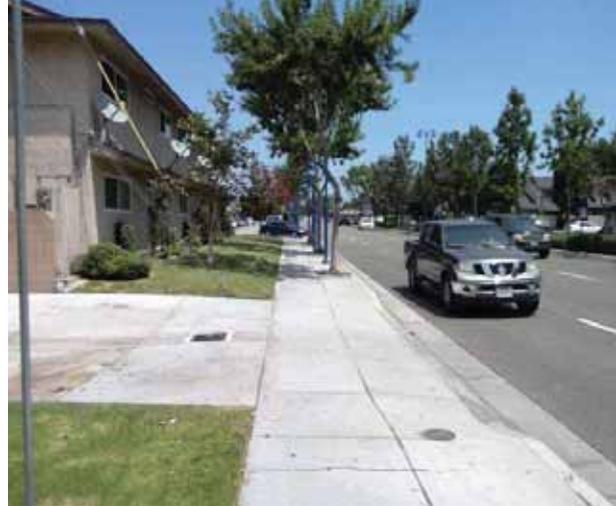
Code Reference ADA 206, 302, CA 11B-403.3

Repave surface \$1,092

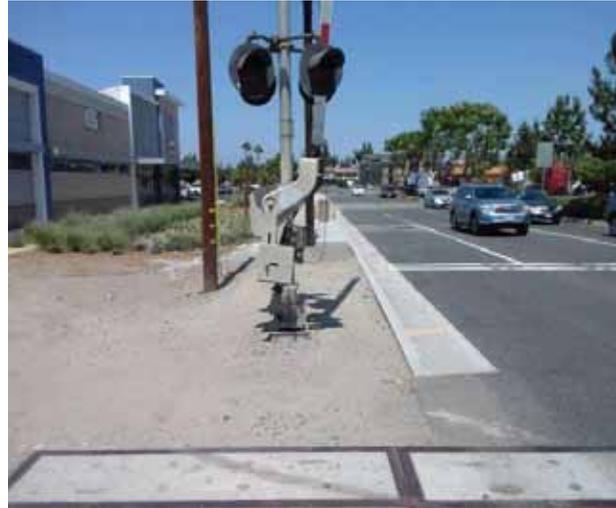
Section of sidewalk is missing and consists of dirt, grass or gravel.

Provide a compliant sidewalk for the missing section.

\$1,260

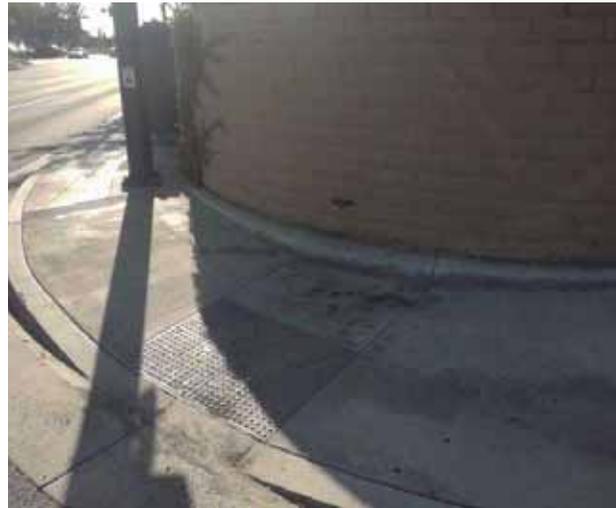
Recommendation Up to 2.08 percent

Provide compliant landing \$240

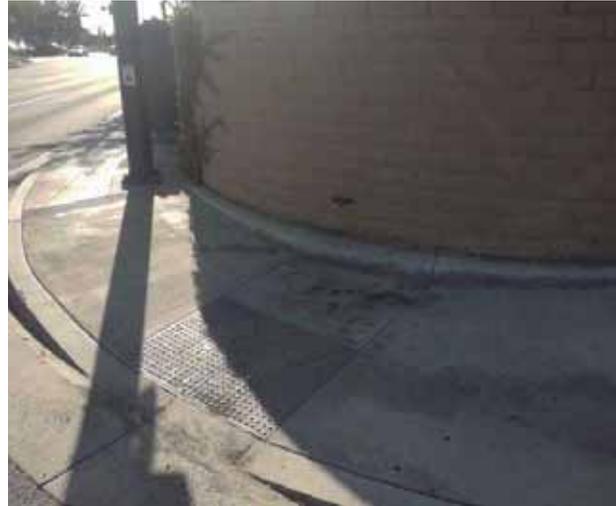
Recommendation Up to 2.08 percent

Provide compliant landing \$1,260

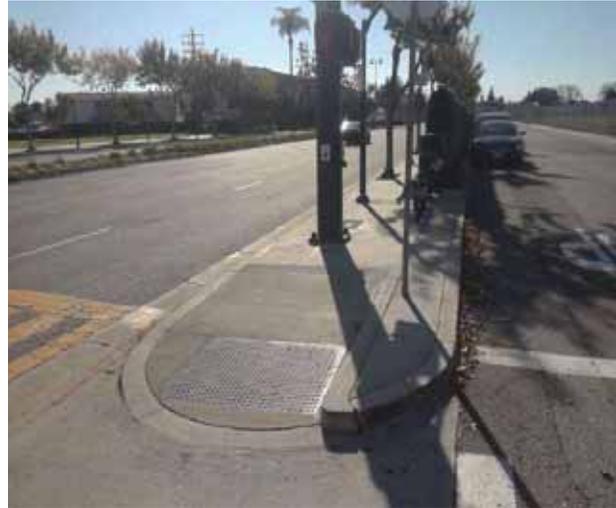
On-Site Finding Not Found

Install crosswalk \$800

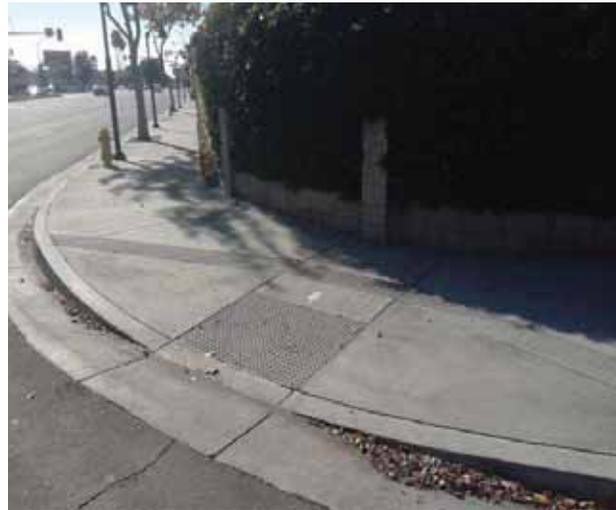
Recommendation Up to 8.33 percent

Install curb ramp \$1,300

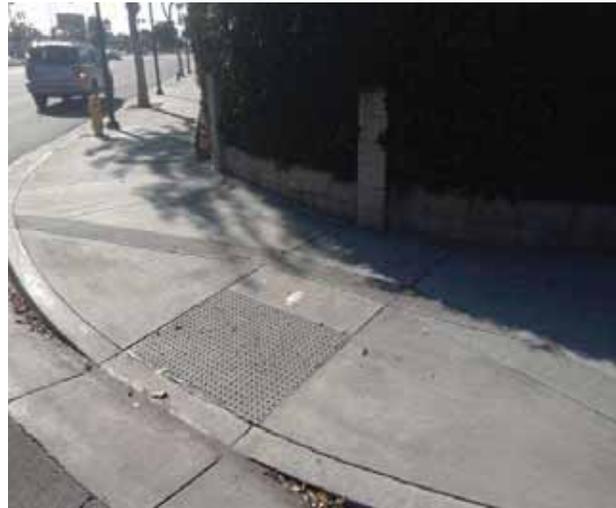
Recommendation Up to 5.00 percent

Repave landing \$1,260

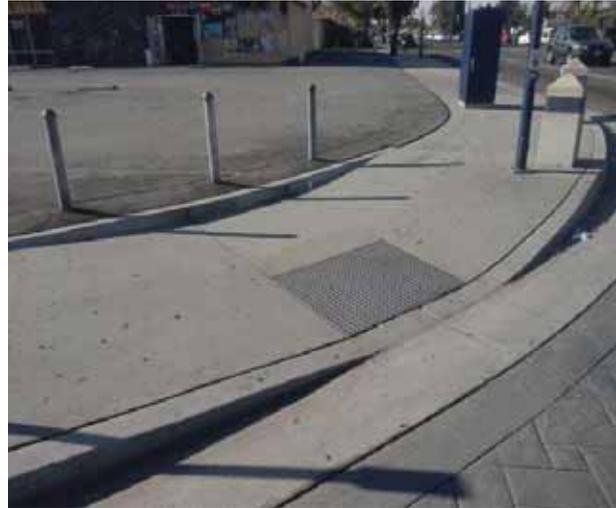
On-Site Finding Not Found

Install crosswalk \$800

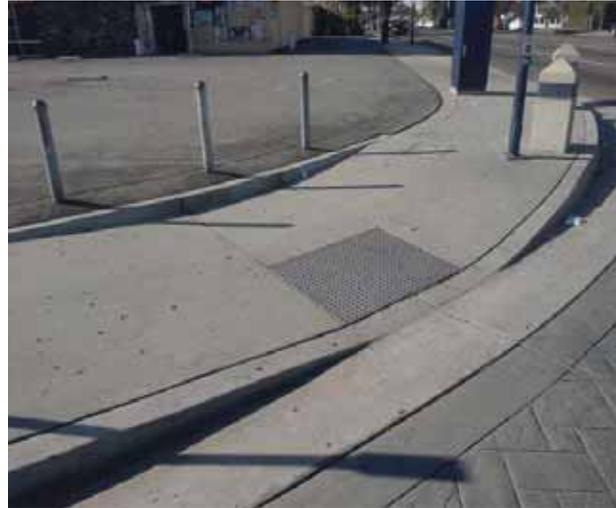
Recommendation Up to 5.00 percent

Repave landing \$1,260

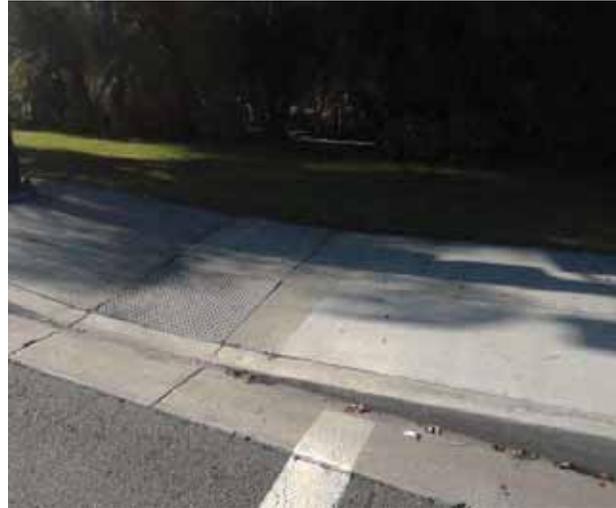
Recommendation Up to 2.08 percent

Install curb ramp \$1,300

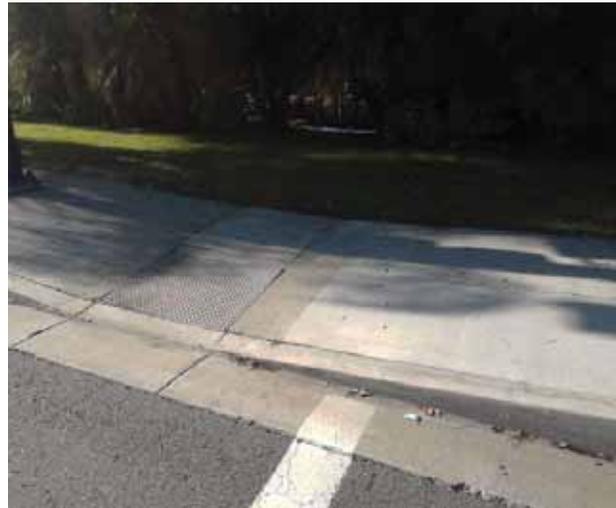
Recommendation Up to 2.08 percent

Provide compliant landing \$240

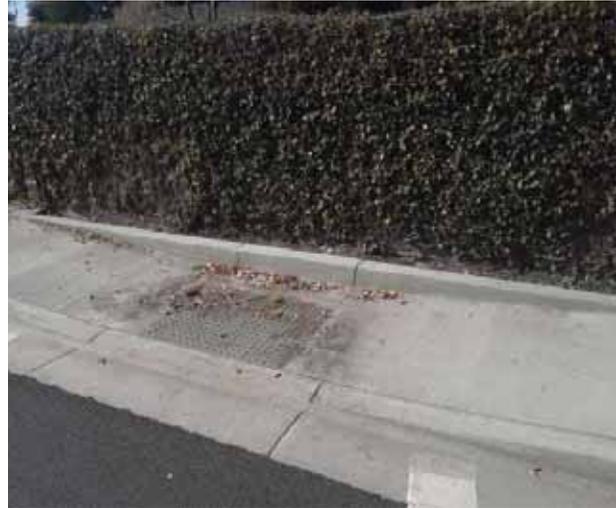
Recommendation At least 48.00 inches

Install curb ramp \$1,300

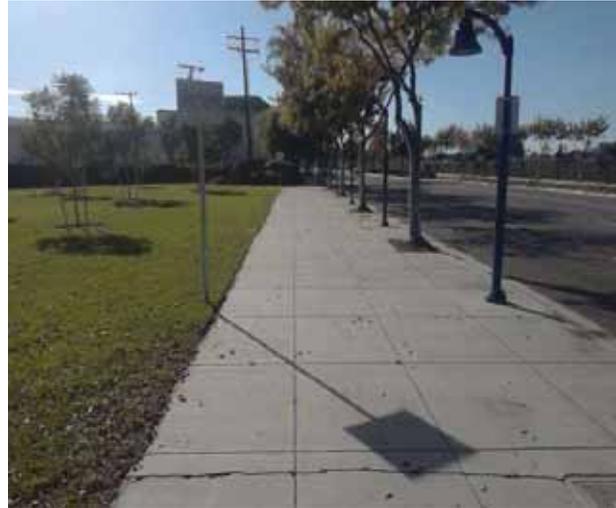
There is a change in elevation greater than recommended value.

Ensure that the change in elevation is within the recommended value.

Remove tripping hazards \$198

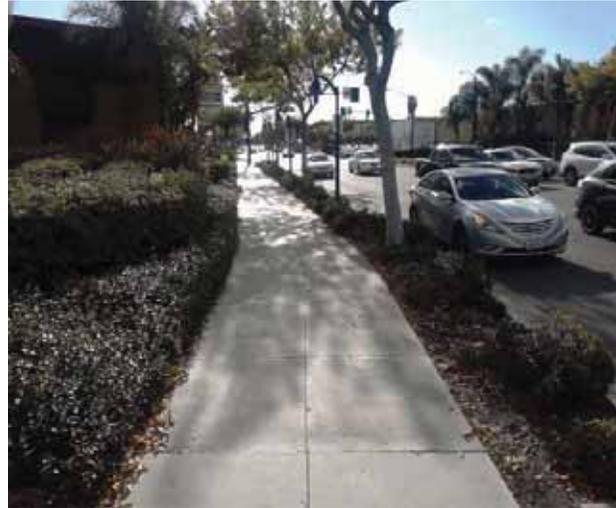
There is a change in elevation greater than recommended value.

Ensure that the change in elevation is within the recommended value.

Remove tripping hazards \$198

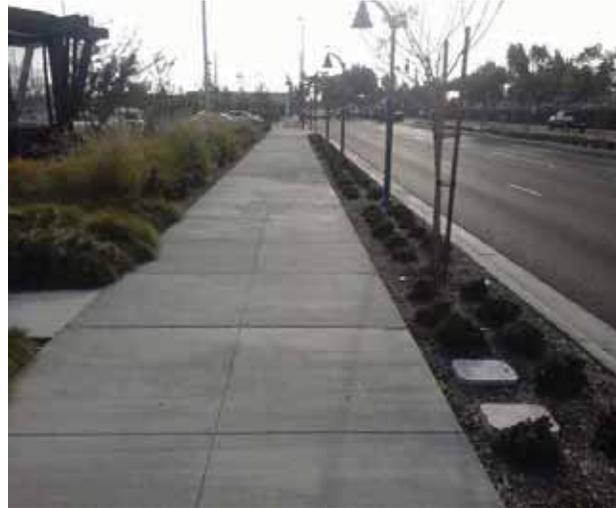
Recommendation Up to 2.08 percent

Repave the sidewalk surface with the recommended cross slope.

Repave surface \$1,092

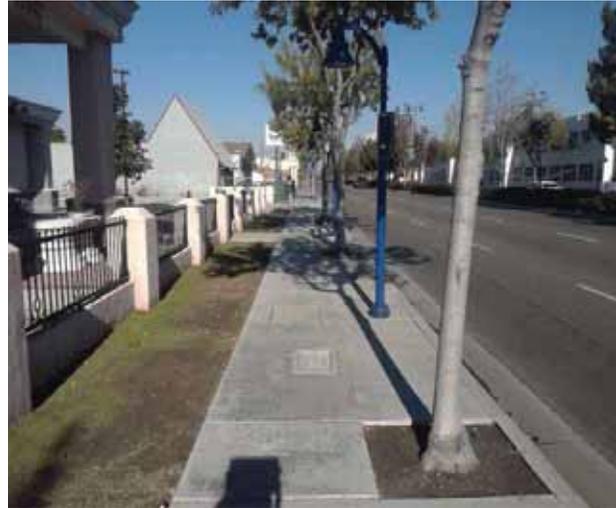
There is a change in elevation greater than recommended value.

Ensure that the change in elevation is within the recommended value.

Remove tripping hazards \$198

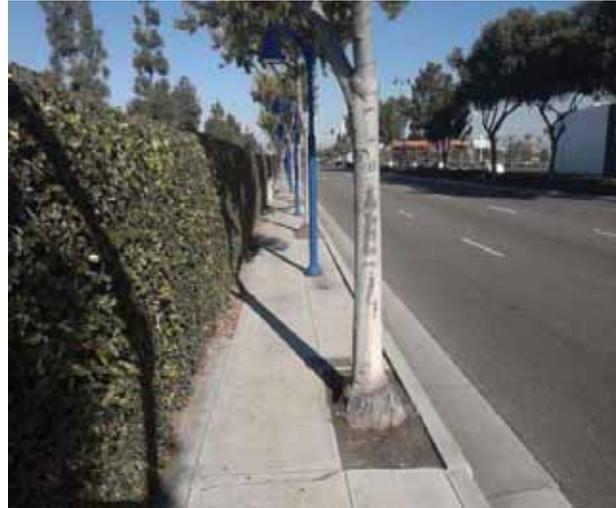
There is a change in elevation greater than recommended value.

Ensure that the change in elevation is within the recommended value.

Remove tripping hazards \$198

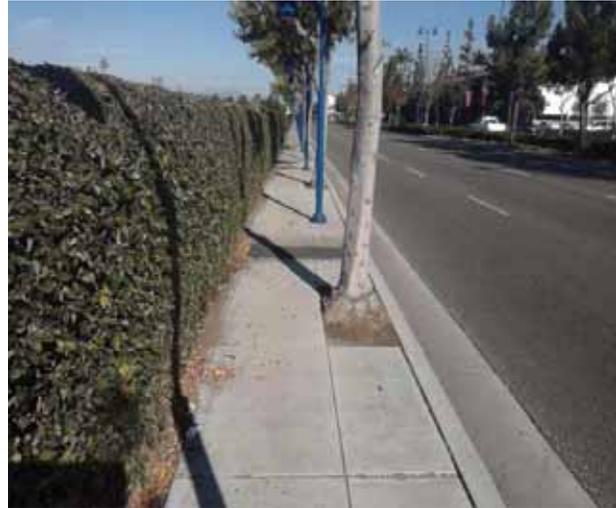
There is a change in elevation greater than recommended value.

Ensure that the change in elevation is within the recommended value.

Remove tripping hazards \$198

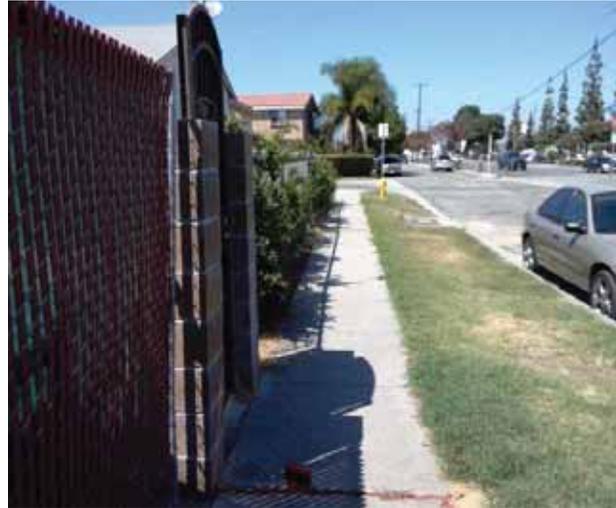
There is a change in elevation greater than recommended value.

Ensure that the change in elevation is within the recommended value.

Recommendation Up to 0.25 inches

Remove tripping hazards \$198

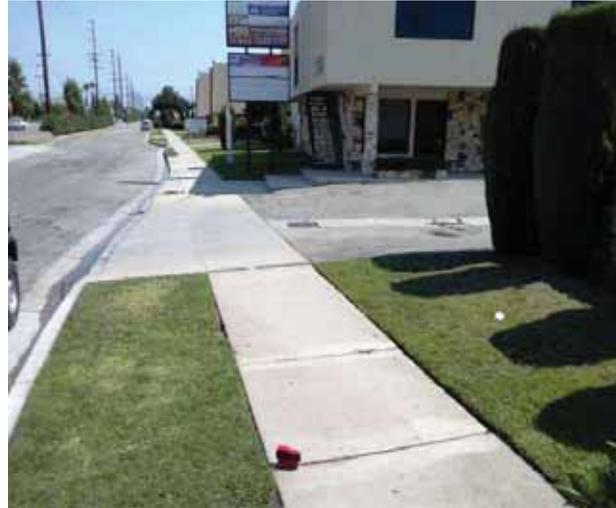
There is a change in elevation greater than recommended value.

Ensure that the change in elevation is within the recommended value.

Recommendation Up to 0.25 inches

Remove tripping hazards \$198

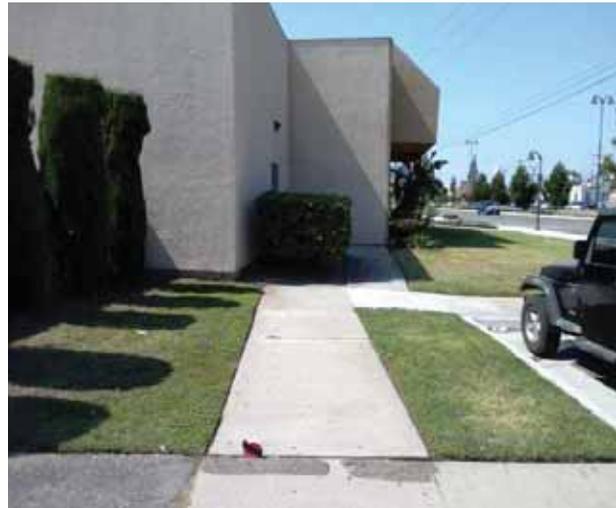
There is a change in elevation greater than recommended value.

Ensure that the change in elevation is within the recommended value.

Recommendation Up to 0.25 inches

Remove tripping hazards \$198

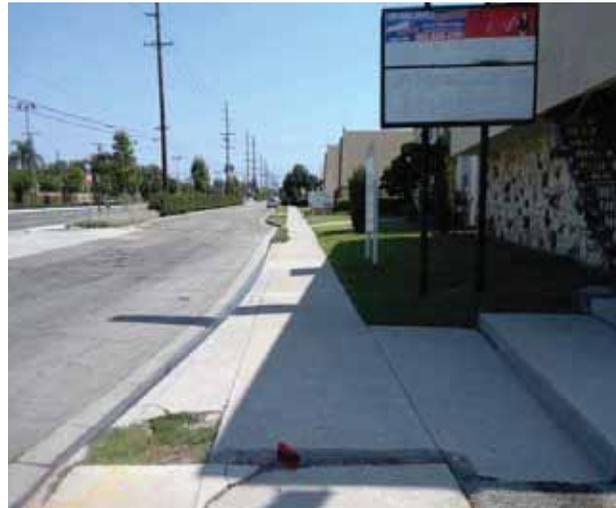
There is a change in elevation greater than recommended value.

Ensure that the change in elevation is within the recommended value.

Recommendation Up to 0.25 inches

Remove tripping hazards \$198

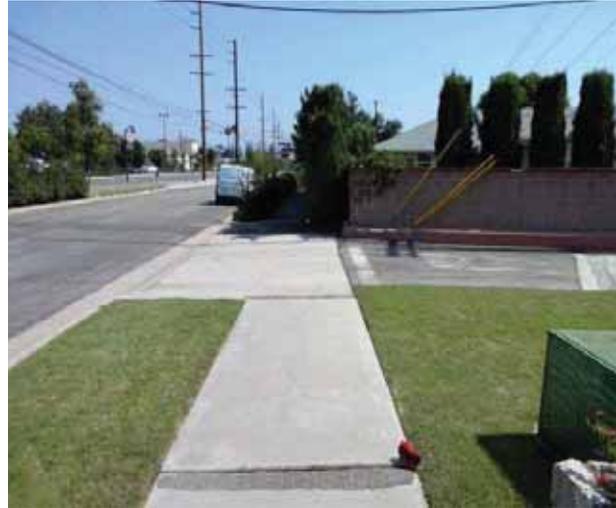
There is a change in elevation greater than recommended value.

Ensure that the change in elevation is within the recommended value.

Recommendation Up to 0.25 inches

Remove tripping hazards \$198

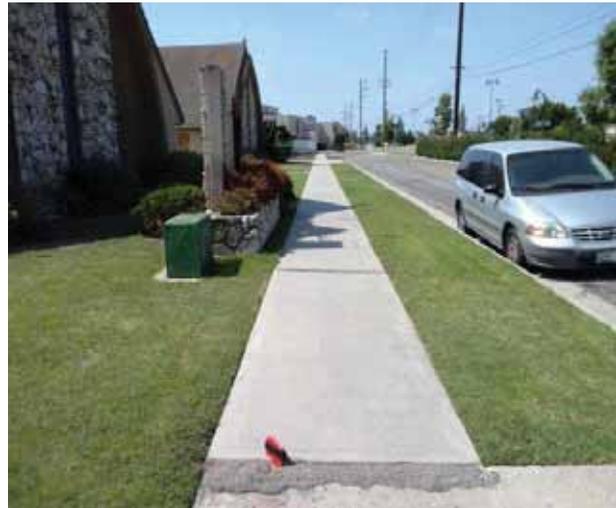
There is a change in elevation greater than recommended value.

Ensure that the change in elevation is within the recommended value.

Recommendation Up to 0.25 inches

Remove tripping hazards \$198

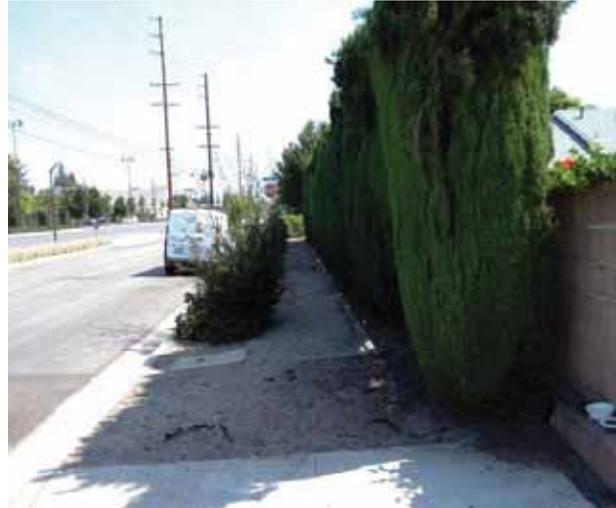
Sidewalks : Missing Sidewalk

Section of sidewalk is missing and consists of dirt, grass or gravel.

Provide a compliant sidewalk for the missing section.

\$1,260

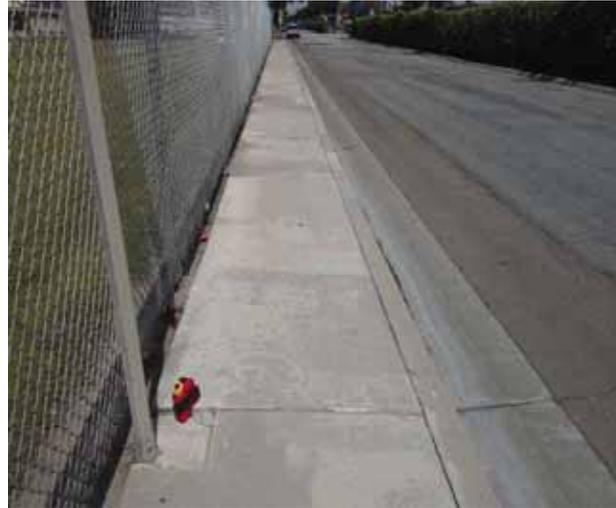
There is a change in elevation greater than recommended value.

Ensure that the change in elevation is within the recommended value.

Recommendation Up to 0.25 inches

Remove tripping hazards \$198

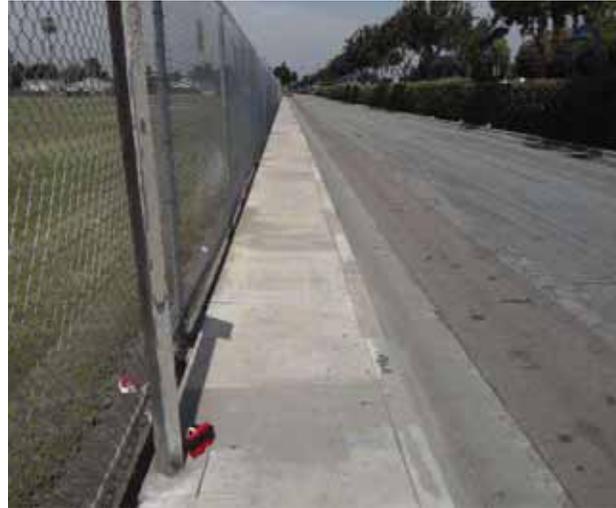
There is a change in elevation greater than recommended value.

Ensure that the change in elevation is within the recommended value.

Recommendation Up to 0.25 inches

Remove tripping hazards \$198

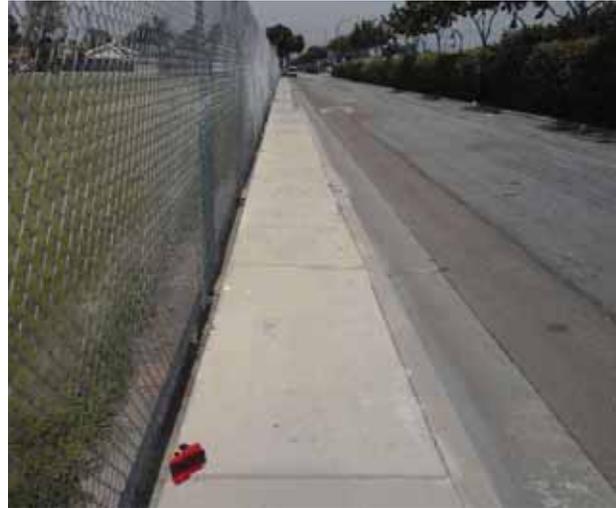
There is a change in elevation greater than recommended value.

Ensure that the change in elevation is within the recommended value.

Recommendation Up to 0.25 inches

Remove tripping hazards \$198

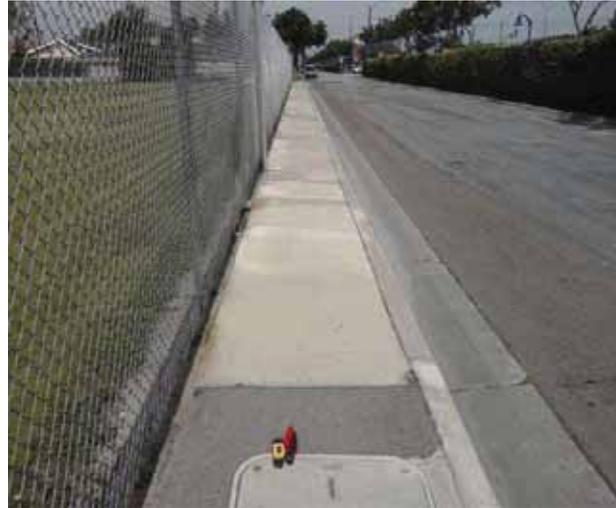
There is a change in elevation greater than recommended value.

Ensure that the change in elevation is within the recommended value.

Recommendation Up to 0.25 inches

Remove tripping hazards \$198

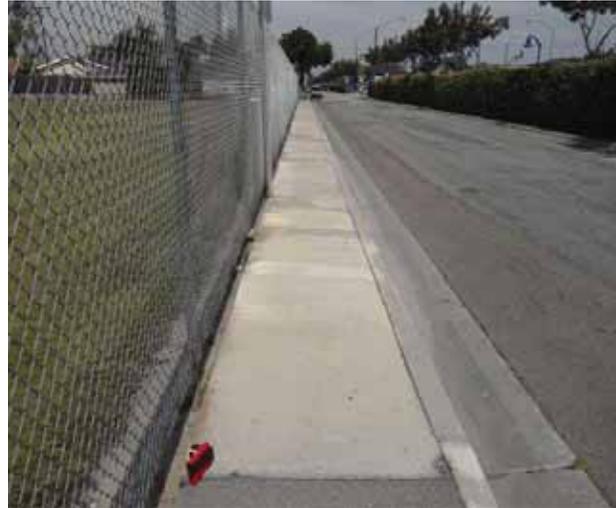
There is a change in elevation greater than recommended value.

Ensure that the change in elevation is within the recommended value.

Recommendation Up to 0.25 inches

Remove tripping hazards \$198

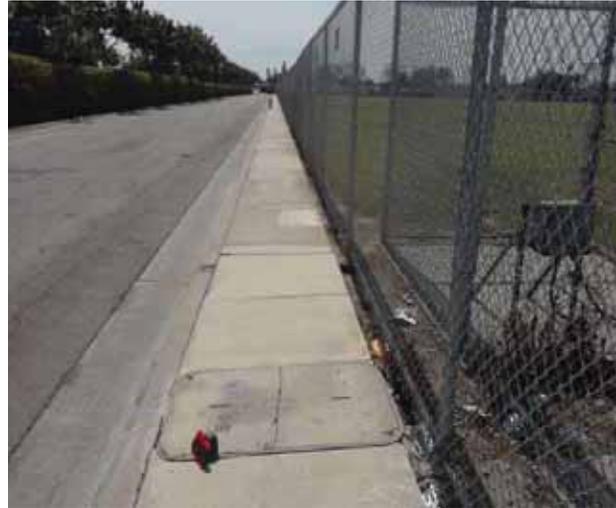
There is a change in elevation greater than recommended value.

Ensure that the change in elevation is within the recommended value.

Recommendation Up to 0.25 inches

Remove tripping hazards \$198

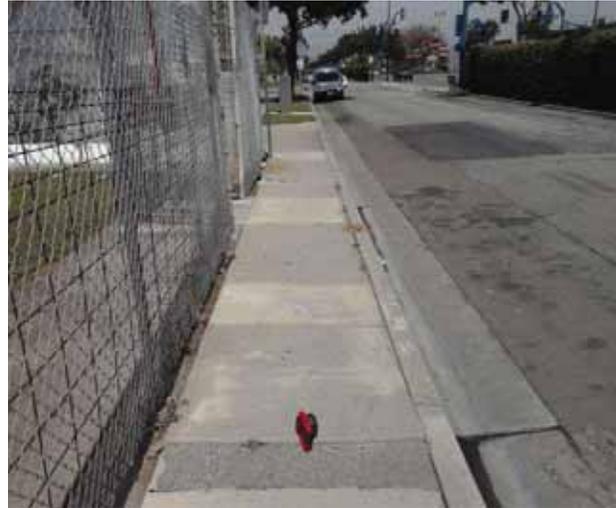
There is a change in elevation greater than recommended value.

Ensure that the change in elevation is within the recommended value.

Recommendation Up to 0.25 inches

Remove tripping hazards \$198

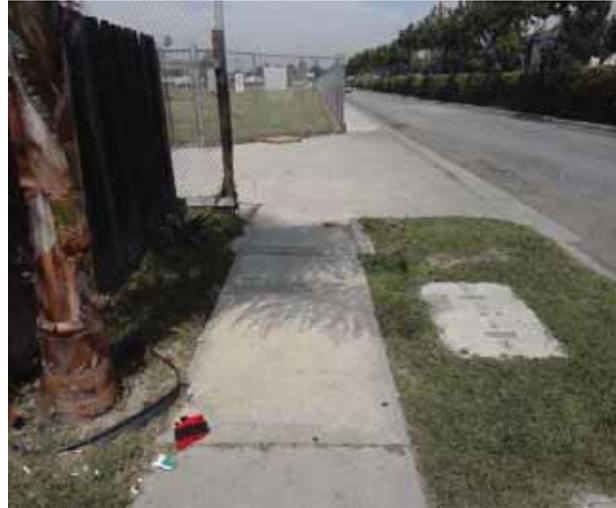
There is a change in elevation greater than recommended value.

Ensure that the change in elevation is within the recommended value.

Recommendation Up to 0.25 inches

Remove tripping hazards \$198

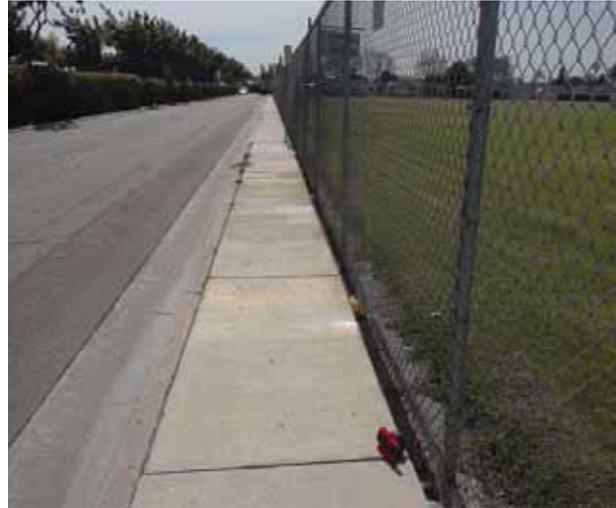
There is a change in elevation greater than recommended value.

Ensure that the change in elevation is within the recommended value.

Recommendation Up to 0.25 inches

Remove tripping hazards \$198

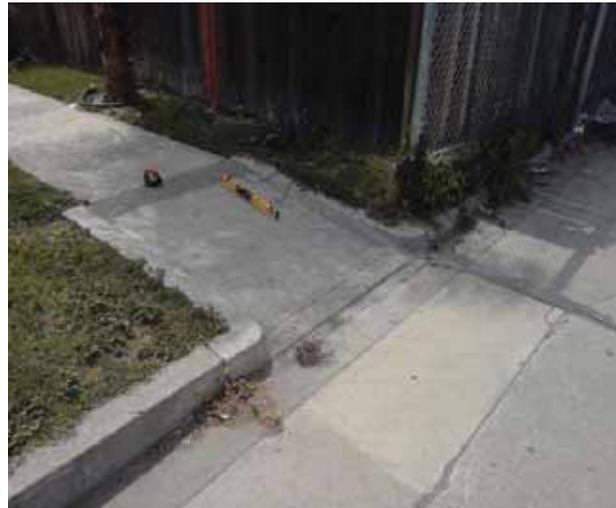
On-Site Finding Not Found

Provide detectable warning to surface \$248

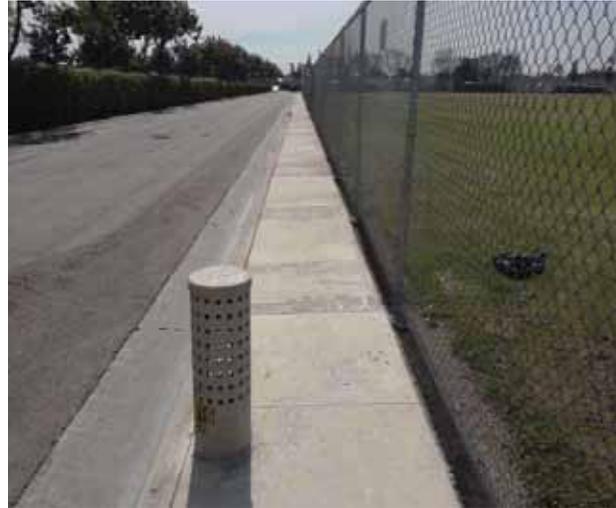
Sidewalks , Hazards & Gratings : Sidewalk Width at Obstruction

Sidewalk width at the obstruction shall have the recommended value.

Recommendation At least 48.00 inches

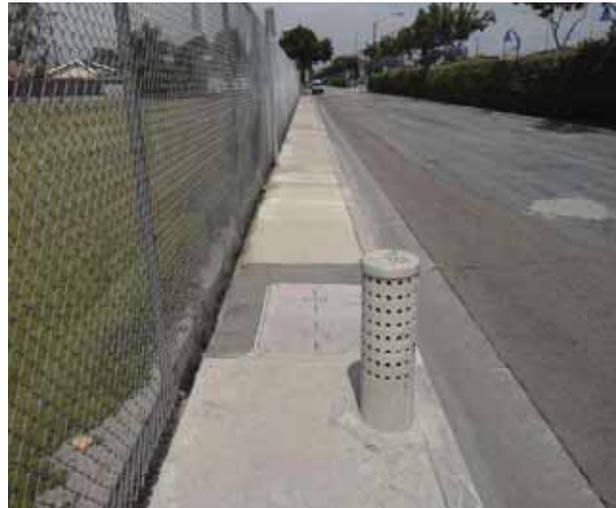
Sidewalks , Hazards & Gratings : Sidewalk Width at Obstruction

Sidewalk width at the obstruction shall have the recommended value.

Recommendation At least 48.00 inches

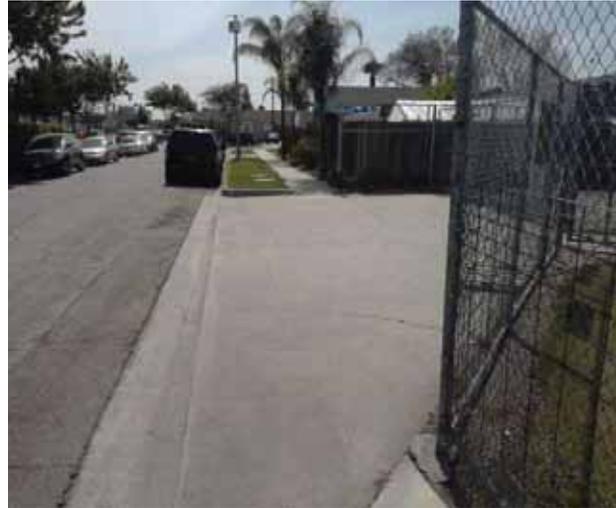
On-Site Finding Not Found

Install compliant detectable warnings \$190

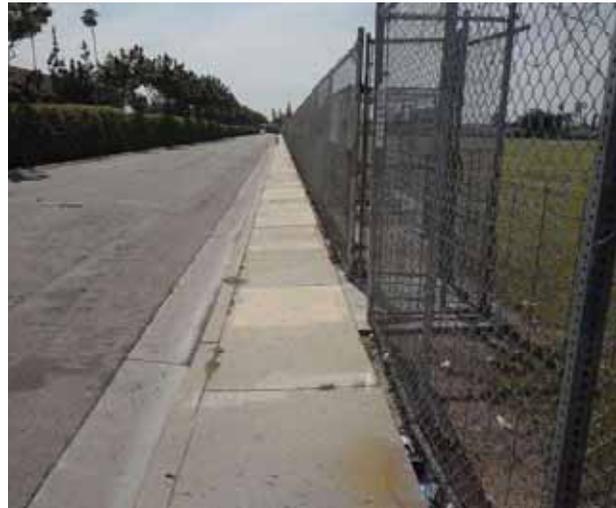
Notes : Has 2 Dropoffs of 4.5"

Repave the sidewalk surface with the recommended cross slope.

Recommendation Up to 2.08 percent

Repave surface \$1,092

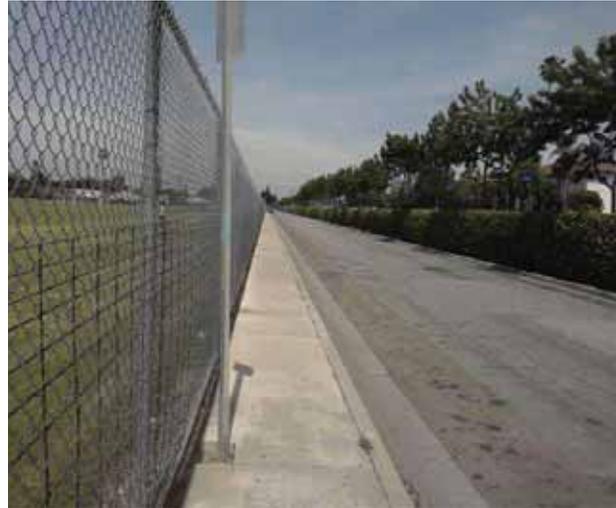
Sidewalks , Hazards & Gratings : Sidewalk Width at Obstruction

Sidewalk width at the obstruction shall have the recommended value.

Recommendation At least 48.00 inches

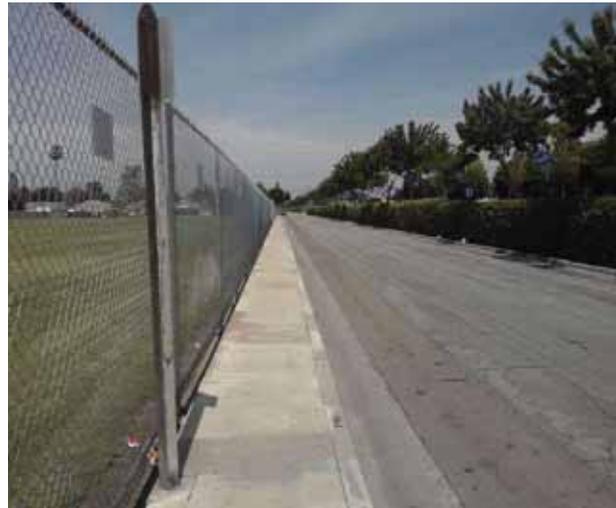
Sidewalks , Hazards & Gratings : Sidewalk Width at Obstruction

Sidewalk width at the obstruction shall have the recommended value.

Recommendation At least 48.00 inches

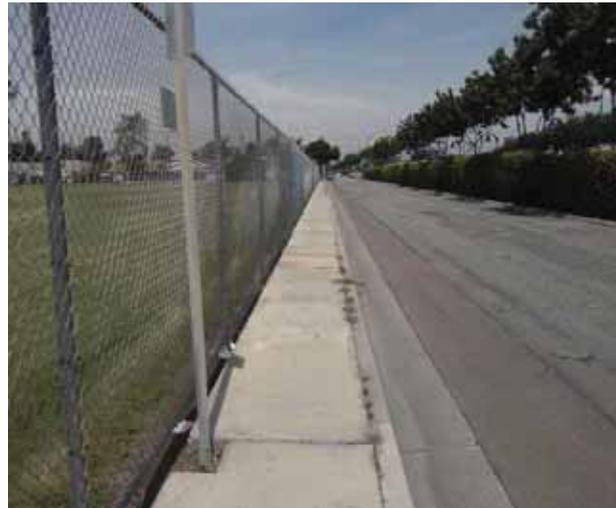
Sidewalks , Hazards & Gratings : Sidewalk Width at Obstruction

Sidewalk width at the obstruction shall have the recommended value.

Recommendation At least 48.00 inches

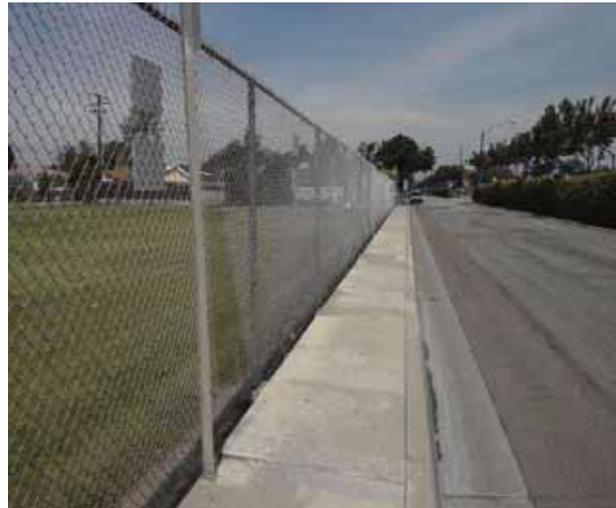
Sidewalks , Hazards & Gratings : Sidewalk Width at Obstruction

Sidewalk width at the obstruction shall have the recommended value.

Recommendation At least 48.00 inches

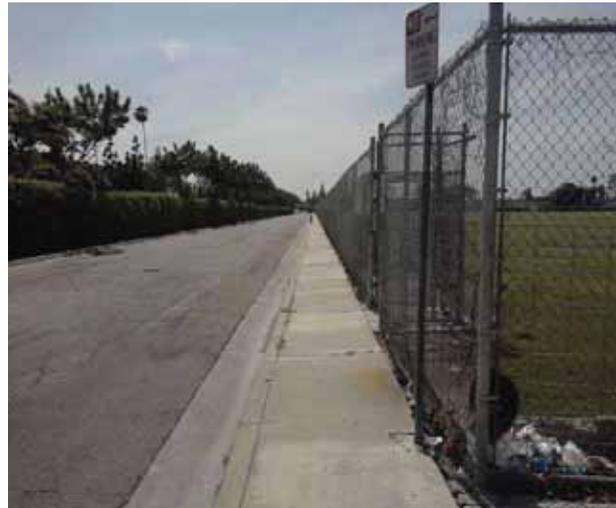
Sidewalks , Hazards & Gratings : Sidewalk Width at Obstruction

Sidewalk width at the obstruction shall have the recommended value.

Recommendation At least 48.00 inches
