Accessibility Survey

City of Downey Birchdale Avenue - 5th Street To End

Date of Inspection
4/18/2017

Disability Access Consultants

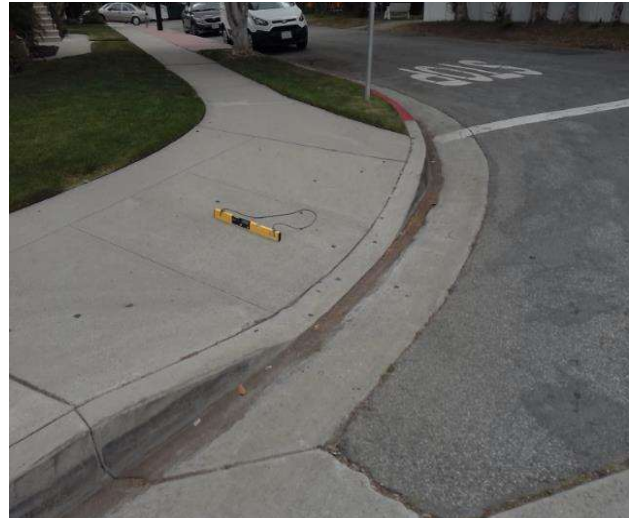
Recommendation

Recommendation Up to 2.08 percent

Install curb ramp \$1,300

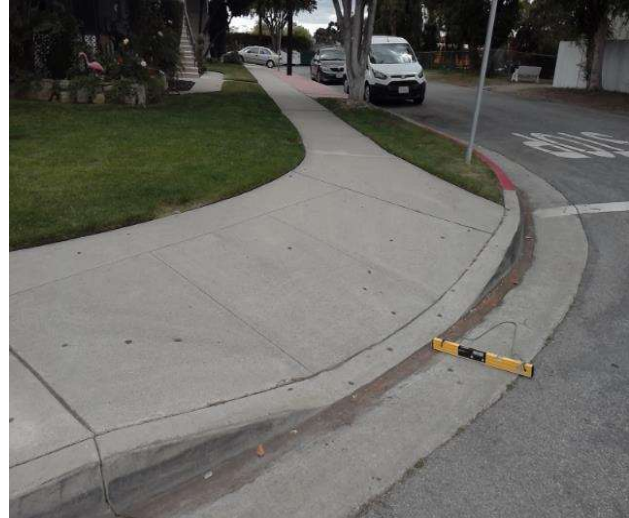
Recommendation

Recommendation At least 48.00 inches

Provide compliant landing \$240

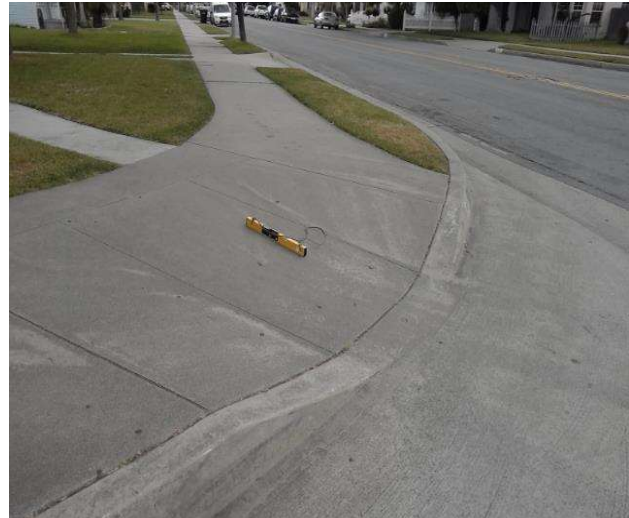
On-Site Finding Not Found

Provide detectable warning to surface \$248

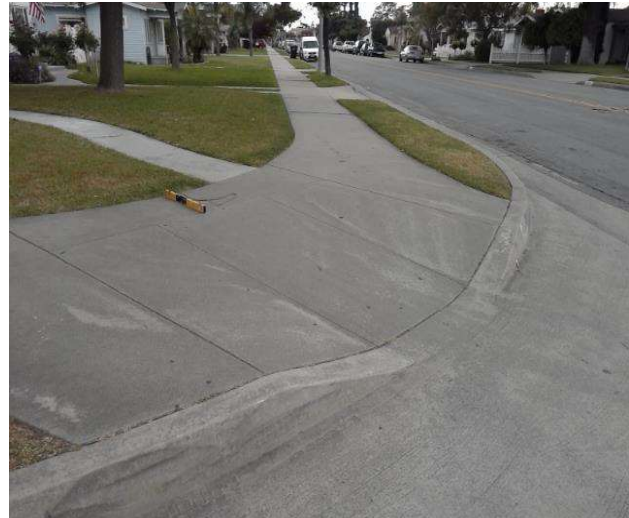
Recommendation

Recommendation Up to 2.08 percent

Provide compliant landing \$1,260

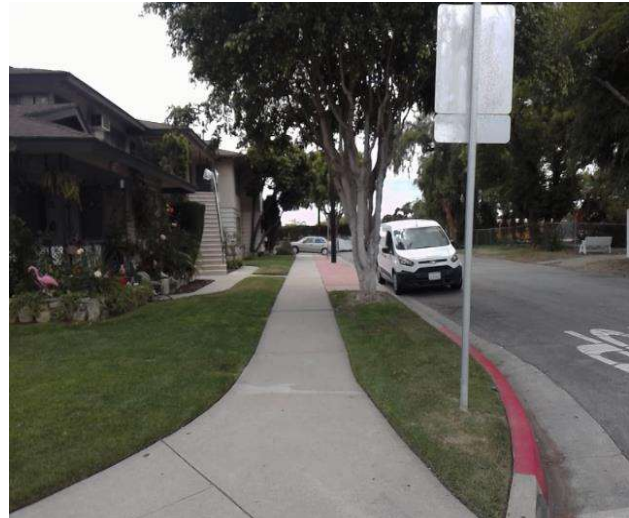
On-Site Finding Not Found

\$2,400

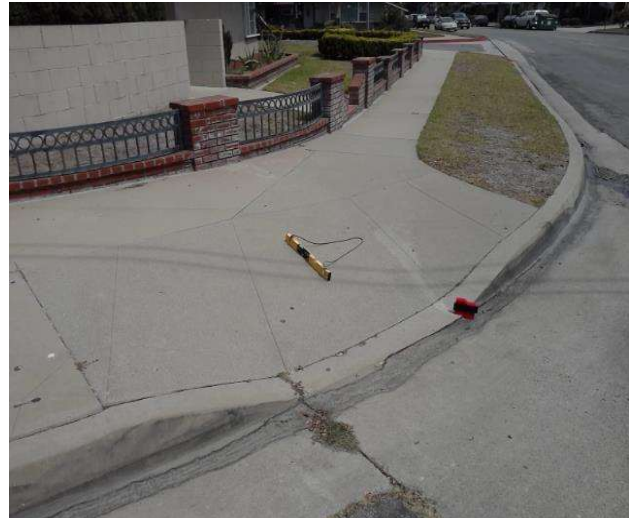
On-Site Finding Not Found

Provide detectable warning to surface \$248

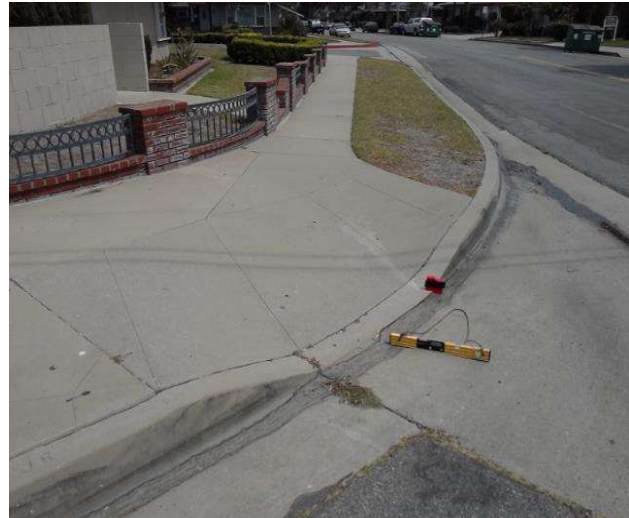
Recommendation

Recommendation Up to 2.08 percent

Provide compliant landing \$1,260

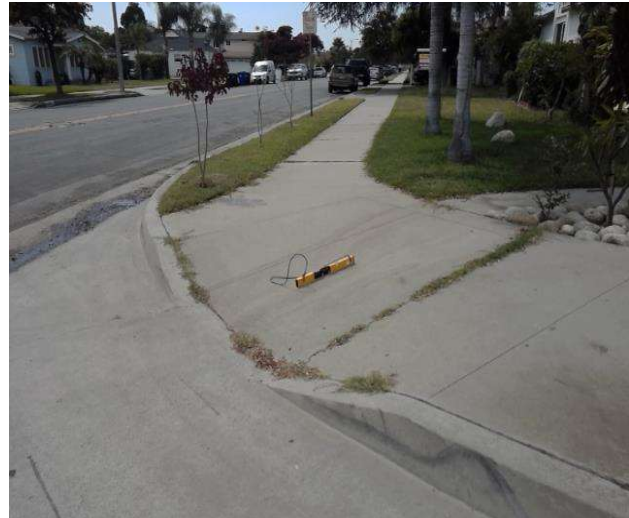
Recommendation

Recommendation At least 48.00 inches

Provide compliant landing \$240

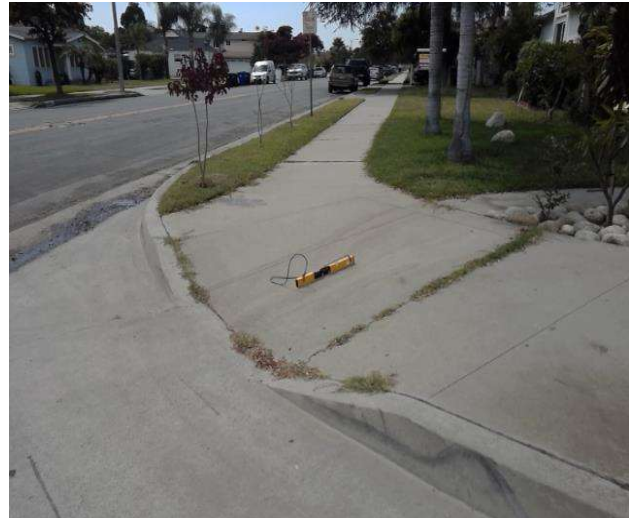
On-Site Finding Not Found

Provide detectable warning to surface \$248

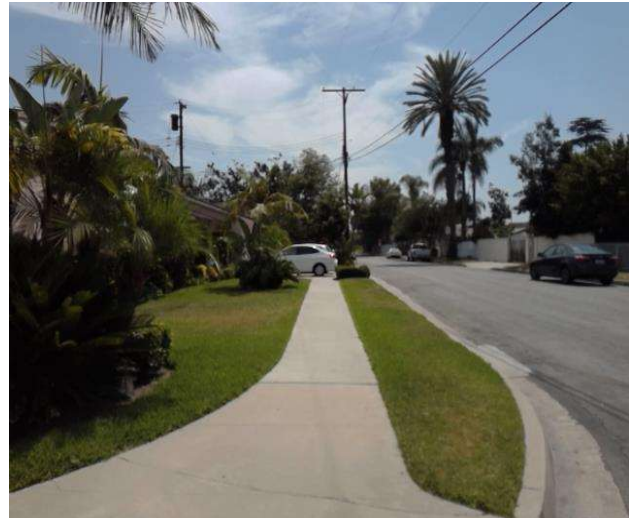
On-Site Finding Not Found

\$2,400

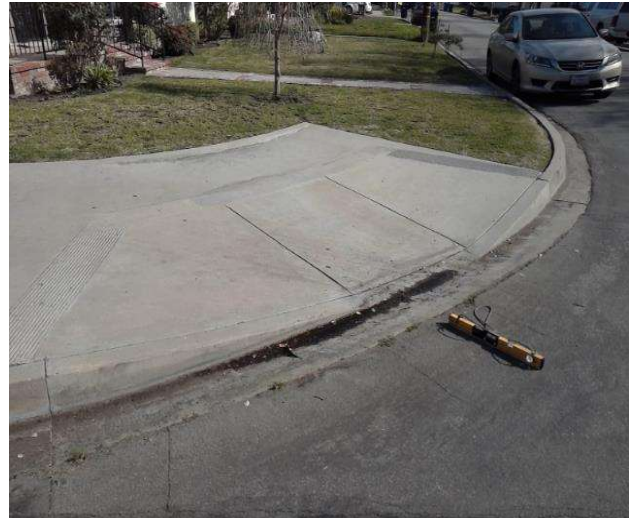
Curb Ramp , Landings and Transitions : Landing Accumulates Water - Wet Conditions

Provide compliant landing \$255

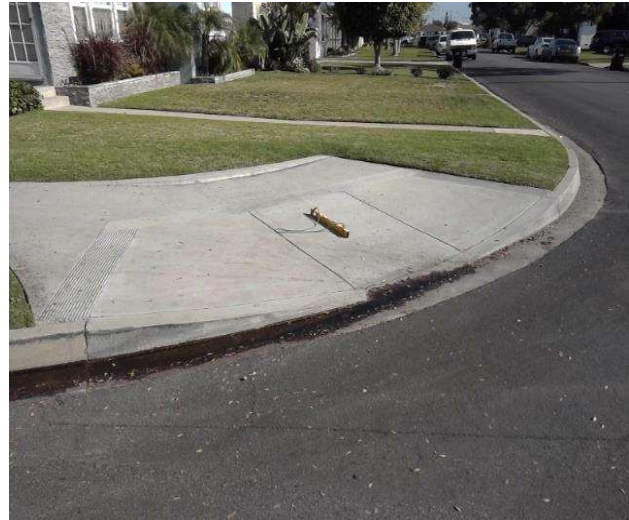
Curb Ramp , Landings and Transitions : Top Landing Clear Length - Landings

Provide compliant landing \$240

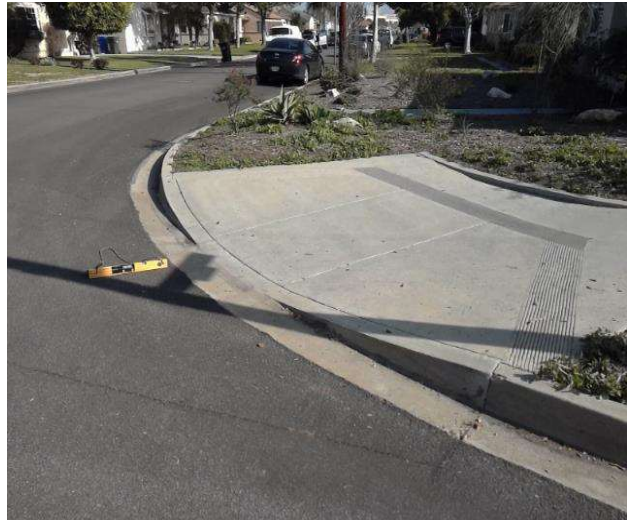
Curb Ramp , Landings and Transitions : Top Landing Clear Length - Landings

Provide compliant landing \$240

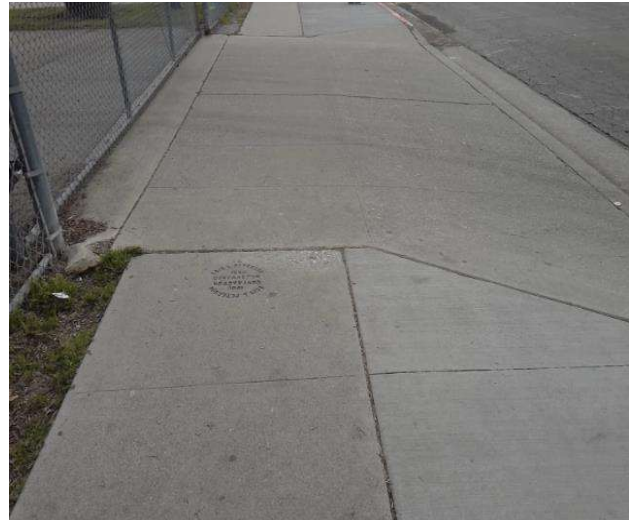
On-Site Finding Not Found

Install compliant detectable warnings \$190

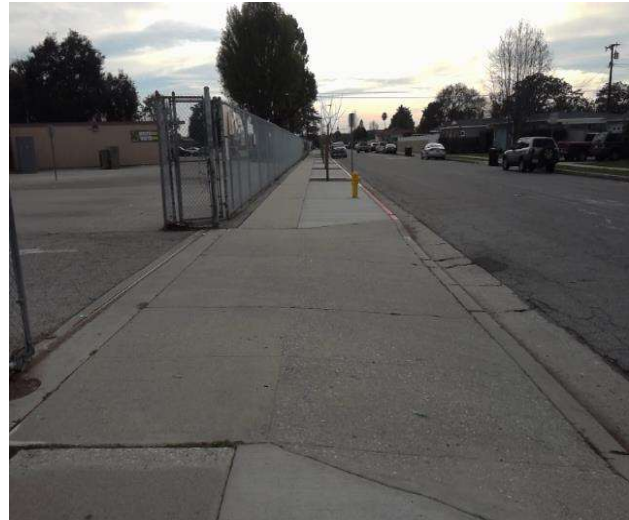
On-Site Finding Not Found

Install compliant detectable warnings \$190

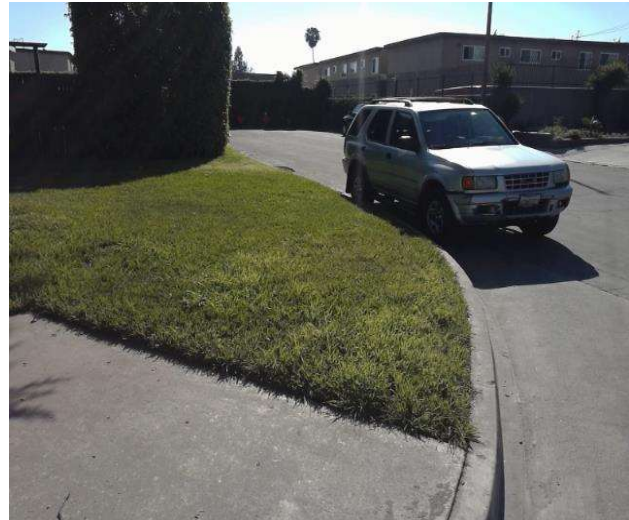
Sidewalks : Missing Sidewalk

Section of sidewalk is missing and consists of dirt, grass or gravel.

Provide a compliant sidewalk for the missing section.

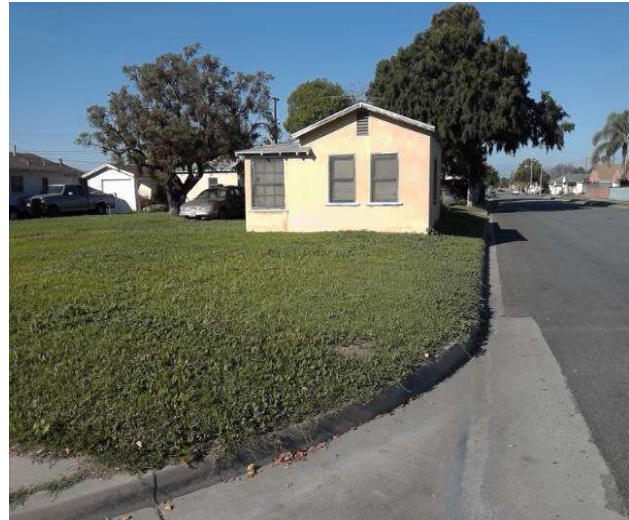
Sidewalks : Missing Sidewalk

Section of sidewalk is missing and consists of dirt, grass or gravel.

Provide a compliant sidewalk for the missing section.

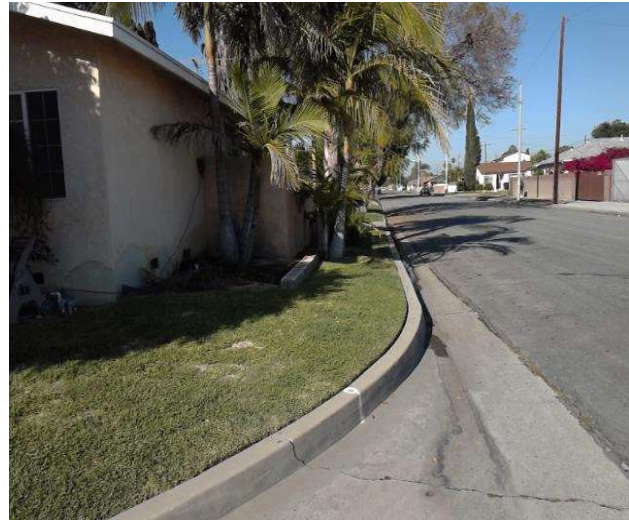
Sidewalks : Missing Sidewalk

Section of sidewalk is missing and consists of dirt, grass or gravel.

Provide a compliant sidewalk for the missing section.

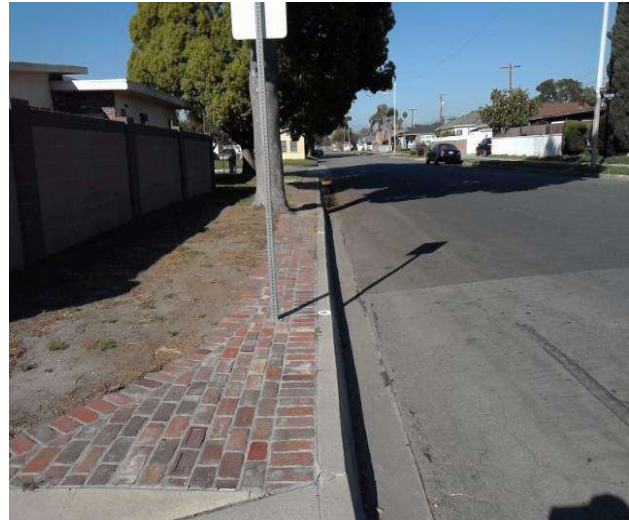
Sidewalks : Missing Sidewalk

Section of sidewalk is missing and consists of dirt, grass or gravel.

Provide a compliant sidewalk for the missing section.

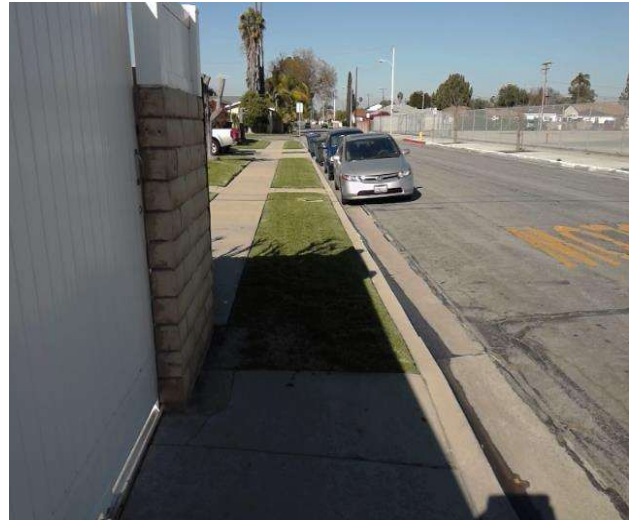
Sidewalks : Missing Sidewalk

Section of sidewalk is missing and consists of dirt, grass or gravel.

Provide a compliant sidewalk for the missing section.

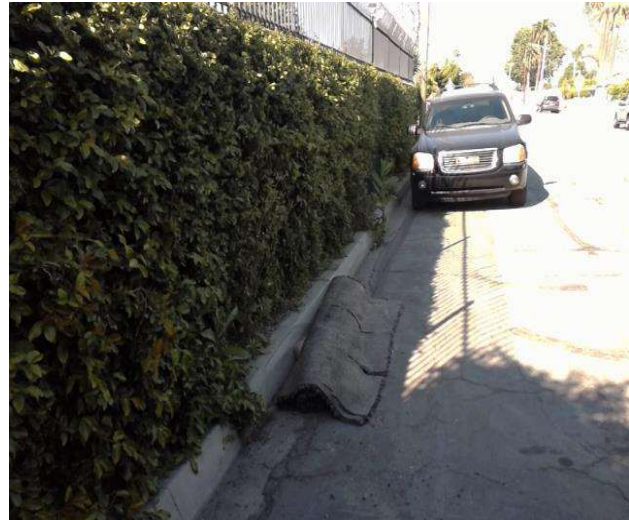
Sidewalks : Missing Sidewalk

Section of sidewalk is missing and consists of dirt, grass or gravel.

Provide a compliant sidewalk for the missing section.

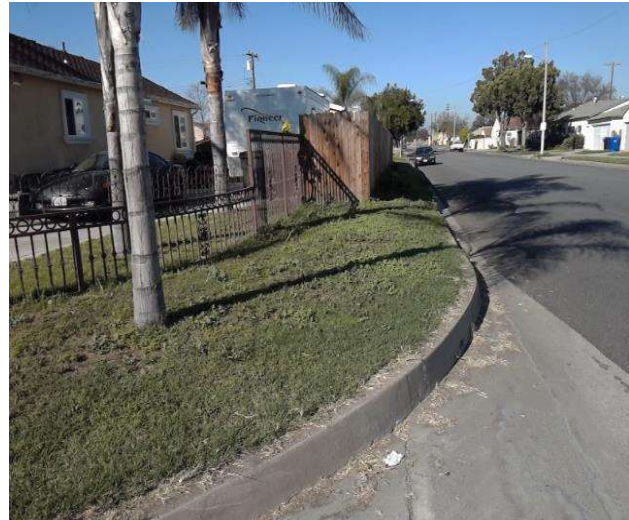
Sidewalks : Missing Sidewalk

Section of sidewalk is missing and consists of dirt, grass or gravel.

Provide a compliant sidewalk for the missing section.

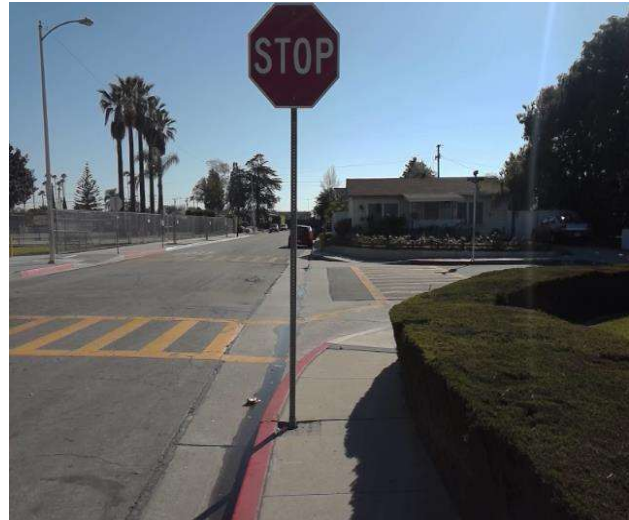
Sidewalks , Hazards & Gratings : Sidewalk Width at Obstruction

Sidewalk width at the obstruction shall have the recommended value.

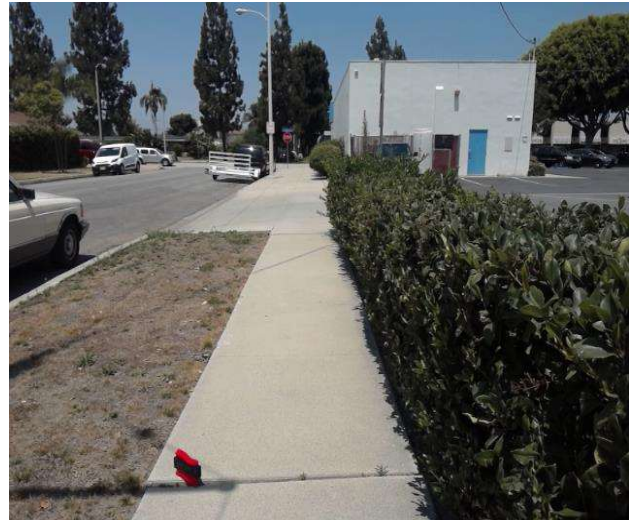
There is a change in elevation greater than recommended value.

Ensure that the change in elevation is within the recommended value.

Remove tripping hazards \$198

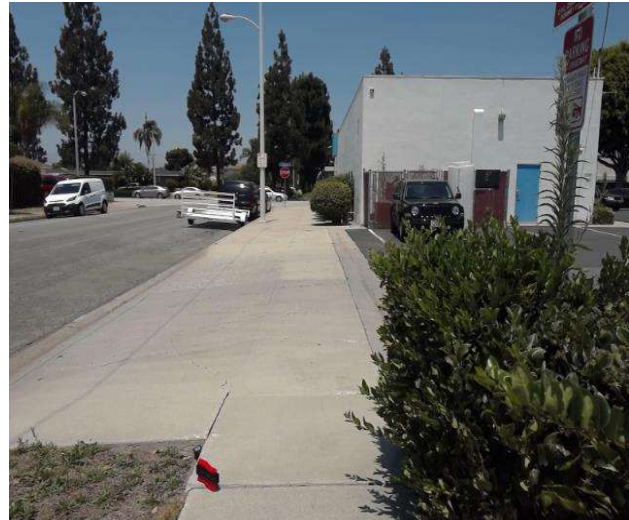
There is a change in elevation greater than recommended value.

Ensure that the change in elevation is within the recommended value.

Remove tripping hazards \$198

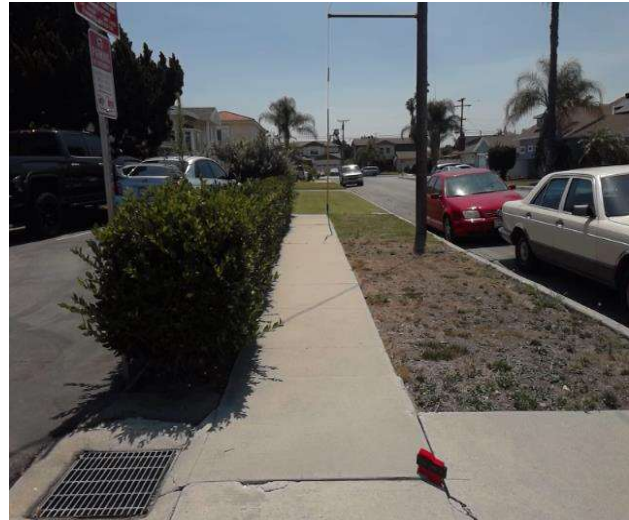
There is a change in elevation greater than recommended value.

Ensure that the change in elevation is within the recommended value.

Remove tripping hazards \$198

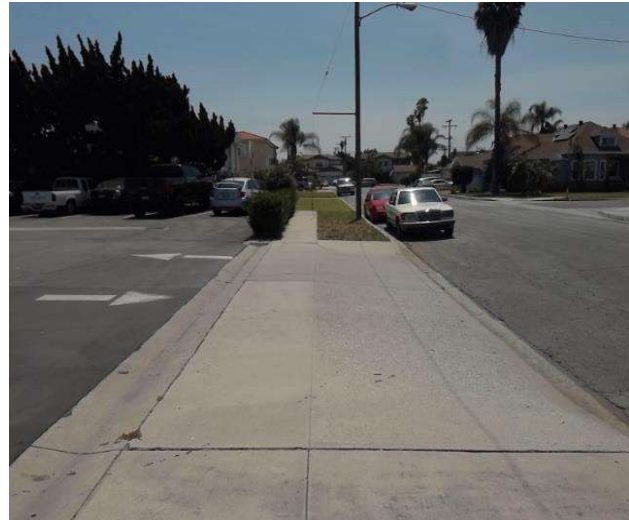
On-Site Finding Not Found

Install compliant detectable warnings \$190

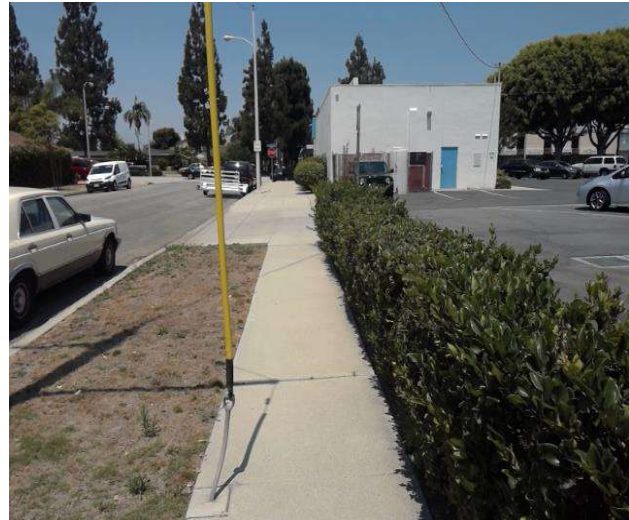
Sidewalks , Hazards & Gratings : Sidewalk Width at Obstruction

Sidewalk width at the obstruction shall have the recommended value.

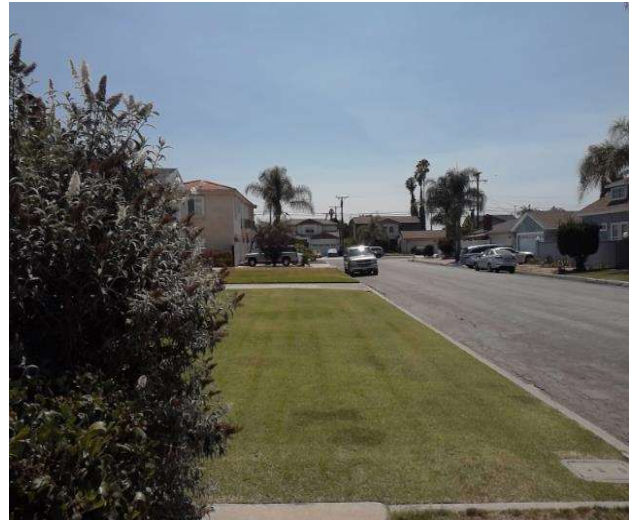
Sidewalks : Missing Sidewalk

Section of sidewalk is missing and consists of dirt, grass or gravel.

Provide a compliant sidewalk for the missing section.

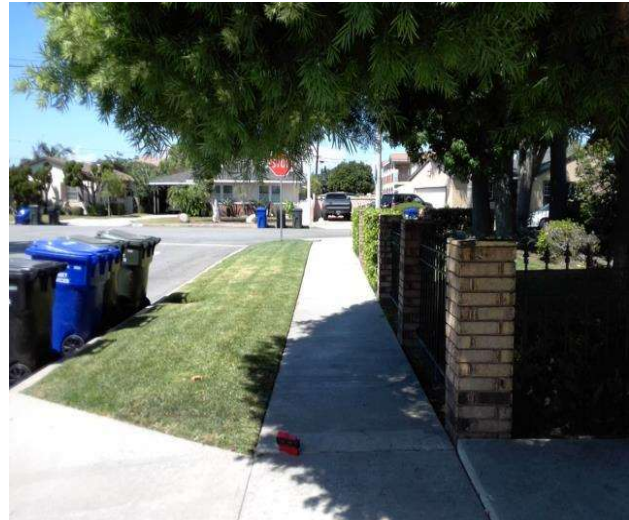
There is a change in elevation greater than recommended value.

Ensure that the change in elevation is within the recommended value.

Recommendation Up to 0.25 inches

Remove tripping hazards \$198

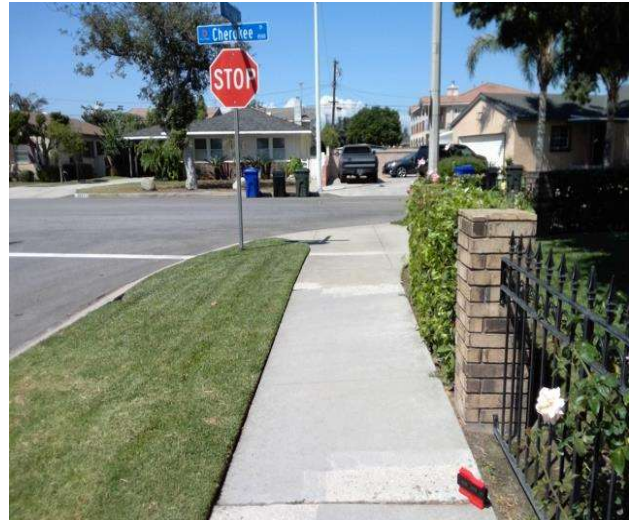
There is a change in elevation greater than recommended value.

Ensure that the change in elevation is within the recommended value.

Recommendation Up to 0.25 inches

Remove tripping hazards \$198

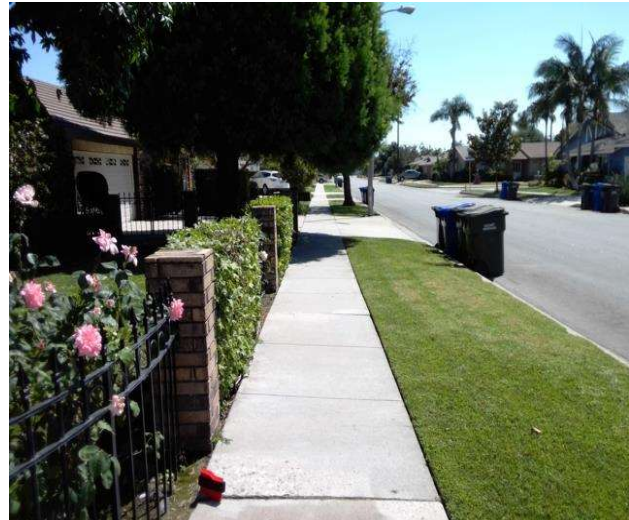
There is a change in elevation greater than recommended value.

Ensure that the change in elevation is within the recommended value.

Recommendation Up to 0.25 inches

Remove tripping hazards \$198

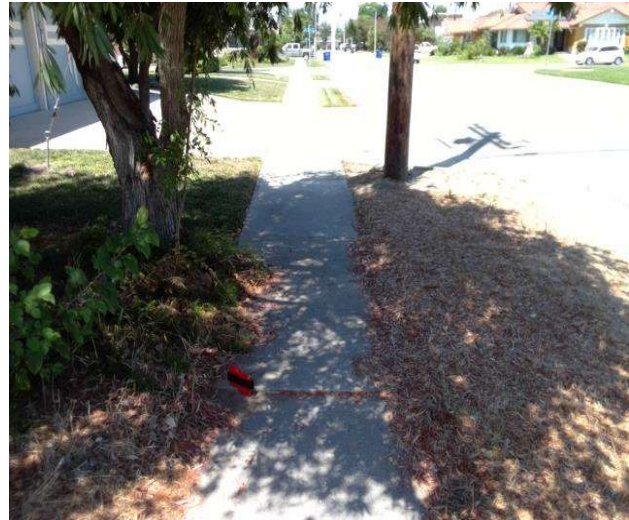
There is a change in elevation greater than recommended value.

Ensure that the change in elevation is within the recommended value.

Recommendation Up to 0.25 inches

Remove tripping hazards \$198

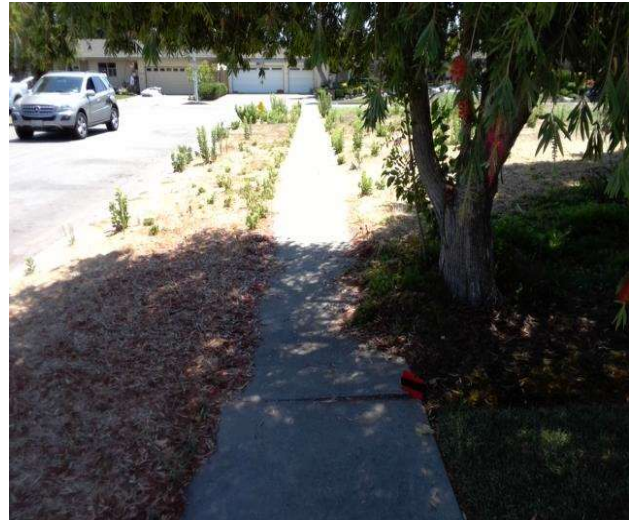
There is a change in elevation greater than recommended value.

Ensure that the change in elevation is within the recommended value.

Recommendation Up to 0.25 inches

Remove tripping hazards \$198

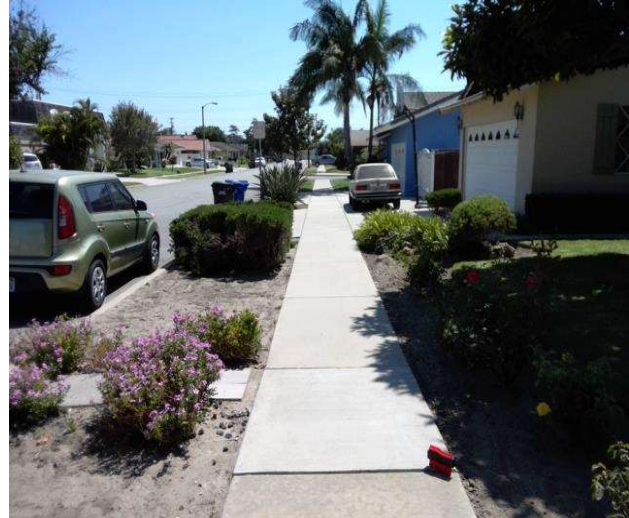
There is a change in elevation greater than recommended value.

Ensure that the change in elevation is within the recommended value.

Recommendation Up to 0.25 inches

Remove tripping hazards \$198

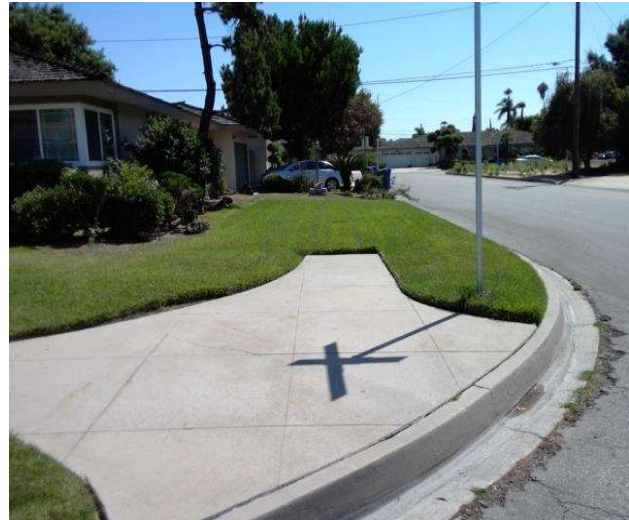
Sidewalks , Hazards & Gratings : Curb is on Path of Travel

Install curb ramp \$2,500

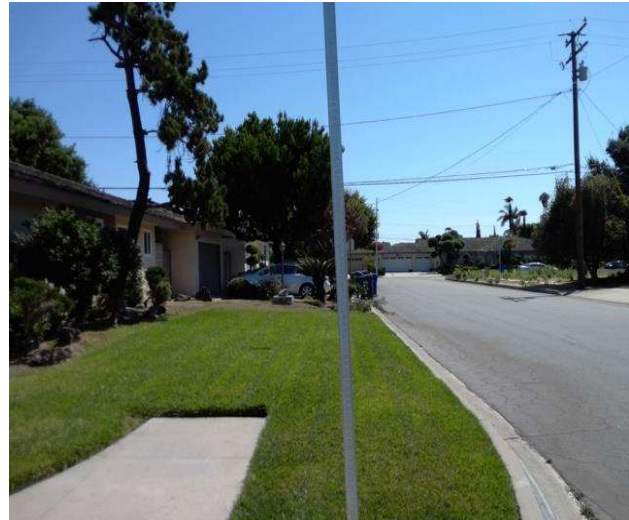
Sidewalks : Missing Sidewalk

Section of sidewalk is missing and consists of dirt, grass or gravel.

Provide a compliant sidewalk for the missing section.

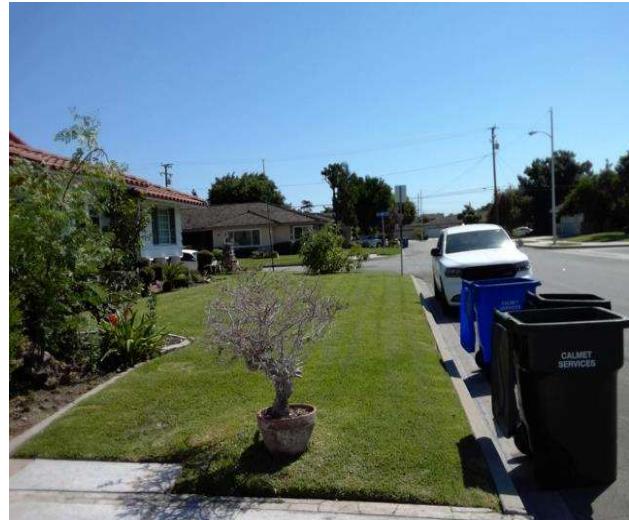
Sidewalks : Missing Sidewalk

Section of sidewalk is missing and consists of dirt, grass or gravel.

Provide a compliant sidewalk for the missing section.

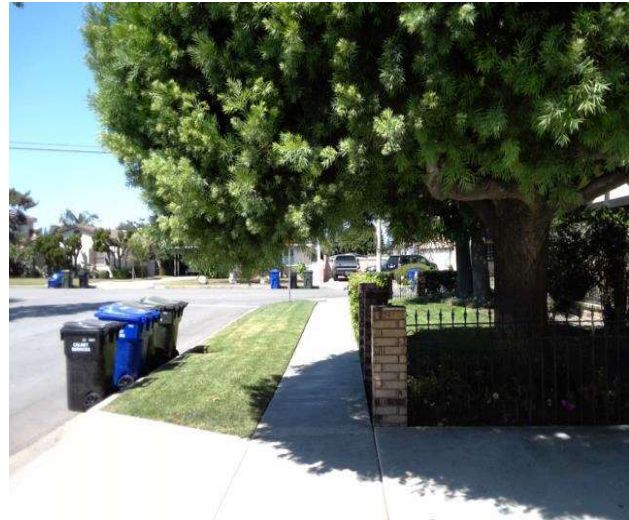
Sidewalks , Hazards & Gratings : Overhead Obstruction Height

Recommendation At least 80.00 inches

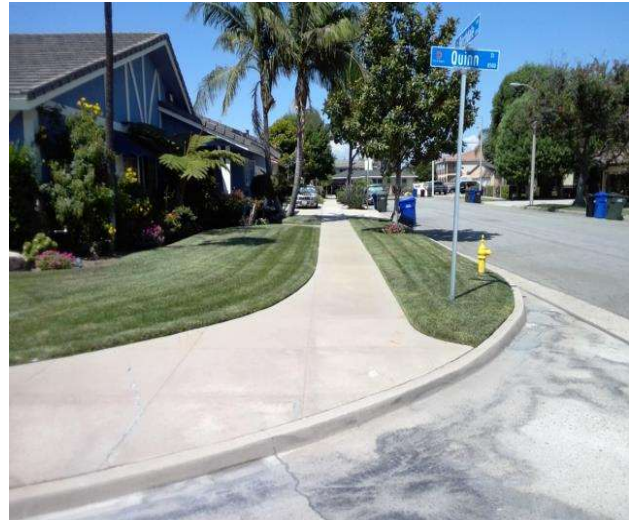
Sidewalks , Hazards & Gratings : Curb is on Path of Travel

Install curb ramp \$2,500

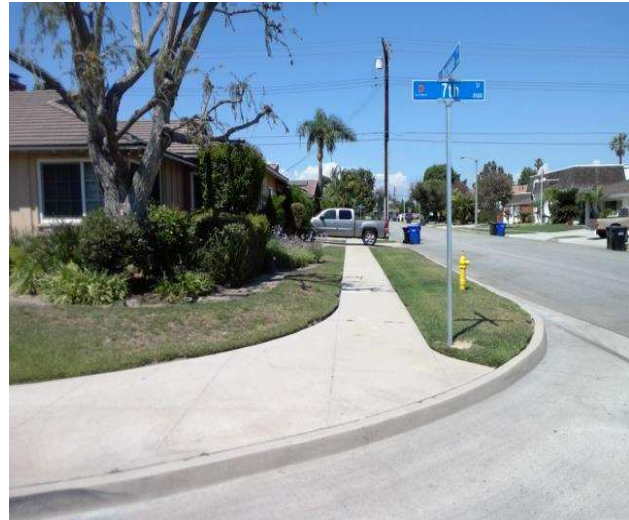
Sidewalks , Hazards & Gratings : Curb is on Path of Travel

Install curb ramp \$2,500

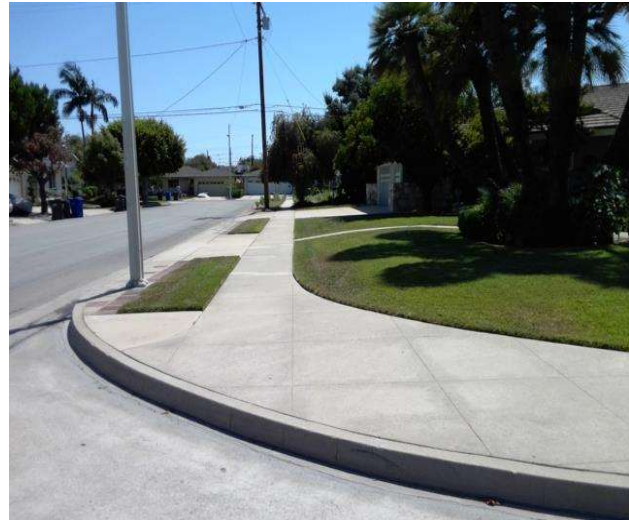
Sidewalks , Hazards & Gratings : Curb is on Path of Travel

Install curb ramp \$2,500

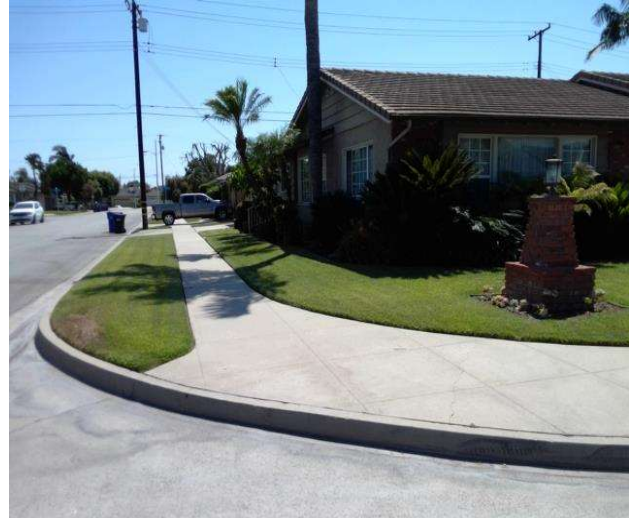
Sidewalks , Hazards & Gratings : Curb is on Path of Travel

Install curb ramp \$2,500

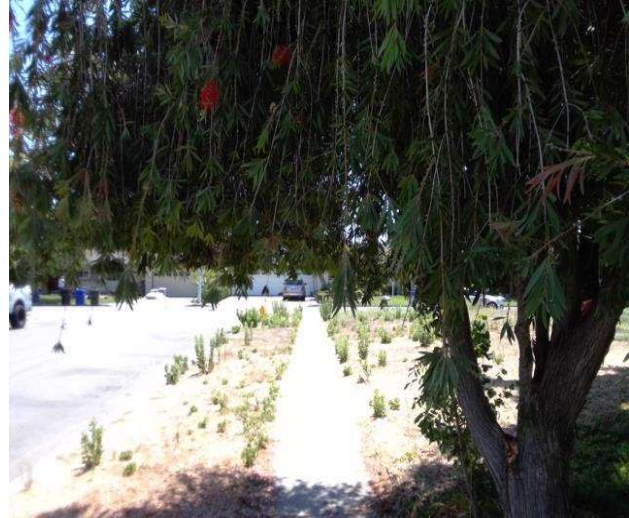
Sidewalks , Hazards & Gratings : Overhead Obstruction Height

Recommendation At least 80.00 inches

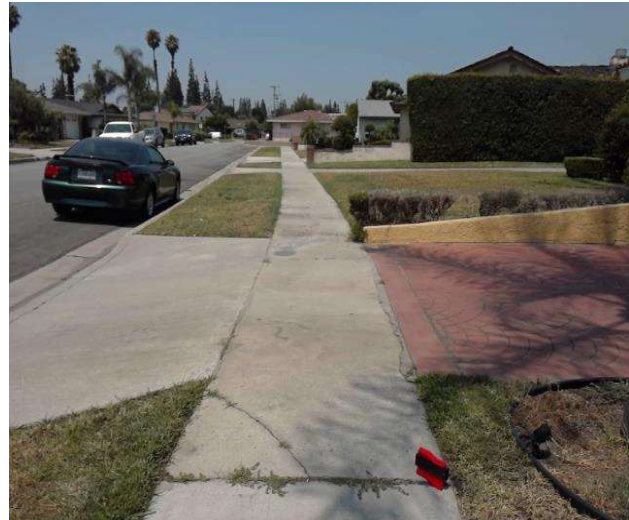
There is a change in elevation greater than recommended value.

Ensure that the change in elevation is within the recommended value.

Recommendation Up to 0.25 inches

Remove tripping hazards \$198

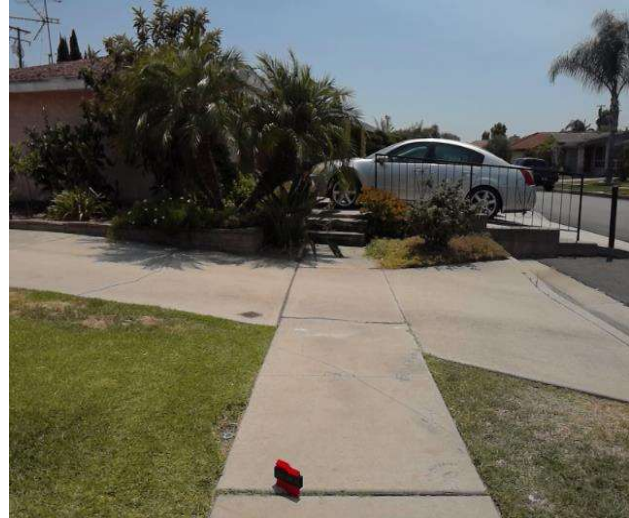
There is a change in elevation greater than recommended value.

Ensure that the change in elevation is within the recommended value.

Recommendation Up to 0.25 inches

Remove tripping hazards \$198

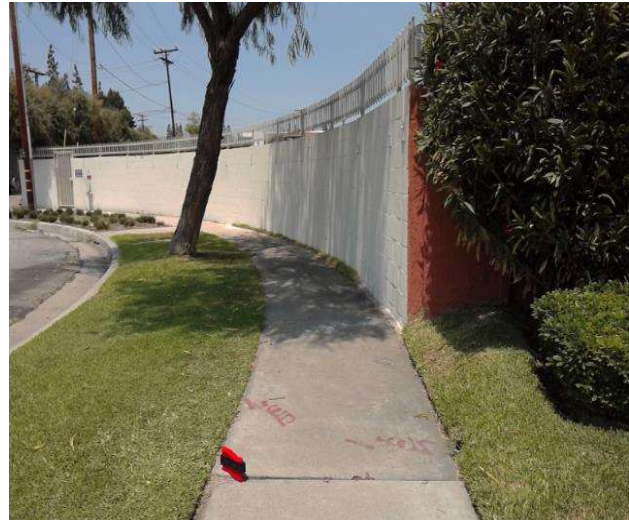
There is a change in elevation greater than recommended value.

Ensure that the change in elevation is within the recommended value.

Recommendation Up to 0.25 inches

Remove tripping hazards \$198

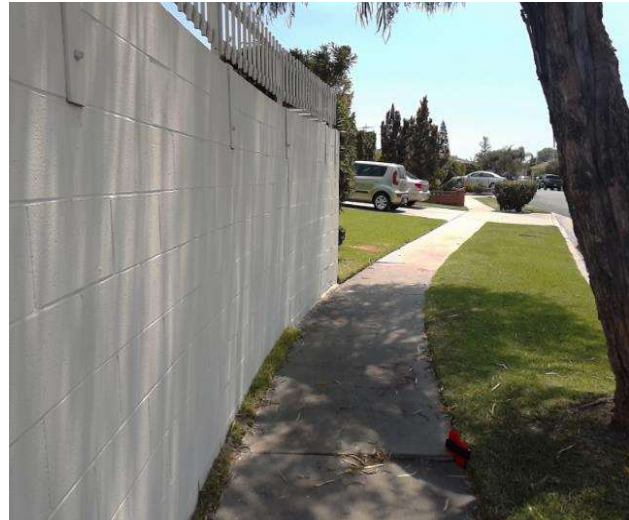
There is a change in elevation greater than recommended value.

Ensure that the change in elevation is within the recommended value.

Recommendation Up to 0.25 inches

Remove tripping hazards \$198

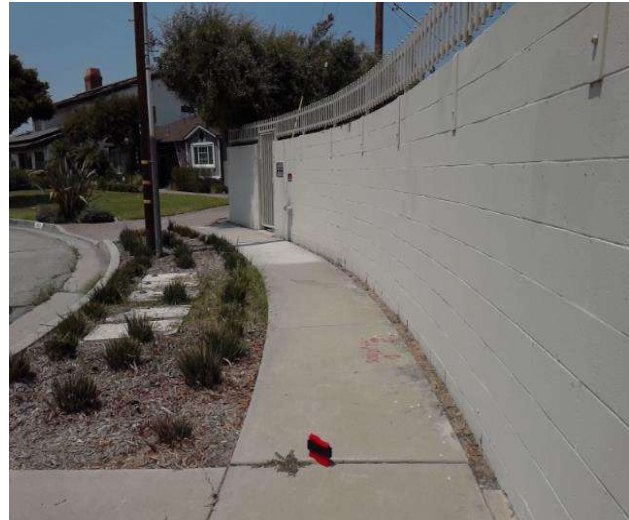
There is a change in elevation greater than recommended value.

Ensure that the change in elevation is within the recommended value.

Recommendation Up to 0.25 inches

Remove tripping hazards \$198

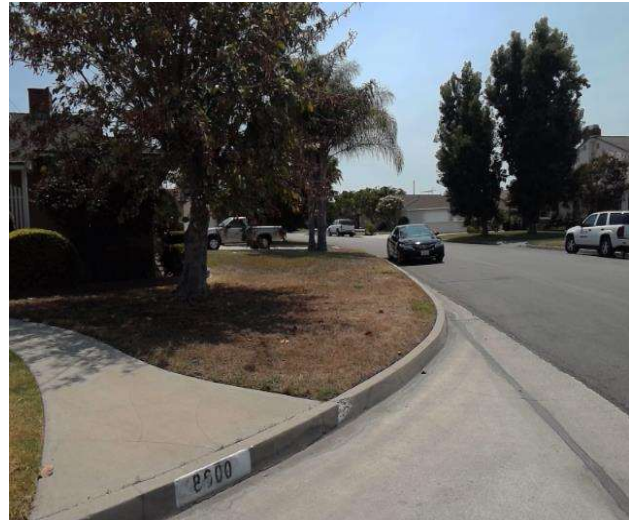
Sidewalks : Missing Sidewalk

Section of sidewalk is missing and consists of dirt, grass or gravel.

Provide a compliant sidewalk for the missing section.

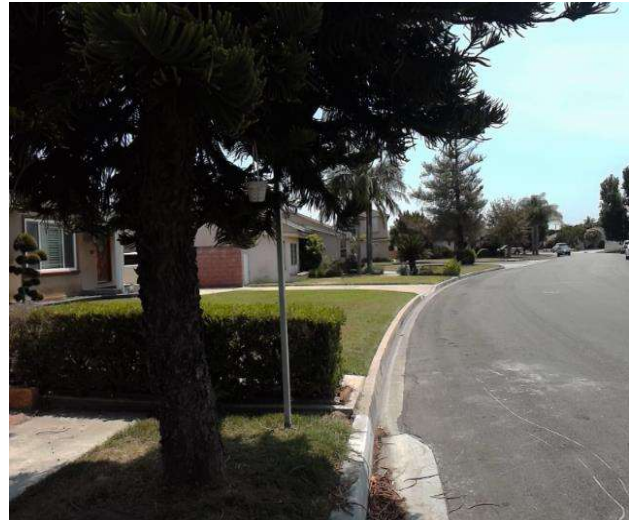
Sidewalks : Missing Sidewalk

Section of sidewalk is missing and consists of dirt, grass or gravel.

Provide a compliant sidewalk for the missing section.

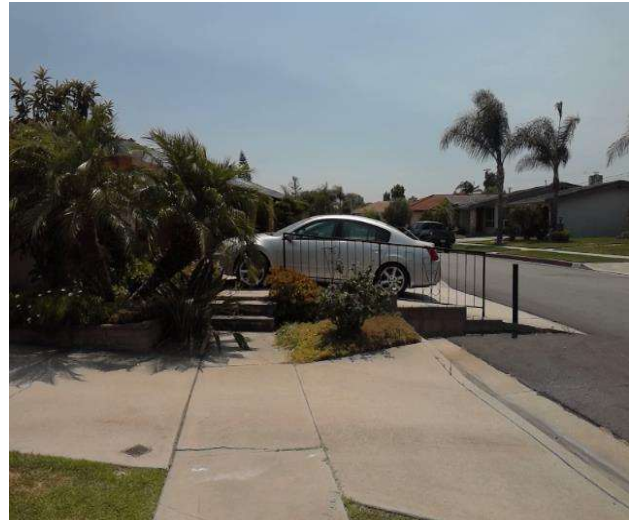
Sidewalks : Missing Sidewalk

Section of sidewalk is missing and consists of dirt, grass or gravel.

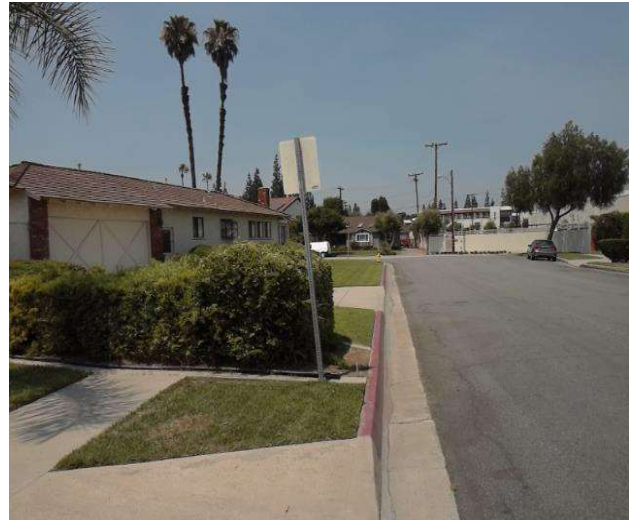
Sidewalks : Missing Sidewalk

Section of sidewalk is missing and consists of dirt, grass or gravel.

Provide a compliant sidewalk for the missing section.

\$1,260

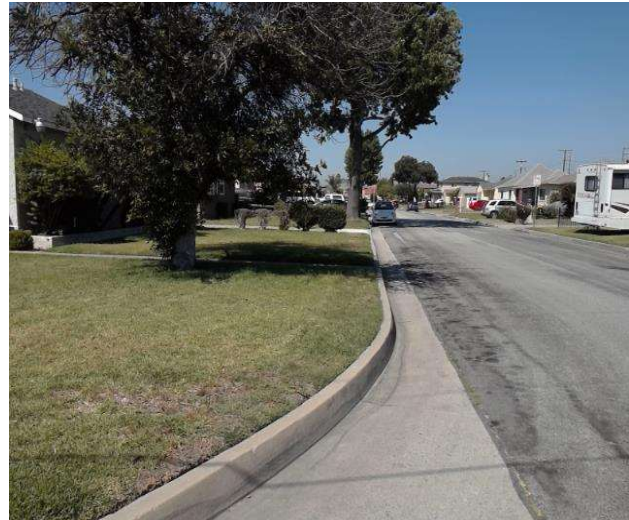
On-Site Finding Not Found
