# **Accessibility Survey**

# 4th Street - Paramount Boulevard to Downey Avenue

Date of Inspection 7/21/2017

**Disability Access Consultants**

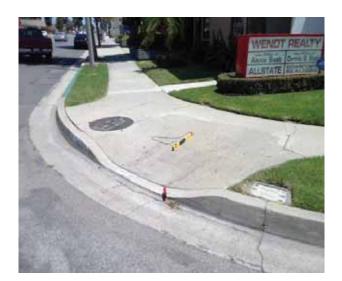
On-Site Finding Not Found

Recommendation See Recommendation

Provide detectable warning to \$248 surface

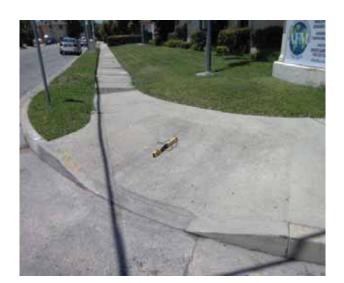
On-Site Finding Not Found

Recommendation See Recommendation

Provide detectable warning to \$248 surface

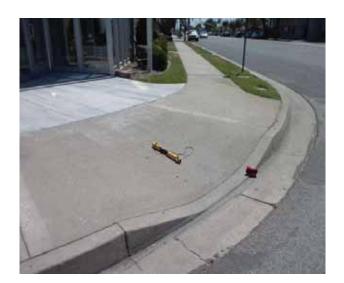
On-Site Finding Not Found

Recommendation See Recommendation

Provide detectable warning to \$248 surface

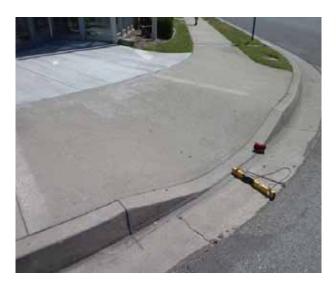
Curb Ramp : Bottom Landing Slope

Recommendation Up to 5.00 percent

Repave landing \$1,260

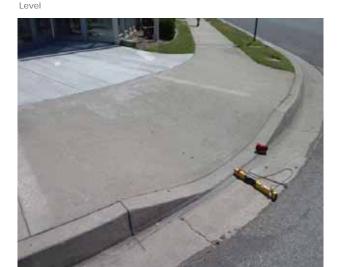
Curb Ramp , Landings And Transitions : Bottom Landing Change in

Recommendation Up to 0.50 inches

Patch lip at curb ramp \$255

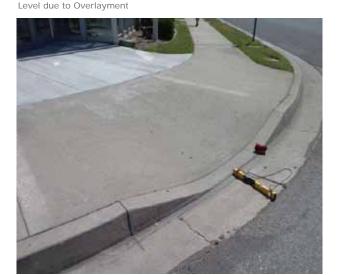
The overlayment causes a noncompliant change in level.

Curb Ramp , Landings And Transitions : Bottom Landing Change in

Ensure the change in elevation is within the recommended height.

Recommendation Up to 0.50 inches

Provide smooth surface \$150

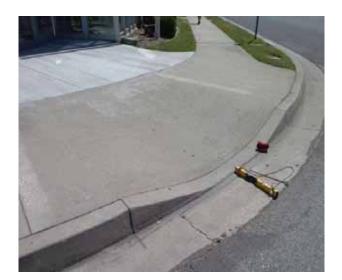
Curb Ramp , Landings and Transitions  $\,:\,$  Top Landing Slope

Recommendation Up to 2.08 percent

Provide compliant landing \$1,260

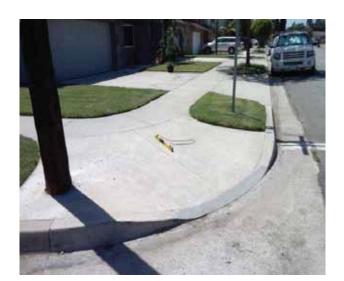
On-Site Finding Not Found

Recommendation See Recommendation

Provide detectable warning to \$248 surface

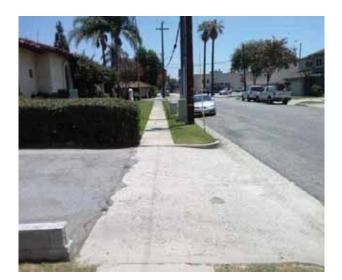
On-Site Finding Not Found

Recommendation See Recommendation

Install compliant detectable \$190 warnings

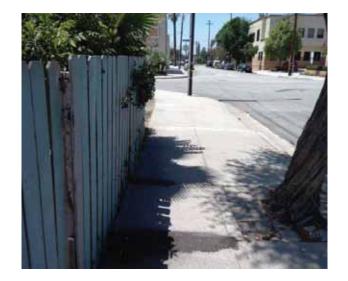
Notes: Surface is Rough And Uneven

Repave surface \$1,092

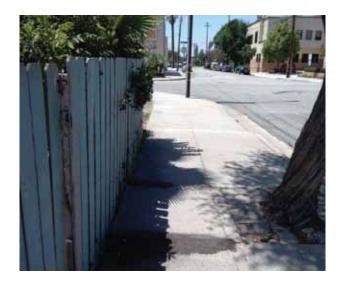
**Code Reference** ADA 206, 302 Notes: Surface is Rough And Uneven

Repave surface \$1,184

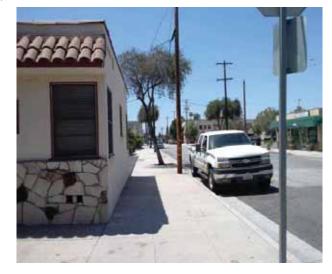
On-Site Finding Not Found

Recommendation See Recommendation

**Costing Info (Estimated)**

\$2,400

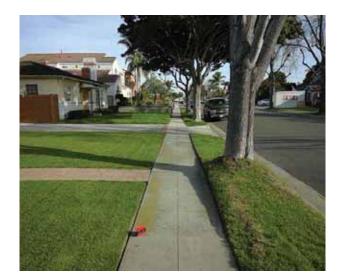
There is a change in elevation greater than recommended value.

Ensure that the change in elevation is within the recommended value.

Recommendation Up to 0.25 inches

Remove tripping hazards \$198

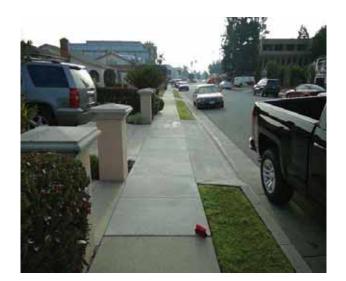
There is a change in elevation greater than recommended value.

Ensure that the change in elevation is within the recommended value.

Recommendation Up to 0.25 inches

Remove tripping hazards \$198

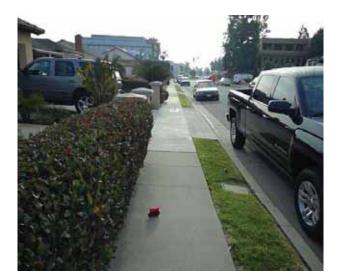
There is a change in elevation greater than recommended value.

Sidewalks , Change in Level : Change in Level Non Beveled

Ensure that the change in elevation is within the recommended value.

Recommendation Up to 0.25 inches

Remove tripping hazards \$198

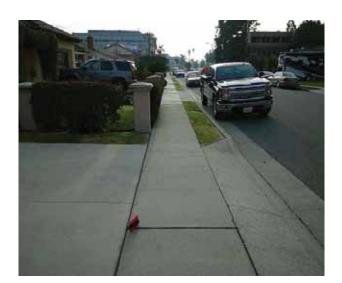
There is a change in elevation greater than recommended value.

Sidewalks , Change in Level : Change in Level Non Beveled

Ensure that the change in elevation is within the recommended value.

Recommendation Up to 0.25 inches

Remove tripping hazards \$198

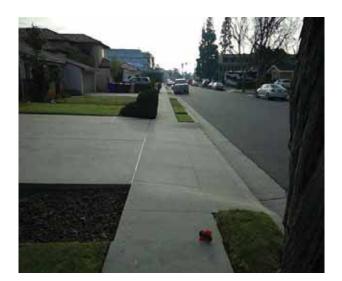
There is a change in elevation greater than recommended value.

Sidewalks , Change in Level : Change in Level Non Beveled

Ensure that the change in elevation is within the recommended value.

Recommendation Up to 0.25 inches

Remove tripping hazards \$198

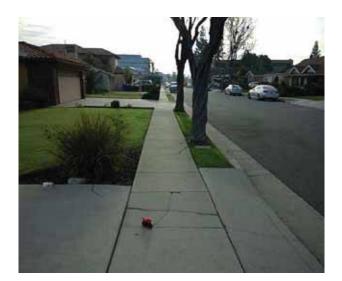
There is a change in elevation greater than recommended value.

Sidewalks , Change in Level : Change in Level Non Beveled

Ensure that the change in elevation is within the recommended value.

Recommendation Up to 0.25 inches

Remove tripping hazards \$198

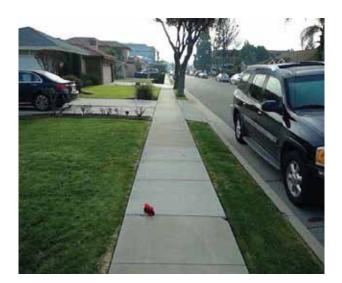
There is a change in elevation greater than recommended value.

Sidewalks , Change in Level : Change in Level Non Beveled

Ensure that the change in elevation is within the recommended value.

Recommendation Up to 0.25 inches

Remove tripping hazards \$198

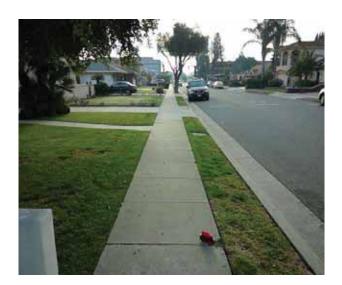
There is a change in elevation greater than recommended value.

Sidewalks , Change in Level : Change in Level Non Beveled

Ensure that the change in elevation is within the recommended value.

Recommendation Up to 0.25 inches

Remove tripping hazards \$198

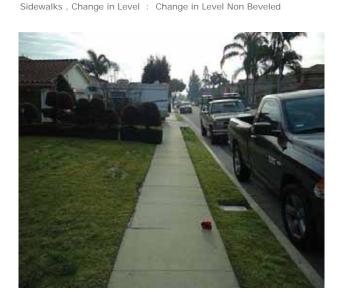
There is a change in elevation greater than recommended value.

Ensure that the change in elevation is within the recommended value.

Recommendation Up to 0.25 inches

Remove tripping hazards \$198

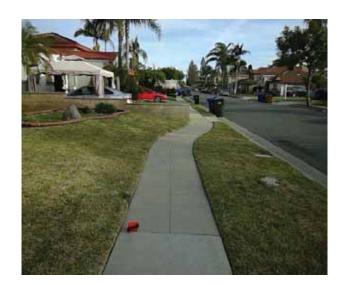
There is a change in elevation greater than recommended value.

Sidewalks , Change in Level : Change in Level Non Beveled

Ensure that the change in elevation is within the recommended value.

Recommendation Up to 0.25 inches

Remove tripping hazards \$198

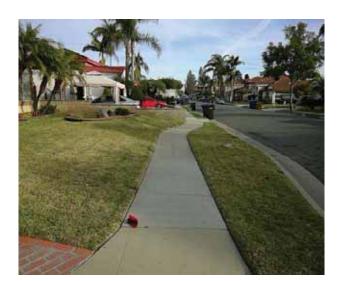
There is a change in elevation greater than recommended value.

Sidewalks , Change in Level : Change in Level Non Beveled

Ensure that the change in elevation is within the recommended value.

Recommendation Up to 0.25 inches

Remove tripping hazards \$198

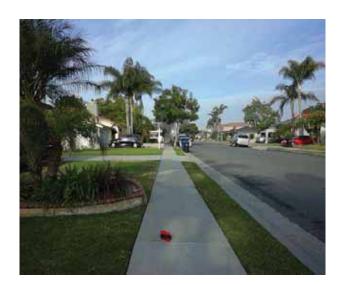
There is a change in elevation greater than recommended value.

Sidewalks , Change in Level : Change in Level Non Beveled

Ensure that the change in elevation is within the recommended value.

Recommendation Up to 0.25 inches

Remove tripping hazards \$198

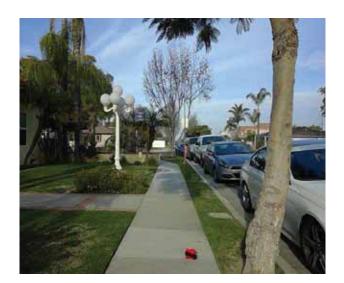
There is a change in elevation greater than recommended value.

Sidewalks , Change in Level : Change in Level Non Beveled

Ensure that the change in elevation is within the recommended value.

Recommendation Up to 0.25 inches

Remove tripping hazards \$198

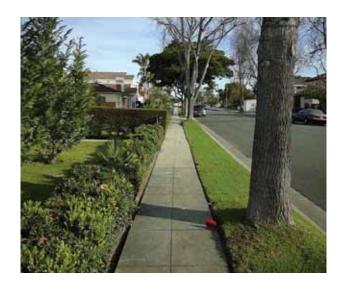
There is a change in elevation greater than recommended value.

Ensure that the change in elevation is within the recommended value.

Recommendation Up to 0.25 inches

Remove tripping hazards \$198

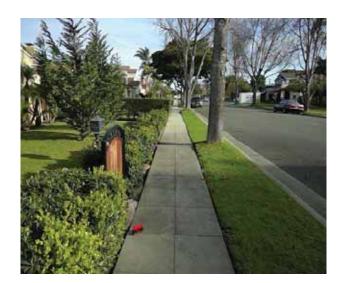
There is a change in elevation greater than recommended value.

Ensure that the change in elevation is within the recommended value.

Recommendation Up to 0.25 inches

Remove tripping hazards \$198

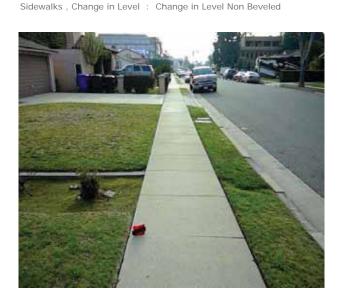
There is a change in elevation greater than recommended value.

Ensure that the change in elevation is within the recommended value.

Recommendation Up to 0.25 inches

Remove tripping hazards \$198

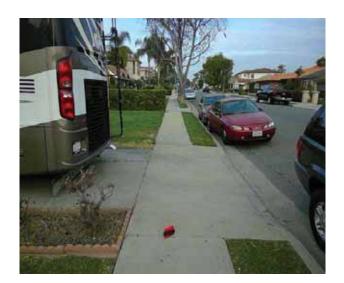
There is a change in elevation greater than recommended value.

Sidewalks , Change in Level : Change in Level Non Beveled

Ensure that the change in elevation is within the recommended value.

Recommendation Up to 0.25 inches

Remove tripping hazards \$198

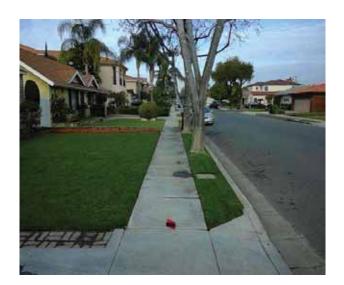
There is a change in elevation greater than recommended value.

Sidewalks , Change in Level : Change in Level Non Beveled

Ensure that the change in elevation is within the recommended value.

Recommendation Up to 0.25 inches

Remove tripping hazards \$198

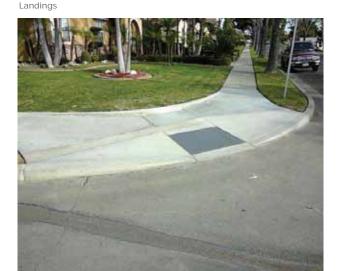
Curb Ramp , Landings and Transitions : Top Landing Clear Length -

Recommendation At least 48.00 inches

Provide compliant landing \$240

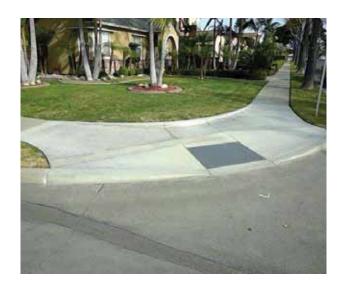
On-Site Finding Not Found

Recommendation See Recommendation

Install crosswalk \$800

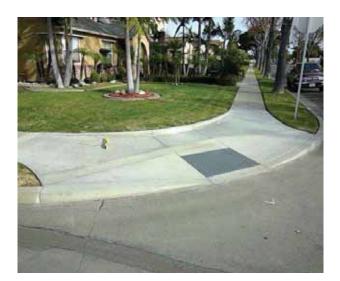
Curb Ramp, Landings and Transitions: Top Landing Slope

Recommendation Up to 2.08 percent

Provide compliant landing \$1,260

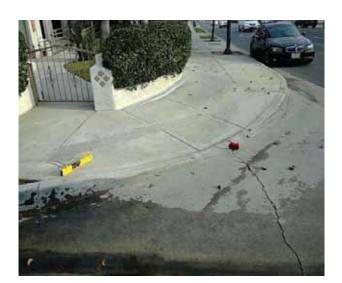
On-Site Finding Not Found

Recommendation See Recommendation

Provide detectable warning to \$248 surface

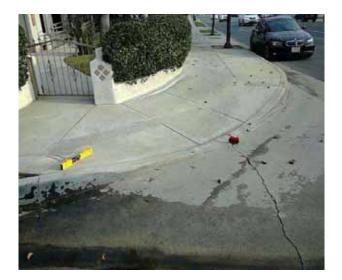
On-Site Finding Not Found

Recommendation See Recommendation

Install crosswalk \$800

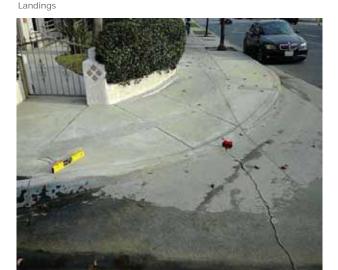
Curb Ramp , Landings and Transitions : Top Landing Clear Length -

Recommendation At least 48.00 inches

Provide compliant landing \$240

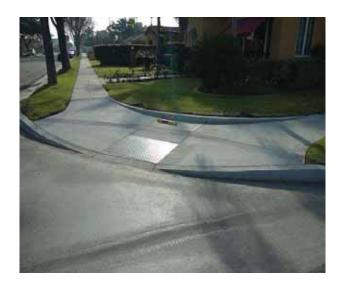
On-Site Finding Not Found

Recommendation See Recommendation

Install crosswalk \$800

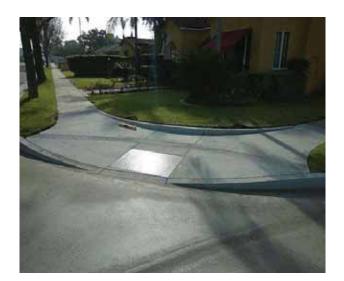
On-Site Finding Not Found

Recommendation See Recommendation

Install crosswalk \$800

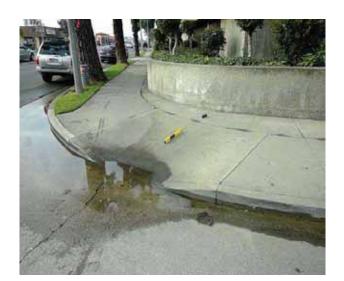
On-Site Finding Not Found

Recommendation See Recommendation

Provide detectable warning to \$248 surface

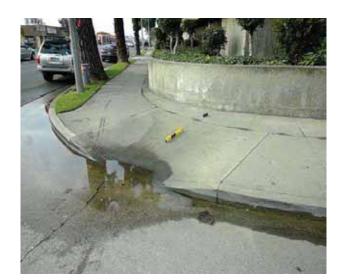
Recommendation See Recommendation

Install crosswalk \$800

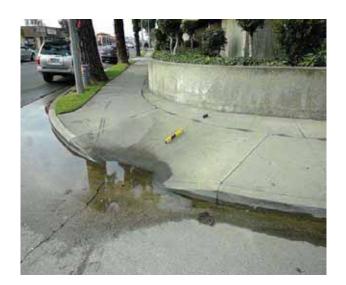
Recommendation At least 48.00 inches

Install curb ramp \$1,300

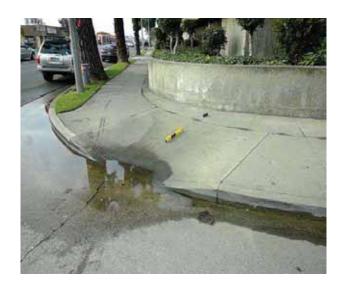
Recommendation Up to 8.33 percent

Install curb ramp \$1,300

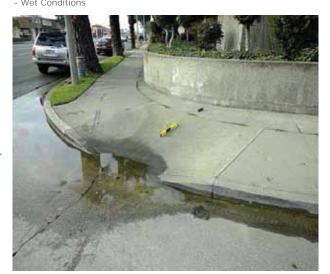
Recommendation See Recommendation

Curb Ramp , Landings and Transitions : Landing Accumulates Water

Provide compliant landing \$255

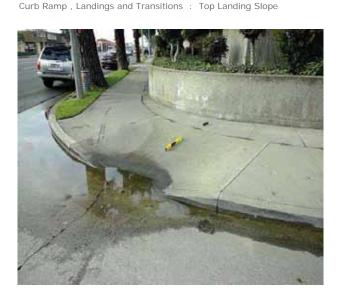
Recommendation Up to 2.08 percent

Provide compliant landing \$1,260

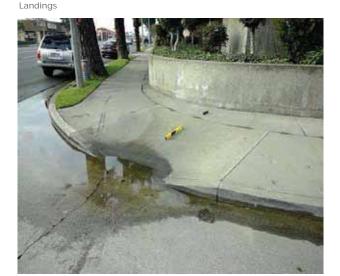
Recommendation At least 48.00 inches

Curb Ramp , Landings and Transitions : Top Landing Clear Length -

Provide compliant landing \$240

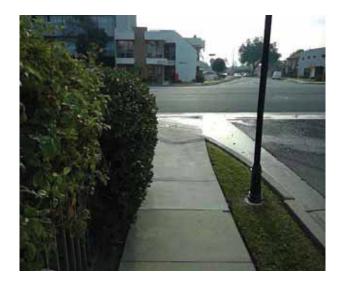
Sidewalks , Hazards & Gratings : Sidewalk Width at Obstruction

Recommendation At least 48.00 inches

Sidewalk width at the obstruction shall have the recommended value.

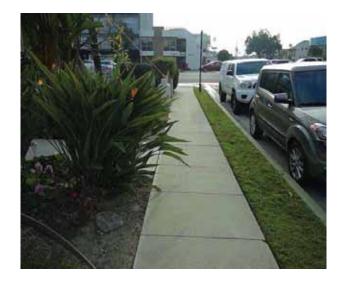
Sidewalks , Hazards & Gratings : Sidewalk Width at Obstruction

Recommendation At least 48.00 inches

Sidewalk width at the obstruction shall have the recommended value.

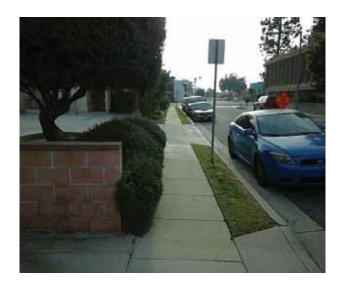
Sidewalks , Hazards & Gratings : Sidewalk Width at Obstruction

Recommendation At least 48.00 inches

Sidewalk width at the obstruction shall have the recommended value.

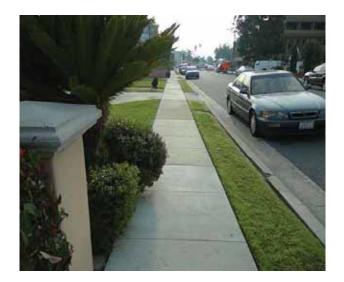
Sidewalks , Hazards & Gratings : Sidewalk Width at Obstruction

Recommendation At least 48.00 inches

Sidewalk width at the obstruction shall have the recommended value.

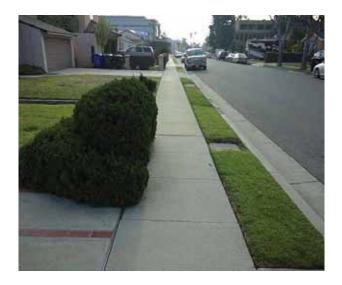
Sidewalks , Hazards & Gratings : Sidewalk Width at Obstruction

Recommendation At least 48.00 inches

Sidewalk width at the obstruction shall have the recommended value.

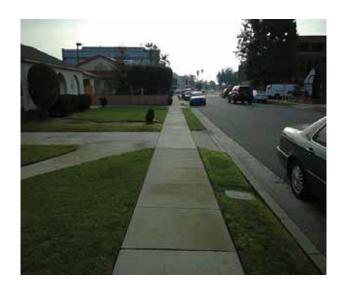
Recommendation Up to 2.08 percent

Repave the sidewalk surface with the recommended cross slope.

Repave surface \$1,092

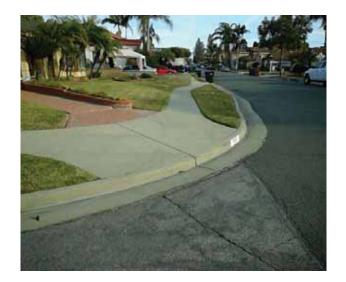
Sidewalks , Hazards & Gratings : Curb is on Path of Travel

Install curb ramp \$2,500

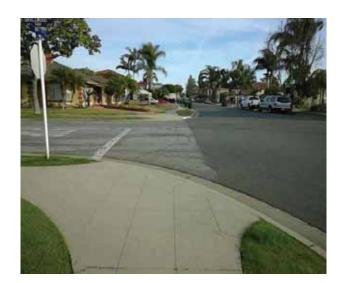
Sidewalks , Hazards & Gratings : Curb is on Path of Travel

Install curb ramp \$2,500

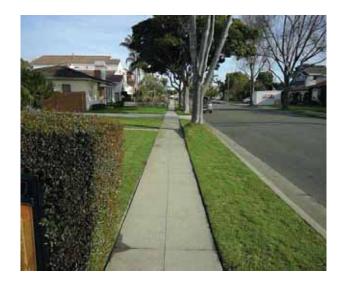
Recommendation Up to 2.08 percent

Repave the sidewalk surface with the recommended cross slope.

Repave surface \$1,092

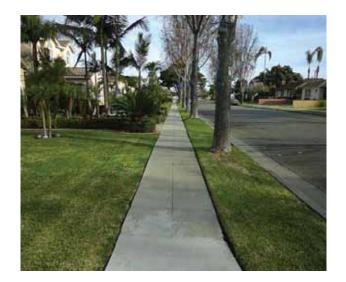
Recommendation Up to 2.08 percent

Repave the sidewalk surface with the recommended cross slope.

Repave surface \$1,092

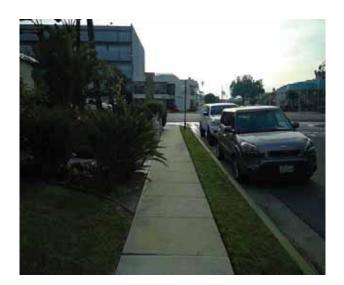
Recommendation Up to 2.08 percent

Repave the sidewalk surface with the recommended cross slope.

Repave surface \$1,092

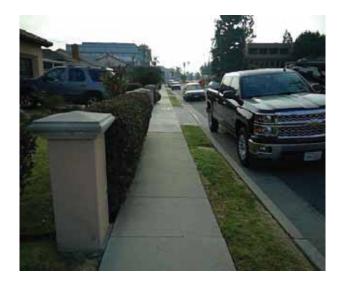
Recommendation Up to 2.08 percent

Repave the sidewalk surface with the recommended cross slope.

Repave surface \$1,092

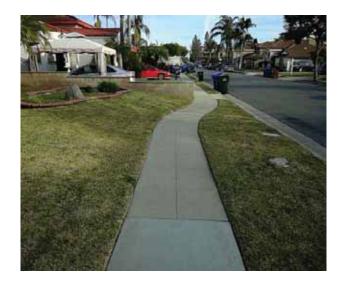
Recommendation Up to 2.08 percent

Repave the sidewalk surface with the recommended cross slope.

Repave surface \$1,092

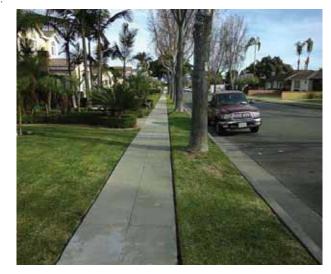
On-Site Finding Not Found

\$2,400

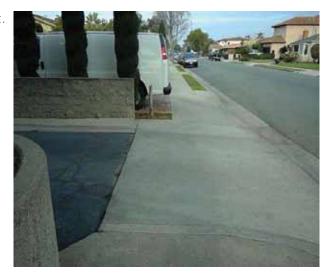
Recommendation Up to 2.08 percent

Repave surface \$1,092

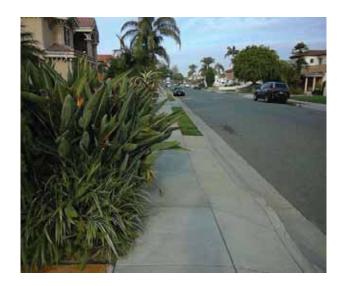
Sidewalks , Hazards & Gratings : Sidewalk Width at Obstruction

Recommendation At least 48.00 inches

Sidewalk width at the obstruction shall have the recommended value.

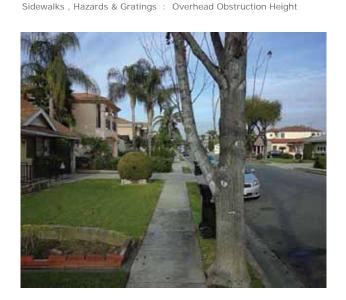
Recommendation At least 80.00 inches

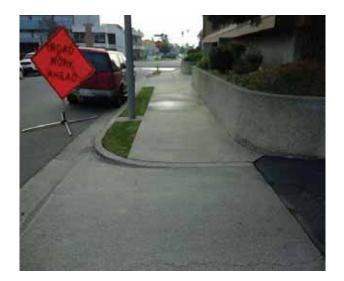
Sidewalks , Hazards & Gratings : Curb is on Path of Travel

Install curb ramp \$2,500

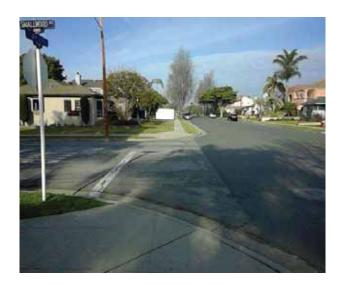
Sidewalks , Hazards & Gratings : Curb is on Path of Travel

Install curb ramp \$2,500

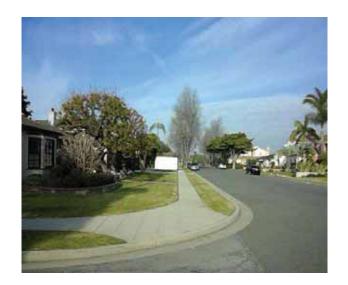
Sidewalks , Hazards & Gratings : Curb is on Path of Travel

Install curb ramp \$2,500

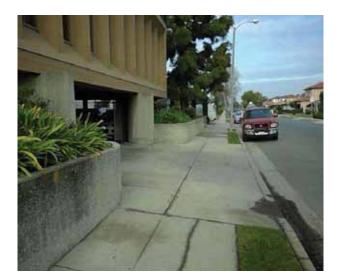
On-Site Finding Not Found

Install compliant detectable \$190 warnings

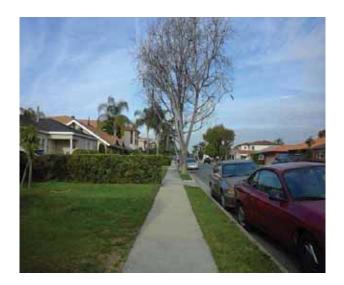
Recommendation Up to 2.08 percent

Repave the sidewalk surface with the recommended cross slope.

Repave surface \$1,092

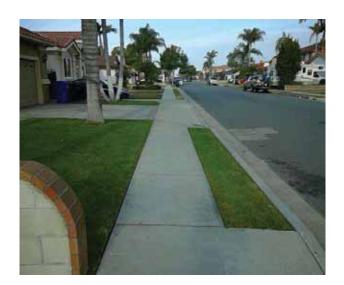
Recommendation Up to 2.08 percent

Repave the sidewalk surface with the recommended cross slope.

Repave surface \$1,092

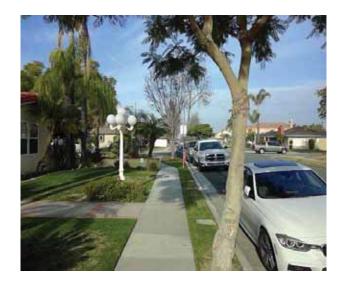
Recommendation Up to 2.08 percent

Repave the sidewalk surface with the recommended cross slope.

Repave surface \$1,092

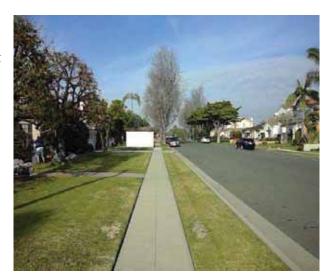
Recommendation Up to 2.08 percent

Repave the sidewalk surface with the recommended cross slope.

Repave surface \$1,092

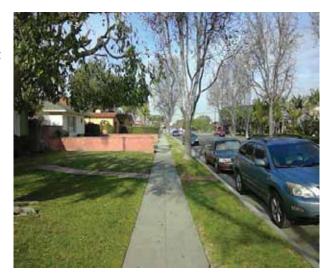
Recommendation Up to 2.08 percent

Repave the sidewalk surface with the recommended cross slope.

Repave surface \$1,092

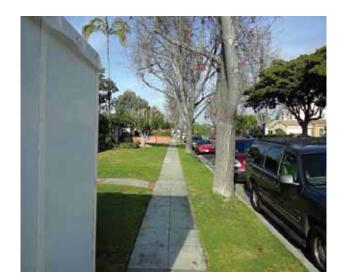
Recommendation Up to 2.08 percent

Repave the sidewalk surface with the recommended cross slope.

Repave surface \$1,092

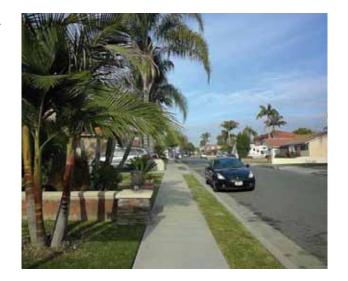
Sidewalks , Hazards & Gratings : Overhead Obstruction Height

Recommendation At least 80.00 inches

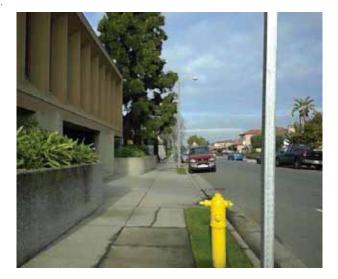
On-Site Finding Not Found

\$2,400
