# Accessibility Survey

## 5th Street & Brookshire Avenue

5th Street & Brookshire Avenue  
Downey, CA 90242

Date of Inspection  
4/18/2017

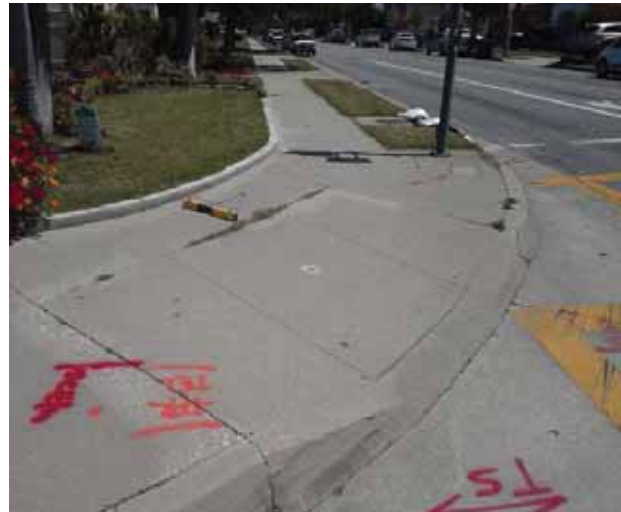
Recommendation At least 48.00 inches

Recommendation

Provide compliant landing \$255

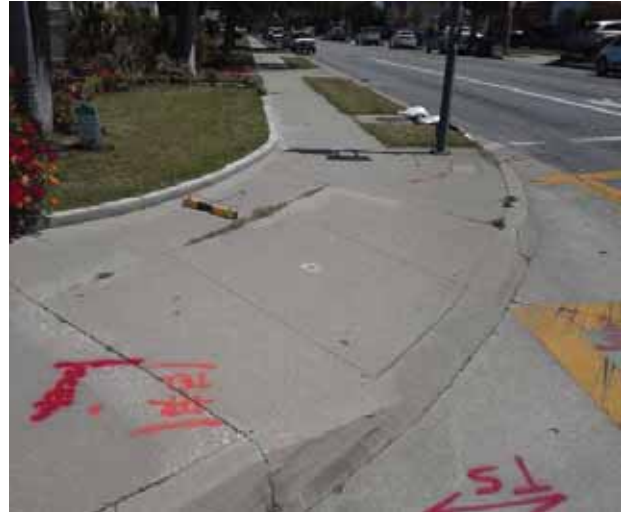
Recommendation Up to 2.08 percent

##### Recommendation

Provide compliant landing \$1,260

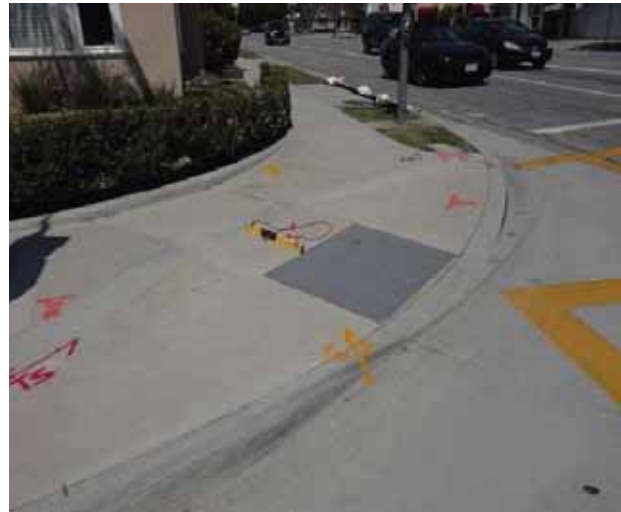
Recommendation Up to 8.33 percent

**Recommendation**

Install curb ramp \$1,300

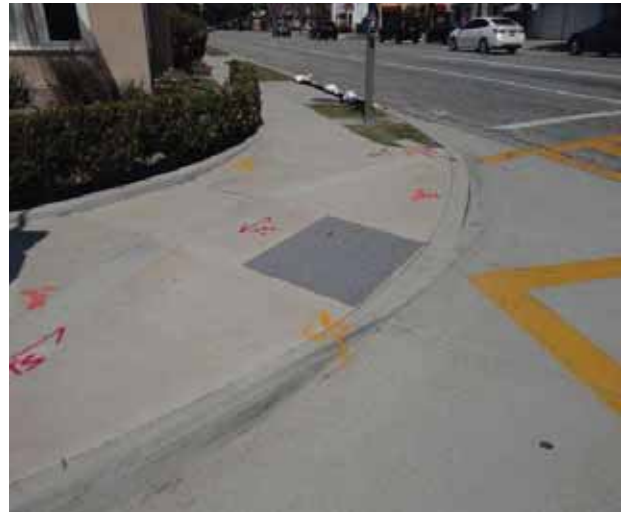
Recommendation At least 48.00 inches

**Recommendation**

Provide compliant landing \$255

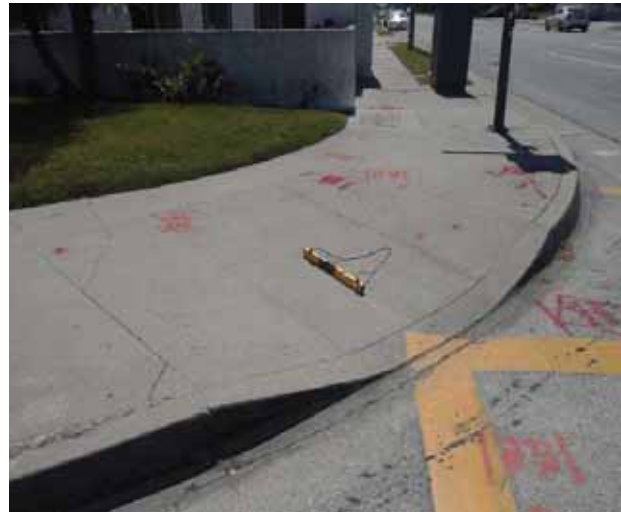
On-Site Finding Not Found

Recommendation

Provide detectable warning to surface \$248

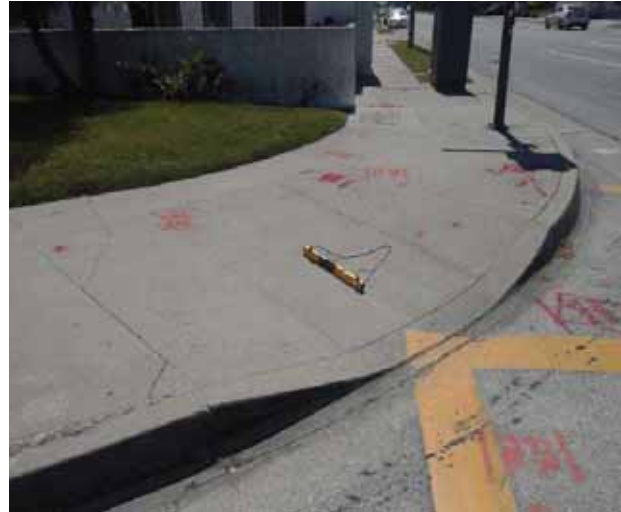
Recommendation Up to 10.00 percent

#### Recommendation

Install flared sides \$1,300

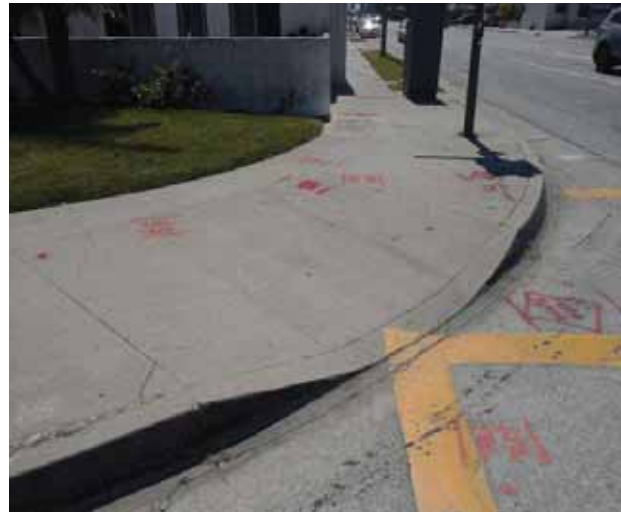
Recommendation At least 48.00 inches

**Recommendation**

Provide compliant landing \$255

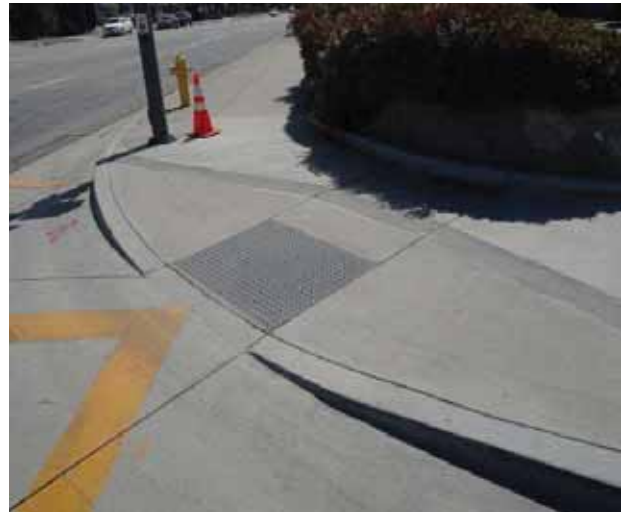
Recommendation At least 48.00 inches

Recommendation

Provide compliant landing \$255

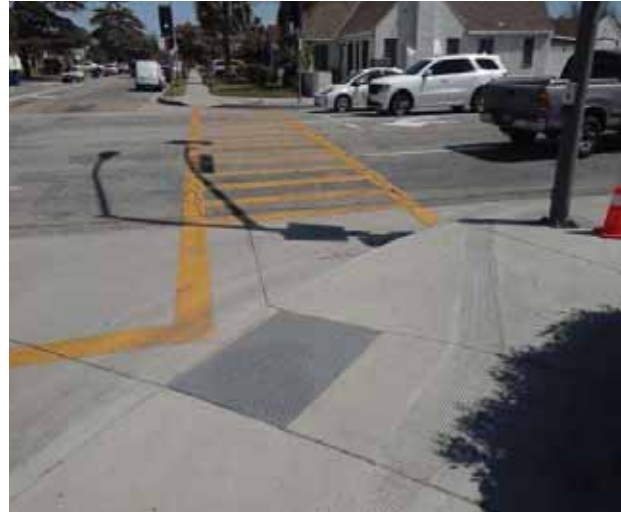
Recommendation Up to 5.00 percent

Repave the walking surface with recommended slope.

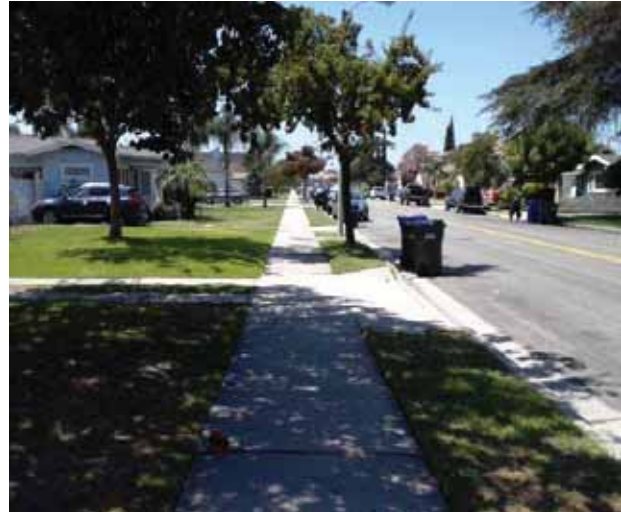
There is a change in elevation greater than recommended value.

Ensure that the change in elevation is within the recommended value.

Recommendation Up to 0.25 inches

Remove tripping hazards \$198

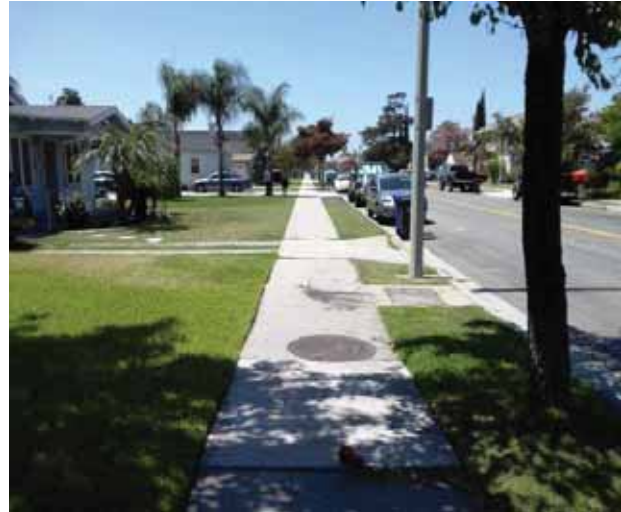
There is a change in elevation greater than recommended value.

Ensure that the change in elevation is within the recommended value.

Recommendation Up to 0.25 inches

Remove tripping hazards \$198

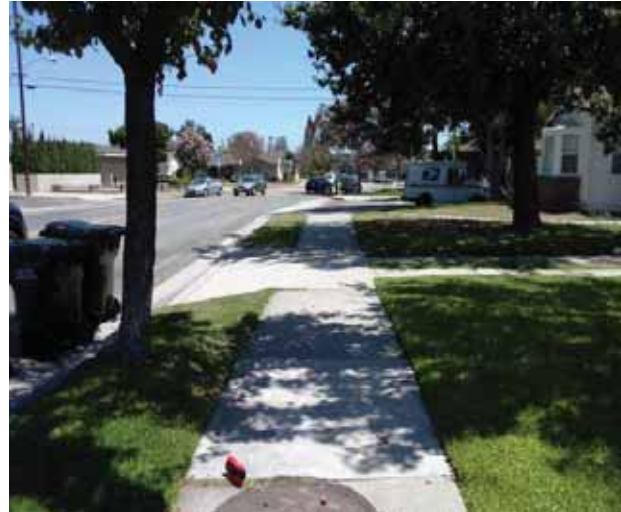
There is a change in elevation greater than recommended value.

Ensure that the change in elevation is within the recommended value.

Recommendation Up to 0.25 inches

Remove tripping hazards \$198

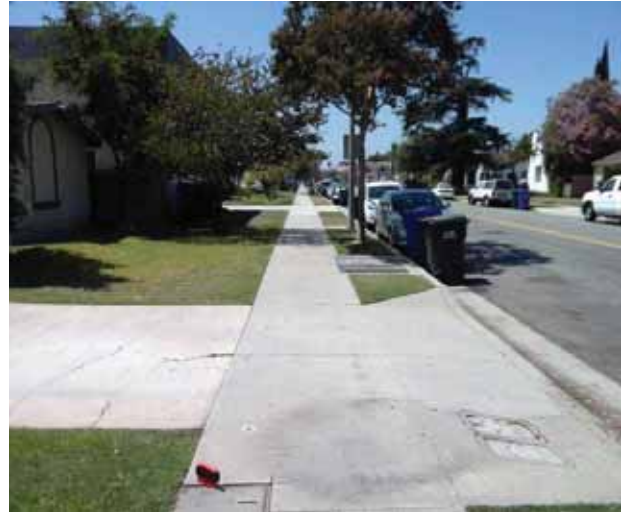
There is a change in elevation greater than recommended value.

Ensure that the change in elevation is within the recommended value.

Recommendation Up to 0.25 inches

Remove tripping hazards \$198

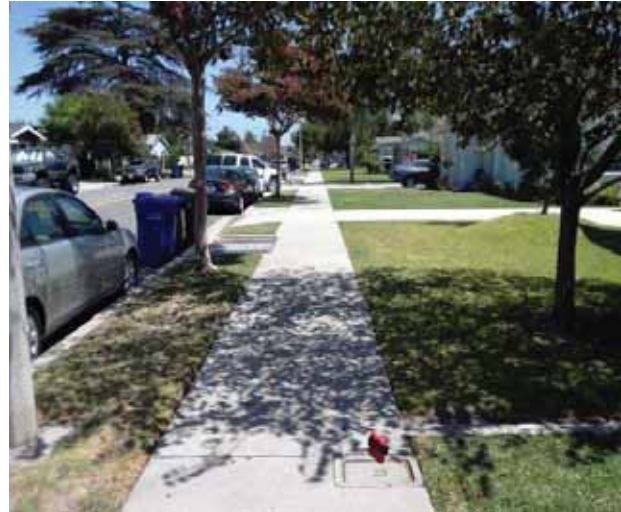
There is a change in elevation greater than recommended value.

Ensure that the change in elevation is within the recommended value.

Recommendation Up to 0.25 inches

Remove tripping hazards \$198

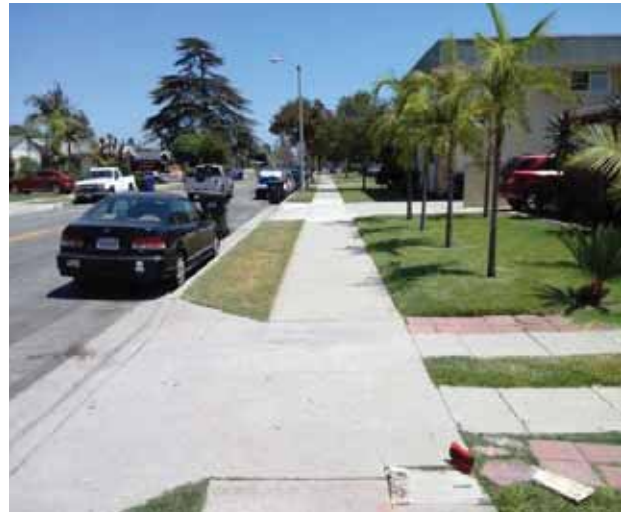
There is a change in elevation greater than recommended value.

Ensure that the change in elevation is within the recommended value.

Recommendation Up to 0.25 inches

Remove tripping hazards \$198

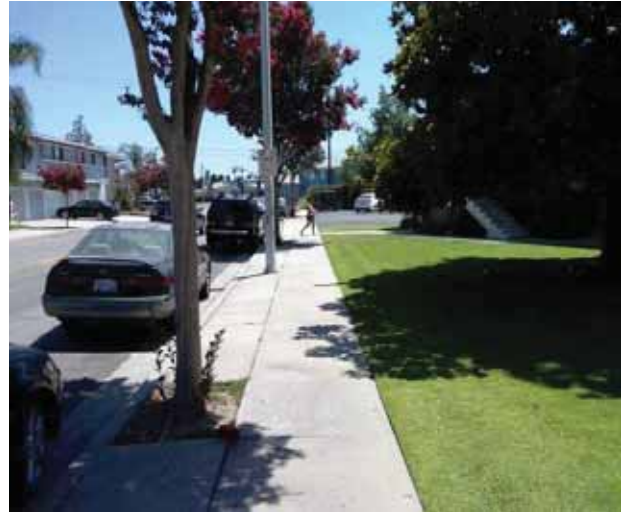
There is a change in elevation greater than recommended value.

Ensure that the change in elevation is within the recommended value.

Recommendation Up to 0.25 inches

Remove tripping hazards \$198

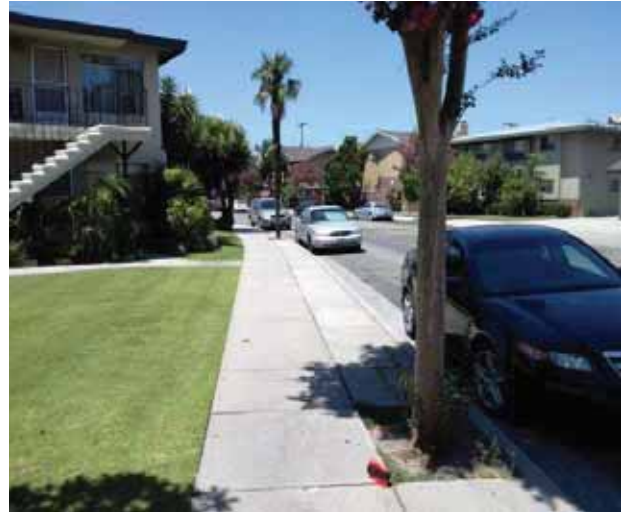
There is a change in elevation greater than recommended value.

Ensure that the change in elevation is within the recommended value.

Recommendation Up to 0.25 inches

Remove tripping hazards \$198

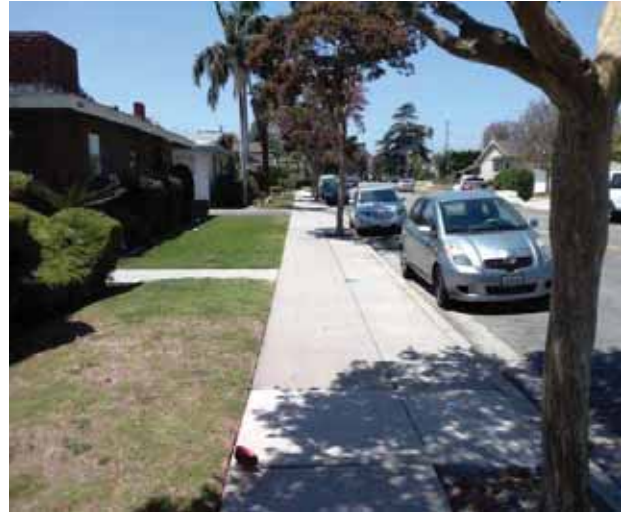
There is a change in elevation greater than recommended value.

Ensure that the change in elevation is within the recommended value.

Recommendation Up to 0.25 inches

Remove tripping hazards \$198

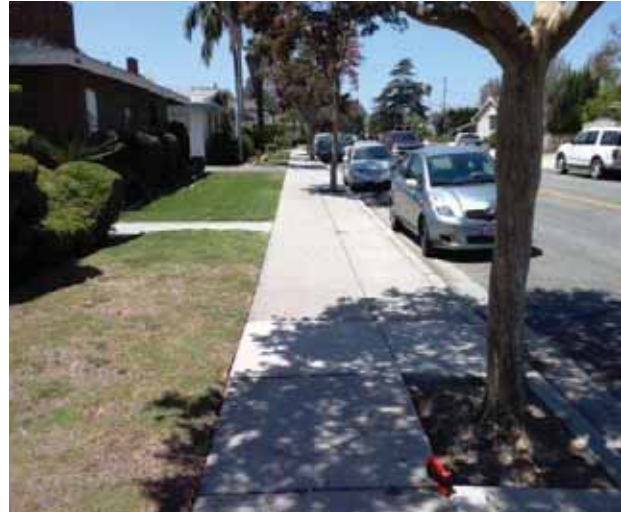
There is a change in elevation greater than recommended value.

Ensure that the change in elevation is within the recommended value.

Recommendation Up to 0.25 inches

Remove tripping hazards \$198

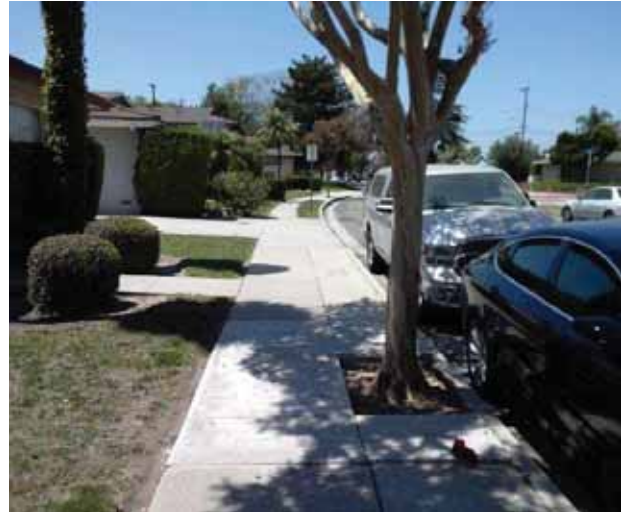
There is a change in elevation greater than recommended value.

Ensure that the change in elevation is within the recommended value.

Recommendation Up to 0.25 inches

Remove tripping hazards \$198

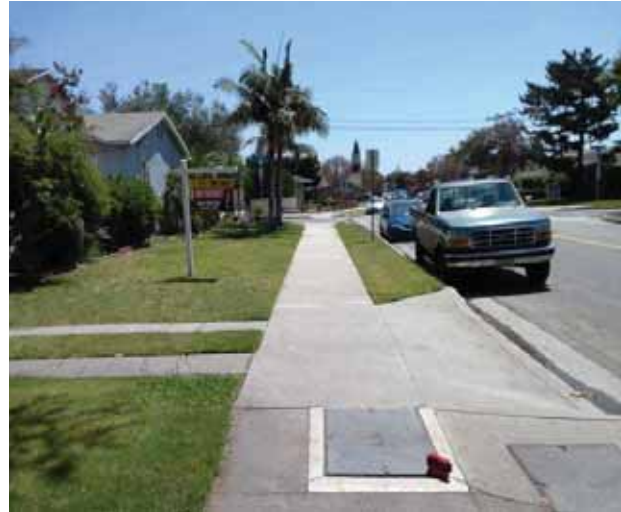
There is a change in elevation greater than recommended value.

Ensure that the change in elevation is within the recommended value.

Recommendation Up to 0.25 inches

Remove tripping hazards \$198

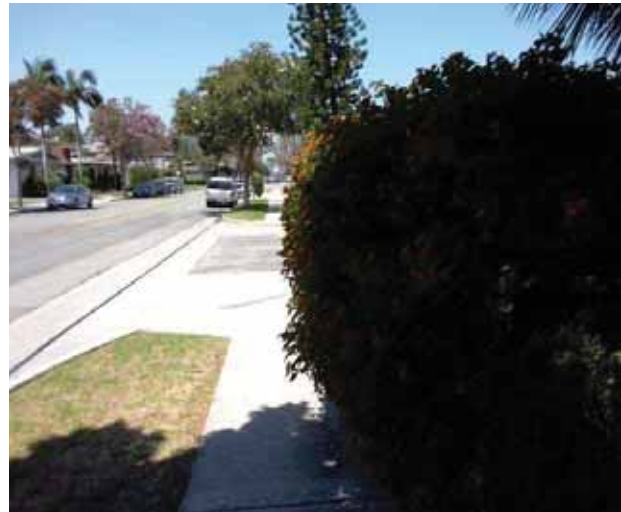
Sidewalks , Hazards & Gratings : Sidewalk Width at Obstruction

Sidewalk width at the obstruction shall have the recommended value.

Recommendation At least 48.00 inches

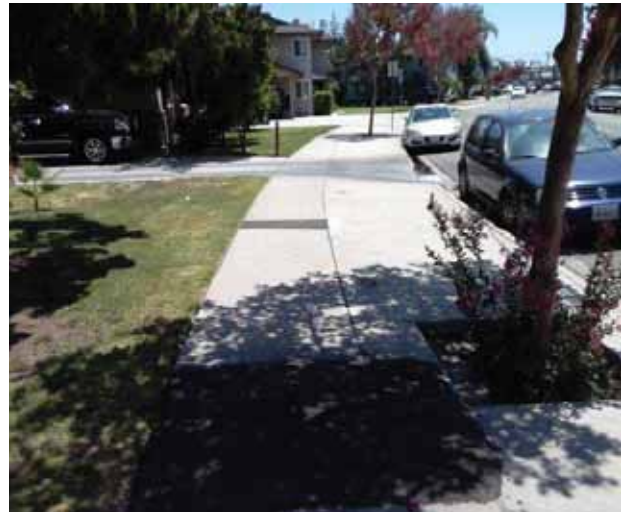
Notes : Surface is Rough And Uneven For 3 Feet

Repave the sidewalk surface with the recommended cross slope.

Recommendation Up to 2.08 percent

Repave surface \$1,092

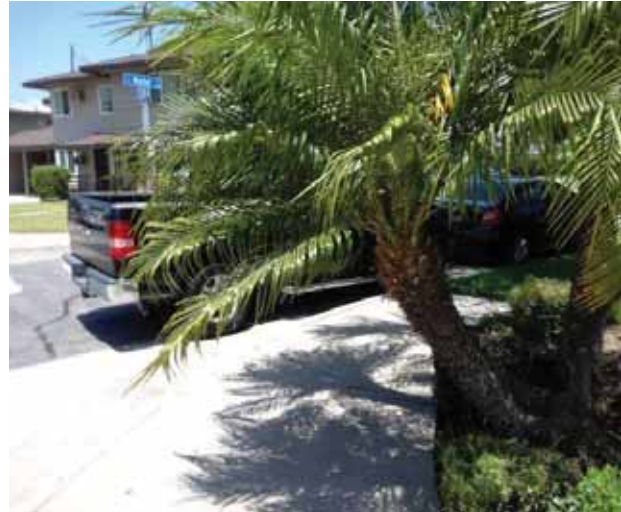
Sidewalks , Hazards & Gratings : Overhead Obstruction Height

Recommendation At least 80.00 inches

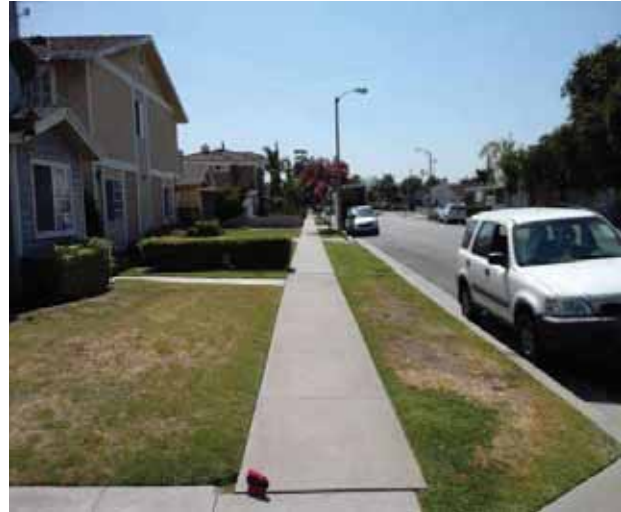
There is a change in elevation greater than recommended value.

Ensure that the change in elevation is within the recommended value.

Recommendation Up to 0.25 inches

Remove tripping hazards \$198

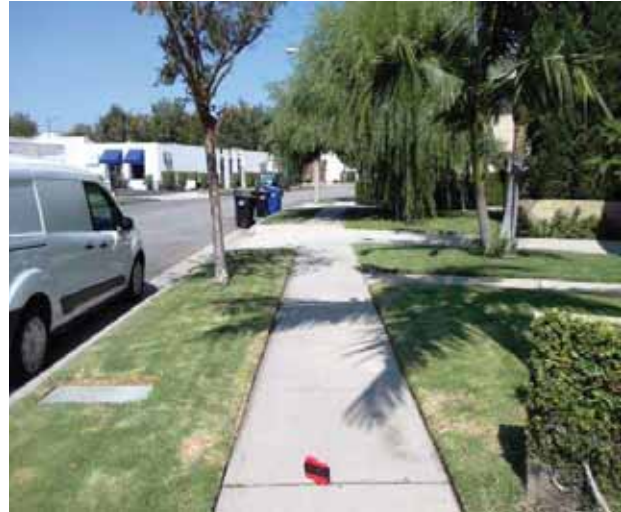
There is a change in elevation greater than recommended value.

Ensure that the change in elevation is within the recommended value.

Recommendation Up to 0.25 inches

Remove tripping hazards \$198

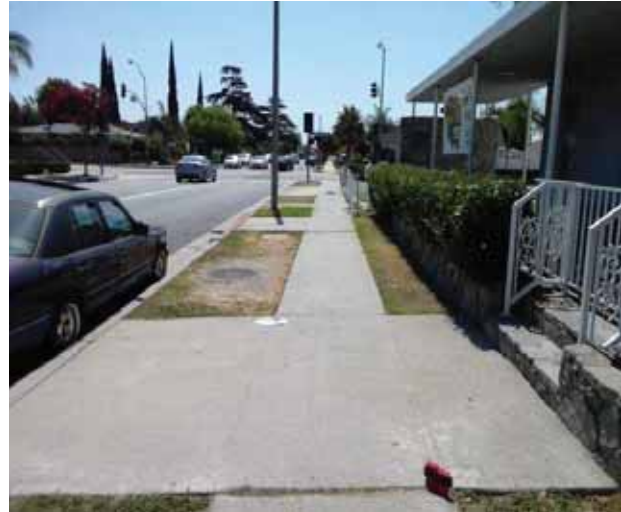
There is a change in elevation greater than recommended value.

Ensure that the change in elevation is within the recommended value.

Recommendation Up to 0.25 inches

Remove tripping hazards \$198

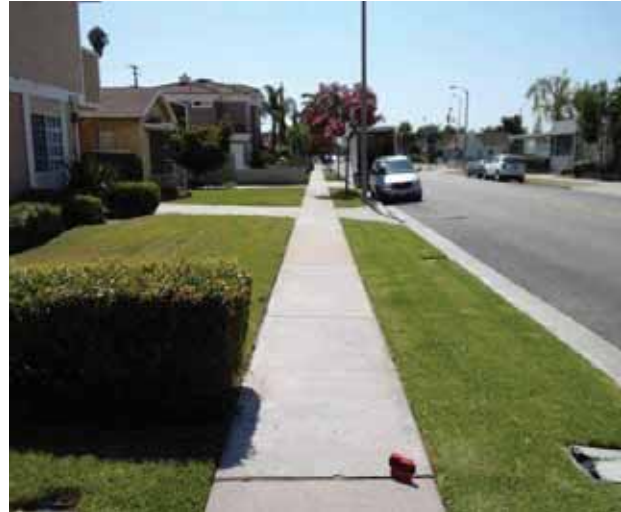
There is a change in elevation greater than recommended value.

Ensure that the change in elevation is within the recommended value.

Recommendation Up to 0.25 inches

Remove tripping hazards \$198

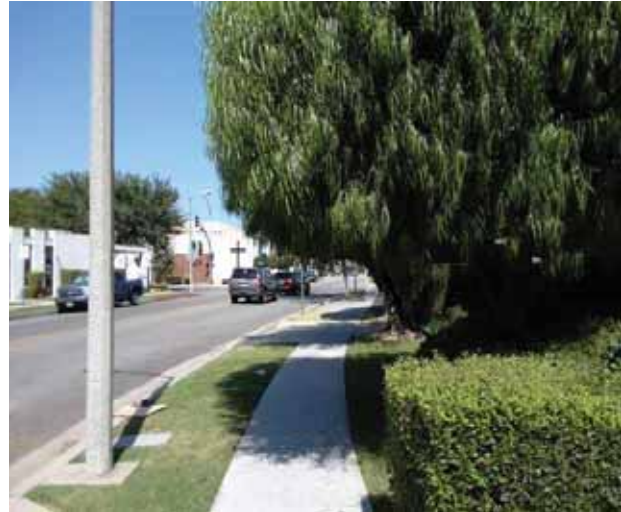
Sidewalks , Hazards & Gratings : Overhead Obstruction Height

Recommendation At least 80.00 inches

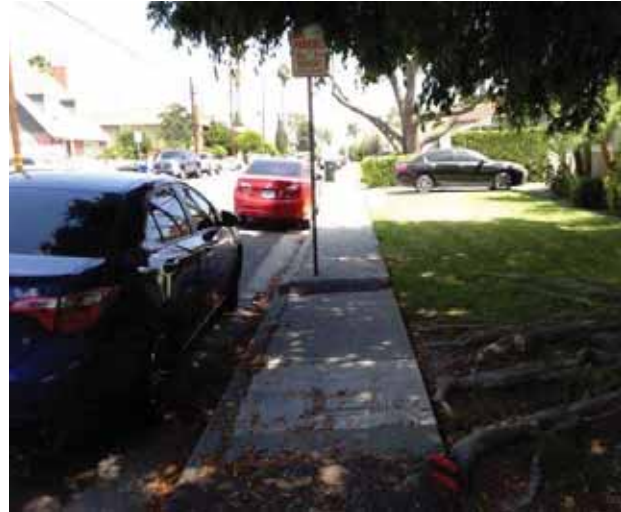
There is a change in elevation greater than recommended value.

Ensure that the change in elevation is within the recommended value.

Recommendation Up to 0.25 inches

Remove tripping hazards \$198

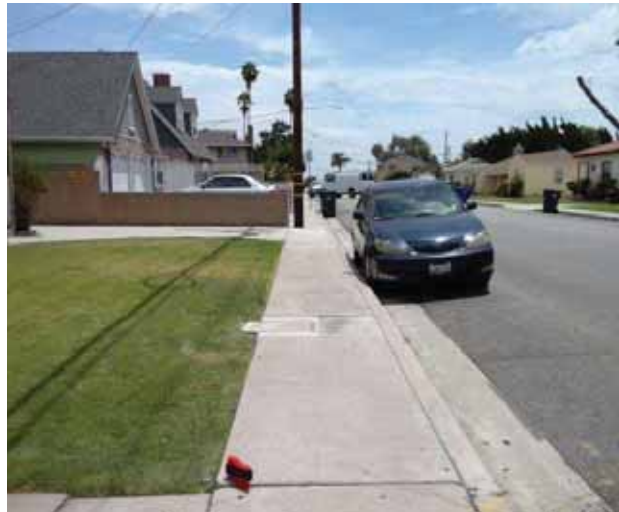
There is a change in elevation greater than recommended value.

Ensure that the change in elevation is within the recommended value.

Recommendation Up to 0.25 inches

Remove tripping hazards \$198

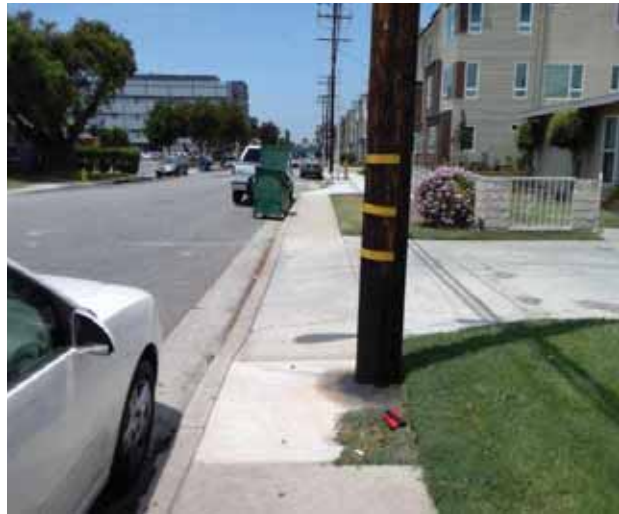
There is a change in elevation greater than recommended value.

Ensure that the change in elevation is within the recommended value.

Recommendation Up to 0.25 inches

Remove tripping hazards \$198

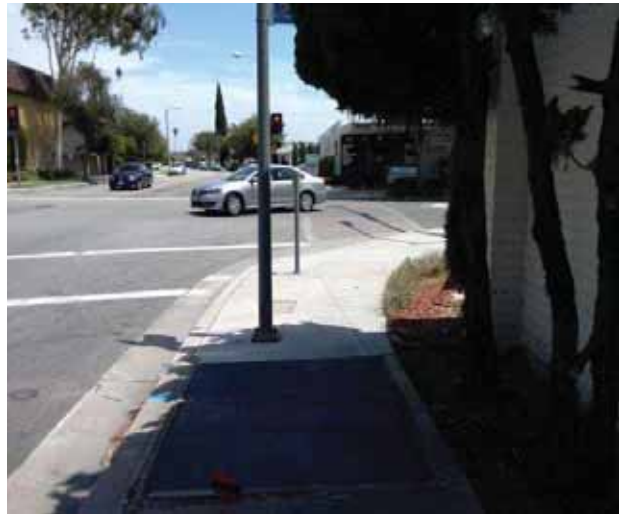
There is a change in elevation greater than recommended value.

Ensure that the change in elevation is within the recommended value.

Recommendation Up to 0.25 inches

Remove tripping hazards \$198

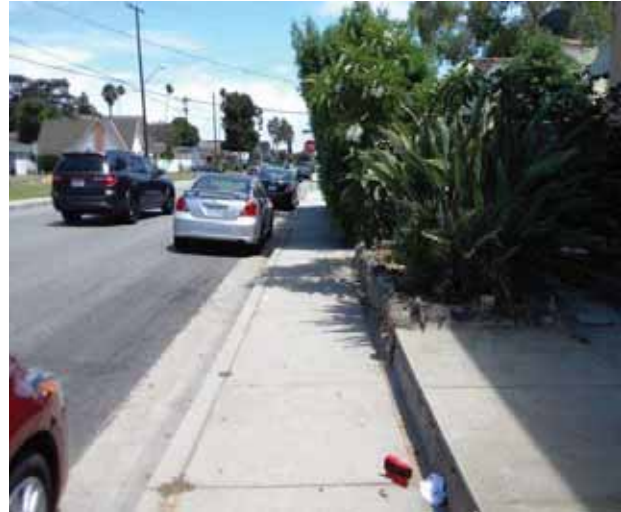
There is a change in elevation greater than recommended value.

Ensure that the change in elevation is within the recommended value.

Recommendation Up to 0.25 inches

Remove tripping hazards \$198

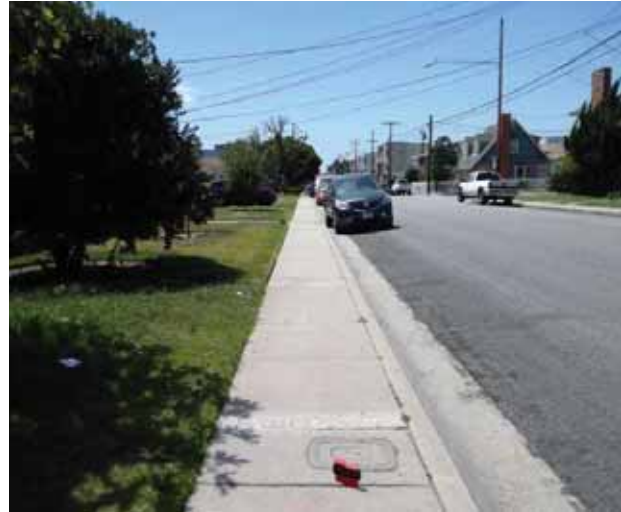
There is a change in elevation greater than recommended value.

Ensure that the change in elevation is within the recommended value.

Recommendation Up to 0.25 inches

Remove tripping hazards \$198

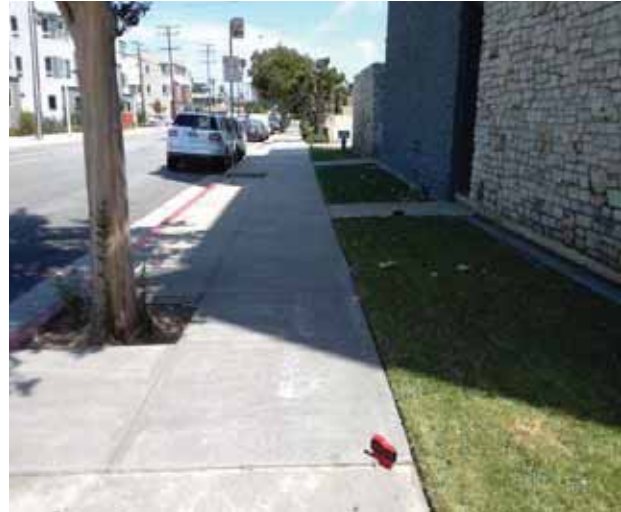
There is a change in elevation greater than recommended value.

Ensure that the change in elevation is within the recommended value.

Recommendation Up to 0.25 inches

Remove tripping hazards \$198

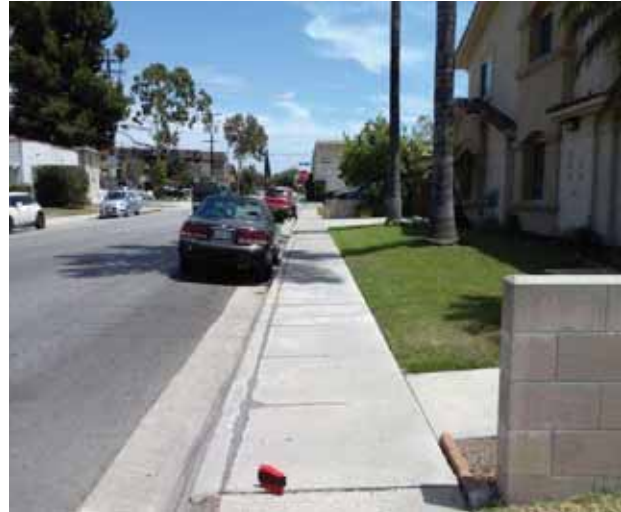
There is a change in elevation greater than recommended value.

Ensure that the change in elevation is within the recommended value.

Recommendation Up to 0.25 inches

Remove tripping hazards \$198

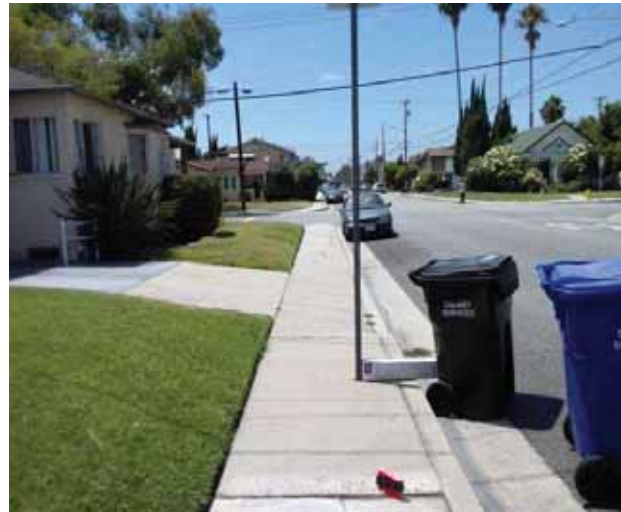
**Code Reference** ADA 206, 302

Remove tripping hazards \$198

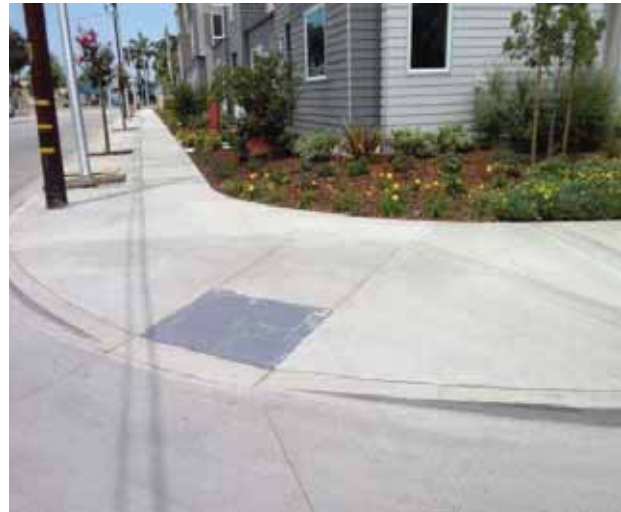
**Code Reference** ADA 406, 406.4, CA 11B-406.5.3

Recommendation At least 48.00 inches

Provide compliant landing \$240

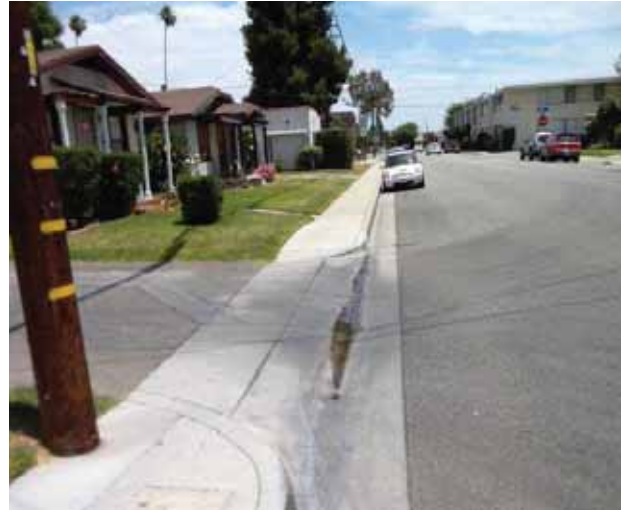
**On-Site Finding** Not Found

**Code Reference** ADA 705,CA 11B-705.1.2.5,CA 11B-247.1.2.5

Recommendation See Recommendation

Install compliant detectable warnings \$190

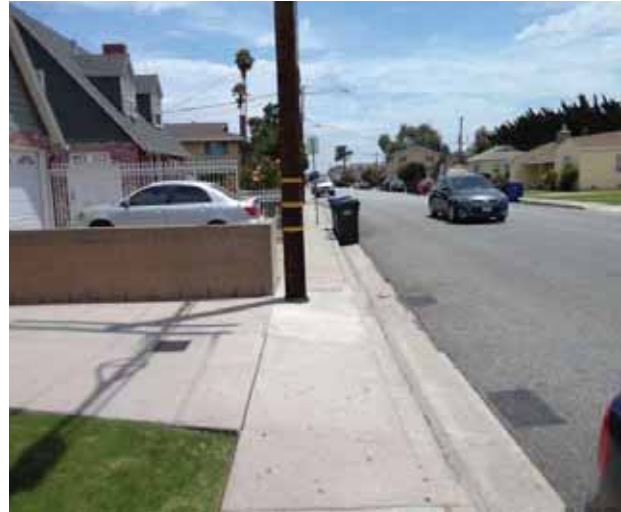
**On-Site Finding** Not Found

**Code Reference** ADA 705,CA 11B-705.1.2.5,CA 11B-247.1.2.5

Recommendation See Recommendation

Install compliant detectable warnings \$190

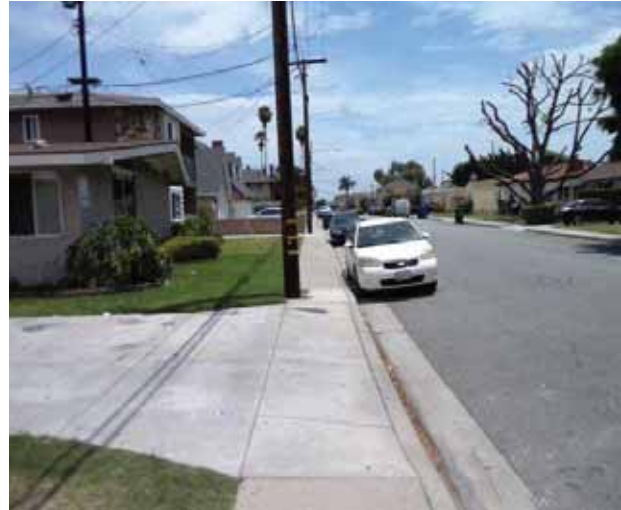
**On-Site Finding** Not Found

**Code Reference** ADA 705,CA 11B-705.1.2.5,CA 11B-247.1.2.5

Recommendation See Recommendation

Install compliant detectable warnings \$190

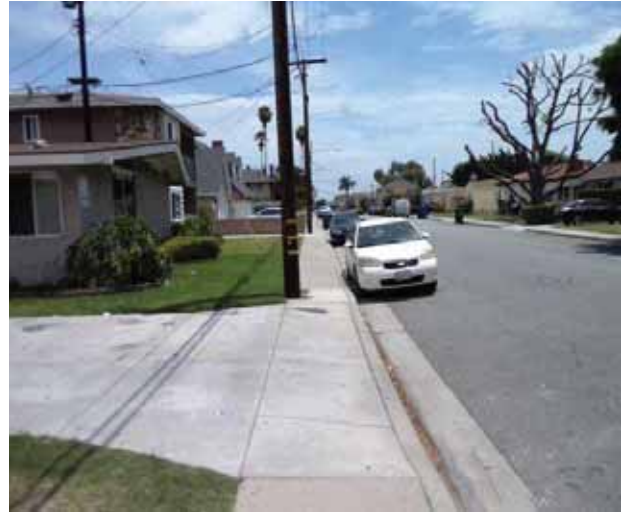
**Code Reference** ADA 206, 302, CA 11B-403.3

Recommendation Up to 2.08 percent

Repave surface \$1,092

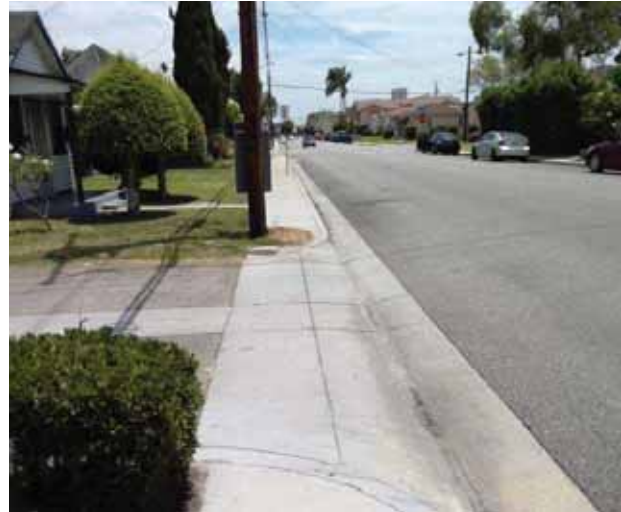
**On-Site Finding** Not Found

**Code Reference** ADA 705,CA 11B-705.1.2.5,CA 11B-247.1.2.5

Recommendation See Recommendation

Install compliant detectable warnings \$190

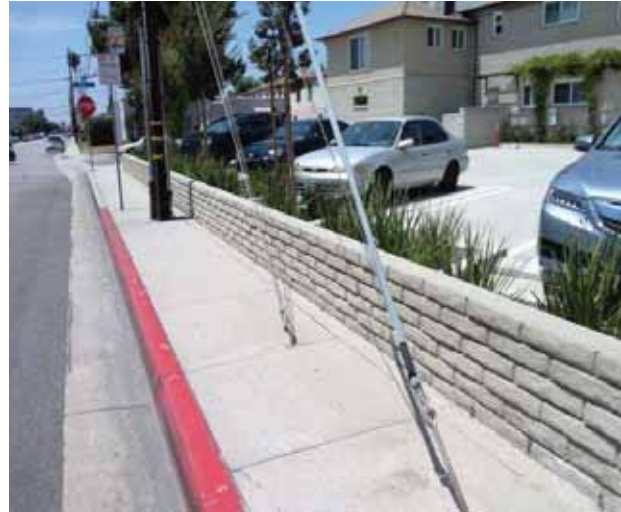
Sidewalks , Hazards & Gratings : Overhead Obstruction Height

**Code Reference** ADA 206, 307.4, CA 11B-307.4

Recommendation At least 80.00 inches

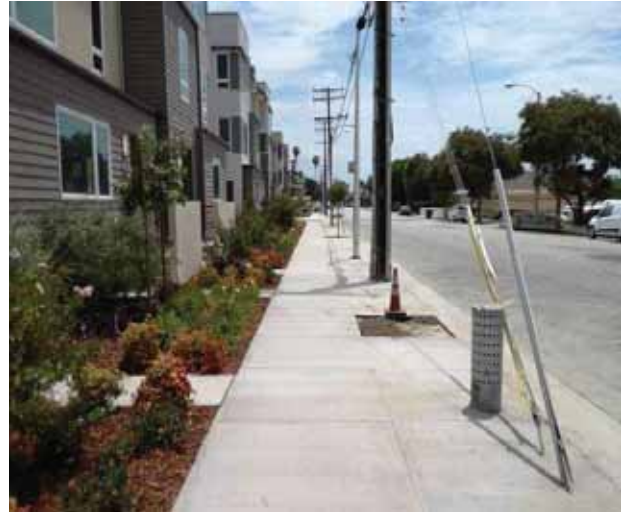
Sidewalks , Hazards & Gratings : Overhead Obstruction Height

**Code Reference** ADA 206, 307.4, CA 11B-307.4

Recommendation At least 80.00 inches

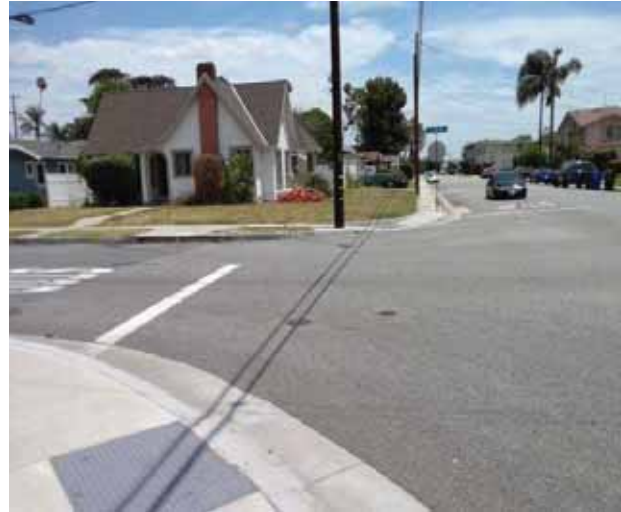
**Code Reference** ADA 206, 302, CA 11B-403.3

Recommendation Up to 2.08 percent

Repave surface \$1,092

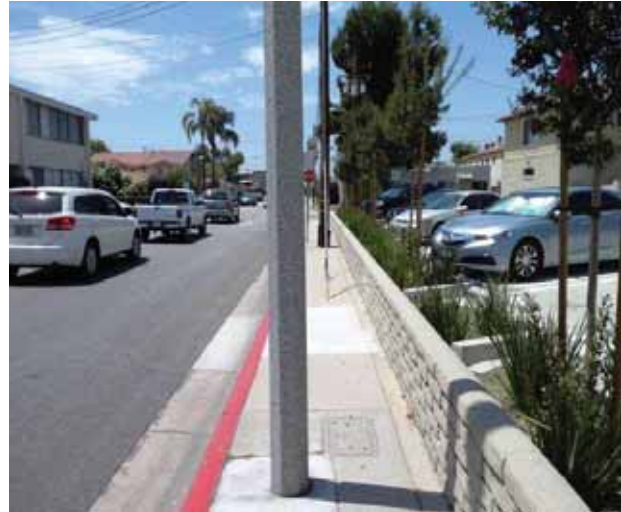
Sidewalks , Hazards & Gratings : Sidewalk Width at Obstruction

**Code Reference** ADA 206, 302, 403.5.1, CA 11B-403.5

Sidewalk width at the obstruction shall have the recommended value.

Recommendation At least 48.00 inches

\$1,260

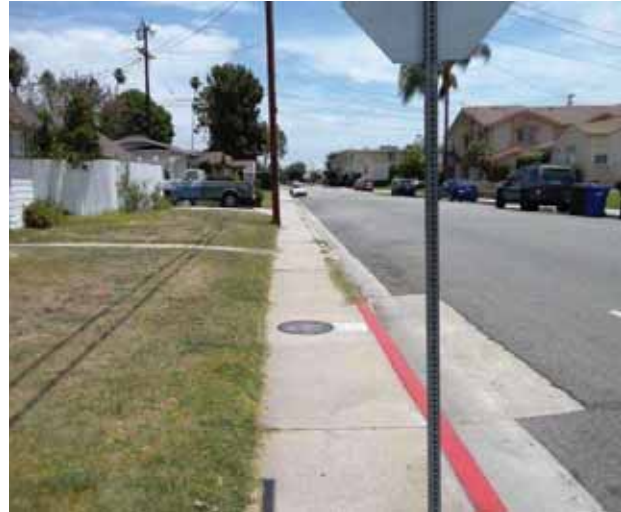
**Code Reference** ADA 206, 302,CA 11B-403.3

Repave the sidewalk surface with the recommended cross slope.

Recommendation Up to 2.08 percent

Repave surface \$1,092

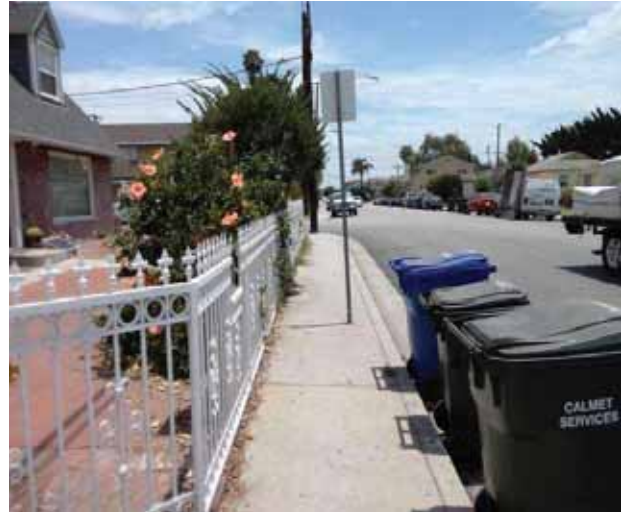
**Code Reference** ADA 206, 302, CA 11B-403.3

Repave the sidewalk surface with the recommended cross slope.

Recommendation Up to 2.08 percent

Repave surface \$1,092

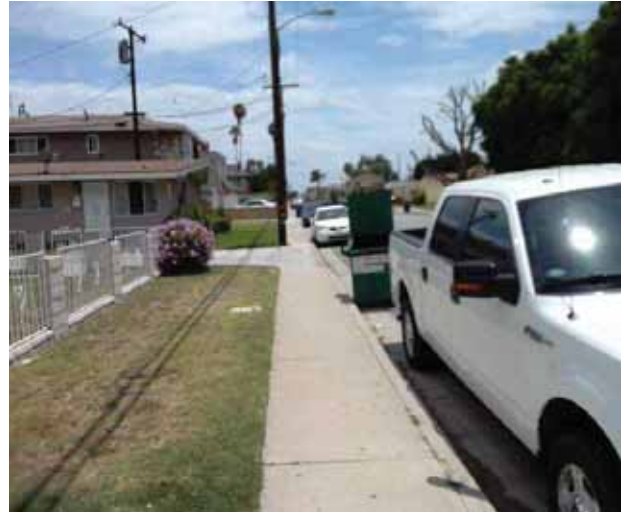
**Code Reference** ADA 206, 302, CA 11B-403.3

Repave the sidewalk surface with the recommended cross slope.

Recommendation Up to 2.08 percent

Repave surface \$1,092

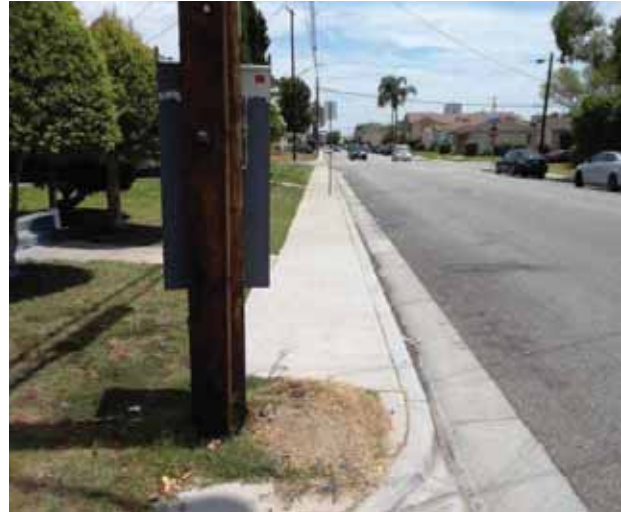
Sidewalks : Missing Sidewalk

Section of sidewalk is missing and consists of dirt, grass or gravel.

**Code Reference** ADA 206, 302,CA 11B-302,CA 11B-206

Provide a compliant sidewalk for the missing section.

\$1,260

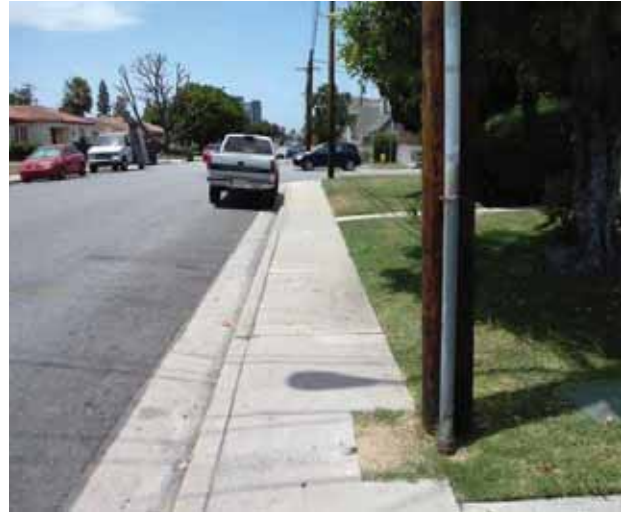
**Code Reference** ADA 206, 302, CA 11B-403.5.1

Widen the sidewalk to the recommended value.

Recommendation At least 48.00 inches

\$1,260

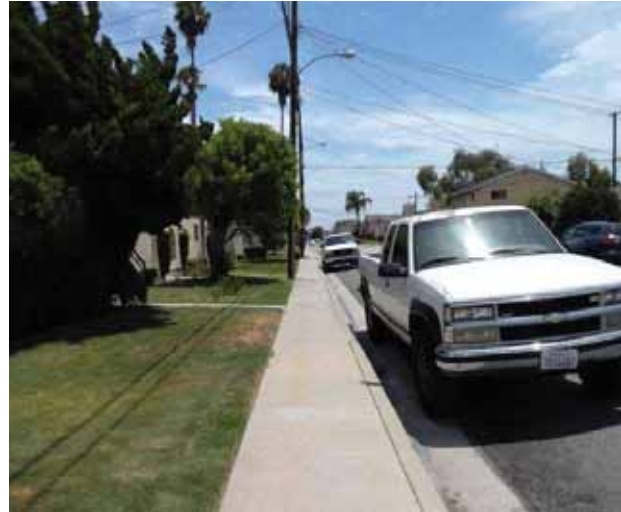
**Code Reference** ADA 206, 302, CA 11B-403.3

Repave the sidewalk surface with the recommended cross slope.

Recommendation Up to 2.08 percent

Repave surface \$1,092

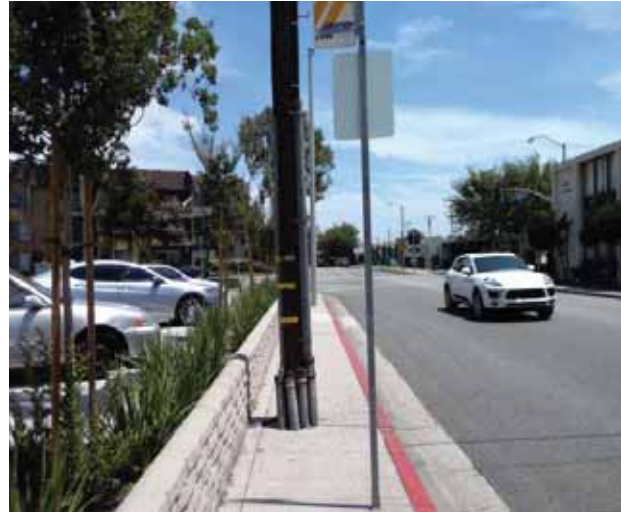
Sidewalks , Hazards & Gratings : Sidewalk Width at Obstruction

**Code Reference** ADA 206, 302, 403.5.1, CA 11B-403.5

Sidewalk width at the obstruction shall have the recommended value.

Recommendation At least 48.00 inches

\$1,260

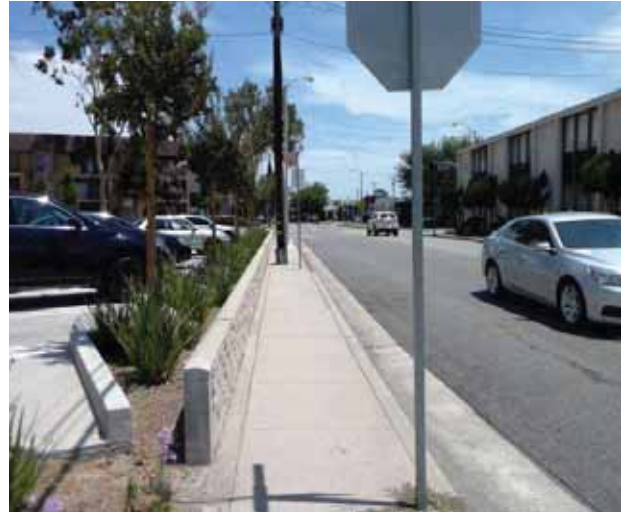
Sidewalks , Hazards & Gratings : Sidewalk Width at Obstruction

**Code Reference** ADA 206, 302, 403.5.1, CA 11B-403.5

Sidewalk width at the obstruction shall have the recommended value.

Recommendation At least 48.00 inches

\$1,260

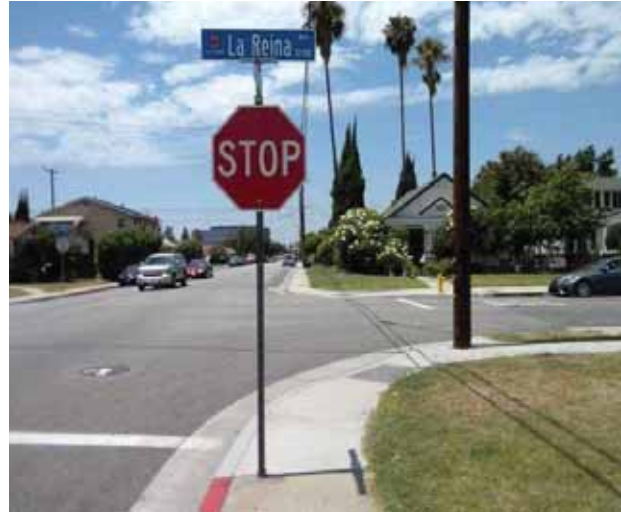
Sidewalks , Hazards & Gratings : Sidewalk Width at Obstruction

**Code Reference** ADA 206, 302, 403.5.1, CA 11B-403.5

Sidewalk width at the obstruction shall have the recommended value.

Recommendation At least 48.00 inches

\$1,260

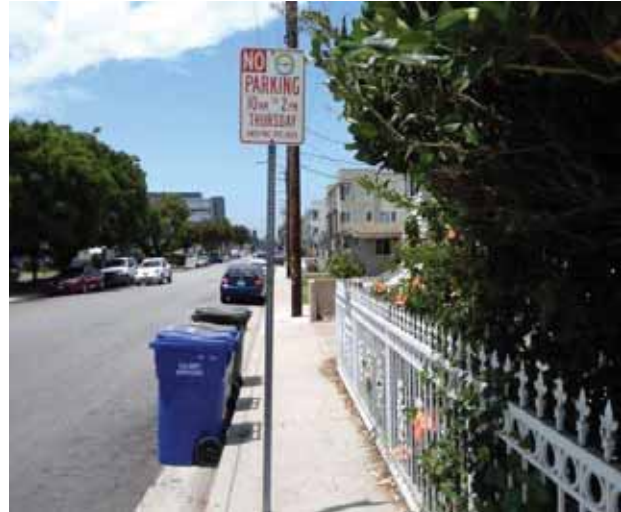
Sidewalks , Hazards & Gratings : Sidewalk Width at Obstruction

**Code Reference** ADA 206, 302, 403.5.1, CA 11B-403.5

Sidewalk width at the obstruction shall have the recommended value.

Recommendation At least 48.00 inches

\$1,260

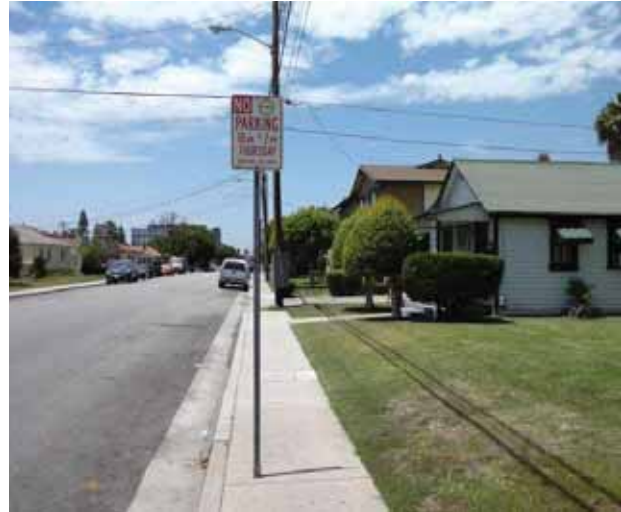
Sidewalks , Hazards & Gratings : Sidewalk Width at Obstruction

**Code Reference** ADA 206, 302, 403.5.1, CA 11B-403.5

Sidewalk width at the obstruction shall have the recommended value.

Recommendation At least 48.00 inches

\$1,260

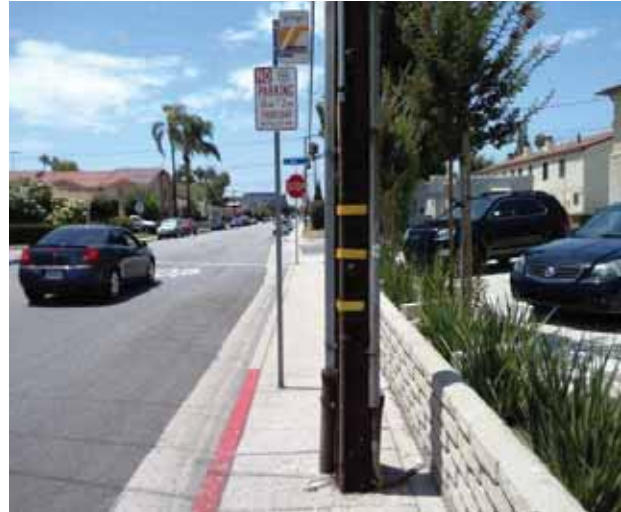
Sidewalks , Hazards & Gratings : Sidewalk Width at Obstruction

**Code Reference** ADA 206, 302, 403.5.1, CA 11B-403.5

Sidewalk width at the obstruction shall have the recommended value.

Recommendation At least 48.00 inches

\$1,260

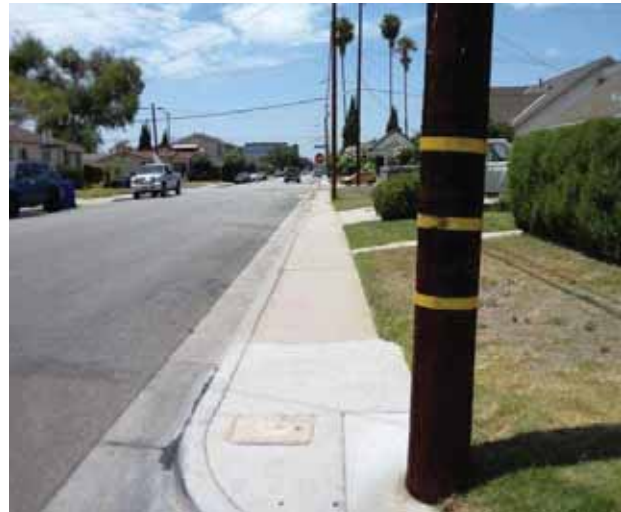
Sidewalks , Hazards & Gratings : Sidewalk Width at Obstruction

**Code Reference** ADA 206, 302, 403.5.1, CA 11B-403.5

Sidewalk width at the obstruction shall have the recommended value.

Recommendation At least 48.00 inches

\$1,260

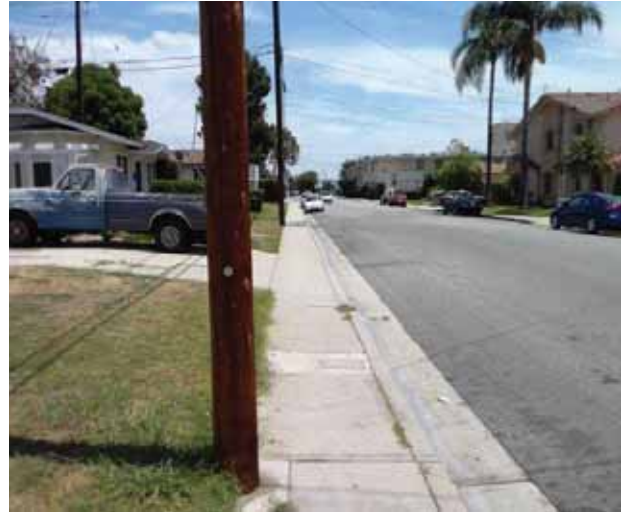
Sidewalks , Hazards & Gratings : Sidewalk Width at Obstruction

**Code Reference** ADA 206, 302, 403.5.1, CA 11B-403.5

Sidewalk width at the obstruction shall have the recommended value.

Recommendation At least 48.00 inches

\$1,260

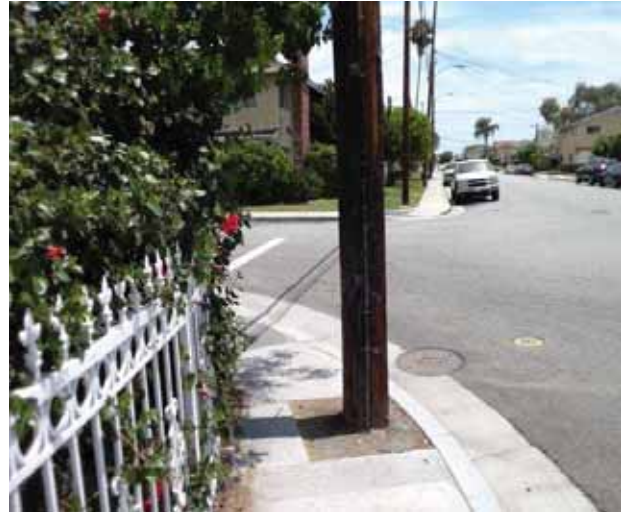
Sidewalks , Hazards & Gratings : Sidewalk Width at Obstruction

**Code Reference** ADA 206, 302, 403.5.1, CA 11B-403.5

Sidewalk width at the obstruction shall have the recommended value.

Recommendation At least 48.00 inches

\$1,260
