# Accessibility Survey

## 5th Street & Brookshire Avenue

5th Street & Brookshire Avenue  
Downey, CA 90242

Date of Inspection  
4/18/2017

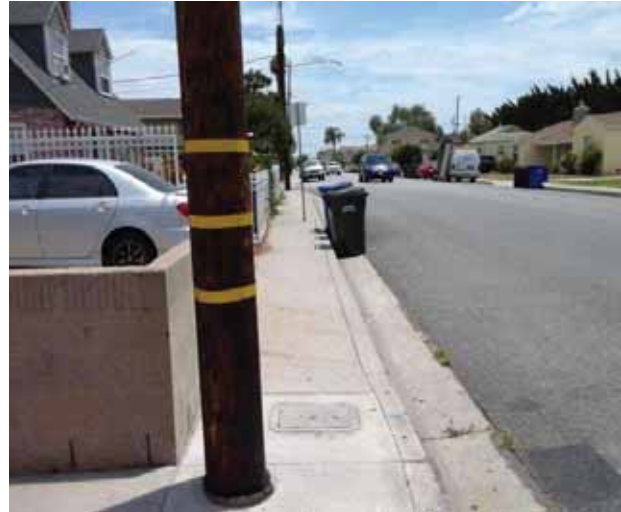
Sidewalks , Hazards & Gratings : Sidewalk Width at Obstruction

**Code Reference** ADA 206, 302, 403.5.1, CA 11B-403.5

Sidewalk width at the obstruction shall have the recommended value.

Recommendation At least 48.00 inches

\$1,260

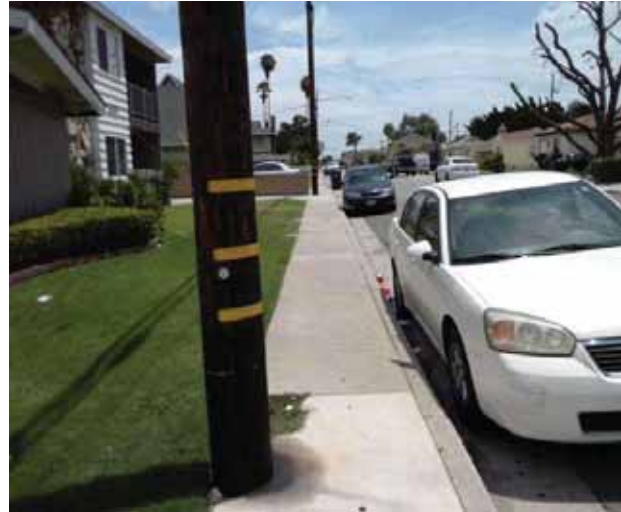
Sidewalks , Hazards & Gratings : Sidewalk Width at Obstruction

**Code Reference** ADA 206, 302, 403.5.1, CA 11B-403.5

Sidewalk width at the obstruction shall have the recommended value.

Recommendation At least 48.00 inches

\$1,260

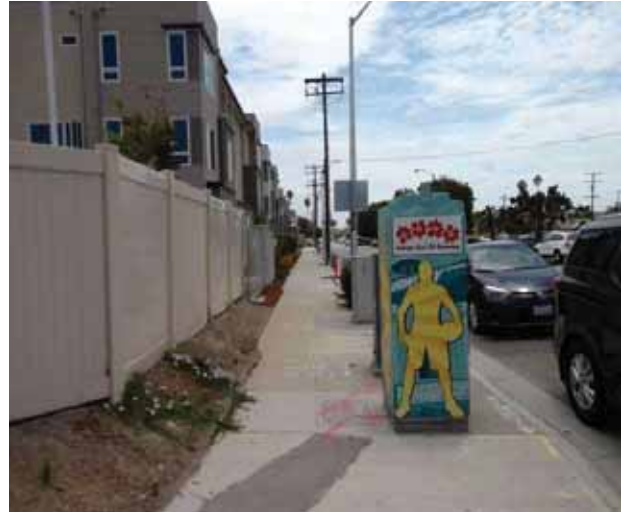
**On-Site Finding** Not Found

**Code Reference** ADA 206, 302

Recommendation See Recommendation

\$2,400

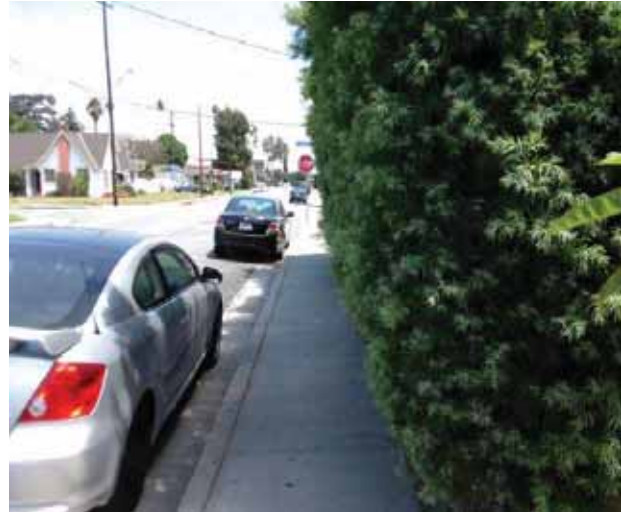
Sidewalks , Hazards & Gratings : Sidewalk Width at Obstruction

**Code Reference** ADA 206, 302, 403.5.1, CA 11B-403.5

Sidewalk width at the obstruction shall have the recommended value.

Recommendation At least 48.00 inches

\$1,260

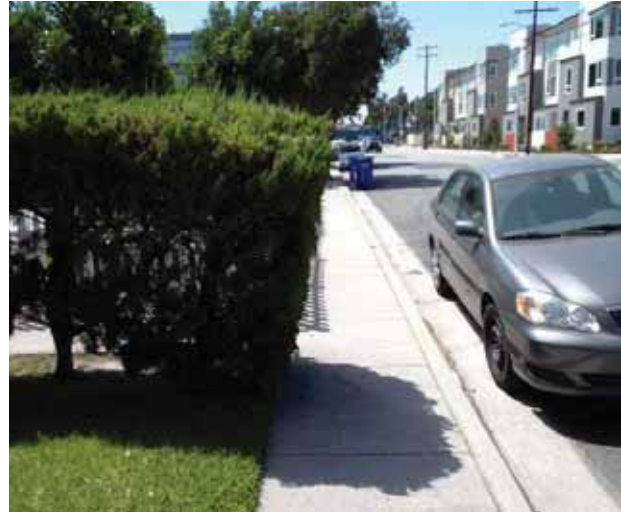
Sidewalks , Hazards & Gratings : Sidewalk Width at Obstruction

**Code Reference** ADA 206, 302, 403.5.1, CA 11B-403.5

Sidewalk width at the obstruction shall have the recommended value.

Recommendation At least 48.00 inches

\$1,260

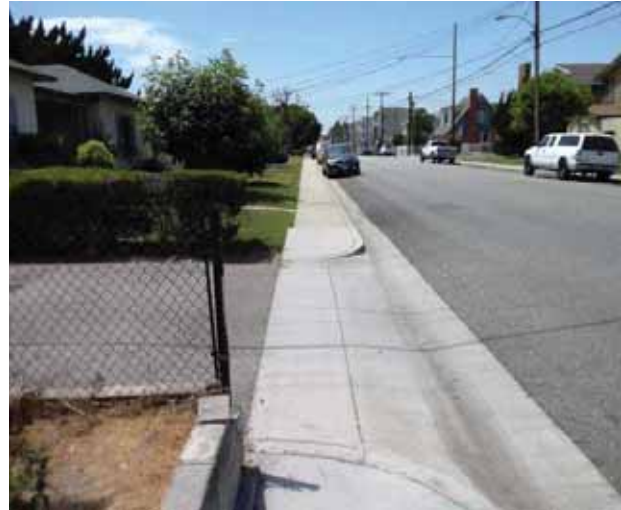
**On-Site Finding** Not Found

**Code Reference** ADA 705,CA 11B-705.1.2.5,CA 11B-247.1.2.5

Recommendation See Recommendation

Install compliant detectable warnings \$190

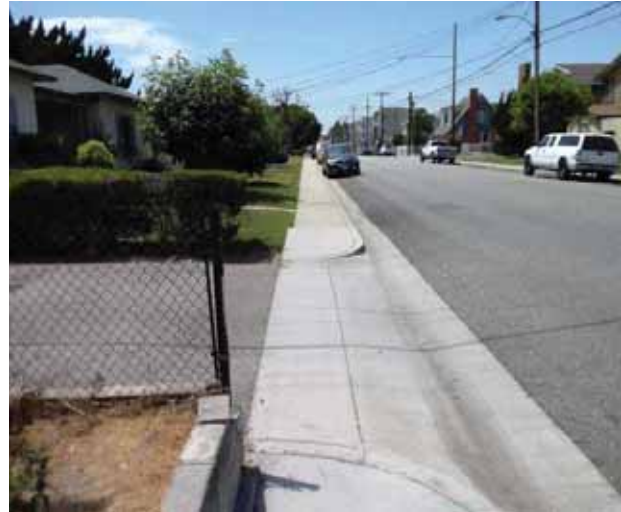
**Code Reference** ADA 206, 302, CA 11B-403.3

Repave surface \$1,092

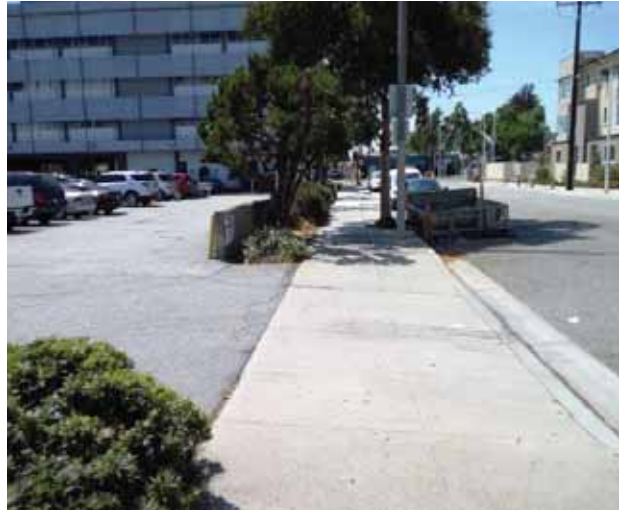
**Code Reference** ADA 705,CA 11B-705.1.2.5,CA 11B-247.1.2.5

Install compliant detectable warnings \$190

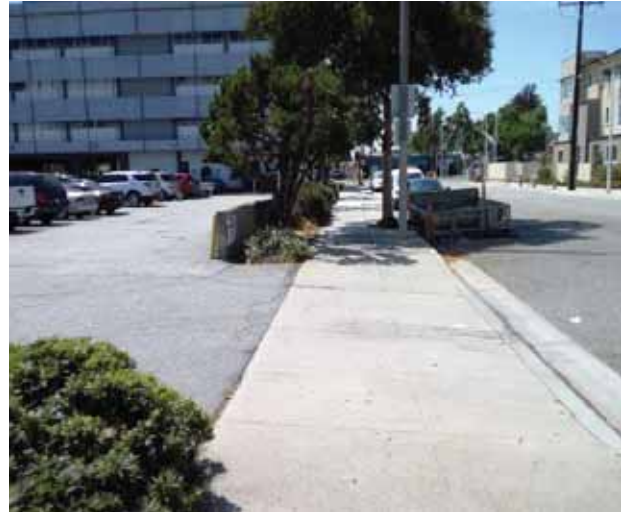
**Code Reference** ADA 206, 302, CA 11B-403.3

Repave surface \$1,092

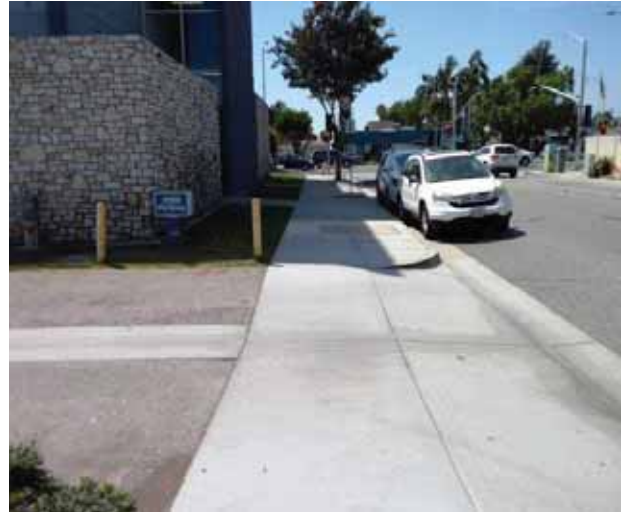
**Code Reference** ADA 705,CA 11B-705.1.2.5,CA 11B-247.1.2.5

Install compliant detectable warnings \$190

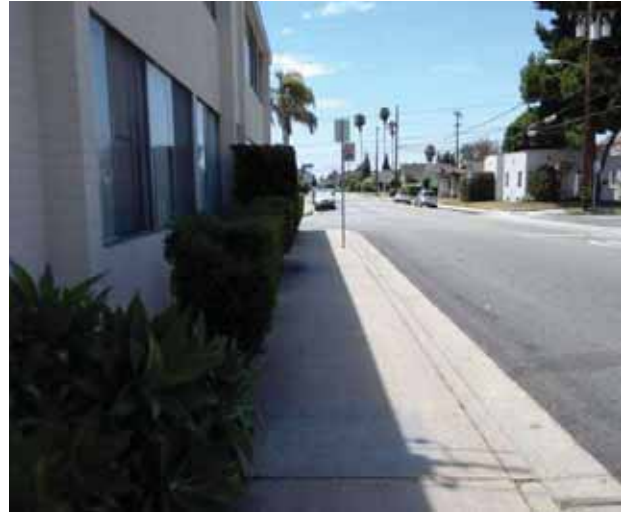
**Code Reference** ADA 206, 302, CA 11B-403.3

Repave surface \$1,092

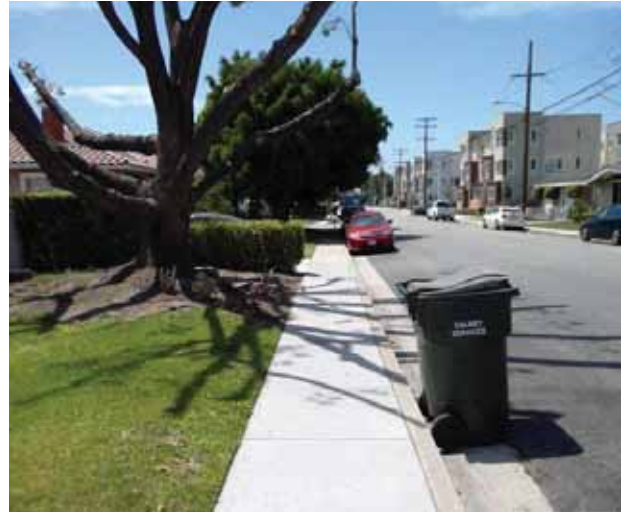
**Code Reference** ADA 206, 302,CA 11B-403.3

Repave surface \$1,092

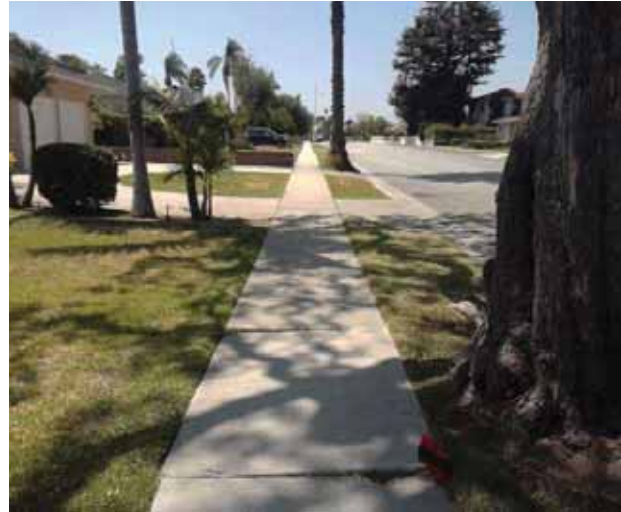
There is a change in elevation greater than recommended value.

Ensure that the change in elevation is within the recommended value.

Recommendation Up to 0.25 inches

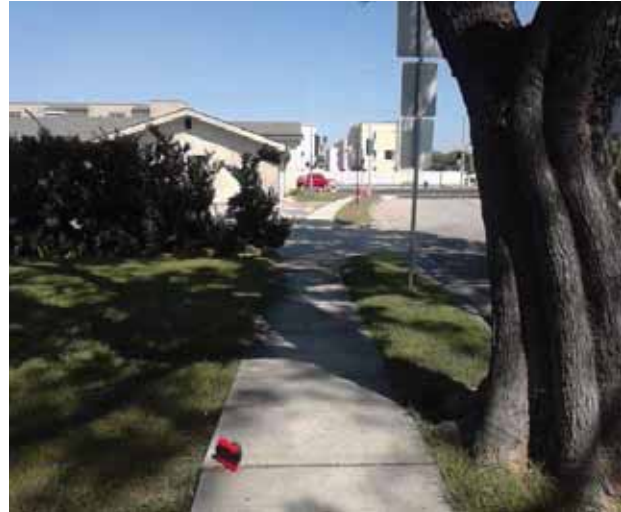
There is a change in elevation greater than recommended value.

Ensure that the change in elevation is within the recommended value.

Recommendation Up to 0.25 inches

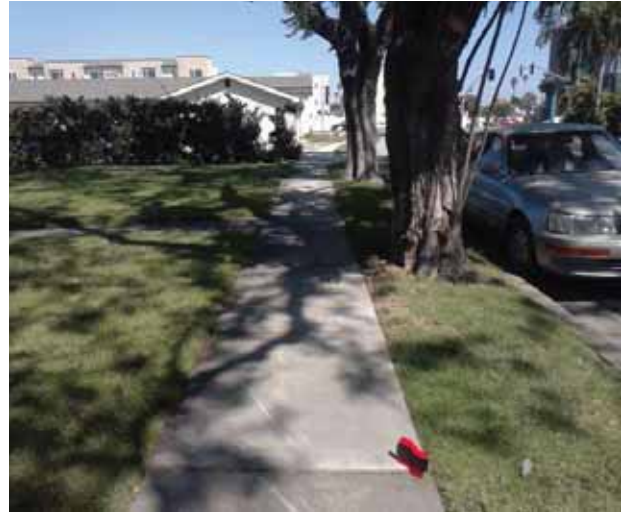
There is a change in elevation greater than recommended value.

Ensure that the change in elevation is within the recommended value.

Recommendation Up to 0.25 inches

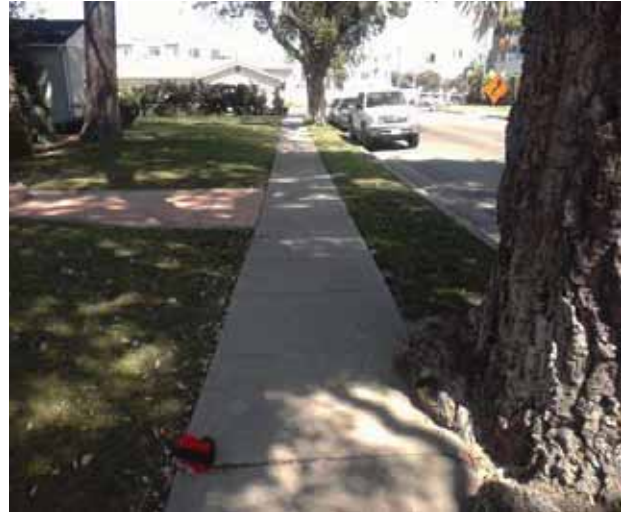
There is a change in elevation greater than recommended value.

Ensure that the change in elevation is within the recommended value.

Recommendation Up to 0.25 inches

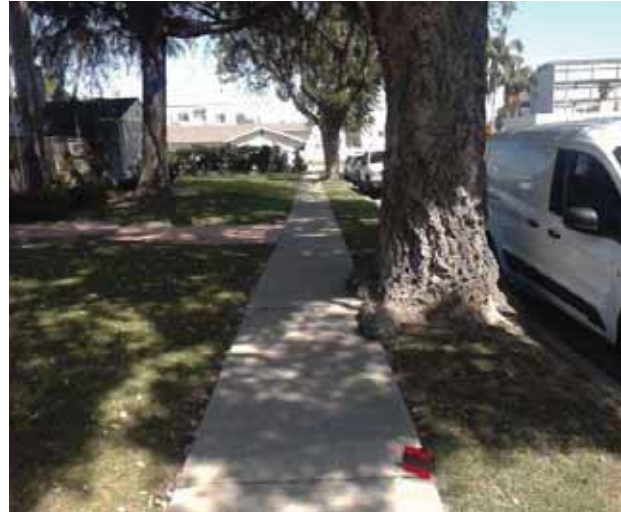
There is a change in elevation greater than recommended value.

Ensure that the change in elevation is within the recommended value.

Recommendation Up to 0.25 inches

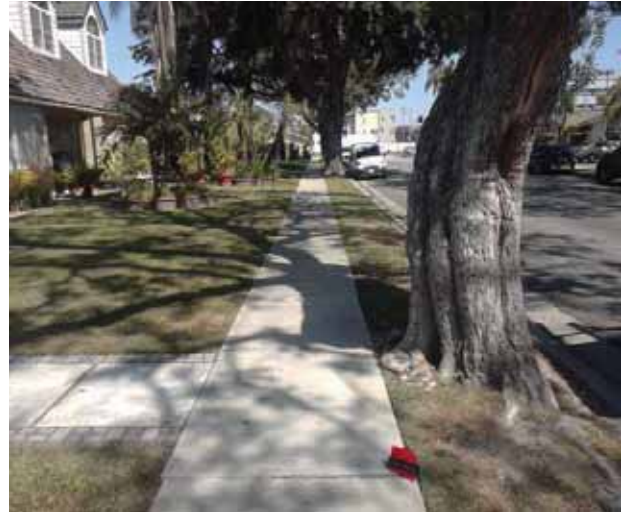
There is a change in elevation greater than recommended value.

Ensure that the change in elevation is within the recommended value.

Recommendation Up to 0.25 inches

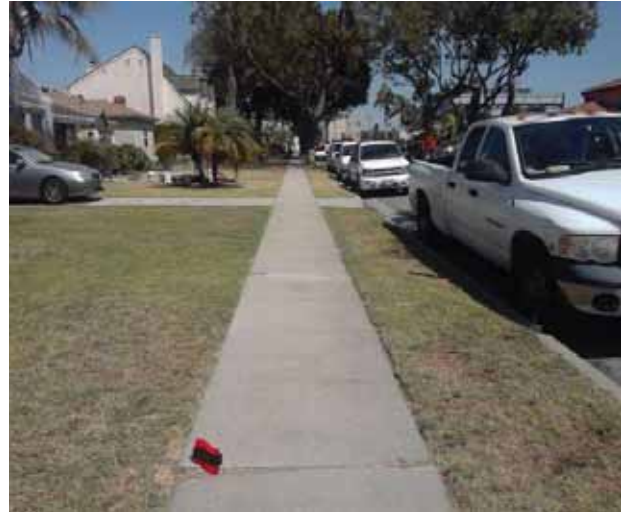
There is a change in elevation greater than recommended value.

Ensure that the change in elevation is within the recommended value.

Recommendation Up to 0.25 inches

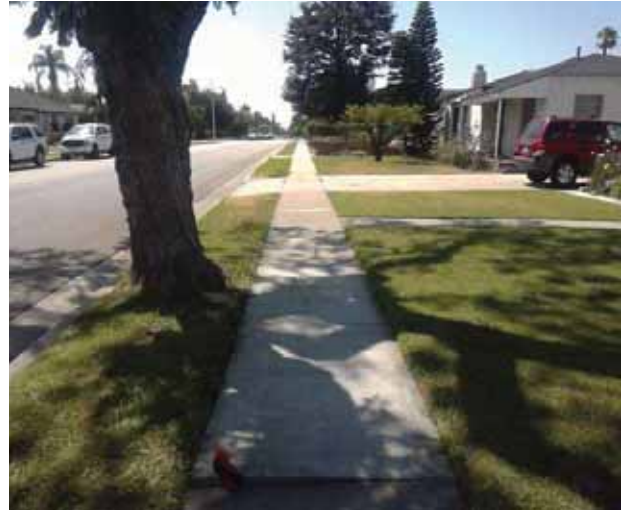
There is a change in elevation greater than recommended value.

Ensure that the change in elevation is within the recommended value.

Recommendation Up to 0.25 inches

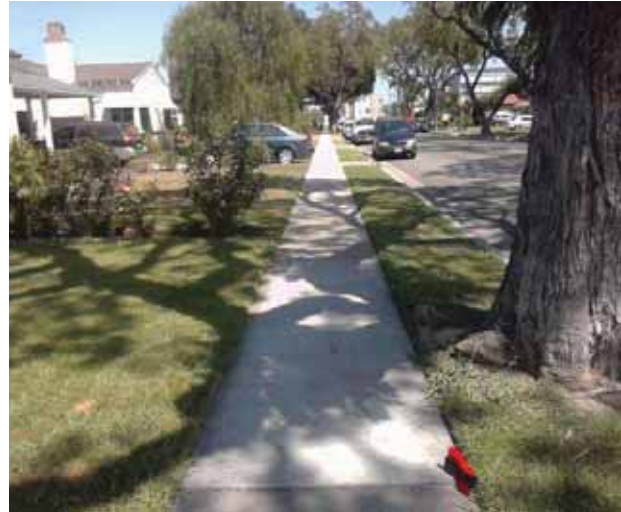
There is a change in elevation greater than recommended value.

Ensure that the change in elevation is within the recommended value.

Recommendation Up to 0.25 inches

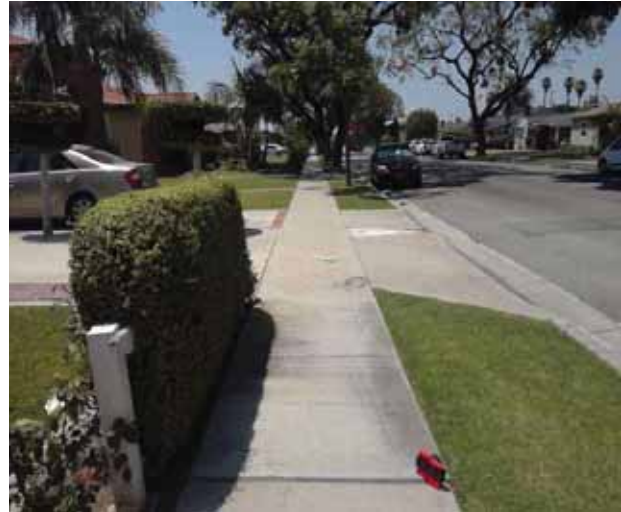
There is a change in elevation greater than recommended value.

Ensure that the change in elevation is within the recommended value.

Recommendation Up to 0.25 inches

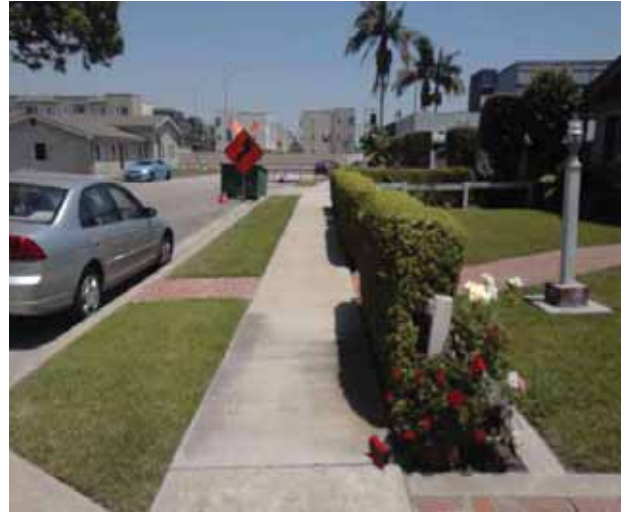
There is a change in elevation greater than recommended value.

Ensure that the change in elevation is within the recommended value.

Recommendation Up to 0.25 inches

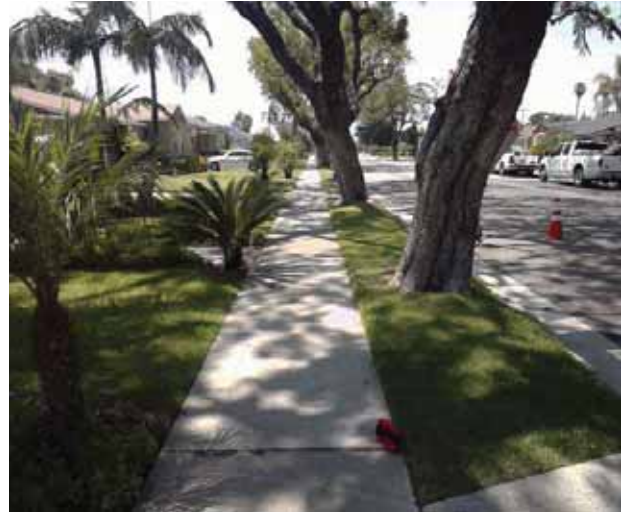
There is a change in elevation greater than recommended value.

Ensure that the change in elevation is within the recommended value.

Recommendation Up to 0.25 inches

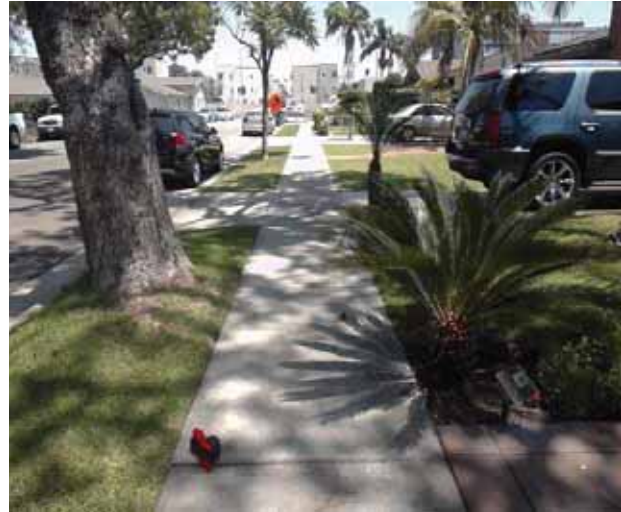
There is a change in elevation greater than recommended value.

Ensure that the change in elevation is within the recommended value.

Recommendation Up to 0.25 inches

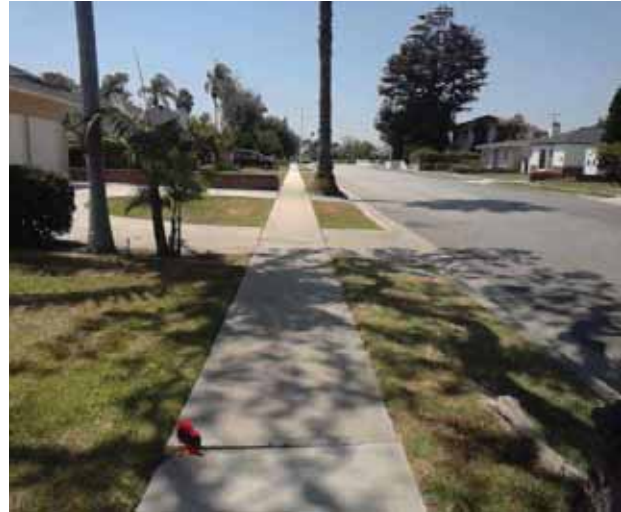
There is a change in elevation greater than recommended value.

Ensure that the change in elevation is within the recommended value.

Recommendation Up to 0.25 inches

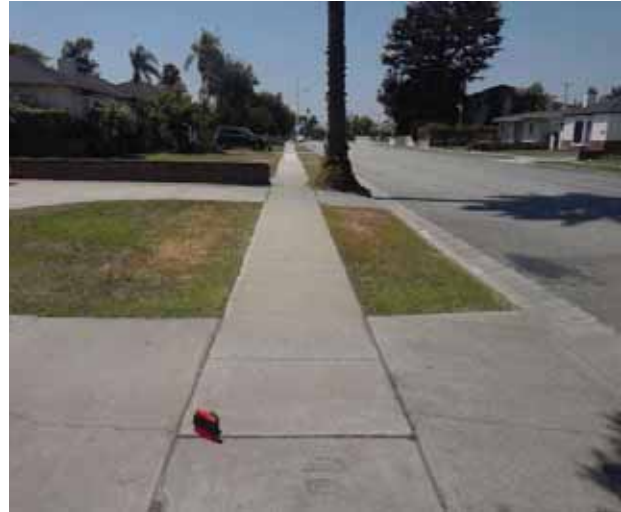
There is a change in elevation greater than recommended value.

Ensure that the change in elevation is within the recommended value.

Recommendation Up to 0.25 inches

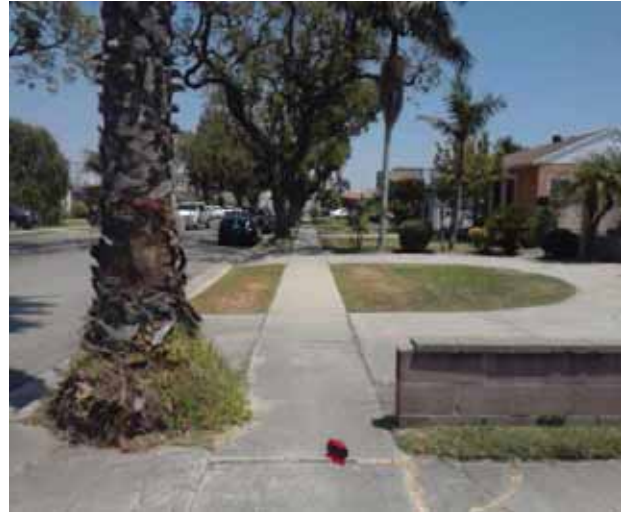
There is a change in elevation greater than recommended value.

Ensure that the change in elevation is within the recommended value.

Recommendation Up to 0.25 inches

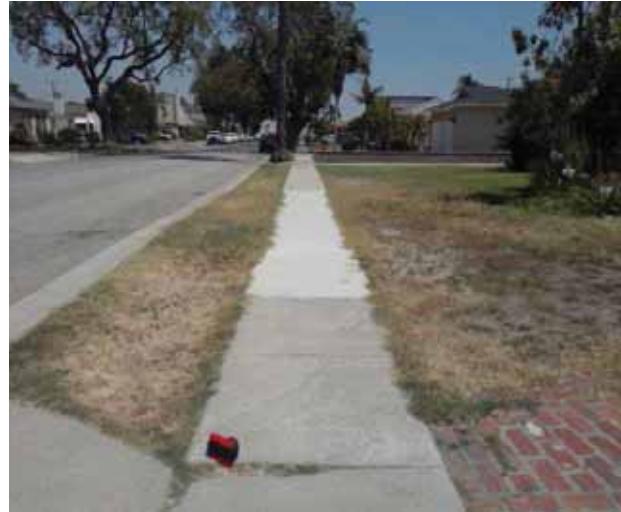
There is a change in elevation greater than recommended value.

Ensure that the change in elevation is within the recommended value.

Recommendation Up to 0.25 inches

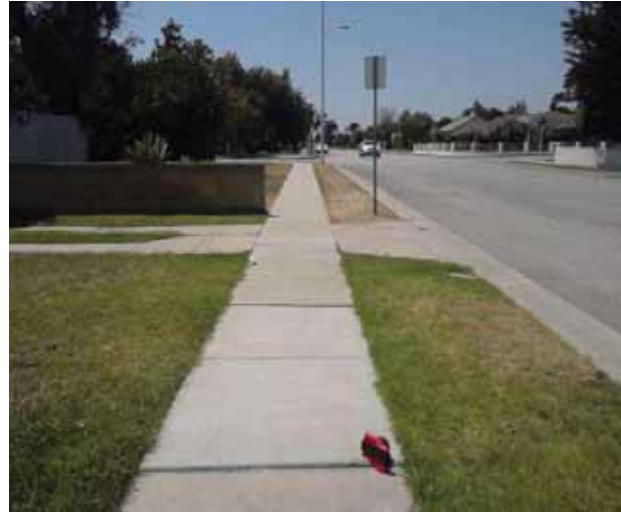
There is a change in elevation greater than recommended value.

Ensure that the change in elevation is within the recommended value.

Recommendation Up to 0.25 inches

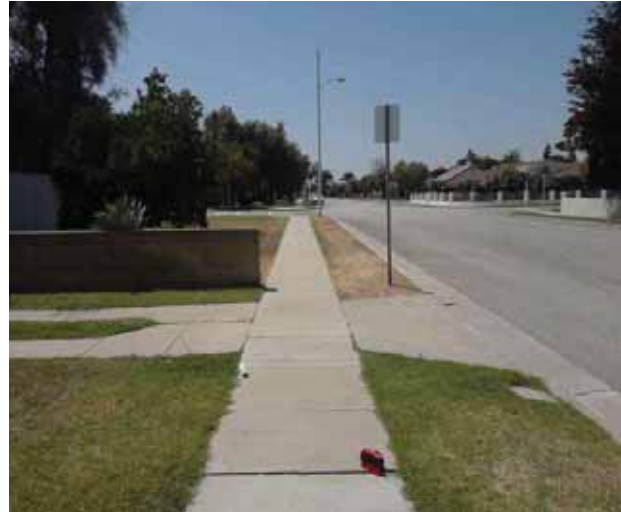
There is a change in elevation greater than recommended value.

Ensure that the change in elevation is within the recommended value.

Recommendation Up to 0.25 inches

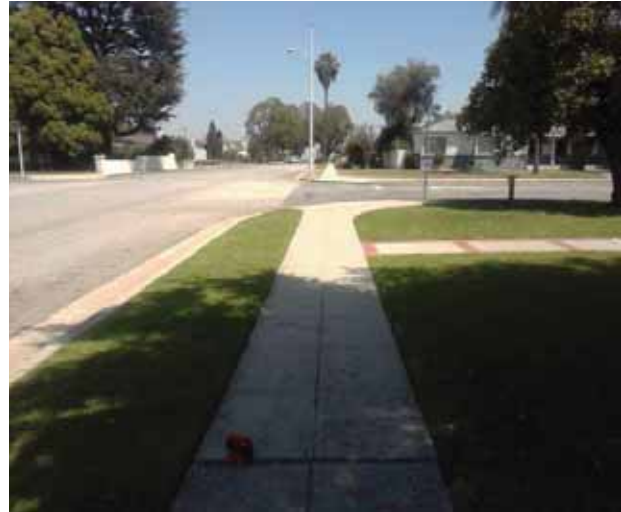
There is a change in elevation greater than recommended value.

Ensure that the change in elevation is within the recommended value.

Recommendation Up to 0.25 inches

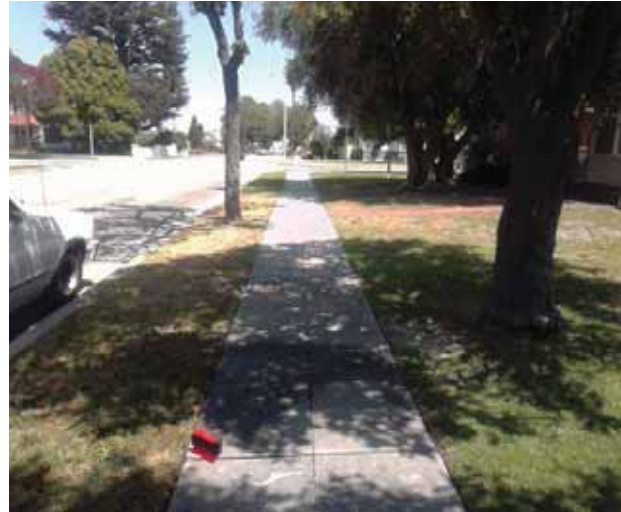
There is a change in elevation greater than recommended value.

Ensure that the change in elevation is within the recommended value.

Recommendation Up to 0.25 inches

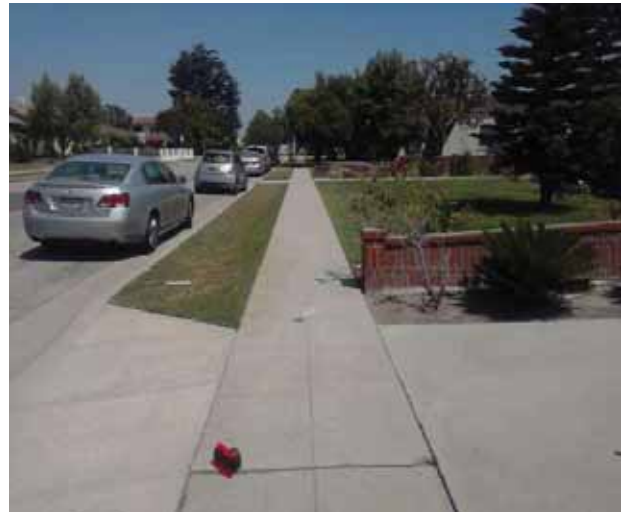
There is a change in elevation greater than recommended value.

Ensure that the change in elevation is within the recommended value.

Recommendation Up to 0.25 inches

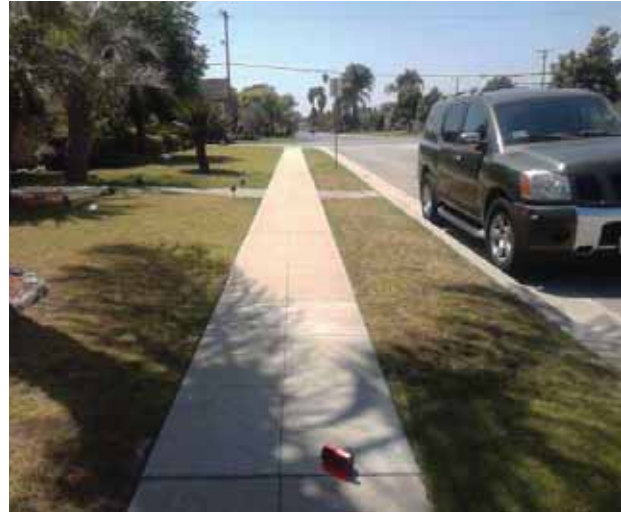
There is a change in elevation greater than recommended value.

Remove tripping hazards \$198

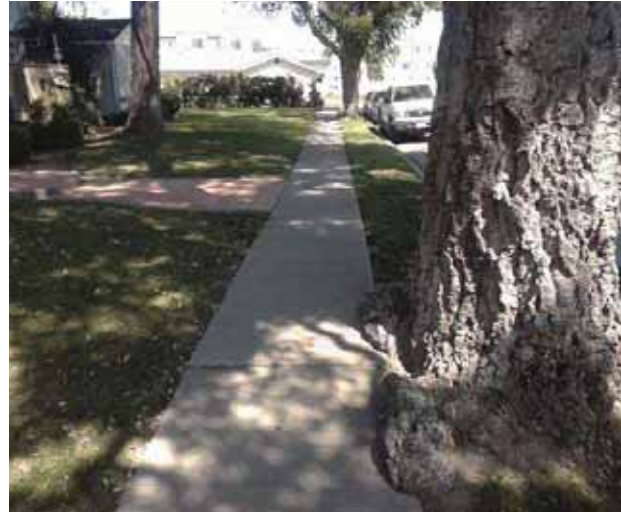
Sidewalks , Hazards & Gratings : Sidewalk Width at Obstruction

Sidewalk width at the obstruction shall have the recommended value.

Recommendation At least 48.00 inches

\$1,260

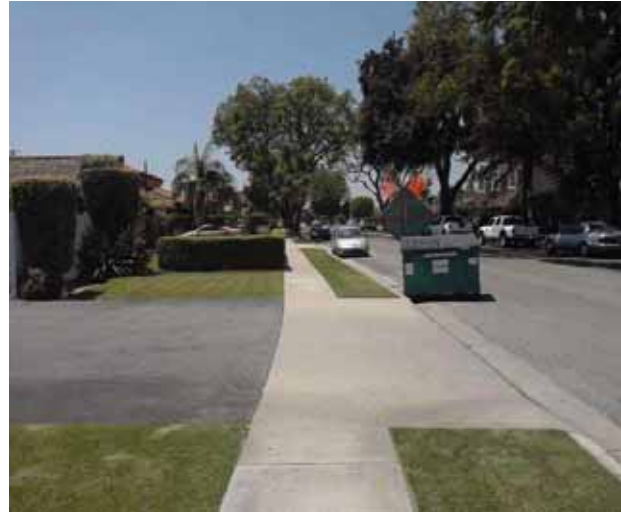
**On-Site Finding** Not Found

Install compliant detectable warnings \$190

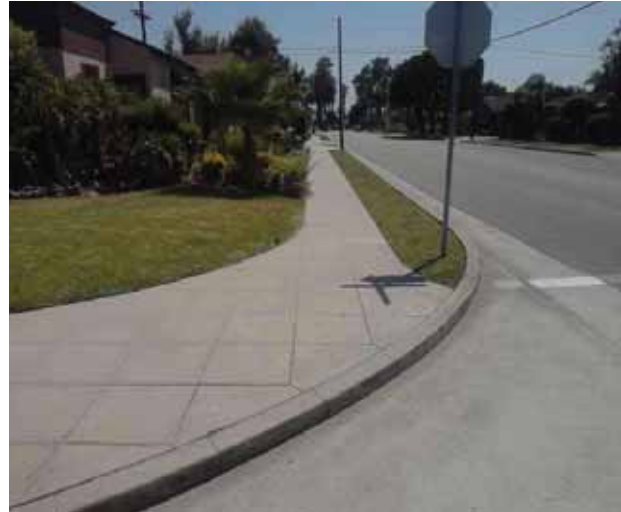
Sidewalks , Hazards & Gratings : Curb is on Path of Travel

Install curb ramp \$2,500

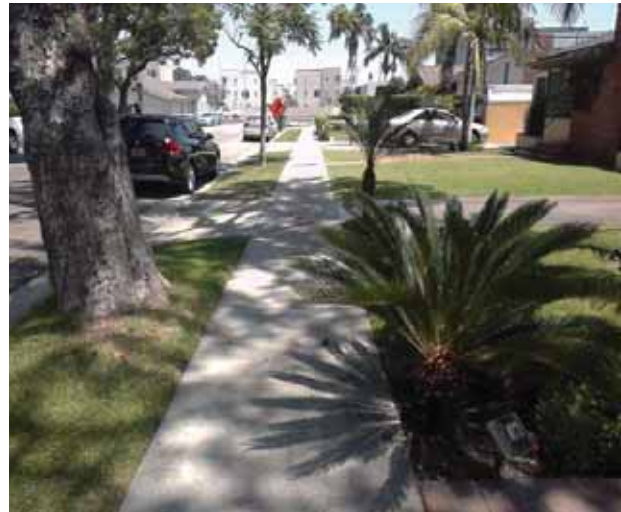
Sidewalks , Hazards & Gratings : Sidewalk Width at Obstruction

Sidewalk width at the obstruction shall have the recommended value.

Recommendation At least 48.00 inches

\$1,260

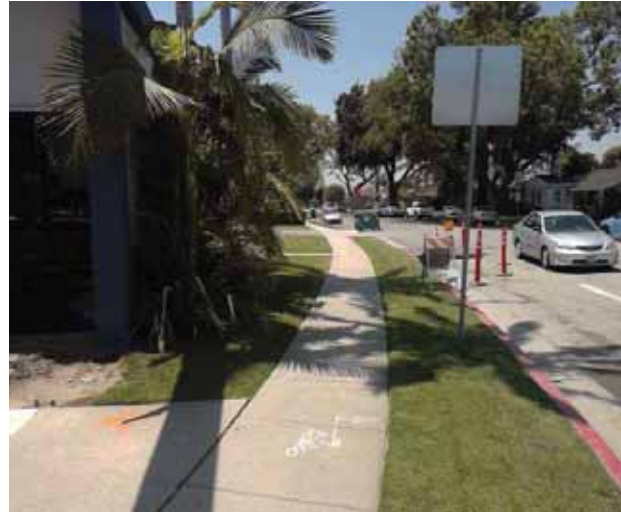
**On-Site Finding** Not Found

\$2,400
