Accessibility Survey

City of Downey Gardendale Street & Barlin Avenue

Date of Inspection
2/2/2017

Prepared By
Disability Access Consultants
(800) 743-7067

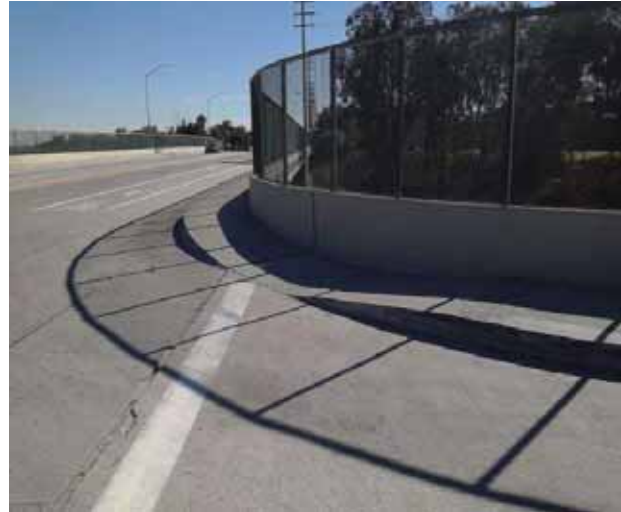
Recommendation Up to 2.08 percent

Curb Ramp , Landings and Transitions : Top Landing Right Side Slope - Parallel Curb Ramp

Provide compliant landing \$1,260
