Accessibility Survey

City of Downey Patton Road - Alameda Street To Stewart & Gray Road

Date of Inspection 4/2/2017

Prepared By **Disability Access Consultants**(800) 743-7067

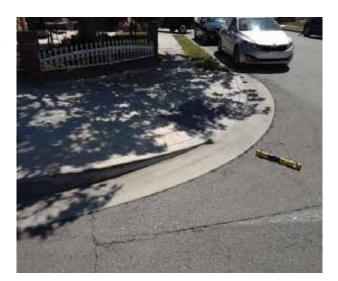
Curb Ramp : Bottom Landing Slope

Recommendation Up to 5.00 percent

Repave landing \$1,260

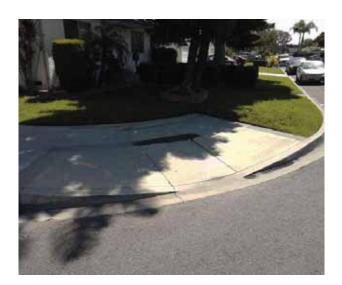
On-Site Finding Not Found

Provide detectable warning to \$248 surface

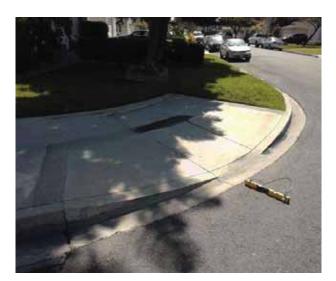
Curb Ramp : Bottom Landing Slope

Recommendation Up to 5.00 percent

Repave landing \$1,260

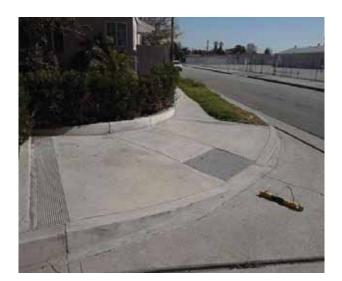
Curb Ramp , Landings and Transitions $\,:\,$ Top Landing Slope

Recommendation Up to 2.08 percent

Provide compliant landing \$1,260

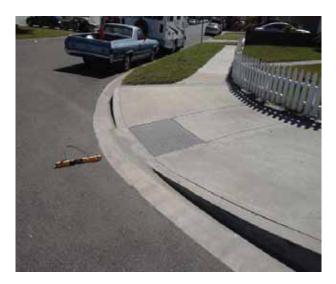
Curb Ramp : Bottom Landing Slope

Recommendation Up to 5.00 percent

Repave landing \$1,260

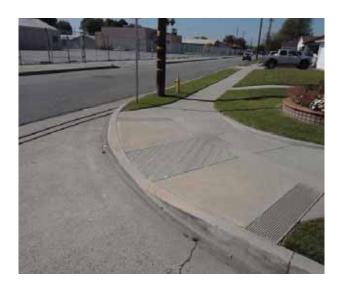
On-Site Finding Not Found

Provide detectable warning to \$248 surface

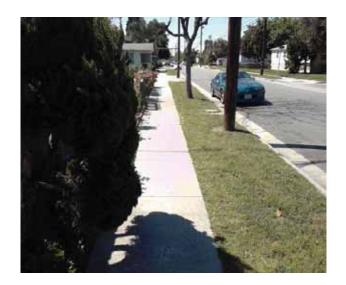
Sidewalks , Hazards & Gratings : Sidewalk Width at Obstruction

Sidewalk width at the obstruction shall have the recommended value.

Recommendation At least 48.00 inches

\$1,260

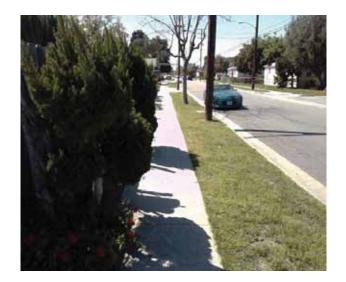
Sidewalks , Hazards & Gratings : Sidewalk Width at Obstruction

Sidewalk width at the obstruction shall have the recommended value.

Recommendation At least 48.00 inches

\$1,260

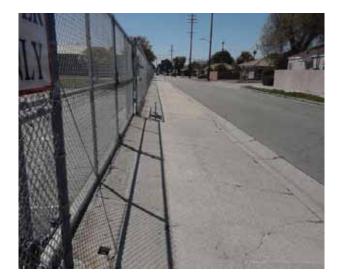
On-Site Finding Not Found

Install compliant detectable \$190 warnings

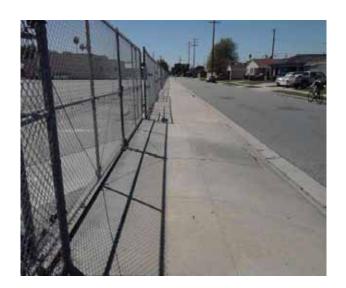
On-Site Finding Not Found

Install compliant detectable \$190

warnings

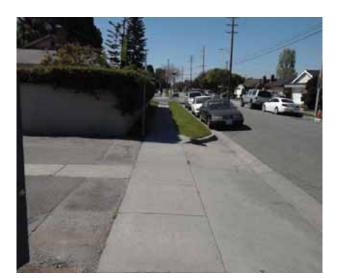
On-Site Finding Not Found

Install compliant detectable \$190 warnings

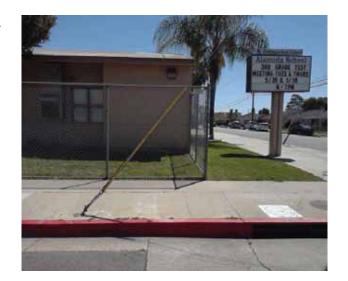
Sidewalks , Hazards & Gratings : Overhead Obstruction Height

Recommendation At least 80.00 inches

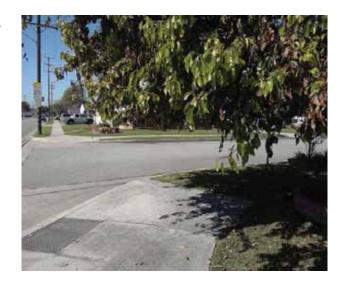
Sidewalks , Hazards & Gratings : Overhead Obstruction Height

Recommendation At least 80.00 inches

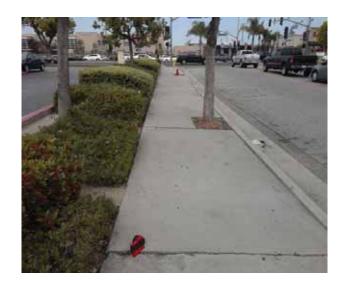
There is a change in elevation greater than recommended value.

Ensure that the change in elevation is within the recommended value.

Recommendation Up to 0.25 inches

Remove tripping hazards \$198

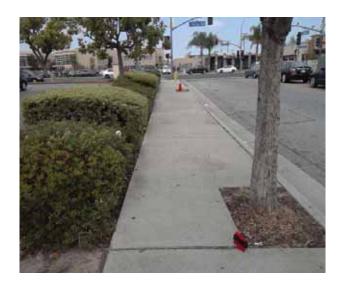
There is a change in elevation greater than recommended value.

Ensure that the change in elevation is within the recommended value.

Recommendation Up to 0.25 inches

Remove tripping hazards \$198

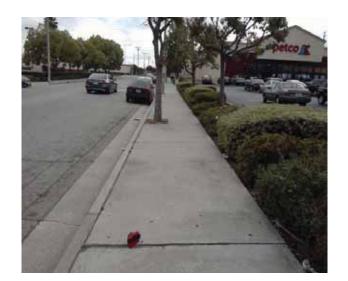
There is a change in elevation greater than recommended value.

Ensure that the change in elevation is within the recommended value.

Recommendation Up to 0.25 inches

Remove tripping hazards \$198

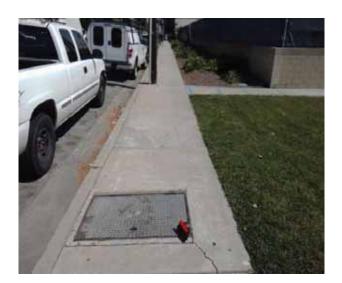
There is a change in elevation greater than recommended value.

Sidewalks , Change in Level : Change in Level Non Beveled

Ensure that the change in elevation is within the recommended value.

Recommendation Up to 0.25 inches

Remove tripping hazards \$198

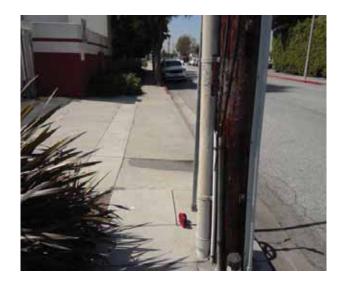
There is a change in elevation greater than recommended value.

Sidewalks , Change in Level : Change in Level Non Beveled

Ensure that the change in elevation is within the recommended value.

Recommendation Up to 0.25 inches

Remove tripping hazards \$198

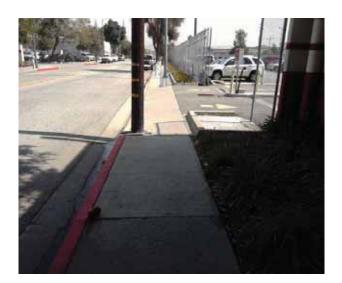
There is a change in elevation greater than recommended value.

Sidewalks , Change in Level : Change in Level Non Beveled

Ensure that the change in elevation is within the recommended value.

Recommendation Up to 0.25 inches

Remove tripping hazards \$198

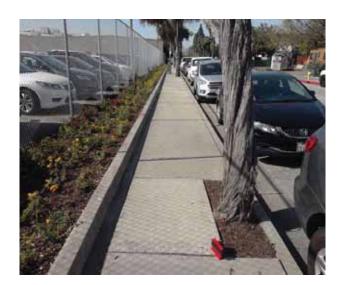
There is a change in elevation greater than recommended value.

Sidewalks , Change in Level : Change in Level Non Beveled

Ensure that the change in elevation is within the recommended value.

Recommendation Up to 0.25 inches

Remove tripping hazards \$198

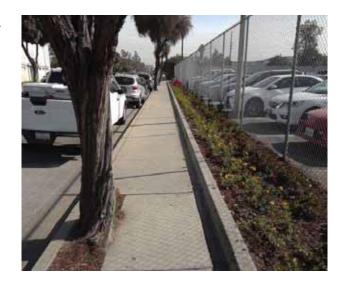
Sidewalks , Hazards & Gratings : Overhead Obstruction Height

Recommendation At least 80.00 inches

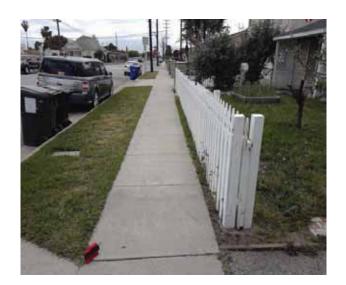
There is a change in elevation greater than recommended value.

Ensure that the change in elevation is within the recommended value.

Recommendation Up to 0.25 inches

Remove tripping hazards \$198

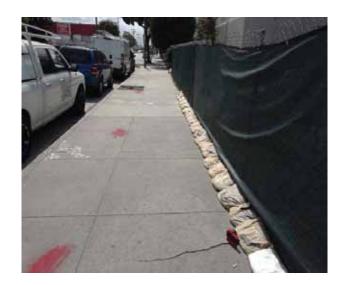
There is a change in elevation greater than recommended value.

Ensure that the change in elevation is within the recommended value.

Recommendation Up to 0.25 inches

Remove tripping hazards \$198

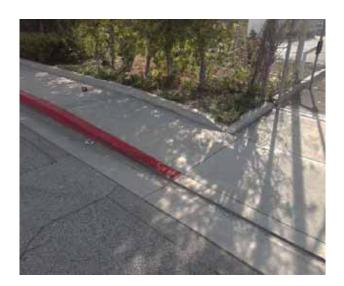
On-Site Finding Not Found

Provide detectable warning to \$248 surface

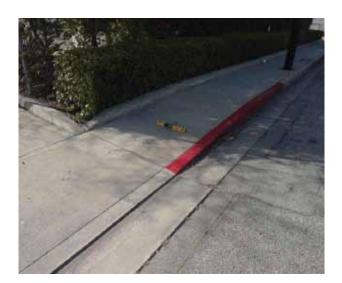
On-Site Finding Not Found

Provide detectable warning to \$248 surface

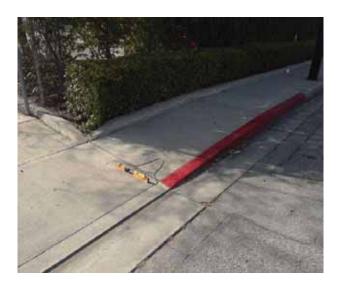
Curb Ramp , Landings and Transitions $\,:\,$ Top Landing Slope

Recommendation Up to 2.08 percent

Provide compliant landing \$1,260

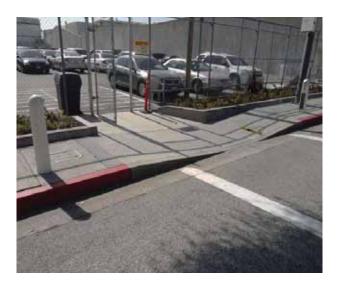
On-Site Finding Not Found

Provide detectable warning to \$248 surface

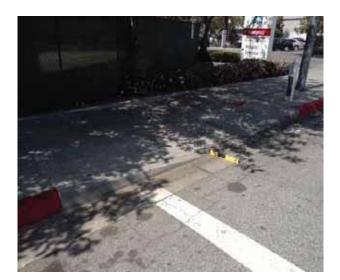
Curb Ramp , Landings and Transitions $\,:\,$ Top Landing Slope

Recommendation Up to 2.08 percent

Provide compliant landing \$1,260

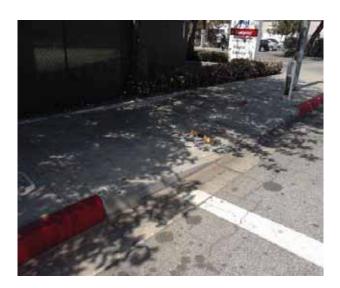
On-Site Finding Not Found

Provide detectable warning to \$248 surface

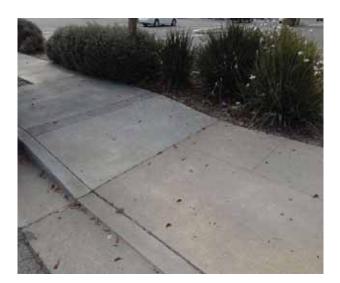
On-Site Finding Not Found

Provide detectable warning to \$248 surface

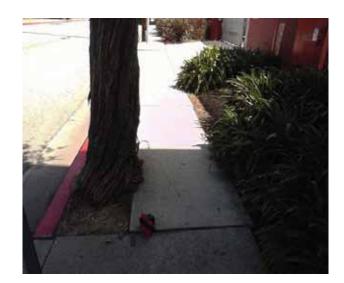
There is a change in elevation greater than recommended value.

Sidewalks , Change in Level : Change in Level Non Beveled

Ensure that the change in elevation is within the recommended value.

Recommendation Up to 0.25 inches

Remove tripping hazards \$198

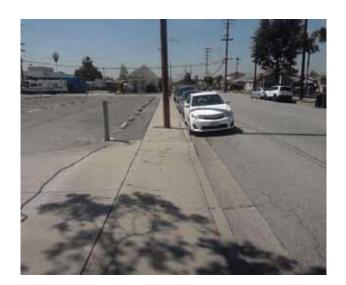
On-Site Finding Not Found

Install compliant detectable \$190

warnings

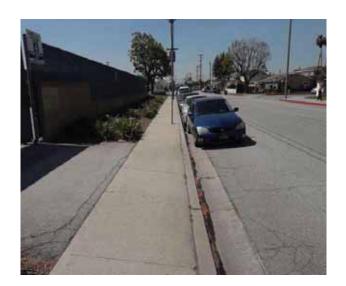
On-Site Finding Not Found

Install compliant detectable \$190

warnings

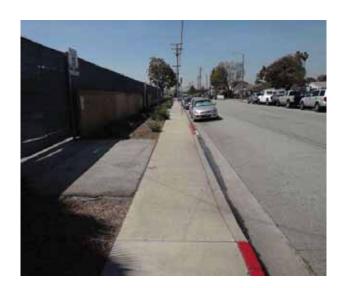
On-Site Finding Not Found

Install compliant detectable \$190

warnings

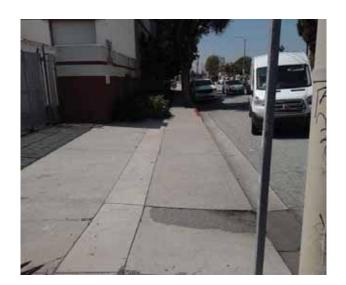
On-Site Finding Not Found

Install compliant detectable \$190 warnings

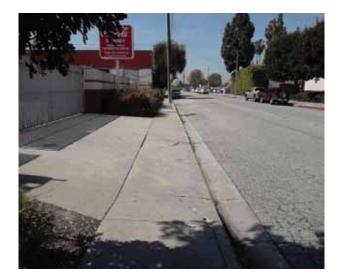
On-Site Finding Not Found

Install compliant detectable \$190 warnings

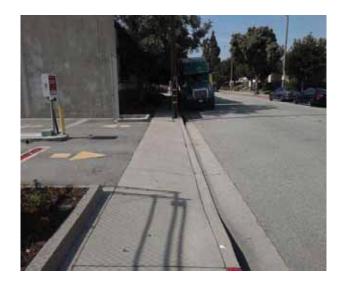
On-Site Finding Not Found

Install compliant detectable \$190

warnings

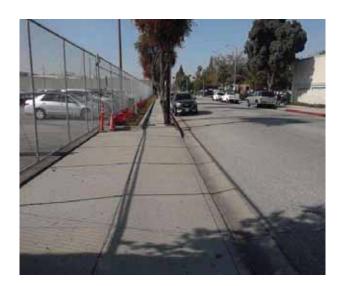
On-Site Finding Not Found

Install compliant detectable \$190

warnings

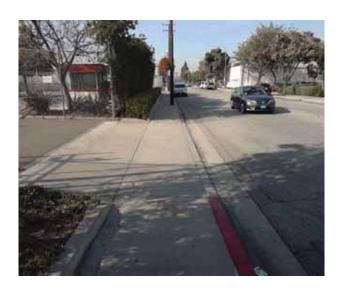
On-Site Finding Not Found

Install compliant detectable \$190 warnings

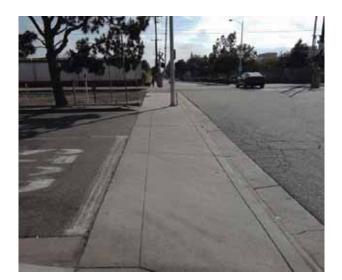
On-Site Finding Not Found

Install compliant detectable \$190 warnings

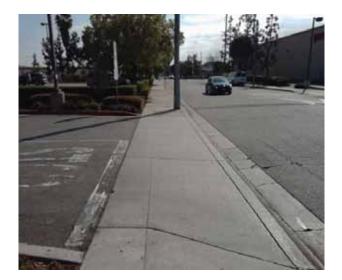
On-Site Finding Not Found

Install compliant detectable \$190 warnings

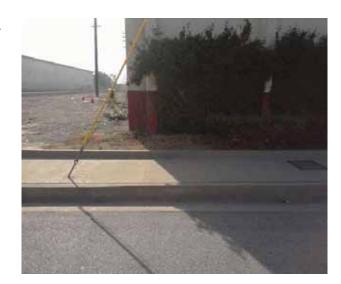
Sidewalks , Hazards & Gratings : Overhead Obstruction Height

Recommendation At least 80.00 inches

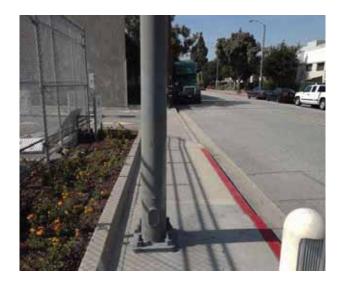
Sidewalks , Hazards & Gratings : Sidewalk Width at Obstruction

Sidewalk width at the obstruction shall have the recommended value.

Recommendation At least 48.00 inches

\$1,260

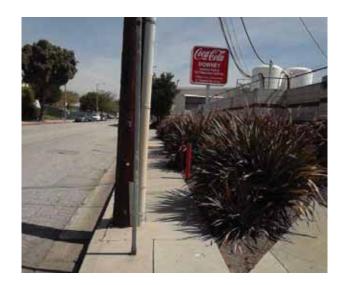
Sidewalks , Hazards & Gratings : Sidewalk Width at Obstruction

Sidewalk width at the obstruction shall have the recommended value.

Recommendation At least 48.00 inches

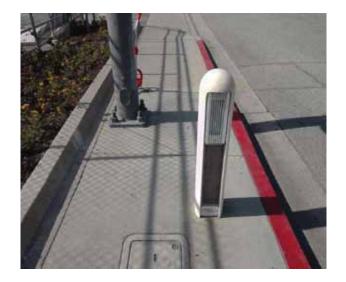
Sidewalks , Hazards & Gratings : Sidewalk Width at Obstruction

Sidewalk width at the obstruction shall have the recommended value.

Recommendation At least 48.00 inches

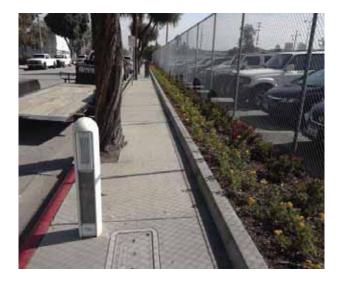
Sidewalks , Hazards & Gratings : Sidewalk Width at Obstruction

Sidewalk width at the obstruction shall have the recommended value.

Recommendation At least 48.00 inches

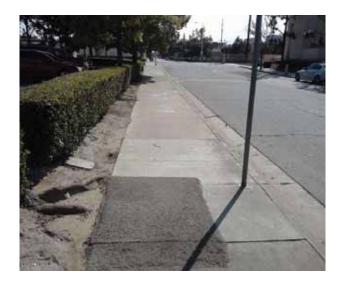
Notes: Surface is rough and uneven.

Repave the sidewalk surface with the recommended cross slope.

Recommendation Up to 2.08 percent

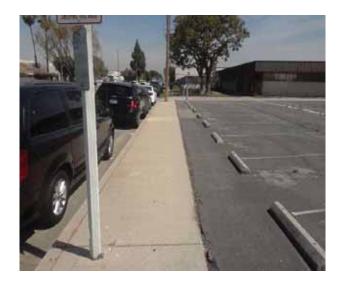
Sidewalks , Hazards & Gratings : Sidewalk Width at Obstruction

Sidewalk width at the obstruction shall have the recommended value.

Recommendation At least 48.00 inches

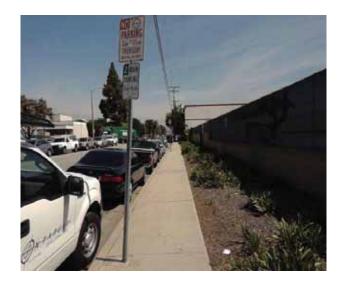
Sidewalks , Hazards & Gratings : Sidewalk Width at Obstruction

Sidewalk width at the obstruction shall have the recommended value.

Recommendation At least 48.00 inches

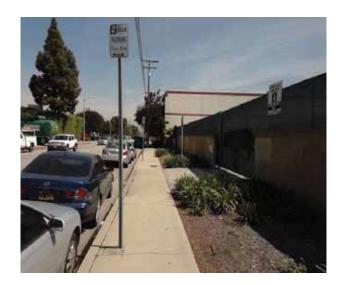
Sidewalks , Hazards & Gratings : Sidewalk Width at Obstruction

Sidewalk width at the obstruction shall have the recommended value.

Recommendation At least 48.00 inches

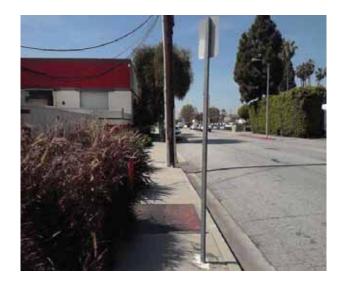
Sidewalks , Hazards & Gratings : Sidewalk Width at Obstruction

Sidewalk width at the obstruction shall have the recommended value.

Recommendation At least 48.00 inches

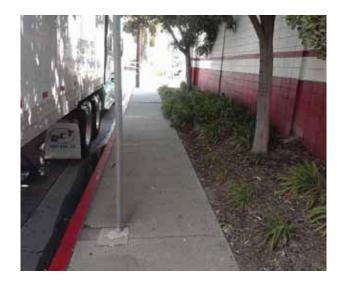
Sidewalks , Hazards & Gratings : Sidewalk Width at Obstruction

Sidewalk width at the obstruction shall have the recommended value.

Recommendation At least 48.00 inches

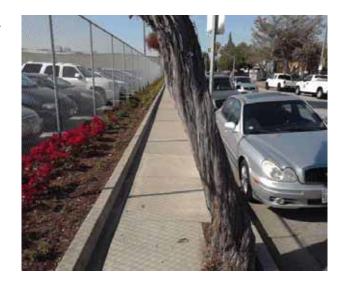
Sidewalks , Hazards & Gratings : Overhead Obstruction Height

Recommendation At least 80.00 inches

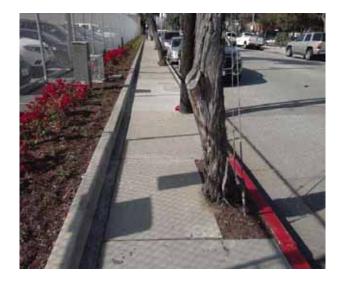
Sidewalks , Hazards & Gratings : Sidewalk Width at Obstruction

Sidewalk width at the obstruction shall have the recommended value.

Recommendation At least 48.00 inches

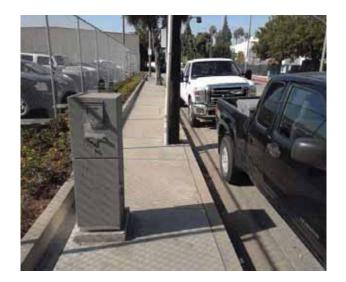
Sidewalks , Hazards & Gratings : Sidewalk Width at Obstruction

Sidewalk width at the obstruction shall have the recommended value.

Recommendation At least 48.00 inches

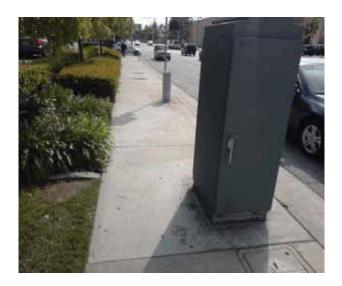
Sidewalks , Hazards & Gratings : Sidewalk Width at Obstruction

Sidewalk width at the obstruction shall have the recommended value.

Recommendation At least 48.00 inches

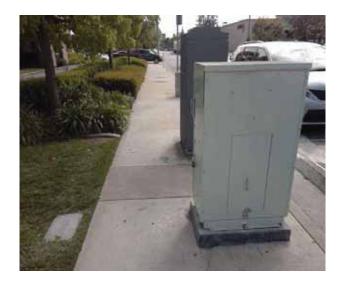
Sidewalks , Hazards & Gratings : Sidewalk Width at Obstruction

Sidewalk width at the obstruction shall have the recommended value.

Recommendation At least 48.00 inches

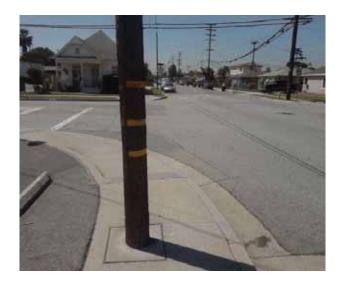
Sidewalks , Hazards & Gratings : Sidewalk Width at Obstruction

Sidewalk width at the obstruction shall have the recommended value.

Recommendation At least 48.00 inches

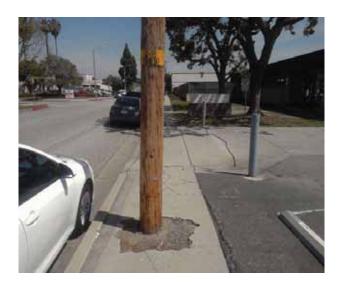
Sidewalks , Hazards & Gratings : Sidewalk Width at Obstruction

Sidewalk width at the obstruction shall have the recommended value.

Recommendation At least 48.00 inches

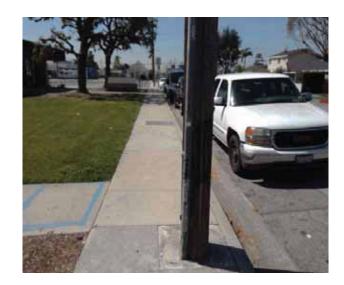
Sidewalks , Hazards & Gratings : Sidewalk Width at Obstruction

Sidewalk width at the obstruction shall have the recommended value.

Recommendation At least 48.00 inches

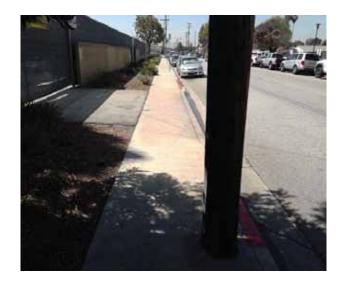
Sidewalks , Hazards & Gratings : Sidewalk Width at Obstruction

Sidewalk width at the obstruction shall have the recommended value.

Recommendation At least 48.00 inches

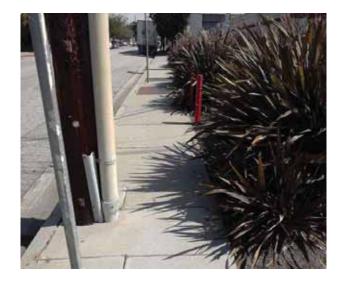
Sidewalks , Hazards & Gratings : Sidewalk Width at Obstruction

Sidewalk width at the obstruction shall have the recommended value.

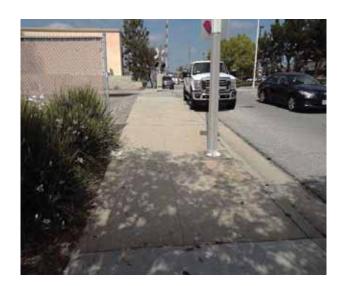
Notes: Railroad opening at 2.75" -- Surface rough and uneven for 25 feet

Repave the sidewalk surface with the recommended cross slope.

Recommendation Up to 2.08 percent

Repave surface \$1,092

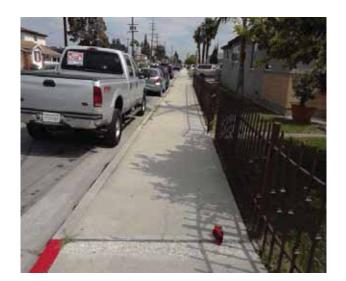
There is a change in elevation greater than recommended value.

Ensure that the change in elevation is within the recommended value.

Recommendation Up to 0.25 inches

Remove tripping hazards \$198

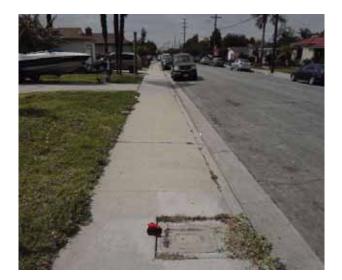
There is a change in elevation greater than recommended value.

Ensure that the change in elevation is within the recommended value.

Recommendation Up to 0.25 inches

Remove tripping hazards \$198

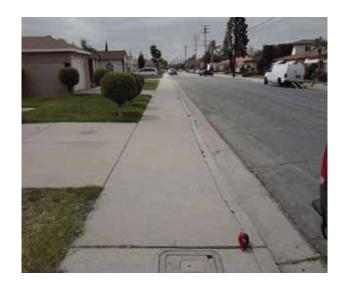
There is a change in elevation greater than recommended value.

Ensure that the change in elevation is within the recommended value.

Recommendation Up to 0.25 inches

Remove tripping hazards \$198

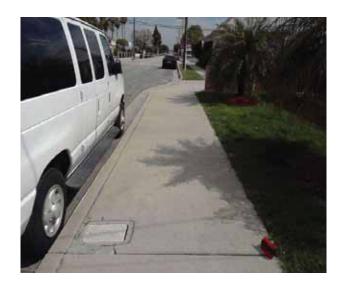
There is a change in elevation greater than recommended value.

Ensure that the change in elevation is within the recommended value.

Recommendation Up to 0.25 inches

Remove tripping hazards \$198

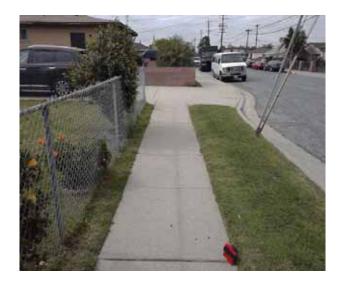
There is a change in elevation greater than recommended value.

Ensure that the change in elevation is within the recommended value.

Recommendation Up to 0.25 inches

Remove tripping hazards \$198

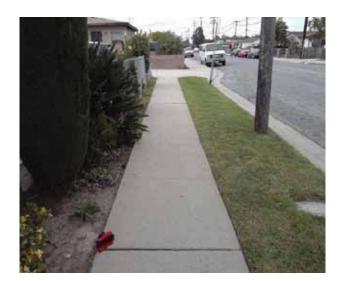
There is a change in elevation greater than recommended value.

Ensure that the change in elevation is within the recommended value.

Recommendation Up to 0.25 inches

Remove tripping hazards \$198

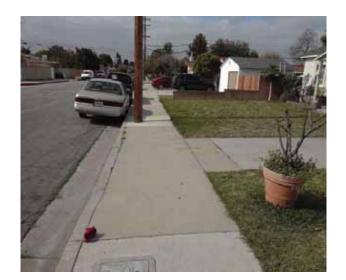
There is a change in elevation greater than recommended value.

Ensure that the change in elevation is within the recommended value.

Recommendation Up to 0.25 inches

Remove tripping hazards \$198

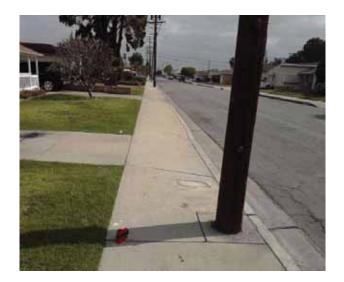
There is a change in elevation greater than recommended value.

Ensure that the change in elevation is within the recommended value.

Recommendation Up to 0.25 inches

Remove tripping hazards \$198

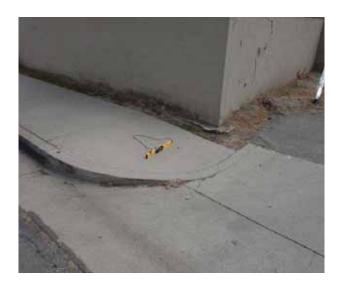
On-Site Finding Not Found

Provide detectable warning to \$248 surface

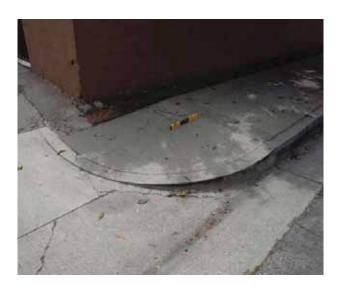
On-Site Finding Not Found

Provide detectable warning to \$248 surface

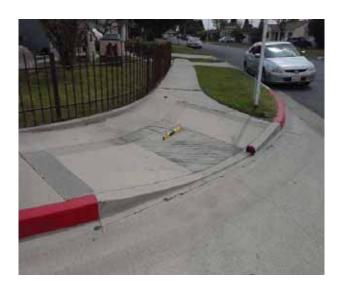
On-Site Finding Not Found

Provide detectable warning to \$248 surface

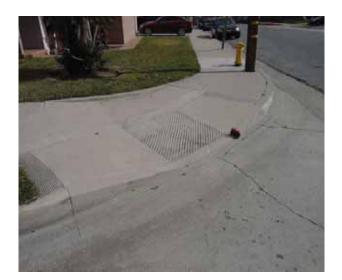
On-Site Finding Not Found

Provide detectable warning to \$248 surface

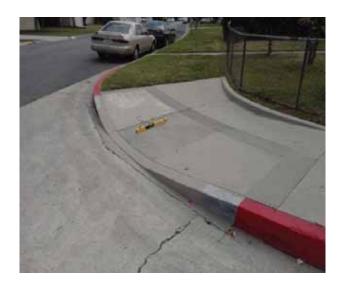
On-Site Finding Not Found

Provide detectable warning to \$248 surface

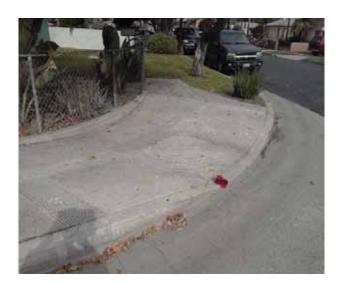
On-Site Finding Not Found

Provide detectable warning to \$248 surface

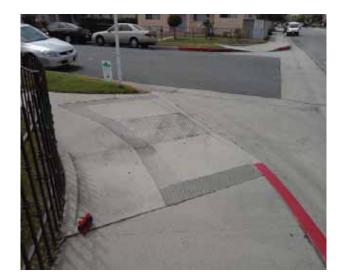
There is a change in elevation greater than recommended value.

Ensure that the change in elevation is within the recommended value.

Recommendation Up to 0.25 inches

Remove tripping hazards \$198

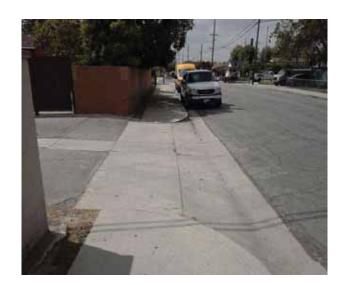
On-Site Finding Not Found

Install compliant detectable \$190

warnings

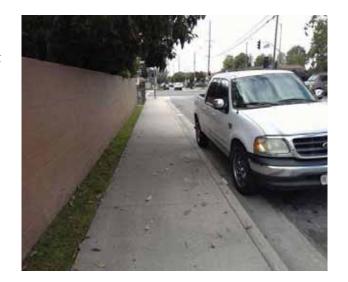
Recommendation Up to 2.08 percent

Recommendation

Repave the sidewalk surface with the recommended cross slope.

Repave surface \$1,092

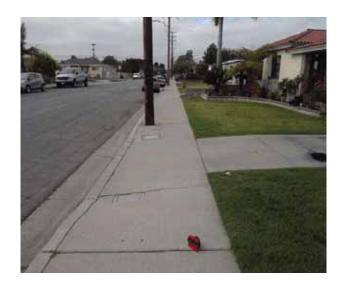
There is a change in elevation greater than recommended value.

Ensure that the change in elevation is within the recommended value.

Recommendation Up to 0.25 inches

Remove tripping hazards \$198

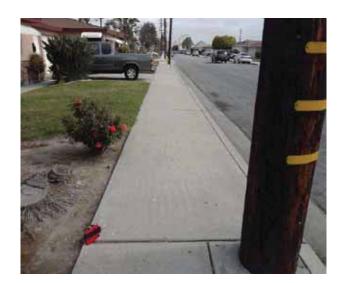
There is a change in elevation greater than recommended value.

Ensure that the change in elevation is within the recommended value.

Recommendation Up to 0.25 inches

Remove tripping hazards \$198

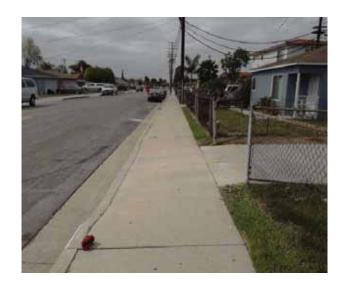
There is a change in elevation greater than recommended value.

Ensure that the change in elevation is within the recommended value.

Recommendation Up to 0.25 inches

Remove tripping hazards \$198

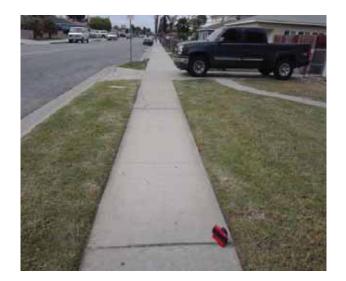
There is a change in elevation greater than recommended value.

Ensure that the change in elevation is within the recommended value.

Recommendation Up to 0.25 inches

Remove tripping hazards \$198

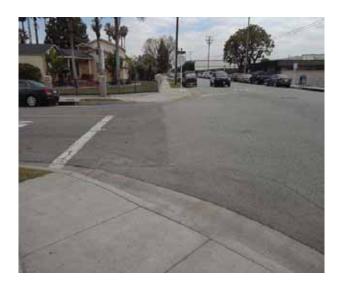
Recommendation Up to 5.00 percent

Repave surface \$1,092

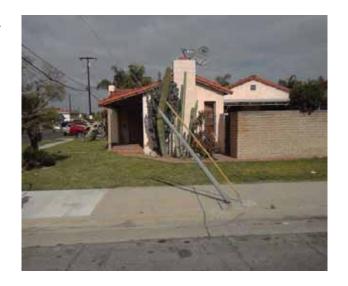
Sidewalks , Hazards & Gratings : Overhead Obstruction Height

At least 80.00 inches Recommendation

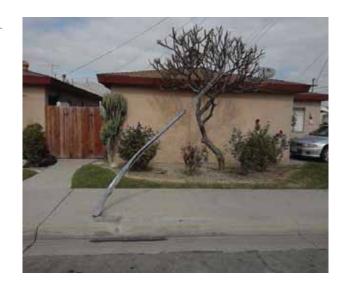
Sidewalks , Hazards & Gratings : Overhead Obstruction Height

Recommendation At least 80.00 inches

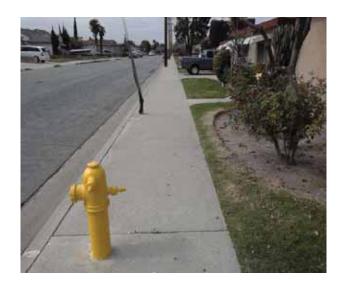
Sidewalks , Hazards & Gratings : Sidewalk Width at Obstruction

Recommendation At least 48.00 inches

Sidewalk width at the obstruction shall have the recommended value.

\$1,260

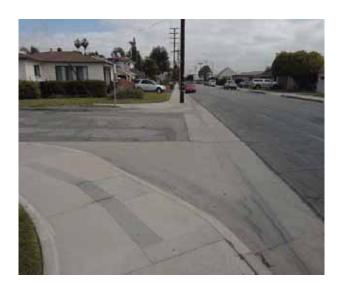
Recommendation Up to 5.00 percent

Repave surface \$1,092

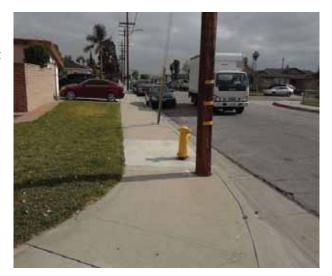
Recommendation Up to 2.08 percent

Notes: Has 10 openings

Repave the sidewalk surface with the recommended cross slope.

Repave surface \$1,092

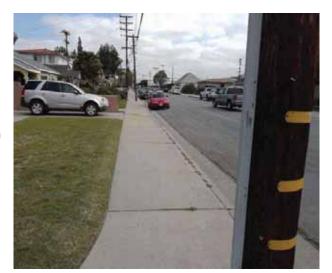
Notes: Has 16 openings

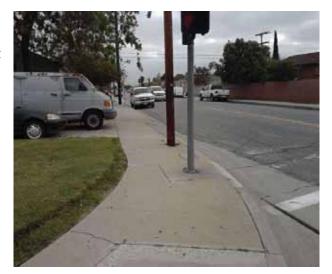
Recommendation Up to 2.08 percent

Repave the sidewalk surface with the recommended cross slope.

Repave surface \$1,092

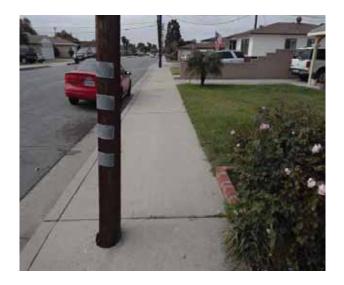
Sidewalks , Hazards & Gratings : Sidewalk Width at Obstruction

Recommendation At least 48.00 inches

Sidewalk width at the obstruction shall have the recommended value.

\$1,260

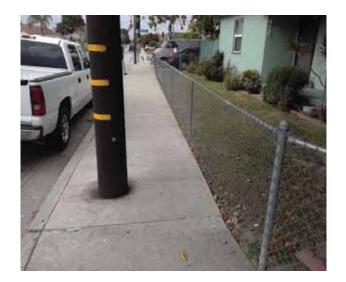
Sidewalks , Hazards & Gratings : Sidewalk Width at Obstruction

Recommendation At least 48.00 inches

Sidewalk width at the obstruction shall have the recommended value.

\$1,260

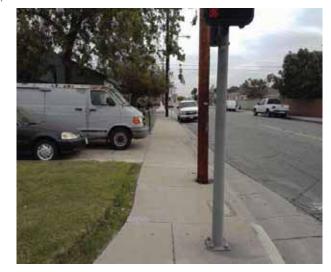
On-Site Finding Not Found

\$2,400
