Accessibility Survey

City of Downey Suva Street & Bluff Road/ Foster Bridge Boulevard

Date of Inspection 6/23/2017

Disability Access Consultants

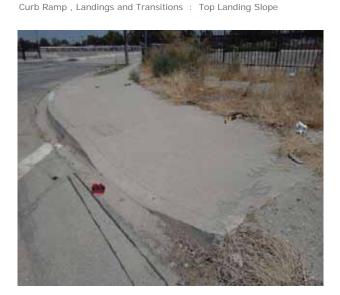
Southeast Corner of Suva Street @ 33.965242435225, - 118.136329650879

The slope at the top landing is greater than allowed.

Recommendation Up to 2.08 percent

Provide compliant landing \$1,260

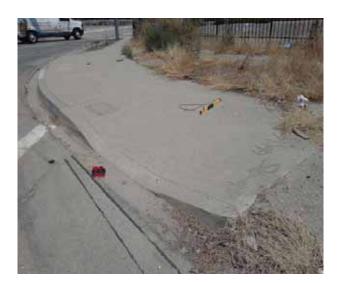
On-Site Finding Not Found

Provide detectable warning to \$248 surface

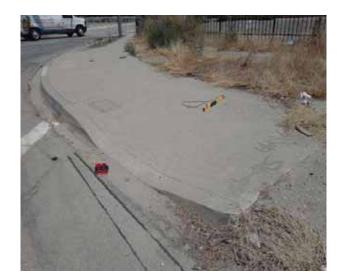
On-Site Finding Not Found

Install crosswalk \$800

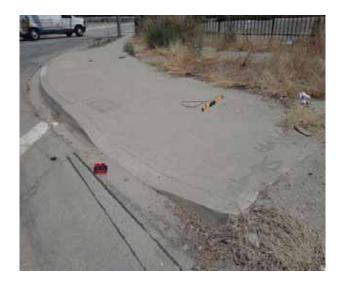
Recommendation At least 48.00 inches

Install curb ramp \$1,300

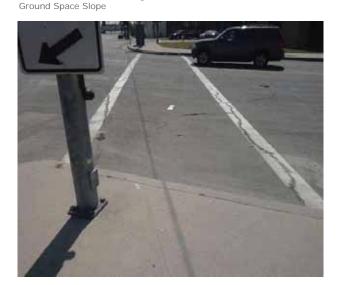
Intersections , Pedestrian Signal Controls : Push Button - Clear

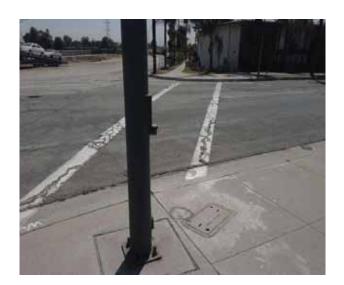
Recommendation At least 2.00 inches

Intersections , Pedestrian Signal Controls : Push Button Diameter

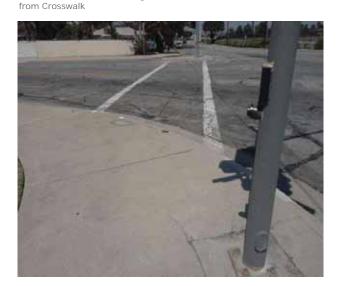
Recommendation Up to 60.00 inches

Intersections , Pedestrian Signal Controls : Push Button - Distance

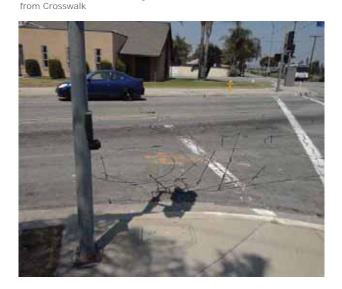
Recommendation Up to 60.00 inches

Intersections , Pedestrian Signal Controls : Push Button - Distance

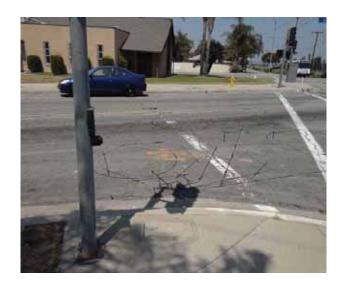
Intersections , Pedestrian Signal Signage : Crosswalk Map

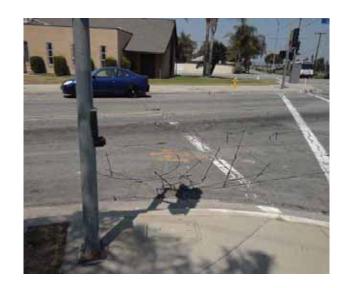
Intersections , Pedestrian Signal Indicator : Locator Tone

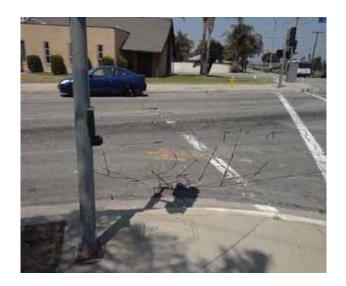
Intersections , Pedestrian Signal Indicator : Walk Interval Tone

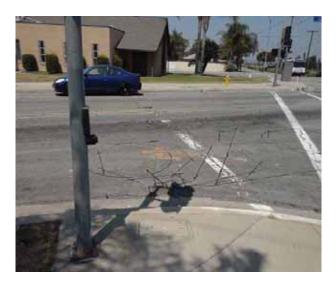
Intersections , Pedestrian Signal Indicator : Vibro-tactile Indicator

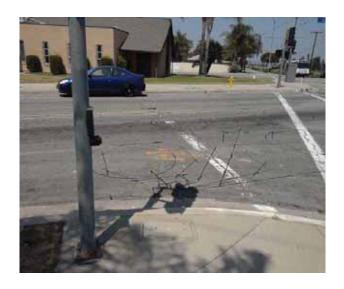
Intersections , Pedestrian Signal Indicator : Speech Walk Message

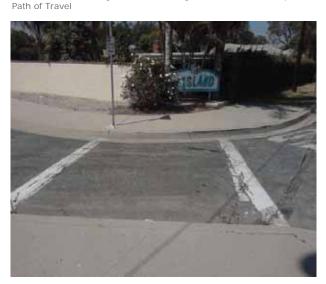
Intersections , Walking Surface : Change In Level - Curb Ramp on

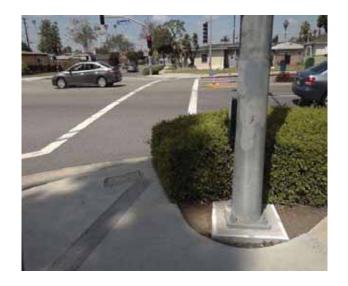
On-Site Finding Not Found

Recommendation See Recommendation

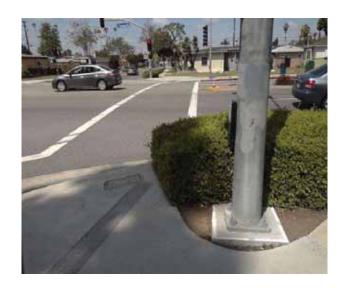
On-Site Finding Not Found

Recommendation See Recommendation

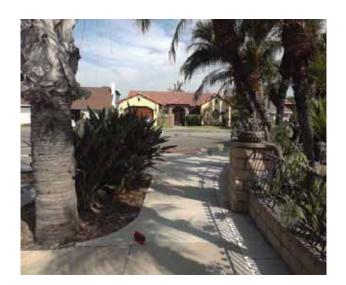
There is a change in elevation greater than recommended value.

Ensure that the change in elevation is within the recommended value.

Recommendation Up to 0.25 inches

Remove tripping hazards \$198

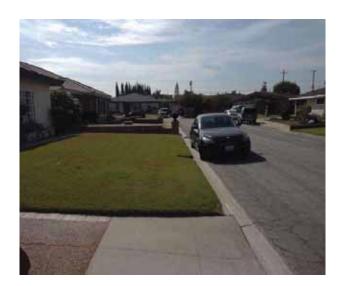
Sidewalks : Missing Sidewalk

Section of sidewalk is missing and consists of dirt, grass or gravel.

Provide a compliant sidewalk for the missing section.

\$1,260

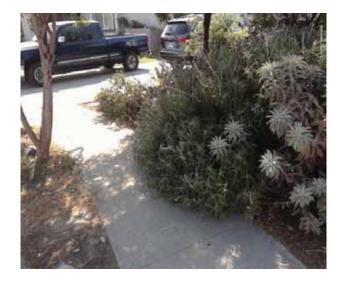
Sidewalks , Hazards & Gratings : Sidewalk Width at Obstruction

Sidewalk width at the obstruction shall have the recommended value.

Recommendation At least 48.00 inches

\$1,260

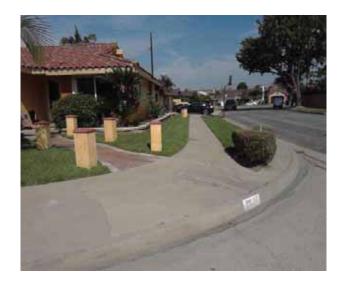
Sidewalks , Hazards & Gratings : Curb is on Path of Travel

Install curb ramp \$2,500

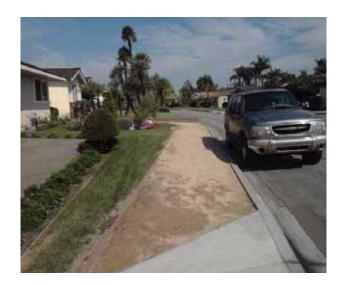
Sidewalks : Missing Sidewalk

Section of sidewalk is missing and consists of dirt, grass or gravel.

Provide a compliant sidewalk for the missing section.

\$1,260

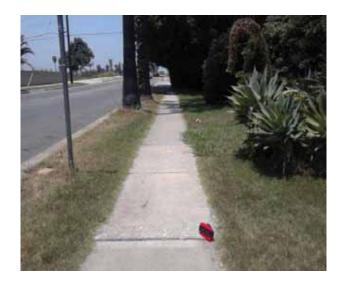
There is a change in elevation greater than recommended value.

Ensure that the change in elevation is within the recommended value.

Recommendation Up to 0.25 inches

Remove tripping hazards \$198

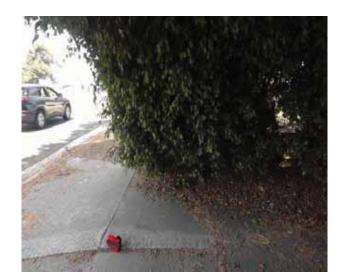
There is a change in elevation greater than recommended value.

Ensure that the change in elevation is within the recommended value.

Recommendation Up to 0.25 inches

Remove tripping hazards \$198

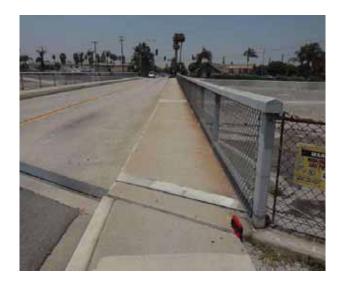
There is a change in elevation greater than recommended value.

Ensure that the change in elevation is within the recommended value.

Recommendation Up to 0.25 inches

Remove tripping hazards \$198

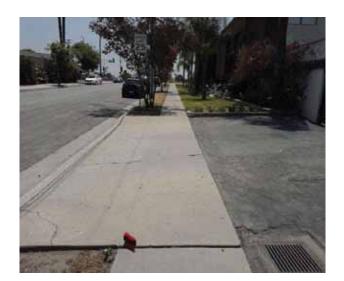
There is a change in elevation greater than recommended value.

Ensure that the change in elevation is within the recommended value.

Recommendation Up to 0.25 inches

Remove tripping hazards \$198

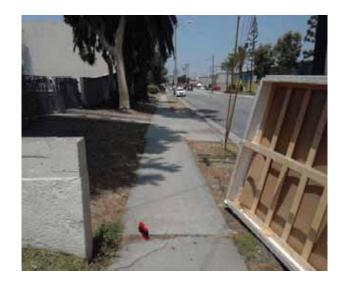
There is a change in elevation greater than recommended value.

Ensure that the change in elevation is within the recommended value.

Remove tripping hazards \$198

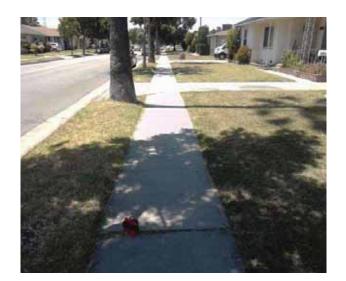
There is a change in elevation greater than recommended value.

Ensure that the change in elevation is within the recommended value.

Recommendation Up to 0.25 inches

Remove tripping hazards \$198

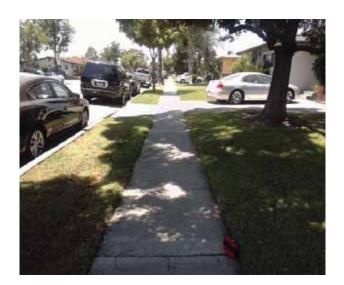
There is a change in elevation greater than recommended value.

Ensure that the change in elevation is within the recommended value.

Recommendation Up to 0.25 inches

Remove tripping hazards \$198

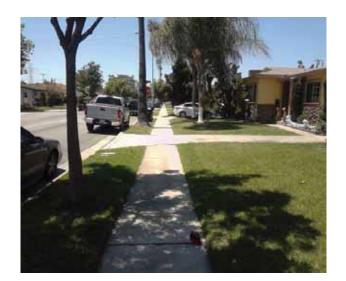
There is a change in elevation greater than recommended value.

Ensure that the change in elevation is within the recommended value.

Recommendation Up to 0.25 inches

Remove tripping hazards \$198

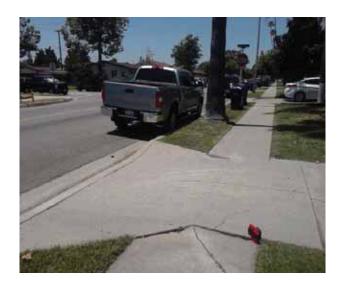
There is a change in elevation greater than recommended value.

Ensure that the change in elevation is within the recommended value.

Recommendation Up to 0.25 inches

Remove tripping hazards \$198

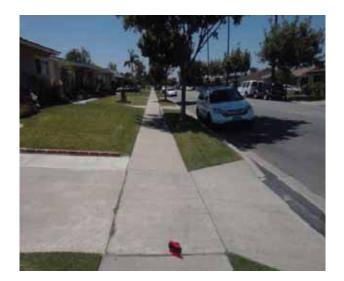
There is a change in elevation greater than recommended value.

Ensure that the change in elevation is within the recommended value.

Recommendation Up to 0.25 inches

Remove tripping hazards \$198

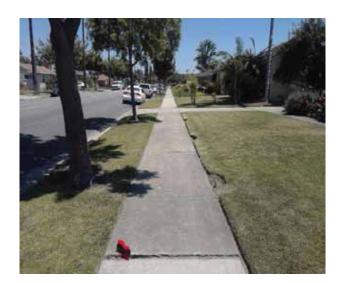
There is a change in elevation greater than recommended value.

Ensure that the change in elevation is within the recommended value.

Recommendation Up to 0.25 inches

Remove tripping hazards \$198

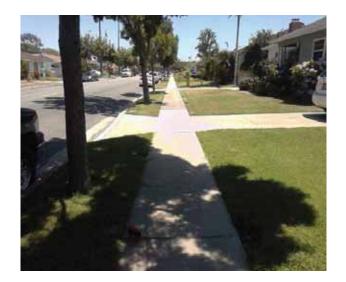
There is a change in elevation greater than recommended value.

Ensure that the change in elevation is within the recommended value.

Recommendation Up to 0.25 inches

Remove tripping hazards \$198

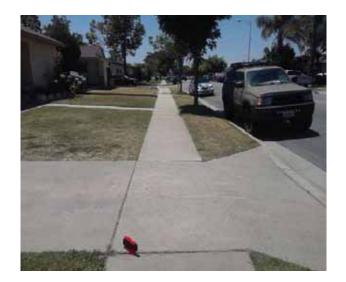
There is a change in elevation greater than recommended value.

Ensure that the change in elevation is within the recommended value.

Recommendation Up to 0.25 inches

Remove tripping hazards \$198

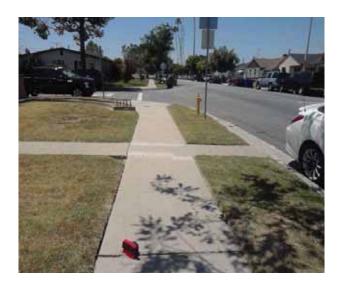
There is a change in elevation greater than recommended value.

Ensure that the change in elevation is within the recommended value.

Recommendation Up to 0.25 inches

Remove tripping hazards \$198

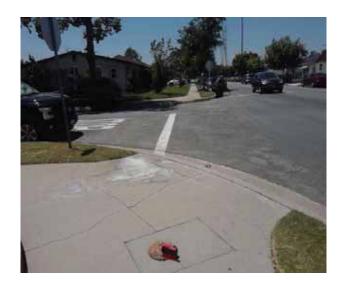
There is a change in elevation greater than recommended value.

Ensure that the change in elevation is within the recommended value.

Recommendation Up to 0.25 inches

Remove tripping hazards \$198

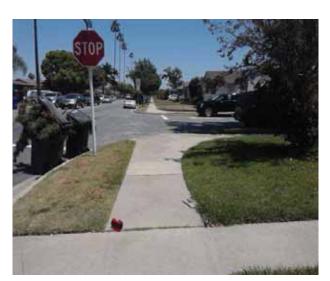
There is a change in elevation greater than recommended value.

Ensure that the change in elevation is within the recommended value.

Recommendation Up to 0.25 inches

Remove tripping hazards \$198

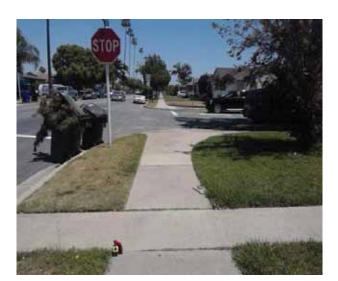
There is a change in elevation greater than recommended value.

Ensure that the change in elevation is within the recommended value.

Recommendation Up to 0.25 inches

Remove tripping hazards \$198

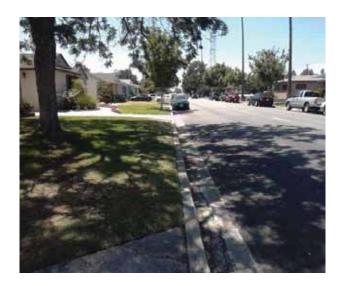
Section of sidewalk is missing and consists of dirt, grass or gravel.

Recommendation

Provide a compliant sidewalk for the missing section.

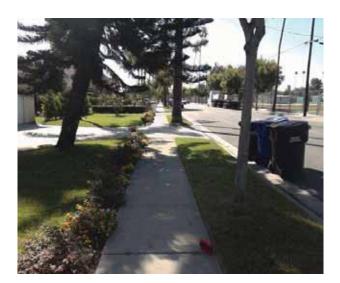
There is a change in elevation greater than recommended value.

Recommendation

Ensure that the change in elevation is within the recommended value.

Recommendation Up to 0.25 inches

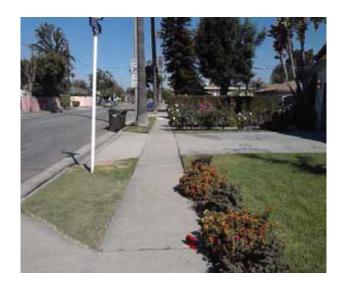
There is a change in elevation greater than recommended value.

Recommendation

Ensure that the change in elevation is within the recommended value.

Recommendation Up to 0.25 inches

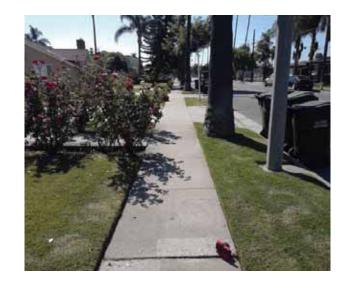
There is a change in elevation greater than recommended value.

Recommendation

Ensure that the change in elevation is within the recommended value.

Recommendation Up to 0.25 inches

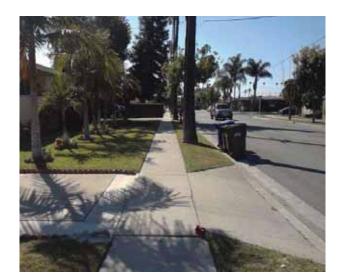
There is a change in elevation greater than recommended value.

Recommendation

Ensure that the change in elevation is within the recommended value.

Recommendation Up to 0.25 inches

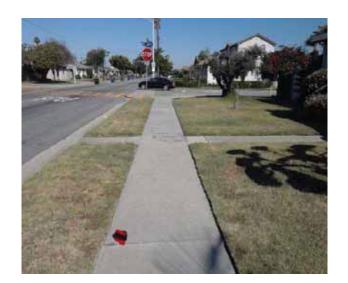
There is a change in elevation greater than recommended value.

Recommendation

Ensure that the change in elevation is within the recommended value.

Recommendation Up to 0.25 inches

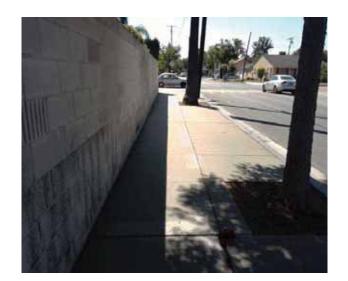
There is a change in elevation greater than recommended value.

Recommendation

Ensure that the change in elevation is within the recommended value.

Recommendation Up to 0.25 inches

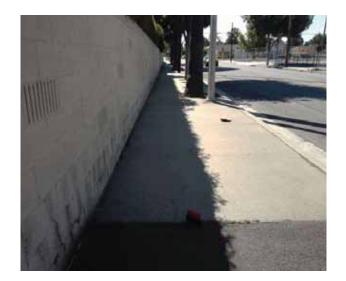
There is a change in elevation greater than recommended value.

Recommendation

Ensure that the change in elevation is within the recommended value.

Recommendation Up to 0.25 inches

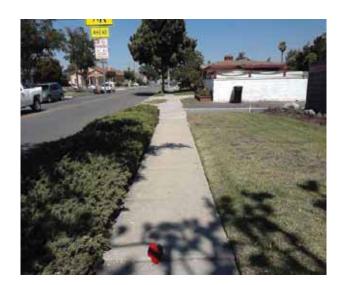
There is a change in elevation greater than recommended value.

Recommendation

Ensure that the change in elevation is within the recommended value.

Recommendation Up to 0.25 inches

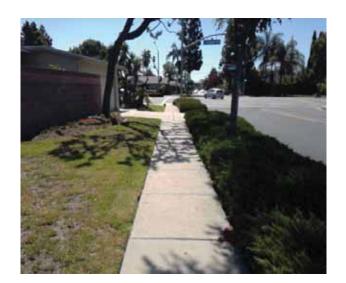
There is a change in elevation greater than recommended value.

Recommendation

Ensure that the change in elevation is within the recommended value.

Recommendation Up to 0.25 inches

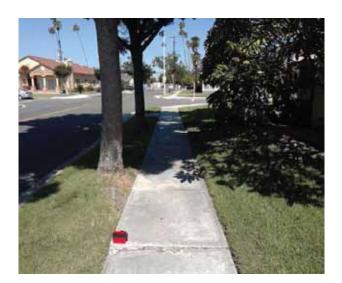
There is a change in elevation greater than recommended value.

Recommendation

Ensure that the change in elevation is within the recommended value.

Recommendation Up to 0.25 inches

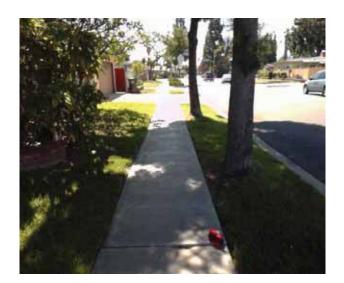
There is a change in elevation greater than recommended value.

Recommendation

Ensure that the change in elevation is within the recommended value.

Recommendation Up to 0.25 inches

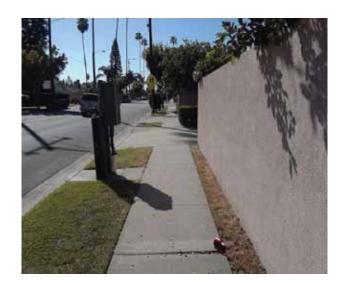
There is a change in elevation greater than recommended value.

Recommendation

Ensure that the change in elevation is within the recommended value.

Recommendation Up to 0.25 inches

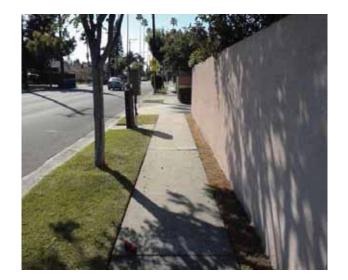
There is a change in elevation greater than recommended value.

Recommendation

Ensure that the change in elevation is within the recommended value.

Recommendation Up to 0.25 inches

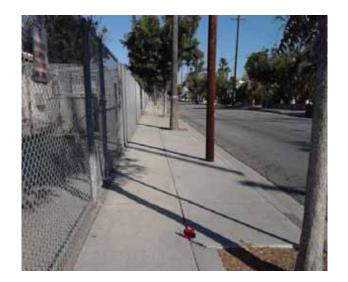
There is a change in elevation greater than recommended value.

Recommendation

Ensure that the change in elevation is within the recommended value.

Recommendation Up to 0.25 inches

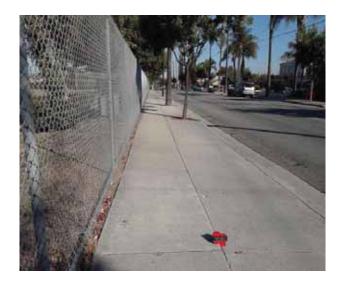
There is a change in elevation greater than recommended value.

Recommendation

Ensure that the change in elevation is within the recommended value.

Recommendation Up to 0.25 inches

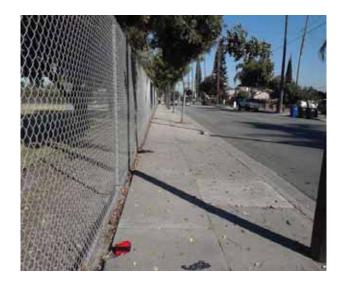
There is a change in elevation greater than recommended value.

Recommendation

Ensure that the change in elevation is within the recommended value.

Recommendation Up to 0.25 inches

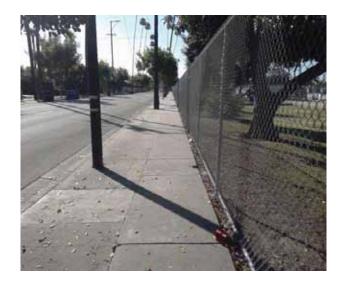
There is a change in elevation greater than recommended value.

Recommendation

Ensure that the change in elevation is within the recommended value.

Recommendation Up to 0.25 inches

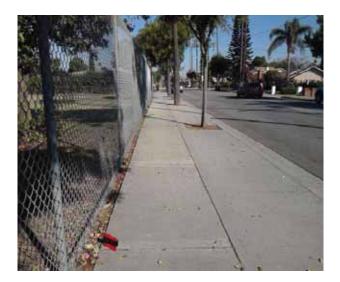
There is a change in elevation greater than recommended value.

Recommendation

Ensure that the change in elevation is within the recommended value.

Recommendation Up to 0.25 inches

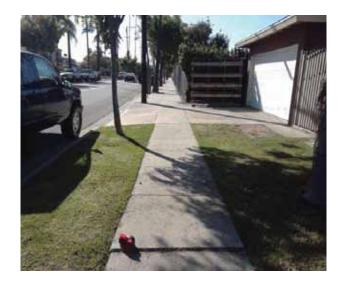
There is a change in elevation greater than recommended value.

Recommendation

Ensure that the change in elevation is within the recommended value.

Recommendation Up to 0.25 inches

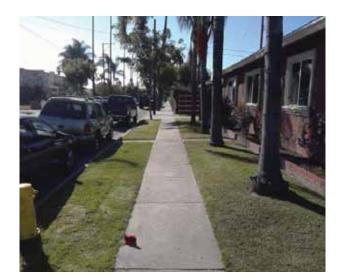
There is a change in elevation greater than recommended value.

Recommendation

Ensure that the change in elevation is within the recommended value.

Recommendation Up to 0.25 inches

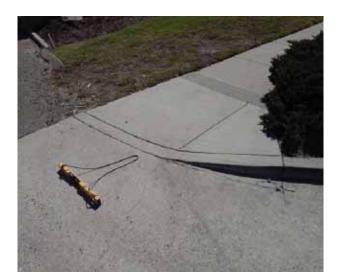
Curb Ramp , Landings and Transitions $\,:\,$ Top Landing Slope

Recommendation Up to 2.08 percent

Provide compliant landing \$1,260

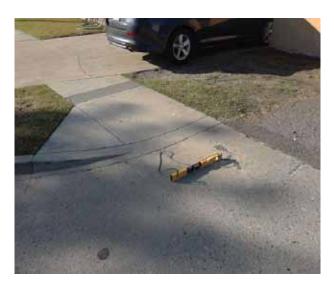
Curb Ramp : Bottom Landing Slope

Recommendation Up to 5.00 percent

Repave landing \$1,260

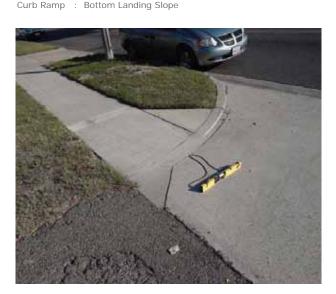
Recommendation Up to 5.00 percent

Repave landing \$1,260

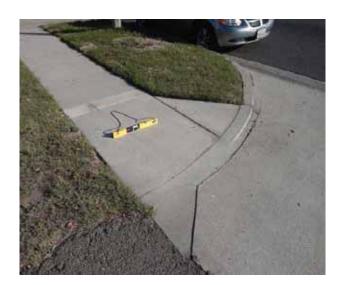
Recommendation See Recommendation

Provide detectable warning to \$248 surface

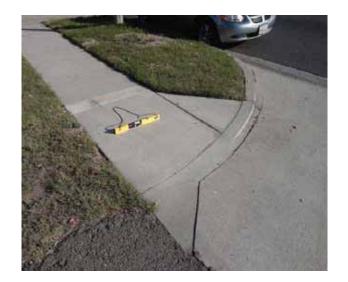
Recommendation At least 48.00 inches

Install curb ramp \$1,300

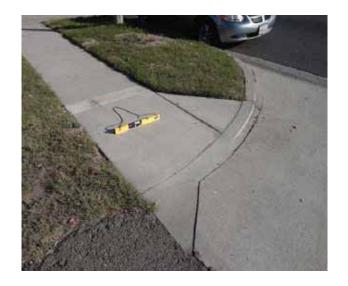
Recommendation Up to 2.08 percent Costing Info (Estimated)

Install curb ramp \$1,300

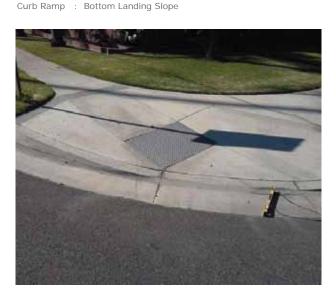
Recommendation Up to 5.00 percent

Repave landing \$1,260

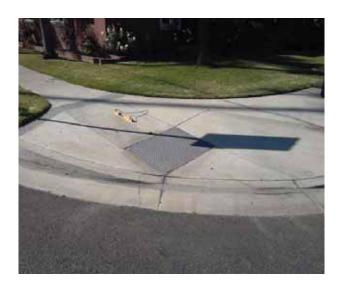
Recommendation Up to 8.33 percent

Install curb ramp \$1,300

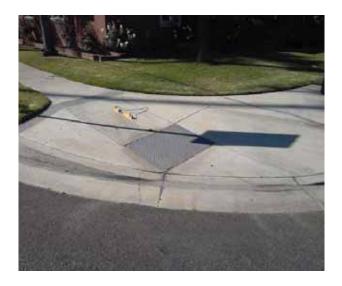
Recommendation Up to 2.08 percent

Install curb ramp \$1,300

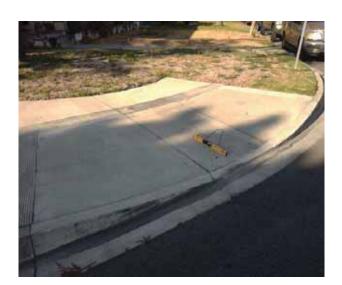
Recommendation See Recommendation

Provide detectable warning to \$248 surface

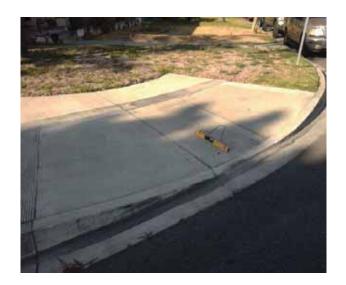
Recommendation Up to 8.33 percent

Install curb ramp \$1,300

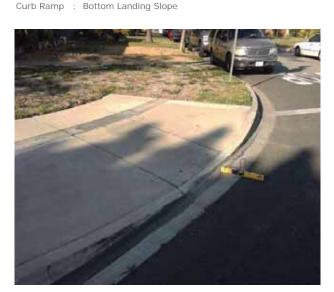
Recommendation Up to 5.00 percent

Repave landing \$1,260

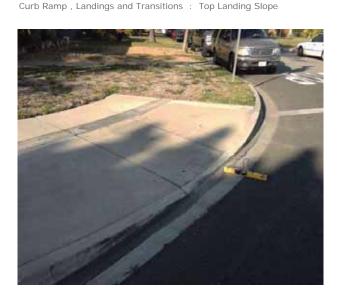
Recommendation Up to 2.08 percent

Provide compliant landing \$1,260

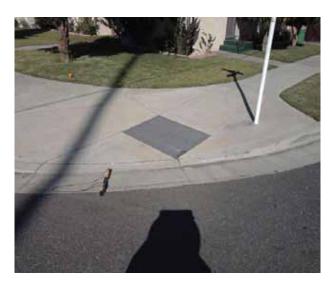
Curb Ramp : Bottom Landing Slope

Recommendation Up to 5.00 percent

Repave landing \$1,260

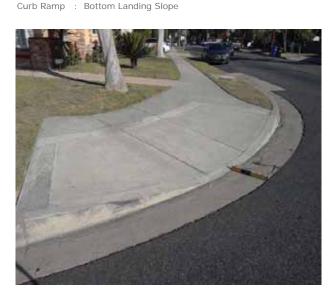
Recommendation Up to 5.00 percent

Repave landing \$1,260

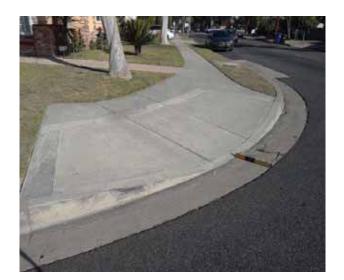
Curb Ramp , Landings and Transitions $\,:\,$ Top Landing Slope

Recommendation Up to 2.08 percent

Provide compliant landing \$1,260

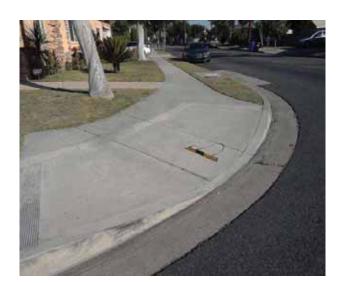
Recommendation See Recommendation

Provide detectable warning to \$248 surface

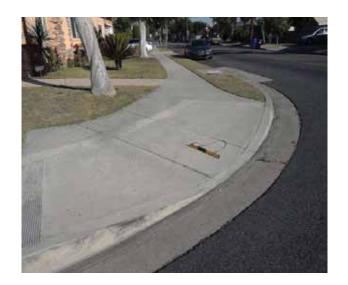
Recommendation Up to 8.33 percent

Install curb ramp \$1,300

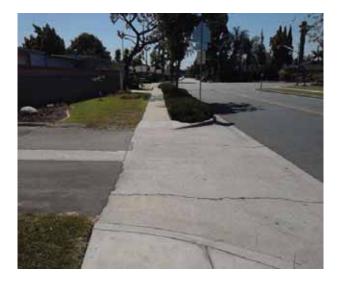
Recommendation See Recommendation

Install compliant detectable \$190 warnings

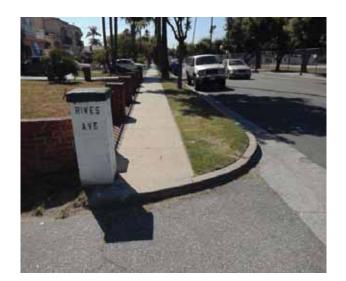
Sidewalks , Hazards & Gratings : Curb is on Path of Travel

Install curb ramp \$2,500

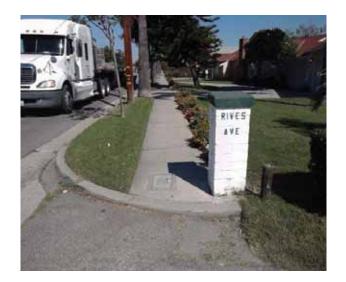
Sidewalks , Hazards & Gratings : Curb is on Path of Travel

Install curb ramp \$2,500

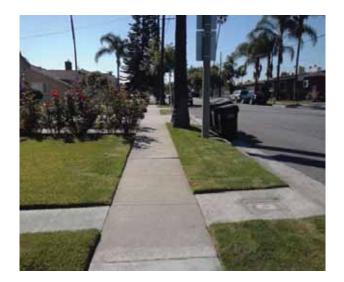
Recommendation Up to 2.08 percent

Repave the sidewalk surface with the recommended cross slope.

Repave surface \$1,092

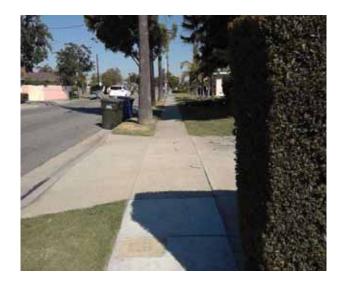
Recommendation Up to 5.00 percent

Repave the sidewalk surface with the recommended running slope.

Repave surface \$1,184

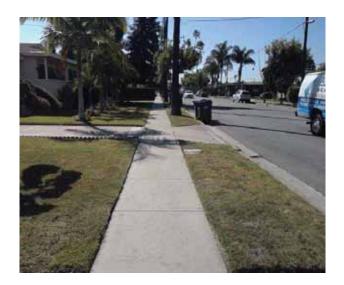
Recommendation Up to 2.08 percent

Repave the sidewalk surface with the recommended cross slope.

Repave surface \$1,092

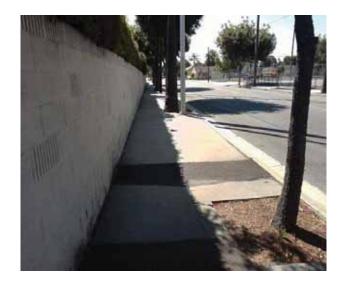
Recommendation Up to 2.08 percent

Repave the sidewalk surface with the recommended cross slope.

Repave surface \$1,092

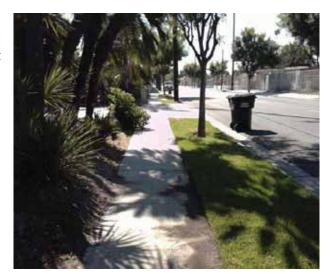
Recommendation Up to 2.08 percent

Repave the sidewalk surface with the recommended cross slope.

Repave surface \$1,092

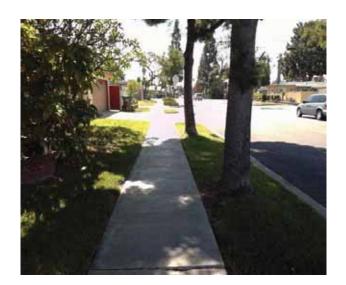
Recommendation Up to 2.08 percent

Repave the sidewalk surface with the recommended cross slope.

Repave surface \$1,092

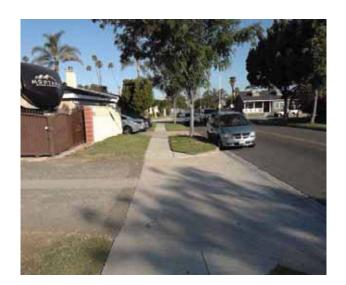
Recommendation See Recommendation

Install compliant detectable \$190

warnings

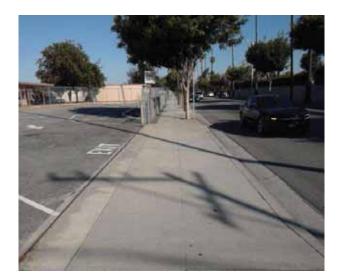
Recommendation See Recommendation

Install compliant detectable \$190 warnings

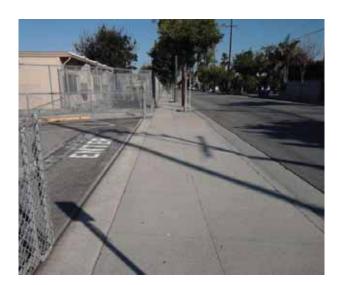
Recommendation See Recommendation

Install compliant detectable \$190 warnings

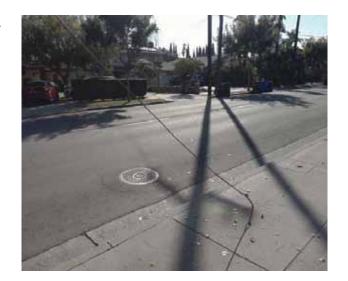
Sidewalks , Hazards & Gratings : Overhead Obstruction Height

Recommendation At least 80.00 inches

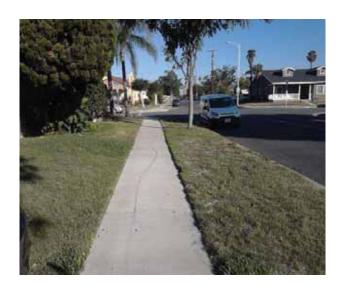
Recommendation At least 48.00 inches

Widen the sidewalk to the recommended value.

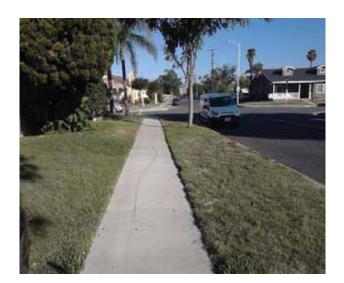
Recommendation Up to 2.08 percent

Repave the sidewalk surface with the recommended cross slope.

Repave surface \$1,092

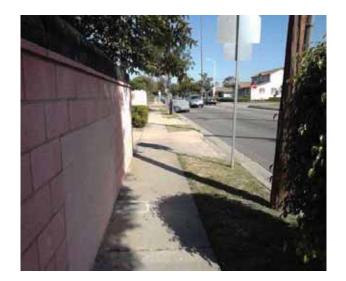
Recommendation Up to 2.08 percent

Repave the sidewalk surface with the recommended cross slope.

Repave surface \$1,092

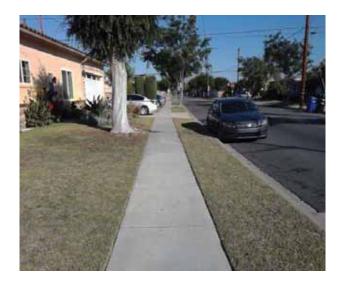
Recommendation Up to 2.08 percent

Repave the sidewalk surface with the recommended cross slope.

Repave surface \$1,092

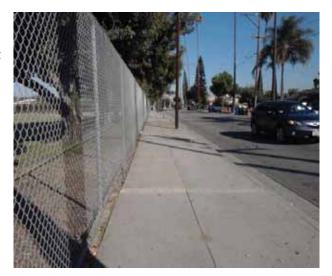
Recommendation Up to 2.08 percent

Repave the sidewalk surface with the recommended cross slope.

Repave surface \$1,092

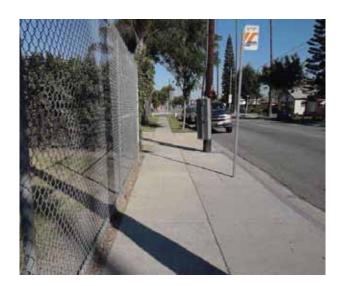
Recommendation Up to 2.08 percent

Repave the sidewalk surface with the recommended cross slope.

Repave surface \$1,092

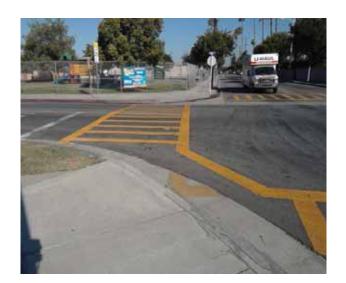
Recommendation Up to 5.00 percent

Repave surface \$1,092

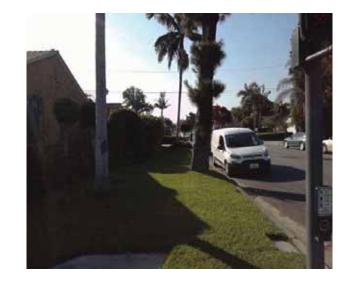
On-Site Finding Not Found

Recommendation See Recommendation

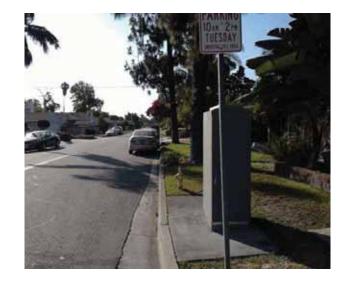
On-Site Finding Not Found

Recommendation See Recommendation

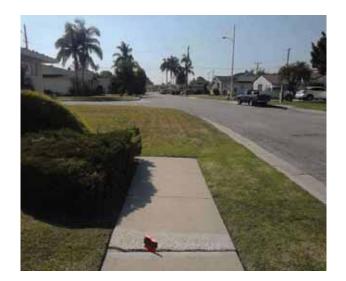
There is a change in elevation greater than recommended value.

Ensure that the change in elevation is within the recommended value.

Recommendation Up to 0.25 inches

Remove tripping hazards \$198

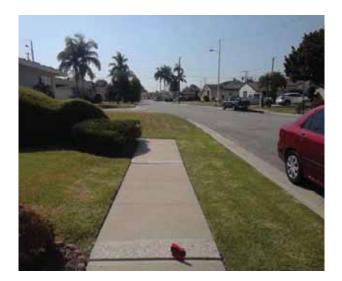
There is a change in elevation greater than recommended value.

Ensure that the change in elevation is within the recommended value.

Recommendation Up to 0.25 inches

Remove tripping hazards \$198

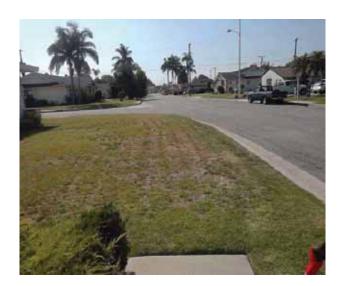
Sidewalks : Missing Sidewalk

Section of sidewalk is missing and consists of dirt, grass or gravel.

Provide a compliant sidewalk for the missing section.

\$1,260

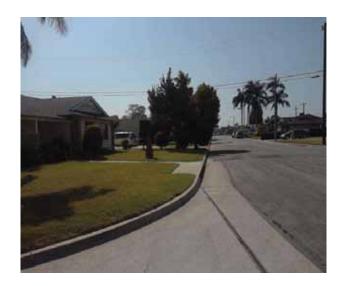
Sidewalks : Missing Sidewalk

Section of sidewalk is missing and consists of dirt, grass or gravel.

Provide a compliant sidewalk for the missing section.

\$1,260

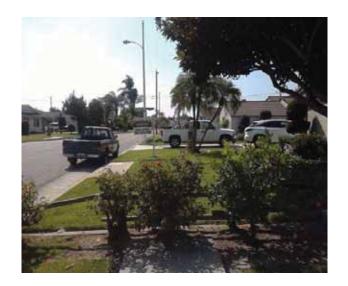
Sidewalks : Missing Sidewalk

Section of sidewalk is missing and consists of dirt, grass or gravel.

Provide a compliant sidewalk for the missing section.

\$1,260
