Accessibility Survey

Adoree Street & Columbia Way
Downey, CA 90242

Date of Inspection
4/10/2017

Disability Access Consultants

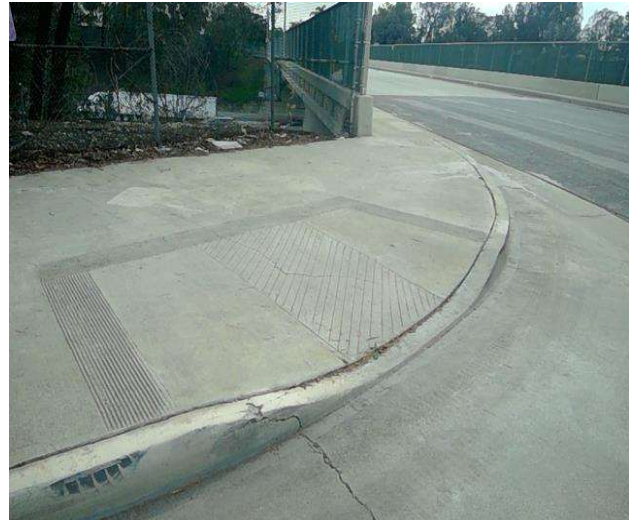
On-Site Finding Not Found

Recommendation

Recommendation See Recommendation

Provide detectable warning to surface \$248

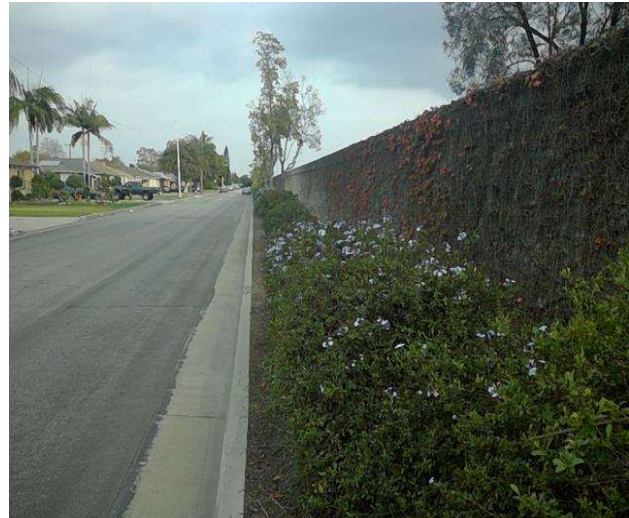
Sidewalks : Missing Sidewalk

Section of sidewalk is missing and consists of dirt, grass or gravel.

Recommendation

Provide a compliant sidewalk for the missing section.

Recommendation See Recommendation

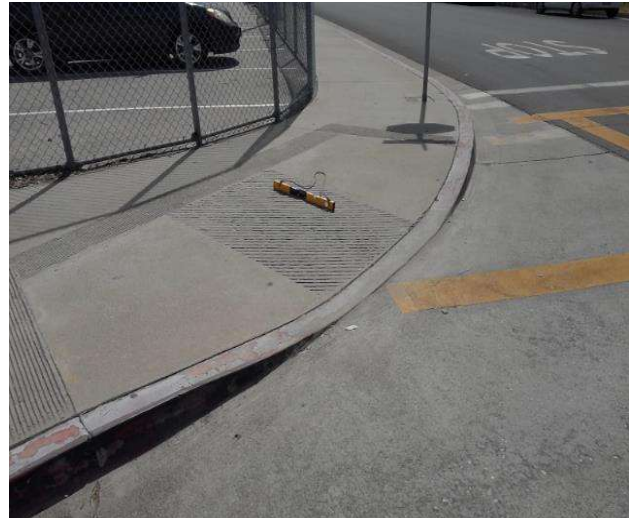
On-Site Finding Not Found

Recommendation

Recommendation See Recommendation

Provide detectable warning to surface \$248

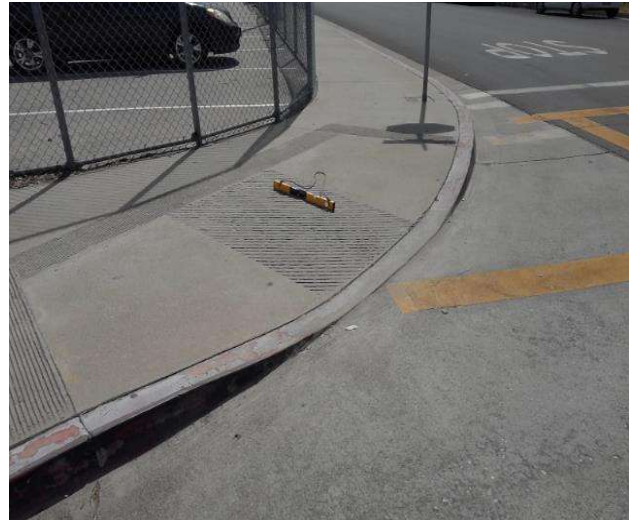
On-Site Finding Not Found

Recommendation

Recommendation See Recommendation

Install crosswalk \$800

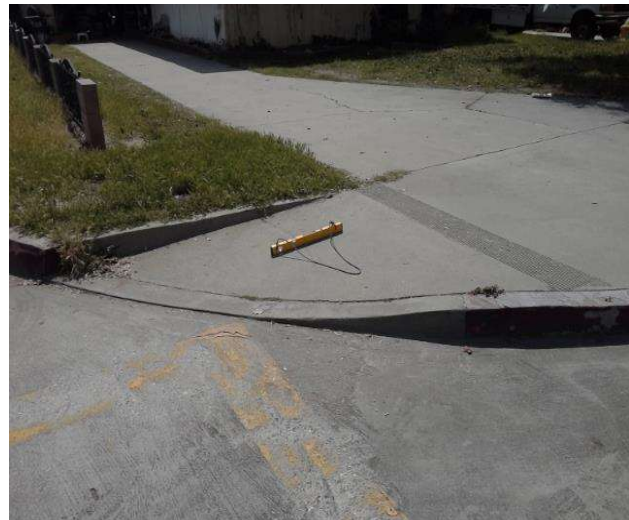
On-Site Finding Not Found

Recommendation

Recommendation See Recommendation

Provide detectable warning to surface \$248

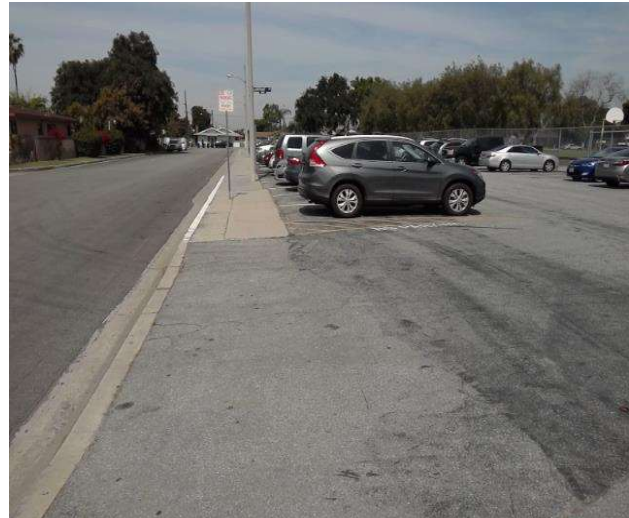
Notes : Surface is rough and uneven.

Recommendation

Recommendation Up to 2.08 percent

Repave surface \$1,092

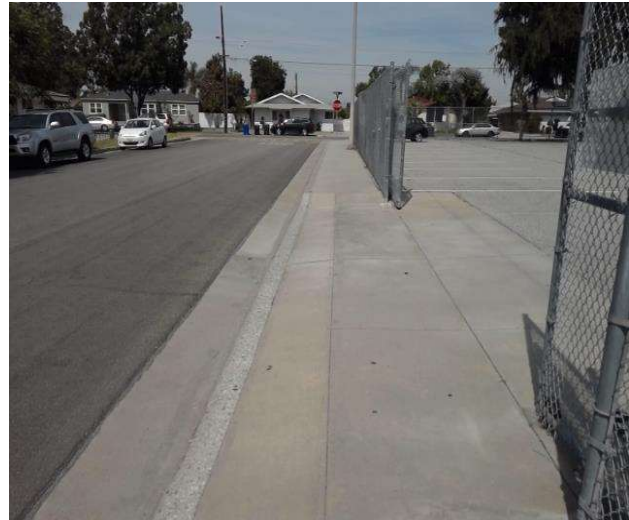
On-Site Finding Not Found

Recommendation

Recommendation See Recommendation

Install compliant detectable warnings \$190

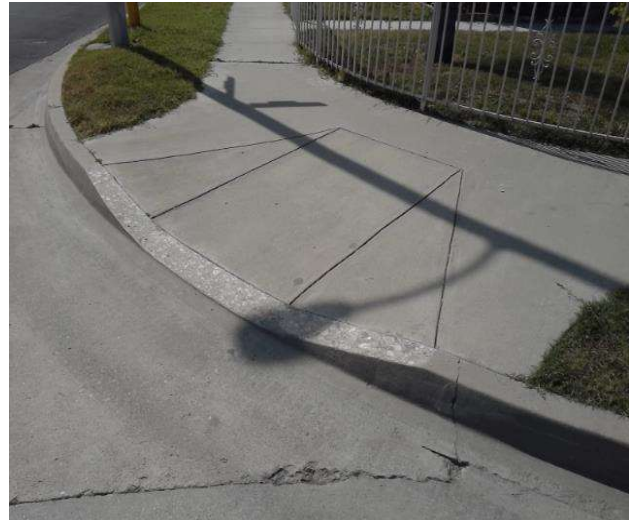
On-Site Finding Not Found

Provide detectable warning to surface \$248

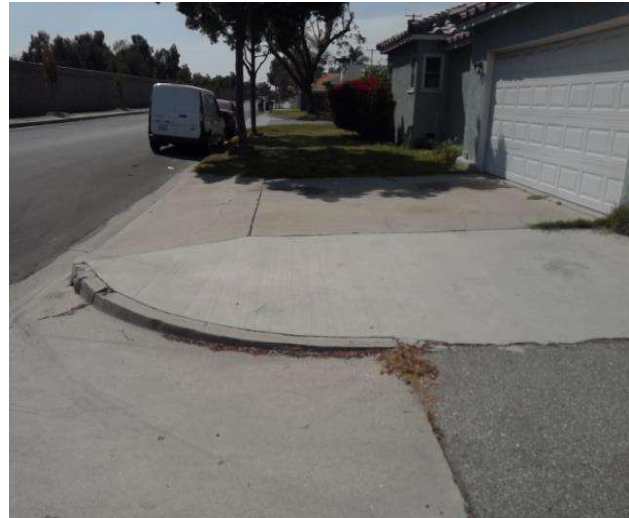
Sidewalks , Hazards & Gratings : Curb is on Path of Travel

Install curb ramp \$2,500

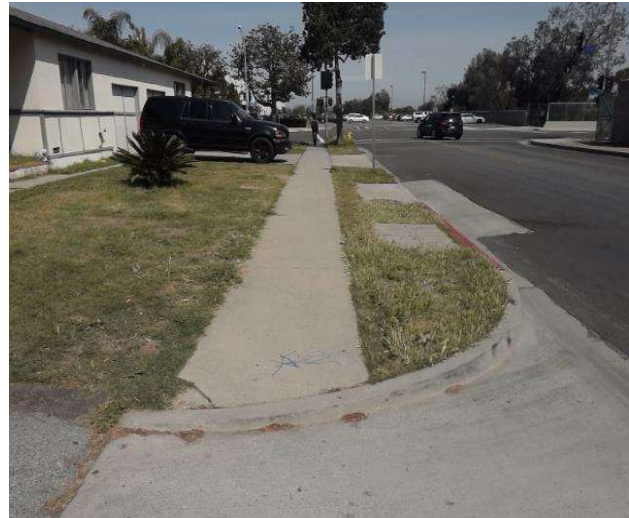
Sidewalks , Hazards & Gratings : Curb is on Path of Travel

Install curb ramp \$2,500

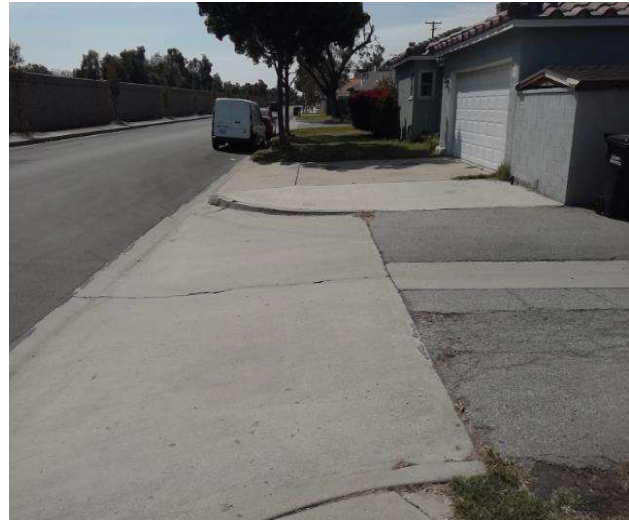
On-Site Finding Not Found

Install compliant detectable warnings \$190

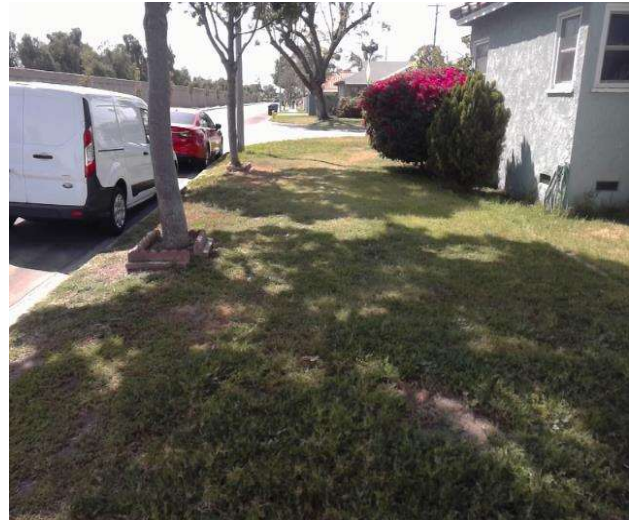
Sidewalks : Missing Sidewalk

Section of sidewalk is missing and consists of dirt, grass or gravel.

Provide a compliant sidewalk for the missing section.

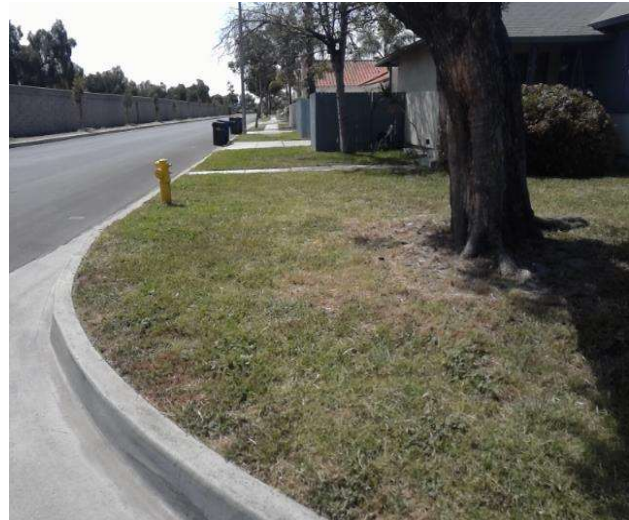
Sidewalks : Missing Sidewalk

Section of sidewalk is missing and consists of dirt, grass or gravel.

Provide a compliant sidewalk for the missing section.

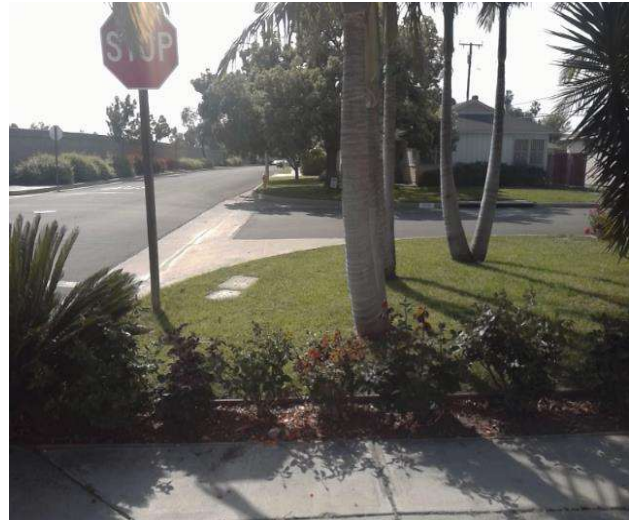
Sidewalks : Missing Sidewalk

Section of sidewalk is missing and consists of dirt, grass or gravel.

Provide a compliant sidewalk for the missing section.

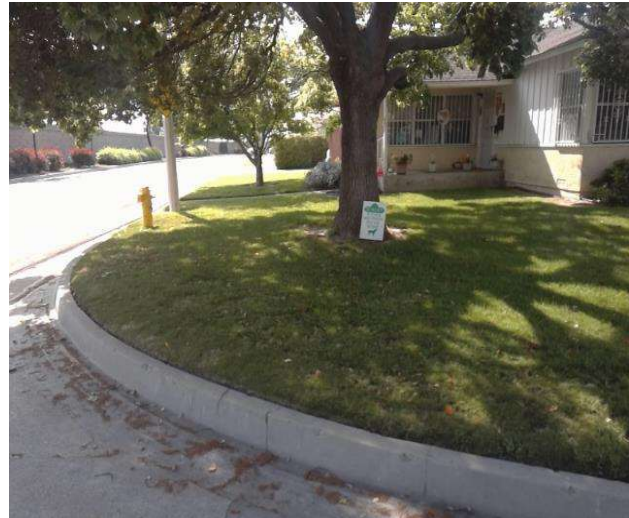
Sidewalks : Missing Sidewalk

Section of sidewalk is missing and consists of dirt, grass or gravel.

Provide a compliant sidewalk for the missing section.

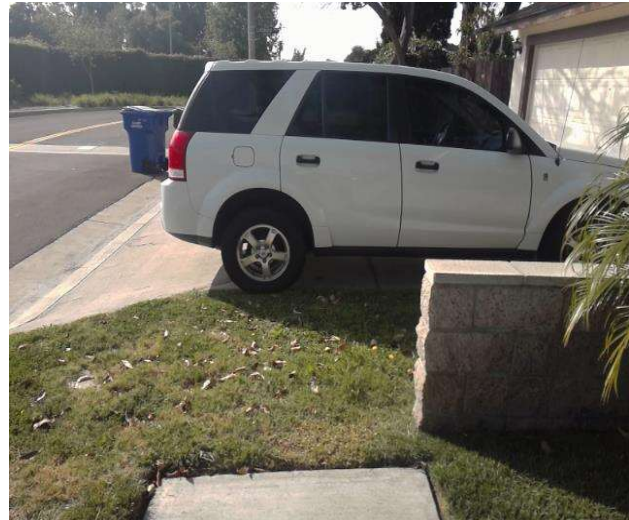
Sidewalks : Missing Sidewalk

Section of sidewalk is missing and consists of dirt, grass or gravel.

Provide a compliant sidewalk for the missing section.

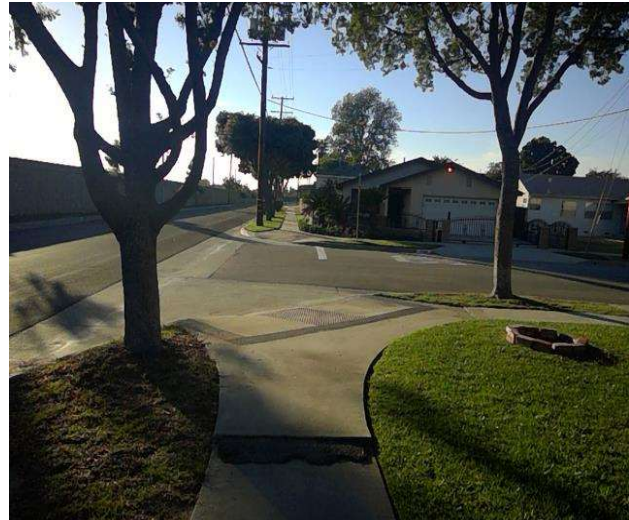
There is a change in elevation greater than recommended value.

Ensure that the change in elevation is within the recommended value.

Remove tripping hazards \$198

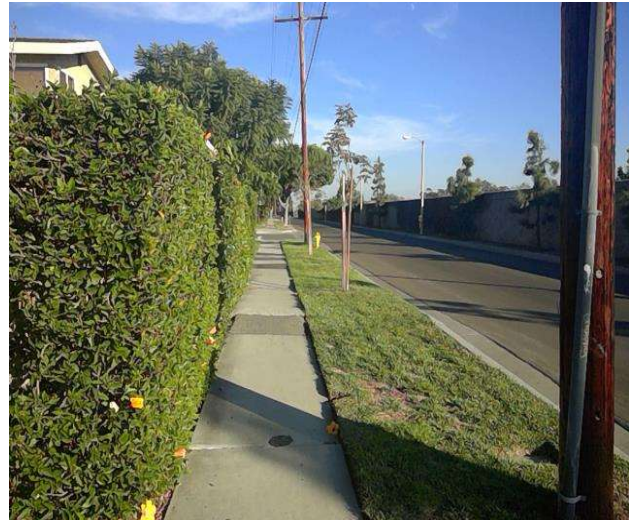
There is a change in elevation greater than recommended value.

Ensure that the change in elevation is within the recommended value.

Remove tripping hazards \$198

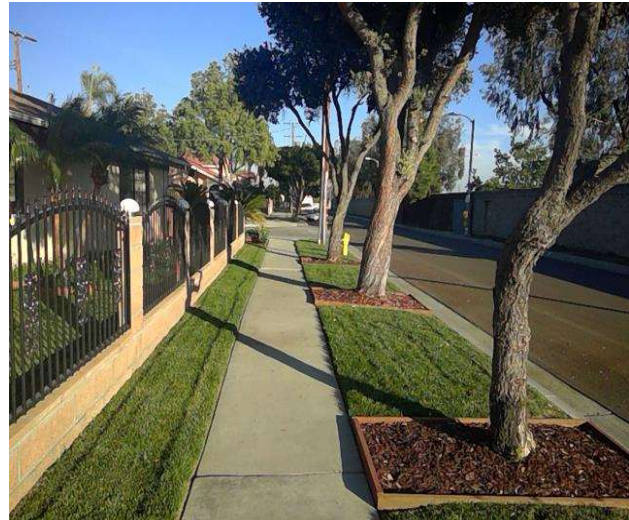
There is a change in elevation greater than recommended value.

Ensure that the change in elevation is within the recommended value.

Remove tripping hazards \$198

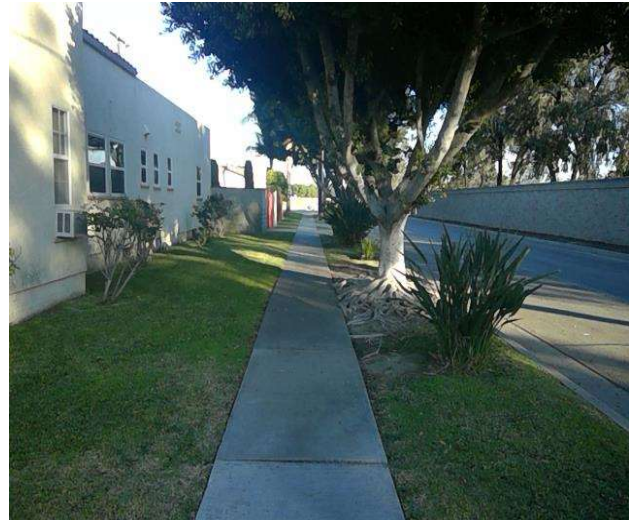
There is a change in elevation greater than recommended value.

Ensure that the change in elevation is within the recommended value.

Remove tripping hazards \$198

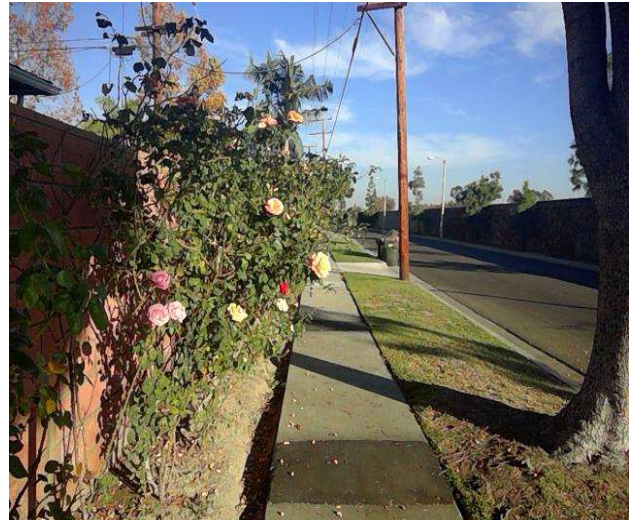
Sidewalks , Hazards & Gratings : Overhead Obstruction Height

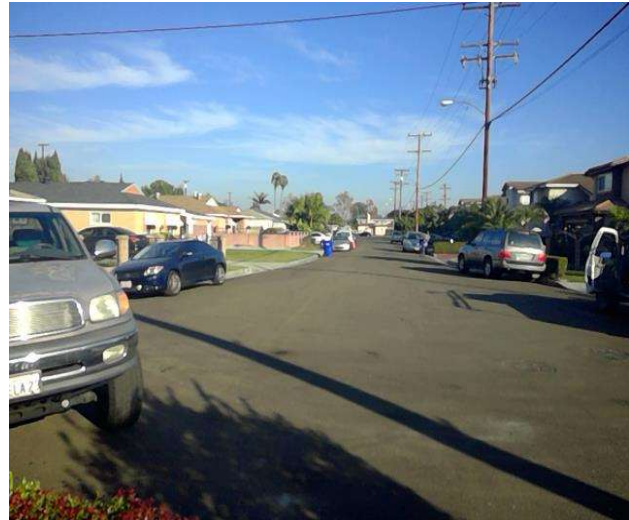
Sidewalks : Missing Sidewalk

Section of sidewalk is missing and consists of dirt, grass or gravel.

Provide a compliant sidewalk for the missing section.

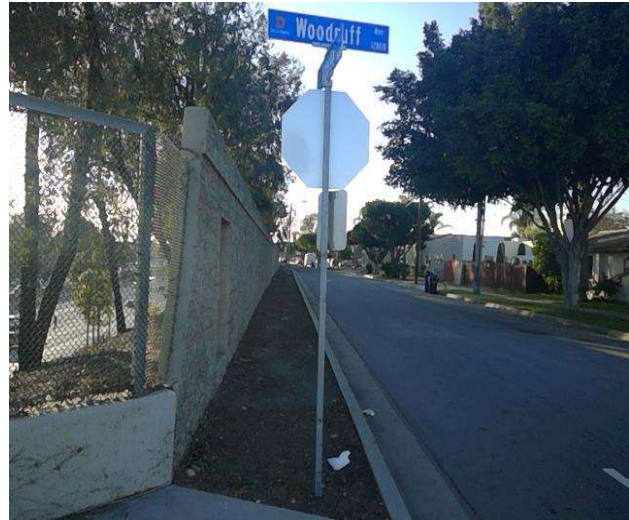
Sidewalks : Missing Sidewalk

Section of sidewalk is missing and consists of dirt, grass or gravel.

Provide a compliant sidewalk for the missing section.

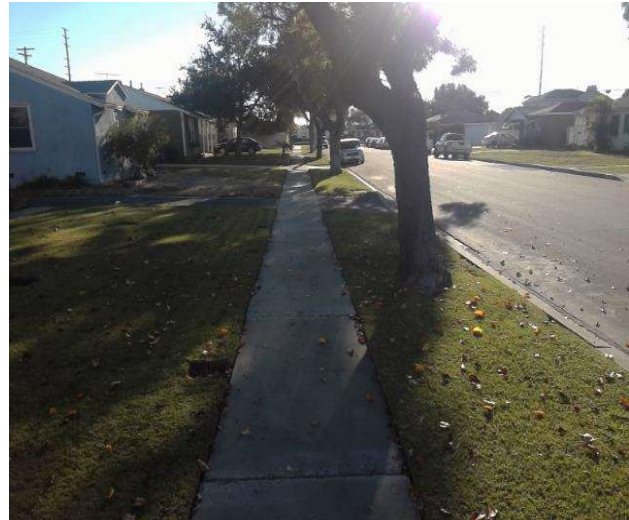
There is a change in elevation greater than recommended value.

Ensure that the change in elevation is within the recommended value.

Remove tripping hazards \$198

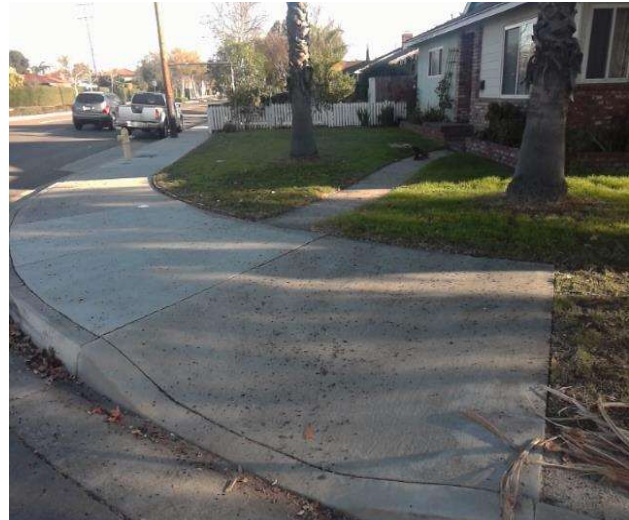
On-Site Finding Not Found

Provide detectable warning to surface \$248

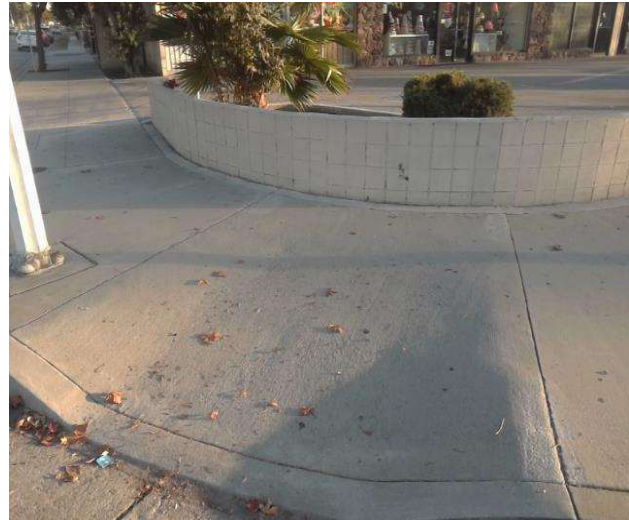
On-Site Finding Not Found

Provide detectable warning to surface \$248

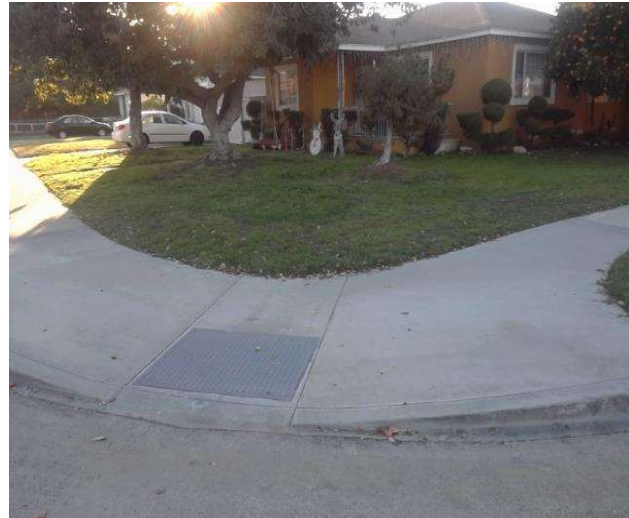
Recommendation Up to 2.08 percent

Install curb ramp \$1,300

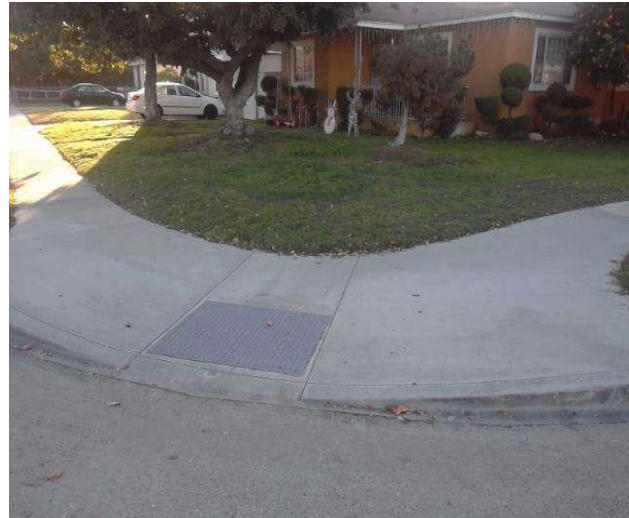
Recommendation Up to 2.08 percent

Provide compliant landing \$240

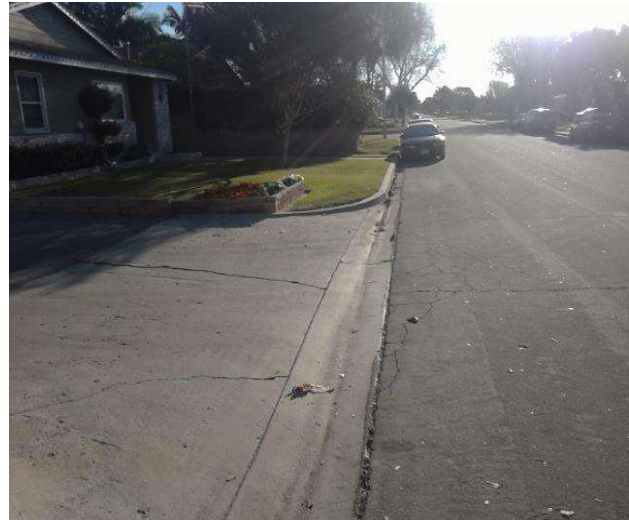
On-Site Finding Not Found

Install compliant detectable warnings \$190

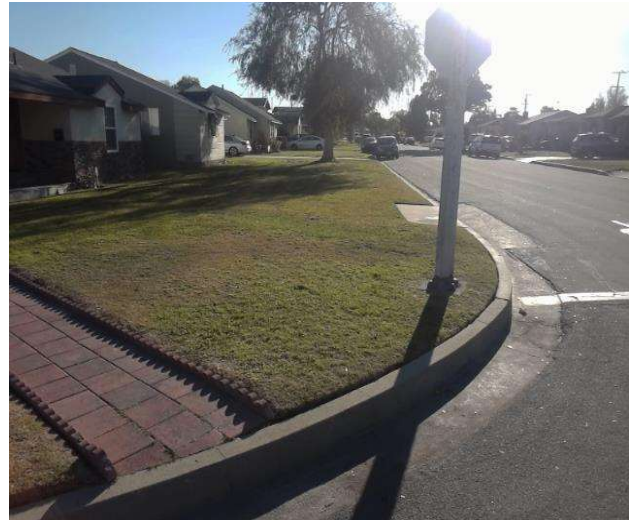
Sidewalks , Hazards & Gratings : Curb is on Path of Travel

Install curb ramp \$2,500

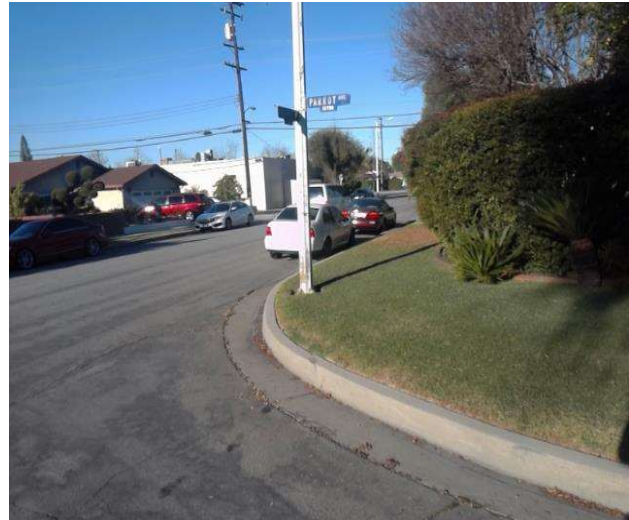
Sidewalks , Hazards & Gratings : Curb is on Path of Travel

Install curb ramp \$2,500

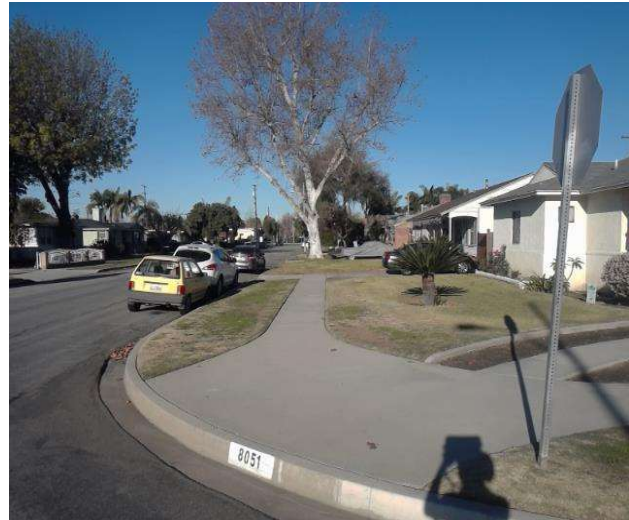
Sidewalks , Hazards & Gratings : Curb is on Path of Travel

Install curb ramp \$2,500

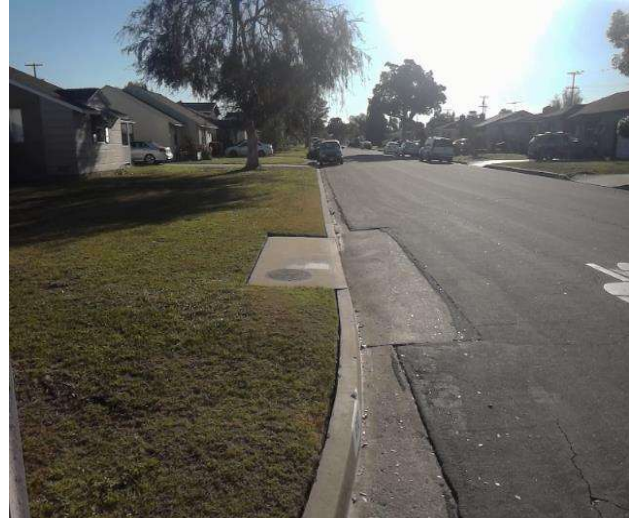
Sidewalks : Missing Sidewalk

Section of sidewalk is missing and consists of dirt, grass or gravel.

Provide a compliant sidewalk for the missing section.

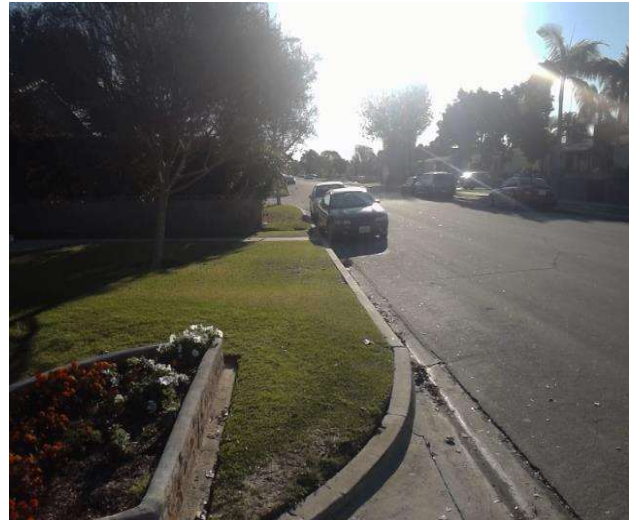
Sidewalks : Missing Sidewalk

Section of sidewalk is missing and consists of dirt, grass or gravel.

Provide a compliant sidewalk for the missing section.

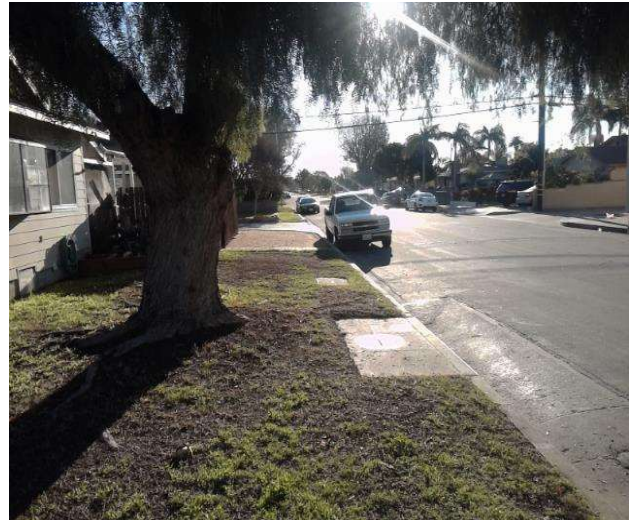
Sidewalks : Missing Sidewalk

Section of sidewalk is missing and consists of dirt, grass or gravel.

Provide a compliant sidewalk for the missing section.

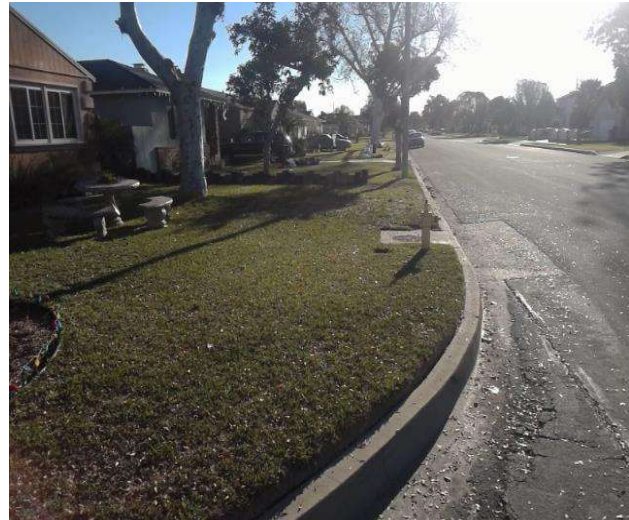
Sidewalks : Missing Sidewalk

Section of sidewalk is missing and consists of dirt, grass or gravel.

Provide a compliant sidewalk for the missing section.

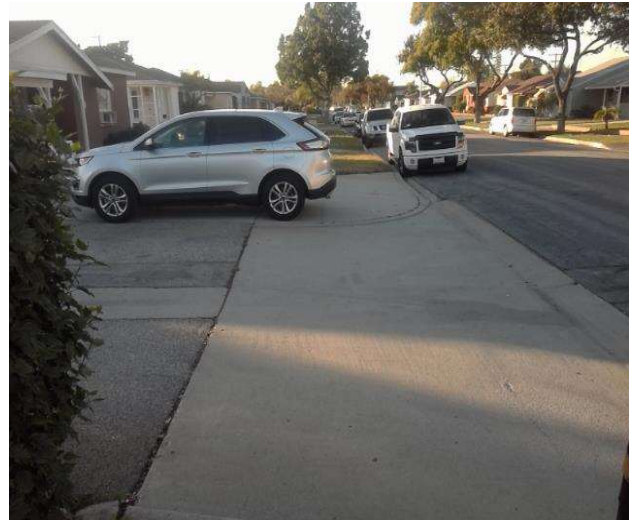
On-Site Finding Not Found

Install compliant detectable warnings \$190

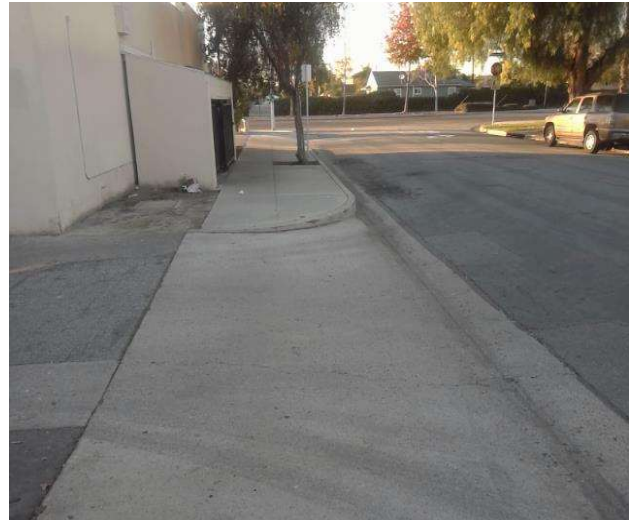
On-Site Finding Not Found

Install compliant detectable warnings \$190

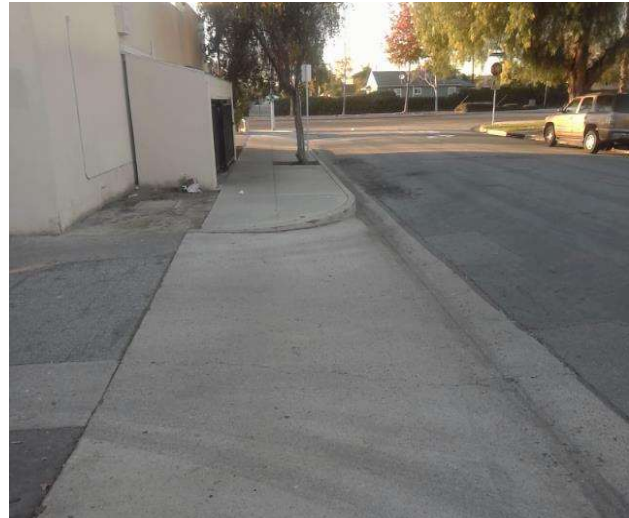
Recommendation Up to 2.08 percent

Repave surface \$1,092

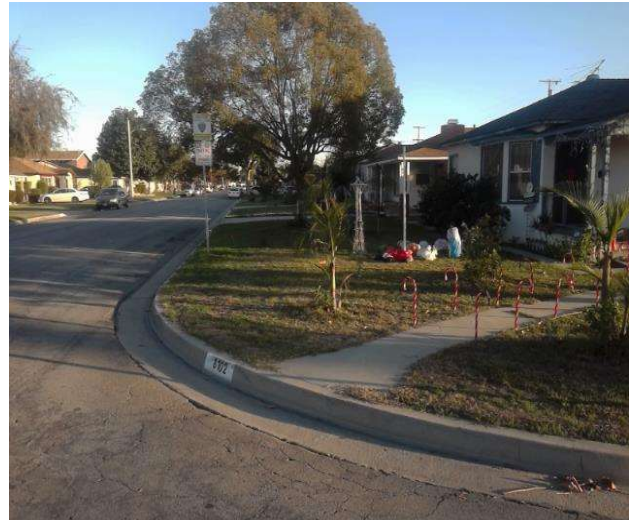
Sidewalks , Hazards & Gratings : Curb is on Path of Travel

Install curb ramp \$2,500

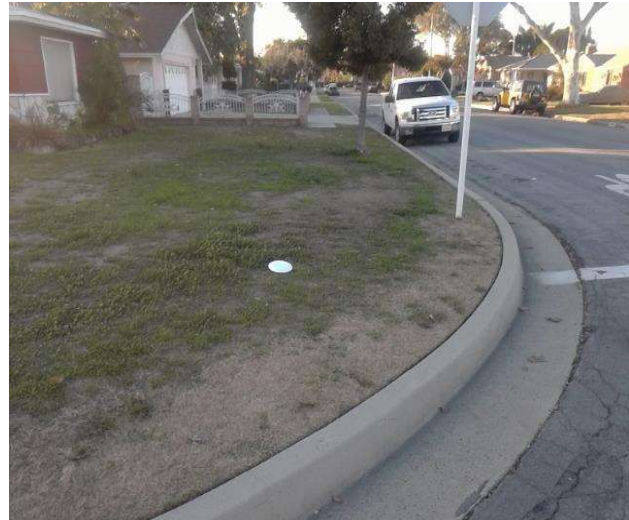
Sidewalks , Hazards & Gratings : Curb is on Path of Travel

Install curb ramp \$2,500

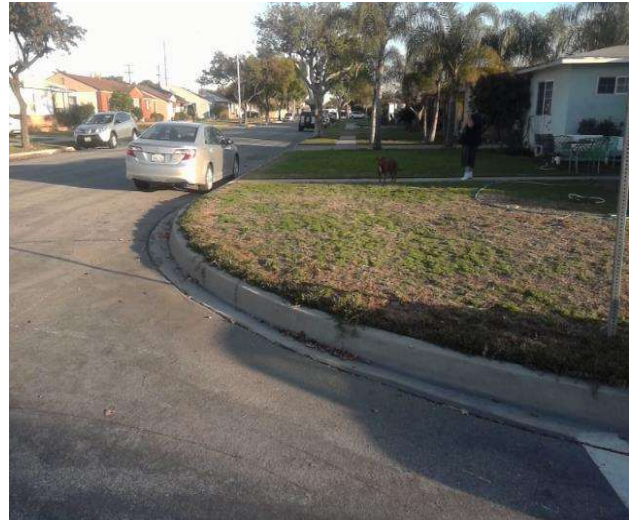
Sidewalks , Hazards & Gratings : Curb is on Path of Travel

Install curb ramp \$2,500

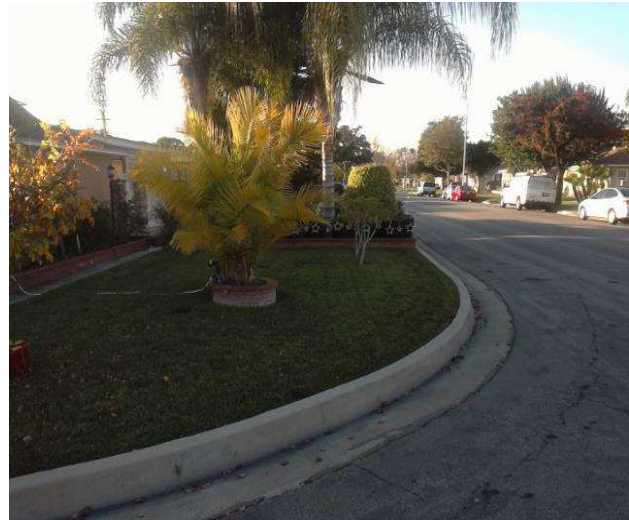
Sidewalks , Hazards & Gratings : Curb is on Path of Travel

Install curb ramp \$2,500

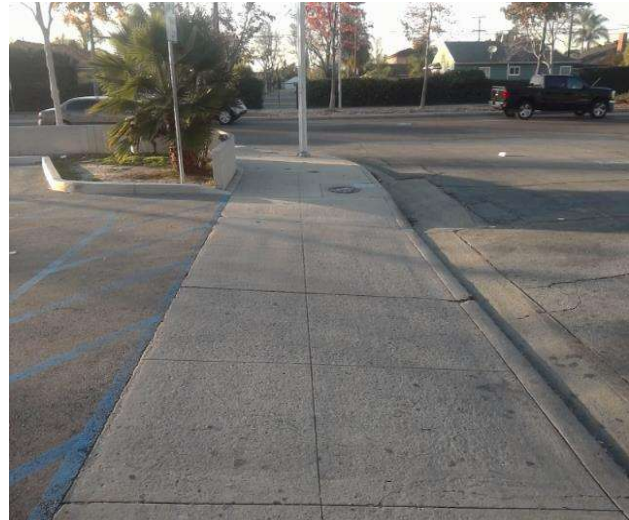
On-Site Finding Not Found

Install compliant detectable warnings \$190

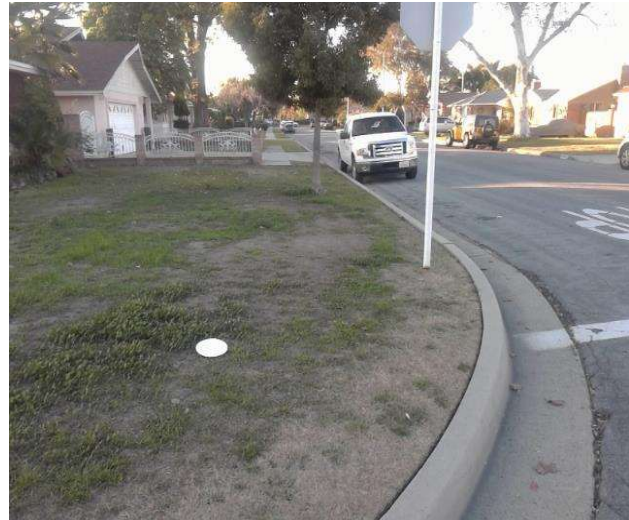
Sidewalks : Missing Sidewalk

Section of sidewalk is missing and consists of dirt, grass or gravel.

Provide a compliant sidewalk for the missing section.

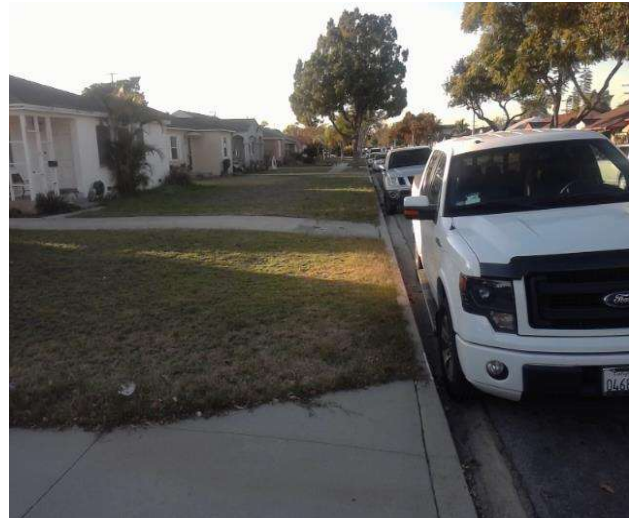
Sidewalks : Missing Sidewalk

Section of sidewalk is missing and consists of dirt, grass or gravel.

Provide a compliant sidewalk for the missing section.

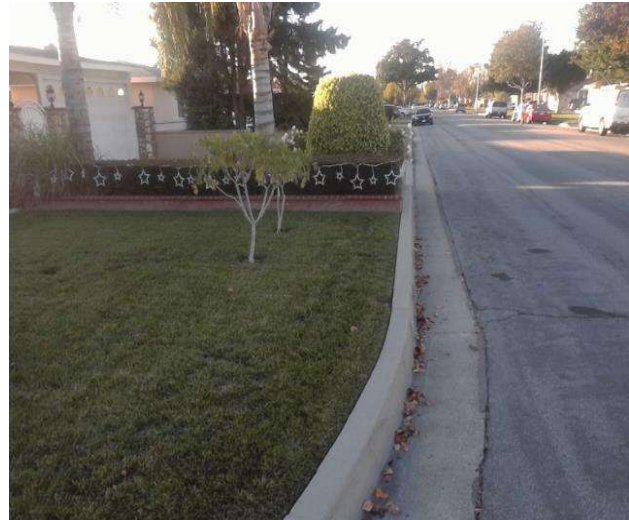
Sidewalks : Missing Sidewalk

Section of sidewalk is missing and consists of dirt, grass or gravel.

Provide a compliant sidewalk for the missing section.
