Accessibility Survey

City of Downey Amigos Avenue - Amigos Avenue to Erickson Avenue

Date of Inspection 8/30/2017

Disability Access Consultants

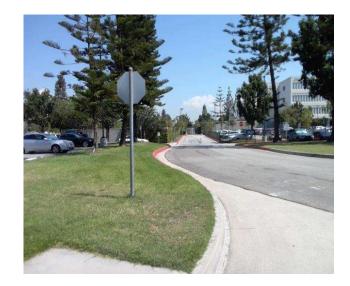
West Side @ 33.926542950752, -118.161456584930

On-Site Finding Not Found

Recommendation See Recommendation

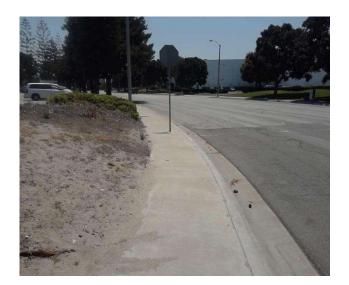
Recommendation Up to 2.08 percent

Repave the sidewalk surface with the recommended cross slope.

Repave surface \$1,092

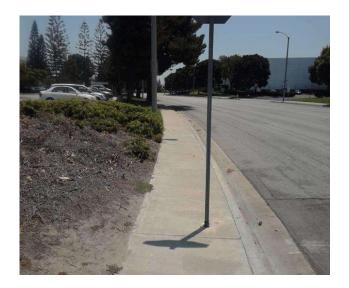
Sidewalks , Hazards & Gratings : Sidewalk Width at Obstruction

Recommendation At least 48.00 inches

Sidewalk width at the obstruction shall have the recommended value.

\$1,260

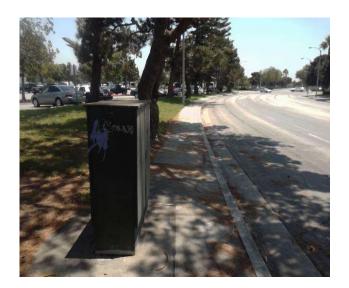
Sidewalks , Hazards & Gratings : Sidewalk Width at Obstruction

Recommendation At least 48.00 inches

Sidewalk width at the obstruction shall have the recommended value.

\$1,260

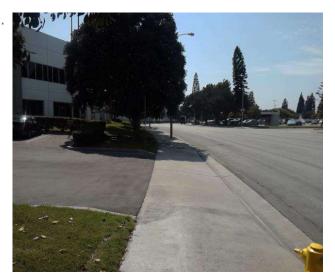
Recommendation Up to 2.08 percent

Repave surface \$1,092

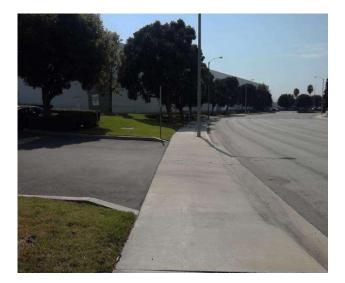
On-Site Finding Not Found

Install compliant detectable \$190 warnings

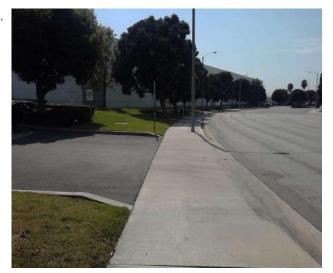
Recommendation Up to 2.08 percent

Repave surface \$1,092

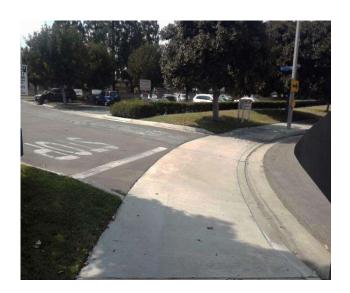
On-Site Finding Not Found

Install compliant detectable \$190

warnings

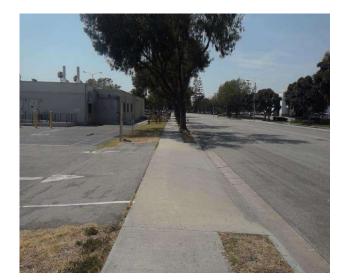
On-Site Finding Not Found

Install compliant detectable \$190 warnings

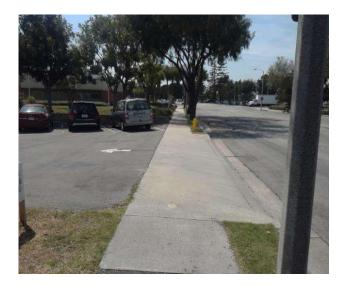
On-Site Finding Not Found

Install compliant detectable \$190 warnings

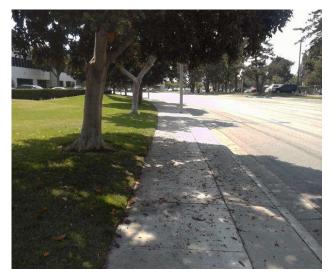
Recommendation Up to 2.08 percent

Repave the sidewalk surface with the recommended cross slope.

Repave surface \$1,092

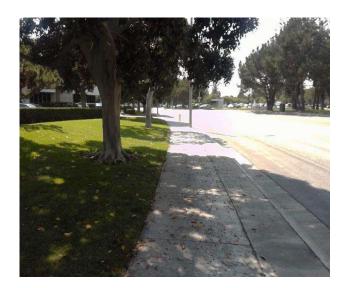
Recommendation Up to 2.08 percent

Repave the sidewalk surface with the recommended cross slope.

Repave surface \$1,092

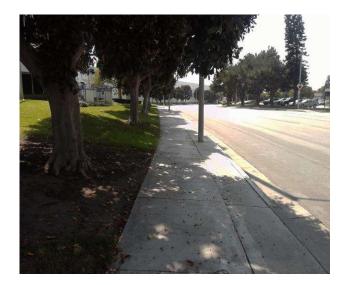
Recommendation Up to 2.08 percent

Repave the sidewalk surface with the recommended cross slope.

Repave surface \$1,092

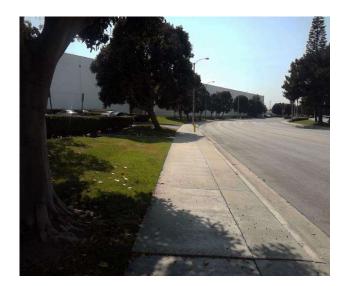
Recommendation Up to 2.08 percent

Repave the sidewalk surface with the recommended cross slope.

Repave surface \$1,092

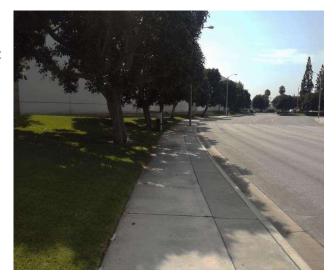
Recommendation Up to 2.08 percent

Repave the sidewalk surface with the recommended cross slope.

Repave surface \$1,092

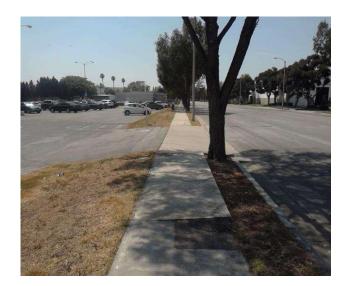
Recommendation Up to 2.08 percent

Repave the sidewalk surface with the recommended cross slope.

Repave surface \$1,092

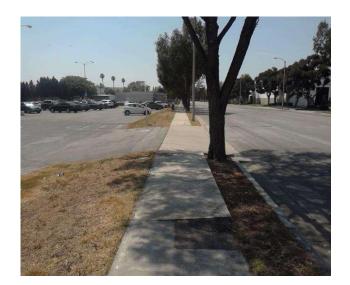
Recommendation Up to 5.00 percent

Repave the sidewalk surface with the recommended running slope.

Repave surface \$1,184

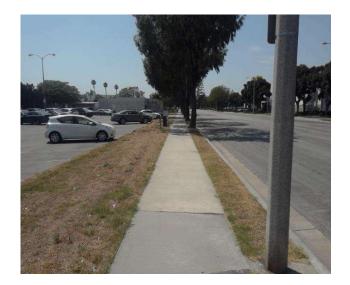
Recommendation Up to 2.08 percent

Repave the sidewalk surface with the recommended cross slope.

Repave surface \$1,092

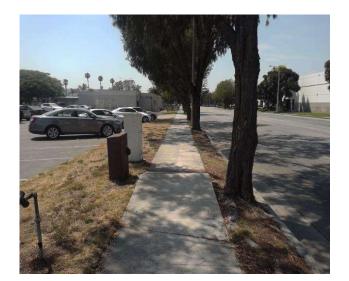
Recommendation Up to 5.00 percent

Repave the sidewalk surface with the recommended running slope.

Repave surface \$1,184

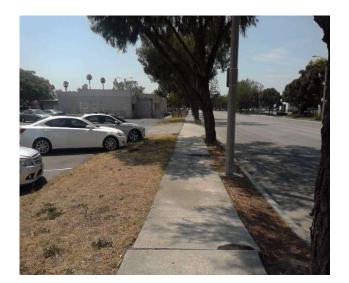
Recommendation Up to 5.00 percent

Repave the sidewalk surface with the recommended running slope.

Repave surface \$1,184

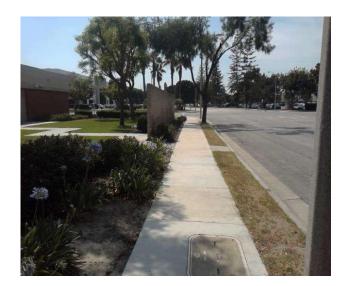
Recommendation Up to 2.08 percent

Repave the sidewalk surface with the recommended cross slope.

Repave surface \$1,092

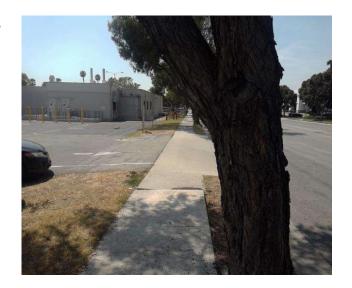
Sidewalks , Hazards & Gratings : Overhead Obstruction Height

Recommendation At least 80.00 inches

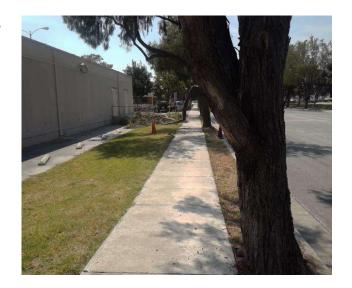
Sidewalks , Hazards & Gratings : Overhead Obstruction Height

Recommendation At least 80.00 inches
