Accessibility Survey

City of Downey Iowa Steet & Brookshire Avenue

Date of Inspection
4/30/2017

Disability Access Consultants

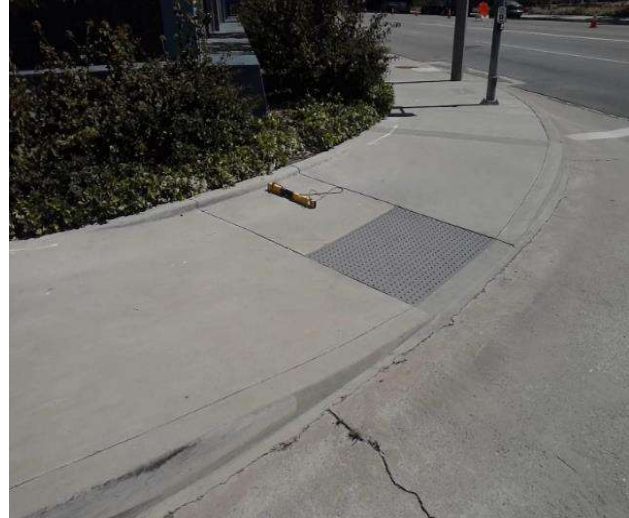
Curb Ramp , Landings and Transitions : Top Landing Slope

Recommendation Up to 2.08 percent

Provide compliant landing \$1,260

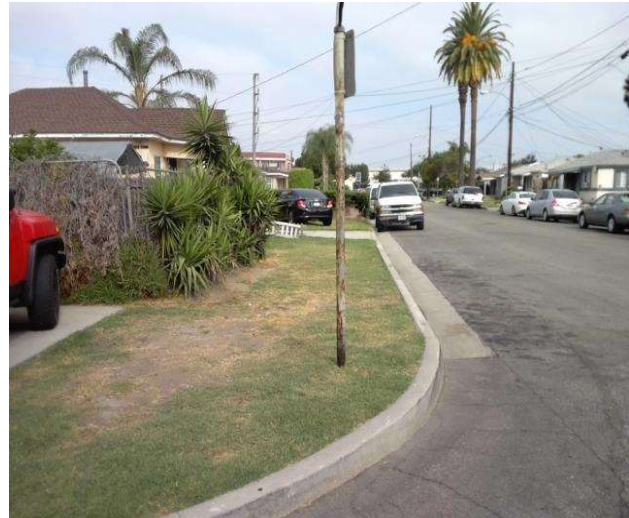
On-Site Finding Not Found

Recommendation See Recommendation

\$2,400

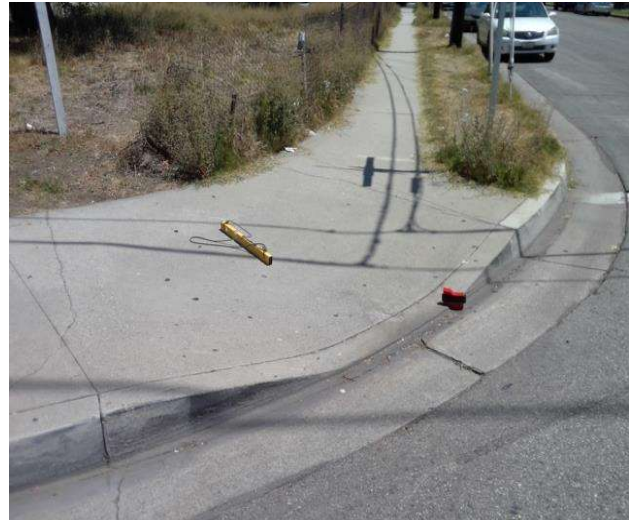
On-Site Finding Not Found

Recommendation See Recommendation

Provide detectable warning to surface \$248

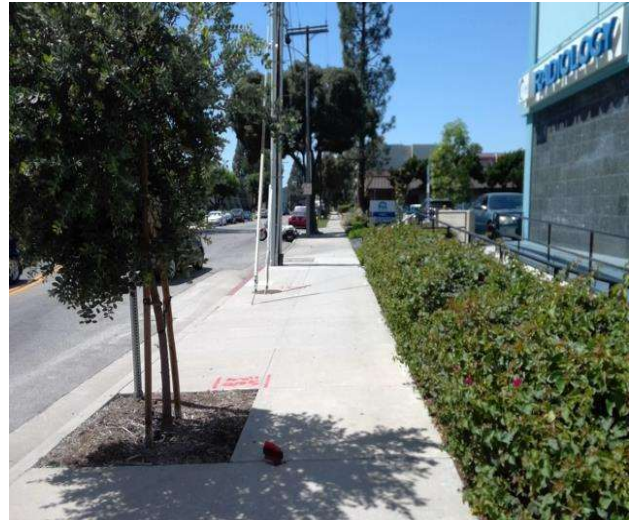
There is a change in elevation greater than recommended value.

Ensure that the change in elevation is within the recommended value.

Recommendation Up to 0.25 inches

Remove tripping hazards \$198

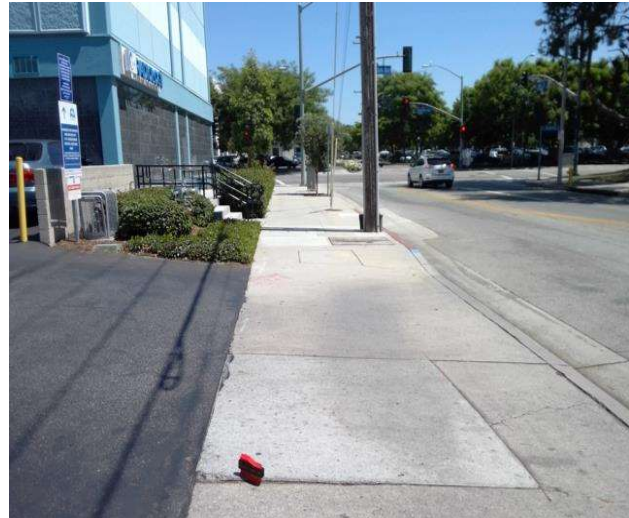
There is a change in elevation greater than recommended value.

Ensure that the change in elevation is within the recommended value.

Recommendation Up to 0.25 inches

Remove tripping hazards \$198

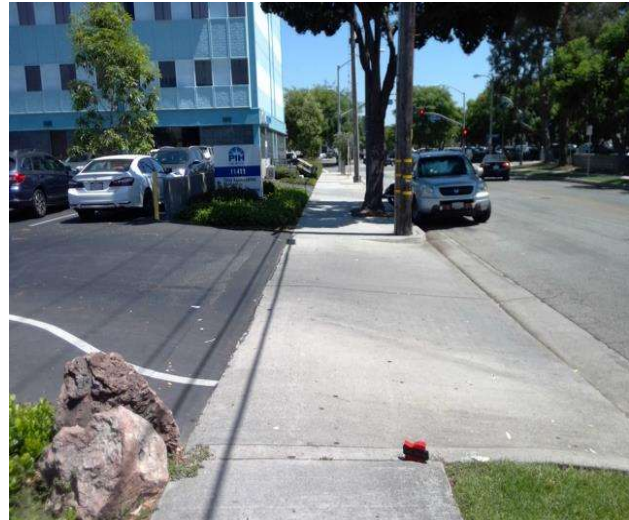
There is a change in elevation greater than recommended value.

Ensure that the change in elevation is within the recommended value.

Recommendation Up to 0.25 inches

Remove tripping hazards \$198

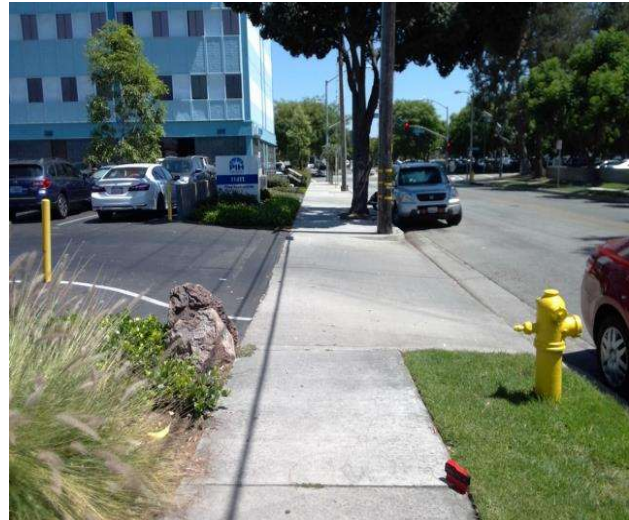
There is a change in elevation greater than recommended value.

Ensure that the change in elevation is within the recommended value.

Recommendation Up to 0.25 inches

Remove tripping hazards \$198

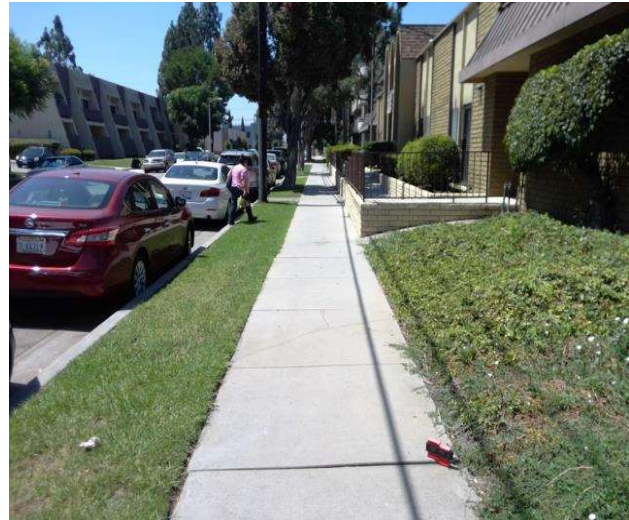
There is a change in elevation greater than recommended value.

Ensure that the change in elevation is within the recommended value.

Recommendation Up to 0.25 inches

Remove tripping hazards \$198

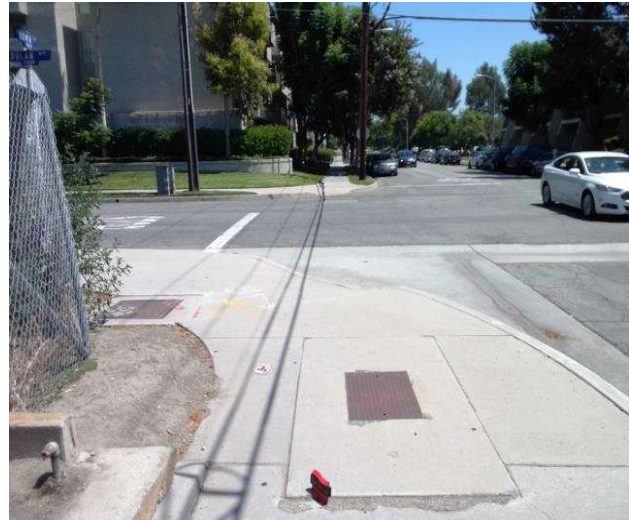
There is a change in elevation greater than recommended value.

Ensure that the change in elevation is within the recommended value.

Recommendation Up to 0.25 inches

Remove tripping hazards \$198

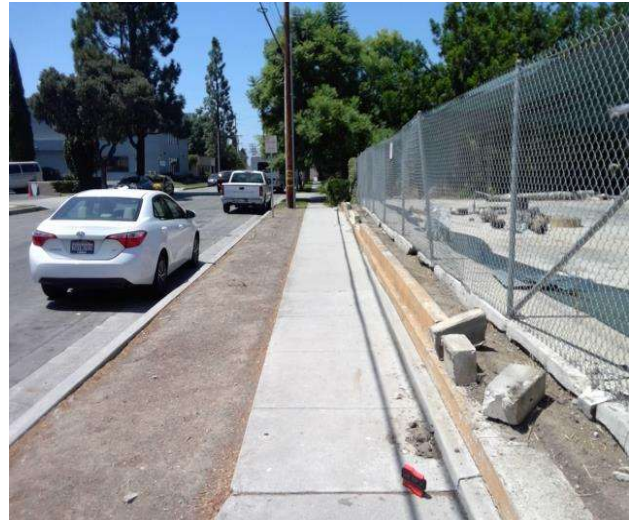
There is a change in elevation greater than recommended value.

Ensure that the change in elevation is within the recommended value.

Recommendation Up to 0.25 inches

Remove tripping hazards \$198

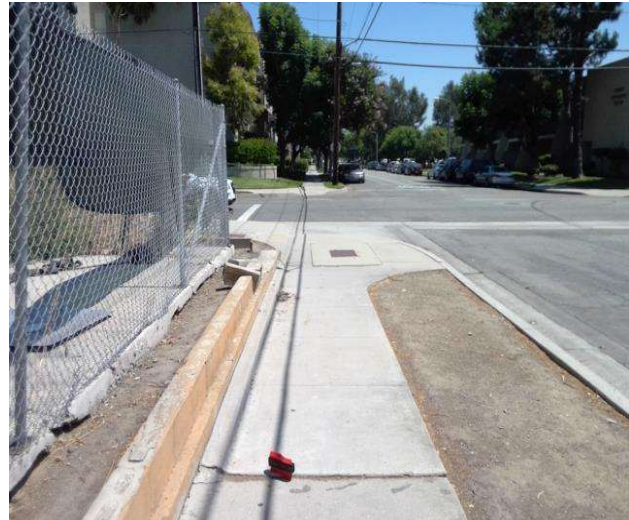
There is a change in elevation greater than recommended value.

Ensure that the change in elevation is within the recommended value.

Recommendation Up to 0.25 inches

Remove tripping hazards \$198

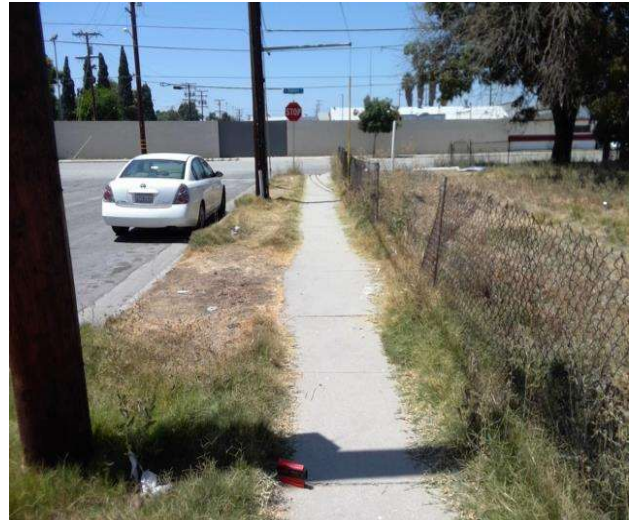
There is a change in elevation greater than recommended value.

Ensure that the change in elevation is within the recommended value.

Recommendation Up to 0.25 inches

Remove tripping hazards \$198

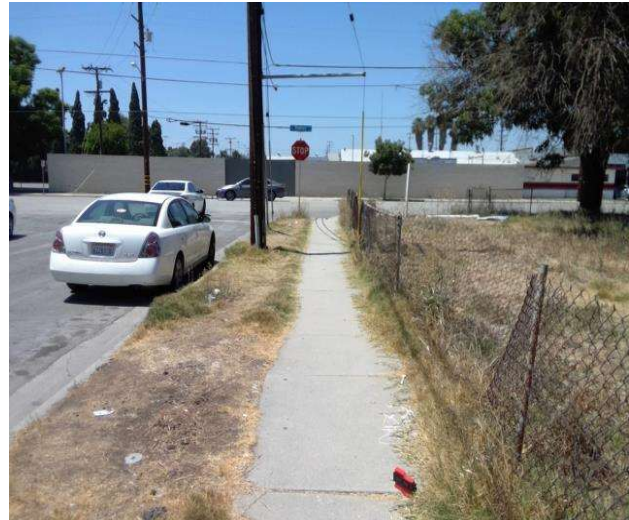
There is a change in elevation greater than recommended value.

Ensure that the change in elevation is within the recommended value.

Recommendation Up to 0.25 inches

Remove tripping hazards \$198

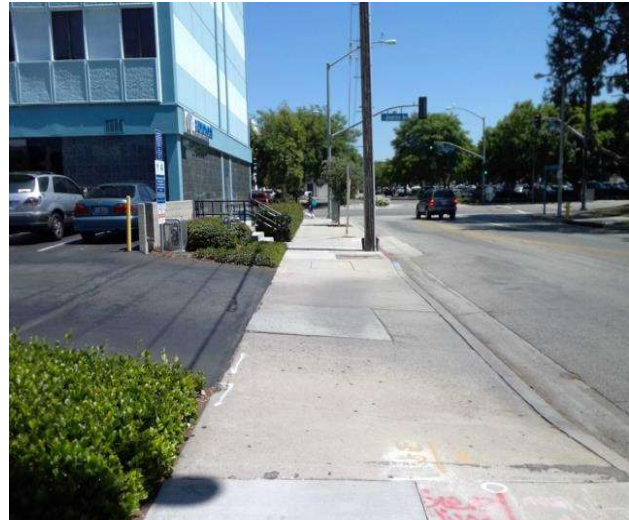
On-Site Finding Not Found

Recommendation See Recommendation

Install compliant detectable warnings \$190

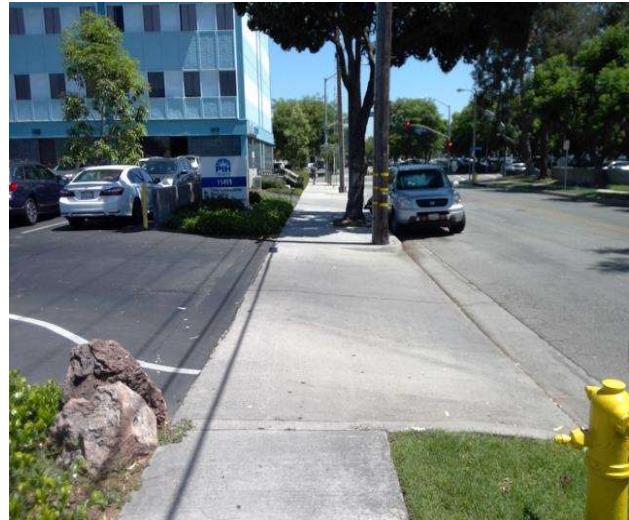
On-Site Finding Not Found

Recommendation See Recommendation

Install compliant detectable warnings \$190

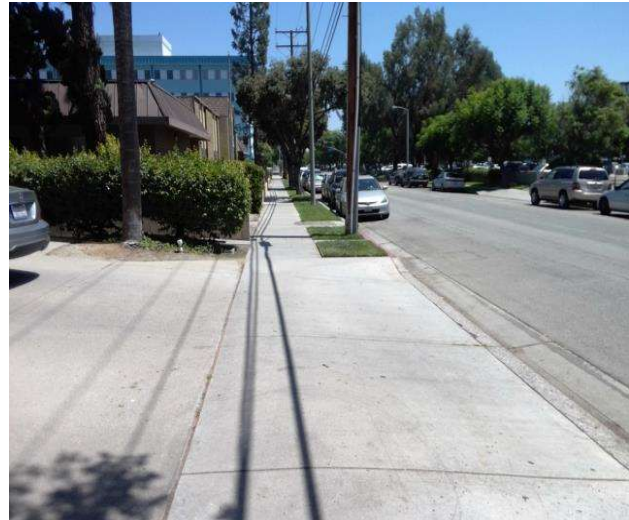
On-Site Finding Not Found

Recommendation See Recommendation

Install compliant detectable warnings \$190

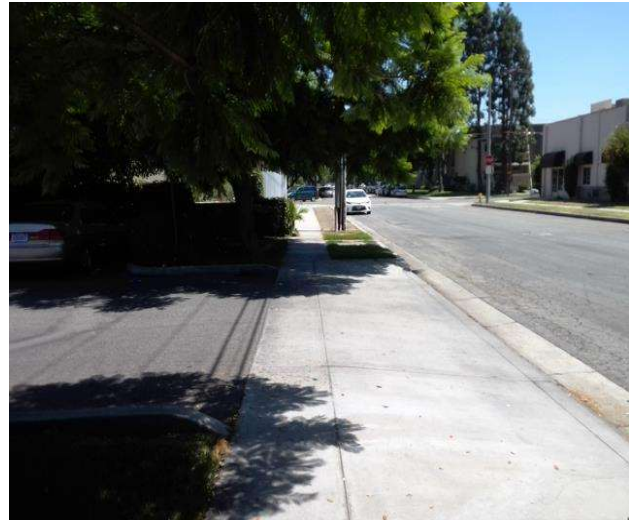
On-Site Finding Not Found

Recommendation See Recommendation

Install compliant detectable warnings \$190

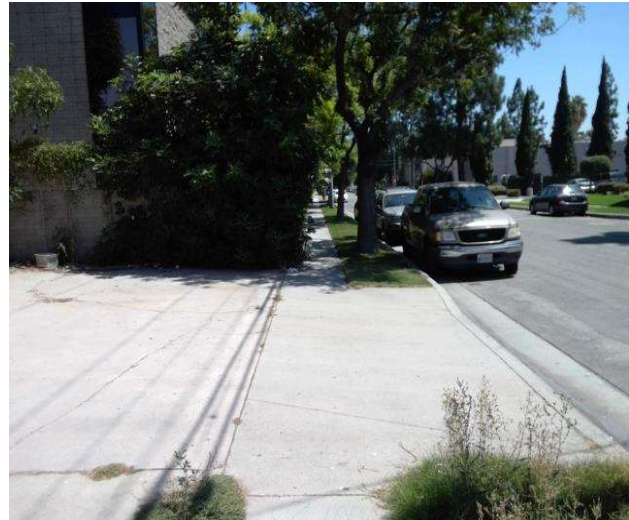
On-Site Finding Not Found

Recommendation See Recommendation

Install compliant detectable warnings \$190

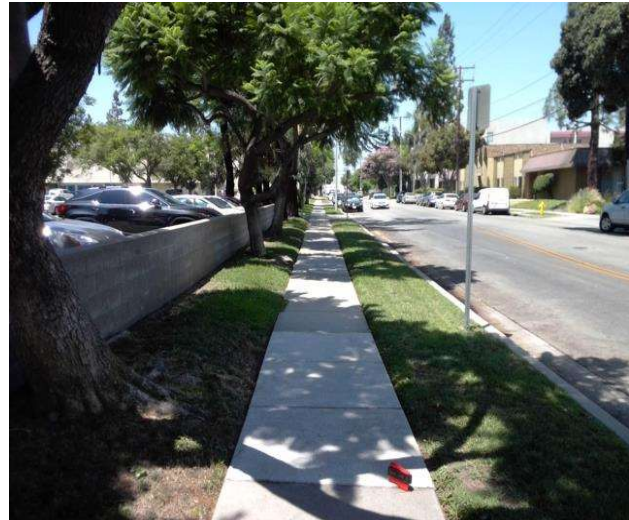
There is a change in elevation greater than recommended value.

Ensure that the change in elevation is within the recommended value.

Recommendation Up to 0.25 inches

Remove tripping hazards \$198

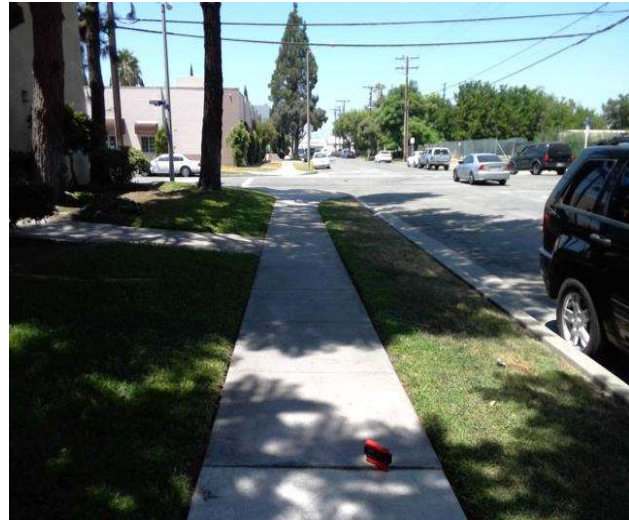
There is a change in elevation greater than recommended value.

Ensure that the change in elevation is within the recommended value.

Recommendation Up to 0.25 inches

Remove tripping hazards \$198

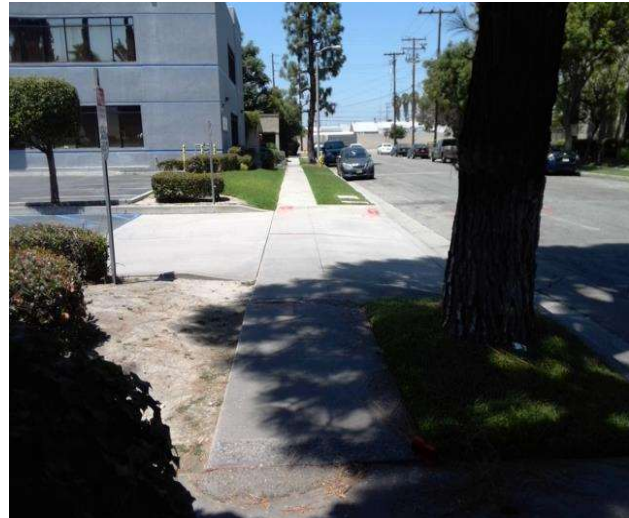
There is a change in elevation greater than recommended value.

Ensure that the change in elevation is within the recommended value.

Recommendation Up to 0.25 inches

Remove tripping hazards \$198

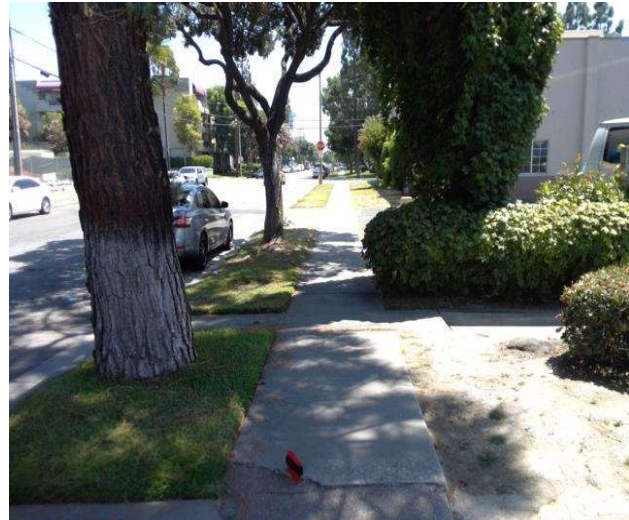
There is a change in elevation greater than recommended value.

Ensure that the change in elevation is within the recommended value.

Recommendation Up to 0.25 inches

Remove tripping hazards \$198

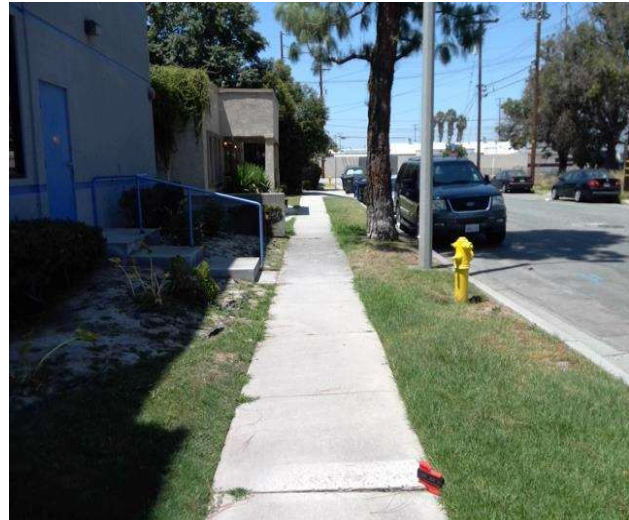
There is a change in elevation greater than recommended value.

Ensure that the change in elevation is within the recommended value.

Recommendation Up to 0.25 inches

Remove tripping hazards \$198

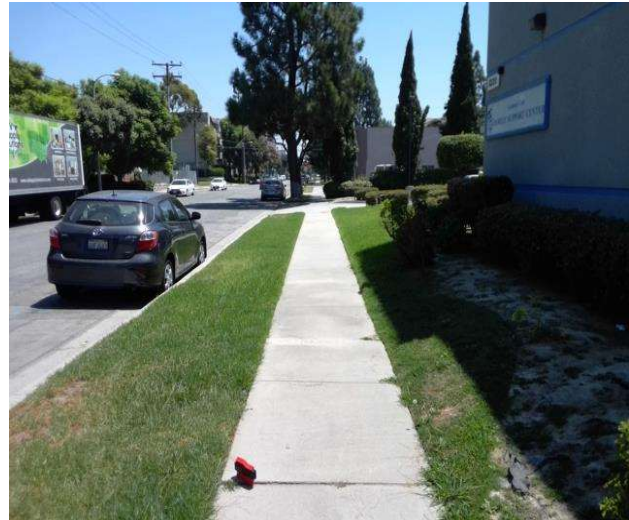
There is a change in elevation greater than recommended value.

Ensure that the change in elevation is within the recommended value.

Recommendation Up to 0.25 inches

Remove tripping hazards \$198

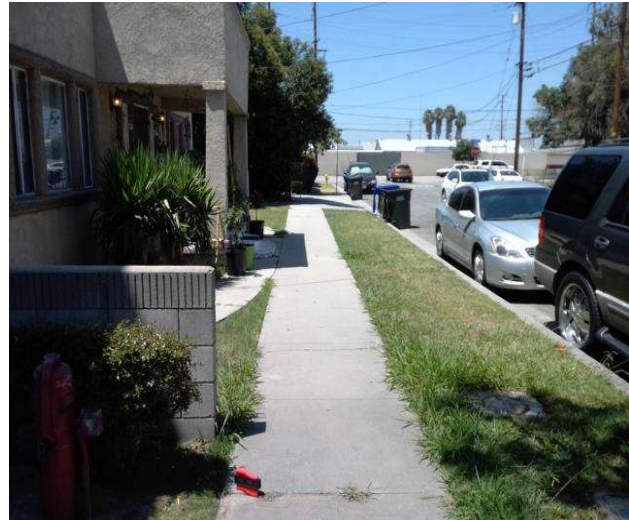
There is a change in elevation greater than recommended value.

Ensure that the change in elevation is within the recommended value.

Recommendation Up to 0.25 inches

Remove tripping hazards \$198

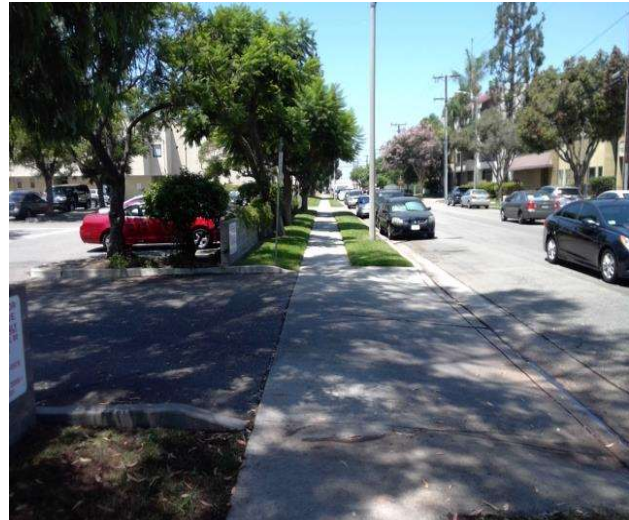
On-Site Finding Not Found

Install compliant detectable warnings \$190

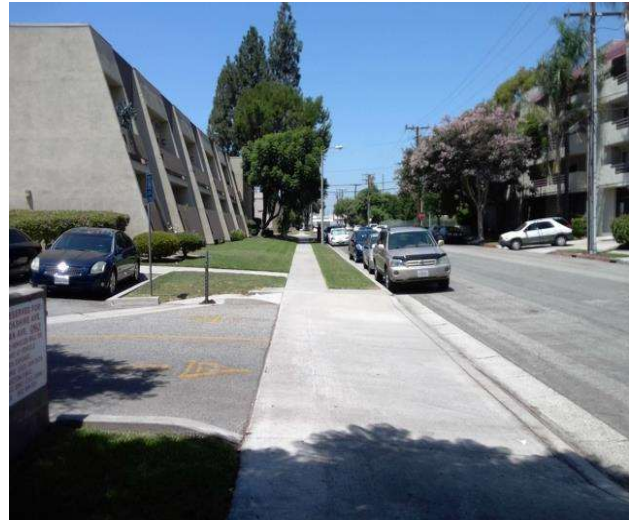
On-Site Finding Not Found

Install compliant detectable warnings \$190

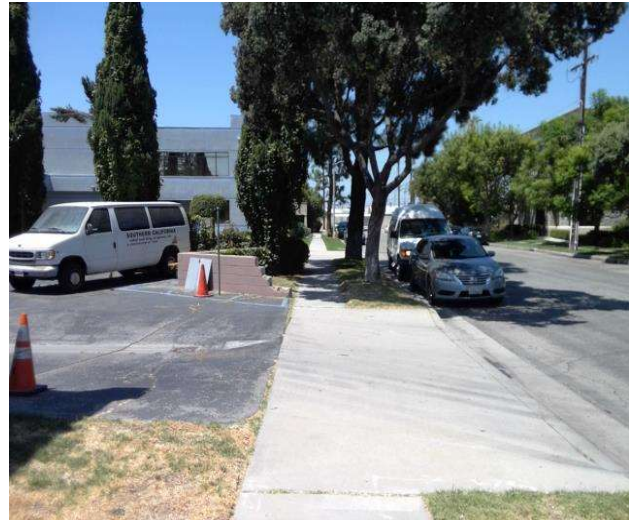
On-Site Finding Not Found

Install compliant detectable warnings \$190

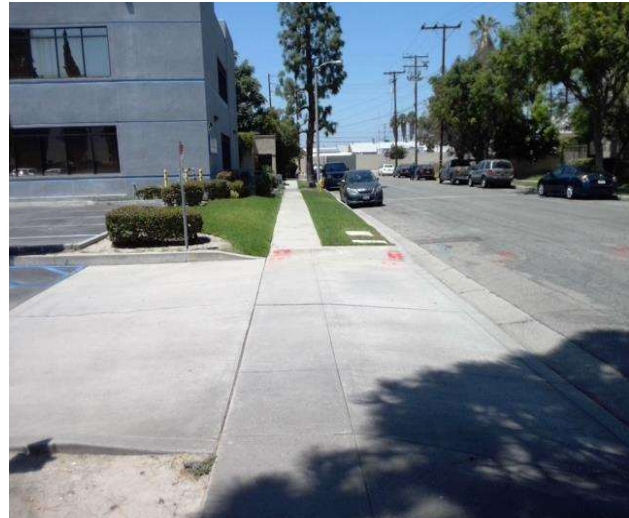
On-Site Finding Not Found

Install compliant detectable warnings \$190

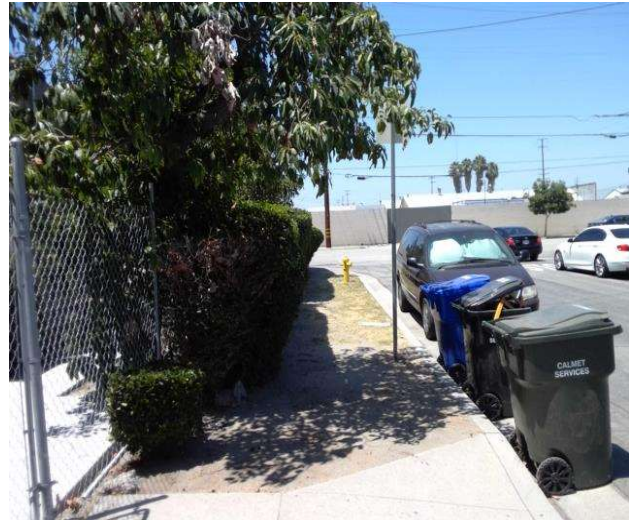
Sidewalks : Missing Sidewalk

Section of sidewalk is missing and consists of dirt, grass or gravel.

Provide a compliant sidewalk for the missing section.

\$1,260

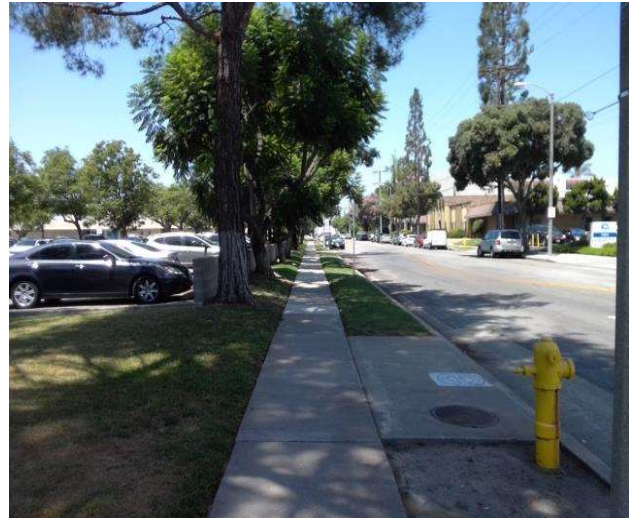
On-Site Finding Not Found

\$2,400
