Accessibility Survey

City of Downey Allengrove Street - Parrot Avenue to Brock Avenue

Date of Inspection
6/23/2017

Disability Access Consultants

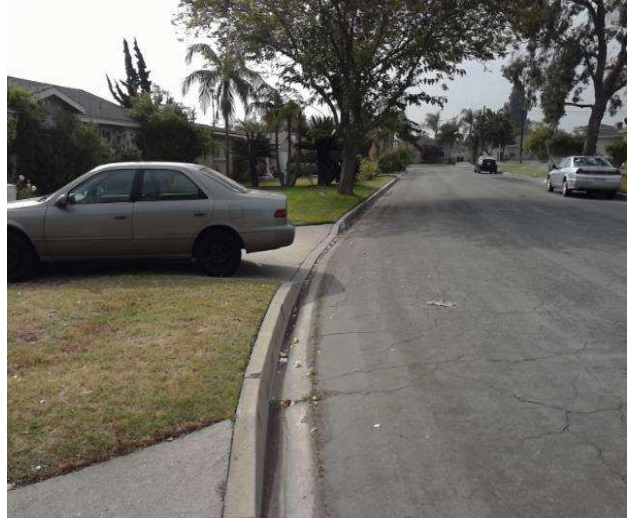
Sidewalks : Missing Sidewalk

Section of sidewalk is missing and consists of dirt, grass or gravel.

Provide a compliant sidewalk for the missing section.

\$1,260

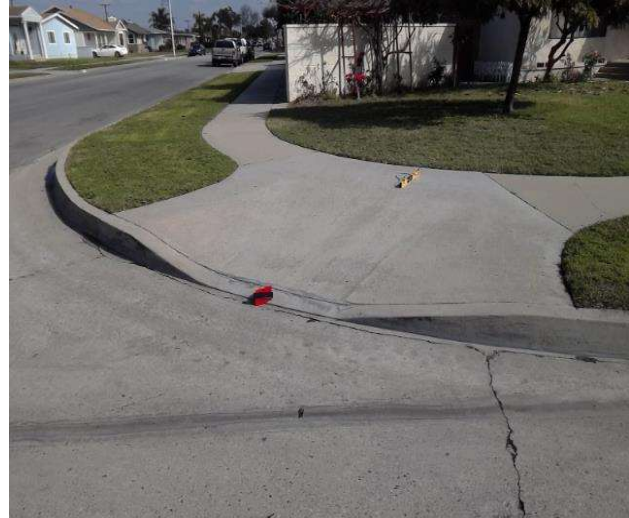
Curb Ramp , Landings And Transitions : Bottom Landing Change in Level

Patch lip at curb ramp \$255
