# Accessibility Survey

## City of Downey Donovan Street & Lakewood Boulevard

Date of Inspection  
2/9/2017

Prepared By  
**Disability Access Consultants**  
(800) 743-7067

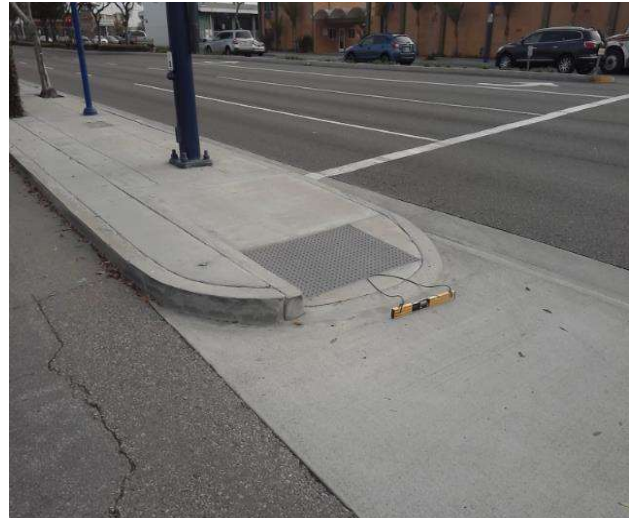
**On-Site Finding** Not Found

Recommendation See Recommendation

Install crosswalk \$800

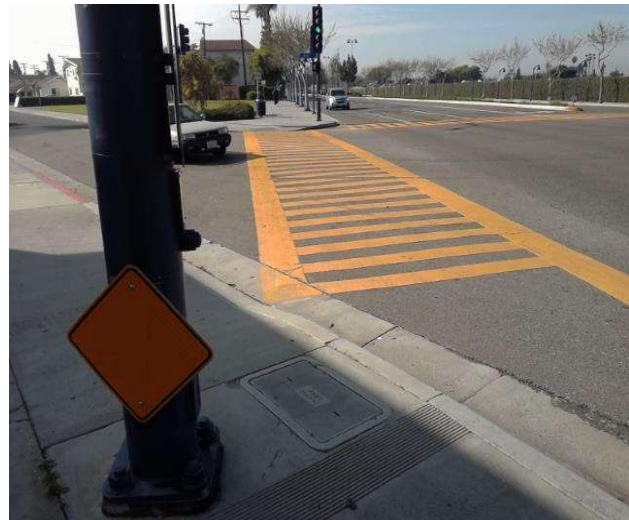
**On-Site Finding** Not Found

Recommendation See Recommendation

\$900

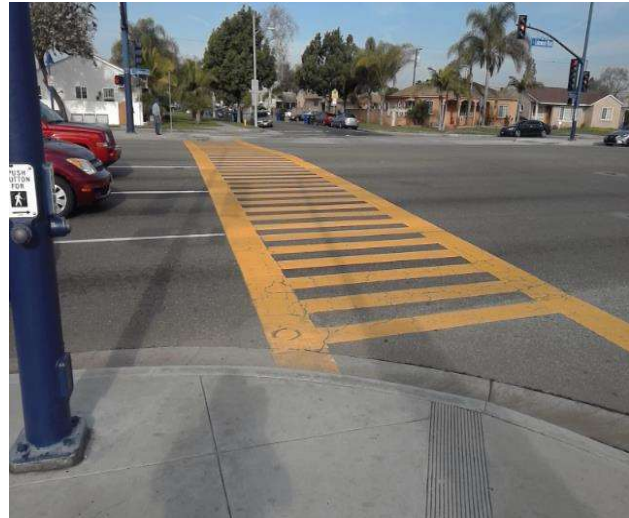
**On-Site Finding** Not Found

Recommendation See Recommendation

\$900

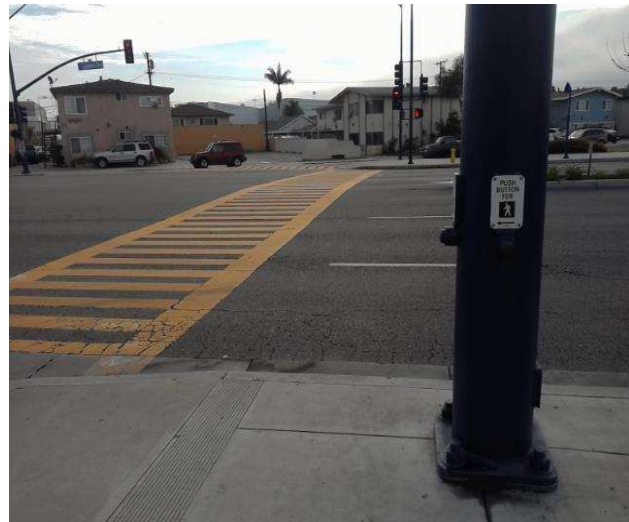
**On-Site Finding** Not Found

Recommendation See Recommendation

\$900

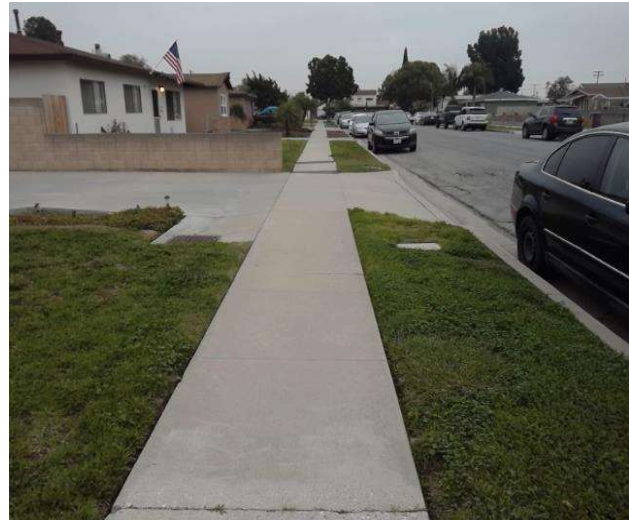
Notes : Surface is rough and uneven for 3 feet.

Repave surface \$1,092

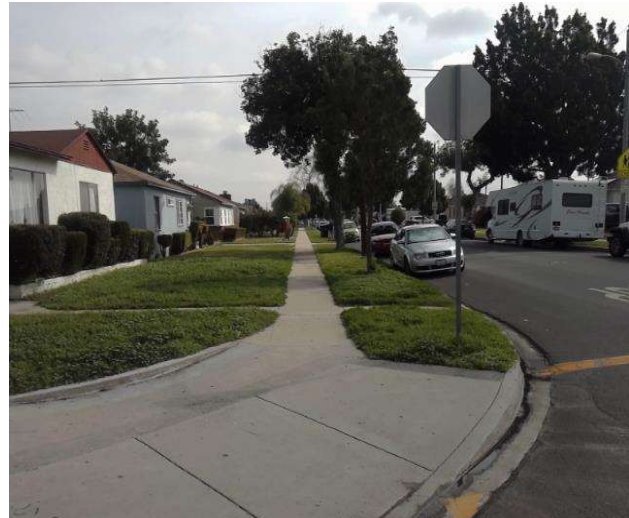
**On-Site Finding** Not Found

Recommendation See Recommendation

\$2,400

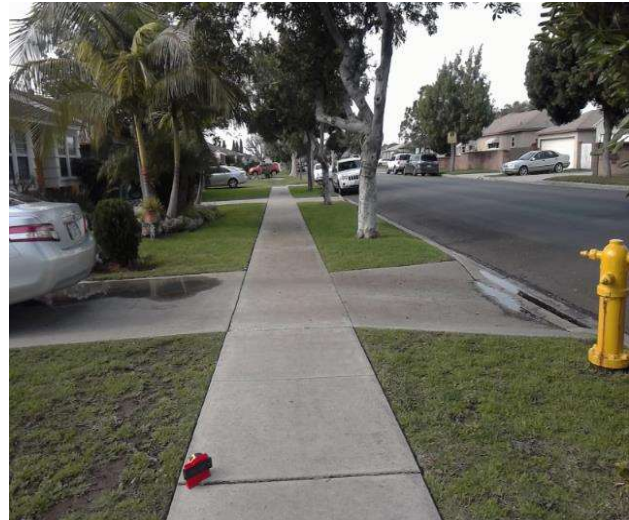
There is a change in elevation greater than recommended value.

Ensure that the change in elevation is within the recommended value.

Recommendation Up to 0.25 inches

Remove tripping hazards \$198

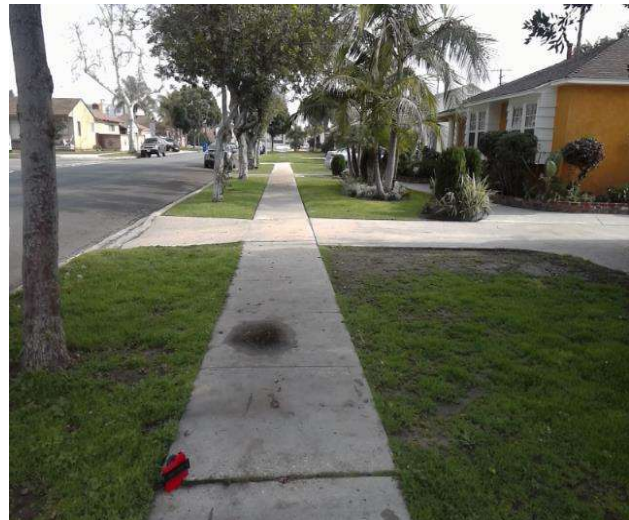
There is a change in elevation greater than recommended value.

Ensure that the change in elevation is within the recommended value.

Recommendation Up to 0.25 inches

Remove tripping hazards \$198

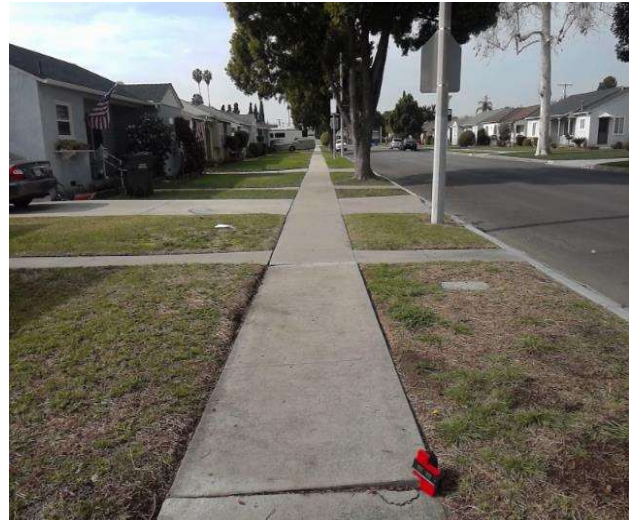
There is a change in elevation greater than recommended value.

Ensure that the change in elevation is within the recommended value.

Recommendation Up to 0.25 inches

Remove tripping hazards \$198

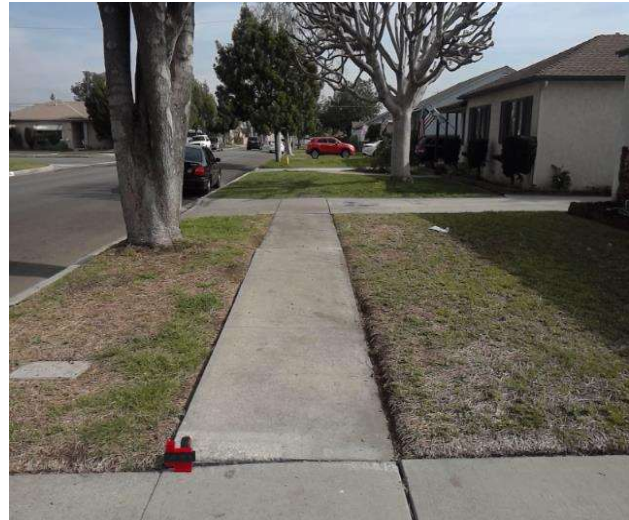
There is a change in elevation greater than recommended value.

Ensure that the change in elevation is within the recommended value.

Recommendation Up to 0.25 inches

Remove tripping hazards \$198

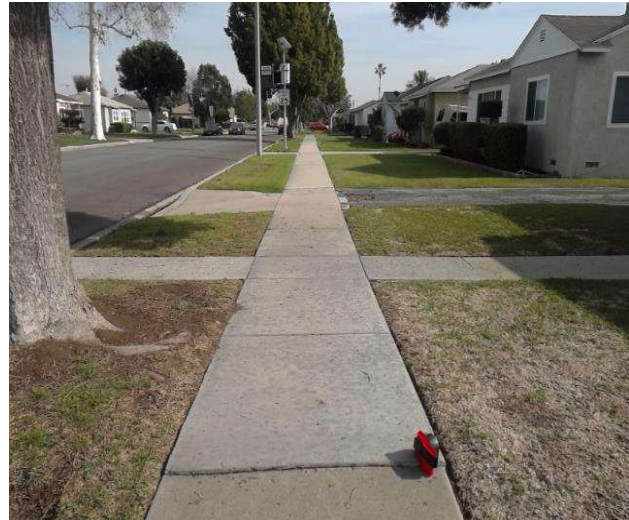
There is a change in elevation greater than recommended value.

Ensure that the change in elevation is within the recommended value.

Recommendation Up to 0.25 inches

Remove tripping hazards \$198

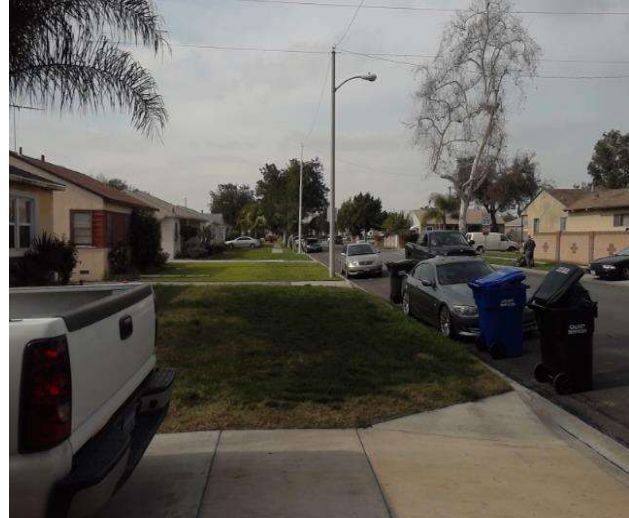
Sidewalks : Missing Sidewalk

Section of sidewalk is missing and consists of dirt, grass or gravel.

Provide a compliant sidewalk for the missing section.

\$1,260

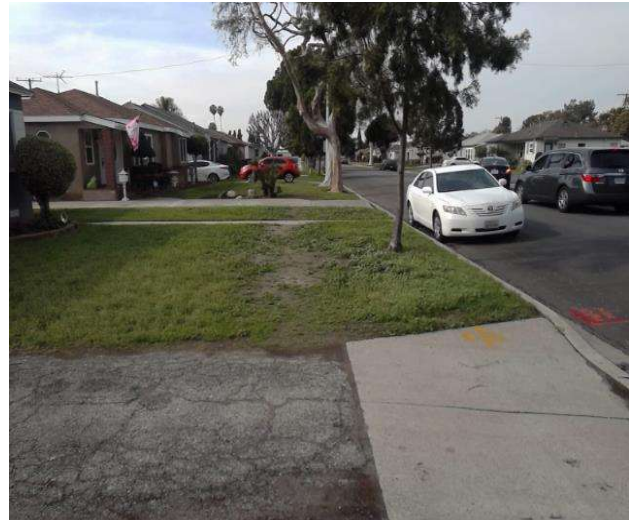
Sidewalks : Missing Sidewalk

Section of sidewalk is missing and consists of dirt, grass or gravel.

Provide a compliant sidewalk for the missing section.

\$1,260

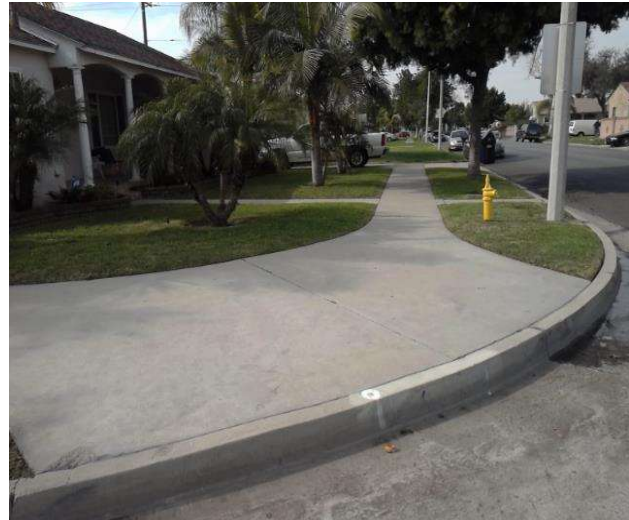
Sidewalks , Hazards & Gratings : Curb is on Path of Travel

Install curb ramp \$2,500

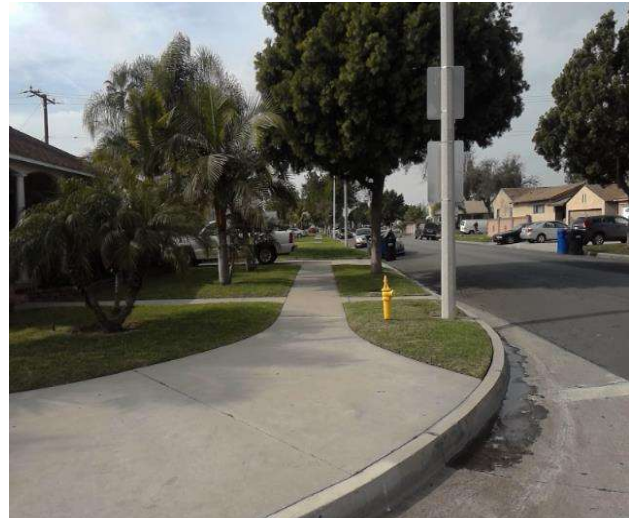
**On-Site Finding** Not Found

Recommendation See Recommendation

\$2,400

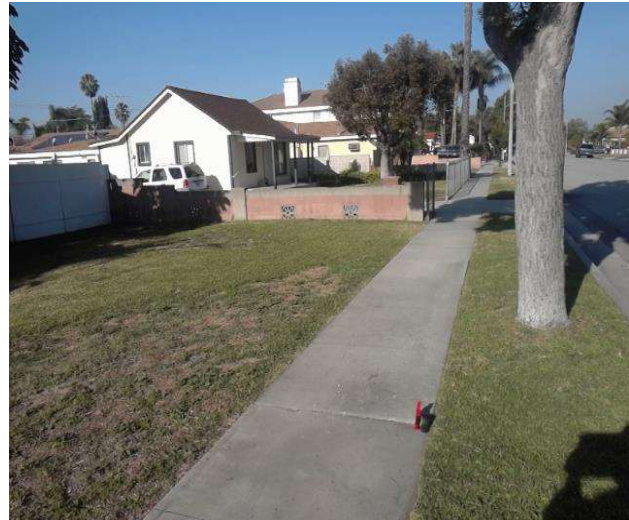
There is a change in elevation greater than recommended value.

Ensure that the change in elevation is within the recommended value.

Recommendation Up to 0.25 inches

Remove tripping hazards \$198

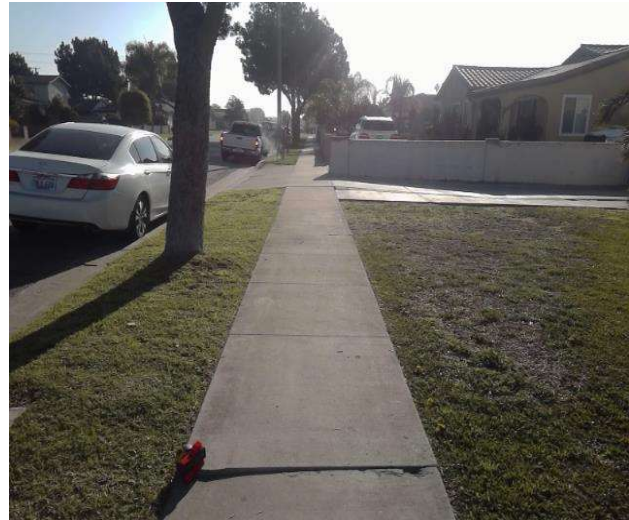
There is a change in elevation greater than recommended value.

Ensure that the change in elevation is within the recommended value.

Recommendation Up to 0.25 inches

Remove tripping hazards \$198

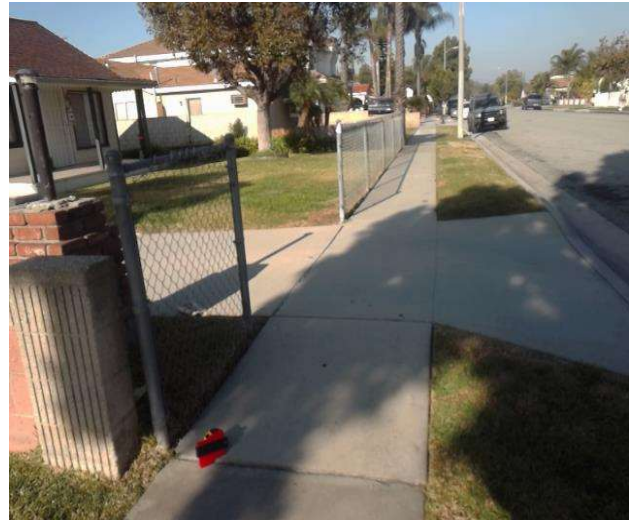
There is a change in elevation greater than recommended value.

Ensure that the change in elevation is within the recommended value.

Recommendation Up to 0.25 inches

Remove tripping hazards \$198

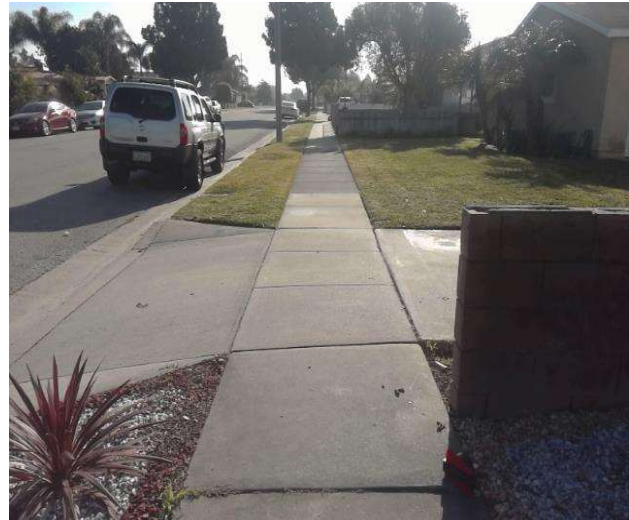
There is a change in elevation greater than recommended value.

Ensure that the change in elevation is within the recommended value.

Recommendation Up to 0.25 inches

Remove tripping hazards \$198

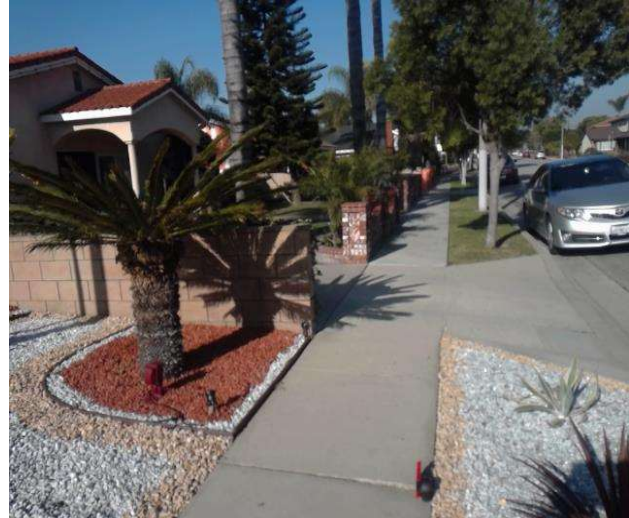
There is a change in elevation greater than recommended value.

Ensure that the change in elevation is within the recommended value.

Recommendation Up to 0.25 inches

Remove tripping hazards \$198

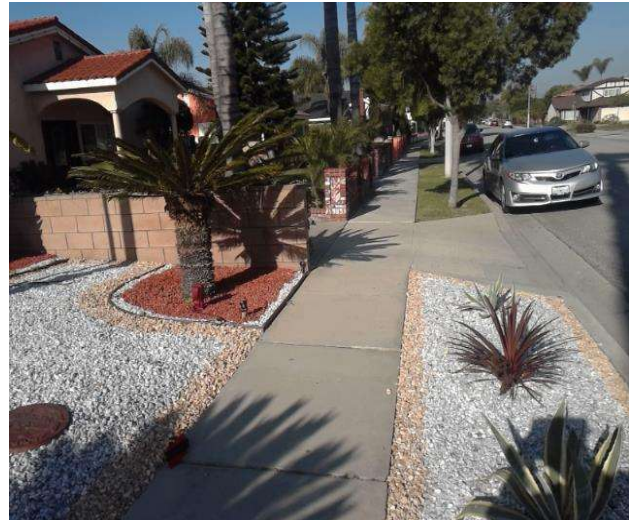
There is a change in elevation greater than recommended value.

Ensure that the change in elevation is within the recommended value.

Recommendation Up to 0.25 inches

Remove tripping hazards \$198

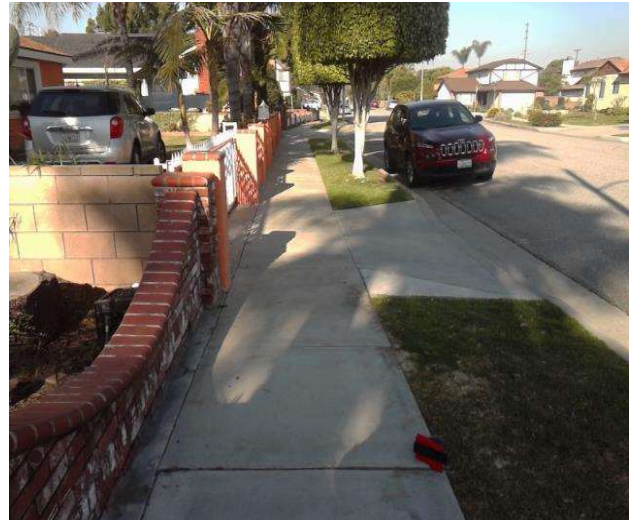
There is a change in elevation greater than recommended value.

Ensure that the change in elevation is within the recommended value.

Recommendation Up to 0.25 inches

Remove tripping hazards \$198

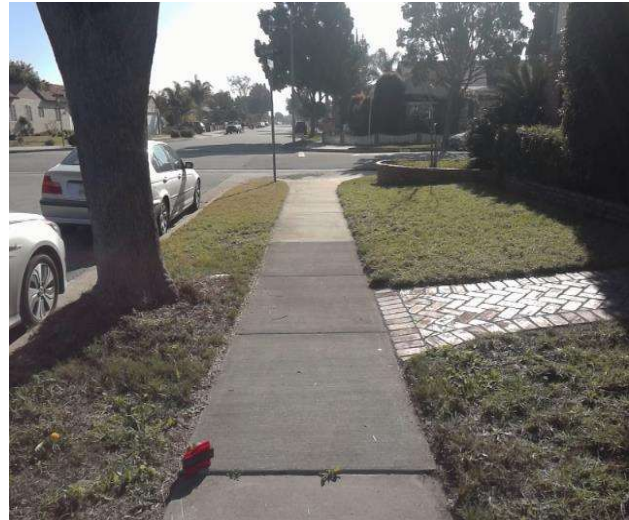
There is a change in elevation greater than recommended value.

Ensure that the change in elevation is within the recommended value.

Recommendation Up to 0.25 inches

Remove tripping hazards \$198

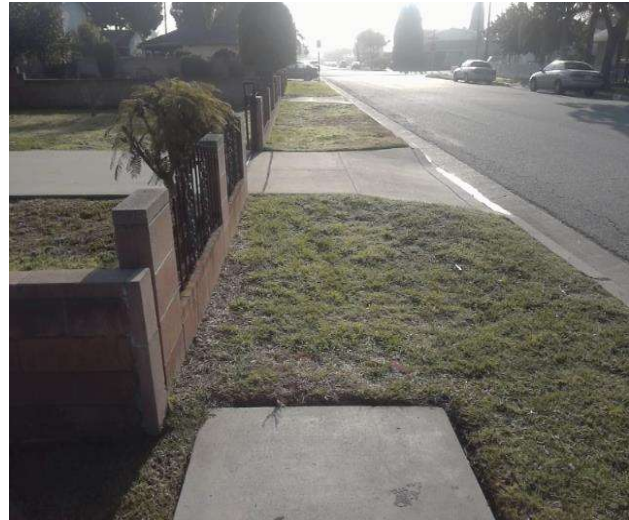
Sidewalks : Missing Sidewalk

Section of sidewalk is missing and consists of dirt, grass or gravel.

Provide a compliant sidewalk for the missing section.

\$1,260

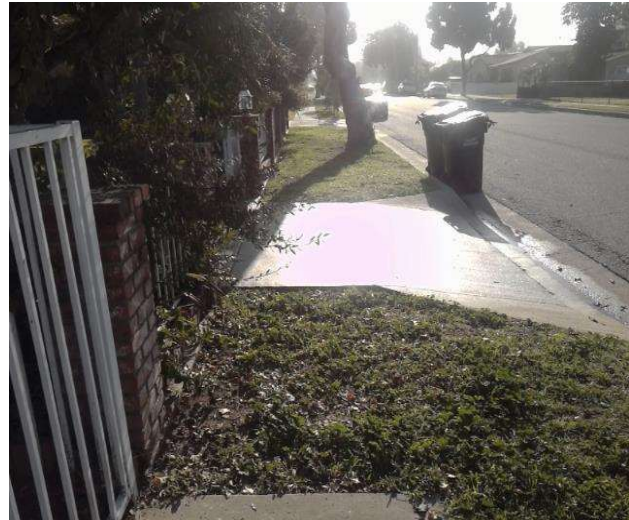
Sidewalks : Missing Sidewalk

Section of sidewalk is missing and consists of dirt, grass or gravel.

Provide a compliant sidewalk for the missing section.

\$1,260

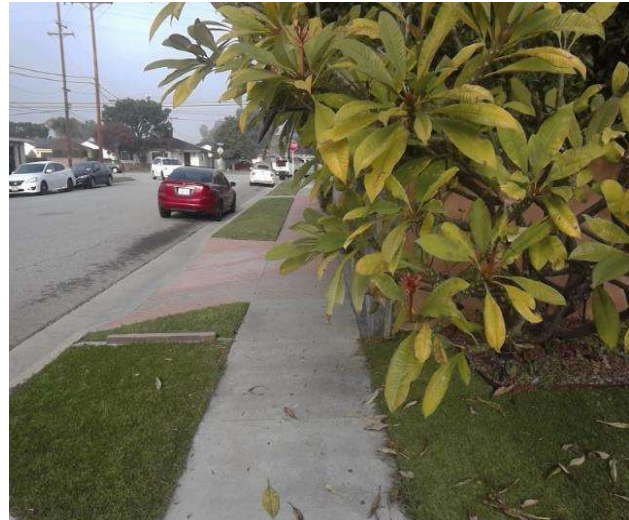
Sidewalks , Hazards & Gratings : Overhead Obstruction Height

Recommendation At least 80.00 inches

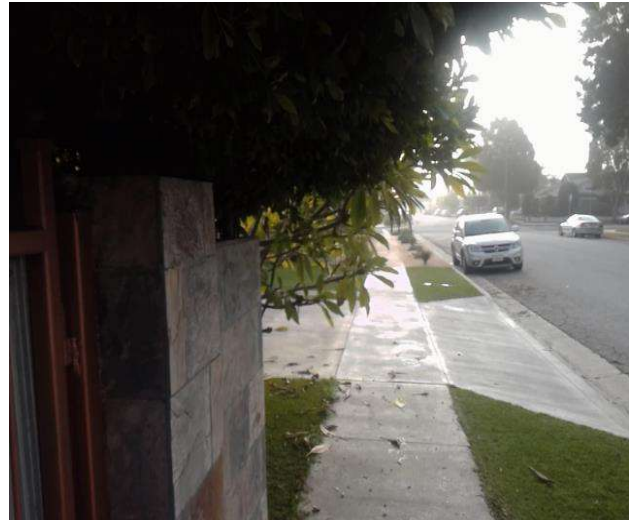
Sidewalks , Hazards & Gratings : Overhead Obstruction Height

Recommendation At least 80.00 inches

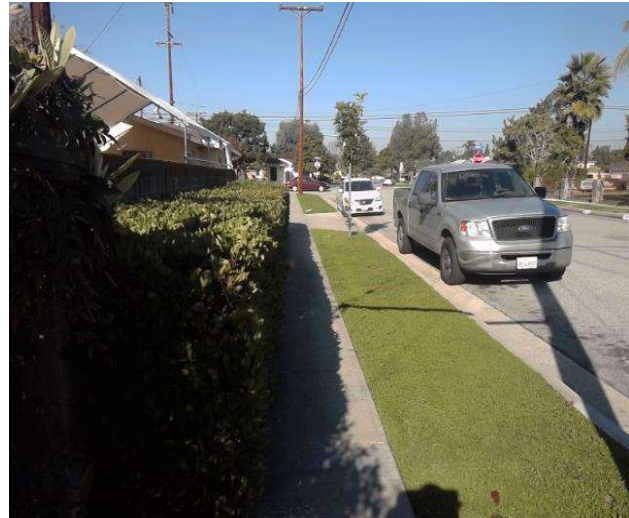
Sidewalks , Hazards & Gratings : Sidewalk Width at Obstruction

Sidewalk width at the obstruction shall have the recommended value.

Recommendation At least 48.00 inches

\$1,260

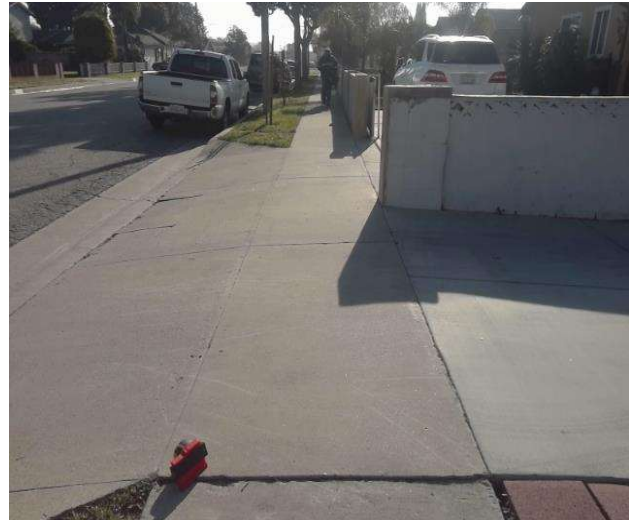
There is a change in elevation greater than recommended value.

Ensure that the change in elevation is within the recommended value.

Recommendation Up to 0.25 inches

Remove tripping hazards \$198
