## Accessibility Survey

## City of Downey Luxor Street - Patton Road To Downey Avenue

Date of Inspection  
12/9/2016

**Disability Access Consultants**

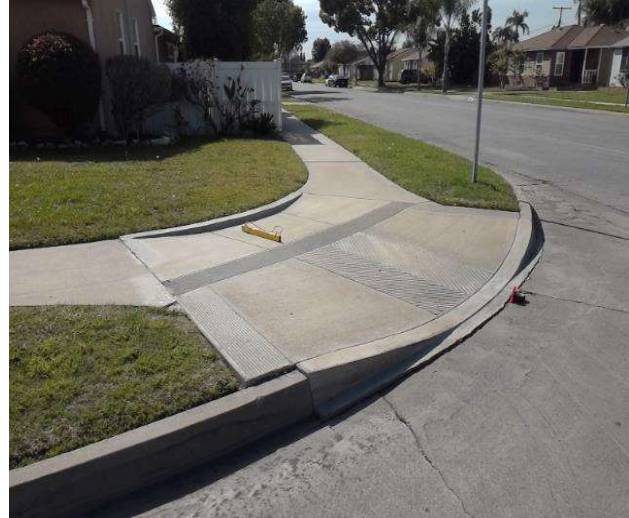
Curb Ramp , Landings and Transitions : Bottom Landing Change in Level - Curb Ramps

Patch lip at curb ramp \$255
