Accessibility Survey

City of Downey Wiley Burke Avenue - 2nd Street to Firestone Boulevard

Date of Inspection
7/6/2017

Disability Access Consultants

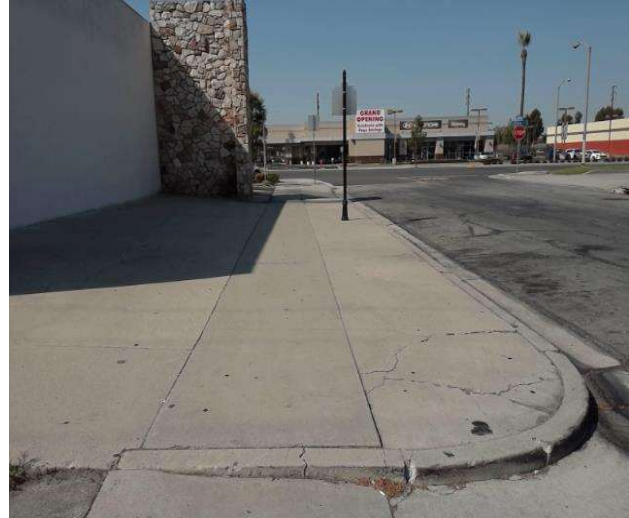
Sidewalks , Hazards & Gratings : Curb is on Path of Travel

Recommendation

Install curb ramp \$2,500

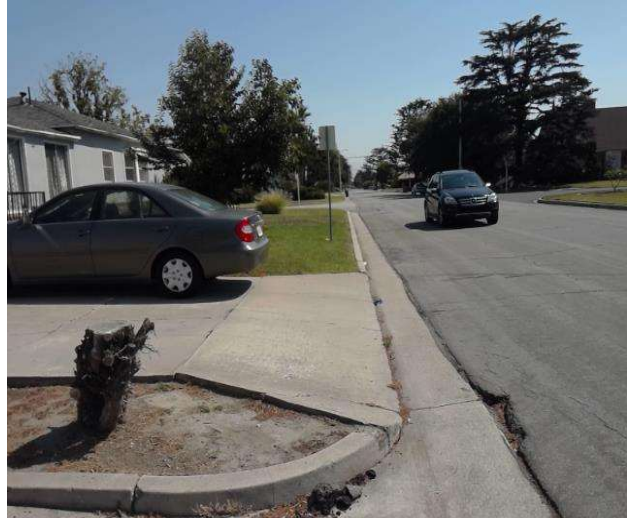
Sidewalks : Missing Sidewalk

Section of sidewalk is missing and consists of dirt, grass or gravel.

Provide a compliant sidewalk for the missing section.

\$1,260

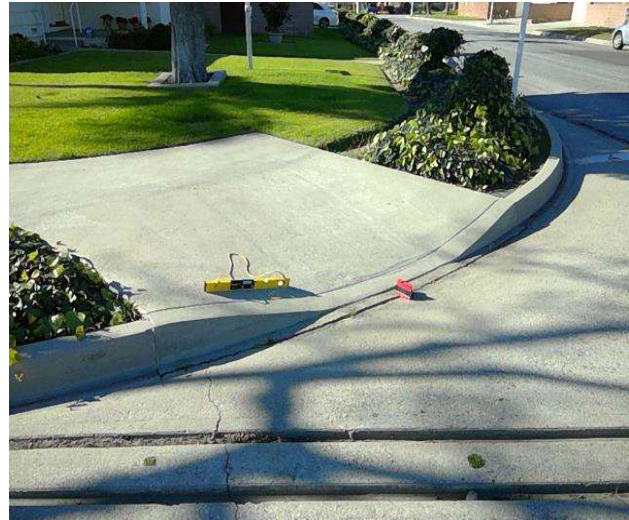
Curb Ramp , Landings And Transitions : Bottom Landing Change in Level

Recommendation Up to 0.50 inches

Patch lip at curb ramp \$255

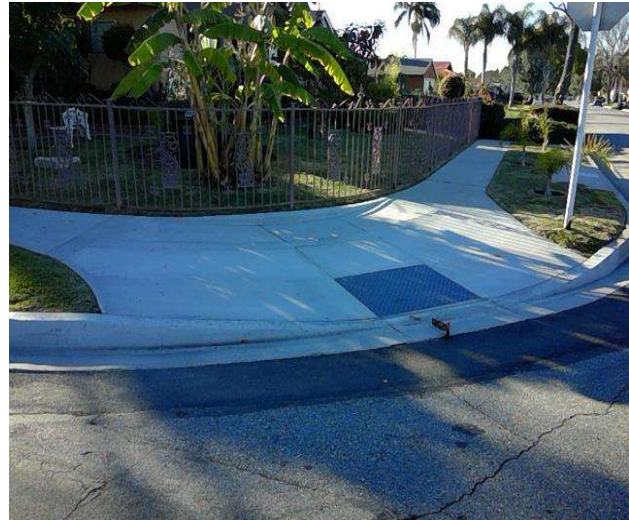
Curb Ramp , Landings and Transitions : Bottom Landing Change in Level - Curb Ramps

Patch lip at curb ramp \$255

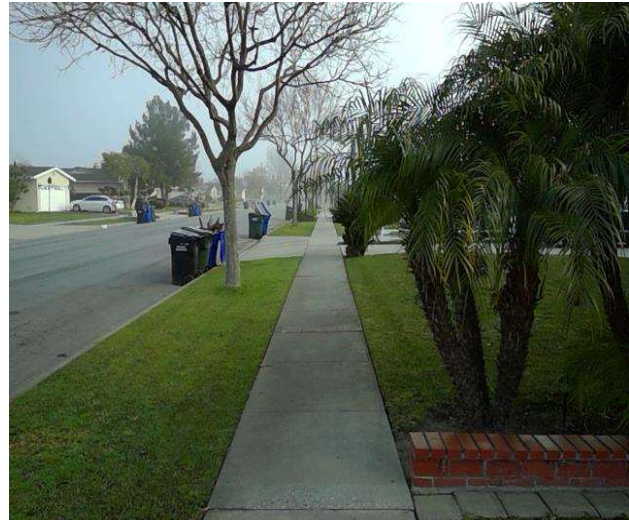
Sidewalks , Hazards & Gratings : Overhead Obstruction Height

Recommendation At least 80.00 inches

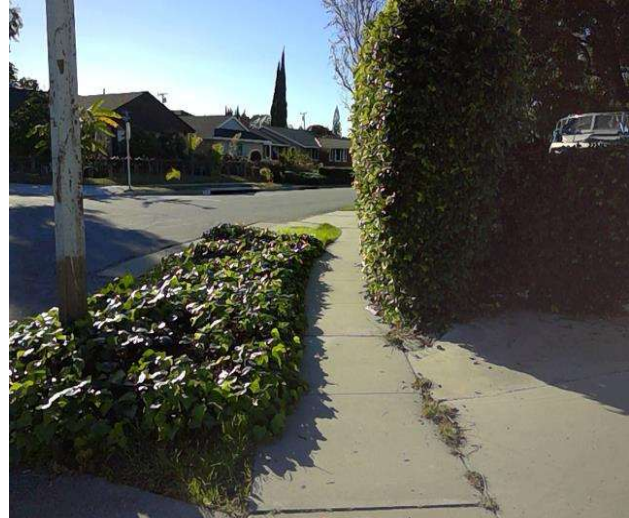
Sidewalks , Hazards & Gratings : Sidewalk Width at Obstruction

Sidewalk width at the obstruction shall have the recommended value.

\$1,260

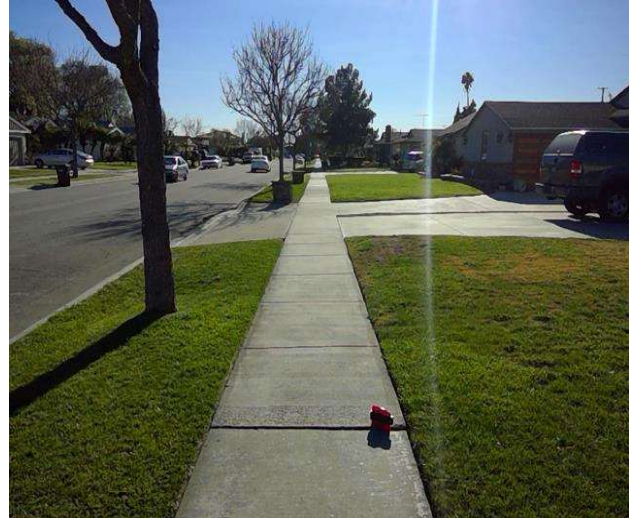
There is a change in elevation greater than recommended value.

Ensure that the change in elevation is within the recommended value.

Recommendation Up to 0.25 inches

Remove tripping hazards \$198

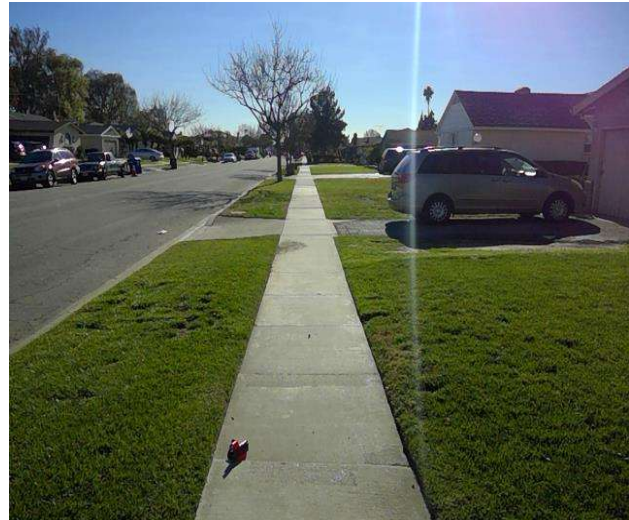
There is a change in elevation greater than recommended value.

Ensure that the change in elevation is within the recommended value.

Recommendation Up to 0.25 inches

Remove tripping hazards \$198

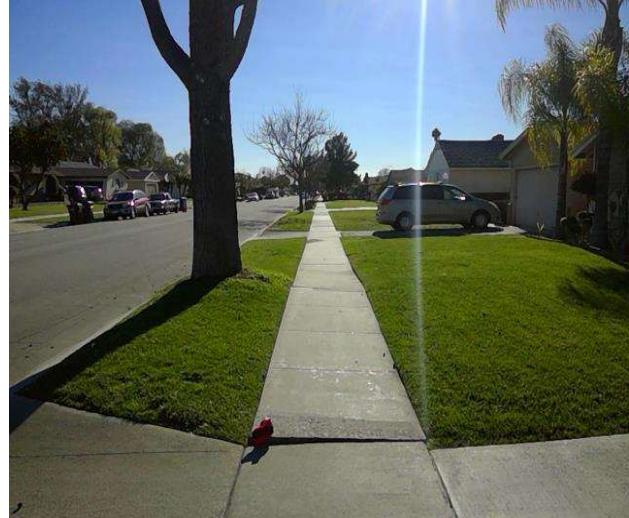
There is a change in elevation greater than recommended value.

Ensure that the change in elevation is within the recommended value.

Recommendation Up to 0.25 inches

Remove tripping hazards \$198

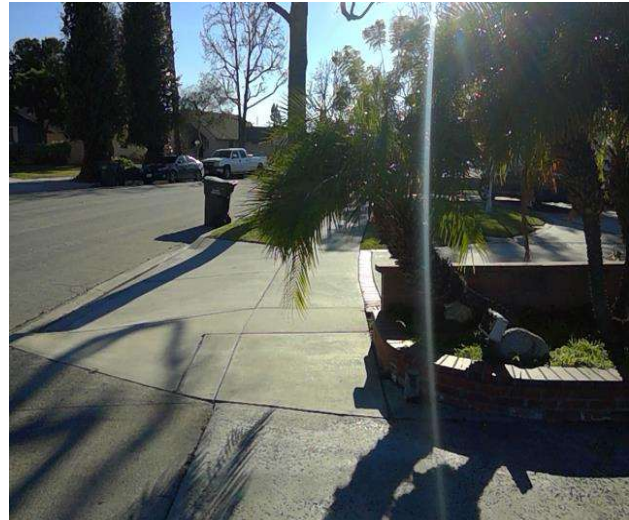
Sidewalks , Hazards & Gratings : Overhead Obstruction Height

Recommendation At least 80.00 inches

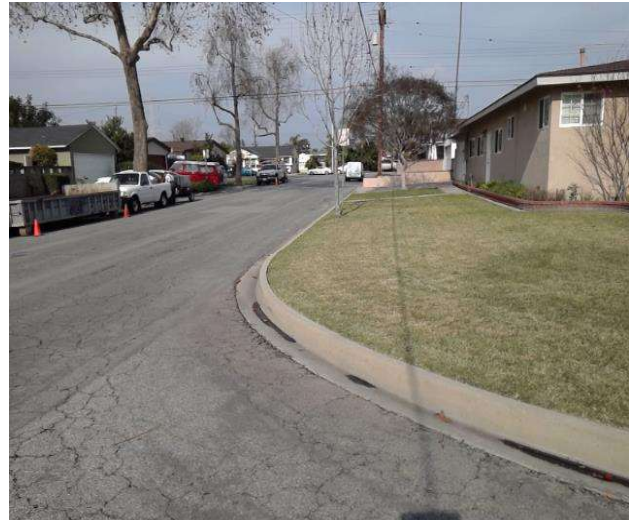
Sidewalks : Missing Sidewalk

Section of sidewalk is missing and consists of dirt, grass or gravel.

Provide a compliant sidewalk for the missing section.

\$1,260

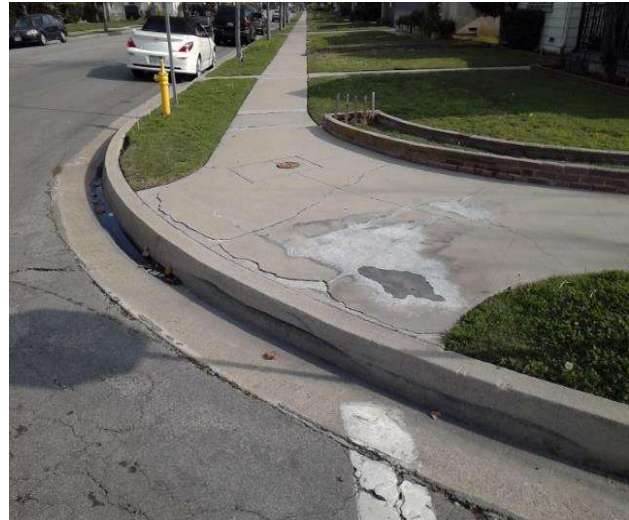
Sidewalks , Hazards & Gratings : Curb is on Path of Travel

Install curb ramp \$2,500

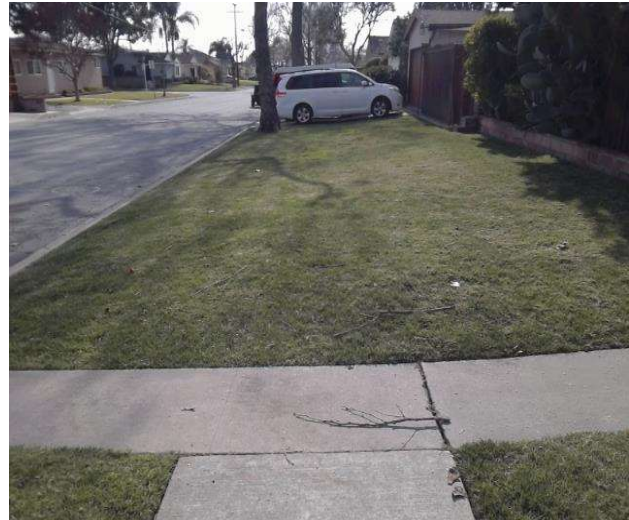
Sidewalks : Missing Sidewalk

Section of sidewalk is missing and consists of dirt, grass or gravel.

Provide a compliant sidewalk for the missing section.

\$1,260
