Accessibility Survey

City of Downey Orizaba Avenue - Borson Street To Imperial Highway

Date of Inspection
2/14/2017

Disability Access Consultants

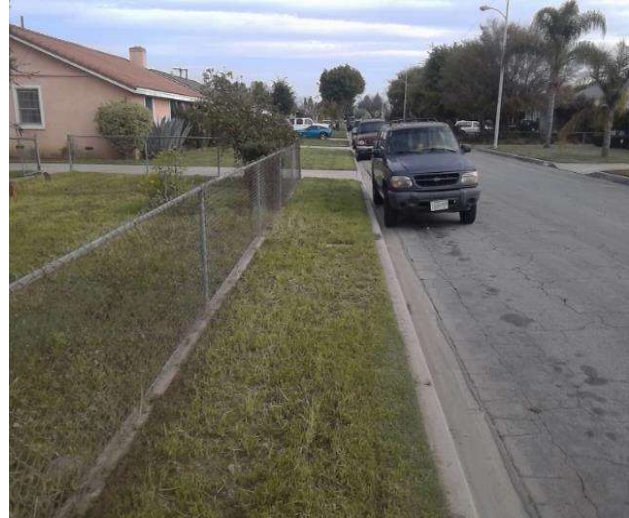
Sidewalks : Missing Sidewalk

Section of sidewalk is missing and consists of dirt, grass or gravel.

Provide a compliant sidewalk for the missing section.

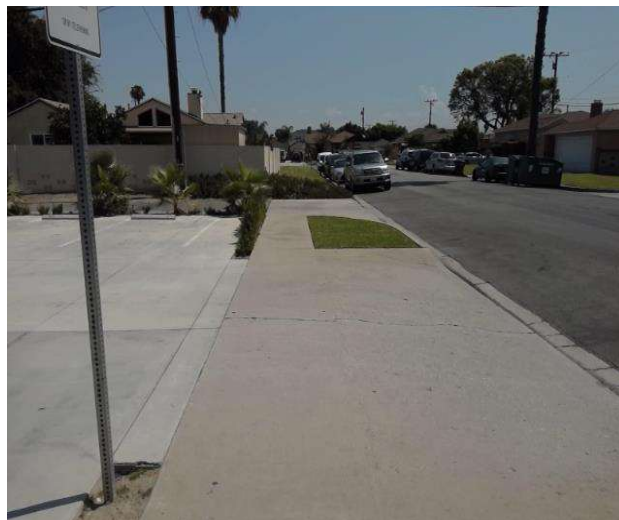
On-Site Finding Not Found

Install compliant detectable warnings \$190

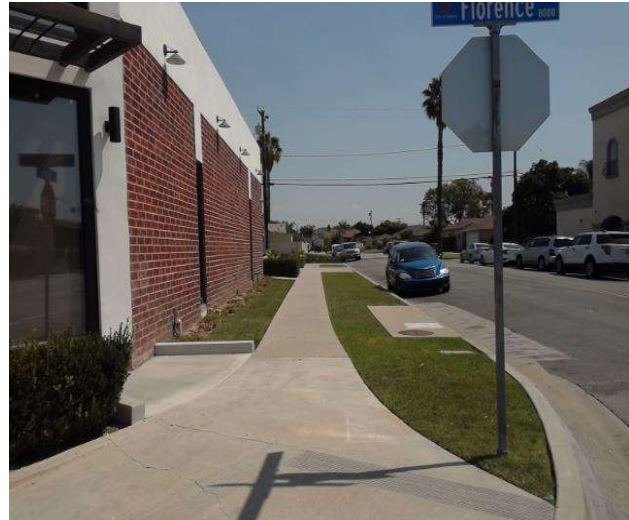
On-Site Finding Not Found

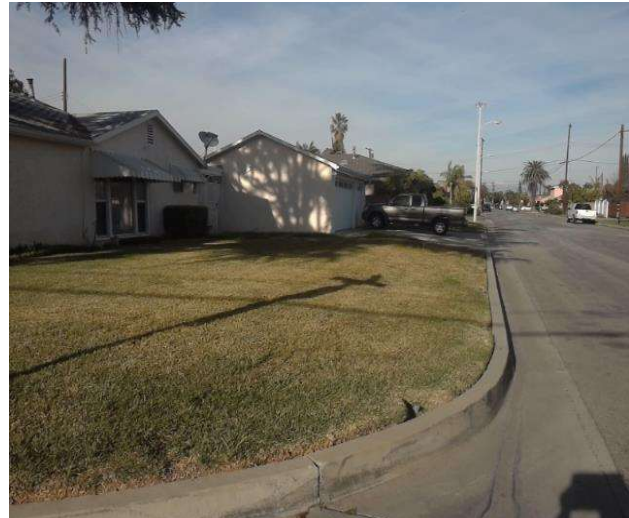
Sidewalks : Missing Sidewalk

Section of sidewalk is missing and consists of dirt, grass or gravel.

Provide a compliant sidewalk for the missing section.

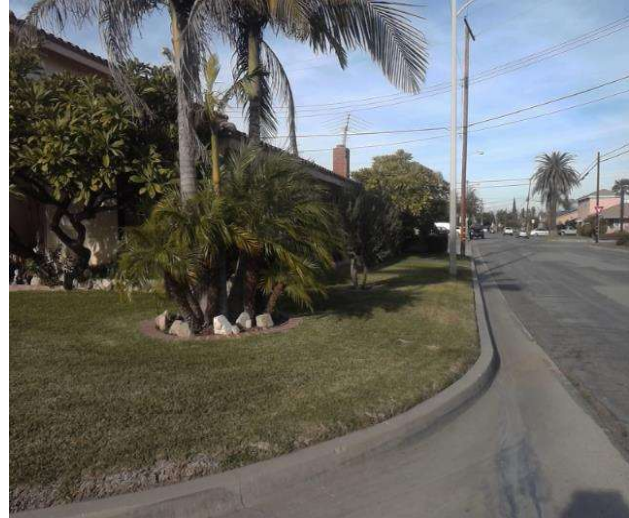
Sidewalks : Missing Sidewalk

Section of sidewalk is missing and consists of dirt, grass or gravel.

Provide a compliant sidewalk for the missing section.

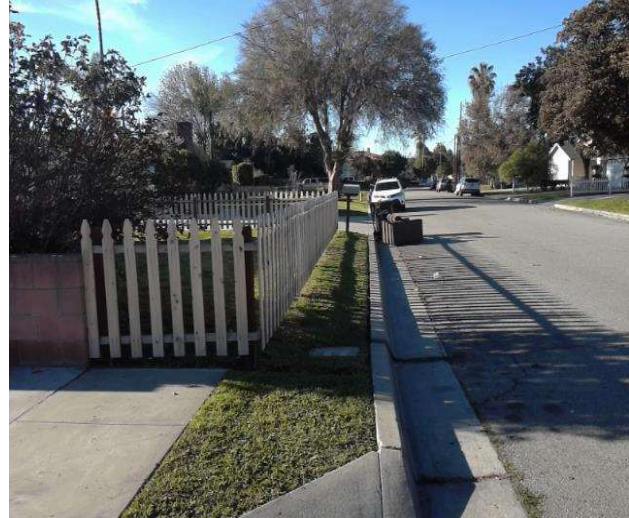
Sidewalks : Missing Sidewalk

Section of sidewalk is missing and consists of dirt, grass or gravel.

Provide a compliant sidewalk for the missing section.

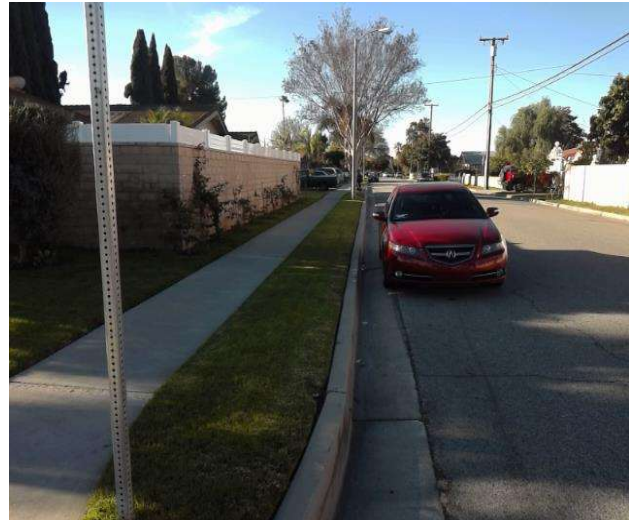
On-Site Finding Not Found

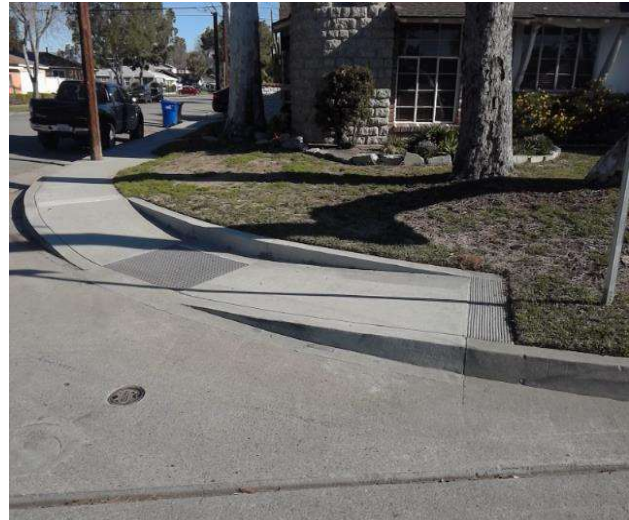
On-Site Finding Not Found

Install crosswalk \$800

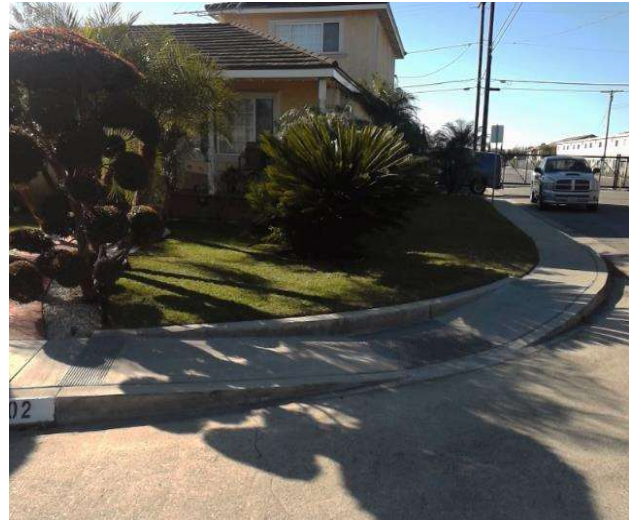
Curb Ramp , Landings and Transitions : Top Landing Right Side
Slope - Parallel Curb Ramp

Recommendation Up to 2.08 percent

Provide compliant landing \$1,260

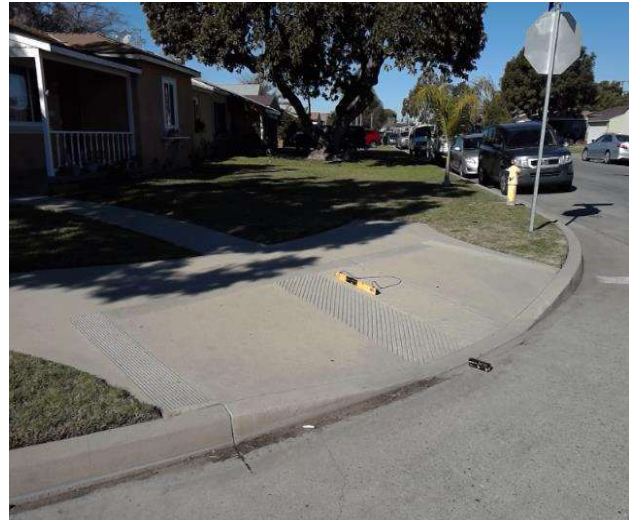
On-Site Finding Not Found

Provide detectable warning to surface \$248
