Accessibility Survey

City of Downey Dalewood Avenue - Brookpark Road to Cul-De-Sac

Date of Inspection
6/17/2017

Disability Access Consultants

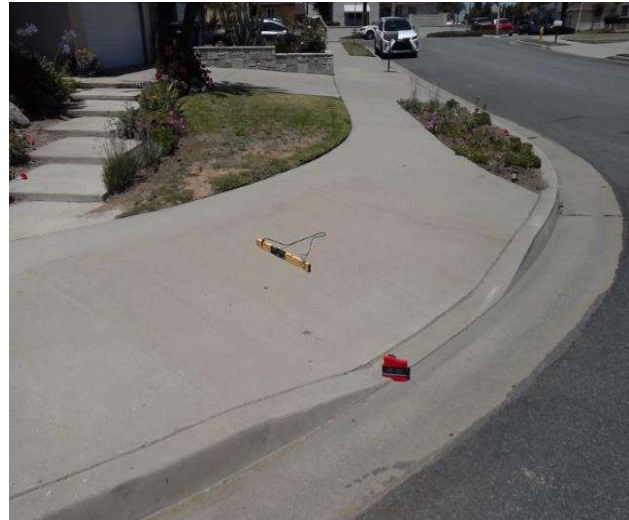
On-Site Finding Not Found

Recommendation See Recommendation

Provide detectable warning to surface \$248

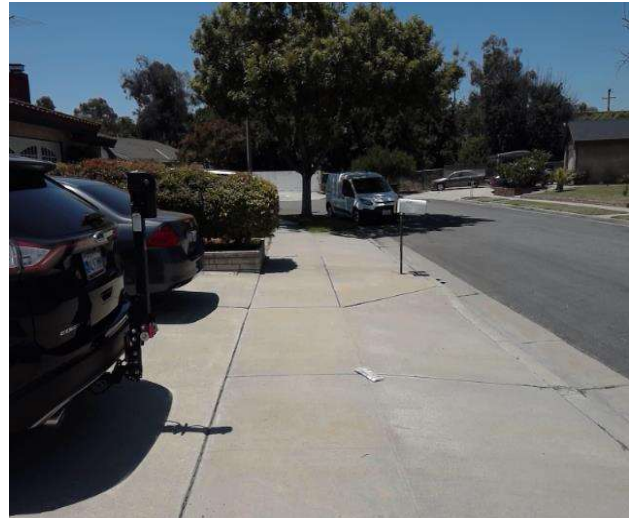
On-Site Finding Not Found

Recommendation See Recommendation

Install compliant detectable warnings \$190

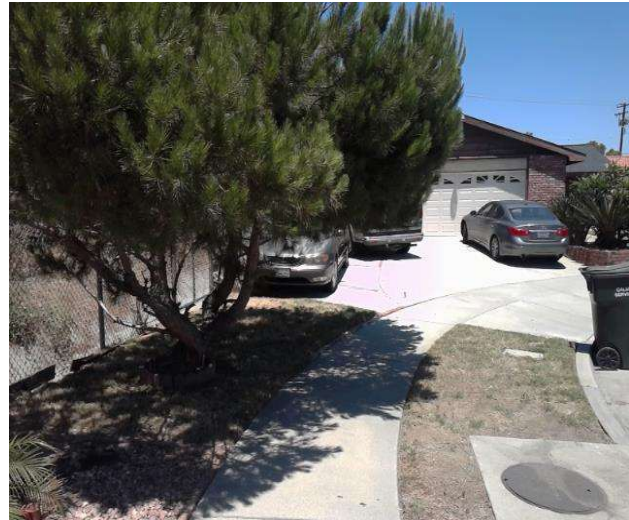
Sidewalks , Hazards & Gratings : Overhead Obstruction Height

Recommendation At least 80.00 inches

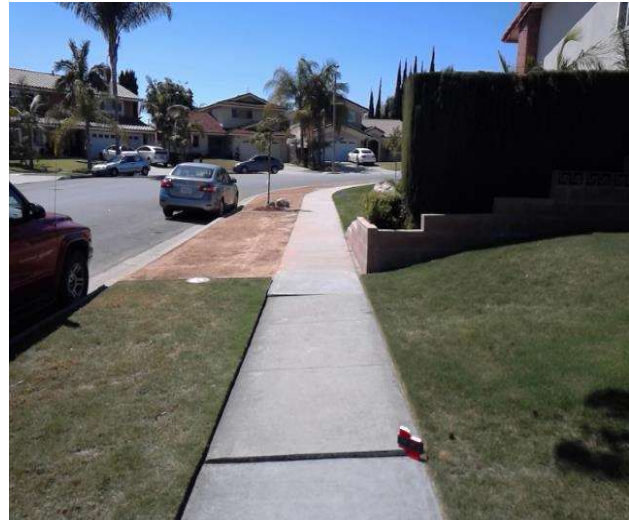
There is a change in elevation greater than recommended value.

Ensure that the change in elevation is within the recommended value.

Recommendation Up to 0.25 inches

Remove tripping hazards \$198

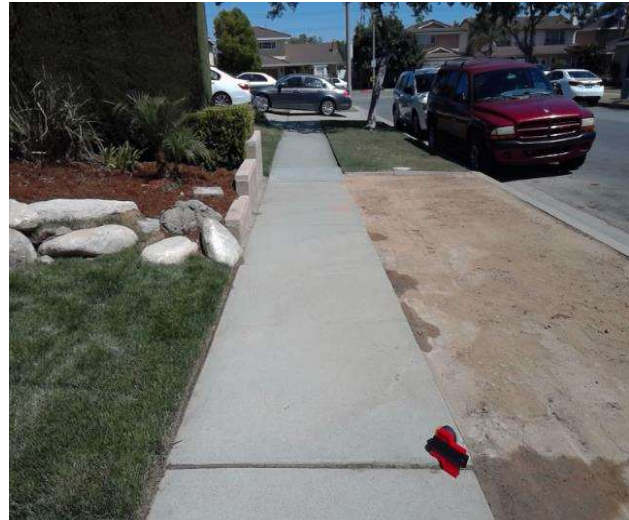
There is a change in elevation greater than recommended value.

Ensure that the change in elevation is within the recommended value.

Recommendation Up to 0.25 inches

Remove tripping hazards \$198

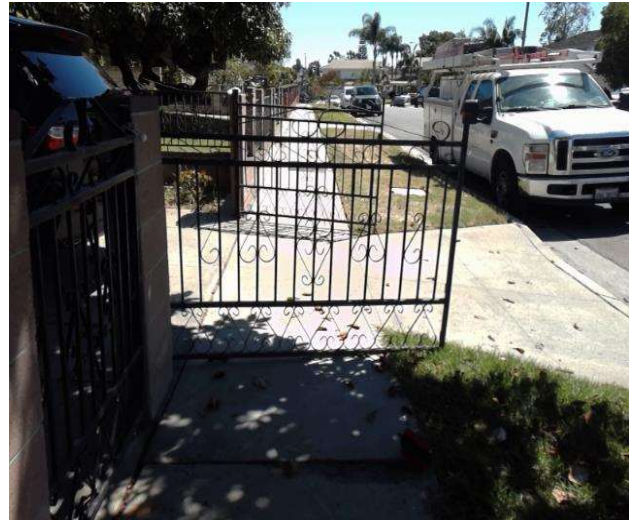
There is a change in elevation greater than recommended value.

Ensure that the change in elevation is within the recommended value.

Recommendation Up to 0.25 inches

Remove tripping hazards \$198

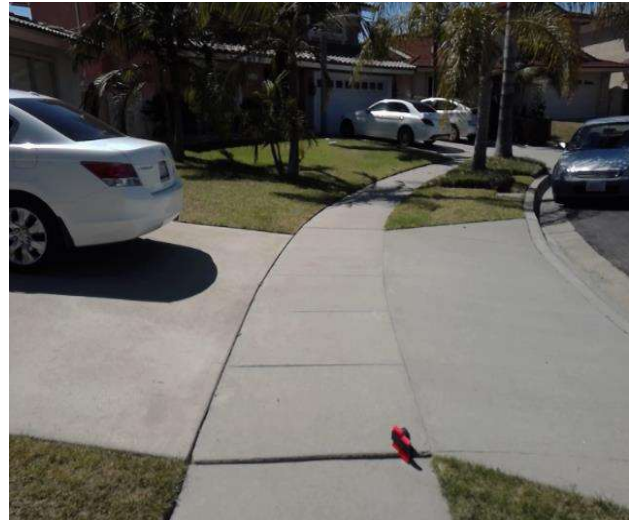
There is a change in elevation greater than recommended value.

Ensure that the change in elevation is within the recommended value.

Recommendation Up to 0.25 inches

Remove tripping hazards \$198

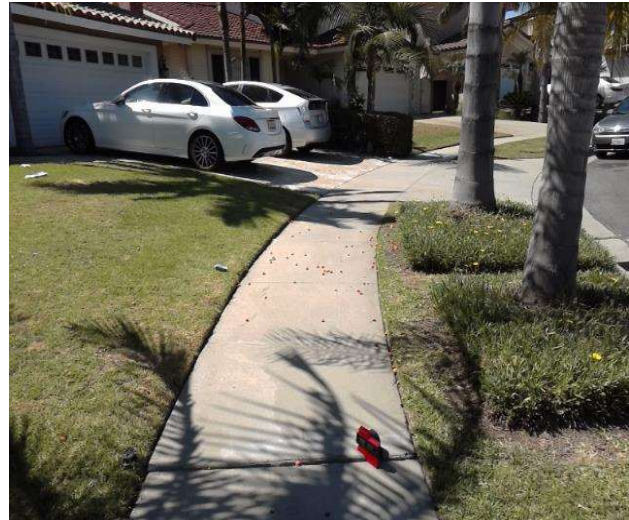
There is a change in elevation greater than recommended value.

Ensure that the change in elevation is within the recommended value.

Recommendation Up to 0.25 inches

Remove tripping hazards \$198

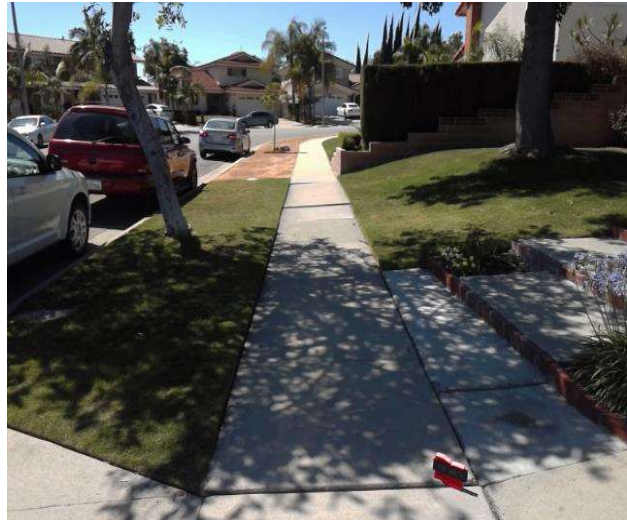
There is a change in elevation greater than recommended value.

Ensure that the change in elevation is within the recommended value.

Recommendation Up to 0.25 inches

Remove tripping hazards \$198

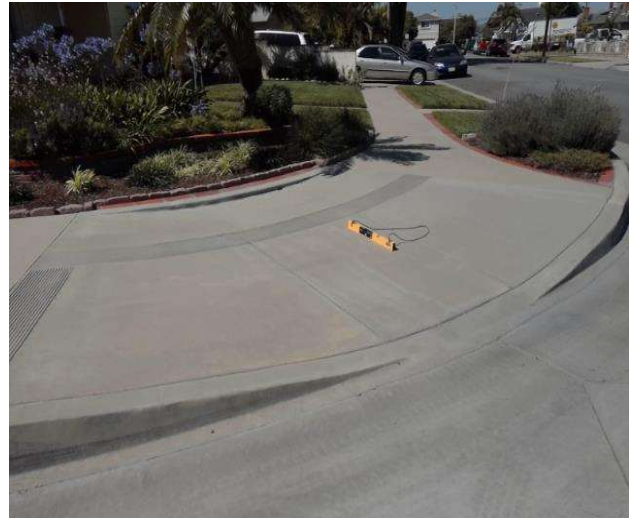
On-Site Finding Not Found

Recommendation See Recommendation

Provide detectable warning to surface \$248

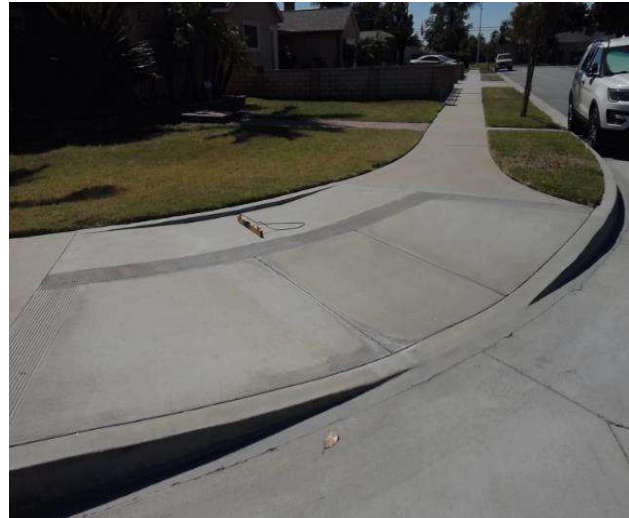
On-Site Finding Not Found

Recommendation See Recommendation

Provide detectable warning to surface \$248

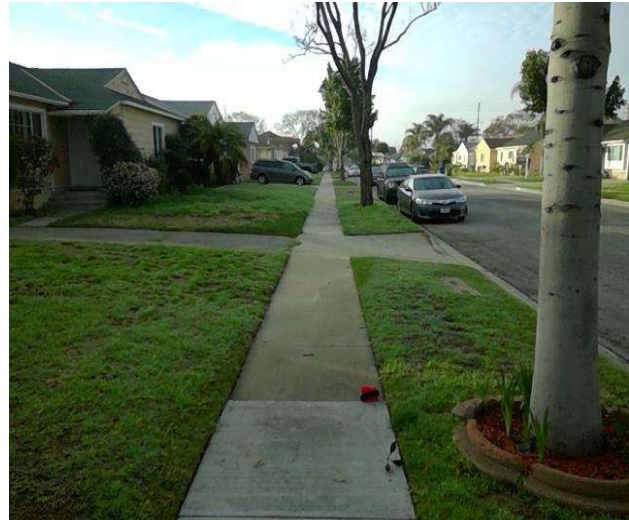
There is a change in elevation greater than recommended value.

Ensure that the change in elevation is within the recommended value.

Recommendation Up to 0.25 inches

Remove tripping hazards \$198

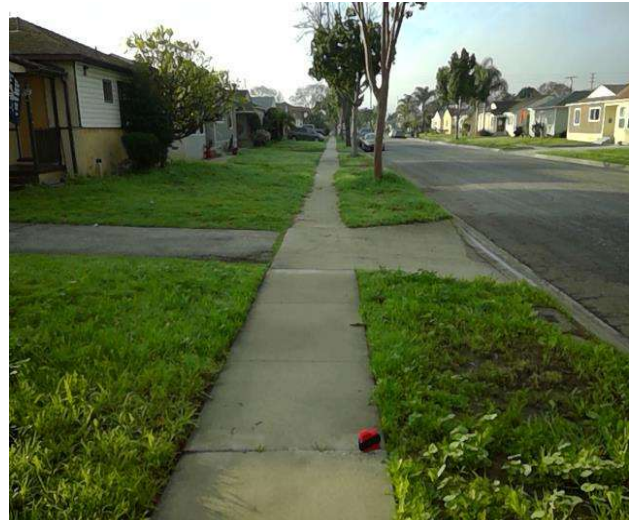
There is a change in elevation greater than recommended value.

Ensure that the change in elevation is within the recommended value.

Recommendation Up to 0.25 inches

Remove tripping hazards \$198

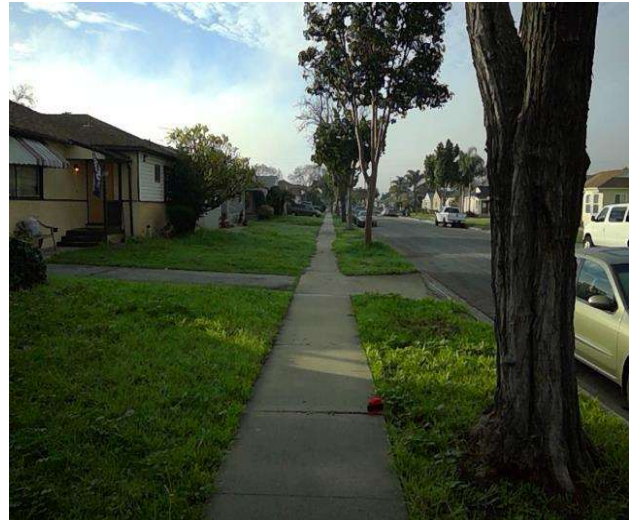
There is a change in elevation greater than recommended value.

Ensure that the change in elevation is within the recommended value.

Recommendation Up to 0.25 inches

Remove tripping hazards \$198

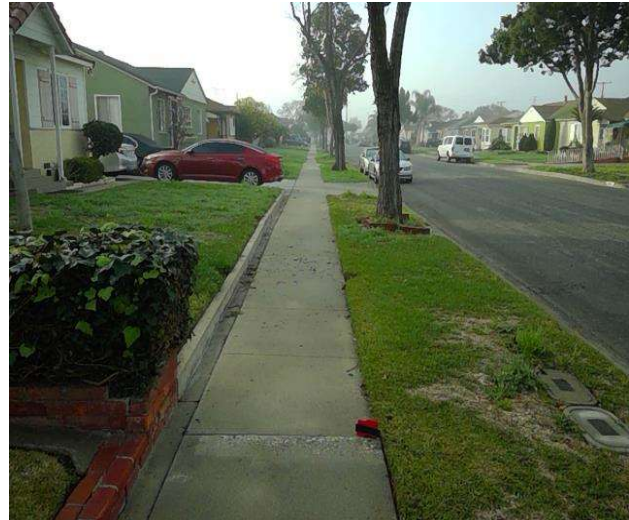
There is a change in elevation greater than recommended value.

Ensure that the change in elevation is within the recommended value.

Recommendation Up to 0.25 inches

Remove tripping hazards \$198

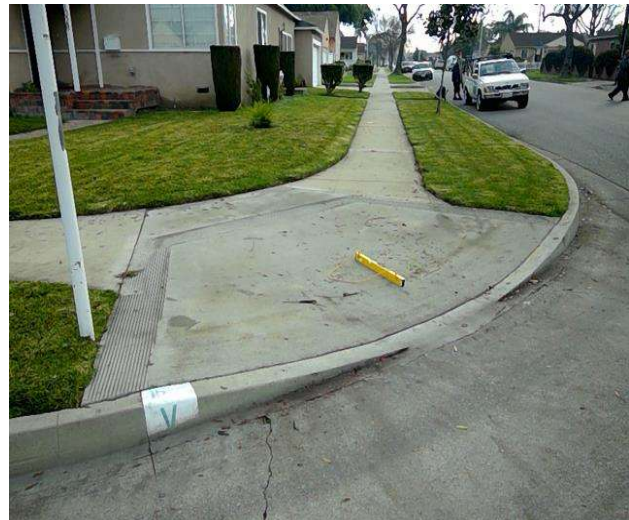
Recommendation Up to 8.33 percent

Install curb ramp \$1,300

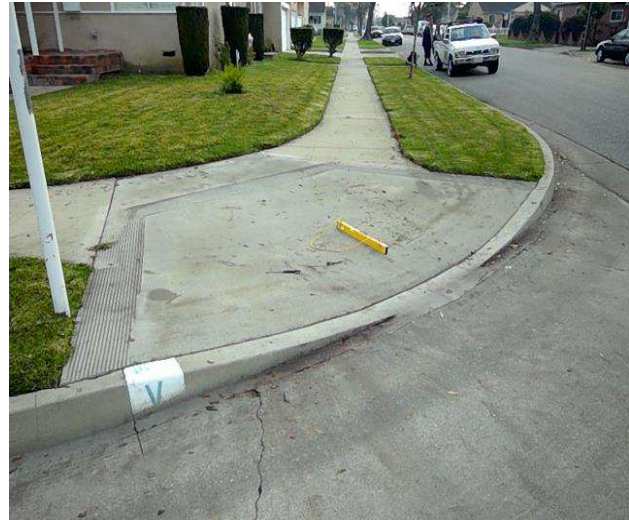
Recommendation See Recommendation

Patch lip at curb ramp \$255

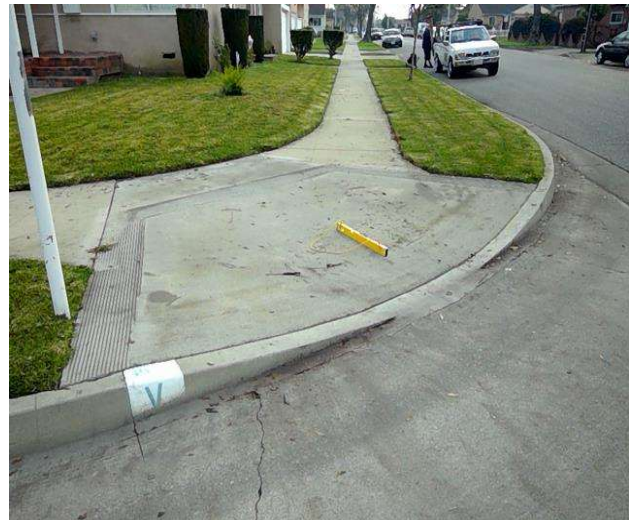
Recommendation Up to 2.08 percent

Provide compliant landing \$1,260

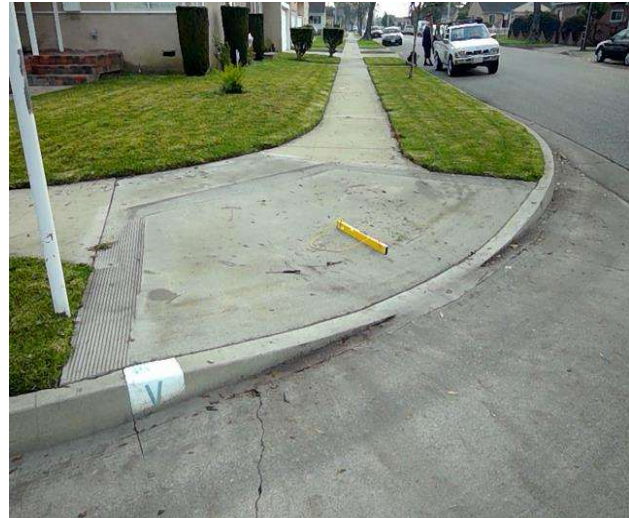
Recommendation At least 48.00 inches

Provide compliant landing \$240

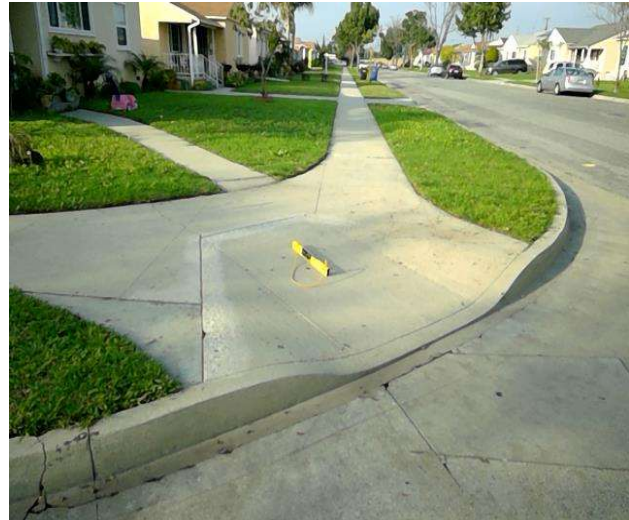
On-Site Finding Not Found

Provide detectable warning to surface \$248

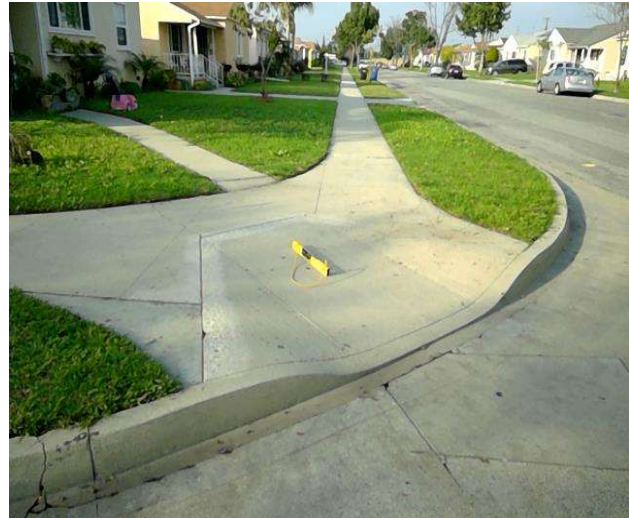
Recommendation Up to 8.33 percent

Install curb ramp \$1,300

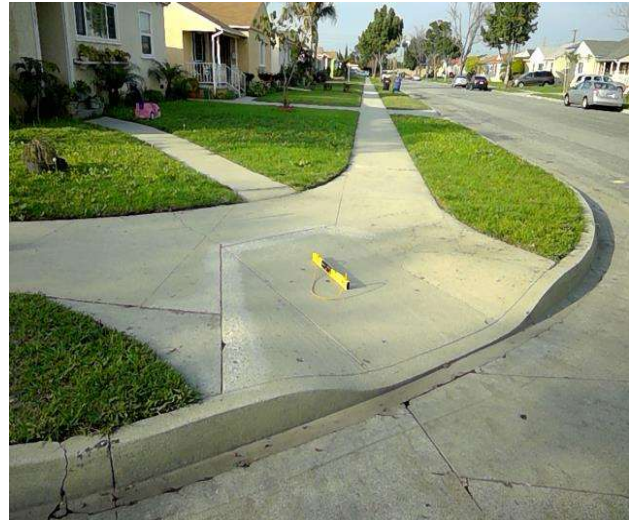
Recommendation Up to 0.50 inches

Patch lip at curb ramp \$255

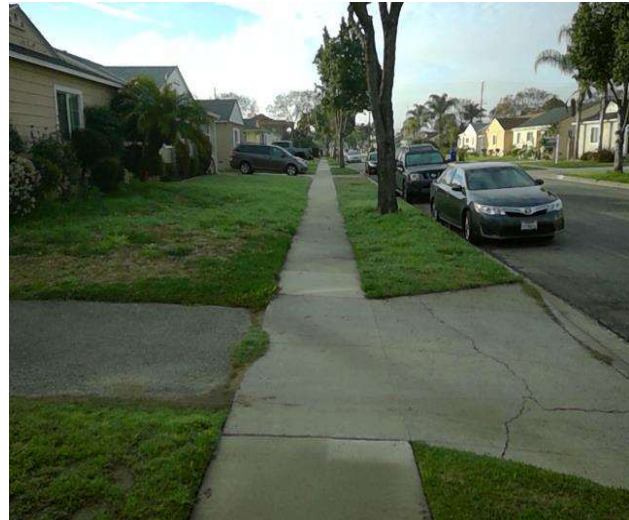
Recommendation Up to 2.08 percent

Repave the sidewalk surface with the recommended cross slope.

Repave surface \$1,092

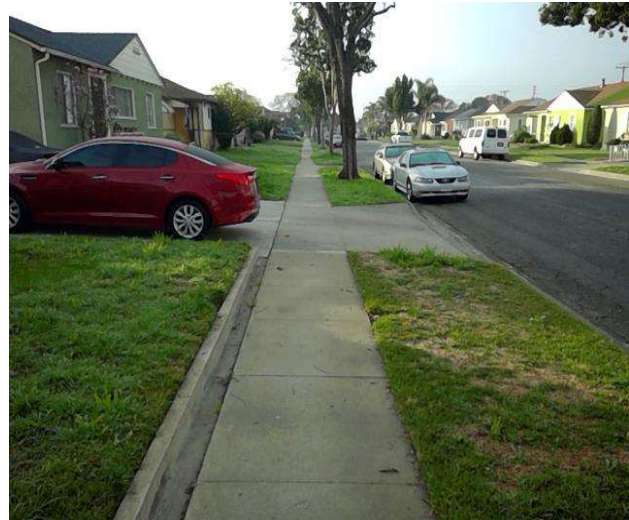
Recommendation Up to 2.08 percent

Repave the sidewalk surface with the recommended cross slope.

Repave surface \$1,092

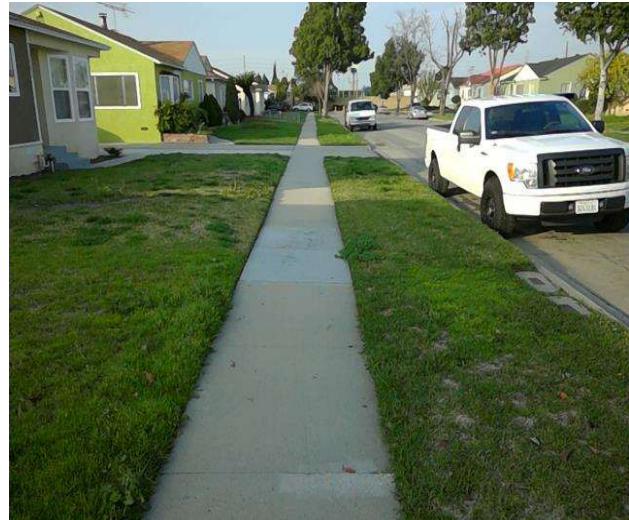
Recommendation Up to 2.08 percent

Repave the sidewalk surface with the recommended cross slope.

Repave surface \$1,092
