Accessibility Survey

City of Downey Ryerson Avenue - De Palma Street To Adwen Street

Date of Inspection
4/20/2017

Disability Access Consultants

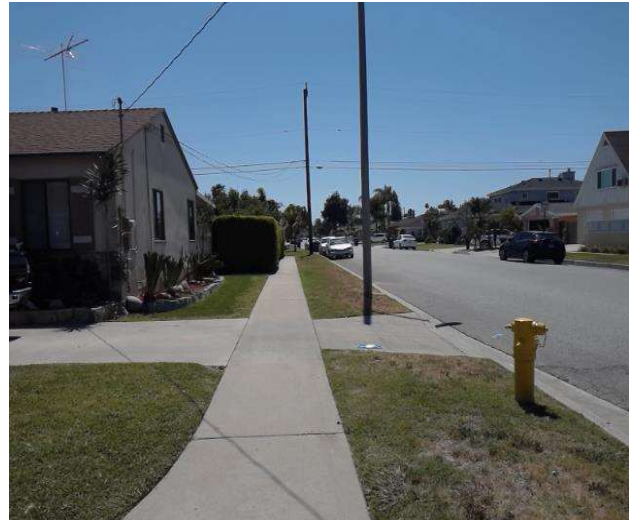
Section of sidewalk is missing and consists of dirt, grass or gravel.

Provide a compliant sidewalk for the missing section.
