## Accessibility Survey

### City of Downey Brookpark Road - Lindsey Avenue to Eglise Avenue

Date of Inspection  
6/14/2017

**Disability Access Consultants**

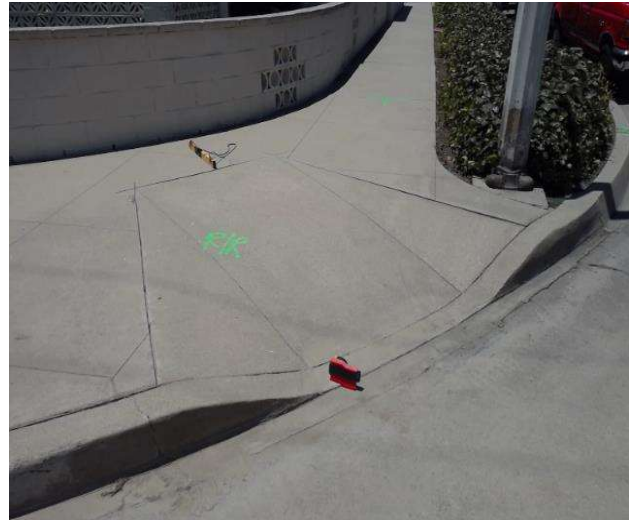
Curb Ramp , Landings and Transitions : Bottom Landing Change in Level - Curb Ramps

Patch lip at curb ramp \$255
