Accessibility Survey

City of Downey Laura Street & Old River School Road

Laura Street & Old River School Road Downey, CA 90242

Date of Inspection 4/18/2017

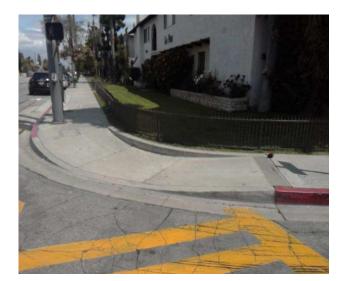
Northeast Corner @ 33.937808057040, -118.155577182770

Curb Ramp : No Detectable Warnings

The curb ramp does not provide a detectable warning surface which includes truncated domes.

Provide compliant detectable warnings to surface.

Provide detectable warning to \$248 surface

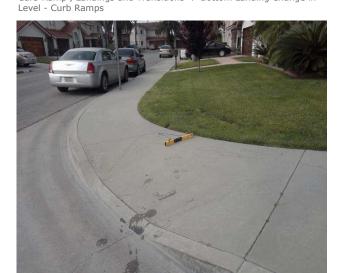
Curb Ramp , Landings and Transitions : Bottom Landing Change in

Patch lip at curb ramp \$255

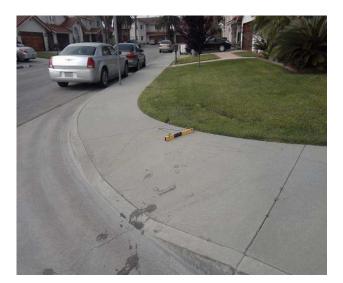
Curb Ramp , Landings and Transitions : Top Landing Slope

Provide compliant landing \$1,260

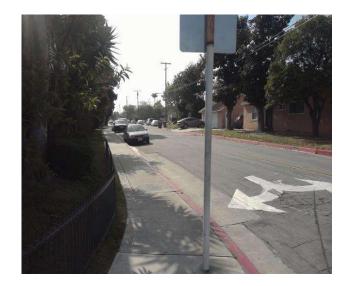
Sidewalks , Hazards & Gratings : Sidewalk Width at Obstruction

Sidewalk width at the obstruction shall have the recommended value.

Recommendation At least 48.00 inches

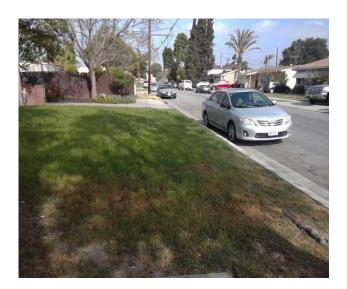
Sidewalks : Missing Sidewalk

Section of sidewalk is missing and consists of dirt, grass or gravel.

Provide a compliant sidewalk for the missing section.
