Accessibility Survey

City of Downey Brookmill Road - Old River School Road To End

Date of Inspection
4/19/2017

Prepared By
Disability Access Consultants
(800) 743-7067

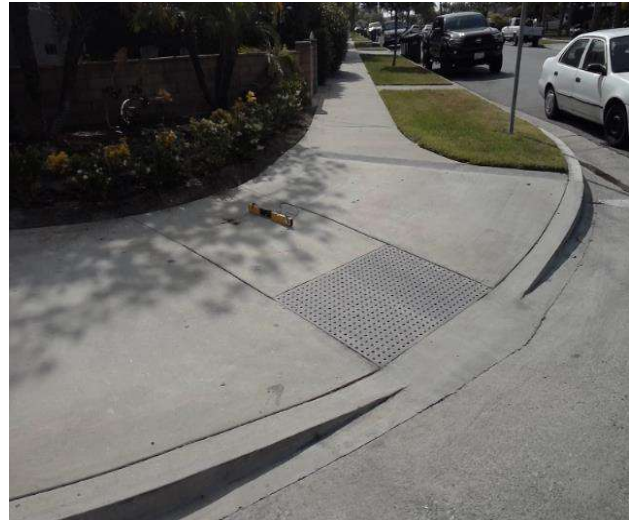
Code Reference ADA 402, 406.4, 403.3, 406.1, CA 11B-406.5.3

Recommendation

Recommendation Up to 2.08 percent

Provide compliant landing \$1,260

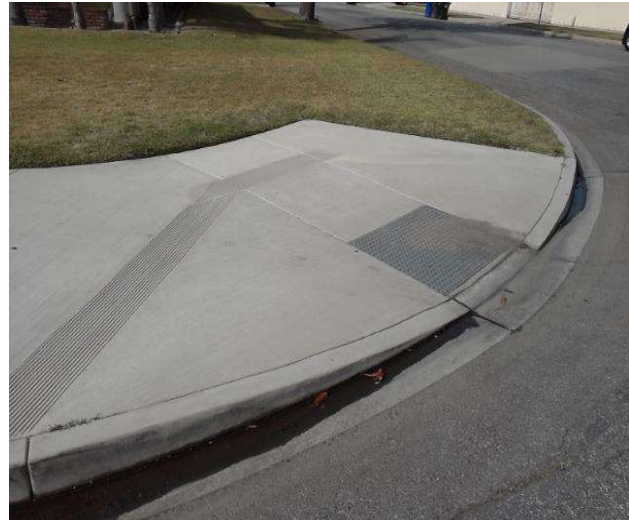
Code Reference ADA 406, 406.3,CA 11B-406.2.2

Recommendation

Recommendation Up to 10.00 percent

Install flared sides \$1,300

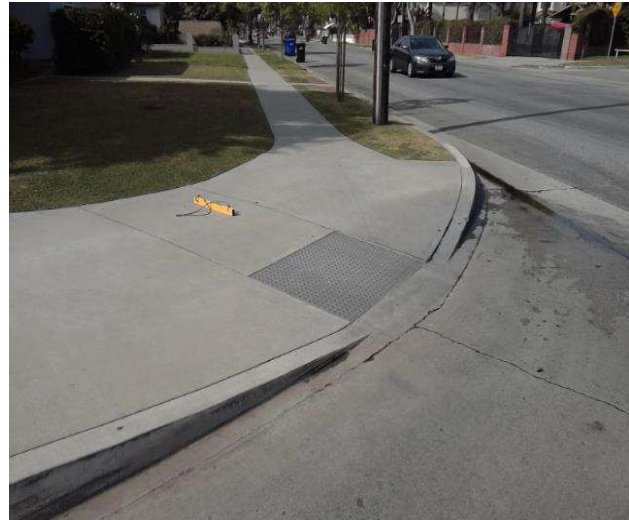
Code Reference ADA 402, 406.4, 403.3, 406.1, CA 11B-406.5.3

Recommendation

Recommendation Up to 2.08 percent

Provide compliant landing \$1,260

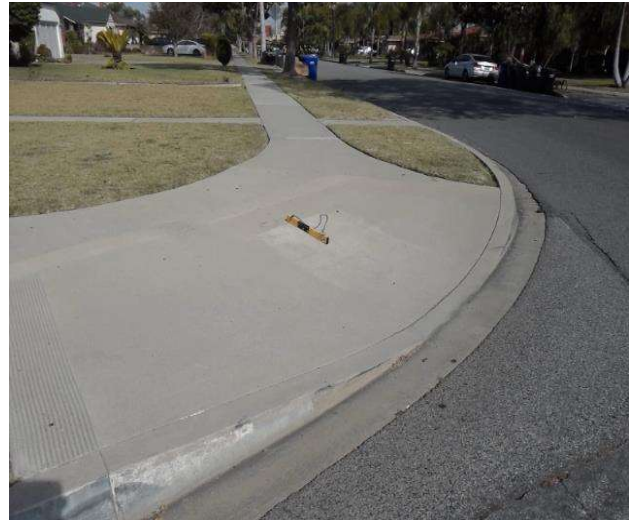
Code Reference CA 11B-406.5.12

Recommendation

Recommendation See Recommendation

Provide detectable warning to surface \$248

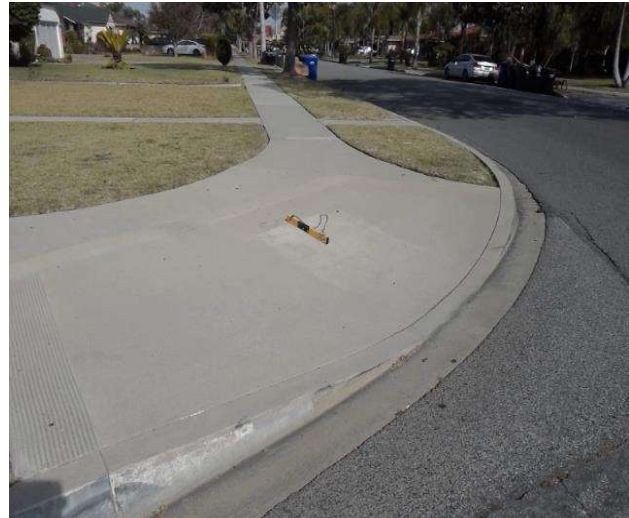
Code Reference ADA 406, 406.1, 405.2, CA 11B-406

Recommendation

Recommendation Up to 8.33 percent

Install curb ramp \$1,300

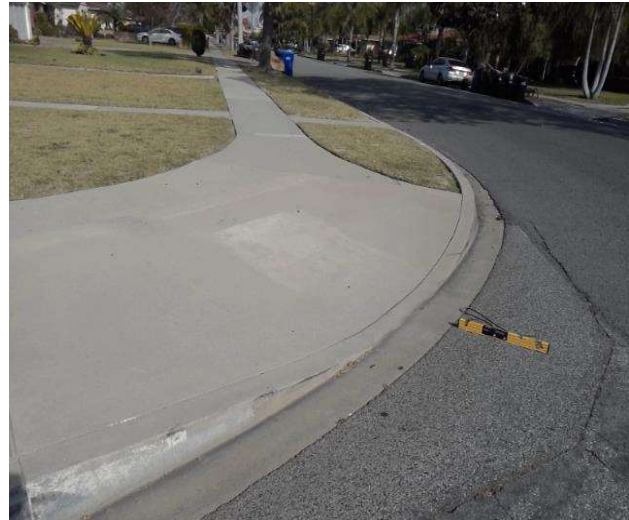
Code Reference ADA 406, 406.2, CA 11B-406.5.8

Recommendation

Recommendation Up to 5.00 percent

Repave landing \$1,260

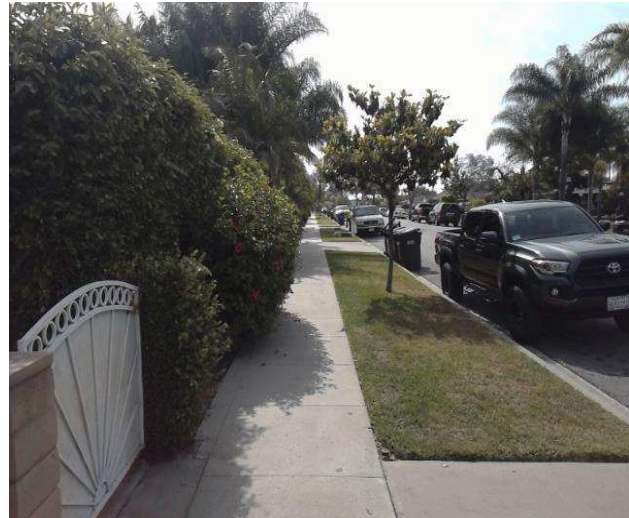
Code Reference ADA 206, 302

Recommendation

Recommendation See Recommendation

\$2,400

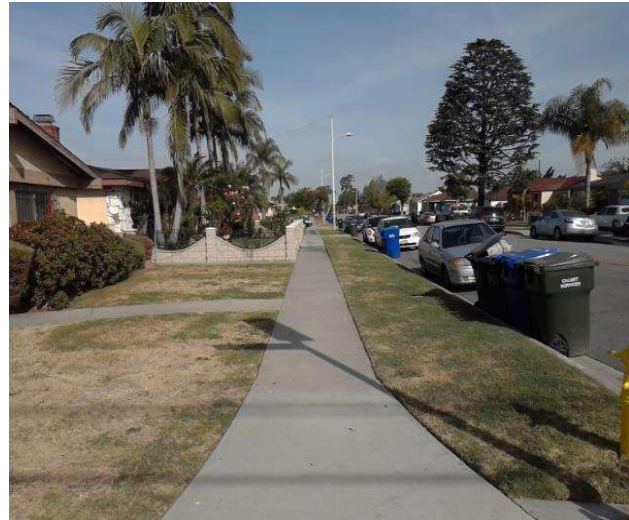
Code Reference ADA 206, 302

Recommendation

Recommendation See Recommendation

\$2,400

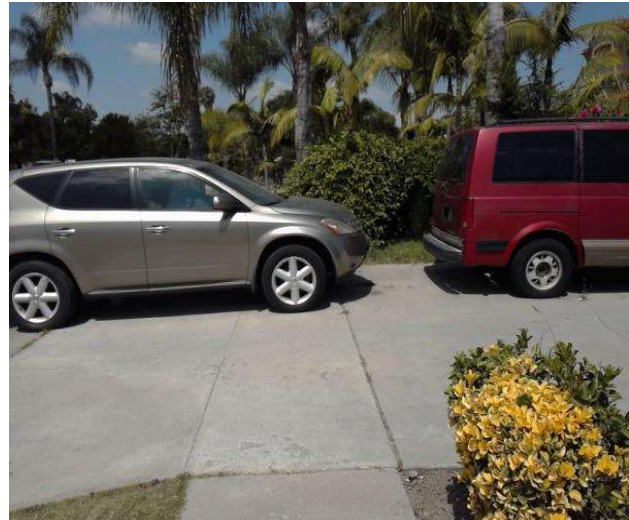
Code Reference ADA 705,CA 11B-705.1.2.5,CA 11B-247.1.2.5

Recommendation

Recommendation See Recommendation

Install compliant detectable warnings \$190

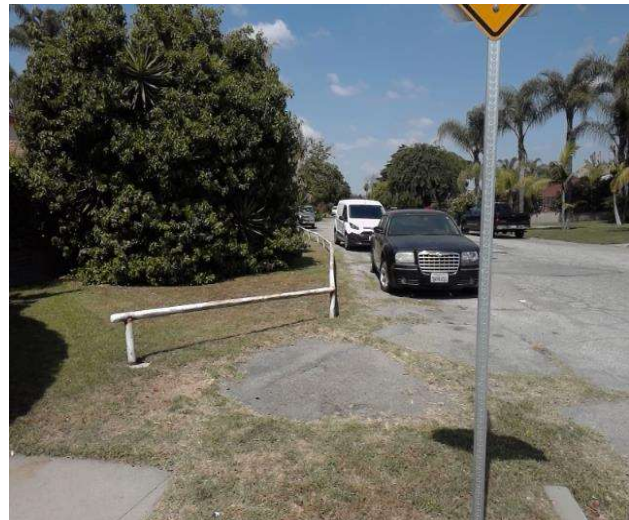
Sidewalks : Missing Sidewalk

Code Reference ADA 206

Recommendation
