Accessibility Survey

City of Downey Quill Drive & Old River School Road

Date of Inspection
4/11/2017

Prepared By
Disability Access Consultants
(800) 743-7067

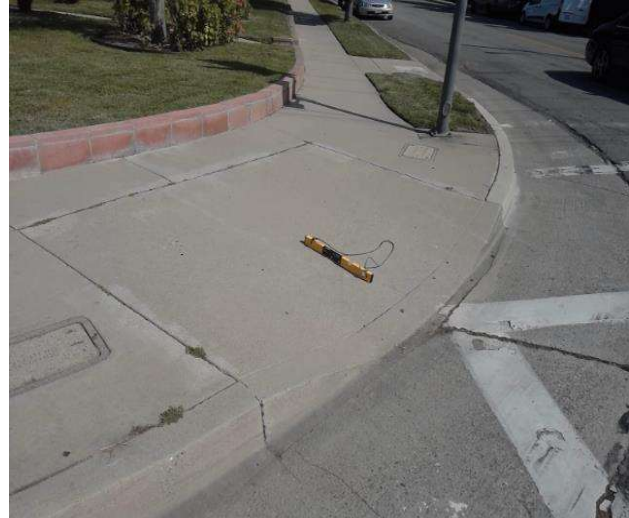
Northeast Corner @ 33.932028811922, -118.159904927015

Curb Ramp : No Detectable Warnings

The curb ramp does not provide a detectable warning surface which includes truncated domes.

Provide compliant detectable warnings to surface.

Provide detectable warning to surface \$248

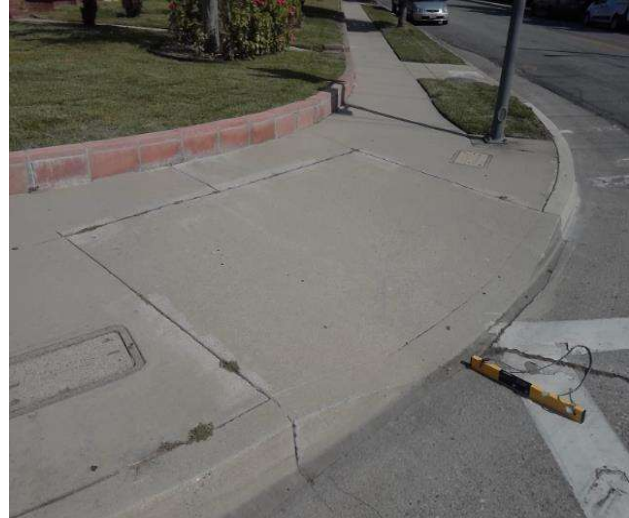
The overlayment causes a noncompliant change in level.

Ensure the change in elevation is within the recommended height.

Recommendation Up to 0.50 inches

Provide smooth surface \$150

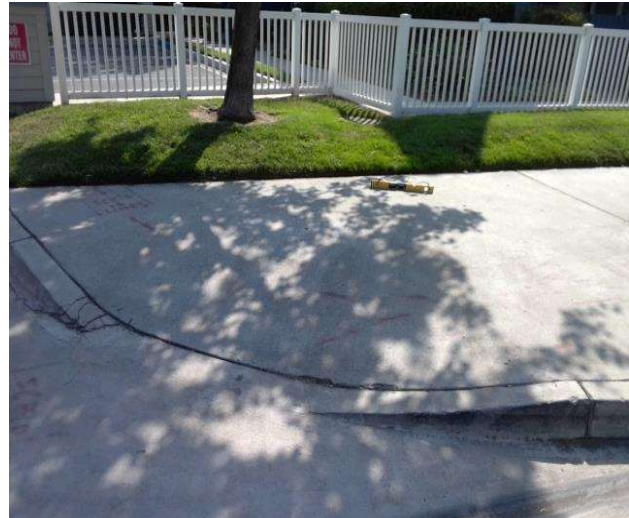
Curb Ramp , Landings And Transitions : Bottom Landing Change in Level

Patch lip at curb ramp \$255

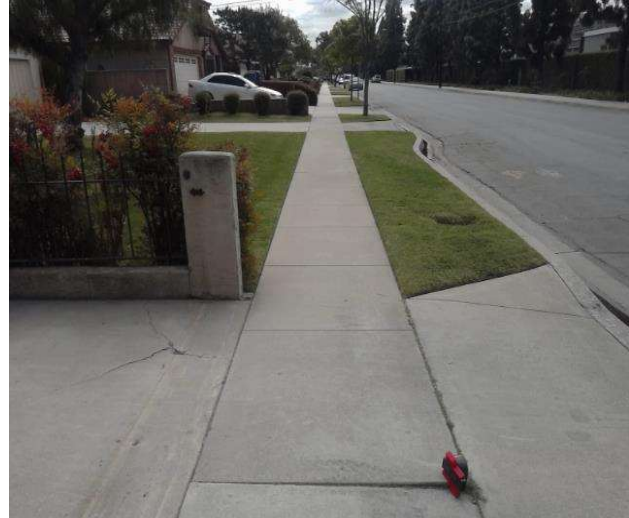
There is a change in elevation greater than recommended value.

Ensure that the change in elevation is within the recommended value.

Recommendation Up to 0.25 inches

Remove tripping hazards \$198

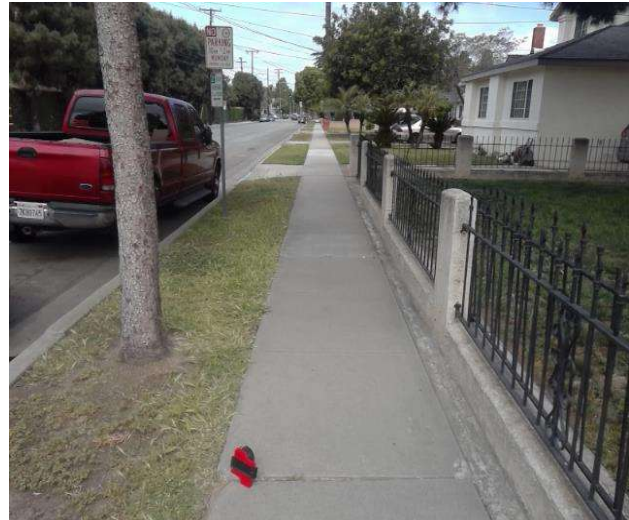
There is a change in elevation greater than recommended value.

Ensure that the change in elevation is within the recommended value.

Recommendation Up to 0.25 inches

Remove tripping hazards \$198

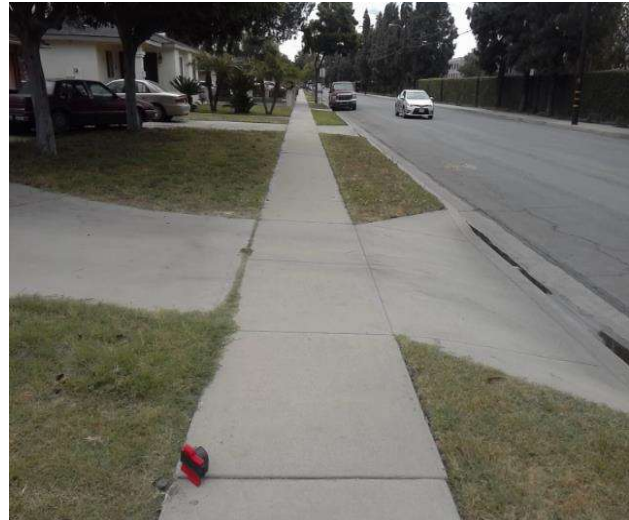
There is a change in elevation greater than recommended value.

Ensure that the change in elevation is within the recommended value.

Recommendation Up to 0.25 inches

Remove tripping hazards \$198

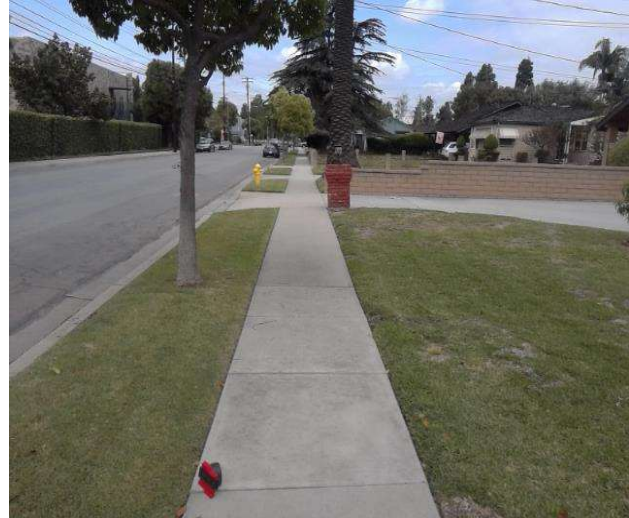
There is a change in elevation greater than recommended value.

Ensure that the change in elevation is within the recommended value.

Recommendation Up to 0.25 inches

Remove tripping hazards \$198

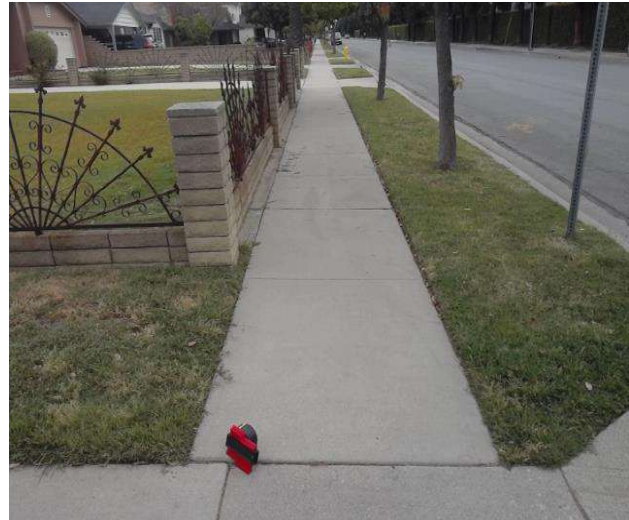
There is a change in elevation greater than recommended value.

Ensure that the change in elevation is within the recommended value.

Recommendation Up to 0.25 inches

Remove tripping hazards \$198

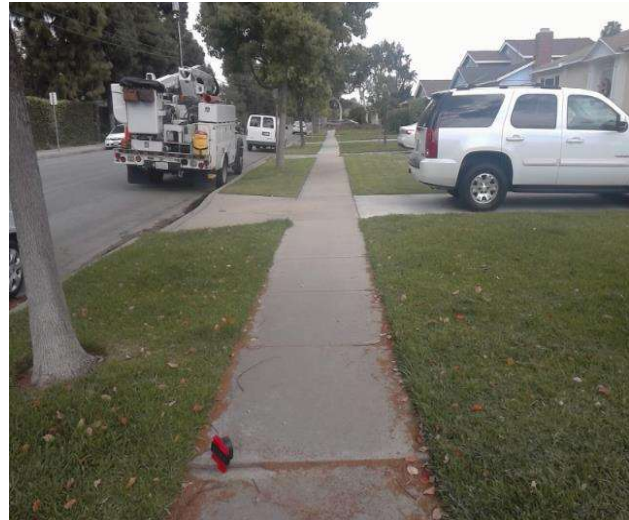
There is a change in elevation greater than recommended value.

Ensure that the change in elevation is within the recommended value.

Recommendation Up to 0.25 inches

Remove tripping hazards \$198

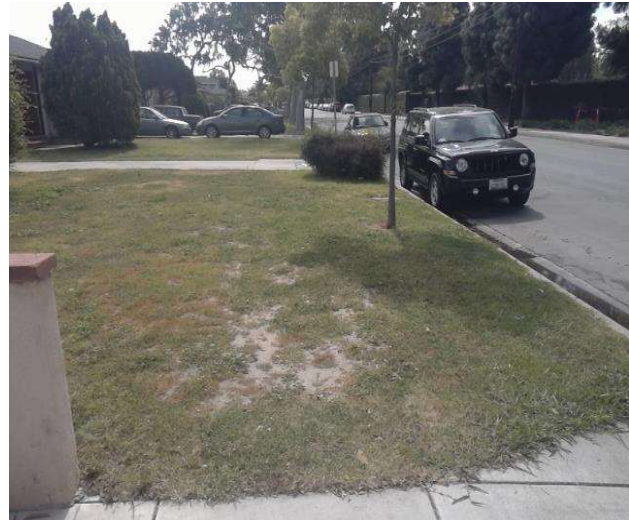
Sidewalks : Missing Sidewalk

Section of sidewalk is missing and consists of dirt, grass or gravel.

Provide a compliant sidewalk for the missing section.

\$1,260

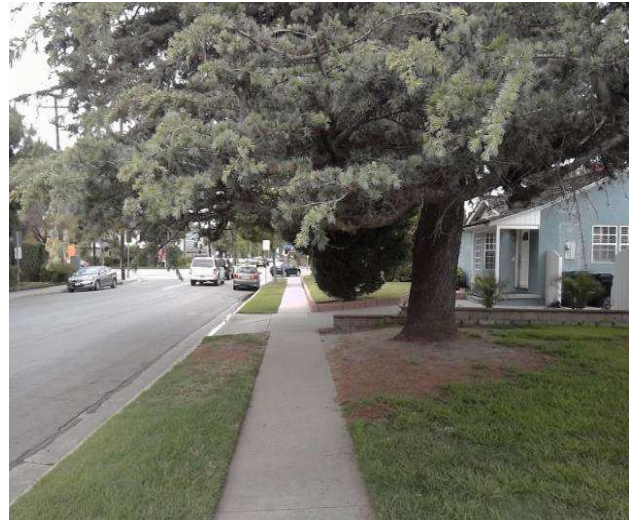
Sidewalks , Hazards & Gratings : Overhead Obstruction Height

Recommendation At least 80.00 inches

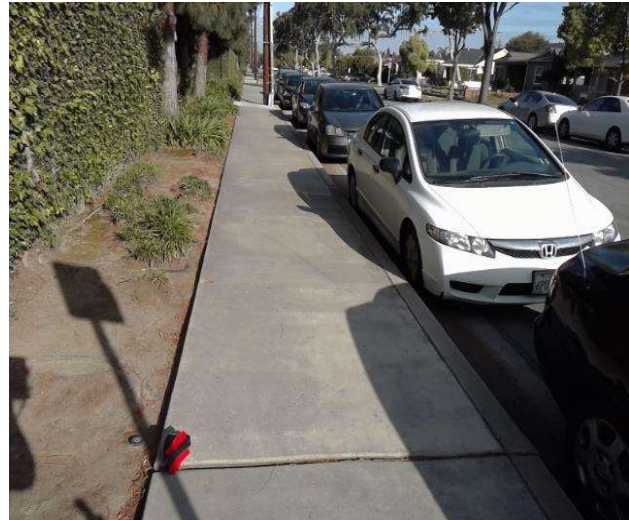
There is a change in elevation greater than recommended value.

Ensure that the change in elevation is within the recommended value.

Recommendation Up to 0.25 inches

Remove tripping hazards \$198

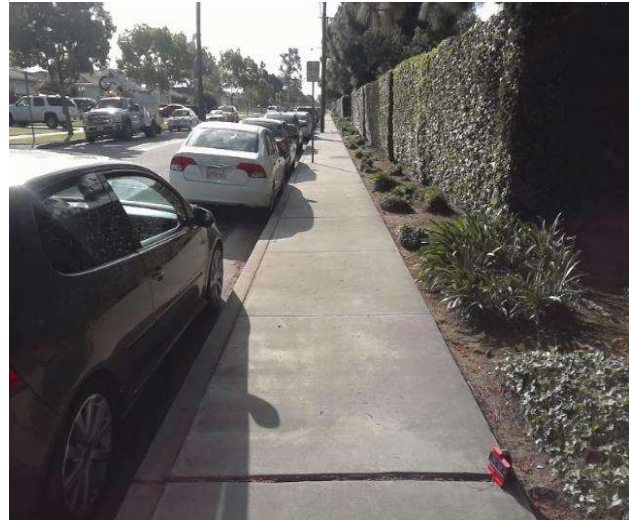
There is a change in elevation greater than recommended value.

Ensure that the change in elevation is within the recommended value.

Recommendation Up to 0.25 inches

Remove tripping hazards \$198

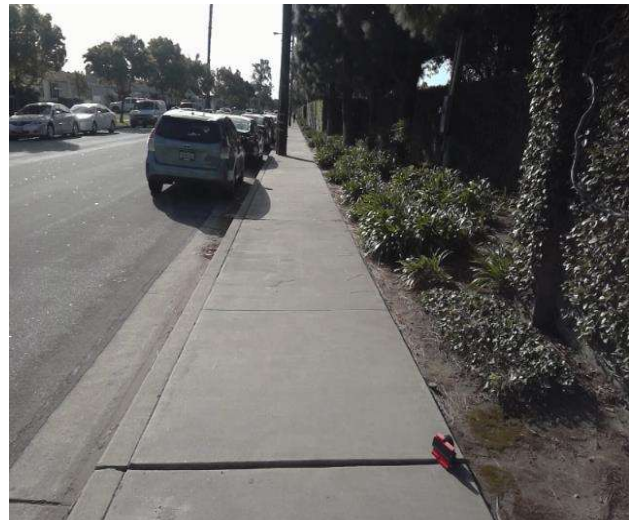
There is a change in elevation greater than recommended value.

Ensure that the change in elevation is within the recommended value.

Recommendation Up to 0.25 inches

Remove tripping hazards \$198

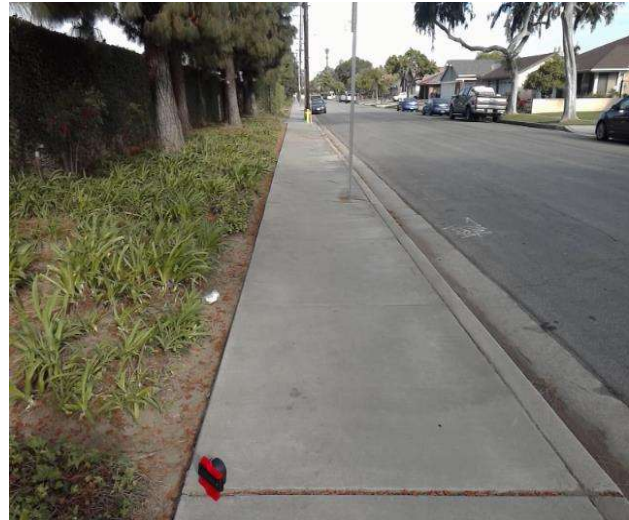
There is a change in elevation greater than recommended value.

Ensure that the change in elevation is within the recommended value.

Recommendation Up to 0.25 inches

Remove tripping hazards \$198

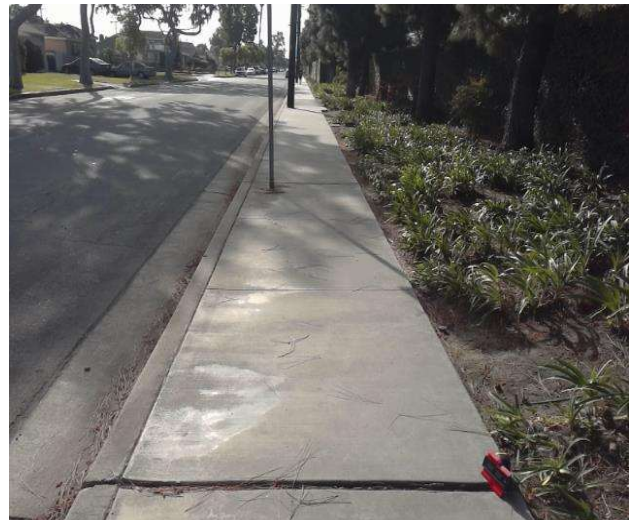
There is a change in elevation greater than recommended value.

Ensure that the change in elevation is within the recommended value.

Recommendation Up to 0.25 inches

Remove tripping hazards \$198

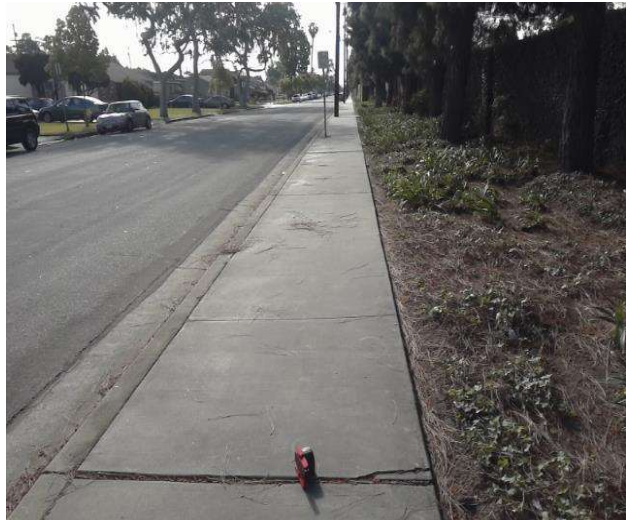
There is a change in elevation greater than recommended value.

Ensure that the change in elevation is within the recommended value.

Recommendation Up to 0.25 inches

Remove tripping hazards \$198

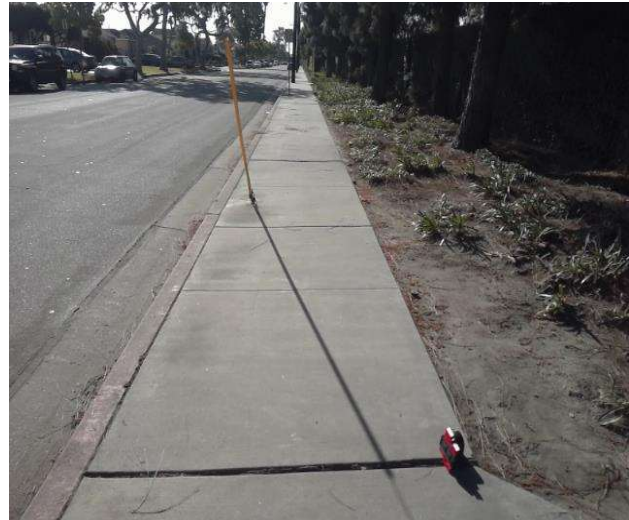
There is a change in elevation greater than recommended value.

Ensure that the change in elevation is within the recommended value.

Recommendation Up to 0.25 inches

Remove tripping hazards \$198

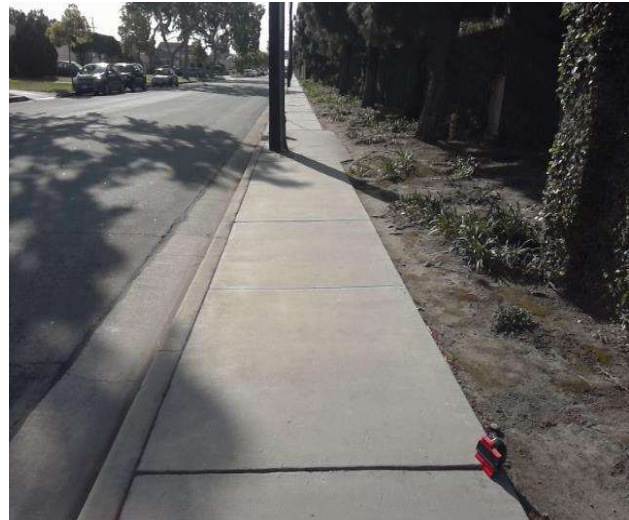
There is a change in elevation greater than recommended value.

Ensure that the change in elevation is within the recommended value.

Recommendation Up to 0.25 inches

Remove tripping hazards \$198

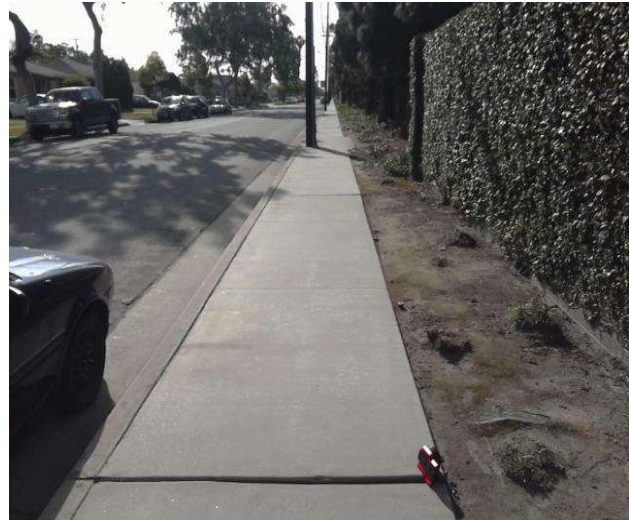
There is a change in elevation greater than recommended value.

Remove tripping hazards \$198

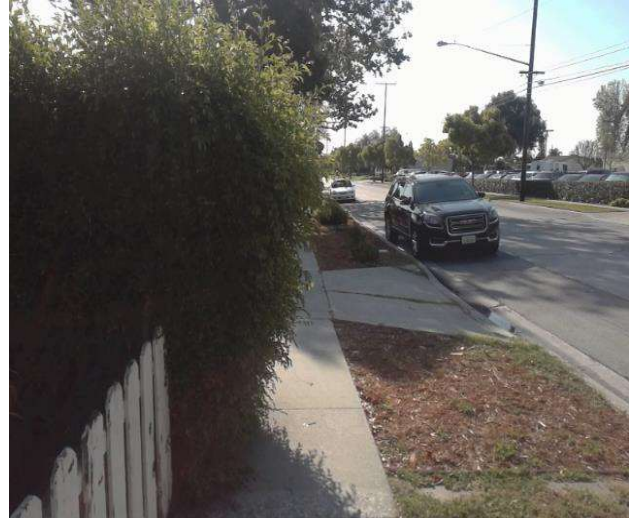
Sidewalks , Hazards & Gratings : Sidewalk Width at Obstruction

Sidewalk width at the obstruction shall have the recommended value.

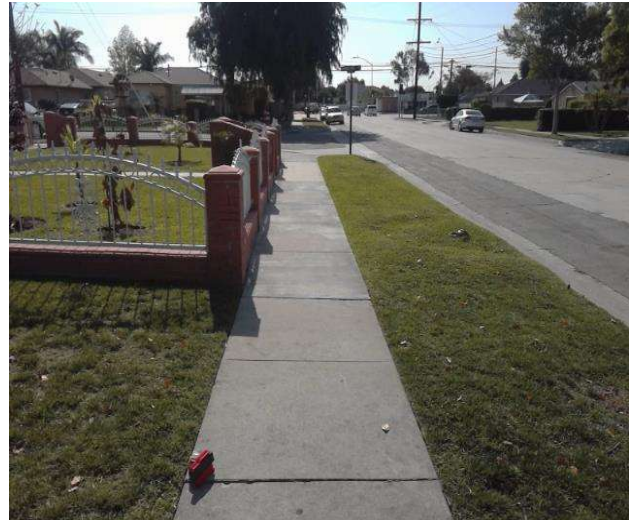
There is a change in elevation greater than recommended value.

Ensure that the change in elevation is within the recommended value.

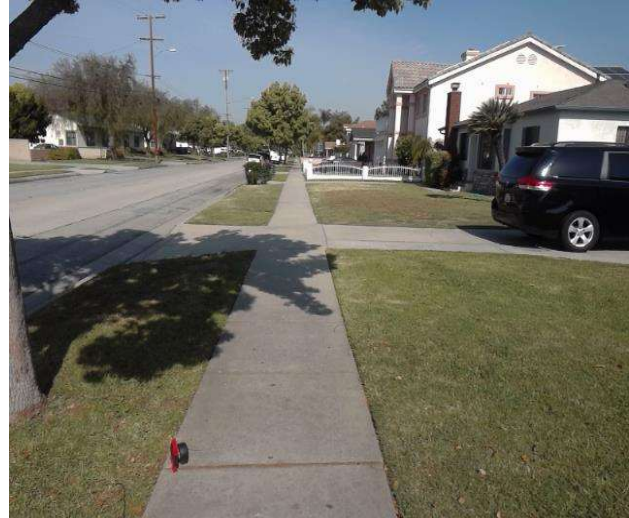
There is a change in elevation greater than recommended value.

Ensure that the change in elevation is within the recommended value.

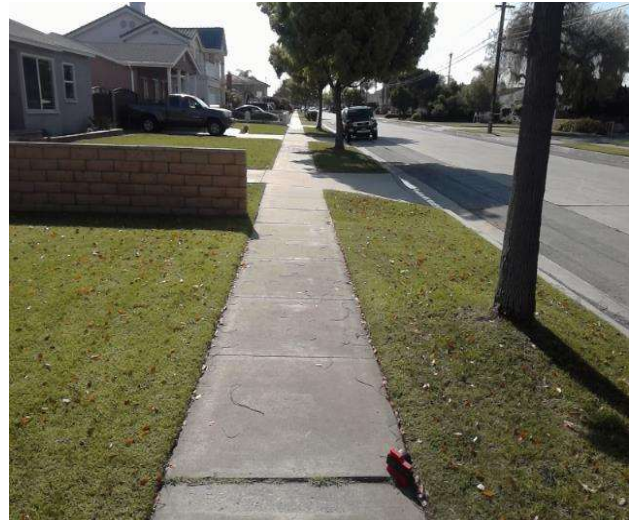
There is a change in elevation greater than recommended value.

Ensure that the change in elevation is within the recommended value.

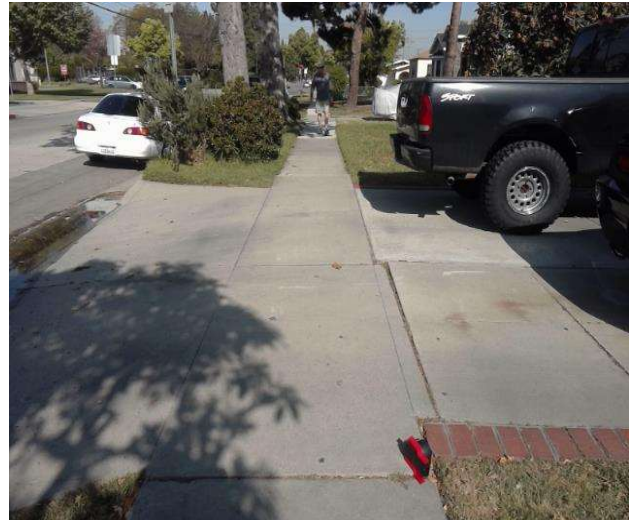
There is a change in elevation greater than recommended value.

Ensure that the change in elevation is within the recommended value.

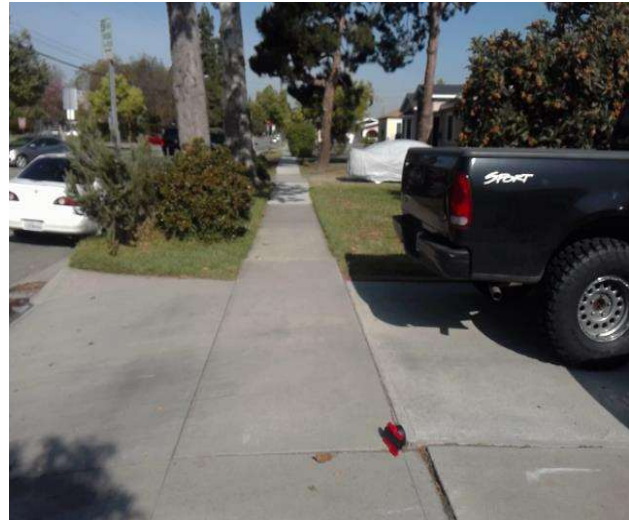
There is a change in elevation greater than recommended value.

Ensure that the change in elevation is within the recommended value.

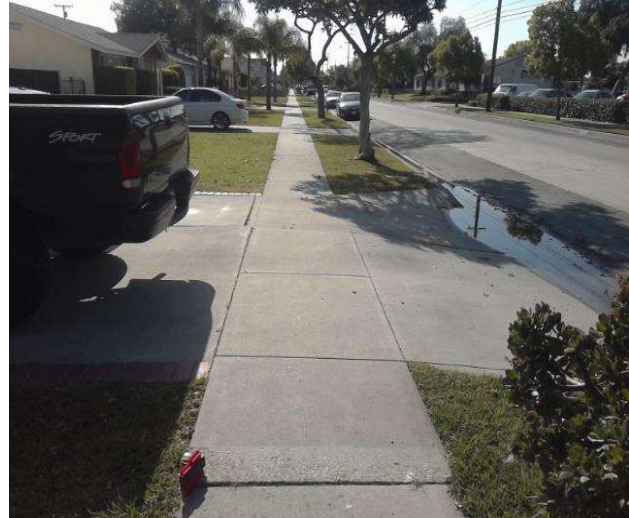
There is a change in elevation greater than recommended value.

Ensure that the change in elevation is within the recommended value.

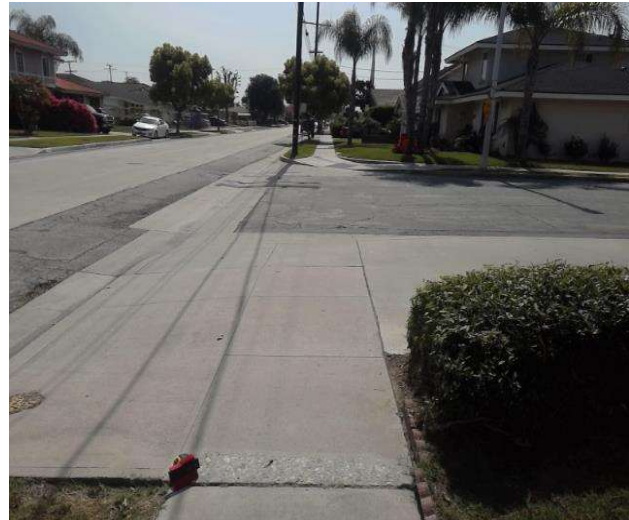
There is a change in elevation greater than recommended value.

Ensure that the change in elevation is within the recommended value.

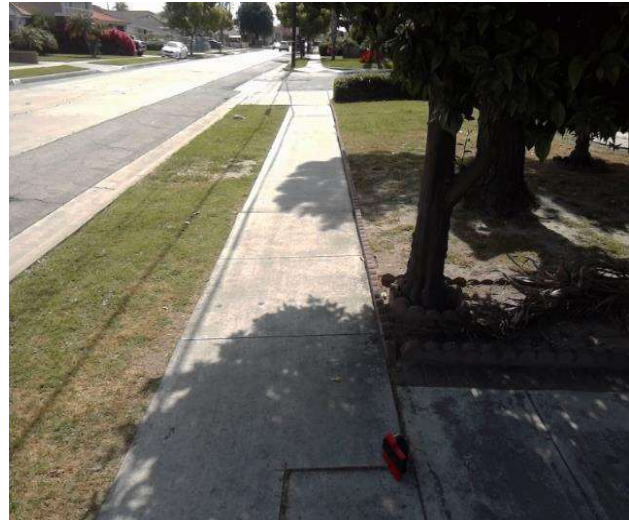
There is a change in elevation greater than recommended value.

Ensure that the change in elevation is within the recommended value.

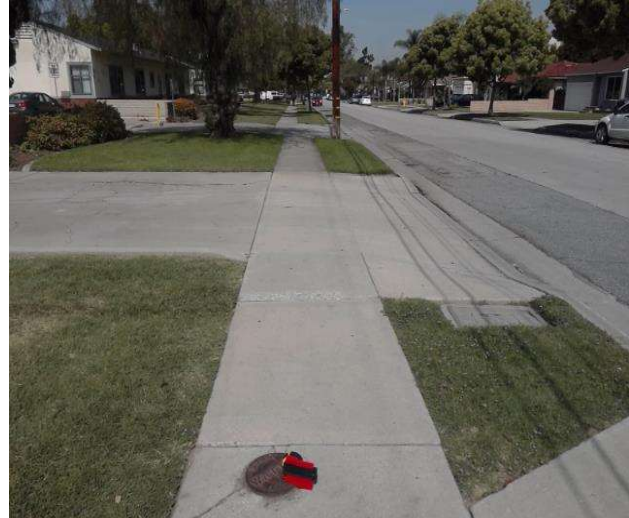
There is a change in elevation greater than recommended value.

Ensure that the change in elevation is within the recommended value.

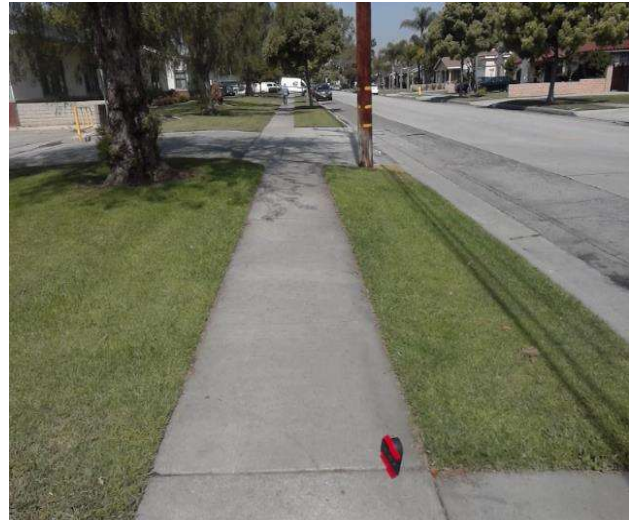
There is a change in elevation greater than recommended value.

Ensure that the change in elevation is within the recommended value.

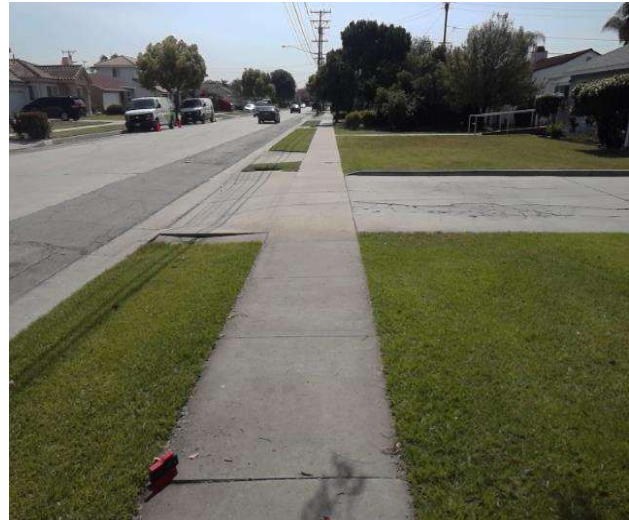
There is a change in elevation greater than recommended value.

Ensure that the change in elevation is within the recommended value.

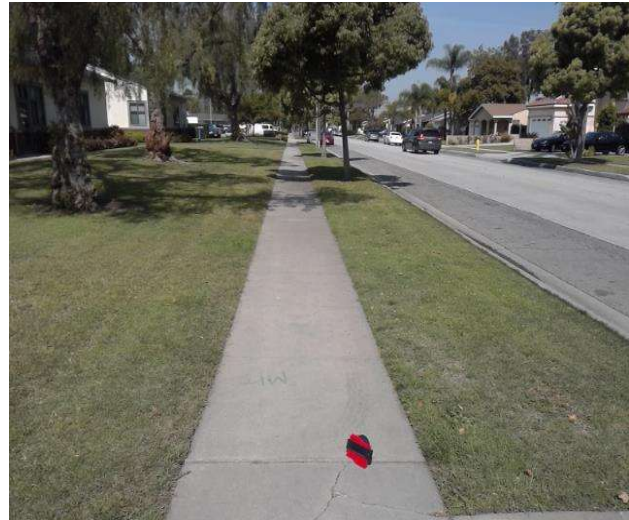
There is a change in elevation greater than recommended value.

Ensure that the change in elevation is within the recommended value.

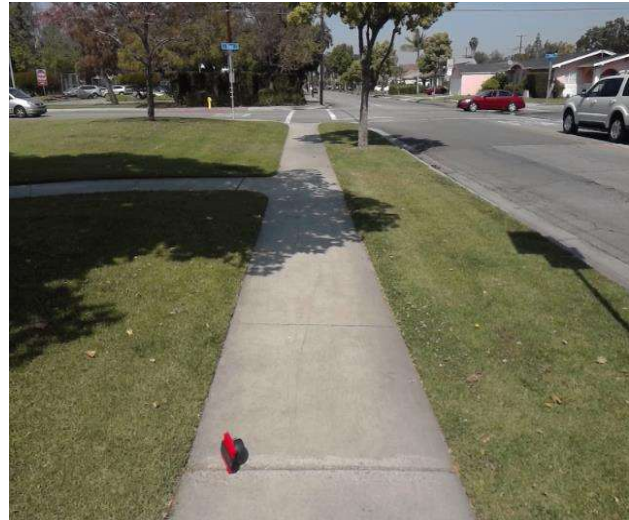
There is a change in elevation greater than recommended value.

Ensure that the change in elevation is within the recommended value.

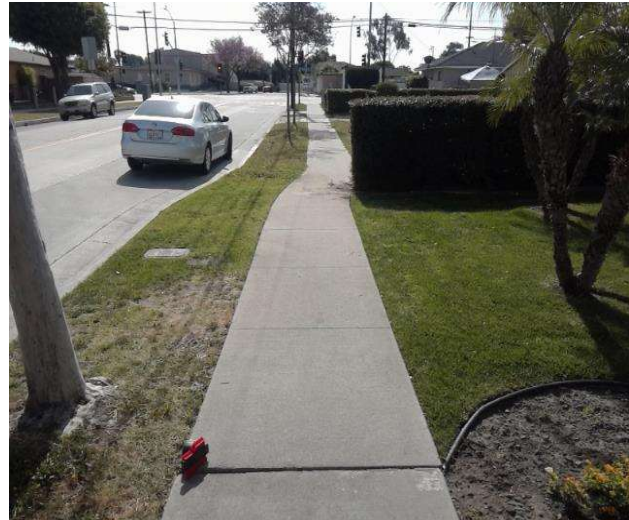
There is a change in elevation greater than recommended value.

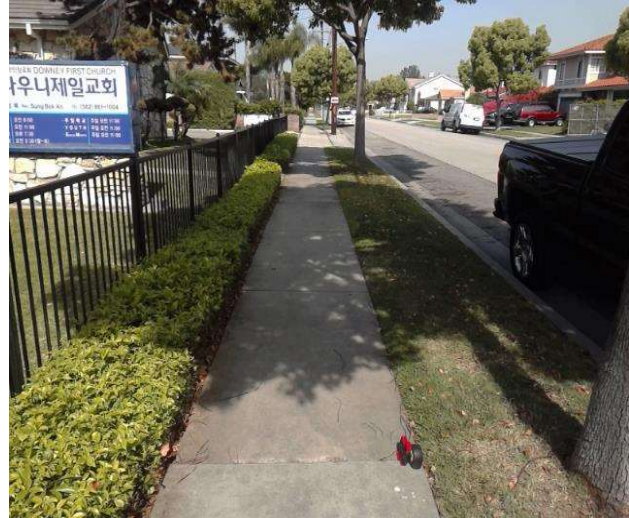
There is a change in elevation greater than recommended value.

Ensure that the change in elevation is within the recommended value.

Recommendation Up to 0.25 inches

Remove tripping hazards \$198

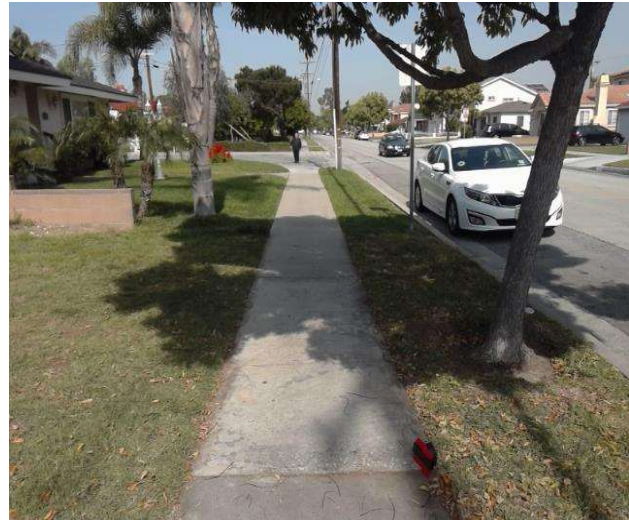
There is a change in elevation greater than recommended value.

Ensure that the change in elevation is within the recommended value.

Recommendation Up to 0.25 inches

Remove tripping hazards \$198

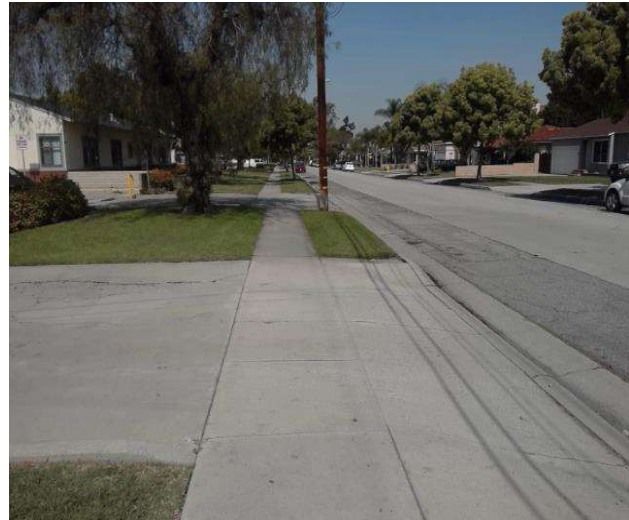
On-Site Finding Not Found

Install compliant detectable warnings \$190

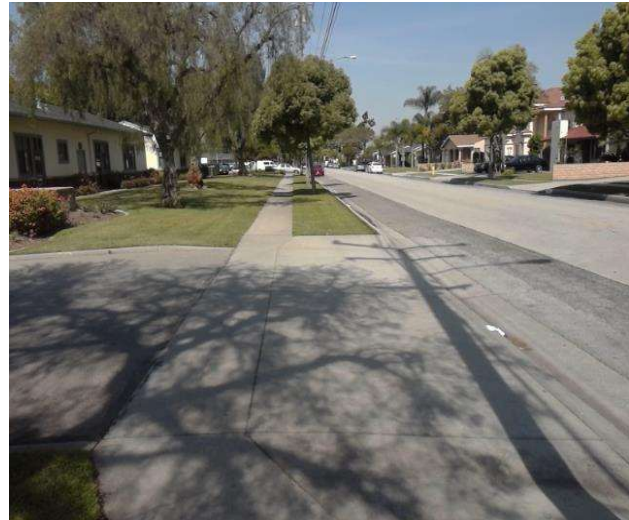
On-Site Finding Not Found

Install compliant detectable warnings \$190

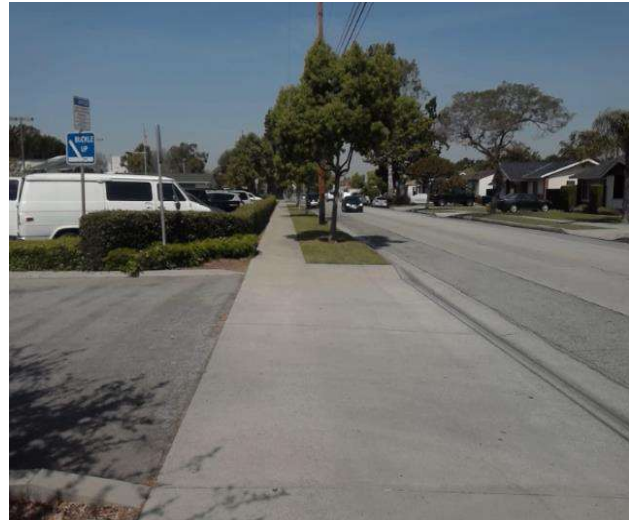
On-Site Finding Not Found

Install compliant detectable warnings \$190

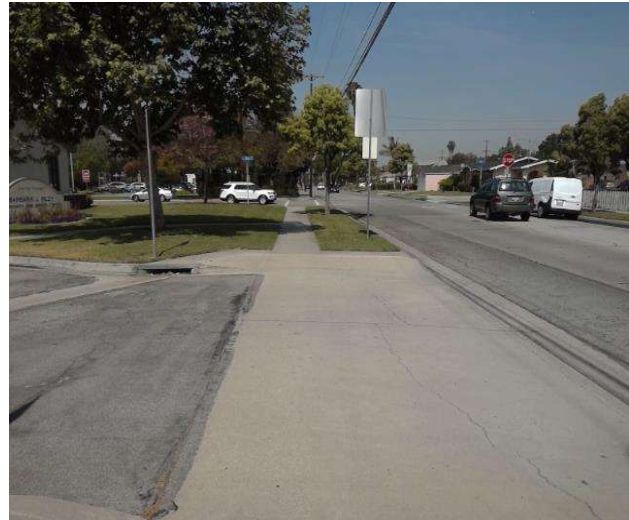
On-Site Finding Not Found

Install compliant detectable warnings \$190

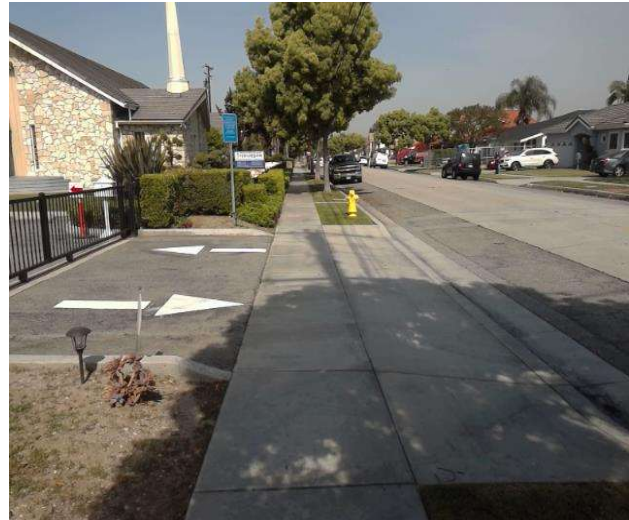
On-Site Finding Not Found

Install compliant detectable warnings \$190

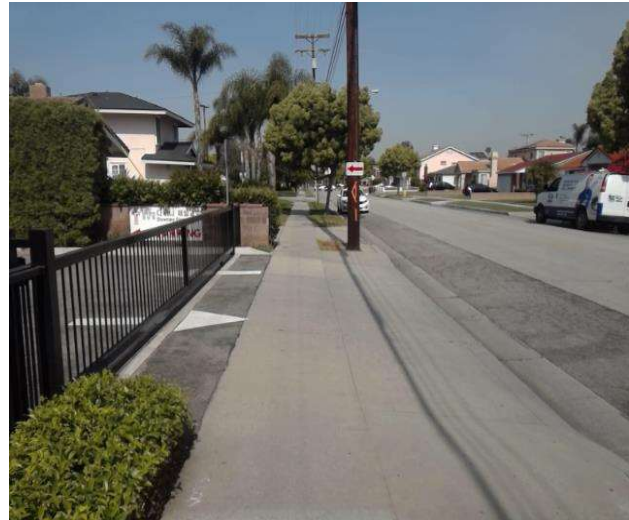
On-Site Finding Not Found

Install compliant detectable warnings \$190

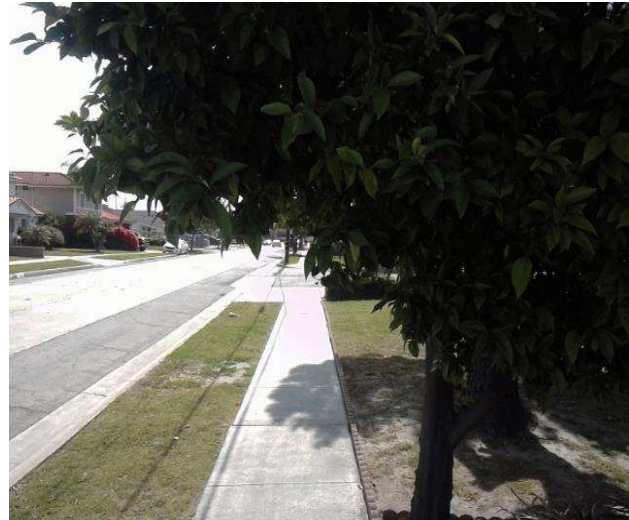
Sidewalks , Hazards & Gratings : Overhead Obstruction Height

Recommendation At least 80.00 inches

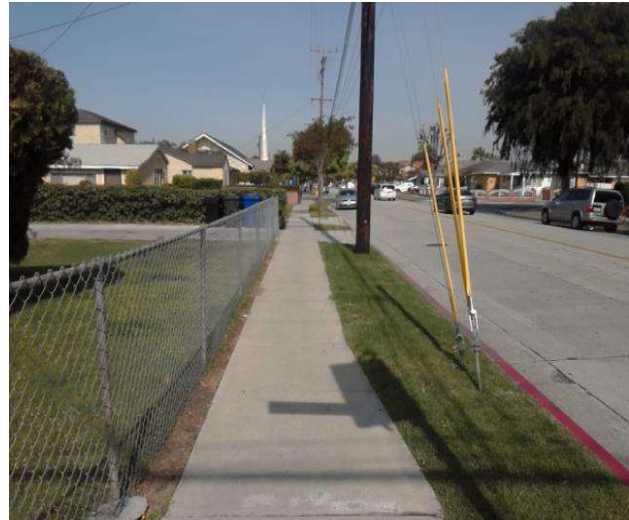
On-Site Finding Not Found

\$2,400
