Accessibility Survey

City of Downey Rives Avenue - Brookpark Avenue to Cul-De-Sac

Date of Inspection 6/22/2017

Disability Access Consultants

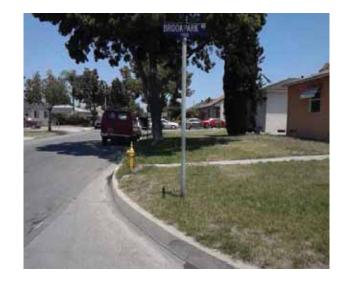
East Side @ 33.969727033004, -118.121974468231

Sidewalks : No Sidewalk

No sidewalk exists at the location.

No action necessary until a sidewalk is provided.

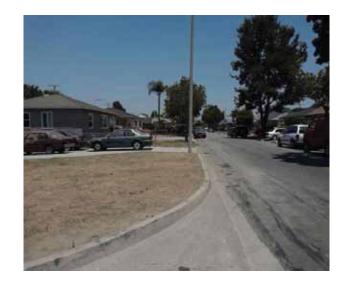
West Side @ 33.969852714009, -118.121983855963

Sidewalks : No Sidewalk

No sidewalk exists at the location.

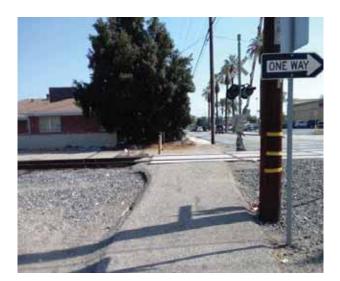
Railroad Crossing North of Burns Avenue @ 33.943944042164, -118.142962753773

Notes: Railroad Crossing Opening = 3.37"

Install compliant detectable \$190 warnings

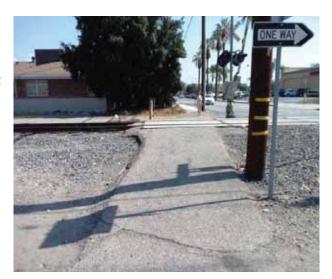
Railroad Crossing North of Burns Avenue @ 33.943949604959, - 118.142964094877

Recommendation Up to 5.00 percent

Path Of Travel , Walking Surfaces : Walking Surface Slope

Install pathway \$3,600

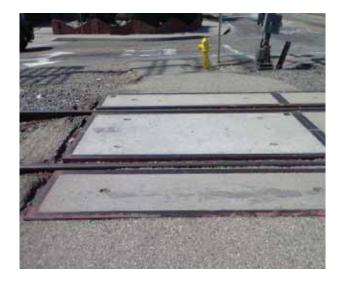
There is a change in elevation greater than recommended value.

Notes: Surface is Rough And Uneven

Ensure that the change in elevation is within the recommended value.

Provide smooth surface \$150

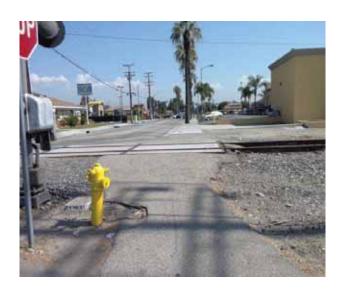
Railroad Crossing South of Burns Avenue @ 33.943905102583, -118.142757564783

Notes: Railroad Crossing Opening = 3.12"

Install compliant detectable \$190

warnings

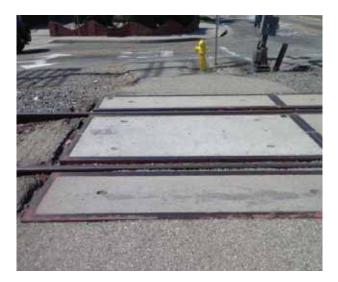
Railroad Crossing South of Burns Avenue @ 33.944027484063, - 118.142675757408

Recommendation Up to 5.00 percent

Path Of Travel , Walking Surfaces : Walking Surface Slope

Install pathway \$3,600

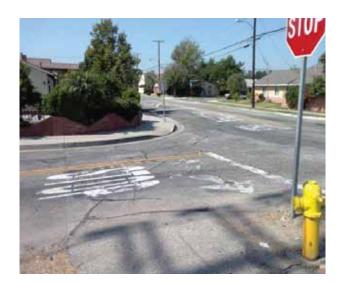
Burns Avenue East Crossing @ 33.943824998246, -118.142835348845

Recommendation Up to 5.00 percent

Repave surface \$1,092

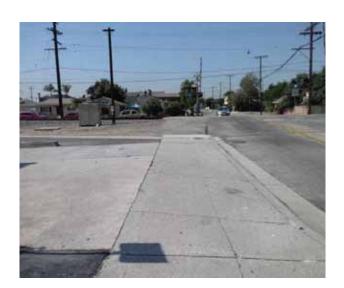
Driveway South of Burns Avenue @ 33.944175454163, -118.142564445734

On-Site Finding Not Found

Install compliant detectable \$190

warnings

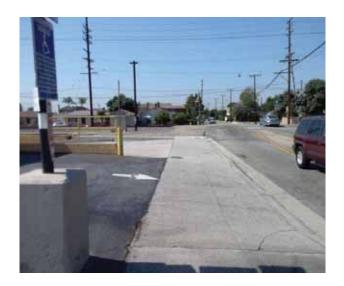
Driveway South of Burns Avenue @ 33.944175454163, -118.142564445734

On-Site Finding Not Found

Install compliant detectable \$190

warnings

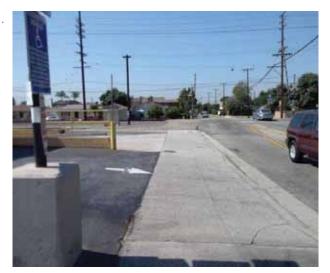
Driveway South of Burns Avenue @ 33.944175454163, -118.142564445734

Recommendation Up to 2.08 percent

Repave surface \$1,092

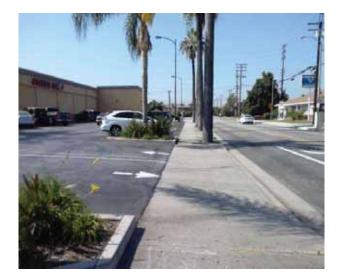
Driveway South of Burns Avenue @ 33.944600449562, -118.142254650593

On-Site Finding Not Found

Install compliant detectable \$190 warnings

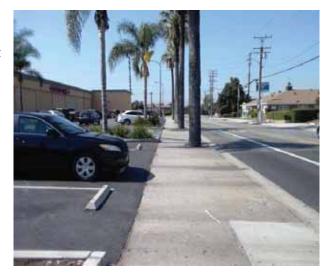
Sidewalk South of Burns Avenue @ 33.944751756312, -118.142125904560

Recommendation Up to 2.08 percent

Repave the sidewalk surface with the recommended cross slope.

Repave surface \$1,092

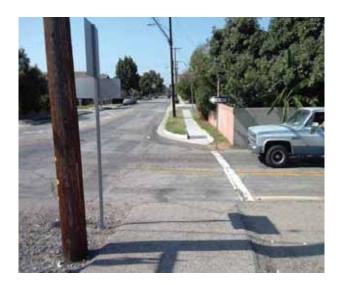
Burns Avenue West Crossing @ 33.943921790977, -118.142988234758

Recommendation Up to 5.00 percent

Repave surface \$1,092

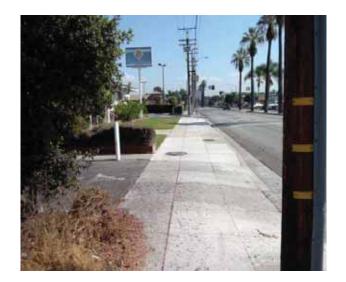
Driveway North of Burns Avenue @ 33.944138739801, -118.142773658037

On-Site Finding Not Found

Install compliant detectable \$190 warnings

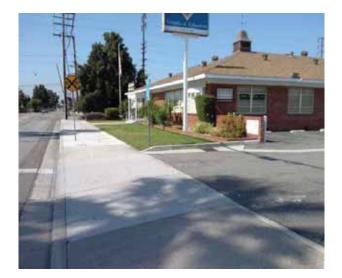
Driveway North of Burns Avenue @ 33.944420216170, -118.142573833466

On-Site Finding Not Found

Install compliant detectable \$190 warnings

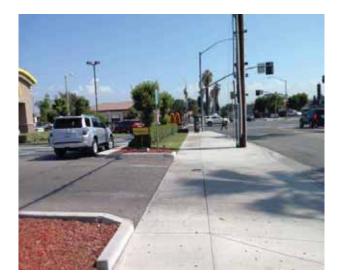
Driveway North of Burns Avenue @ 33.944584873851, -118.142459839582

On-Site Finding Not Found

Install compliant detectable \$190 warnings

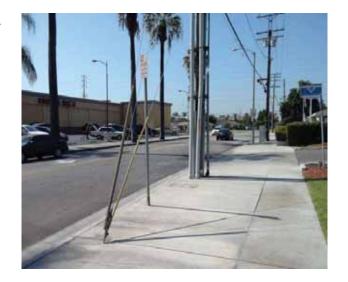
Guy Wire North of Burns Avenue @ 33.944688341015, -118.142363280058

Sidewalks , Hazards & Gratings : Overhead Obstruction Height

Recommendation At least 80.00 inches

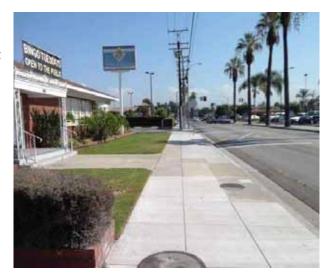
Sidewalk North of Burns Avenue @ 33.944160990931, -118.142770975828

Recommendation Up to 2.08 percent

Repave the sidewalk surface with the recommended cross slope.

Repave surface \$1,092

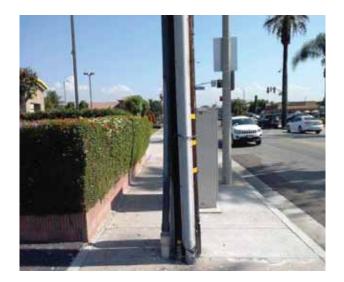
Utility Pole North of Burns Avenue @ 33.944452480200, -118.142560422421

Sidewalks , Hazards & Gratings : Sidewalk Width at Obstruction

Recommendation At least 48.00 inches

Sidewalk width at the obstruction shall have the recommended value.

\$1,260

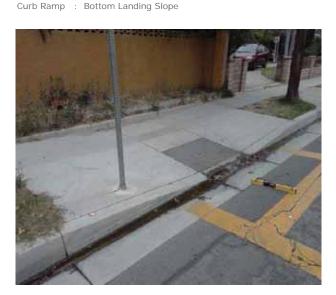
Recommendation Up to 5.00 percent

Repave landing \$1,260

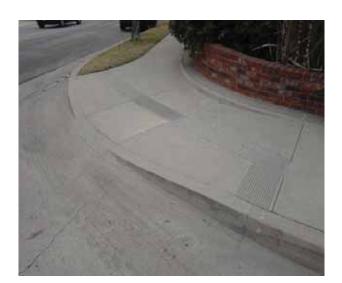
On-Site Finding Not Found

Provide detectable warning to \$248 surface

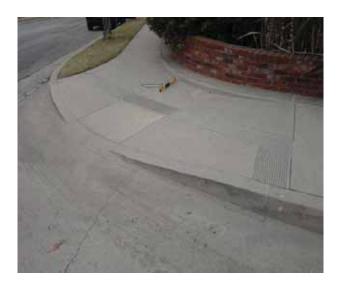
Recommendation Up to 2.08 percent

Curb Ramp , Landings and Transitions $\,:\,$ Top Landing Slope

Provide compliant landing \$1,260

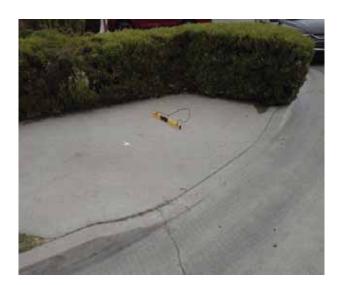
On-Site Finding Not Found

Provide detectable warning to \$248 surface

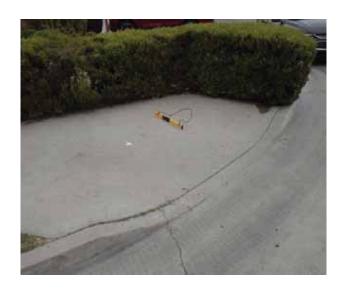
Recommendation Up to 8.33 percent

Install curb ramp \$1,300

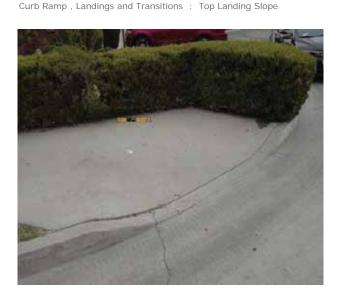
Recommendation Up to 2.08 percent

Provide compliant landing \$1,260

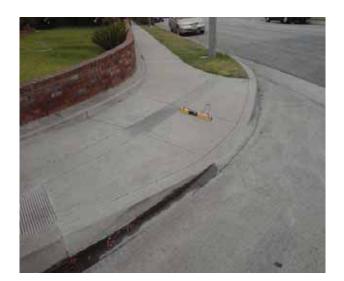
On-Site Finding Not Found

Provide detectable warning to \$248 surface

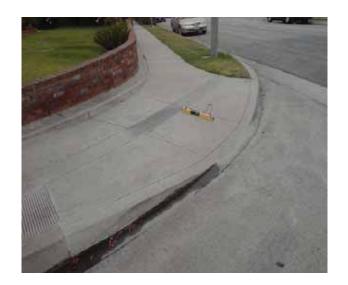
Recommendation Up to 8.33 percent

Install curb ramp \$1,300

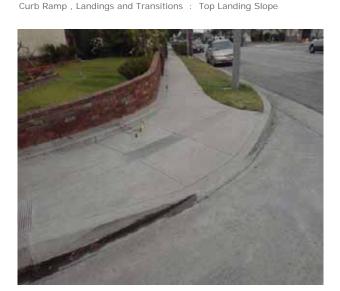
Recommendation Up to 2.08 percent

Provide compliant landing \$1,260

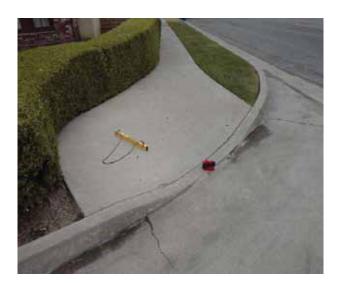
On-Site Finding Not Found

Provide detectable warning to \$248 surface

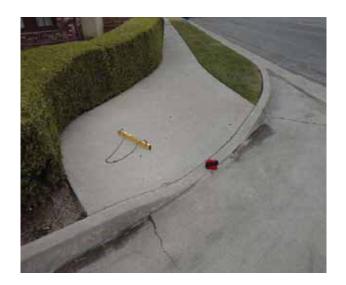
Recommendation At least 48.00 inches

Install curb ramp \$1,300

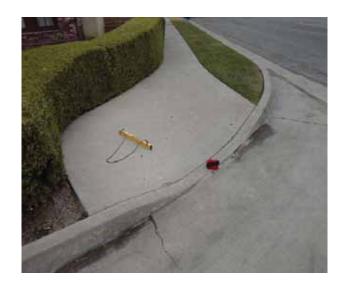
Recommendation Up to 8.33 percent

Install curb ramp \$1,300

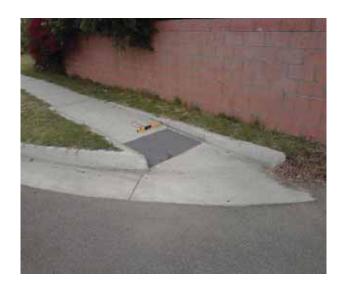
Southwest Corner of Burns Avenue @ 33.943858375062, - 118.143045902252

Recommendation Up to 2.08 percent

Install curb ramp \$1,300

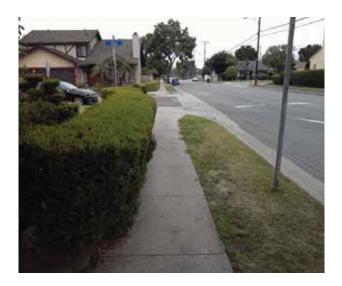
Bush South of Burns Avenue @ 33.943303205651, -118.143253773451

Sidewalks , Hazards & Gratings : Sidewalk Width at Obstruction

Sidewalk width at the obstruction shall have the recommended value.

Recommendation At least 48.00 inches

\$1,260

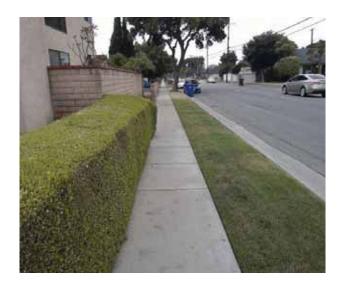
Sidewalks , Hazards & Gratings : Sidewalk Width at Obstruction

Sidewalk width at the obstruction shall have the recommended value.

Recommendation At least 48.00 inches

\$1,260

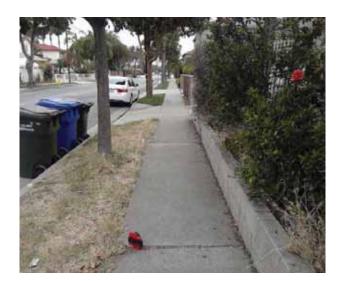
There is a change in elevation greater than recommended value.

Ensure that the change in elevation is within the recommended value.

Recommendation Up to 0.25 inches

Remove tripping hazards \$198

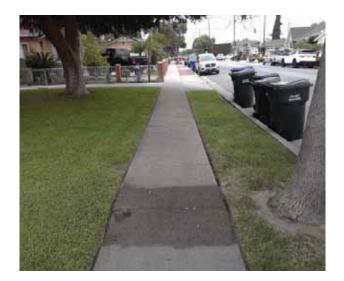
Code Reference ADA 206, 302 Notes: Surface is Rough And Uneven.

Repave the sidewalk surface with the recommended running slope.

Recommendation Up to 5.00 percent

Repave surface \$1,184

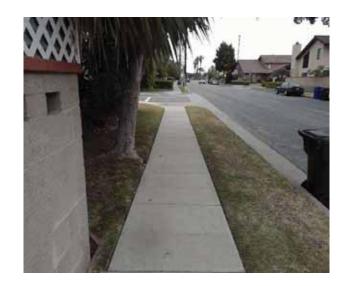
Recommendation At least 48.00 inches

Widen the sidewalk to the recommended value.

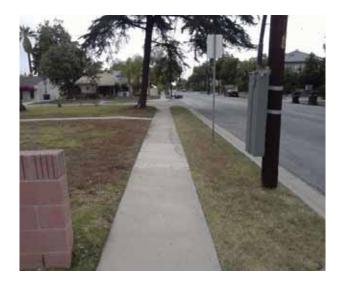
Recommendation Up to 2.08 percent

Repave the sidewalk surface with the recommended cross slope.

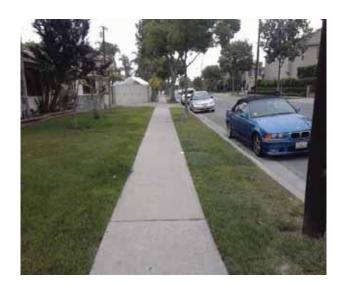
Recommendation Up to 2.08 percent

Repave the sidewalk surface with the recommended cross slope.

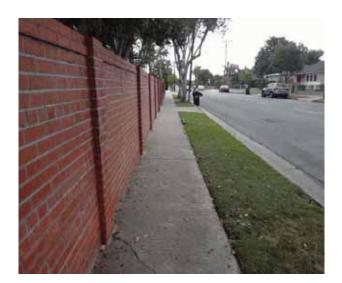
Recommendation Up to 2.08 percent

Repave the sidewalk surface with the recommended cross slope.

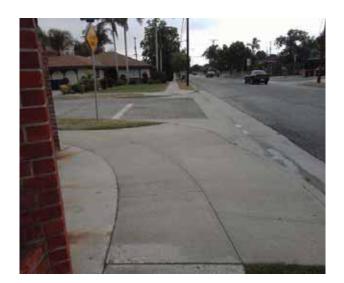
Recommendation Up to 2.08 percent

Repave the sidewalk surface with the recommended cross slope.

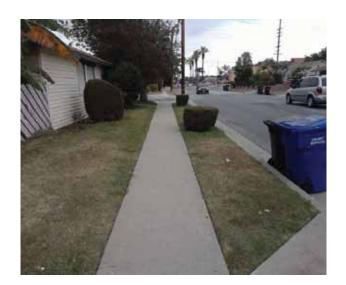
Recommendation Up to 2.08 percent

Repave the sidewalk surface with the recommended cross slope.

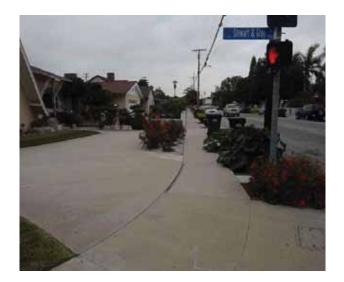
Recommendation Up to 2.08 percent

Repave the sidewalk surface with the recommended cross slope.

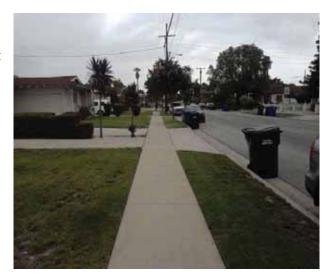
Recommendation Up to 2.08 percent

Repave the sidewalk surface with the recommended cross slope.

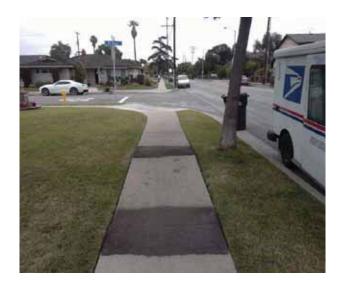
Recommendation Up to 5.00 percent

Code Reference ADA 206, 302 Notes: Surface is Rough And Uneven.

Repave the sidewalk surface with the recommended running slope.

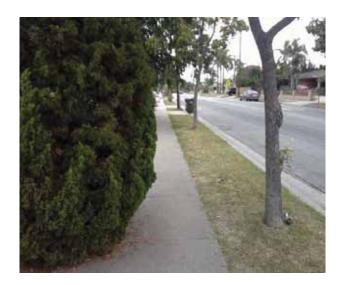
Sidewalks , Hazards & Gratings : Sidewalk Width at Obstruction

Recommendation At least 48.00 inches

Sidewalk width at the obstruction shall have the recommended value.

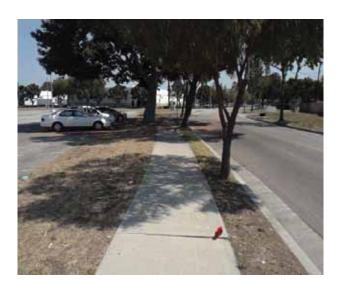
There is a change in elevation greater than recommended value.

Sidewalks , Change in Level : Change in Level Non Beveled

Ensure that the change in elevation is within the recommended value.

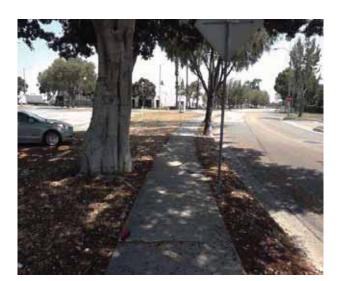
There is a change in elevation greater than recommended value.

Sidewalks , Change in Level : Change in Level Non Beveled

Ensure that the change in elevation is within the recommended value.

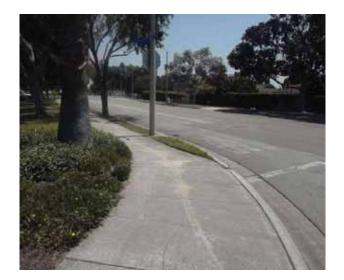
Recommendation Up to 2.08 percent

Repave the sidewalk surface with the recommended cross slope.

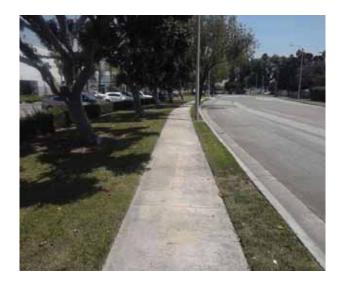
Recommendation Up to 2.08 percent

Repave the sidewalk surface with the recommended cross slope.

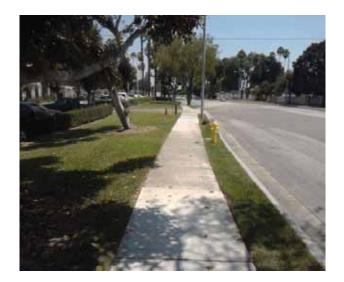
Recommendation Up to 2.08 percent

Repave the sidewalk surface with the recommended cross slope.

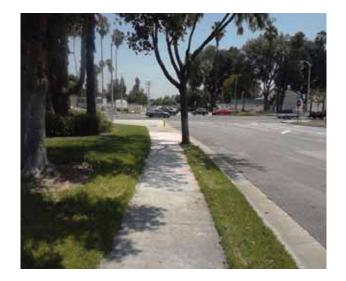
Recommendation Up to 2.08 percent

Repave the sidewalk surface with the recommended cross slope.

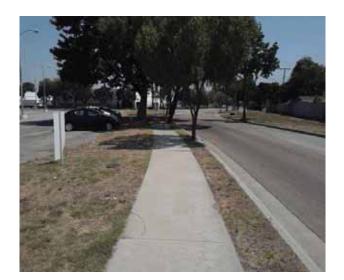
Recommendation Up to 2.08 percent

Repave the sidewalk surface with the recommended cross slope.

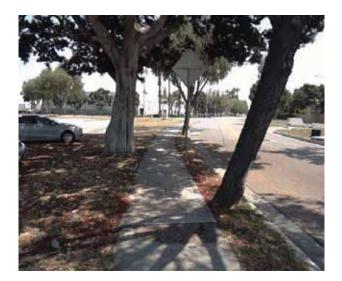
Recommendation Up to 5.00 percent

Repave the sidewalk surface with the recommended running slope.

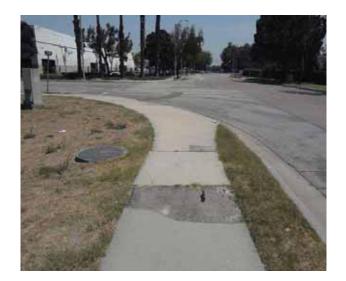
Recommendation Up to 5.00 percent

Repave the sidewalk surface with the recommended running slope.

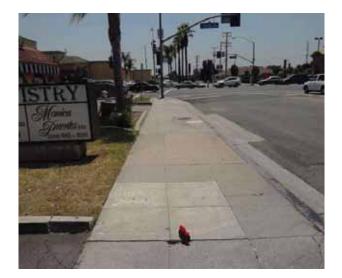
There is a change in elevation greater than recommended value.

Ensure that the change in elevation is within the recommended value.

Recommendation Up to 0.25 inches

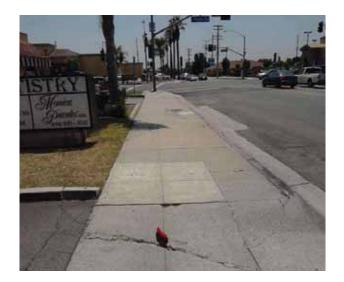
There is a change in elevation greater than recommended value.

Ensure that the change in elevation is within the recommended value.

Recommendation Up to 0.25 inches

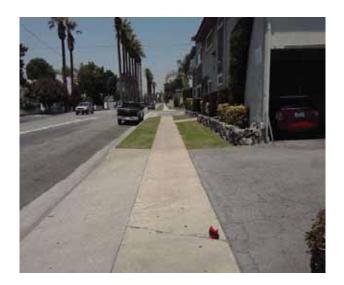
There is a change in elevation greater than recommended value.

Ensure that the change in elevation is within the recommended value.

Recommendation Up to 0.25 inches

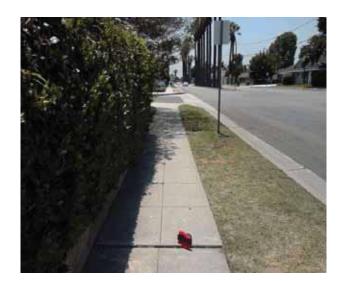
There is a change in elevation greater than recommended value.

Ensure that the change in elevation is within the recommended value.

Recommendation Up to 0.25 inches

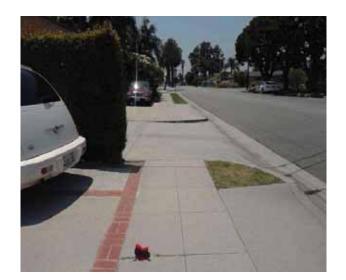
There is a change in elevation greater than recommended value.

Ensure that the change in elevation is within the recommended value.

Recommendation Up to 0.25 inches

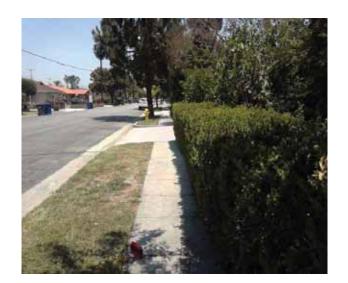
There is a change in elevation greater than recommended value.

Ensure that the change in elevation is within the recommended value.

Recommendation Up to 0.25 inches

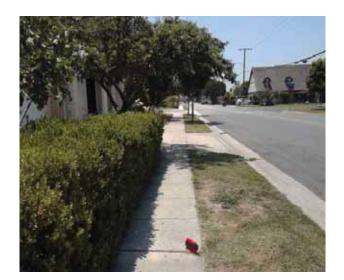
There is a change in elevation greater than recommended value.

Ensure that the change in elevation is within the recommended value.

Recommendation Up to 0.25 inches

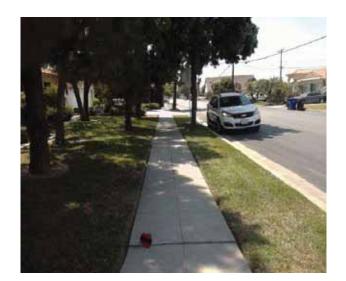
There is a change in elevation greater than recommended value.

Ensure that the change in elevation is within the recommended value.

Recommendation Up to 0.25 inches

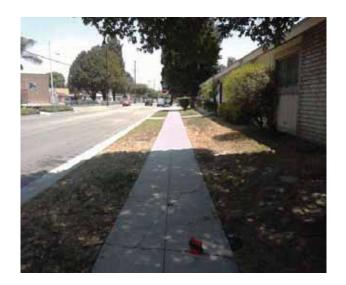
There is a change in elevation greater than recommended value.

Ensure that the change in elevation is within the recommended value.

Recommendation Up to 0.25 inches

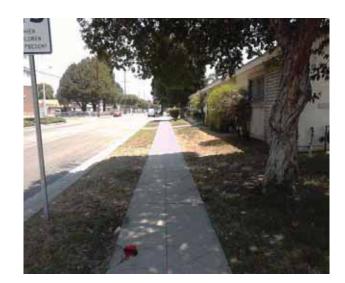
There is a change in elevation greater than recommended value.

Ensure that the change in elevation is within the recommended value.

Recommendation Up to 0.25 inches

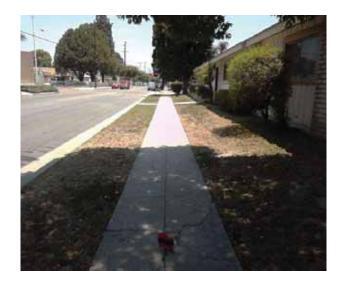
There is a change in elevation greater than recommended value.

Ensure that the change in elevation is within the recommended value.

Recommendation Up to 0.25 inches

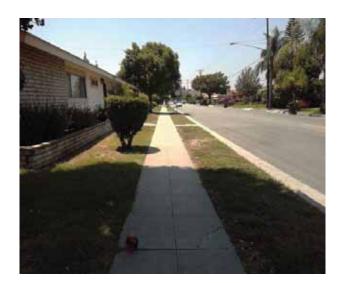
There is a change in elevation greater than recommended value.

Ensure that the change in elevation is within the recommended value.

Recommendation Up to 0.25 inches

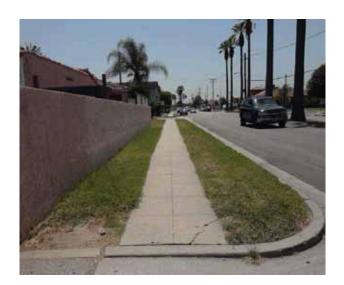
Sidewalks , Hazards & Gratings : Curb is on Path of Travel

Install curb ramp \$2,500

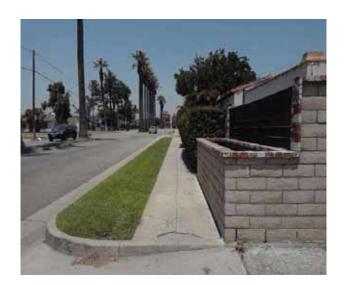
Sidewalks , Hazards & Gratings : Curb is on Path of Travel

Install curb ramp \$2,500

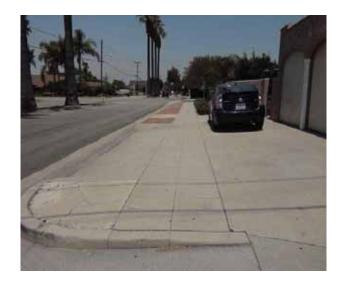
Sidewalks , Hazards & Gratings : Curb is on Path of Travel

Install curb ramp \$2,500

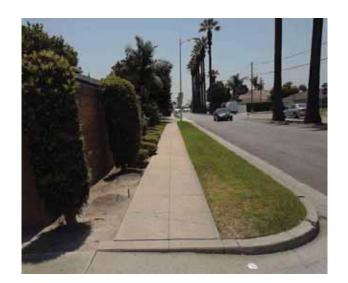
Sidewalks , Hazards & Gratings : Curb is on Path of Travel

Install curb ramp \$2,500

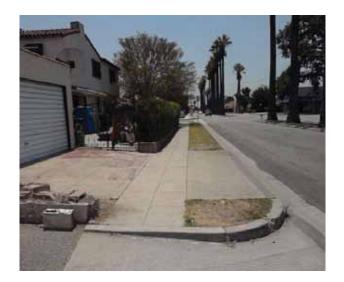
Sidewalks , Hazards & Gratings : Curb is on Path of Travel

Install curb ramp \$2,500

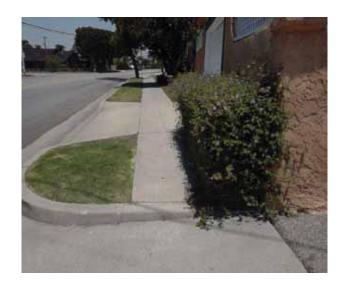
Sidewalks , Hazards & Gratings : Curb is on Path of Travel

Install curb ramp \$2,500

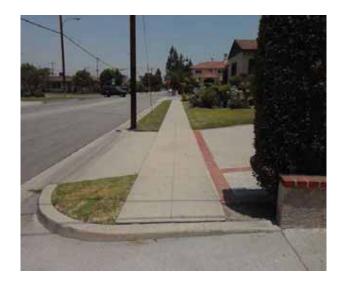
Sidewalks , Hazards & Gratings : Curb is on Path of Travel

Install curb ramp \$2,500

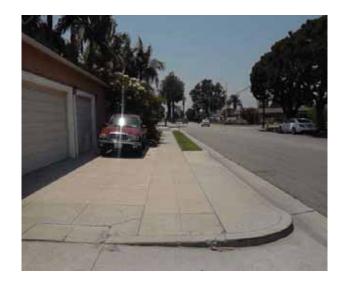
Sidewalks , Hazards & Gratings : Curb is on Path of Travel

Install curb ramp \$2,500

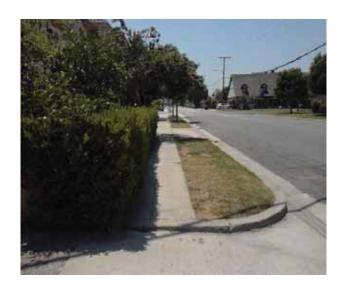
Sidewalks , Hazards & Gratings : Curb is on Path of Travel

Install curb ramp \$2,500

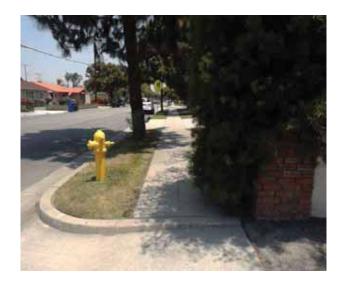
Sidewalks , Hazards & Gratings : Curb is on Path of Travel

Install curb ramp \$2,500

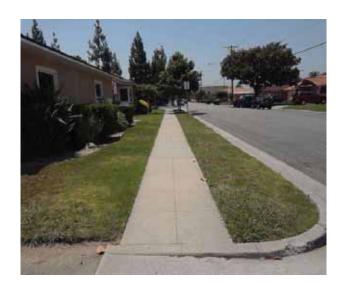
Sidewalks , Hazards & Gratings : Curb is on Path of Travel

Install curb ramp \$2,500

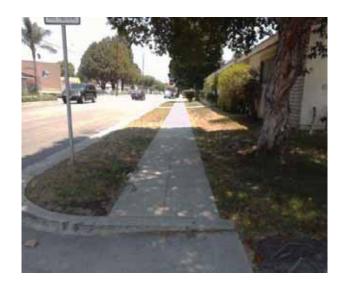
Sidewalks , Hazards & Gratings : Curb is on Path of Travel

Install curb ramp \$2,500

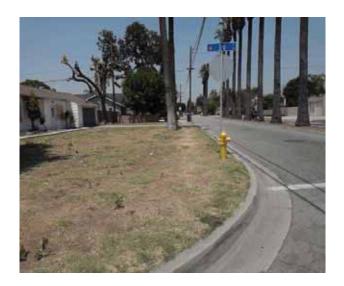
Sidewalks : Missing Sidewalk

Section of sidewalk is missing and consists of dirt, grass or gravel.

Provide a compliant sidewalk for the missing section.

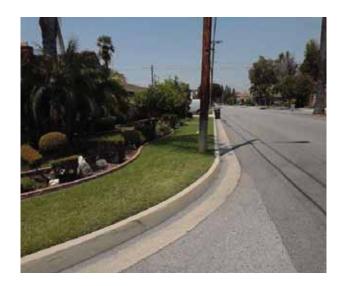
Sidewalks : Missing Sidewalk

Section of sidewalk is missing and consists of dirt, grass or gravel.

Provide a compliant sidewalk for the missing section.

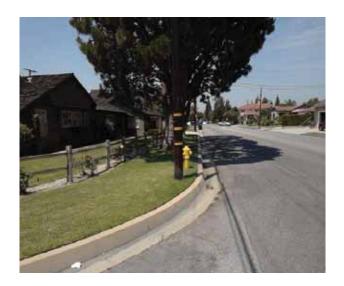
Sidewalks : Missing Sidewalk

Section of sidewalk is missing and consists of dirt, grass or gravel.

Provide a compliant sidewalk for the missing section.

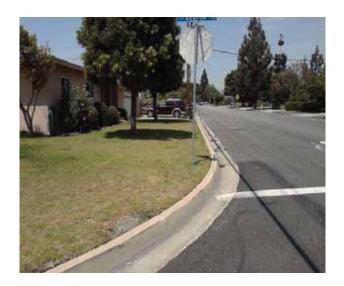
Sidewalks : Missing Sidewalk

Section of sidewalk is missing and consists of dirt, grass or gravel.

Provide a compliant sidewalk for the missing section.

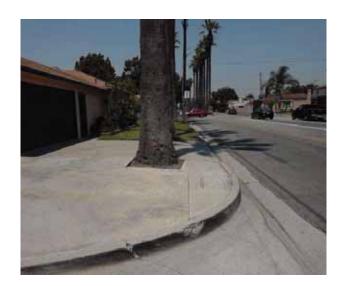
Sidewalks : Missing Sidewalk

Section of sidewalk is missing and consists of dirt, grass or gravel.

Provide a compliant sidewalk for the missing section.

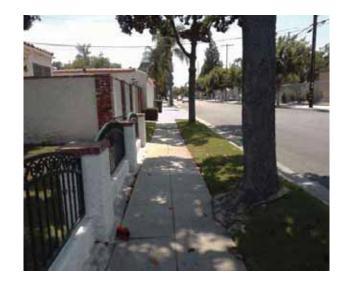
There is a change in elevation greater than recommended value.

Ensure that the change in elevation is within the recommended value.

Recommendation Up to 0.25 inches

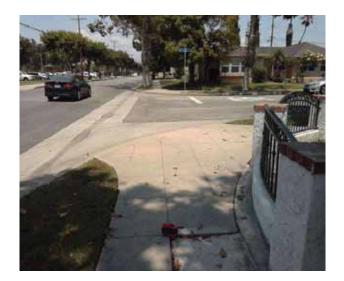
There is a change in elevation greater than recommended value.

Ensure that the change in elevation is within the recommended value.

Recommendation Up to 0.25 inches

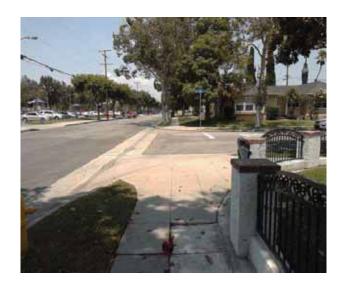
There is a change in elevation greater than recommended value.

Ensure that the change in elevation is within the recommended value.

Recommendation Up to 0.25 inches

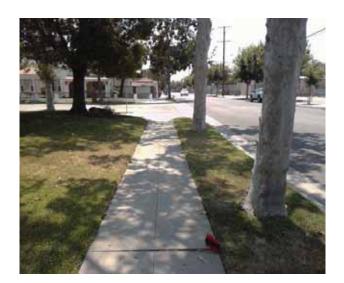
There is a change in elevation greater than recommended value.

Ensure that the change in elevation is within the recommended value.

Recommendation Up to 0.25 inches

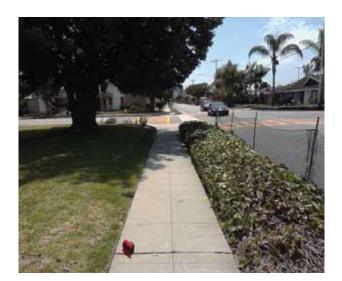
There is a change in elevation greater than recommended value.

Ensure that the change in elevation is within the recommended value.

Recommendation Up to 0.25 inches

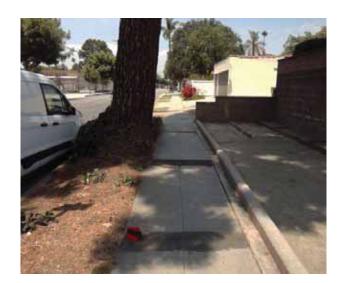
There is a change in elevation greater than recommended value.

Ensure that the change in elevation is within the recommended value.

Recommendation Up to 0.25 inches

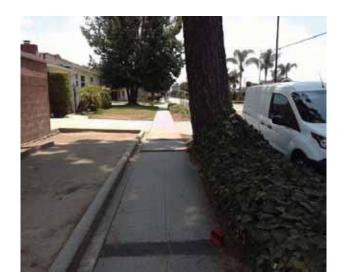
There is a change in elevation greater than recommended value.

Ensure that the change in elevation is within the recommended value.

Recommendation Up to 0.25 inches

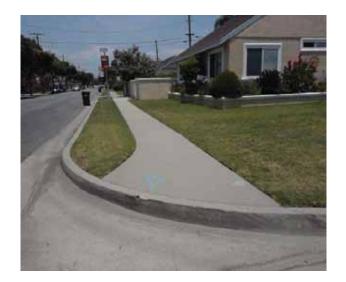
Sidewalks , Hazards & Gratings : Curb is on Path of Travel

Install curb ramp \$2,500

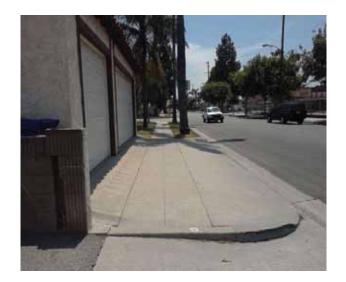
Sidewalks , Hazards & Gratings : Curb is on Path of Travel

Install curb ramp \$2,500

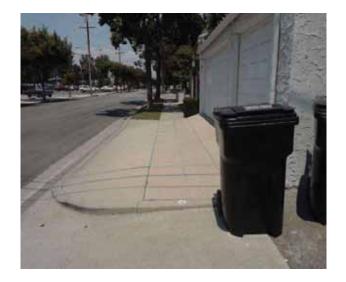
Sidewalks , Hazards & Gratings : Curb is on Path of Travel

Install curb ramp \$2,500

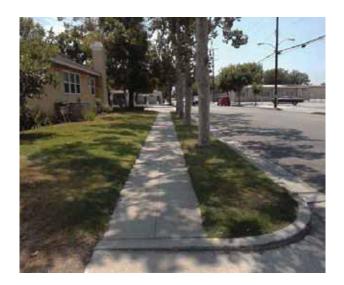
Sidewalks , Hazards & Gratings : Curb is on Path of Travel

Install curb ramp \$2,500

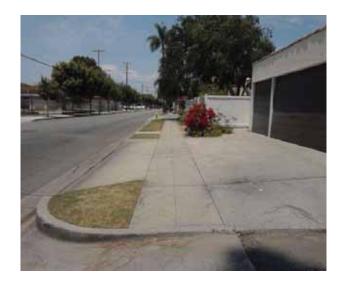
Sidewalks , Hazards & Gratings : Curb is on Path of Travel

Install curb ramp \$2,500

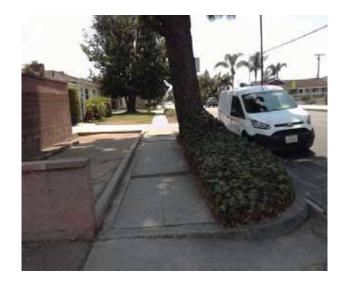
Sidewalks , Hazards & Gratings : Curb is on Path of Travel

Install curb ramp \$2,500

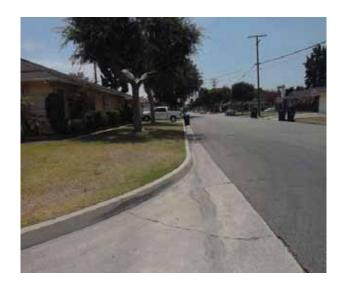
Sidewalks : Missing Sidewalk

Section of sidewalk is missing and consists of dirt, grass or gravel.

Provide a compliant sidewalk for the missing section.

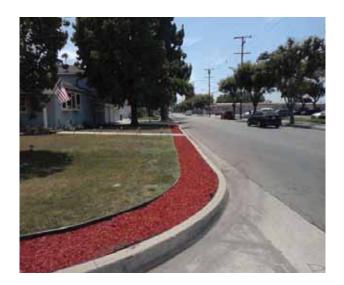
Sidewalks : Missing Sidewalk

Section of sidewalk is missing and consists of dirt, grass or gravel.

Provide a compliant sidewalk for the missing section.

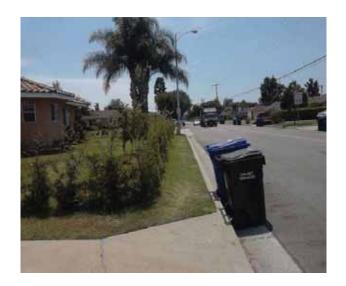
Sidewalks : Missing Sidewalk

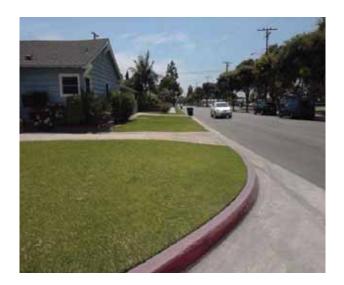
Sidewalks : Missing Sidewalk

Section of sidewalk is missing and consists of dirt, grass or gravel.

Provide a compliant sidewalk for the missing section.

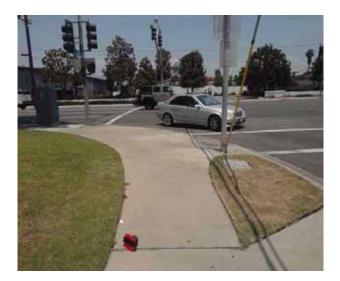
There is a change in elevation greater than recommended value.

Ensure that the change in elevation is within the recommended value.

Remove tripping hazards \$198

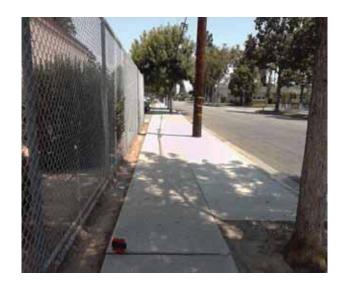
There is a change in elevation greater than recommended value.

Ensure that the change in elevation is within the recommended value.

Remove tripping hazards \$198

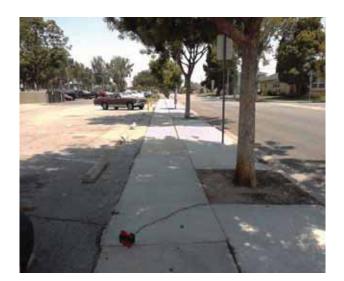
There is a change in elevation greater than recommended value.

Ensure that the change in elevation is within the recommended value.

Remove tripping hazards \$198

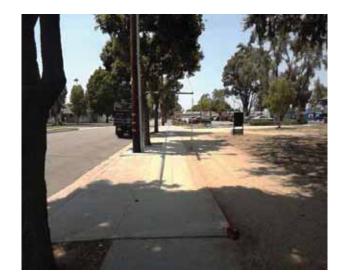
There is a change in elevation greater than recommended value.

Ensure that the change in elevation is within the recommended value.

Remove tripping hazards \$198

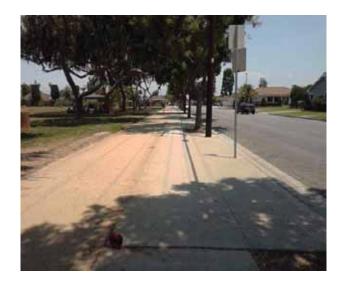
There is a change in elevation greater than recommended value.

Ensure that the change in elevation is within the recommended value.

Remove tripping hazards \$198

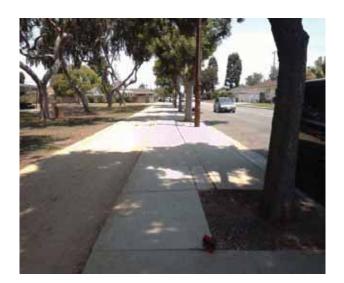
There is a change in elevation greater than recommended value.

Ensure that the change in elevation is within the recommended value.

Remove tripping hazards \$198

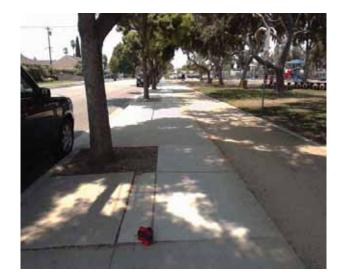
There is a change in elevation greater than recommended value.

Ensure that the change in elevation is within the recommended value.

Remove tripping hazards \$198

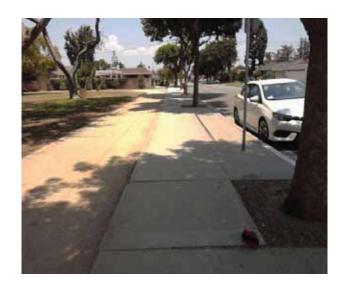
There is a change in elevation greater than recommended value.

Ensure that the change in elevation is within the recommended value.

Remove tripping hazards \$198

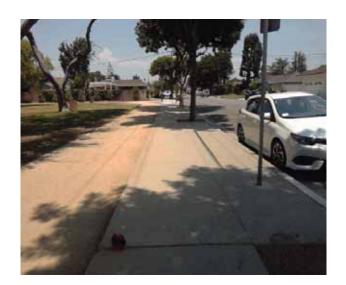
There is a change in elevation greater than recommended value.

Ensure that the change in elevation is within the recommended value.

Remove tripping hazards \$198

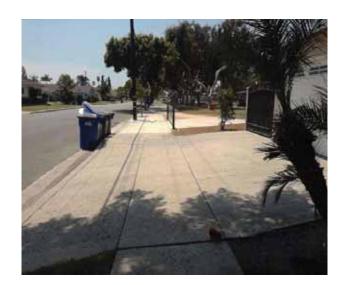
There is a change in elevation greater than recommended value.

Ensure that the change in elevation is within the recommended value.

Remove tripping hazards \$198

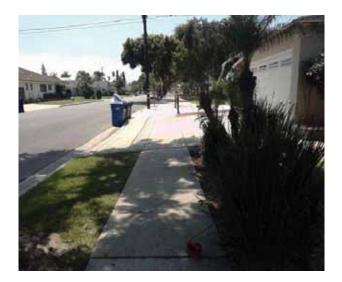
There is a change in elevation greater than recommended value.

Ensure that the change in elevation is within the recommended value.

Remove tripping hazards \$198

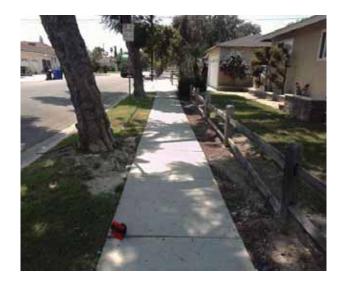
There is a change in elevation greater than recommended value.

Ensure that the change in elevation is within the recommended value.

Remove tripping hazards \$198

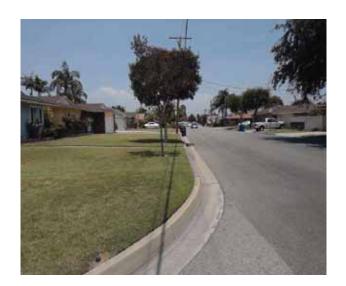
Sidewalks : Missing Sidewalk

Section of sidewalk is missing and consists of dirt, grass or gravel.

Provide a compliant sidewalk for the missing section.

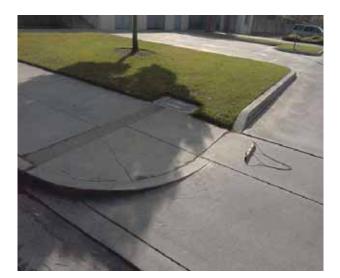
Curb Ramp , Landings and Transitions $\,:\,$ Top Landing Slope

Provide compliant landing \$1,260

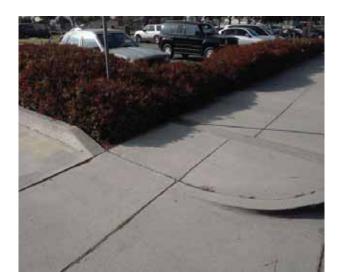
Curb Ramp , Landings and Transitions $\,:\,$ Top Landing Slope

Provide compliant landing \$1,260

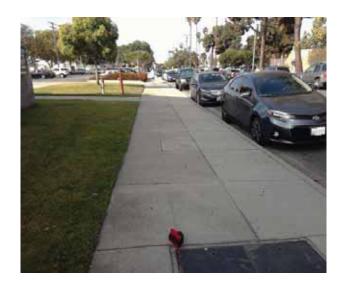
There is a change in elevation greater than recommended value.

Ensure that the change in elevation is within the recommended value.

Recommendation Up to 0.25 inches

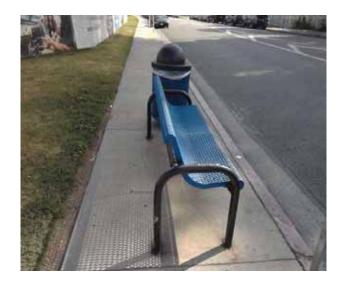
Sidewalks , Hazards & Gratings : Sidewalk Width at Obstruction

Sidewalk width at the obstruction shall have the recommended value.

Recommendation At least 48.00 inches

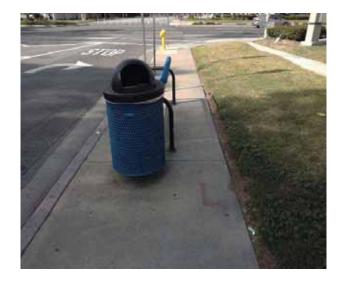
Sidewalks , Hazards & Gratings : Sidewalk Width at Obstruction

Sidewalk width at the obstruction shall have the recommended value.

Recommendation At least 48.00 inches

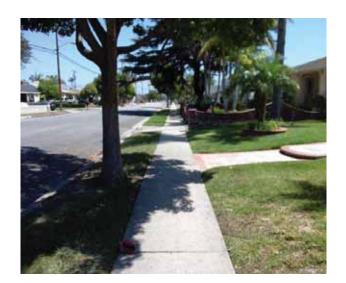
There is a change in elevation greater than recommended value.

Ensure that the change in elevation is within the recommended value.

Recommendation Up to 0.25 inches

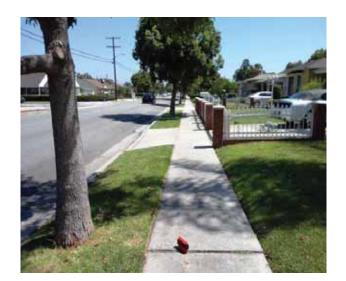
There is a change in elevation greater than recommended value.

Ensure that the change in elevation is within the recommended value.

Recommendation Up to 0.25 inches

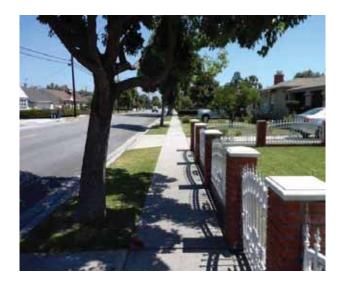
There is a change in elevation greater than recommended value.

Ensure that the change in elevation is within the recommended value.

Recommendation Up to 0.25 inches

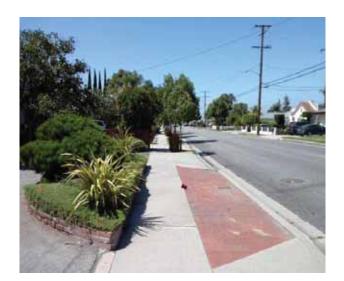
There is a change in elevation greater than recommended value.

Notes: Change in Level Parallel With Path of Travel For 25 Feet

Ensure that the change in elevation is within the recommended value.

Recommendation Up to 0.25 inches

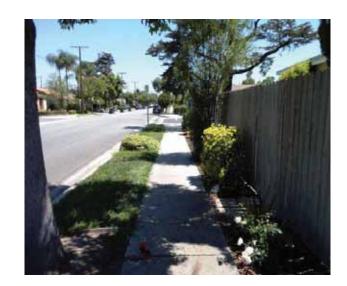
There is a change in elevation greater than recommended value.

Ensure that the change in elevation is within the recommended value.

Recommendation Up to 0.25 inches

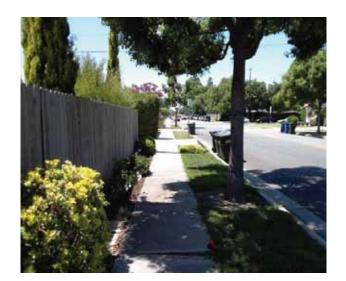
There is a change in elevation greater than recommended value.

Ensure that the change in elevation is within the recommended value.

Recommendation Up to 0.25 inches

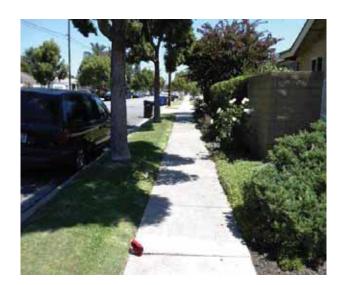
There is a change in elevation greater than recommended value.

Ensure that the change in elevation is within the recommended value.

Recommendation Up to 0.25 inches

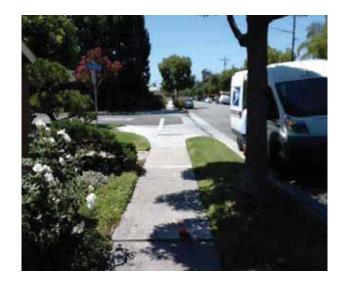
There is a change in elevation greater than recommended value.

Ensure that the change in elevation is within the recommended value.

Recommendation Up to 0.25 inches

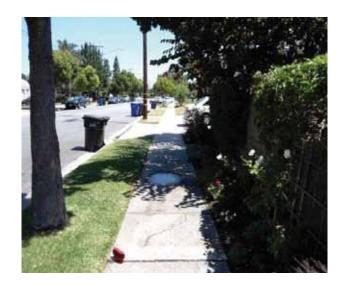
There is a change in elevation greater than recommended value.

Ensure that the change in elevation is within the recommended value.

Recommendation Up to 0.25 inches

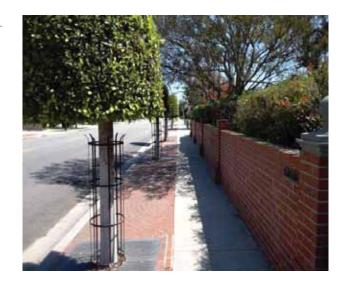
Recommendation At least 80.00 inches

Recommendation

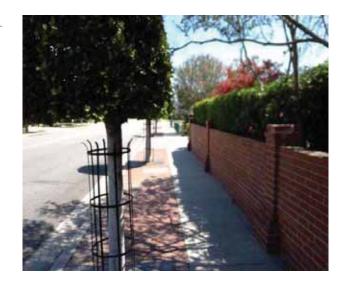
Recommendation At least 80.00 inches

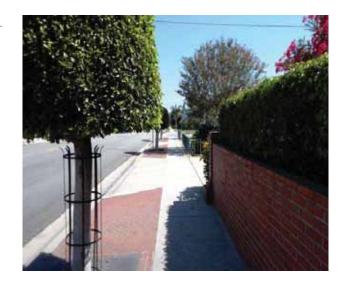
Recommendation At least 80.00 inches

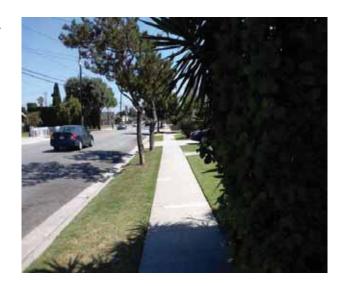
Recommendation At least 80.00 inches

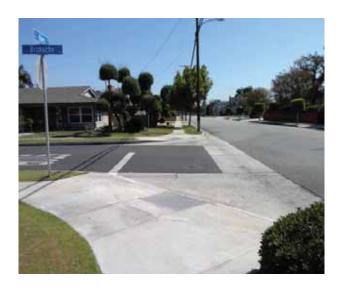
Recommendation Up to 5.00 percent

Repave surface \$1,092

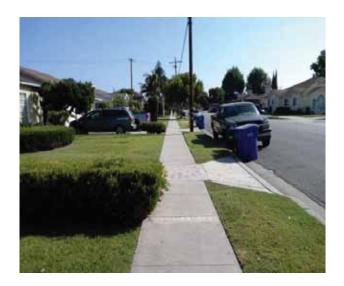
Sidewalks , Hazards & Gratings : Sidewalk Width at Obstruction

Recommendation At least 48.00 inches

Sidewalk width at the obstruction shall have the recommended value.

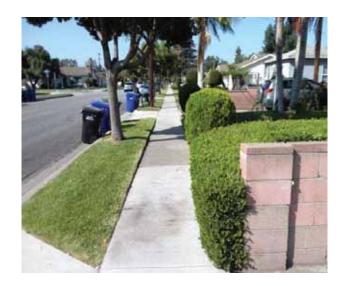
Sidewalks , Hazards & Gratings : Sidewalk Width at Obstruction

Recommendation At least 48.00 inches

Sidewalk width at the obstruction shall have the recommended value.

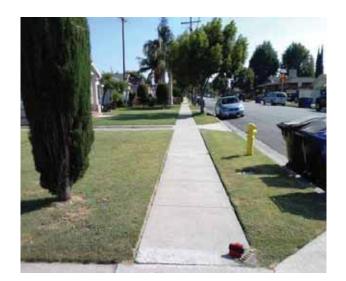
There is a change in elevation greater than recommended value.

Recommendation Up to 0.25 inches

Ensure that the change in elevation is within the recommended value.

Remove tripping hazards \$198

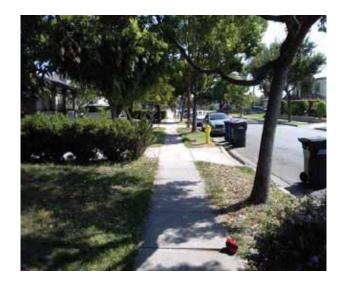
There is a change in elevation greater than recommended value.

Recommendation Up to 0.25 inches

Ensure that the change in elevation is within the recommended value.

Remove tripping hazards \$198

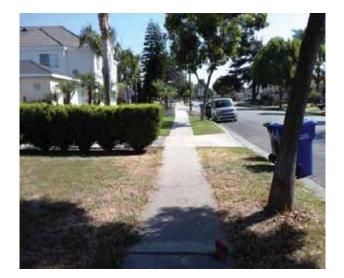
There is a change in elevation greater than recommended value.

Recommendation Up to 0.25 inches

Ensure that the change in elevation is within the recommended value.

Remove tripping hazards \$198

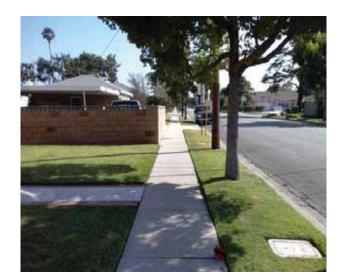
There is a change in elevation greater than recommended value.

Recommendation Up to 0.25 inches

Ensure that the change in elevation is within the recommended value.

Remove tripping hazards \$198

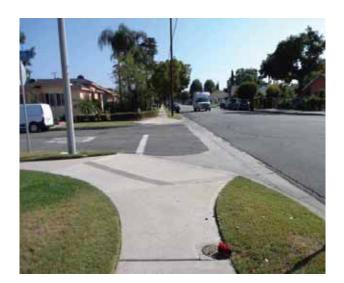
There is a change in elevation greater than recommended value.

Recommendation Up to 0.25 inches

Ensure that the change in elevation is within the recommended value.

Remove tripping hazards \$198

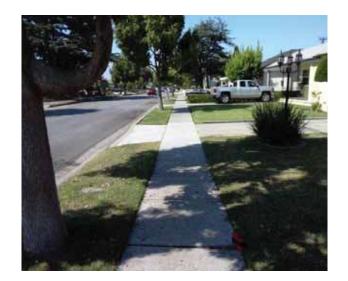
There is a change in elevation greater than recommended value.

Recommendation Up to 0.25 inches

Ensure that the change in elevation is within the recommended value.

Remove tripping hazards \$198

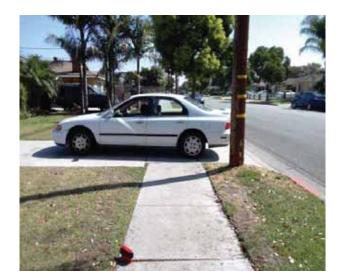
There is a change in elevation greater than recommended value.

Recommendation Up to 0.25 inches

Ensure that the change in elevation is within the recommended value.

Remove tripping hazards \$198

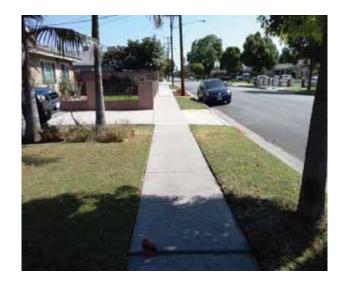
There is a change in elevation greater than recommended value.

Recommendation Up to 0.25 inches

Ensure that the change in elevation is within the recommended value.

Remove tripping hazards \$198

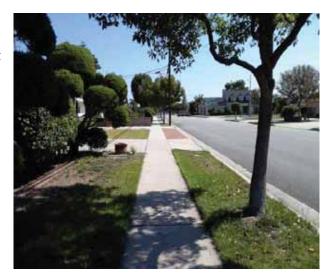
Recommendation Up to 2.08 percent

Repave the sidewalk surface with the recommended cross slope.

Repave surface \$1,092

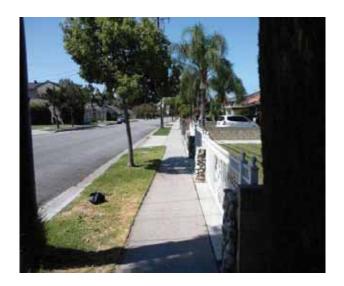
Recommendation At least 48.00 inches

Widen the sidewalk to the recommended value.

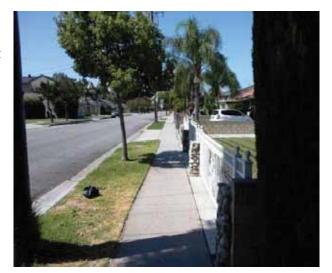
Recommendation Up to 2.08 percent

Repave the sidewalk surface with the recommended cross slope.

Repave surface \$1,092

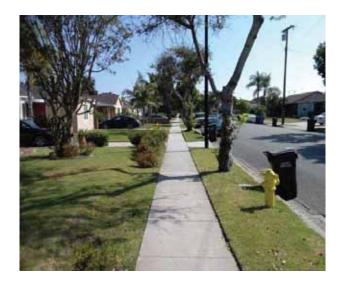
Recommendation Up to 2.08 percent

Repave the sidewalk surface with the recommended cross slope.

Repave surface \$1,092

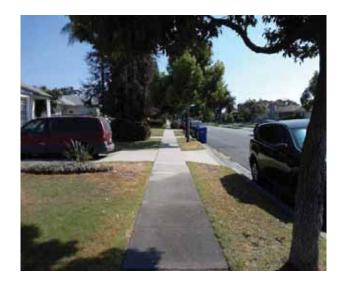
Recommendation Up to 2.08 percent

Repave the sidewalk surface with the recommended cross slope.

Repave surface \$1,092

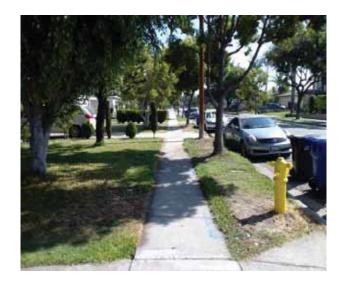
Recommendation Up to 2.08 percent

Repave the sidewalk surface with the recommended cross slope.

Repave surface \$1,092

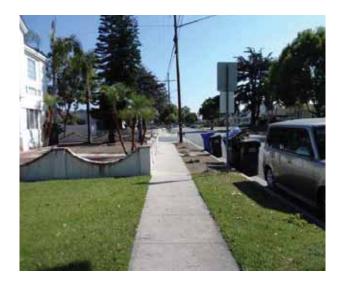
Recommendation Up to 2.08 percent

Repave the sidewalk surface with the recommended cross slope.

Repave surface \$1,092

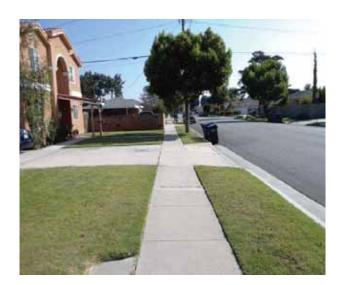
Recommendation Up to 2.08 percent

Repave the sidewalk surface with the recommended cross slope.

Repave surface \$1,092

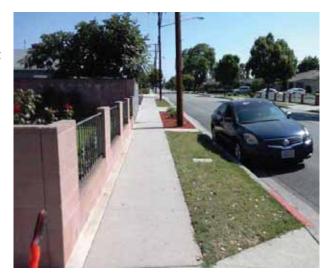
Recommendation Up to 2.08 percent

Repave the sidewalk surface with the recommended cross slope.

Repave surface \$1,092

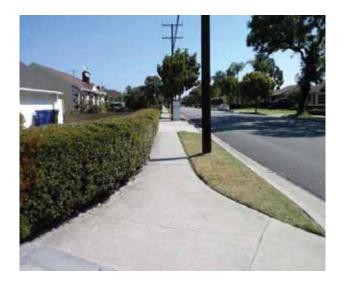
Recommendation Up to 2.08 percent

Repave the sidewalk surface with the recommended cross slope.

Repave surface \$1,092

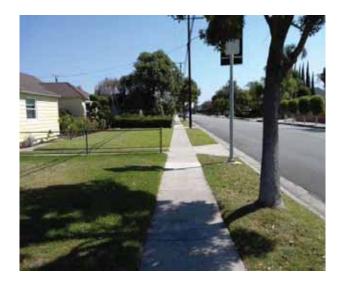
Recommendation Up to 2.08 percent

Repave the sidewalk surface with the recommended cross slope.

Repave surface \$1,092

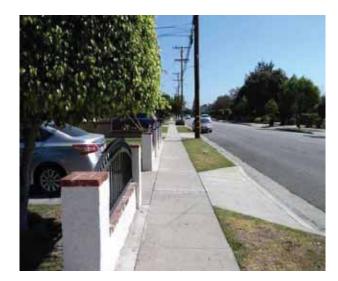
Recommendation Up to 2.08 percent

Repave the sidewalk surface with the recommended cross slope.

Repave surface \$1,092

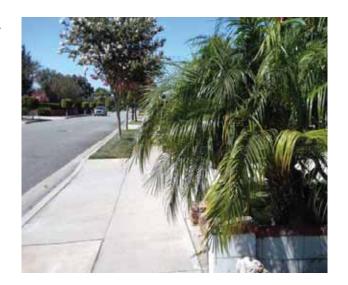
Recommendation At least 80.00 inches
